GEOTECHNICAL INVESTIGATION REPORT
John Hunter Health and Innovation Precinct

Prepared for Health Infrastructure

Prepared by RCA Australia

RCA ref 14399-207/1

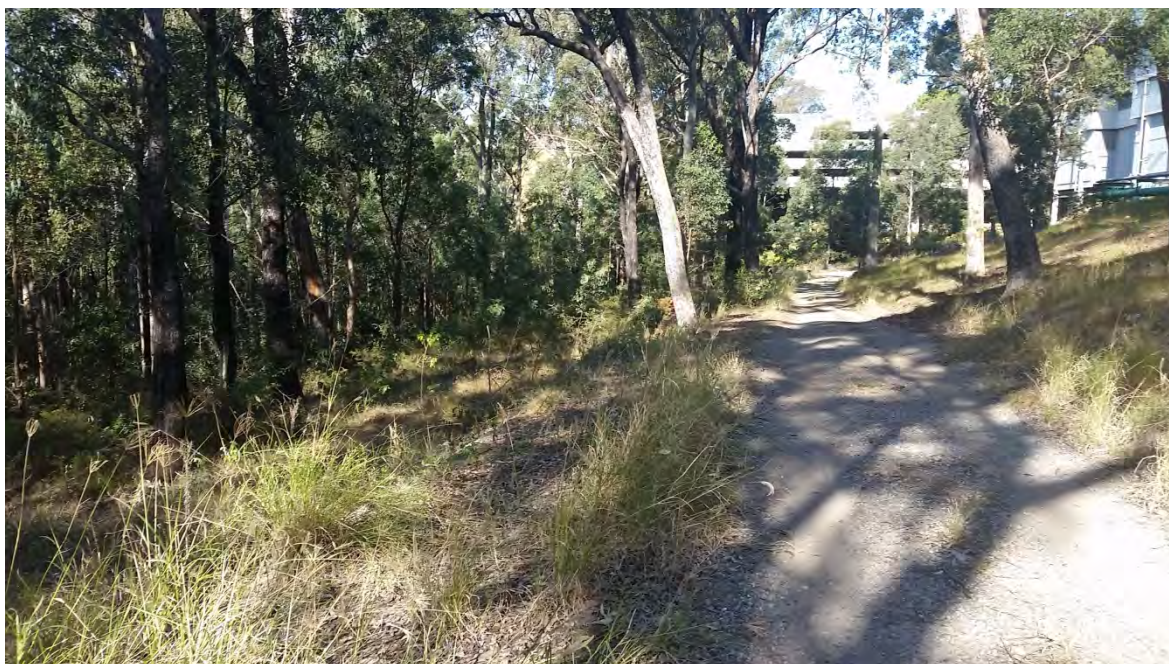
Photograph 1 *View to the east from near the western limit of the Stage 1 building footprint.*

Photographs of the site of the proposed Stage 1 building are provided in **Photograph 1** and **Photograph 2**.

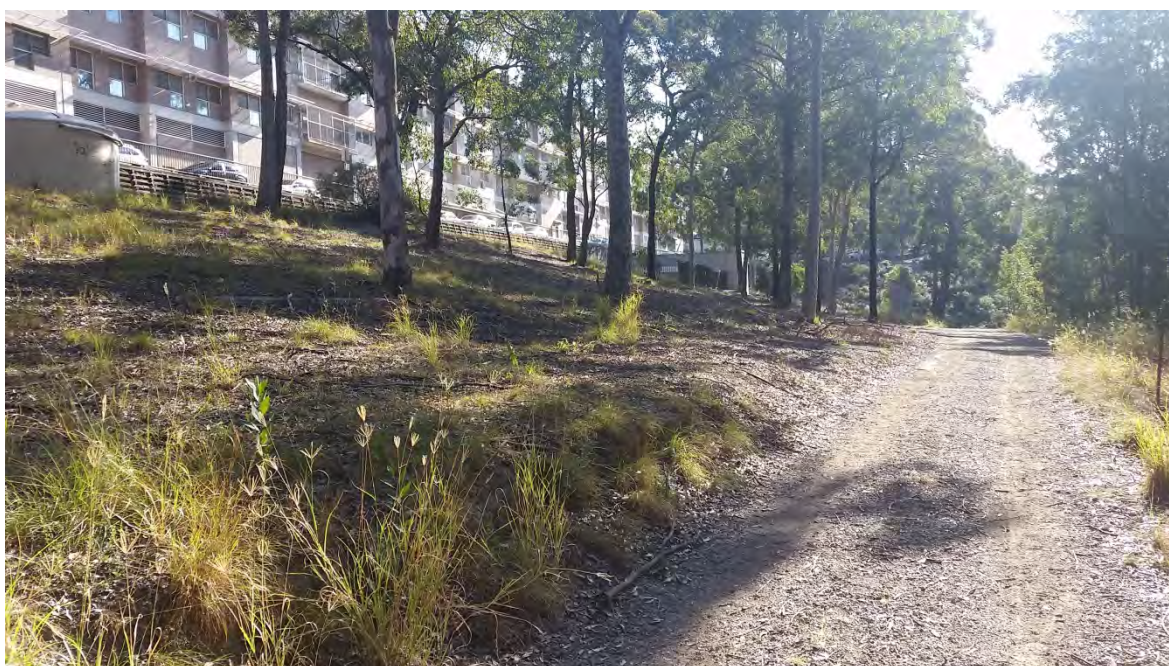
Photograph 2 *View to the west from near the eastern limit of the Stage 1 building footprint.*

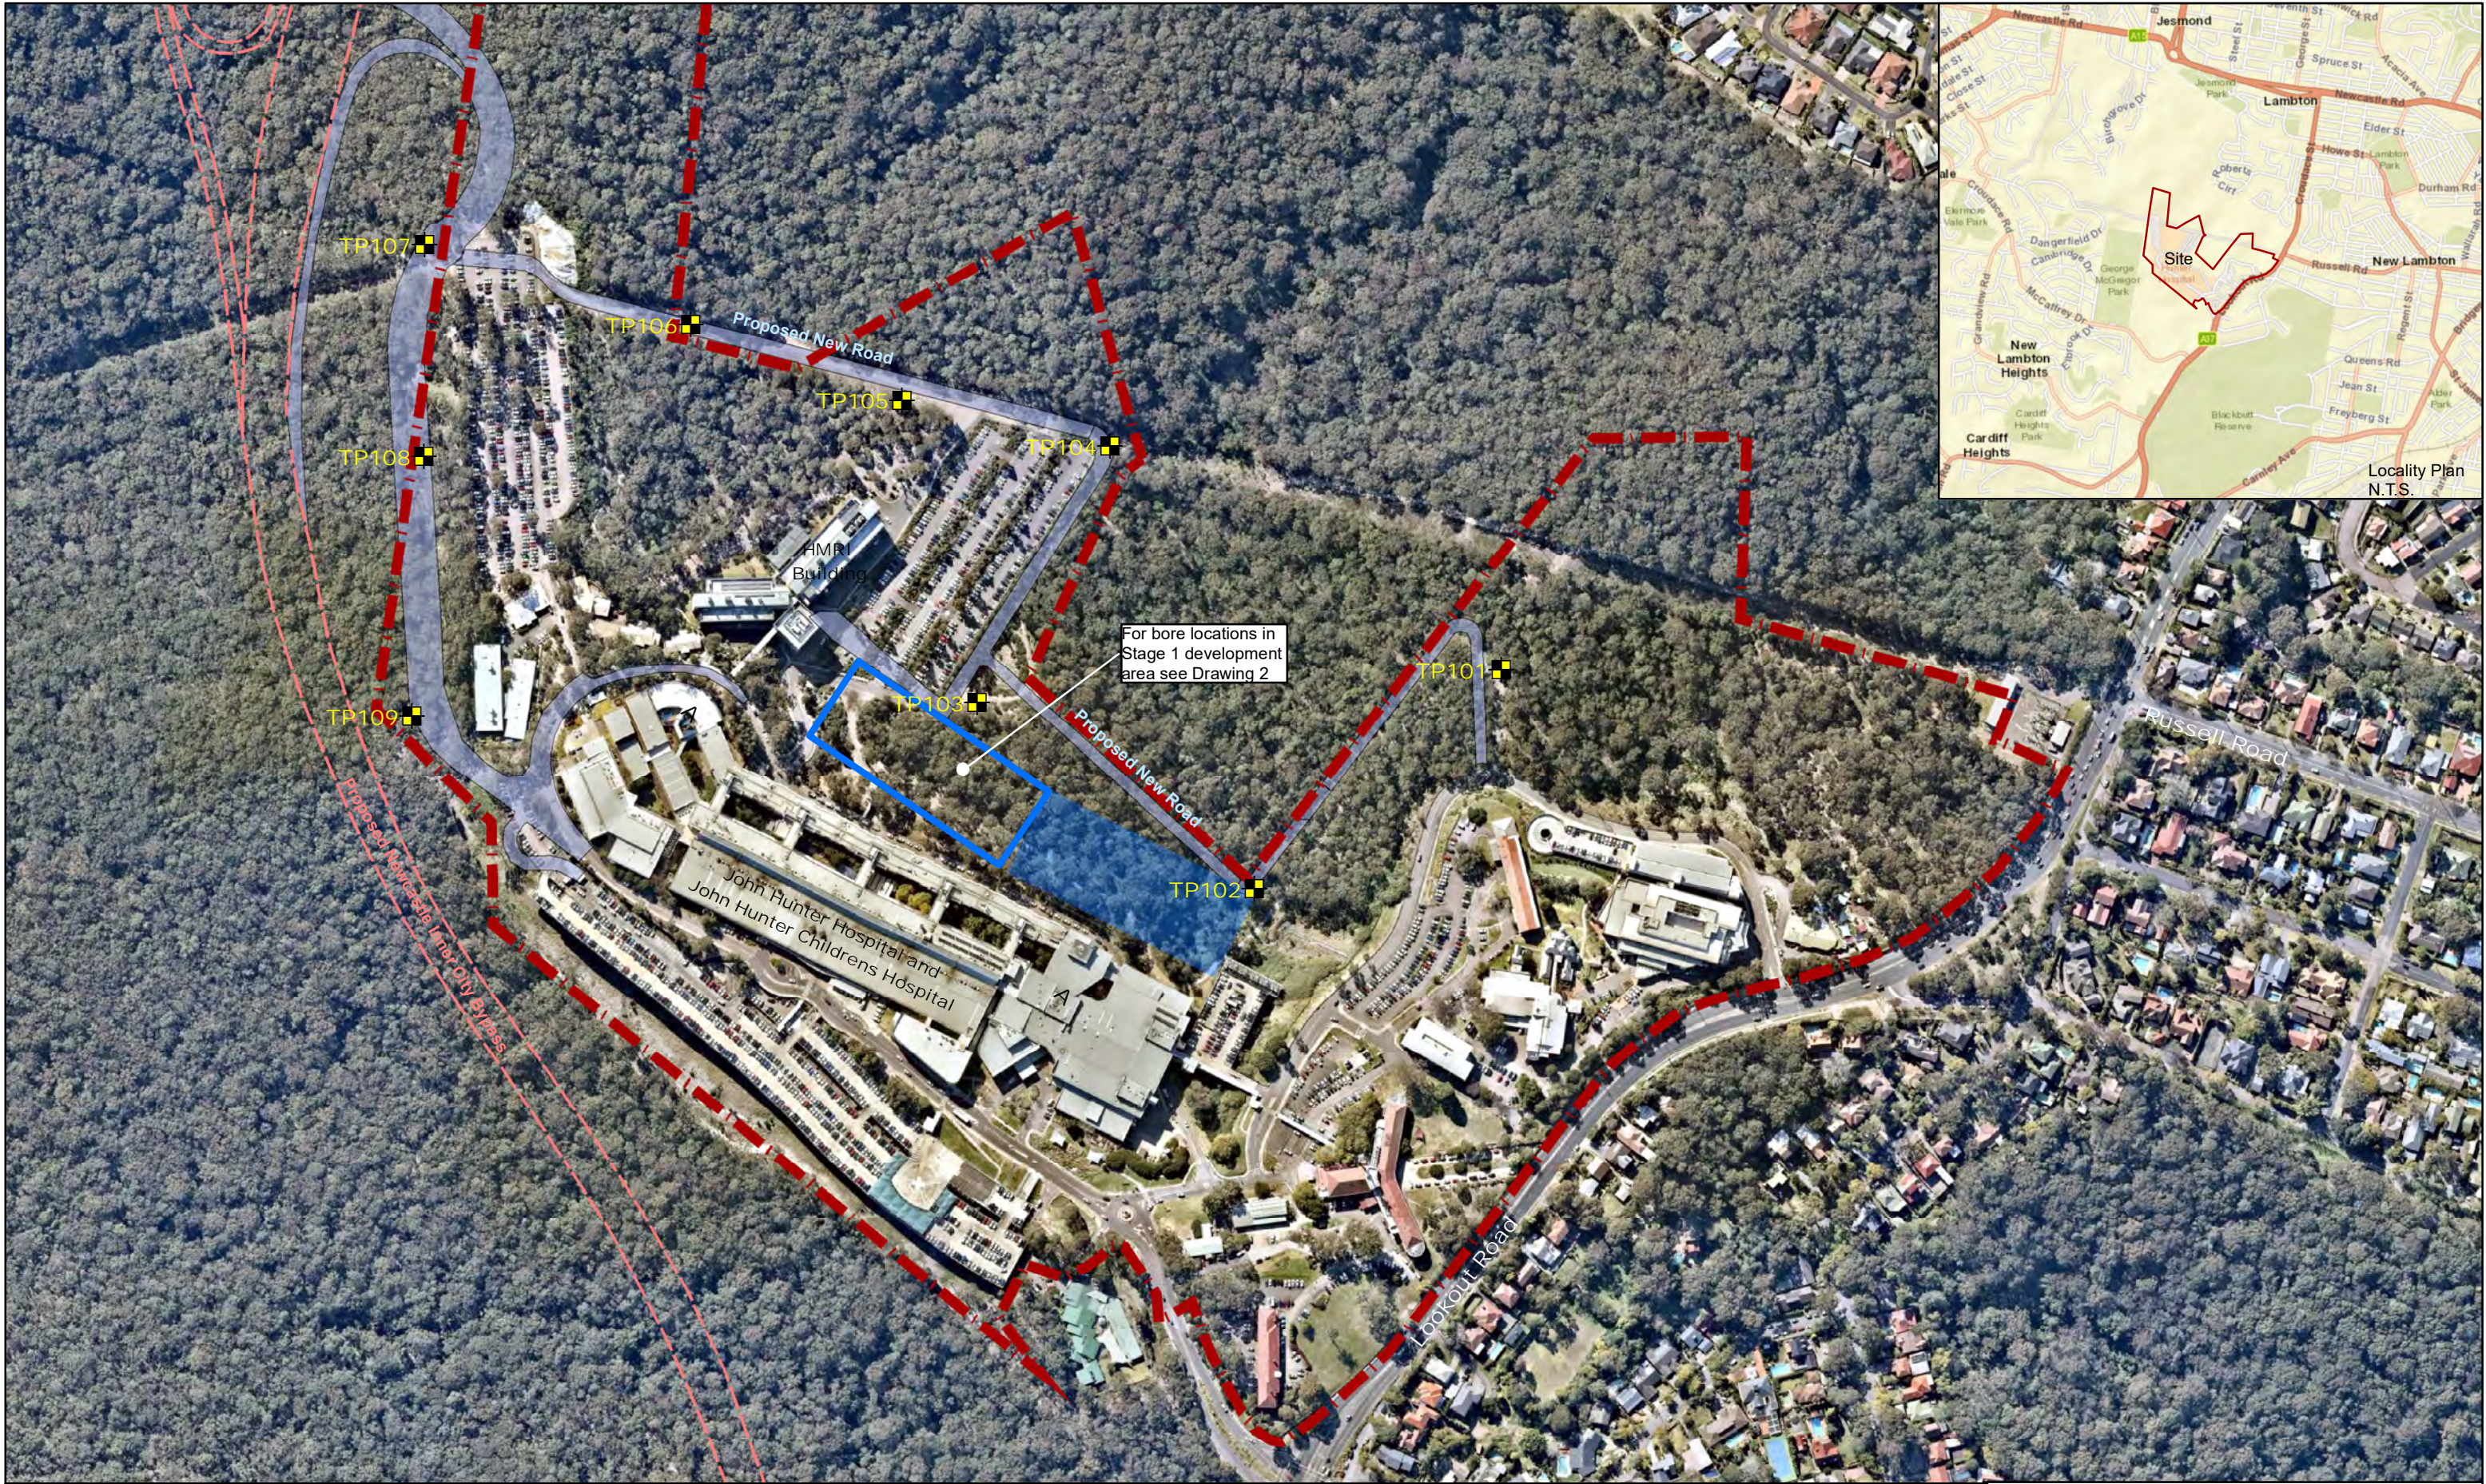
SITE AND TEST LOCATION PLAN
GEOTECHNICAL INVESTIGATION REPORT
JOHN HUNTER HEALTH AND
INNOVATION PRECINCT

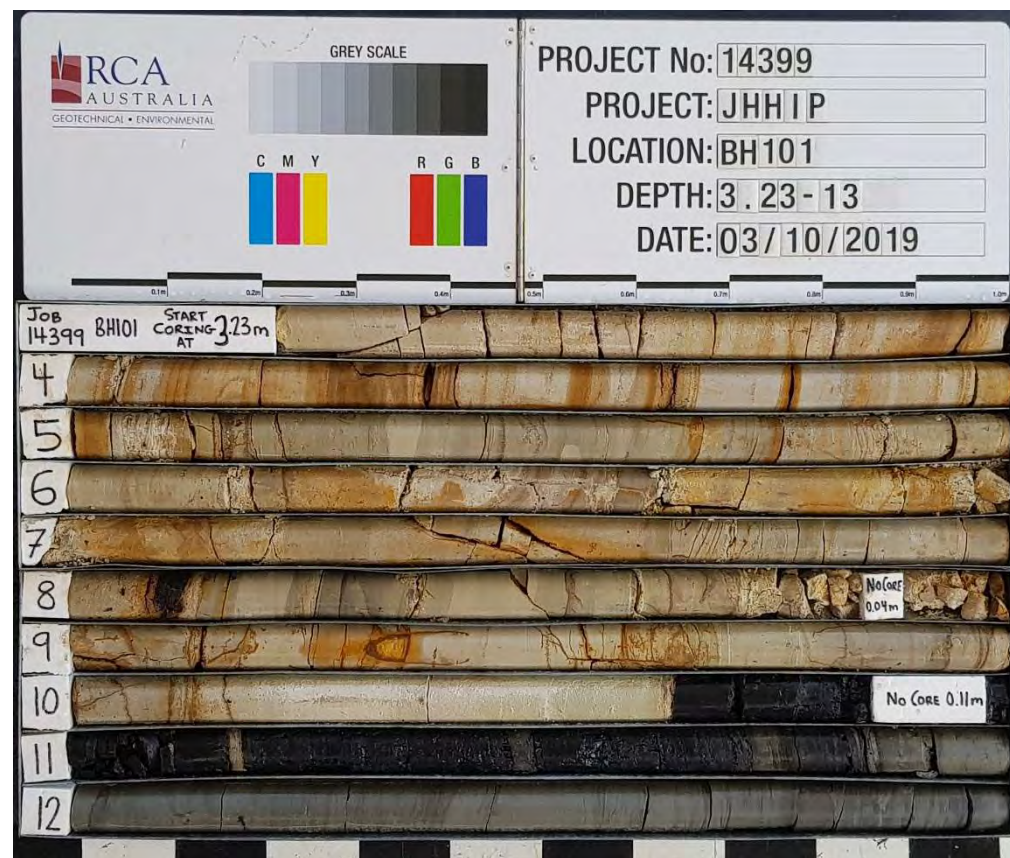
PHOTOGRAPH 1 OF 2 – BH101 3.23m to 13.0m

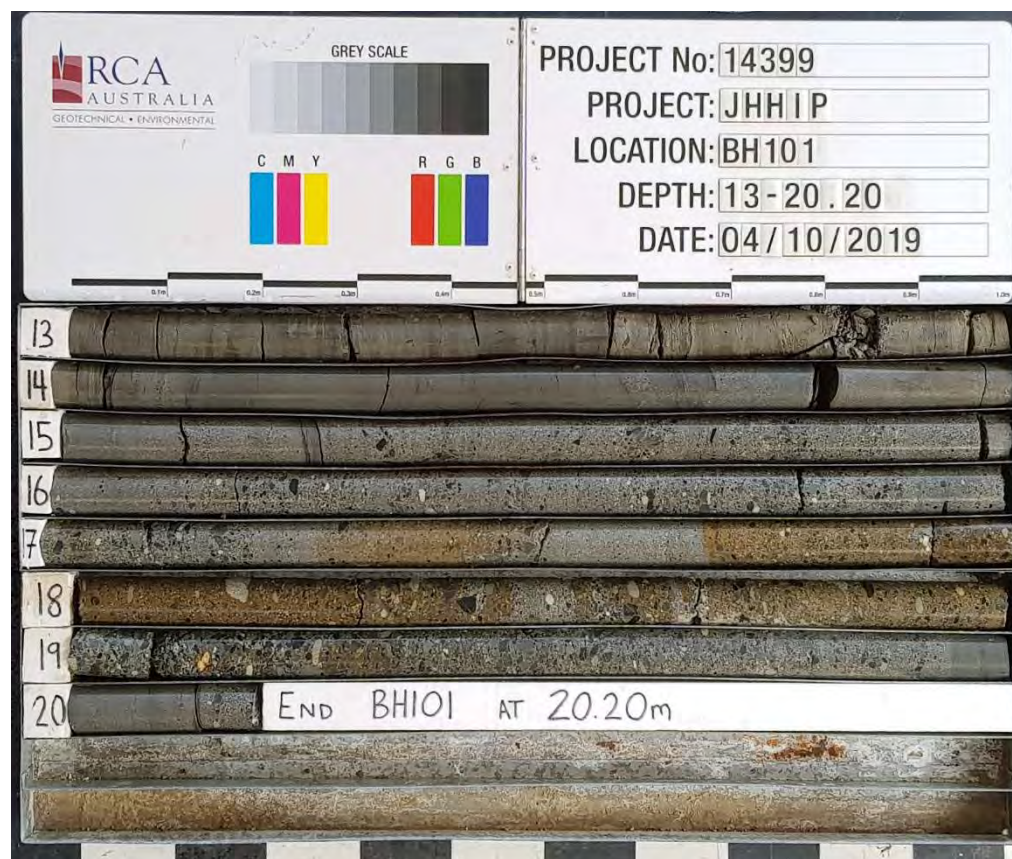
PHOTOGRAPH 2 OF 2 – BH101 13.0m to 20.20m

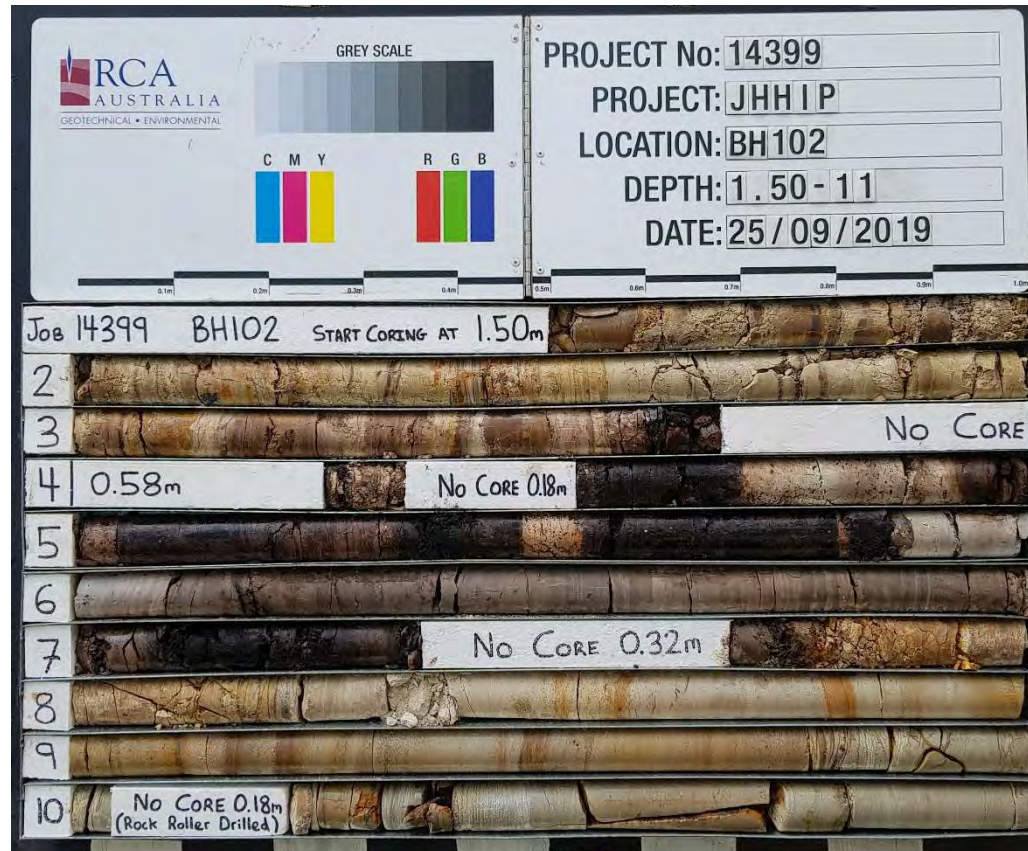
PHOTOGRAPH 1 of 2 – BH102 1.5m to 11.0m

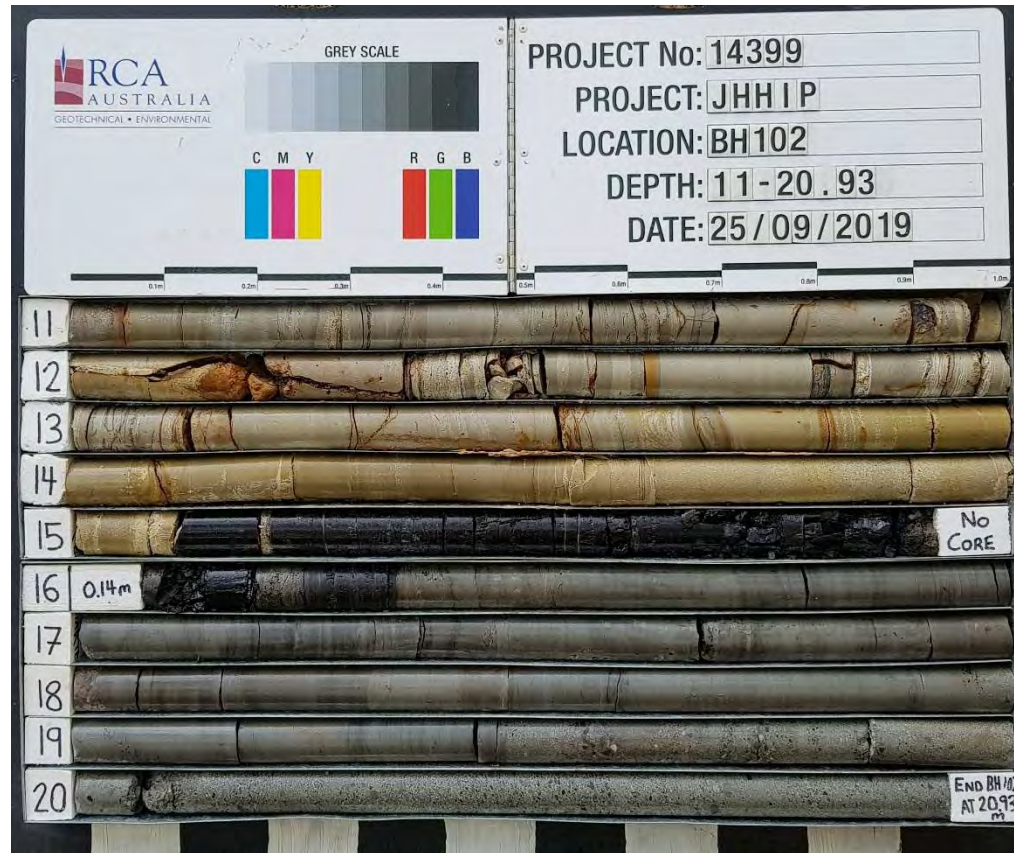
PHOTOGRAPH 2 of 2 – BH102 11.0m to 20.93m

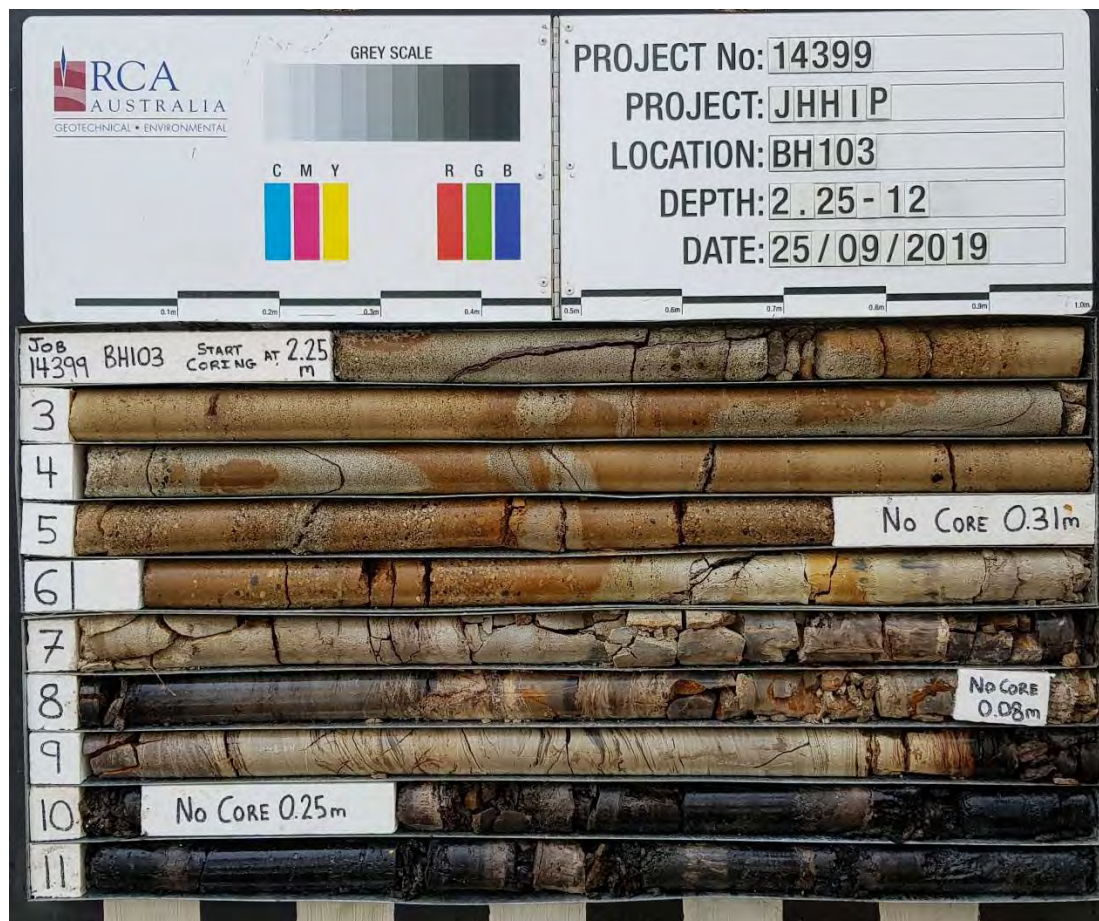
PHOTOGRAPH 1 of 2 – BH103 2.25m to 12.0m

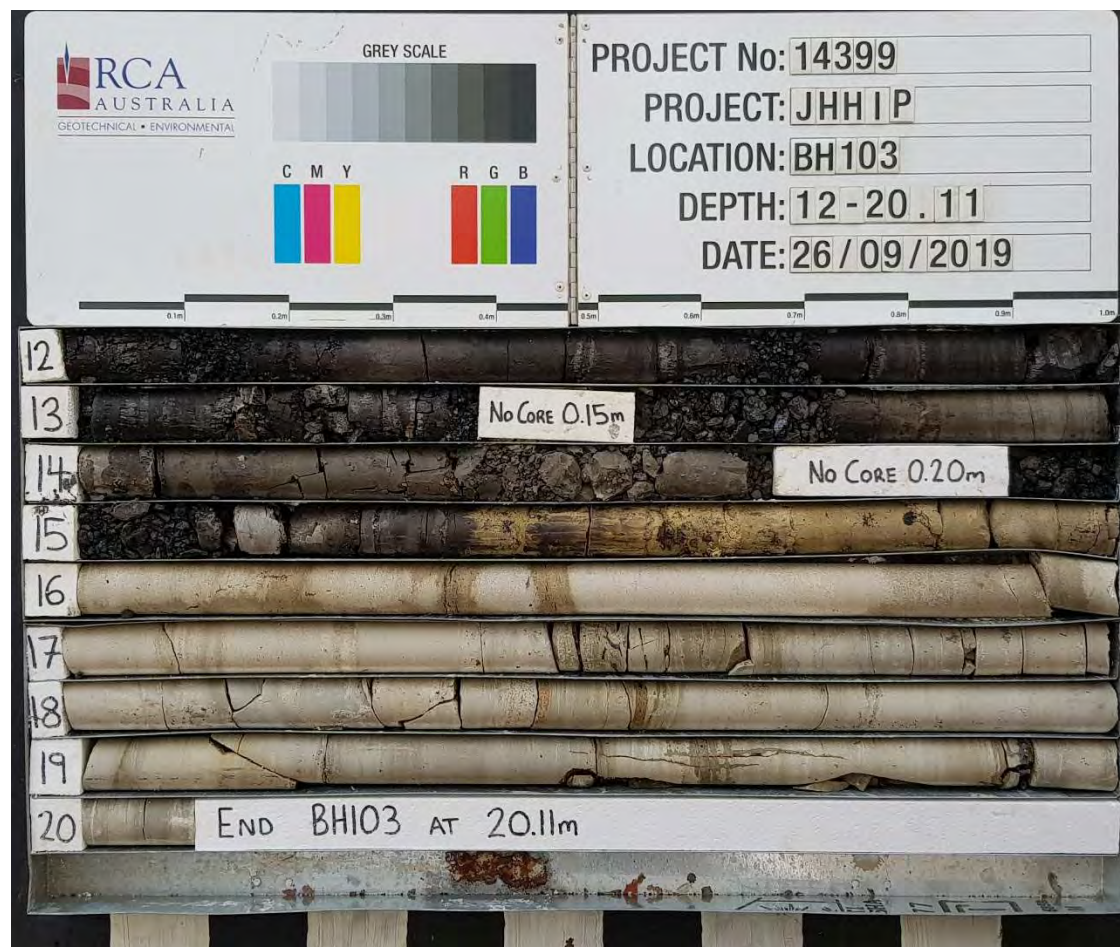
PHOTOGRAPH 2 of 2 – BH103 12.0m to 20.11m

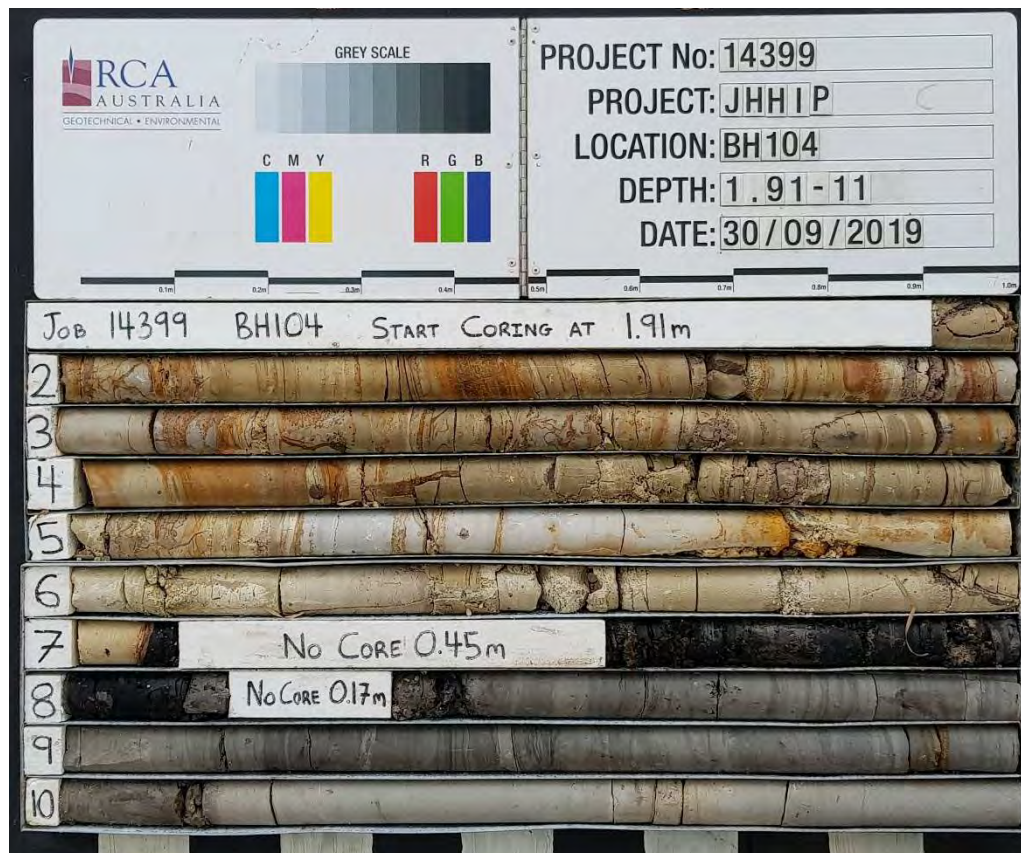
PHOTOGRAPH 1 of 2 – BH104 1.91m to 11.0m

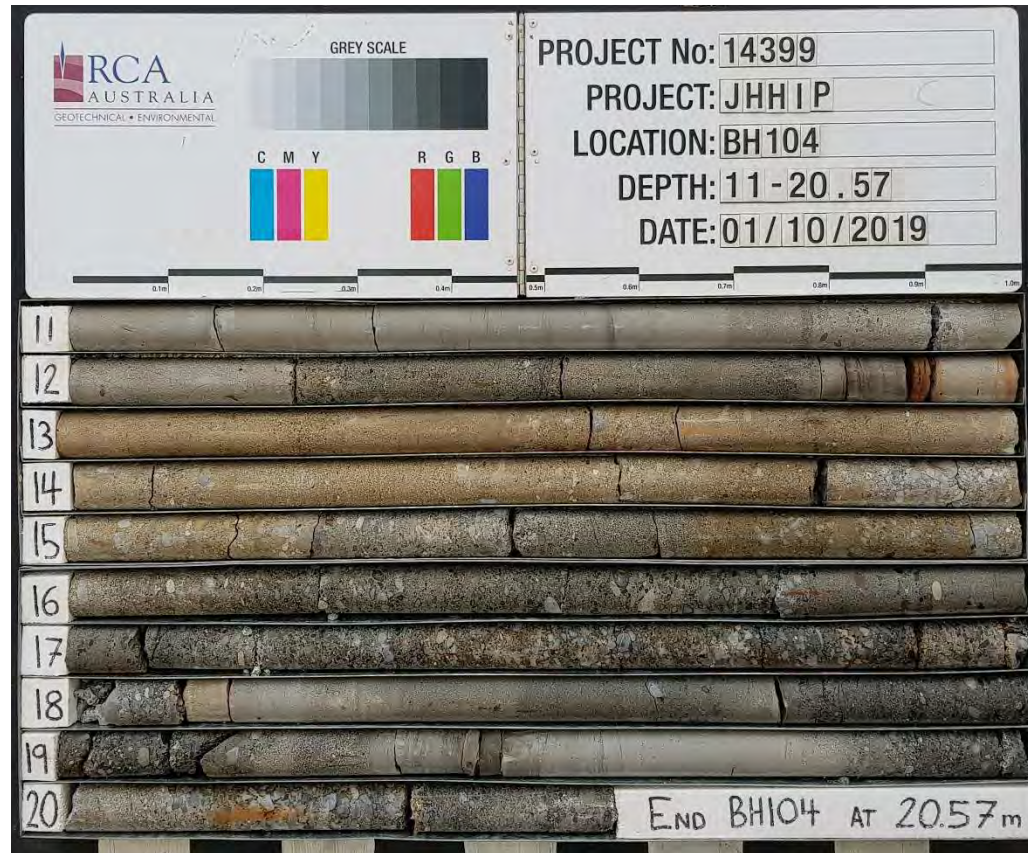
PHOTOGRAPH 2 of 2 – BH104 11.0m to 20.57m
