Client: Health Infrastructure

RCA Australia

Project: John Hunter Health and Innovation Precinct

GEOTECHNICAL BOREHOLE LOG

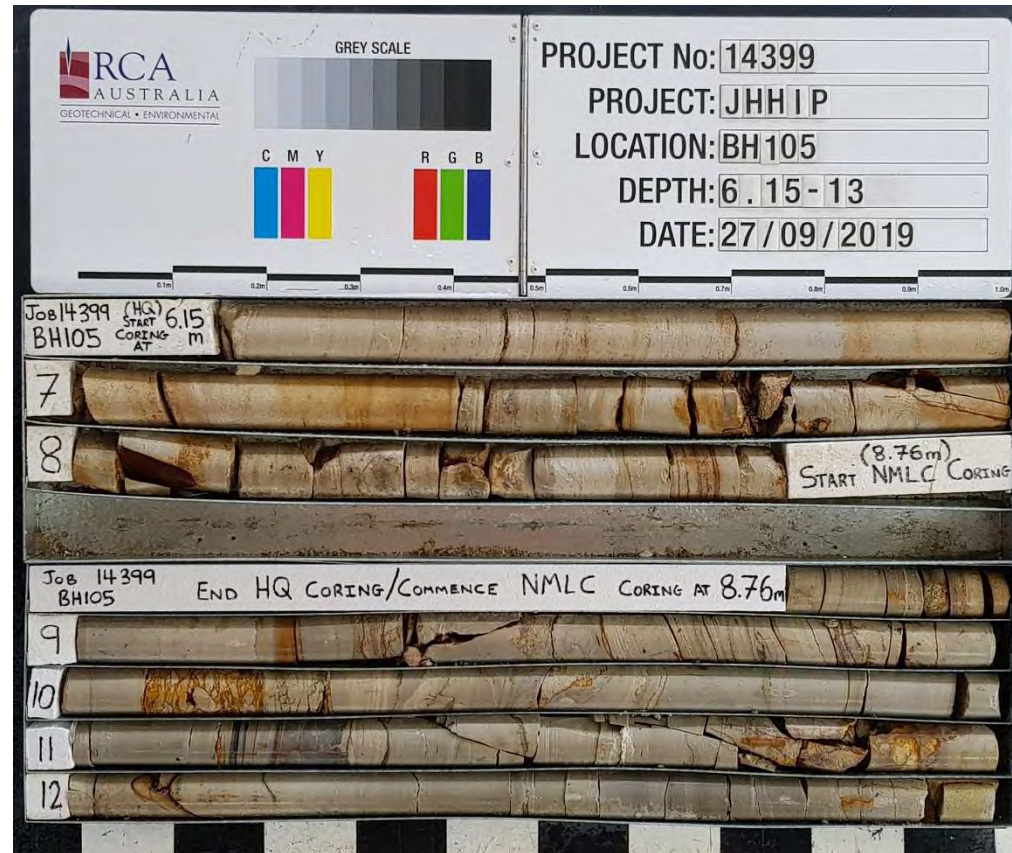
PHOTOGRAPH 1 of 2 – BH105 6.15m to 13.0m

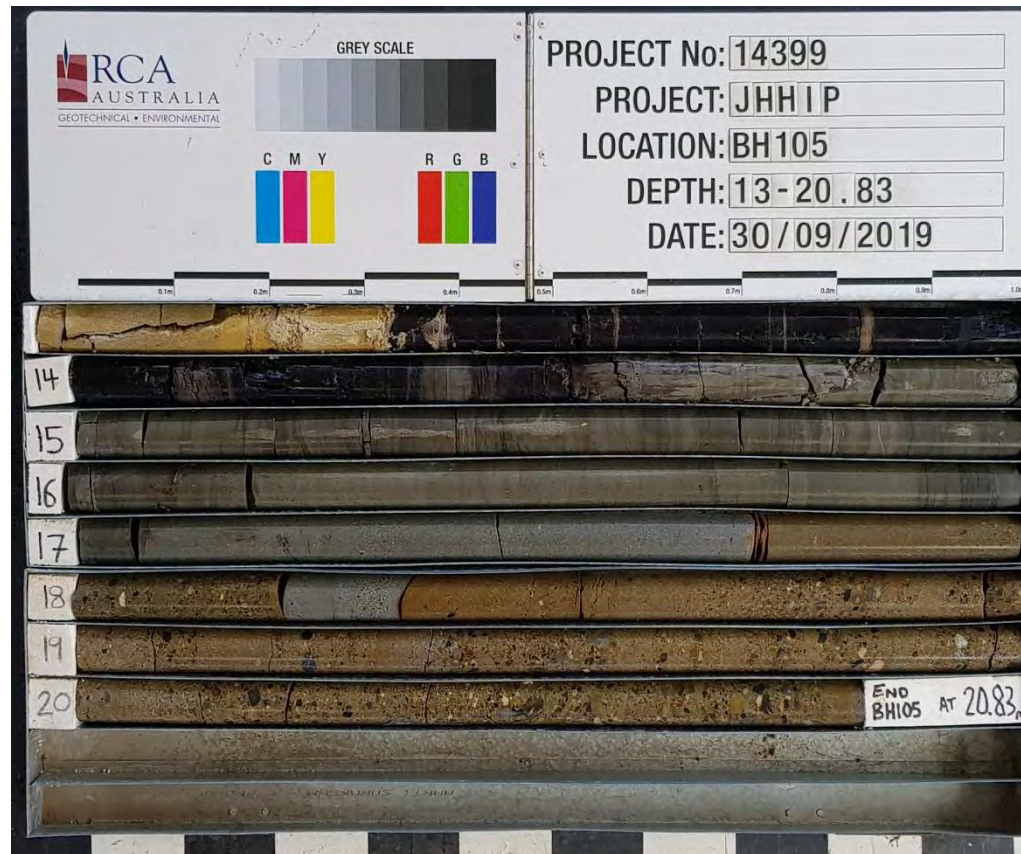
PHOTOGRAPH 2 of 2 – BH105 13.0m to 20.83m

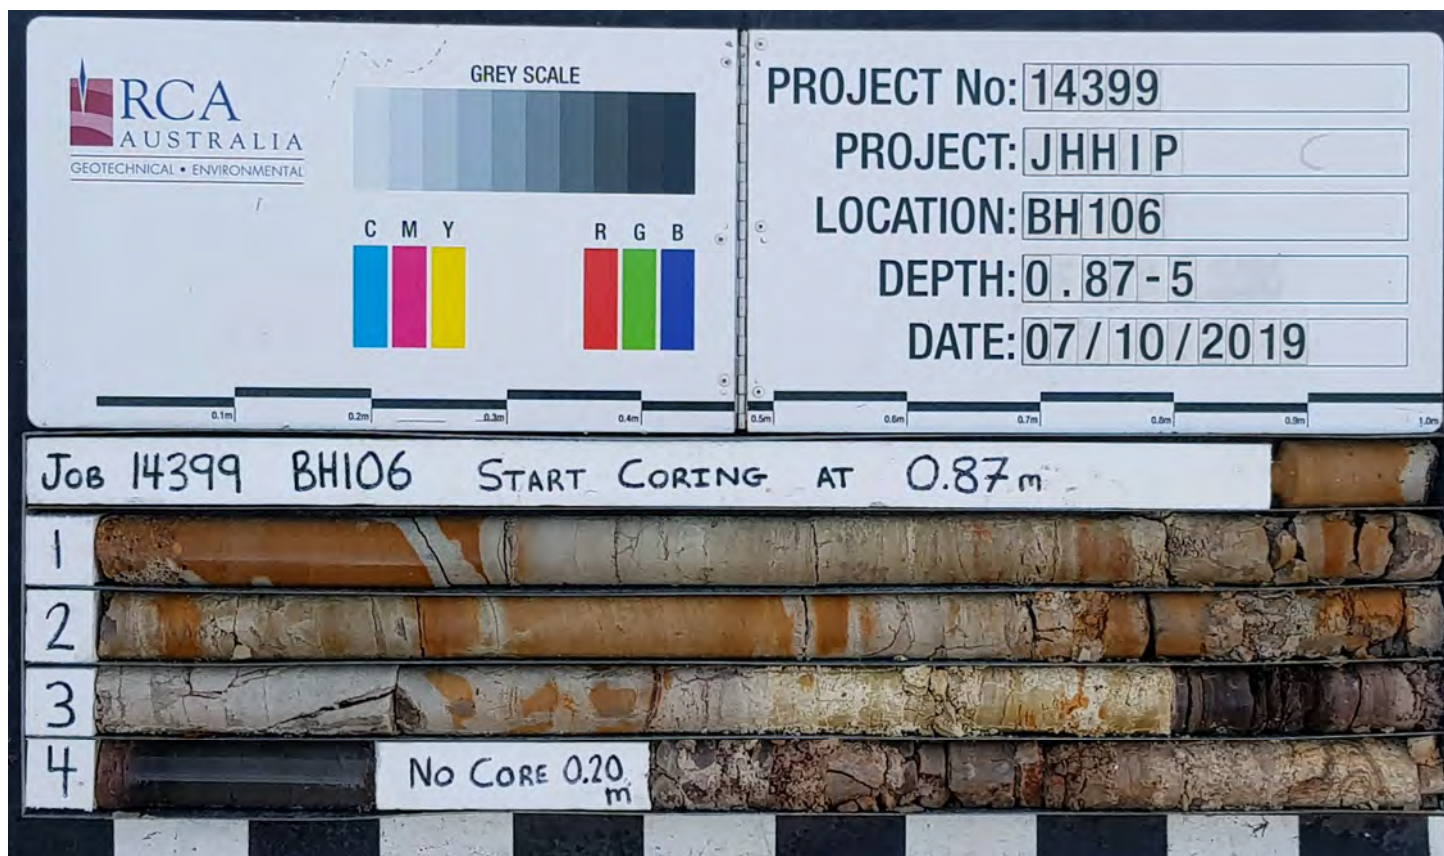
PHOTOGRAPH 1 of 3 – BH106 0.87m to 5.0m

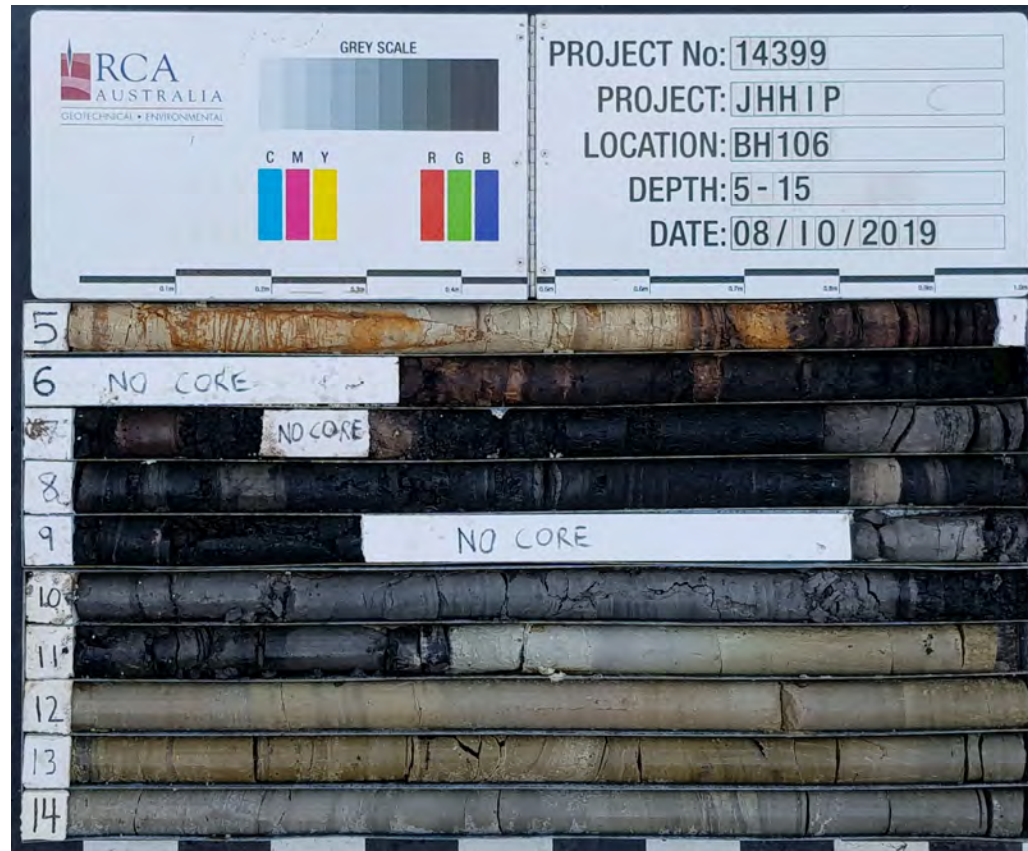
PHOTOGRAPH 2 of 3 – BH106 5.0m to 15.0m

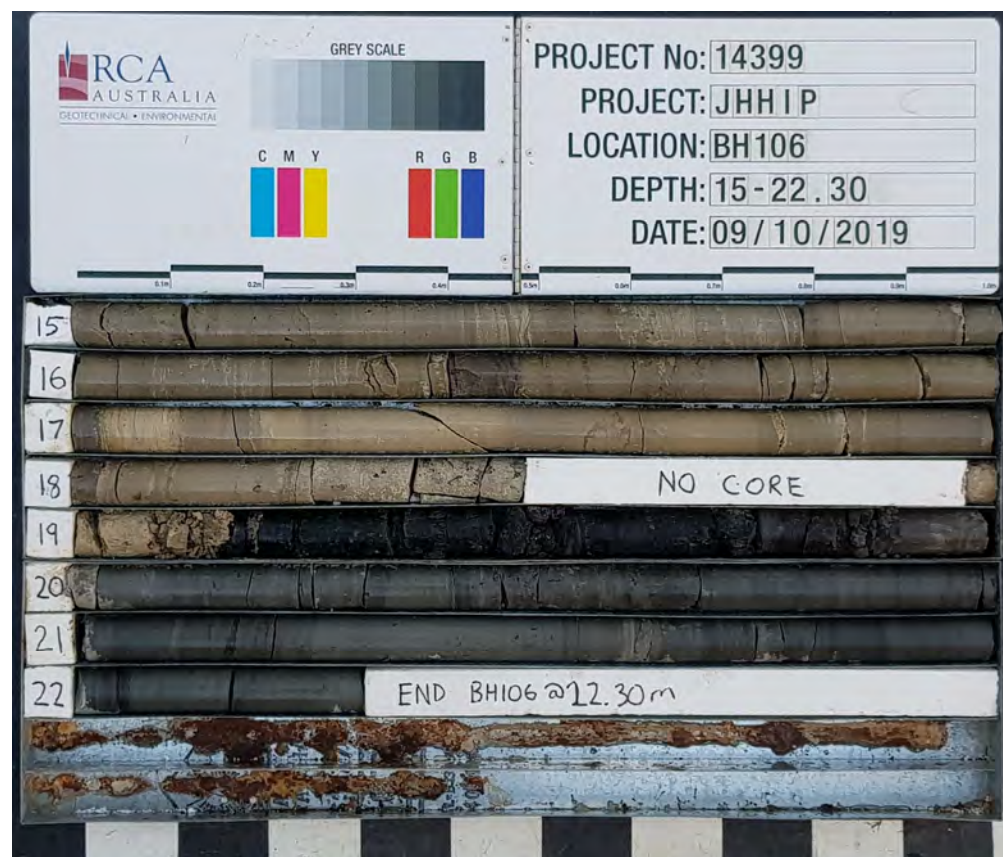
PHOTOGRAPH 3 of 3 – BH106 15.0m to 22.3m

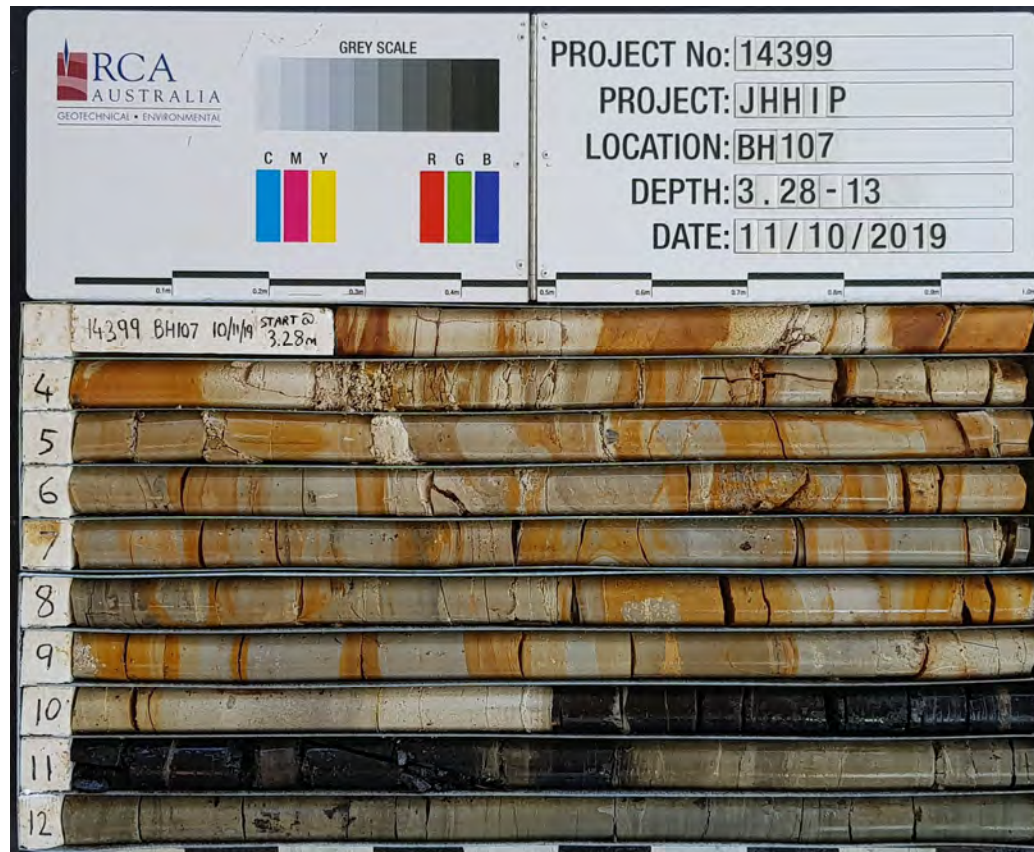
PHOTOGRAPH 1 of 2 – BH107 3.28m to 13.0m

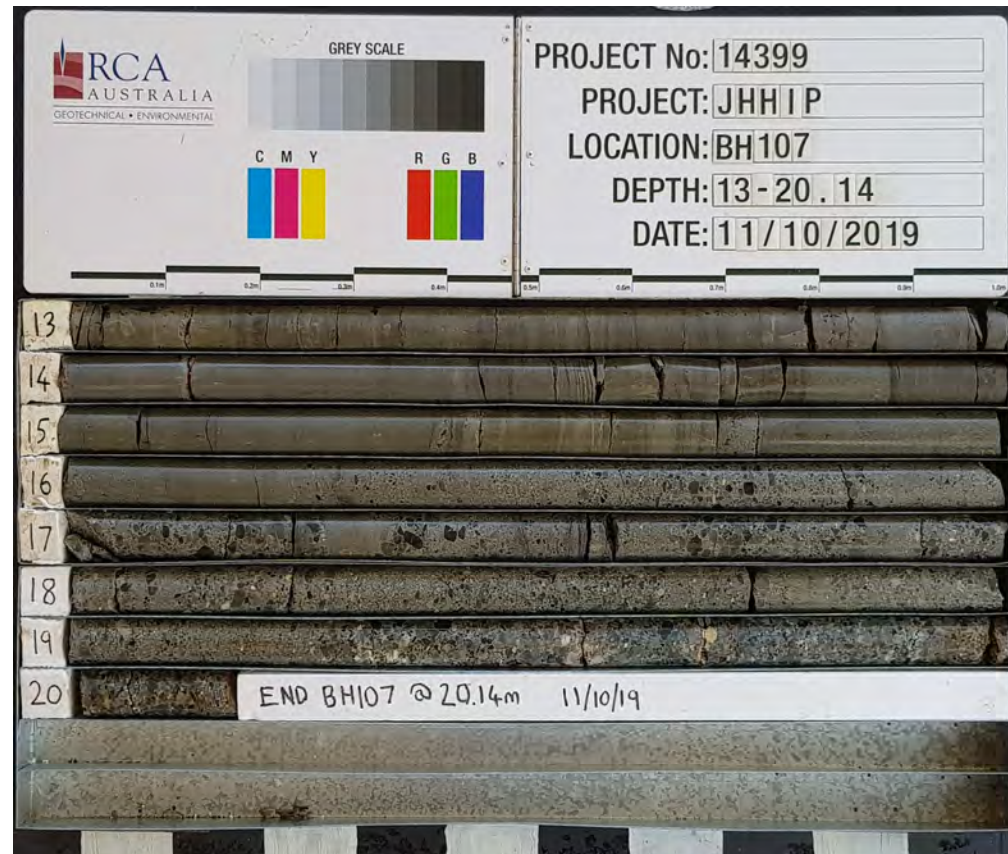
PHOTOGRAPH 2 of 2 – BH107 13.0m to 20.14m

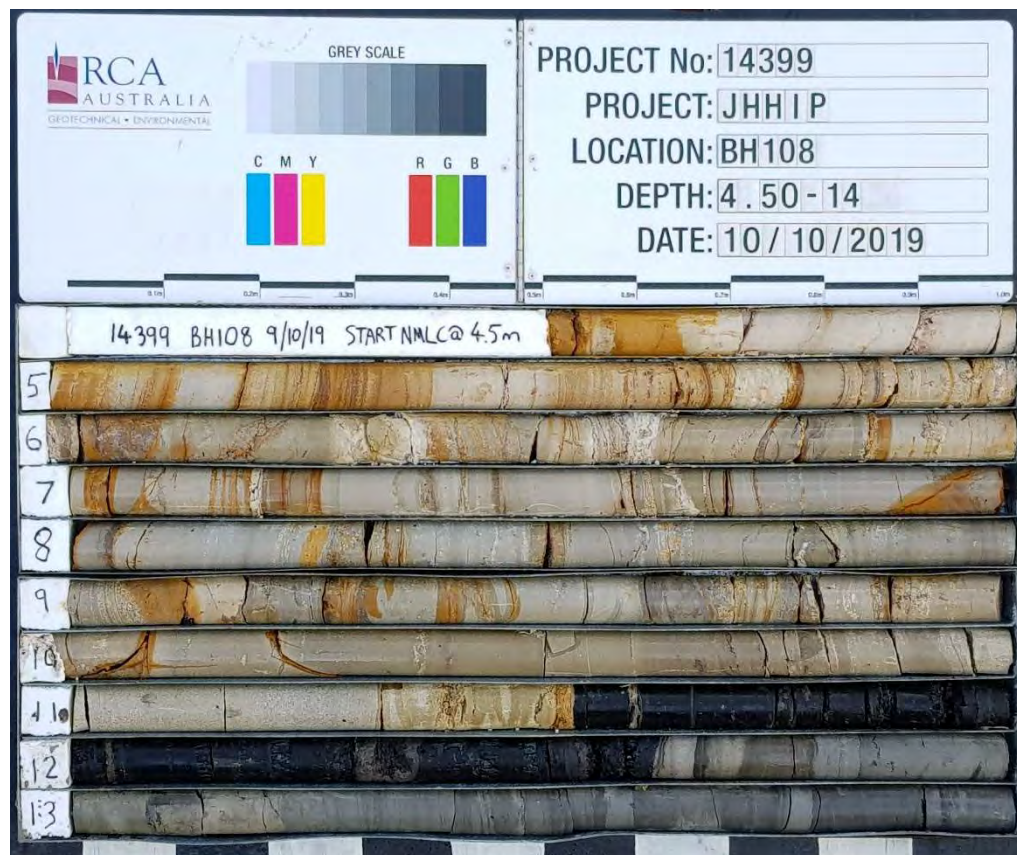
PHOTOGRAPH 1 of 2 – BH108 4.5m to 14.0m

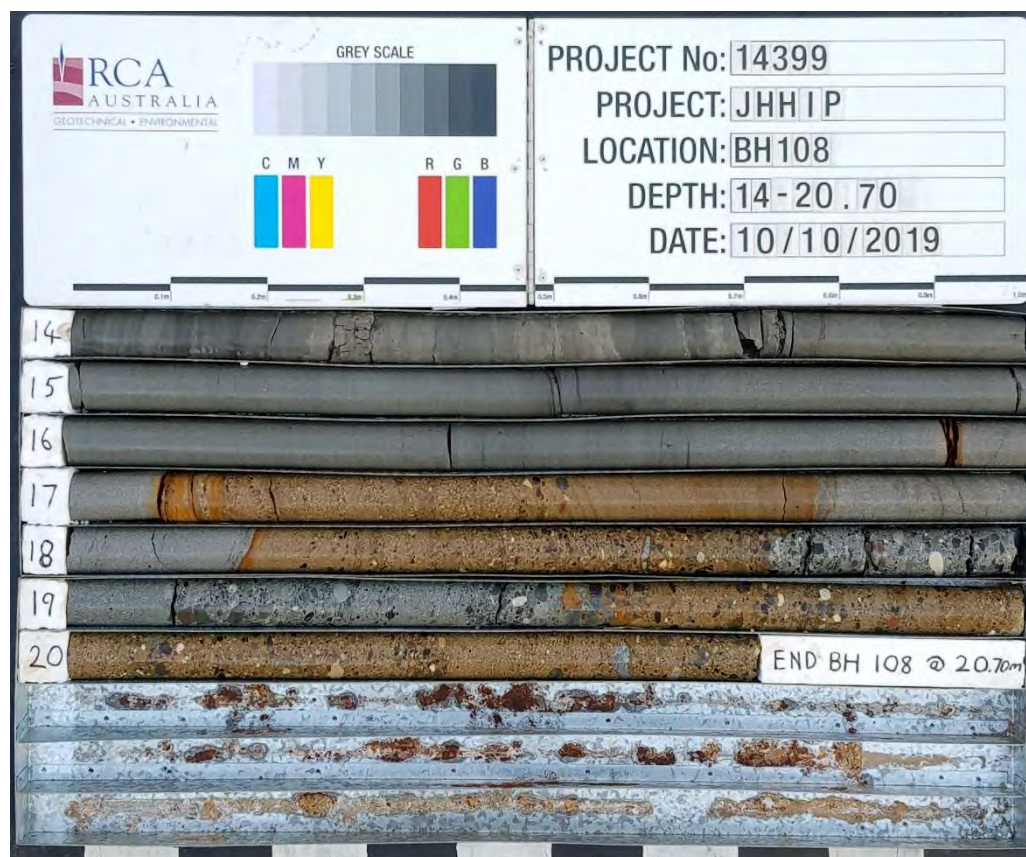
PHOTOGRAPH 2 of 2 – BH108 14.0m to 20.7m

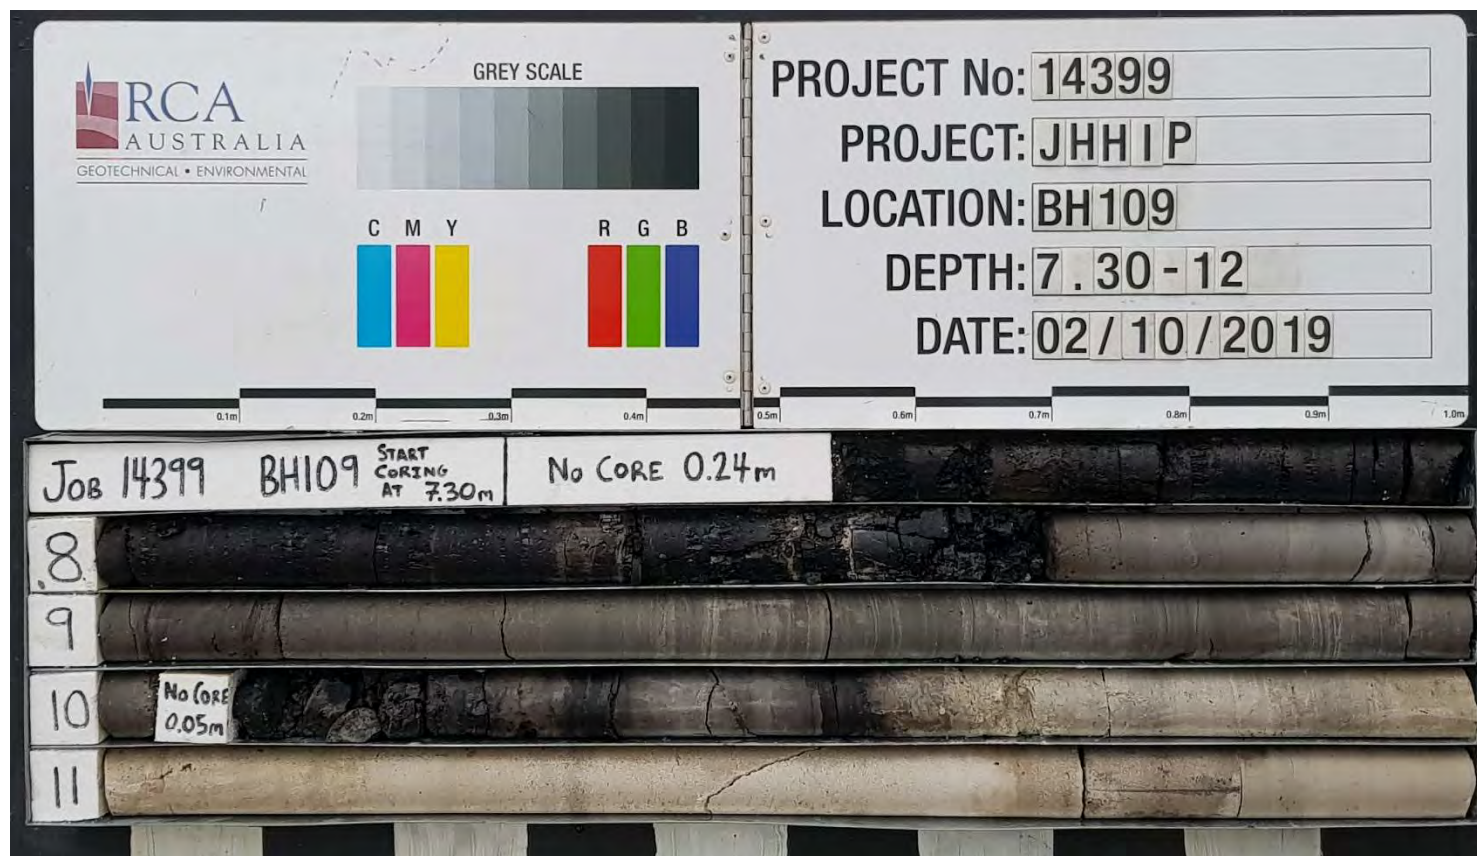
PHOTOGRAPH 1 of 2 – BH109 7.3m to 12.0m

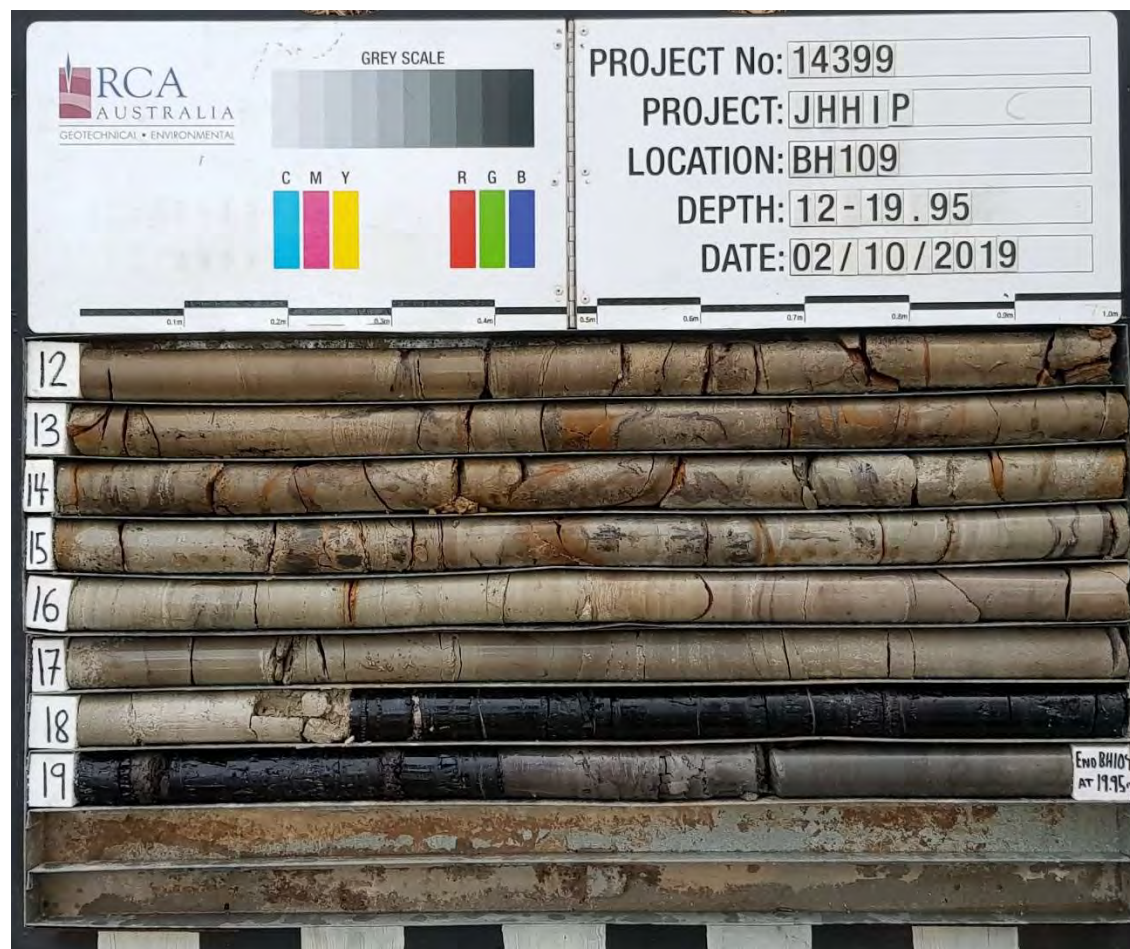
PHOTOGRAPH 2 of 2 – BH109 12.0m to 19.95m

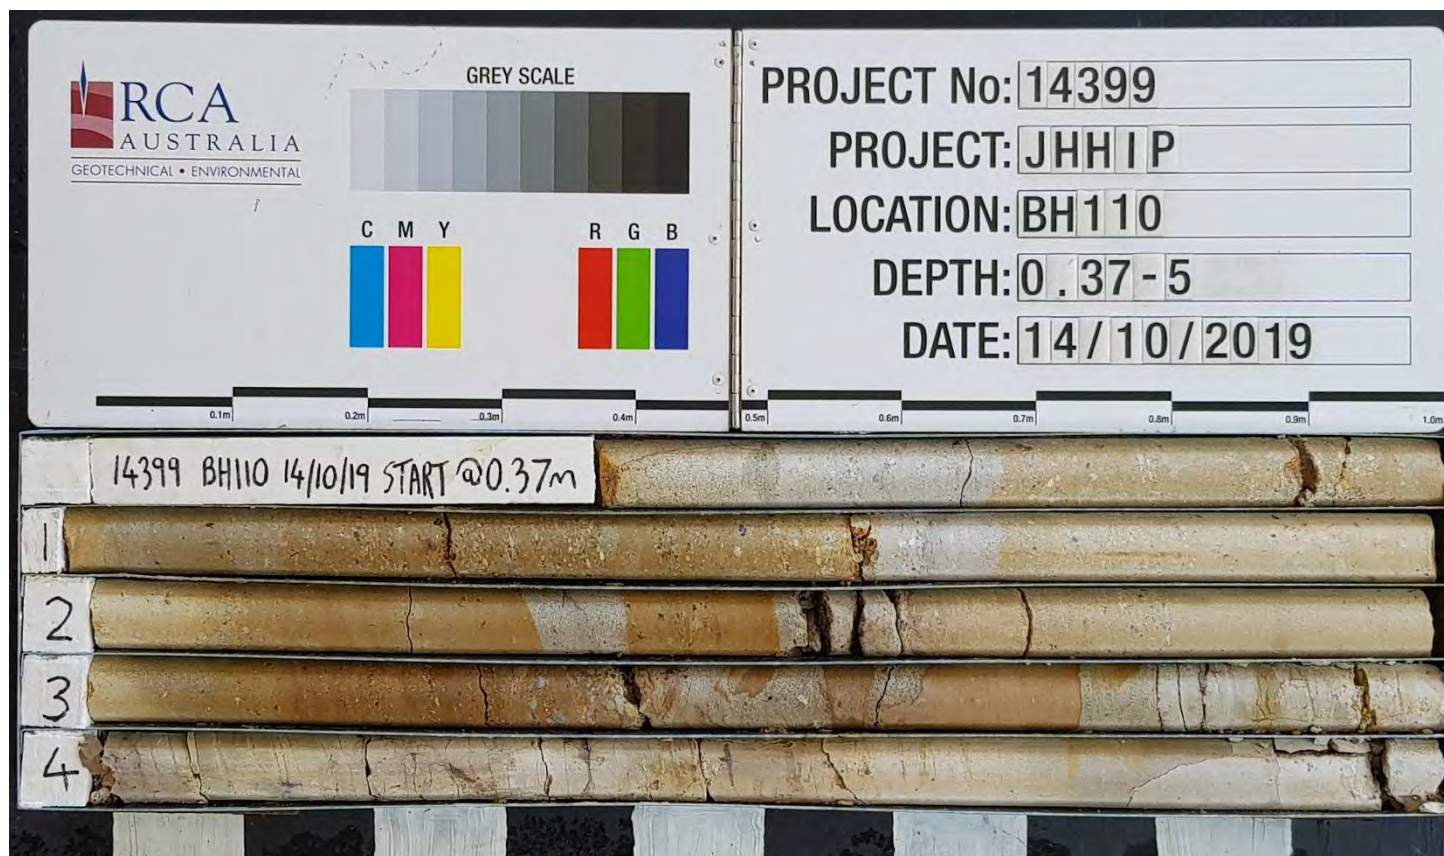
PHOTOGRAPH 1 of 3 – BH110 0.37m to 5.0m

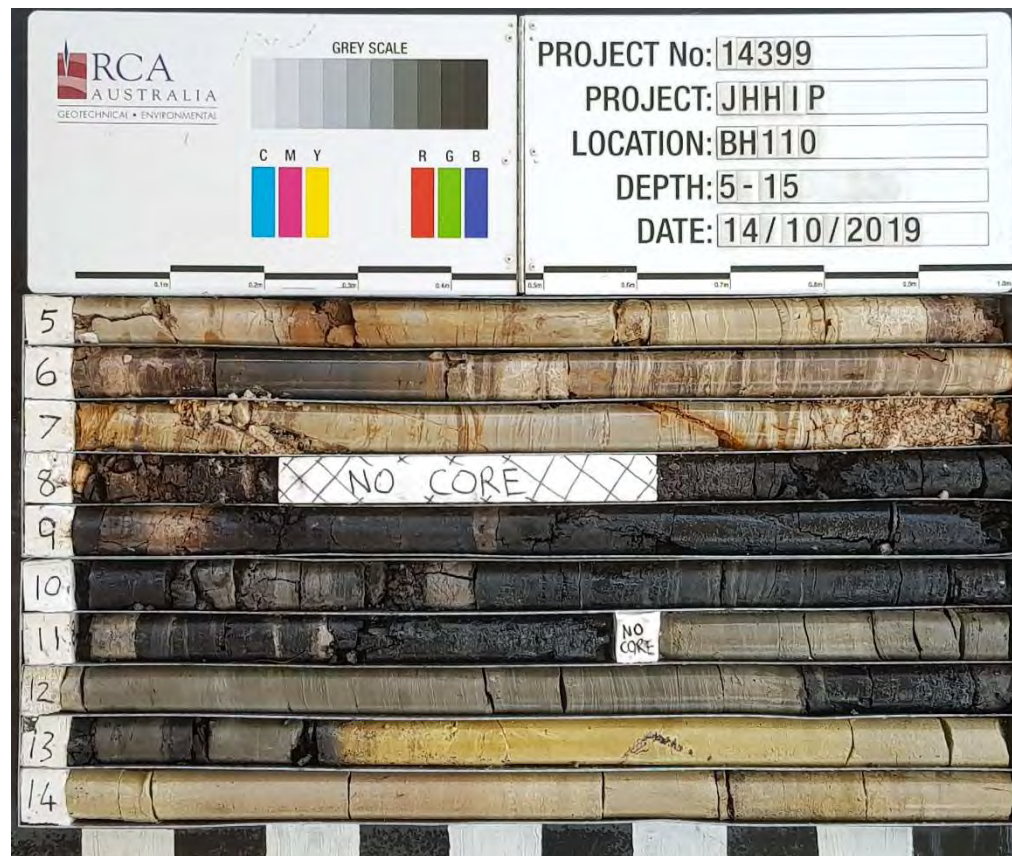
PHOTOGRAPH 2 of 3 – BH110 5.0m to 15.0m

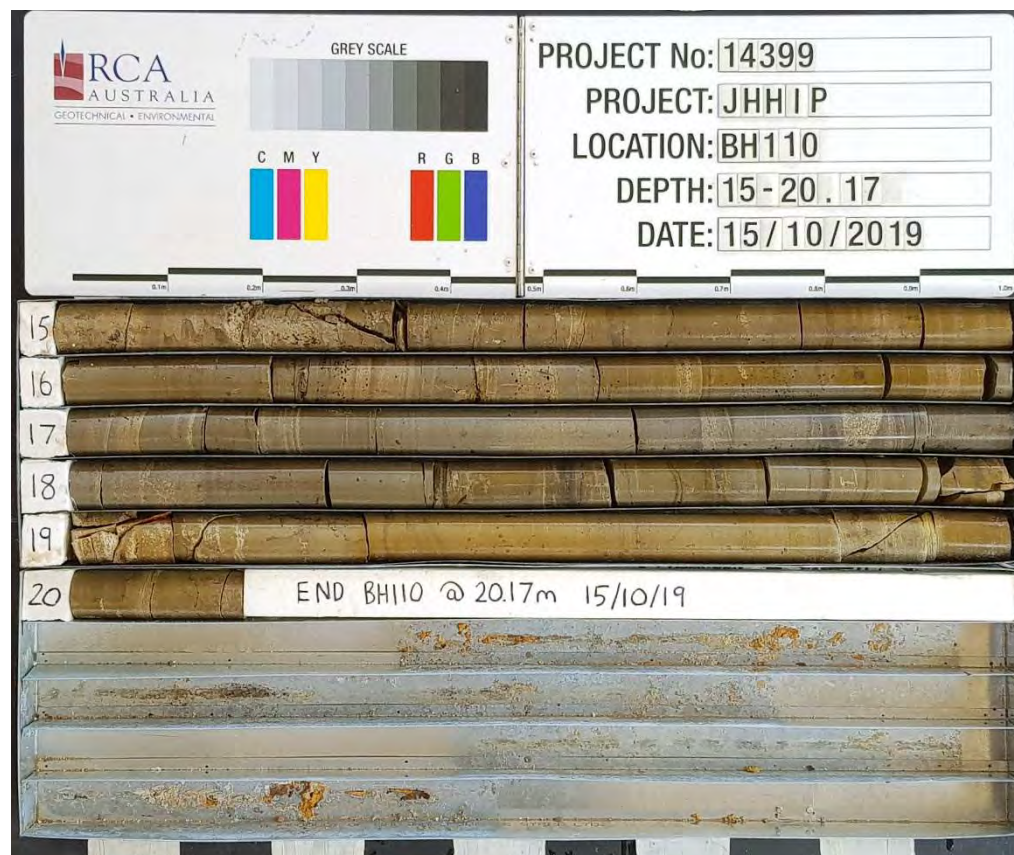
PHOTOGRAPH 3 of 3 – BH110 15.0m to 20.17m

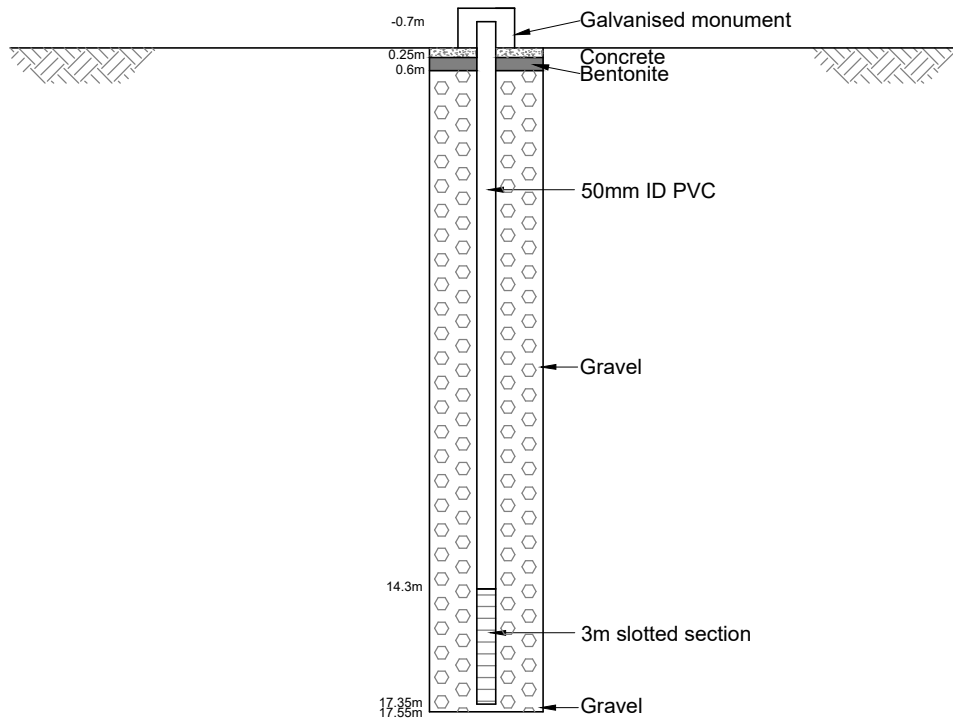
STANDPIPE PIEZOMETER CONSTRUCTION DETAILS BH102 JOHN HUNTER HEALTH AND INNOVATION PRECINCT

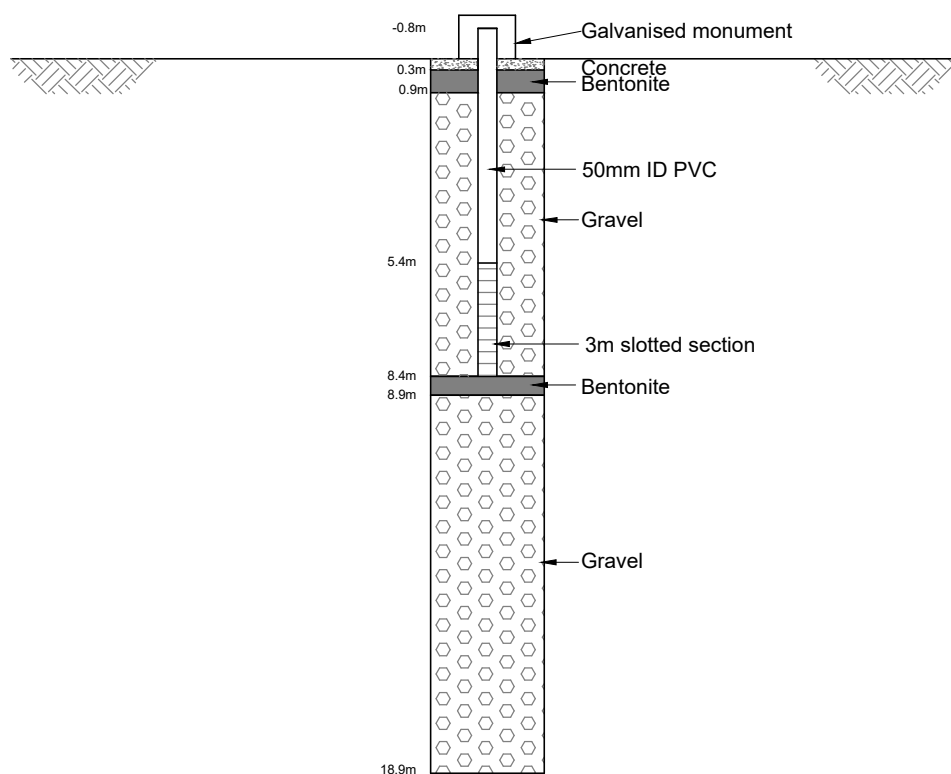
STANDPIPE PIEZOMETER CONSTRUCTION DETAILS BH103 JOHN HUNTER HEALTH AND INNOVATION PRECINCT

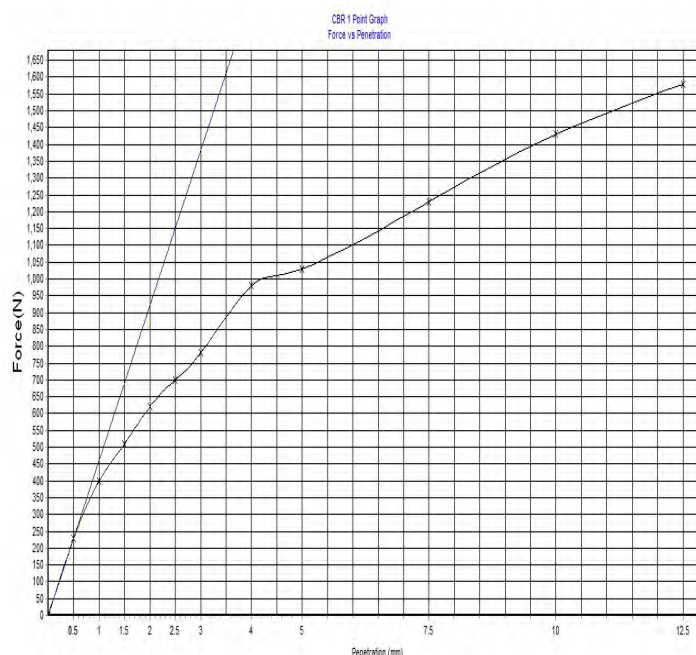
Moisture Method :	AS 1289.2.1.1
Maximum Dry Density (t/m ³) :	1.623
Optimum Moisture Content (%) :	20.6
Compactive Effort :	Standard
Nominated Percentage of MDD :	100
Nominated Percentage of OMC :	100
Achieved Percentage of MDD :	100
Achieved Percentage of OMC :	100.0
Dry Density Before Soak (t/m ³) :	1.623
Dry Density After Soak (t/m ³) :	1.617
Moisture Content Before Soak (%) :	20.7
Moisture Content After Soak (%) :	24.3
Density Ratio After Soak (%) :	100
Field Moisture Content (%) :	16.0
Top Moisture Content - After Penetration (%) :	26.2
Total Moisture Content - After Penetration (%) :	23.6
Soak Condition :	Soaked
Soak Period (days) :	4
Swell (%) :	0.5
CBR Surcharge (kg) :	4.5
Oversize (%) :	2
Oversize Material Replaced (%) :	Excluded

CBR 2.5mm (%) : 5

CBR 5.0mm (%) : 5

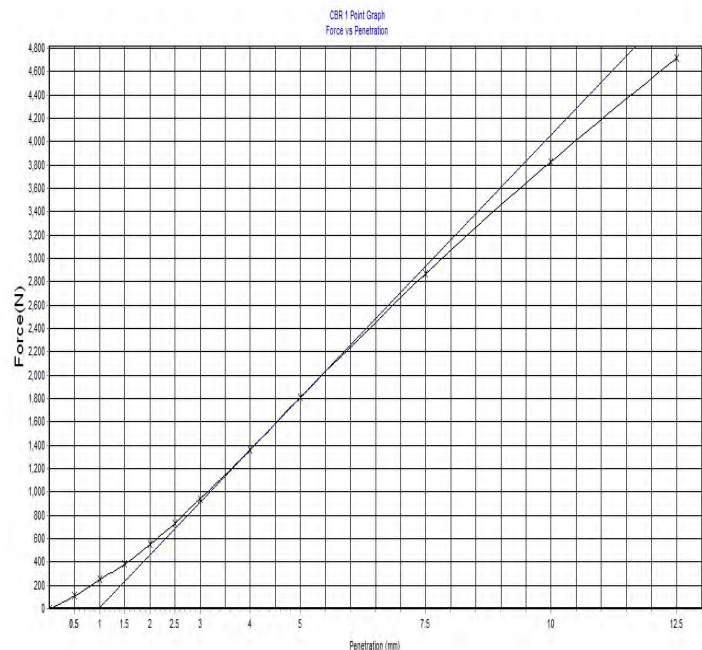
Moisture Method :	AS 1289.2.1.1
Maximum Dry Density (t/m ³) :	1.86
Optimum Moisture Content (%) :	13.9
Compactive Effort :	Standard
Nominated Percentage of MDD :	100
Nominated Percentage of OMC :	100
Achieved Percentage of MDD :	100
Achieved Percentage of OMC :	99.0
Dry Density Before Soak (t/m ³) :	1.863
Dry Density After Soak (t/m ³) :	1.86
Moisture Content Before Soak (%) :	13.8
Moisture Content After Soak (%) :	14.9
Density Ratio After Soak (%) :	100
Field Moisture Content (%) :	12.2
Top Moisture Content - After Penetration (%) :	15.0
Total Moisture Content - After Penetration (%) :	14.3
Soak Condition :	Soaked
Soak Period (days) :	4
Swell (%) :	0.0
CBR Surcharge (kg) :	4.5
Oversize (%) :	5
Oversize Material Replaced (%) :	Excluded

CBR 2.5mm (%) : 9

CBR 5.0mm (%) : 11

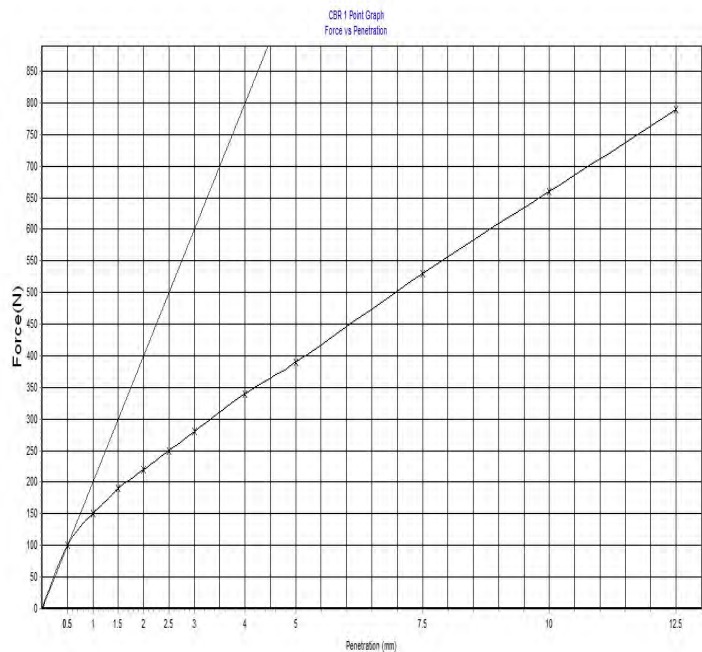
Moisture Method :	AS 1289.2.1.1
Maximum Dry Density (t/m ³) :	1.542
Optimum Moisture Content (%) :	23.8
Compactive Effort :	Standard
Nominated Percentage of MDD :	100
Nominated Percentage of OMC :	100
Achieved Percentage of MDD :	101
Achieved Percentage of OMC :	97.0
Dry Density Before Soak (t/m ³) :	1.555
Dry Density After Soak (t/m ³) :	1.516
Moisture Content Before Soak (%) :	23.2
Moisture Content After Soak (%) :	27.8
Density Ratio After Soak (%) :	98
Field Moisture Content (%) :	24.7
Top Moisture Content - After Penetration (%) :	35.2
Total Moisture Content - After Penetration (%) :	26.5
Soak Condition :	Soaked
Soak Period (days) :	4
Swell (%) :	2.5
CBR Surcharge (kg) :	4.5
Oversize (%) :	1
Oversize Material Replaced (%) :	Excluded

CBR 2.5mm (%) : 2

CBR 5.0mm (%) : 2

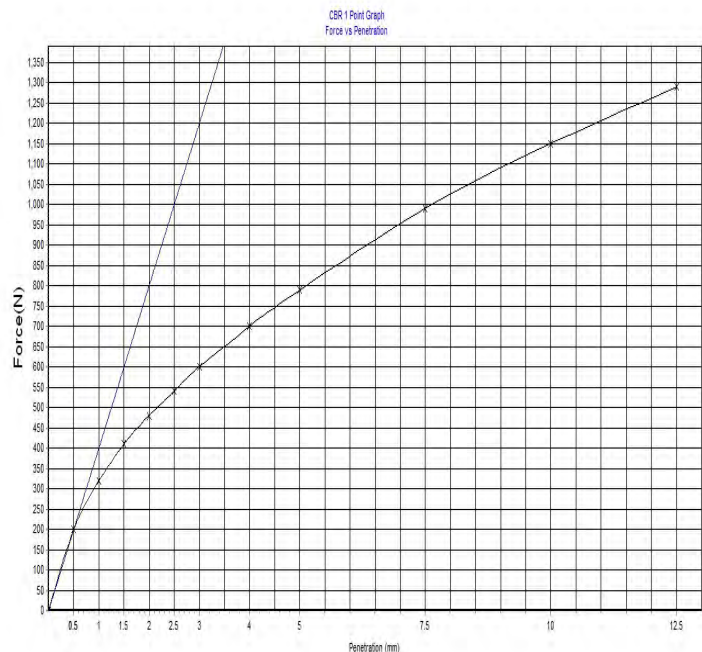
Moisture Method :	AS 1289.2.1.1
Maximum Dry Density (t/m ³) :	1.579
Optimum Moisture Content (%) :	20.1
Compactive Effort :	Standard
Nominated Percentage of MDD :	100
Nominated Percentage of OMC :	100
Achieved Percentage of MDD :	101
Achieved Percentage of OMC :	99.0
Dry Density Before Soak (t/m ³) :	1.6
Dry Density After Soak (t/m ³) :	1.566
Moisture Content Before Soak (%) :	19.8
Moisture Content After Soak (%) :	25.7
Density Ratio After Soak (%) :	99
Field Moisture Content (%) :	19.7
Top Moisture Content - After Penetration (%) :	28.0
Total Moisture Content - After Penetration (%) :	24.4
Soak Condition :	Soaked
Soak Period (days) :	4
Swell (%) :	2.0
CBR Surcharge (kg) :	4.5
Oversize (%) :	0

CBR 2.5mm (%) : 4

CBR 5.0mm (%) : 4

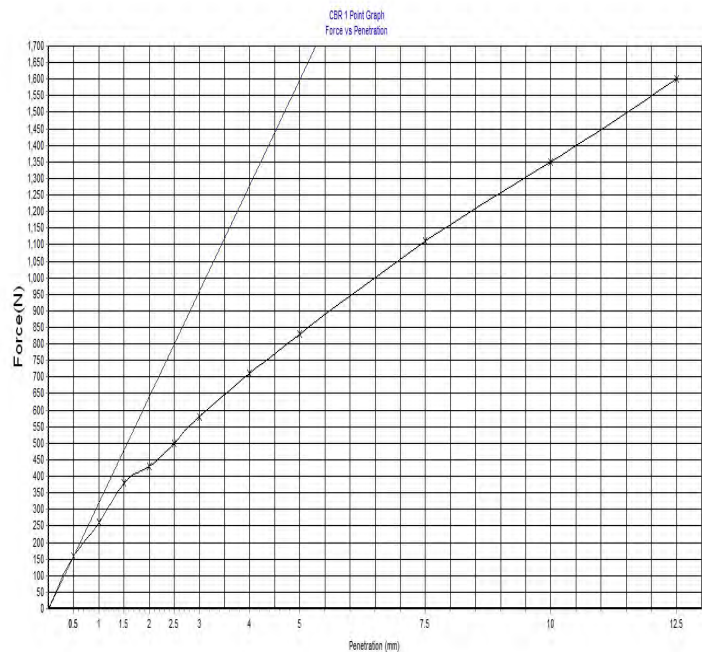
Moisture Method :	AS 1289.2.1.1
Maximum Dry Density (t/m³) :	1.634
Optimum Moisture Content (%) :	17.9
Compactive Effort :	Standard
Nominated Percentage of MDD :	100
Nominated Percentage of OMC :	100
Achieved Percentage of MDD :	100
Achieved Percentage of OMC :	101.0
Dry Density Before Soak (t/m³) :	1.626
Dry Density After Soak (t/m³) :	1.598
Moisture Content Before Soak (%) :	18.0
Moisture Content After Soak (%) :	25.4
Density Ratio After Soak (%) :	98
Field Moisture Content (%) :	18.0
Top Moisture Content - After Penetration (%) :	28.2
Total Moisture Content - After Penetration (%) :	23.4
Soak Condition :	Soaked
Soak Period (days) :	4
Swell (%) :	2.0
CBR Surcharge (kg) :	4.5
Oversize (%) :	5
Oversize Material Replaced (%) :	Excluded

CBR 2.5mm (%) :	4
CBR 5.0mm (%) :	4
CBR Value (%) :	4

Site Selection :	
Soil Description :	Extremely Weathered Sandy SILTSTONE

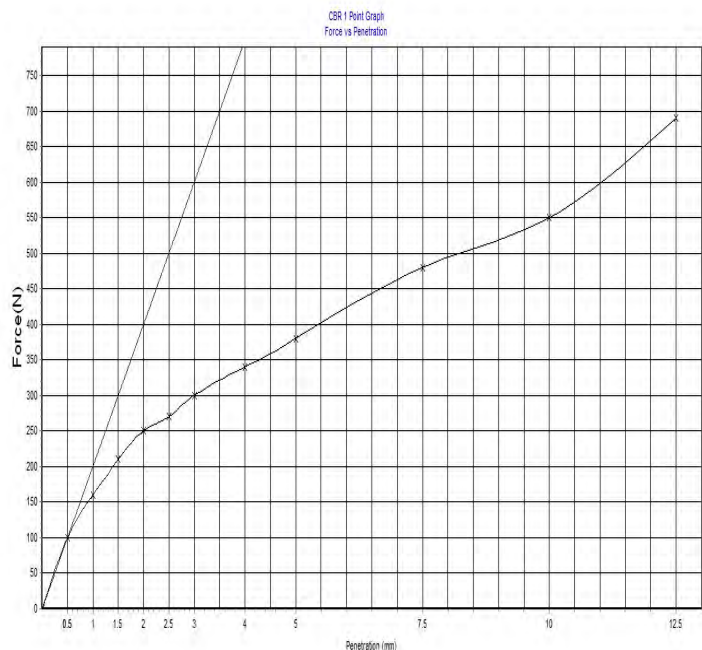
Moisture Method :	AS 1289.2.1.1
Maximum Dry Density (t/m ³) :	1.421
Optimum Moisture Content (%) :	28.9
Compactive Effort :	Standard
Nominated Percentage of MDD :	100
Nominated Percentage of OMC :	100
Achieved Percentage of MDD :	100
Achieved Percentage of OMC :	101.0
Dry Density Before Soak (t/m ³) :	1.416
Dry Density After Soak (t/m ³) :	1.359
Moisture Content Before Soak (%) :	29.3
Moisture Content After Soak (%) :	35.3
Density Ratio After Soak (%) :	96
Field Moisture Content (%) :	33.4
Top Moisture Content - After Penetration (%) :	53.9
Total Moisture Content - After Penetration (%) :	30.8
Soak Condition :	Soaked
Soak Period (days) :	4
Swell (%) :	4.0
CBR Surcharge (kg) :	4.5
Oversize (%) :	1
Oversize Material Replaced (%) :	Excluded

CBR 2.5mm (%) :	2
CBR 5.0mm (%) :	2
CBR Value (%) :	2

Site Selection :	
Soil Description :	CLAY

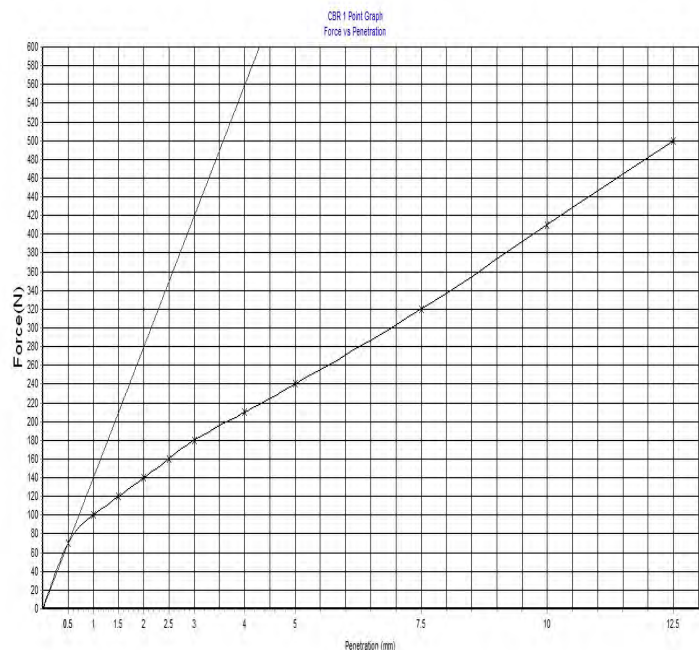
Moisture Method :	AS 1289.2.1.1
Maximum Dry Density (t/m ³) :	1.584
Optimum Moisture Content (%) :	22.0
Compactive Effort :	Standard
Nominated Percentage of MDD :	100
Nominated Percentage of OMC :	100
Achieved Percentage of MDD :	100
Achieved Percentage of OMC :	101.0
Dry Density Before Soak (t/m ³) :	1.578
Dry Density After Soak (t/m ³) :	1.542
Moisture Content Before Soak (%) :	22.2
Moisture Content After Soak (%) :	28.6
Density Ratio After Soak (%) :	97
Field Moisture Content (%) :	26.3
Top Moisture Content - After Penetration (%) :	40.4
Total Moisture Content - After Penetration (%) :	27.7
Soak Condition :	Soaked
Soak Period (days) :	4
Swell (%) :	2.5
CBR Surcharge (kg) :	4.5
Oversize (%) :	2
Oversize Material Replaced (%) :	Excluded

CBR 2.5mm (%) : 1

CBR 5.0mm (%) : 1

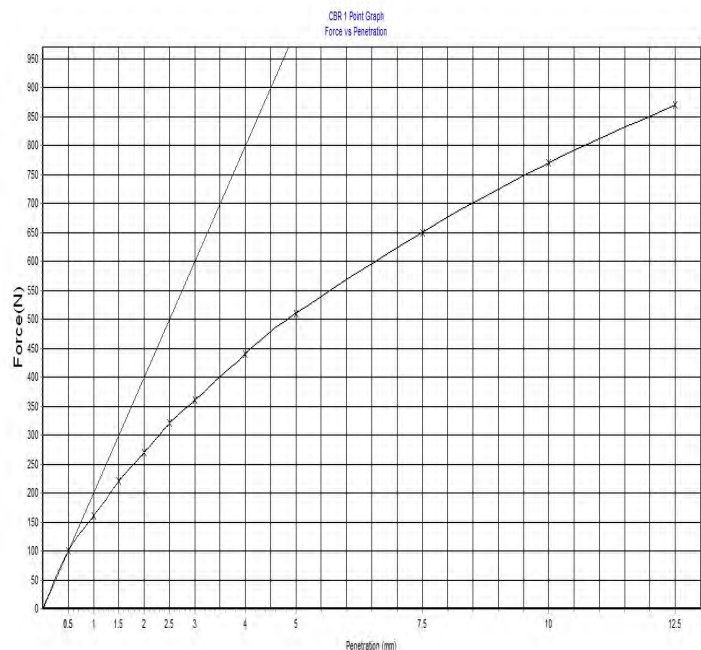
Moisture Method :	AS 1289.2.1.1
Maximum Dry Density (t/m³) :	1.561
Optimum Moisture Content (%) :	24.3
Compactive Effort :	Standard
Nominated Percentage of MDD :	100
Nominated Percentage of OMC :	100
Achieved Percentage of MDD :	99
Achieved Percentage of OMC :	100.0
Dry Density Before Soak (t/m³) :	1.542
Dry Density After Soak (t/m³) :	1.519
Moisture Content Before Soak (%) :	24.4
Moisture Content After Soak (%) :	28.0
Density Ratio After Soak (%) :	97
Field Moisture Content (%) :	24.0
Top Moisture Content - After Penetration (%) :	31.7
Total Moisture Content - After Penetration (%) :	26.9
Soak Condition :	Soaked
Soak Period (days) :	4
Swell (%) :	1.5
CBR Surcharge (kg) :	4.5
Oversize (%) :	0
Oversize Material Replaced (%) :

CBR 2.5mm (%) : 2.5

CBR 5.0mm (%) : 2.5

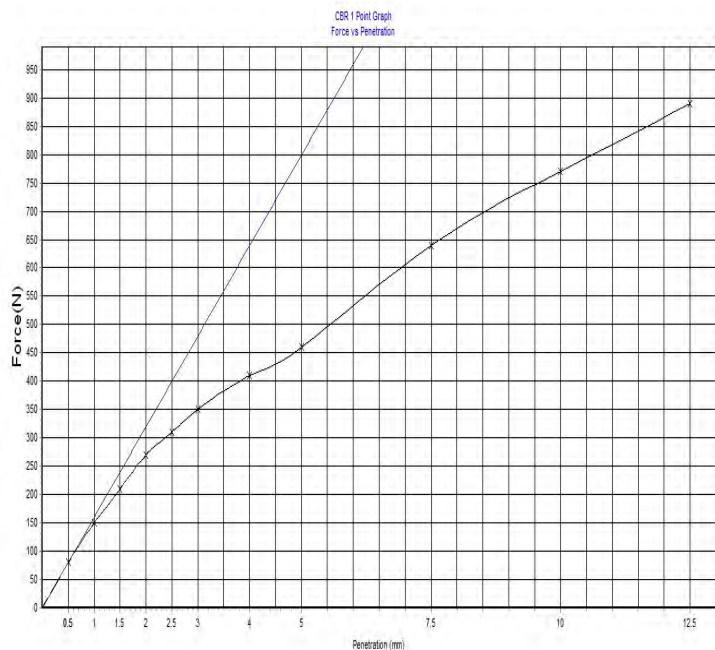
Moisture Method :	AS 1289.2.1.1
Maximum Dry Density (t/m ³) :	1.714
Optimum Moisture Content (%) :	20.0
Compactive Effort :	Standard
Nominated Percentage of MDD :	100
Nominated Percentage of OMC :	100
Achieved Percentage of MDD :	100
Achieved Percentage of OMC :	101.0
Dry Density Before Soak (t/m ³) :	1.706
Dry Density After Soak (t/m ³) :	1.672
Moisture Content Before Soak (%) :	20.1
Moisture Content After Soak (%) :	23.3
Density Ratio After Soak (%) :	98
Field Moisture Content (%) :	20.2
Top Moisture Content - After Penetration (%) :	27.4
Total Moisture Content - After Penetration (%) :	22.0
Soak Condition :	Soaked
Soak Period (days) :	4
Swell (%) :	2.0
CBR Surcharge (kg) :	4.5
Oversize (%) :	1
Oversize Material Replaced (%) :	Excluded

CBR 2.5mm (%) : 2.5

CBR 5.0mm (%) : 2.5
