- A ADMINISTRATION / LIBRARY
- D STAFF & STUDENT FACILITIES
- E GENERAL LEARNING (HERITAGE)
- H HALL & COMMUNAL FACILITIES
- I GENERAL LEARNING
- P GENERAL LEARNING
- Q GENERAL LEARNING

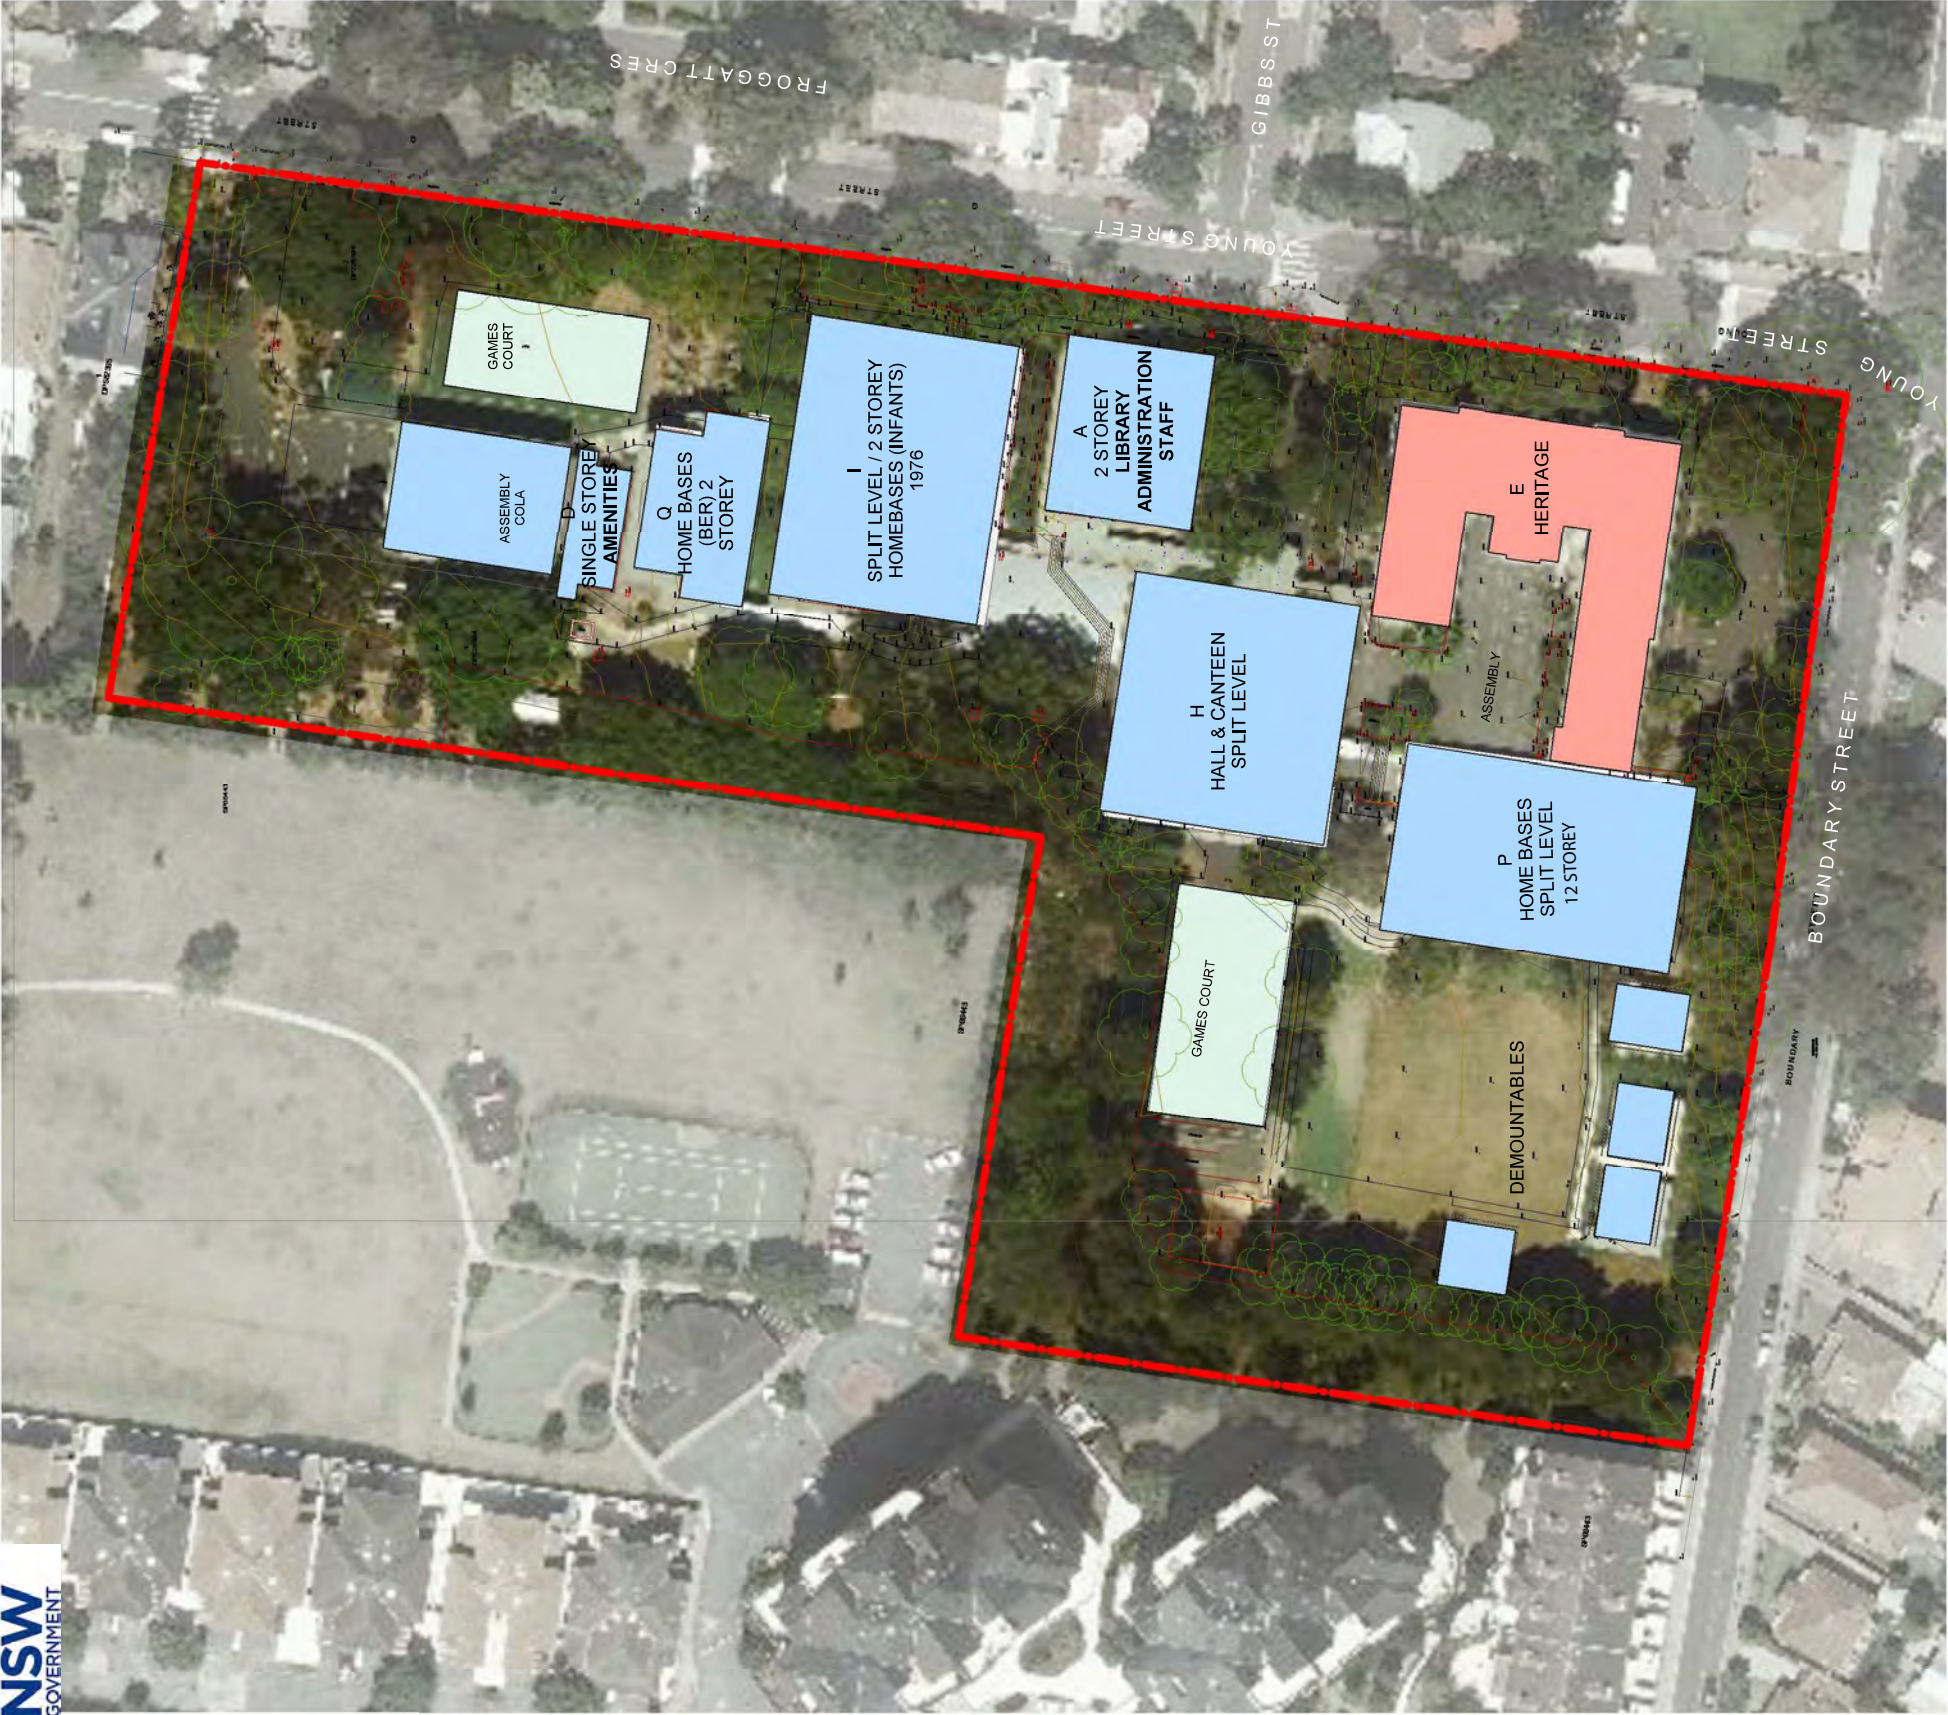
BUILDING Q: 2009 BER BUILDING. 4 HOMEBASES &  
STOREROOMS. EFSG COMPLIANT. 2 STOREY BUILDING  
WITH RAMP ACCESS. GOOD CONDITION, POORLY SITED  
BLOCKING REMAINING BUILDINGS.

BUILDING I: 1977s SPLIT LEVEL BUILDING.  
DIFFICULTIES WITH ACCESSIBILITY, EXISTING INFANT  
HOMEBASES, UNDERSIZED ROOMS FOR EFSG

BUILDING A: 1976. 2 STOREY  
LIBRARY & ADMINISTRATION. UNDERSIZED  
FOR EFSG, INTRUSIVE EXTERNAL RAMP  
ACCESS TO UPPER FLOOR

INTRUSIVE CARPARK TO CENTRAL AREA OF  
SCHOOL

BUILDING H: 1976. SPLIT LEVEL  
HALL & CANTEN OPENING TO BACK  
OF STAGE.

BUILDING P: SPLIT / 2 LEVEL HOMEBASES,  
UNDERSIZED TO EFSG, DIFFICULTIES WITH  
ACCESSIBILITY ACCESS.

BUILDING E: HERITAGE ITEM. SIGNIFICANT  
CRACKING TO EXISTING FABRIC, BUILDING IS ON  
MULTIPLE SPLIT LEVELS WITH STAIR ACCESS.

SIGNIFICANT TREES, WELL SHADED PLAY AREAS,  
EXISTING PLAY EQUIPMENT

BUILDING D: 1960s AMENITIES BLOCK, CONVENIENT  
TO OUTDOOR PLAY BUT BLOCKS CONNECTION TO  
REMAINING BUILDINGS.

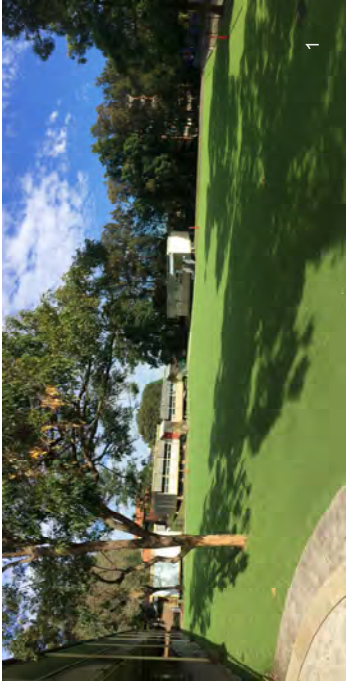
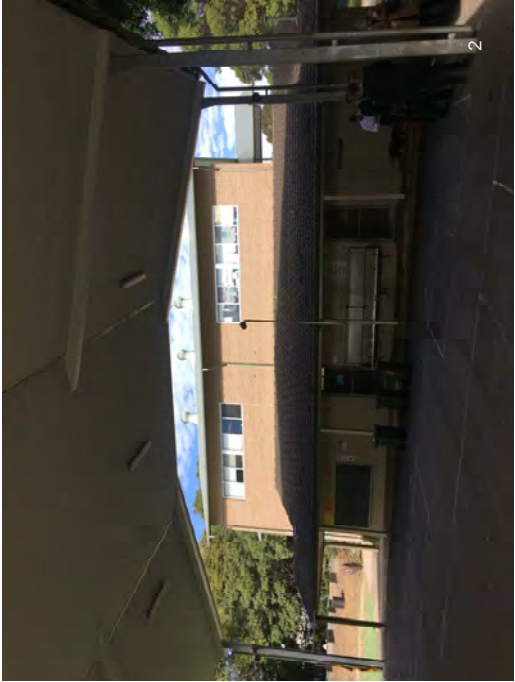
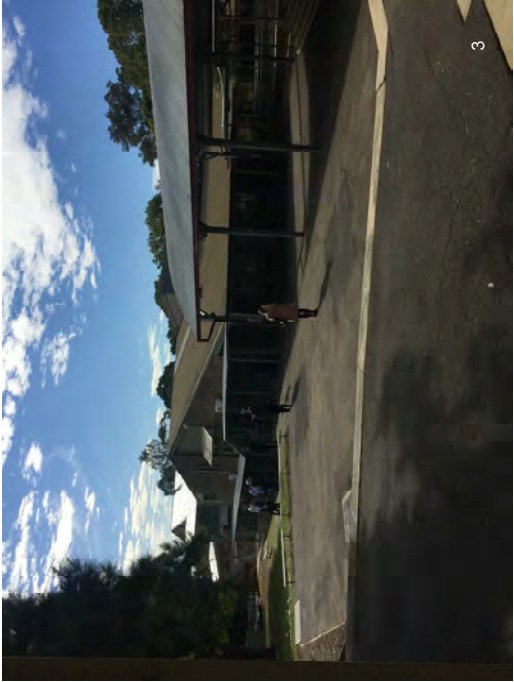
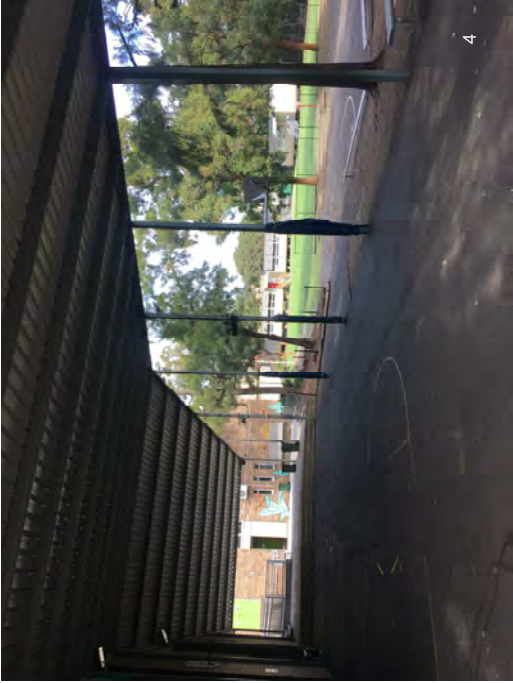
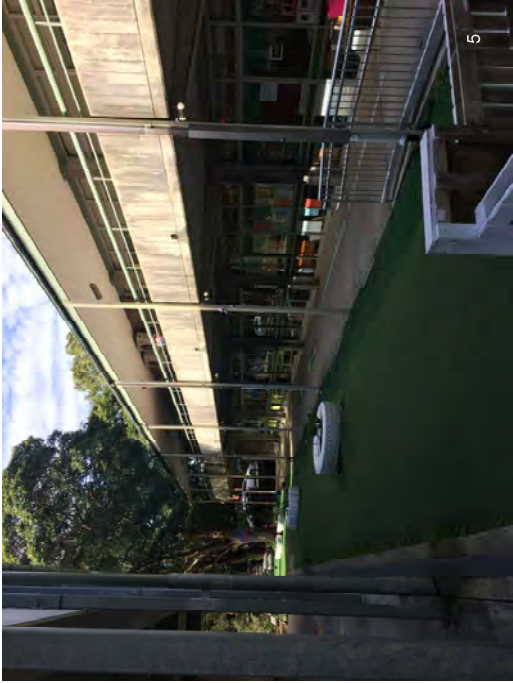
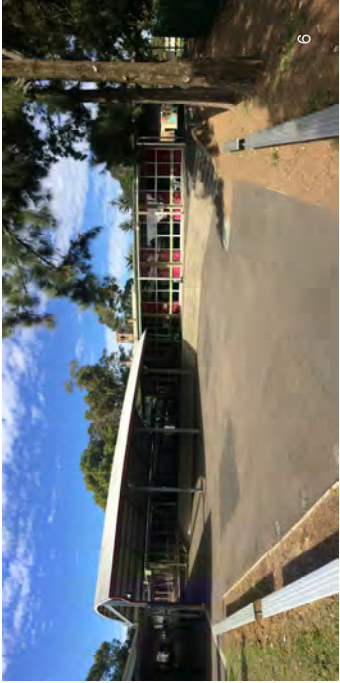
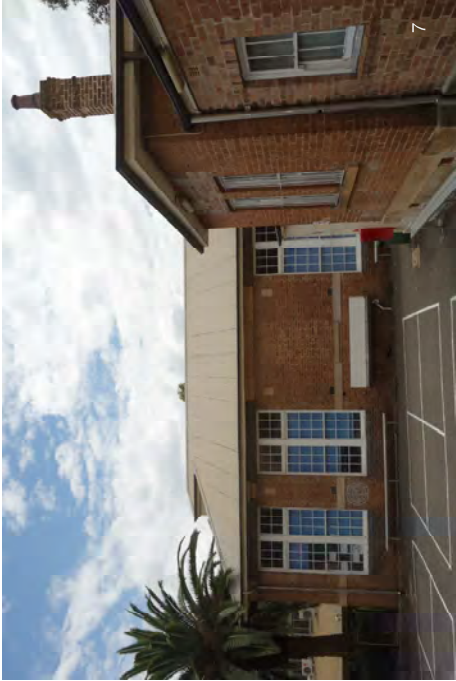
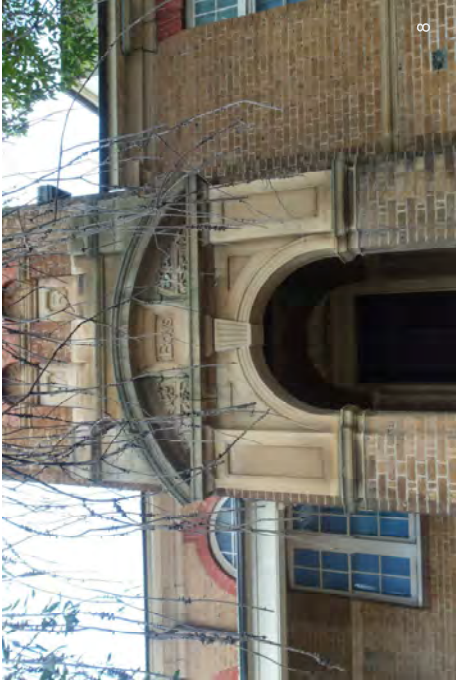
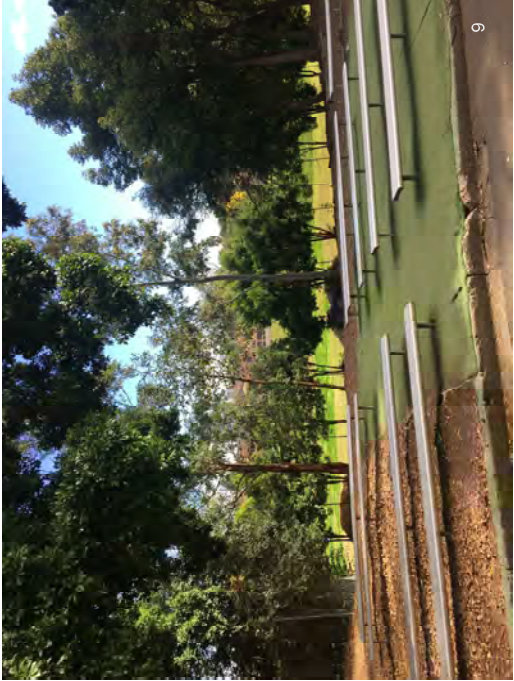
1. SOUTH WEST PLAYGROUND & DEMOUNTABLE CLASSROOMS
2. NORTH COLA & BUILDING D (AMENITIES) WITH BUILDING Q IN BACKGROUND
3. COLA & BUILDINGS I & Q
4. COLA (WESTSIDE OF HALL)
5. NORTHERN VERANDAH OF BUILDING I
6. COLA AND NORTHERN FACADE OF BUILDING H (HALL)
7. HERITAGE BUILDING E
8. HERITAGE BUILDING ENTRY
9. OUTDOOR SEATING LOOKING WEST

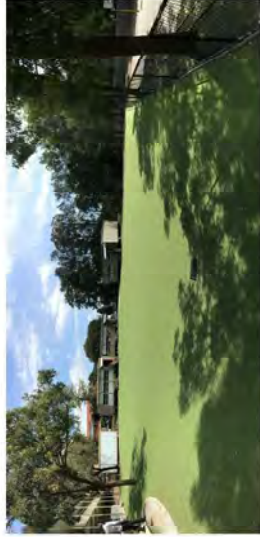
EXISTING  
DEMOUNTABLES AND  
SYNTHETIC GRASS  
OVER AREA OF  
FORMER BRICK PIT

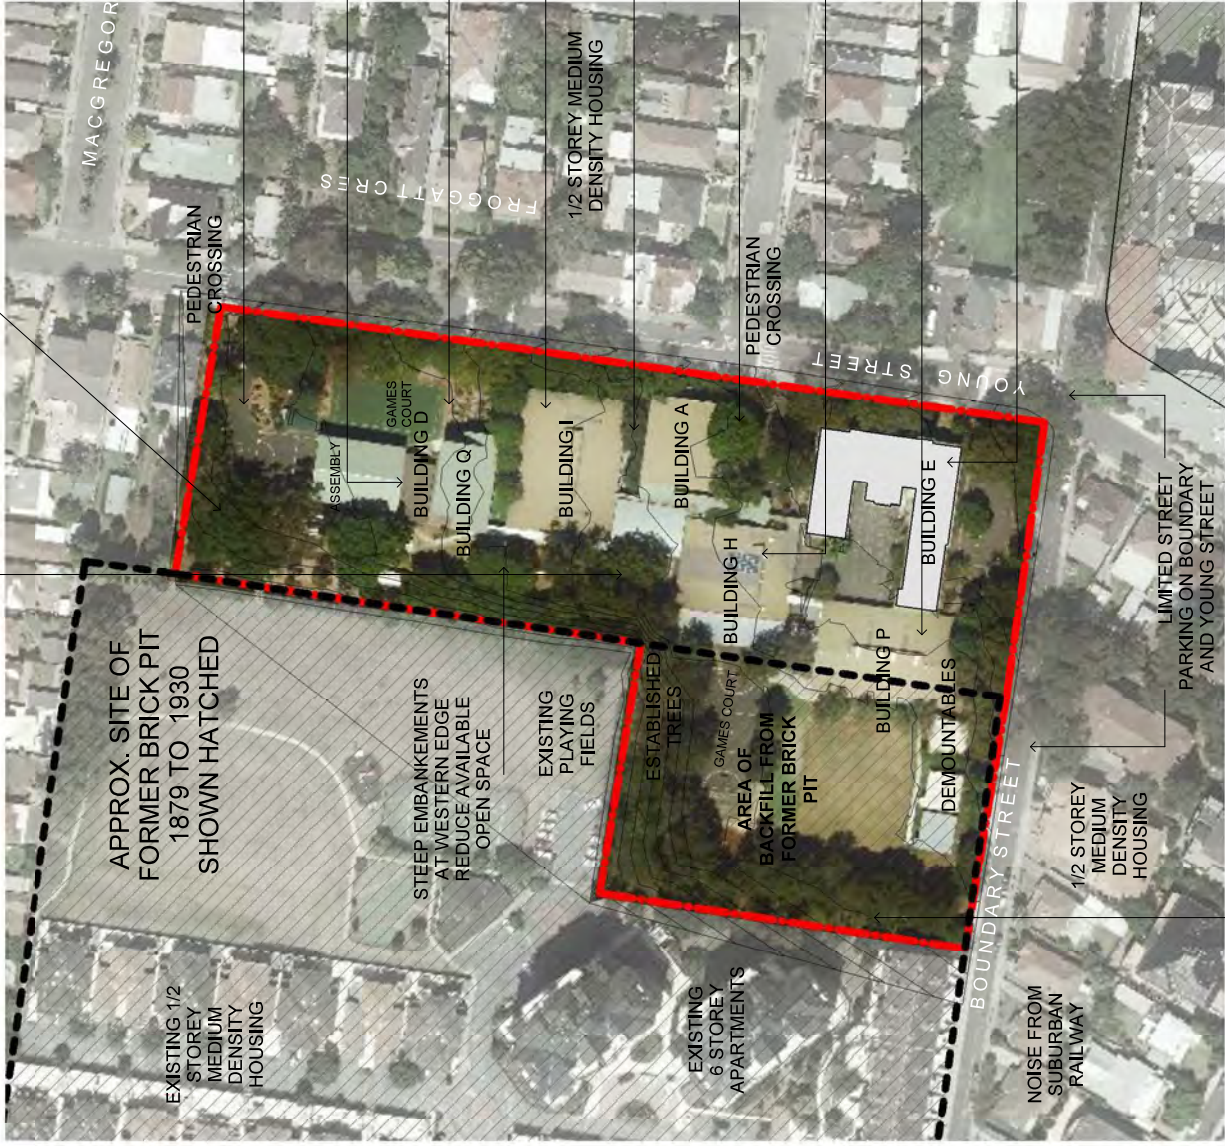
APPROX. SITE OF  
FORMER BRICK PIT  
1879 TO 1930  
SHOWN HATCHED

EXISTING 1/2  
STOREY  
MEDIUM  
DENSITY  
HOUSING

STEEP EMBANKMENTS  
AT WESTERN EDGE  
REDUCE AVAILABLE  
OPEN SPACE

EXISTING  
PLAYING  
FIELDS

EXISTING 6 STOREY  
APARTMENTS

ESTABLISHED  
TREES

GAIES COURT  
AREA OF  
BACKFILL FROM  
FORMER BRICK  
PIT

DEMOUNTABLES

NOISE FROM  
SUBURBAN  
RAILWAY

1/2 STOREY  
MEDIUM  
DENSITY  
HOUSING

LIMITED STREET  
PARKING ON BOUNDARY  
AND YOUNG STREET

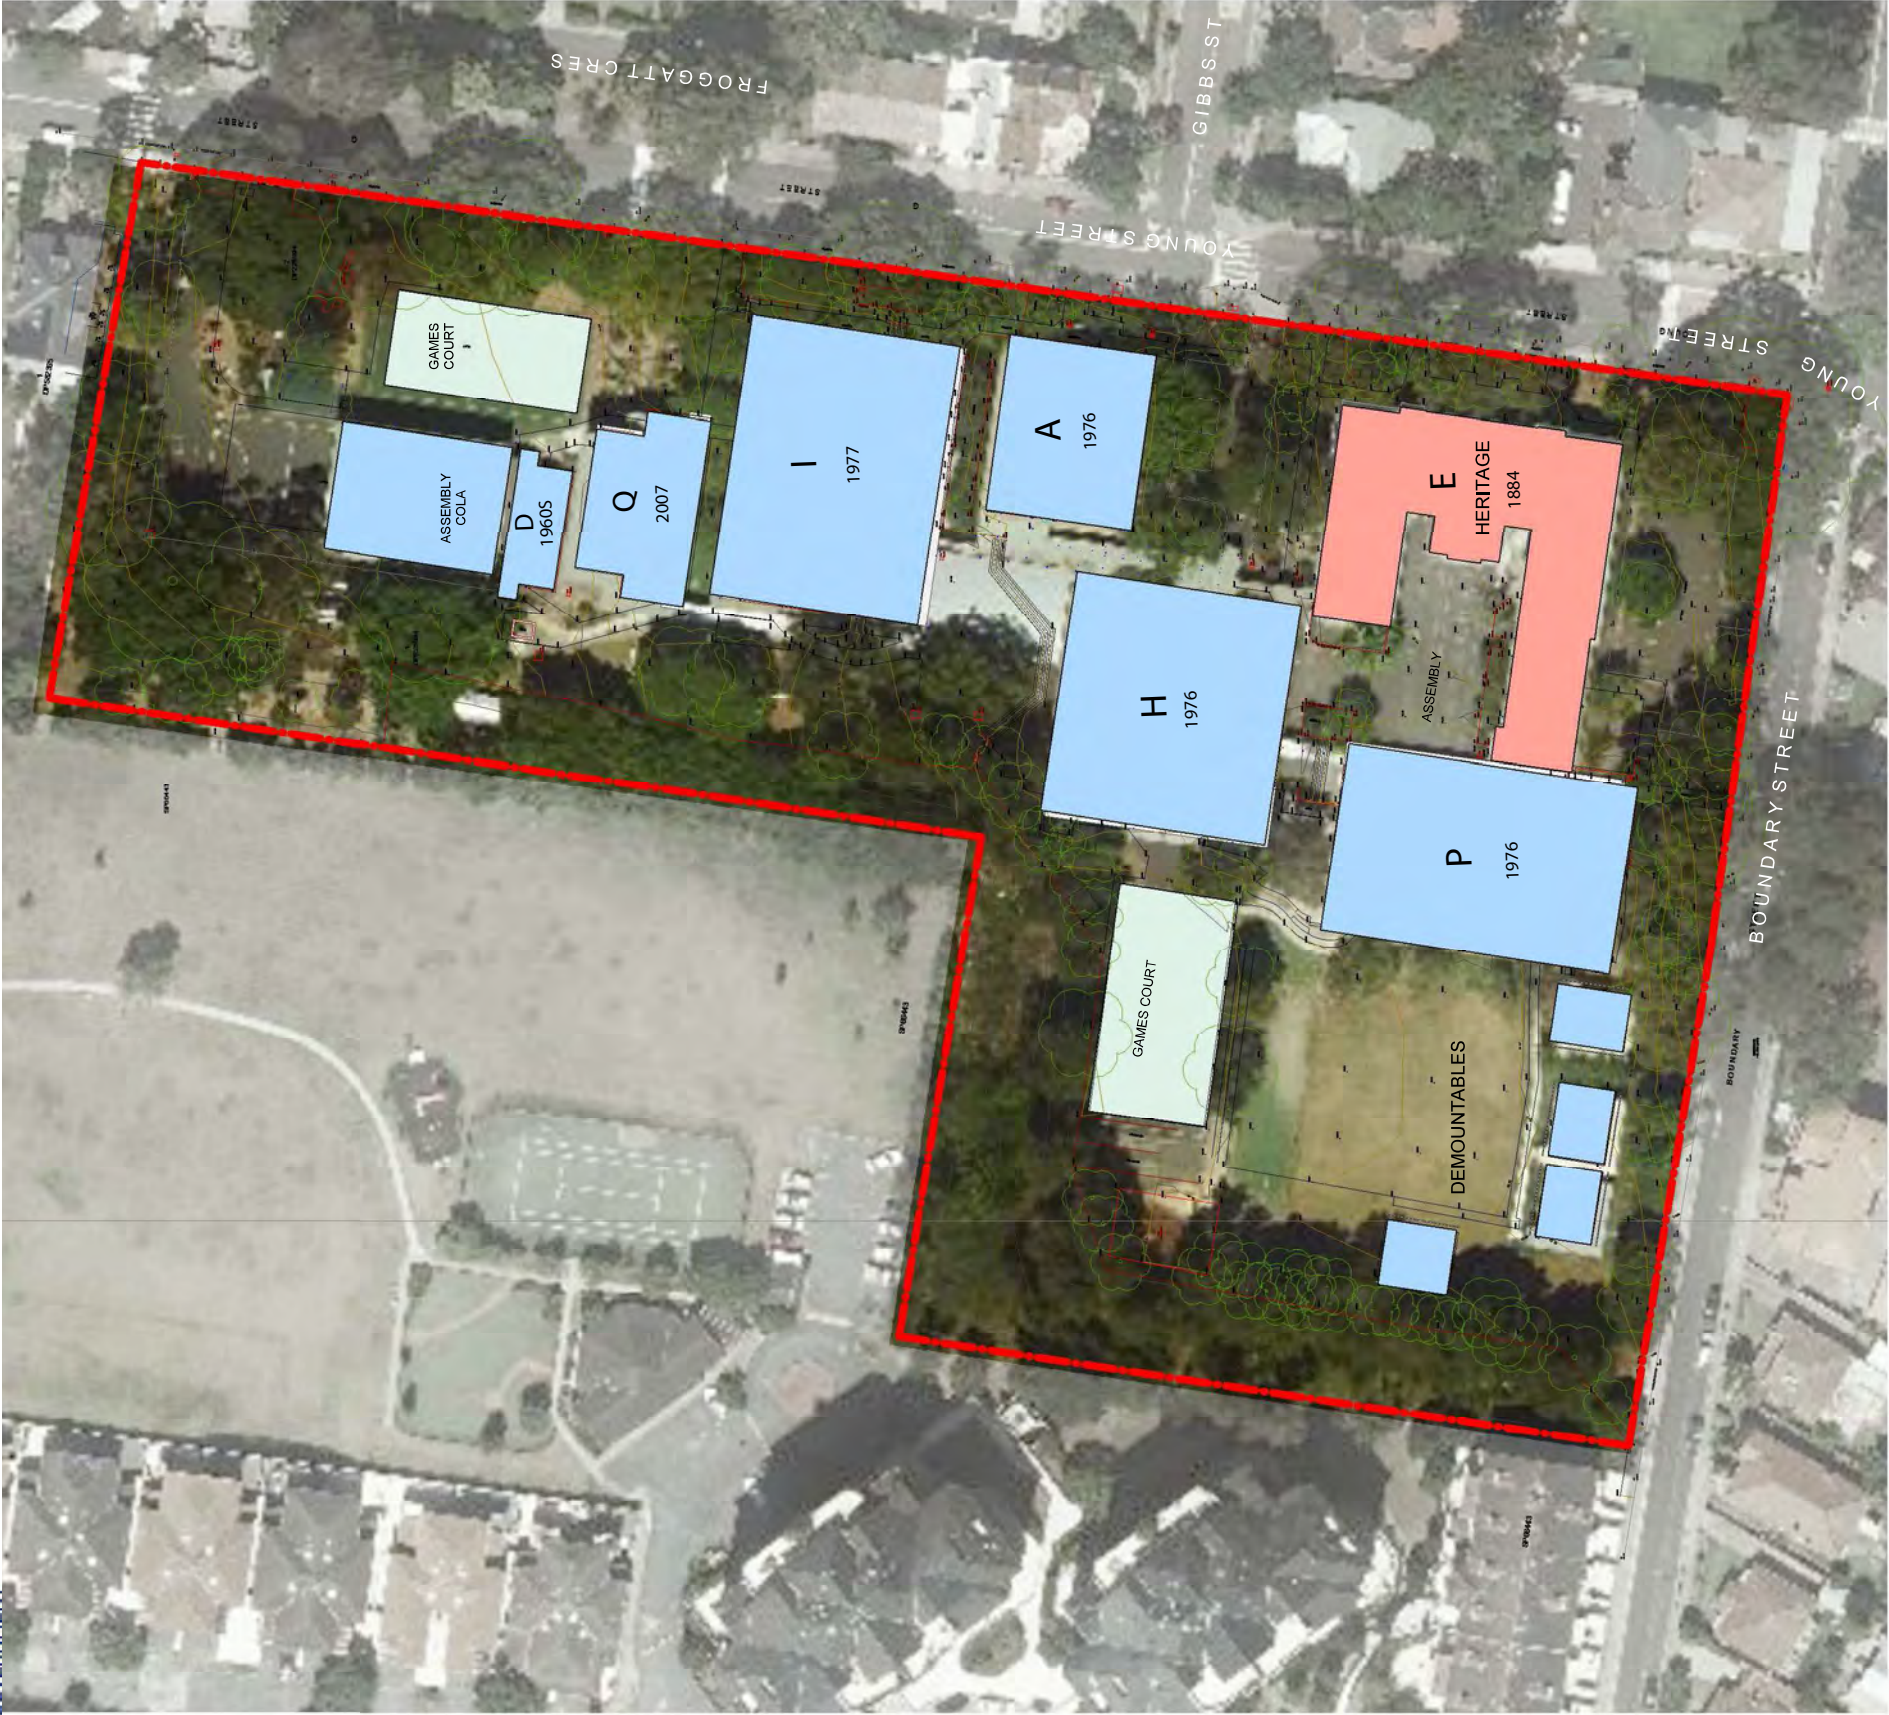
BUILDING Q: 2009 BER BUILDING. 4 HOMEBASES &  
STOREROOMS. EFSG COMPLIANT. 2 STOREY BUILDING  
WITH RAMP ACCESS. GOOD CONDITION, POORLY SITED  
BLOCKING REMAINING BUILDINGS.

BUILDING I: 1977s SPLIT LEVEL BUILDING.  
DIFFICULTIES WITH ACCESSIBILITY, EXISTING INFANT  
HOMEBASES, UNDERSIZED ROOMS FOR EFSG

BUILDING A: 1976. 2 STOREY  
LIBRARY & ADMINISTRATION. UNDERSIZED  
FOR EFSG, INTRUSIVE EXTERNAL RAMP  
ACCESS TO UPPER FLOOR

INTRUSIVE CARPARK TO CENTRAL AREA OF  
SCHOOL

BUILDING H: 1976. SPLIT LEVEL  
HALL & CANTEN OPENING TO BACK  
OF STAGE.

BUILDING P: SPLIT / 2 LEVEL HOMEBASES,  
UNDERSIZED TO EFSG, DIFFICULTIES WITH  
ACCESSIBILITY ACCESS.

BUILDING E: HERITAGE ITEM. SIGNIFICANT  
CRACKING TO EXISTING FABRIC, BUILDING IS ON  
MULTIPLE SPLIT LEVELS WITH STAIR ACCESS.
