Proposed Alex Avenue Public School, 28 Farmland Drive, Schofields NSW 2762

Richard Crooks Constructions Pty Ltd 10 September 2019

19175_SAR155

Site Audit Statement

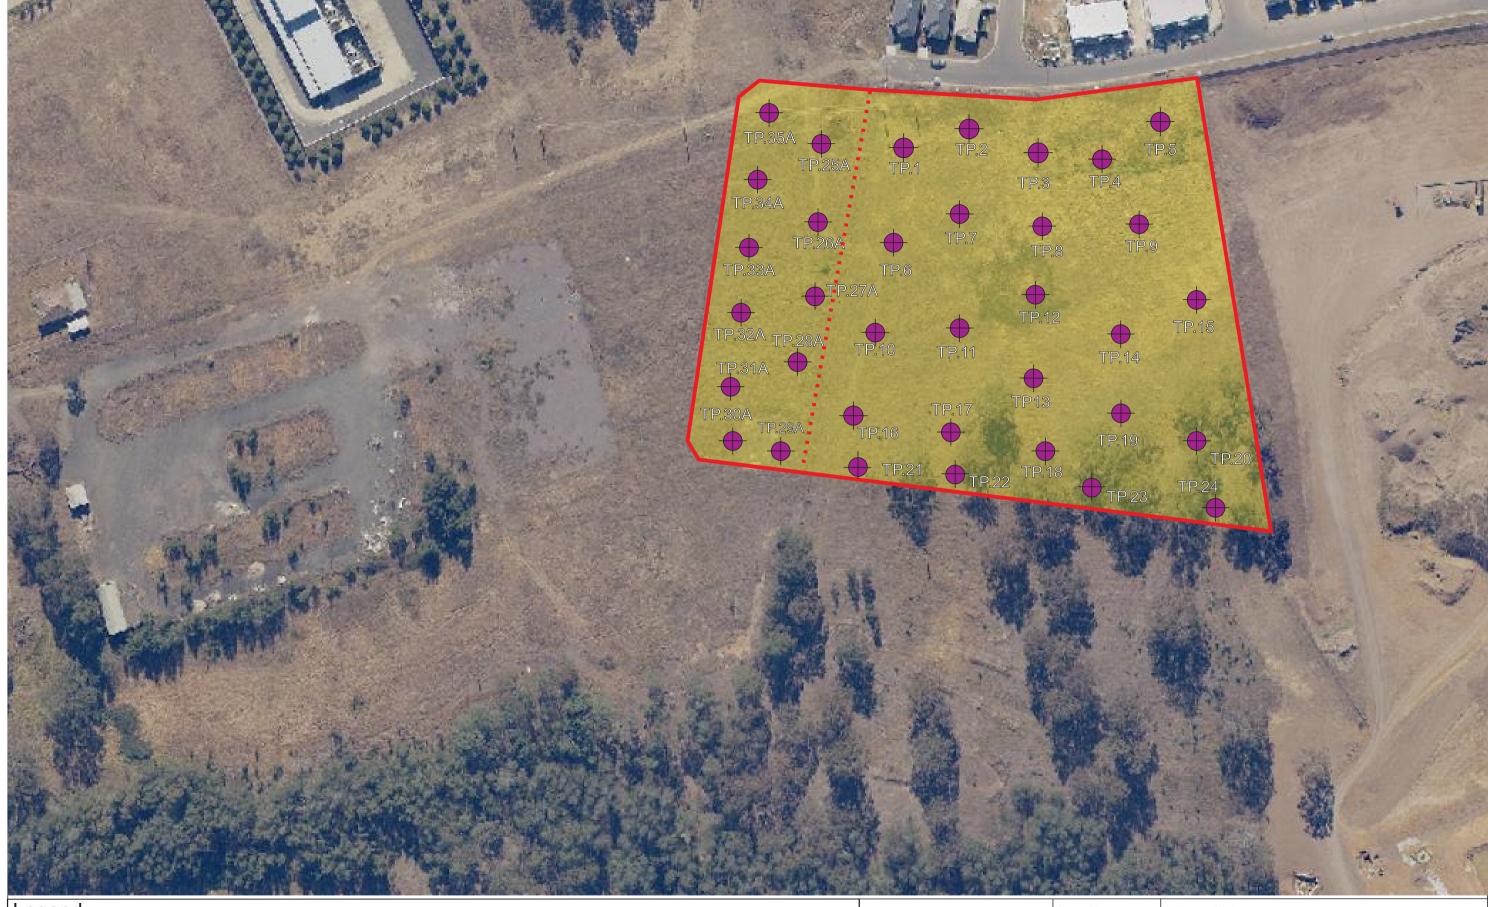
Client Name:		Group GSA				
GREENCAP	Client Number:		C122140 Project Number:		: J157372		
Going Further in Managing Risk	Project Description:		Detailed Site Assessment				
Level 2, 11-17 Khartoum Road North Ryde, NSW 2113	Address:		Cnr Farmland Dr & future realignment of Pelican Rd, Schofields NSW 2762				
Ph: 02-9889-1800	Prepared:	: NXB Reviewed: MB Date: 2			21/01/2019		
Fx: 02-9889-1811	Figure 1	Sample	Sample Locations

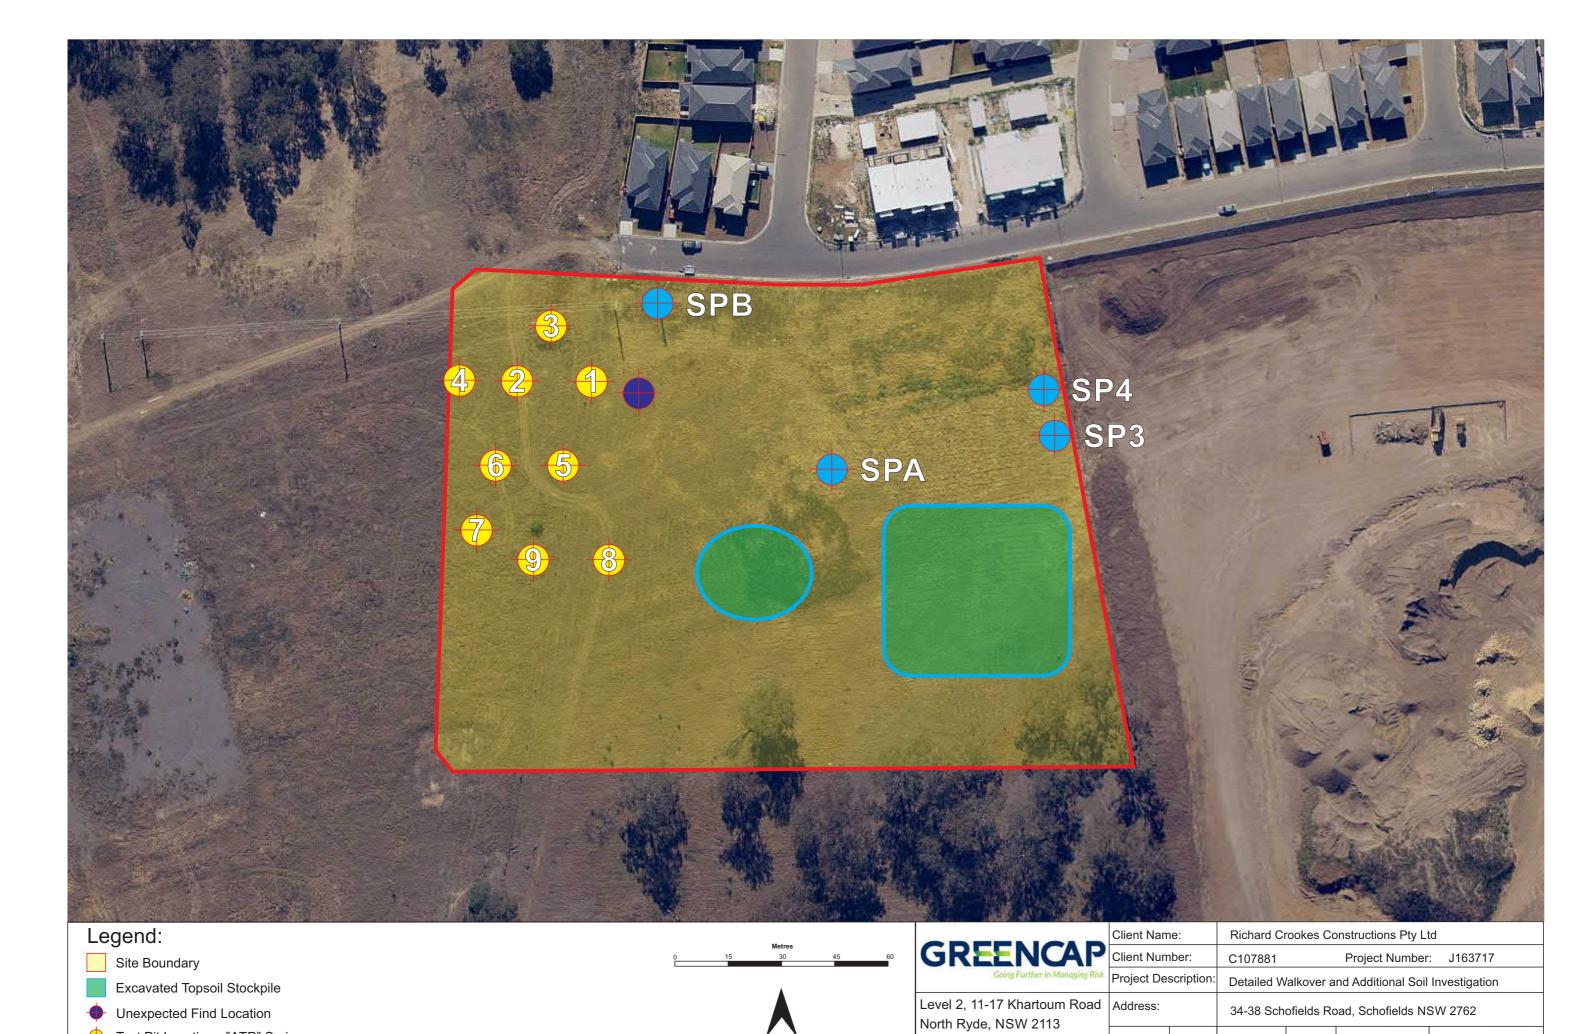
Fx: 02-9889-1811 Site Boundary & Stockpile Locations Disclaimer: Greencap-NAA Pty Ltd has produced this map for the purpose of presenting a summary of relevant spatial information and gives no warranty in relation to the data (including accuracy, reliability, for negligence) for any loss, damage or costs (including consequential damage) relating to any use of or reliance upon the data. Data must not be used for direct marketing or be used in breach of privacy laws. Service Layer Credits: © 2019 NSW Land and Property Information (Six Maps) and © 2019 NearMap Pty Ltd.

Test Pit Location - "ATP" Series

Fill Stockpile Location

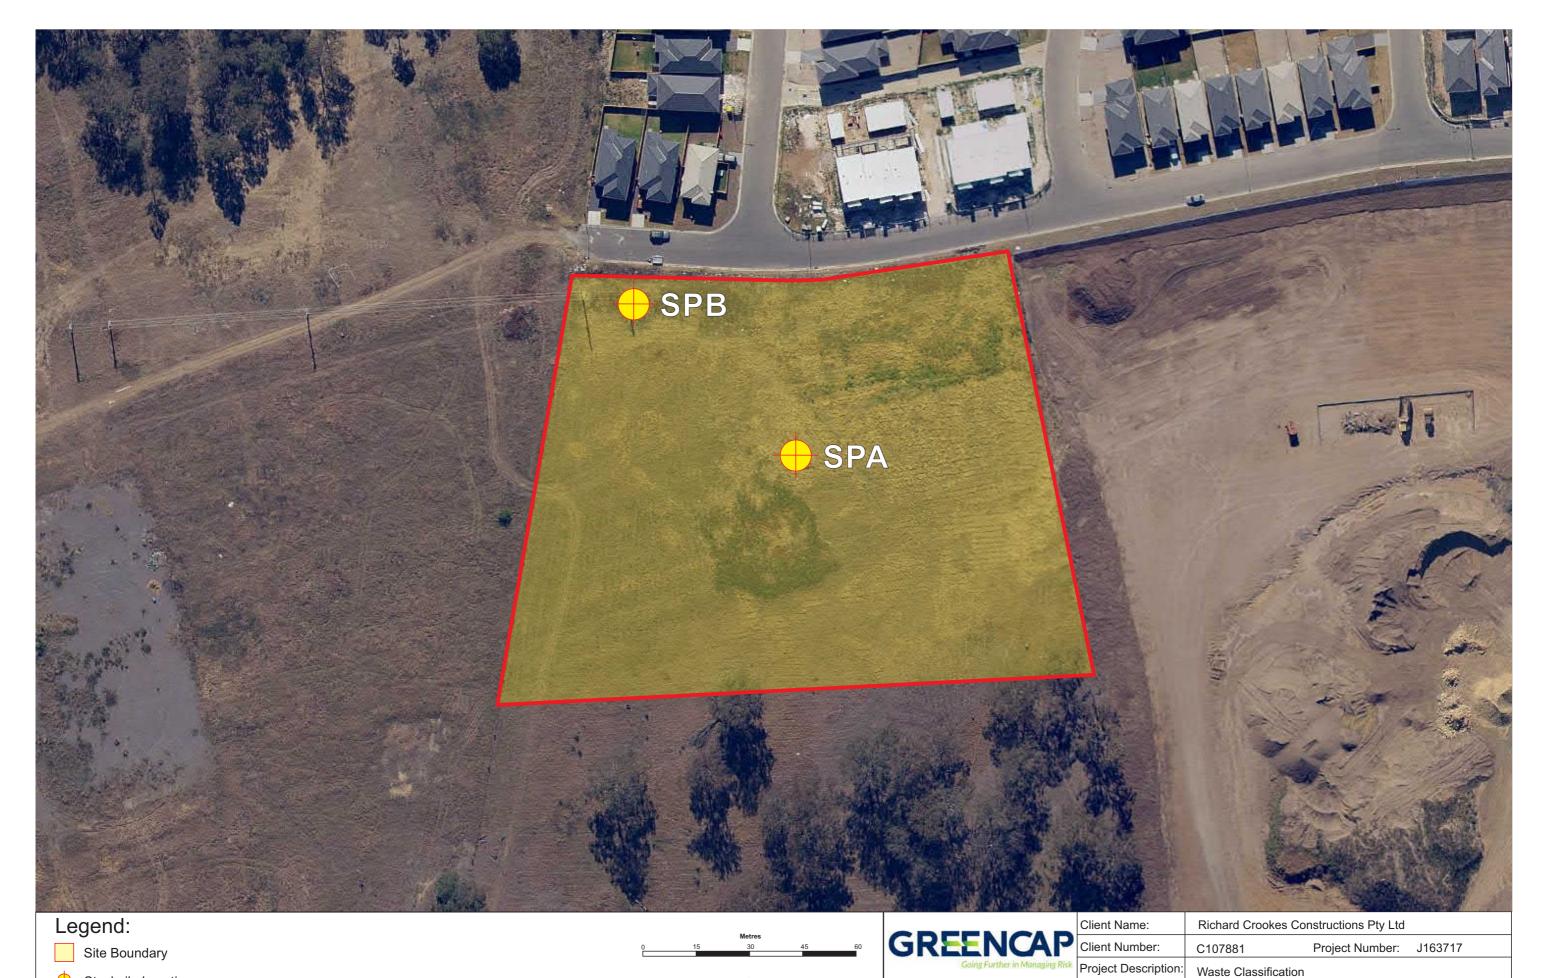
Figure 2

Site Boundary & Stockpile Locations

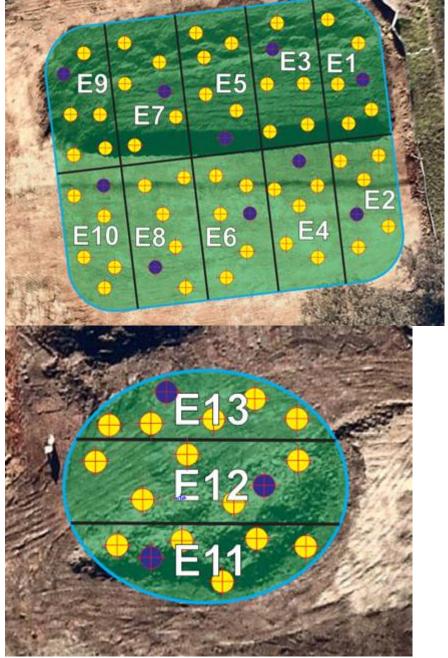
Stockpile 1 Stockpile 2

Please see below the sampling locations of the two stockpiles.

As a result, the four above-mentioned quadrants will be required to be separated and stockpiled separately. However, as a minimum of three valid ENM samples are required for stockpile 2, this stockpile cannot be classified as ENM. Therefore, we recommend that E3, E5 & E6 are removed from stockpile 1 and combined with stockpile 2. Stockpile 2 (now consisting of E3, E5, E6, E11, E12 and E13) may be classified as GSW with the laboratory analysis which has already been undertaken. We can provide a separate waste classification for the new "Stockpile 2" at our standard rate of \$850 excl.GST (if this material will be required to be exported from the site).
