Report on
Geotechnical Investigation

Carpark P6D (Site 2)
Cnr Australia Ave and Parkview Dr
Sydney Olympic Park

Prepared for
Ecove Group Pty Ltd

Project 86411.00
September 2018

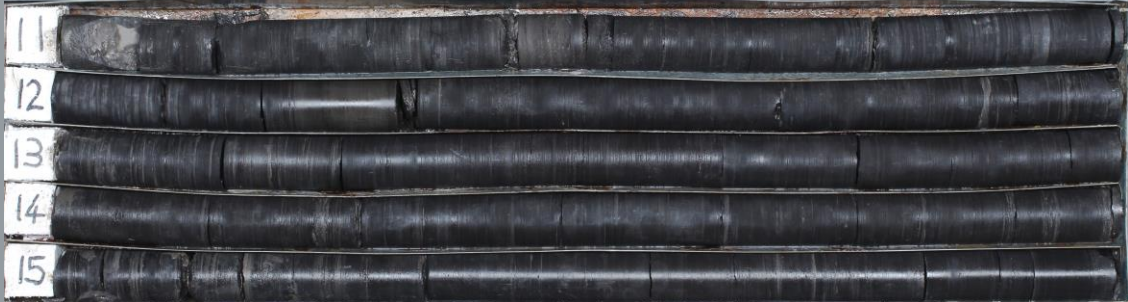
11.0 - 16.0m

Project No: 86411.00
BH ID: BH 1
Depth: 11.00 - 16.00 m
Core Box No.: 3

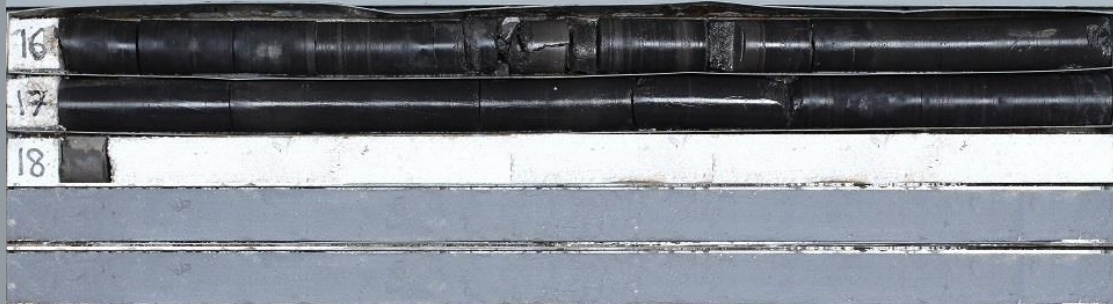
16.0 - 18.05m

Project No: 86411.00
BH ID: BH 1
Depth: 16.00 - 18.05 m
Core Box No.: 4

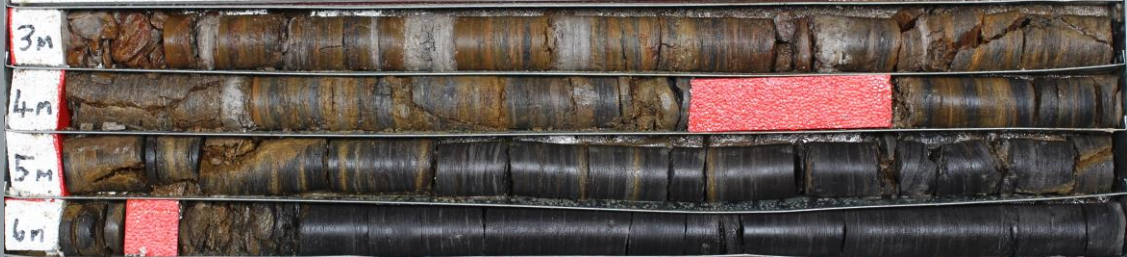
3.0 - 7.0 m

OLYMIC Park BH2 86411.00 START 3.M

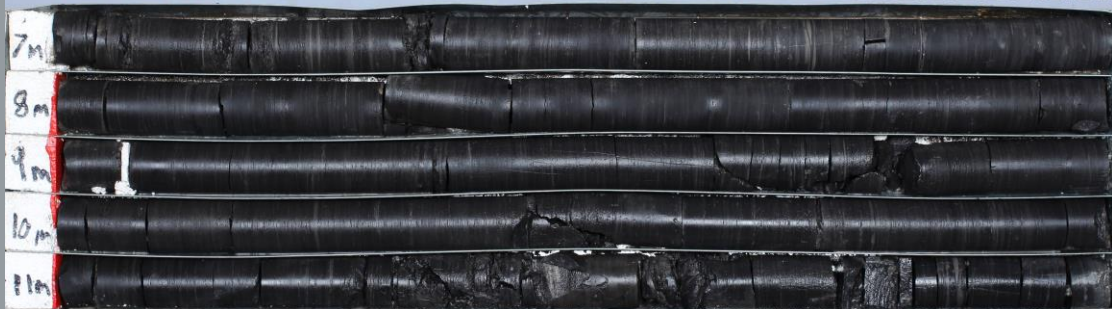
7.0 - 12.0 m

Project No: 86411.00
BH ID: BH 2
Depth: 7.00 - 12.00 m
Core Box No.: 2

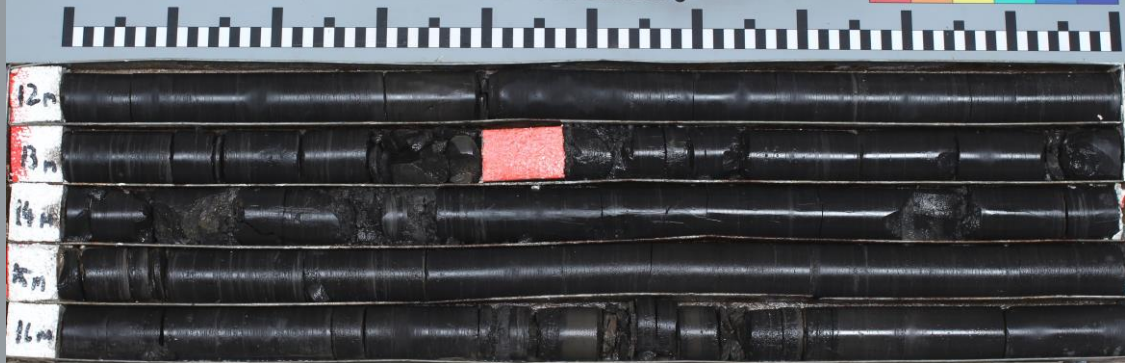
12.0 - 17.0m

Project No: 86411.00
BH ID: BM 2
Depth: 12.00 - 17.00 m
Core Box No.: 3

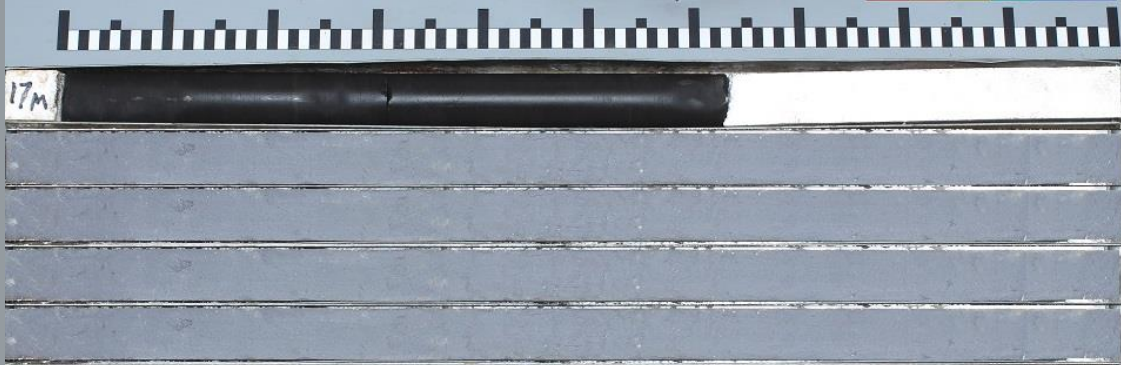
17.0 - 17.6m

Project No: 86411.00
BH ID: BM 2
Depth: 17.00 - 17.60 m
Core Box No.: 4

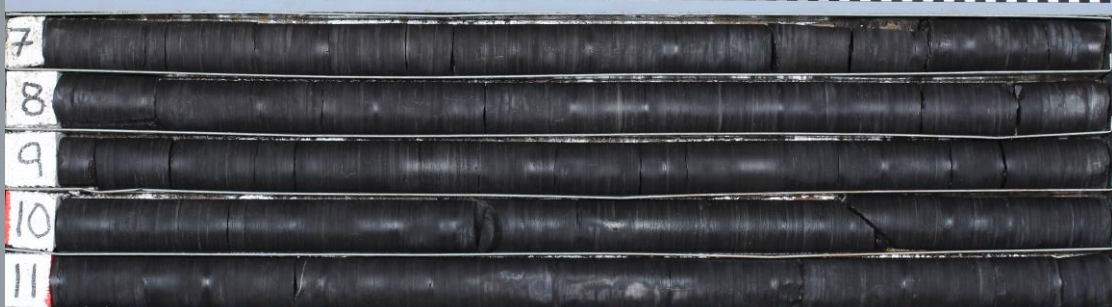
7.0 - 12.0m

Project No: 86411.00
BH ID: BH 3
Depth: 7.00 - 12.00 m
Core Box No.: 2

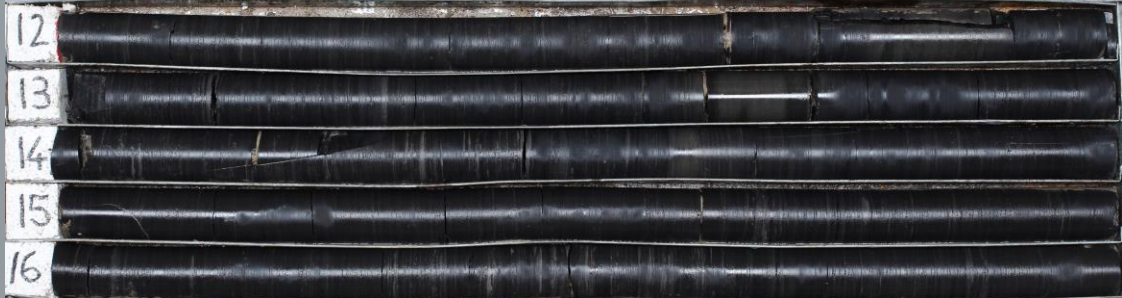
12.0 – 17.0m

Project No: 86411.00
BH ID: BH 3
Depth: 12.00 — 17.00 m
Core Box No.: 3

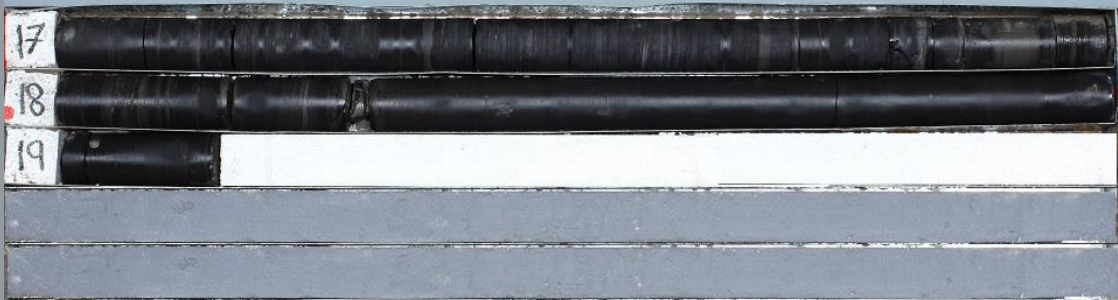
17.0 – 19.15m

Project No: 86411.00
BH ID: BH 3
Depth: 17.00 — 19.15 m
Core Box No.: 4

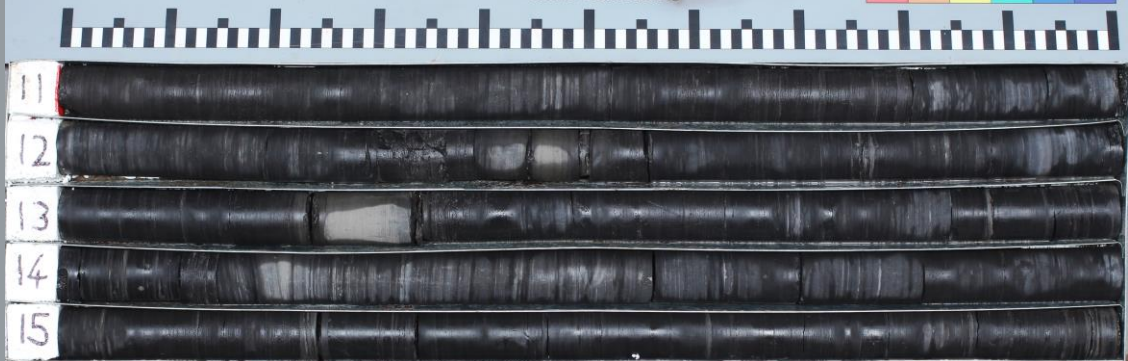
11.0 - 16.0m

Project No: 86411.00
BH ID: BH 4
Depth: 11.00 - 16.00m
Core Box No.: 3

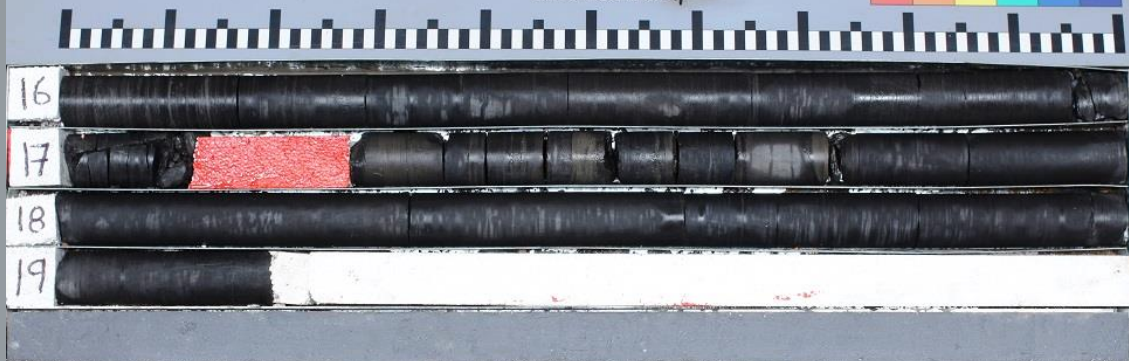
16.0 - 19.2m

Project No: 86411.00
BH ID: BH 4
Depth: 16.00 - 19.20
Core Box No.: 4

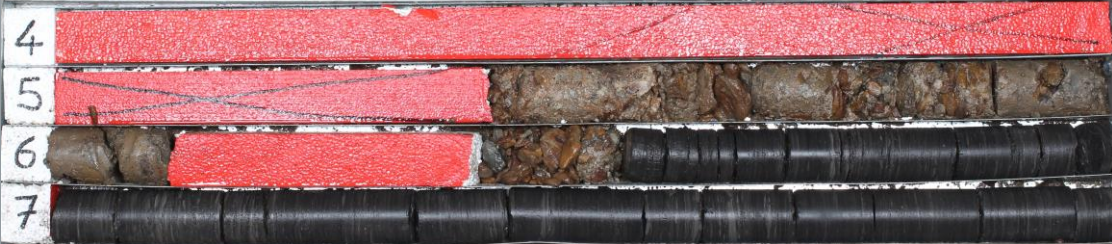
4.0 - 8.0m

Olympic Park 86411.00 BHS 3/9/12 Start coring @ 4m

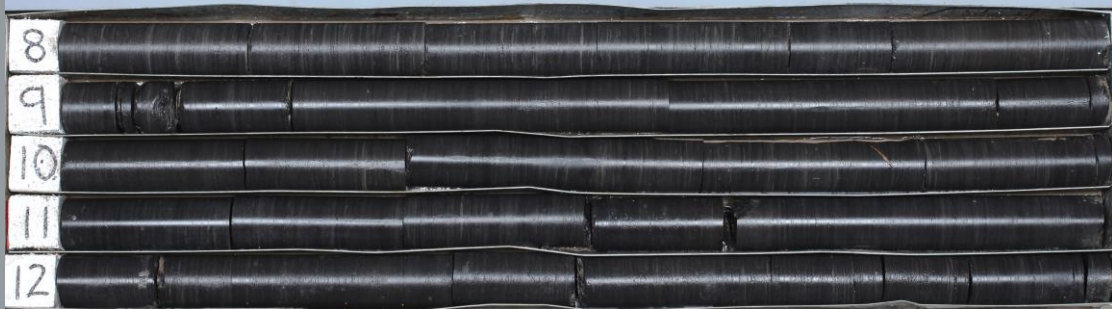
8.0 - 13.0m

Project No: 86411.00
BH ID: BH 5
Depth: 8.00 - 13.00 m
Core Box No.: 2

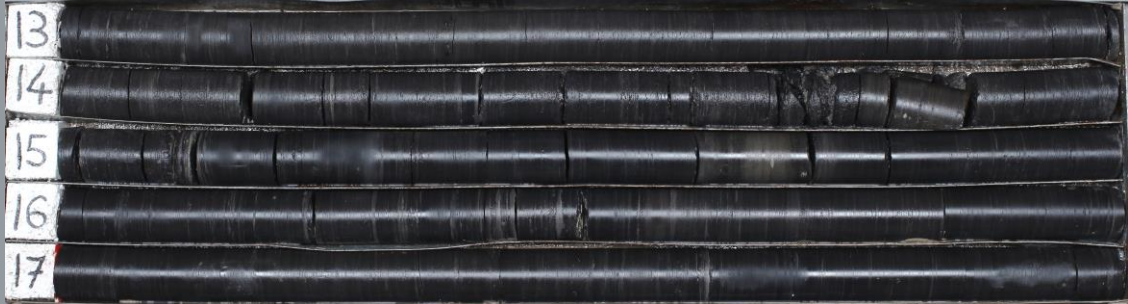
13.0 - 18.0m

Project No: 86411.00
BH ID: 8# 5
Depth: 13.00 - 18.00 m
Core Box No.: 3

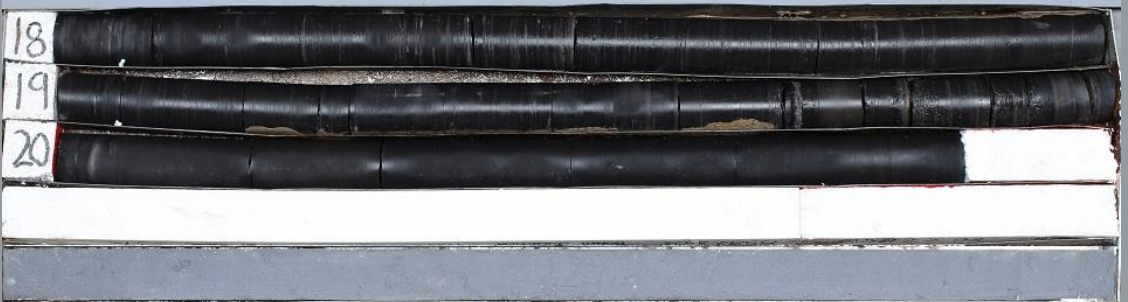
18.0 - 20.85m

Project No: 86411.00
BH ID: 8# 5
Depth: 18.00 - 20.85 m
Core Box No.: 4

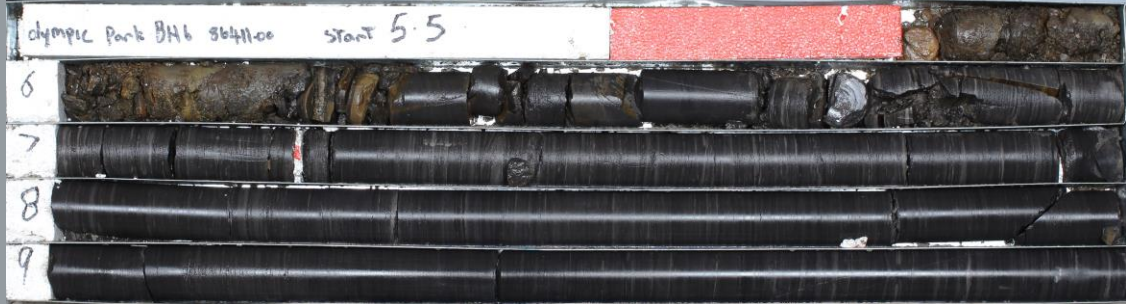
5.5 - 10.0m

Discontinuities observed in the core included bedding planes, joints, and the occasional sheared zone. Bedding planes dipped between 0 and 10° and joints between 45° and 90°, which is typical for Ashfield Shale in Sydney. Sheared zones were also identified, in particular in BH6 between RL 2.5 m and RL -2.5 m.

Project No: 86411.00
BH ID: 8H16
Depth: 5.50 - 10.00 m
Core Box No.: 1

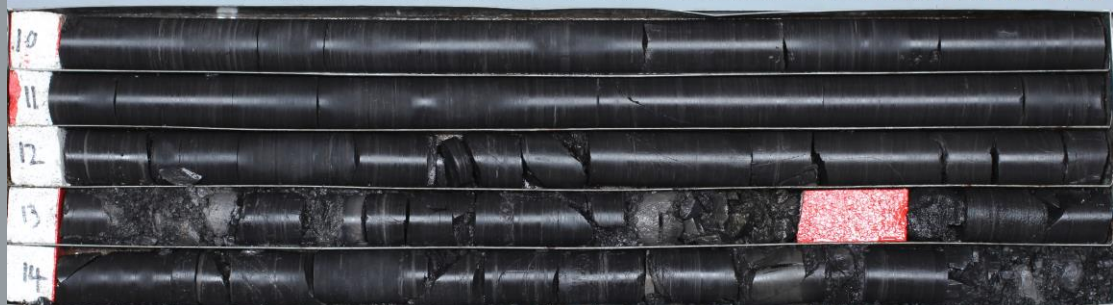
10.0 - 15.0m

Project No: 86411.00
BH ID: 8H16
Depth: 10.00 - 15.00 m
Core Box No.: 2

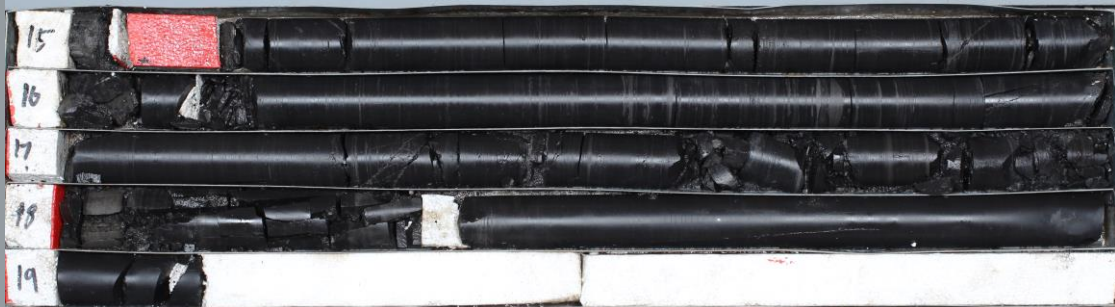
15.0 - 19.1m

Project No: 86411.00
BH ID: BH 16
Depth: 15.00 - 19.10 m
Core Box No.: 3
