New Primary School at Warnervale for SSD Application

Strategic Design (Pre-Construction) Road Safety Audit

12 December 2019

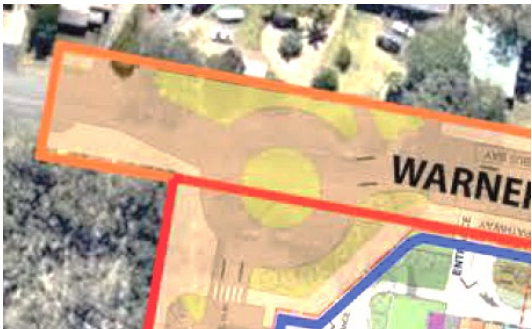
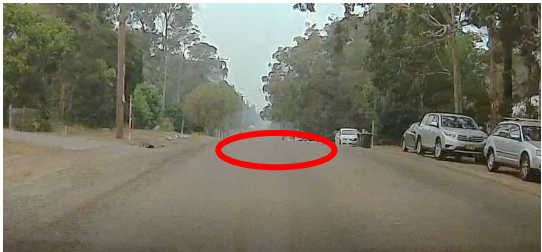
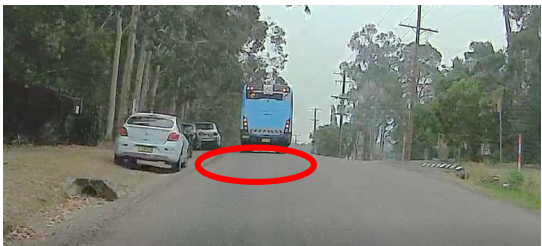
| Item No. | Location | Descriptions of Findings | Design | Likelihood | Severity | Risk Rating | Designer Response |
|---|--|---|--|---|---|---|---|
| 1. | Proposed roundabout on Warnervale Road | <p>The proposed roundabout is located on a crest. Motorists' sight lines may be compromised and hence not expecting a roundabout on Warnervale Road.</p> <p>Furthermore, the design does not include a splitter island on any approaches to the roundabout to enhance visibility to the roundabout and deflect vehicles to curve around the roundabout island.</p> <p>Risk of motorists travelling straight through the roundabout island resulting in conflicts with other vehicles.</p> | <p>Diagram above: strategic design of the roundabout</p> <p>Photo above: Eastbound approach to the proposed roundabout location</p> <p>Photo above: Westbound approach to the proposed roundabout location</p> | Occasional | Moderate | Medium | |

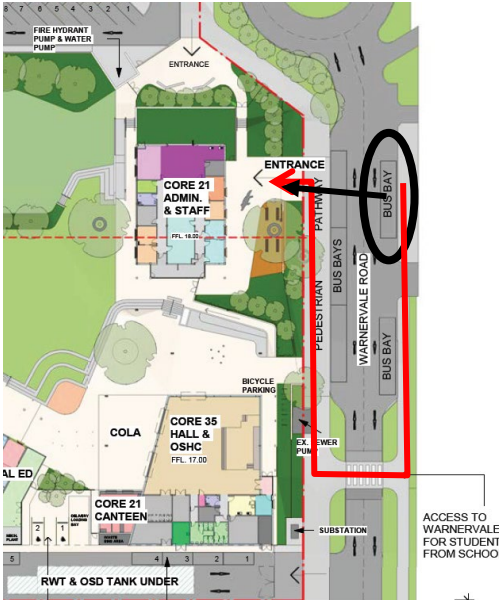
| Item No. | Location | Descriptions of Findings | Design | Likelihood | Severity | Risk Rating | Designer Response |
|---|---|--|---|---|---|---|---|
| 4. | Proposed pedestrian crossing on Warnervale Road | <p>The proposed pedestrian crossing on Warnervale Road is located away from the main school entrance.</p> <p>Consequently, students alighting a bus at the westernmost bus stop on the north side of Warnervale Road may not use the proposed pedestrian crossing and may take the shortest route across Warnervale Road which may lead to incidents with vehicles on Warnervale Road.</p> | | Improbable | Moderate | Low | |

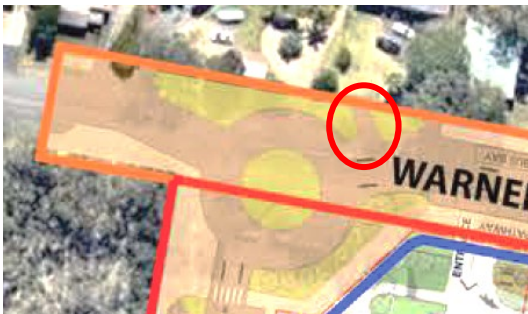
| Item No. | Location | Descriptions of Findings | Design | Likelihood | Severity | Risk Rating | Designer Response |
|---|---|--|---|---|---|---|---|
| 5. | No. 50 Warnervale Road driveway | <p>The distance between the existing driveway of No. 50 Warnervale Road and the roundabout is approximately 3m which is less than the minimum requirement of 6m according to AS2890.1.</p> <p>In addition, there are no physical measures to prevent vehicles turning right into and out of the driveway adjacent to the roundabout.</p> <p>Risk of a vehicle entering the roundabout circulation lane directly from the No. 50 Warnervale Road driveway. This would increase traffic conflicts at the roundabout.</p> | | Improbable | Moderate | Low | |

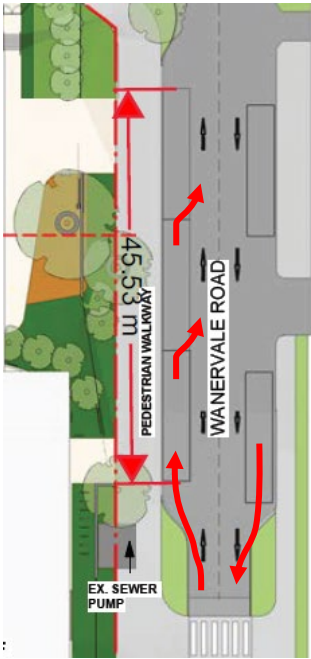
| Item No. | Location | Descriptions of Findings | Design | Likelihood | Severity | Risk Rating | Designer Response |
|---|---|--|---|---|---|---|---|
| 6. | Proposed bus zones on Warnervale Road | <p>The bus zone on the south side of Warnervale Road appears to be 45m to accommodate three buses. This is insufficient to enable a bus to manoeuvre into the third bus bay, and a bus to leave the second and third bus bay, when other bus bays are occupied.</p> <p>Furthermore, the length of the first bus zone on the north side of Warnervale Road is insufficient to enable a bus to draw out due to the kerb build out.</p> | | - | - | Note only | |

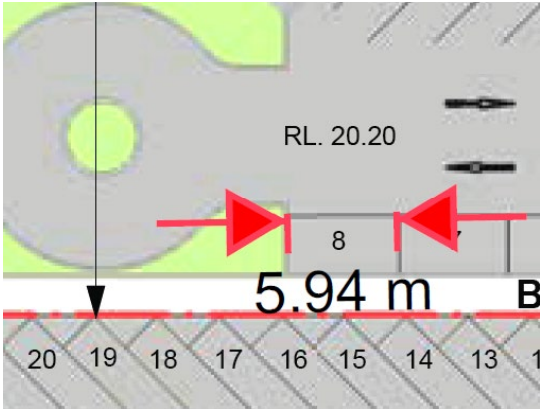
| Item No. | Location | Descriptions of Findings | Design | Likelihood | Severity | Risk Rating | Designer Response |
|---|---|--|---|---|---|---|---|
| 7. | Proposed off-street car park | Parking bay 8 appears to be approximately 6m long which is less than the minimum requirement of 6.2m as an obstructed end space according to AS2890.1. | | - | - | Note only | |

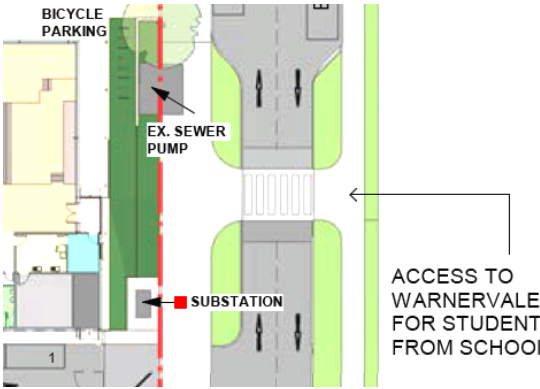
| Item No. | Location | Descriptions of Findings | Design | Likelihood | Severity | Risk Rating | Designer Response |
|---|---|--|---|---|---|---|---|
| 8. | Proposed pedestrian crossing on Warnervale Road | The proposed pedestrian crossing may not meet the numerical warrant given the low pedestrian volumes across Warnervale Road. | | - | - | Note only | |

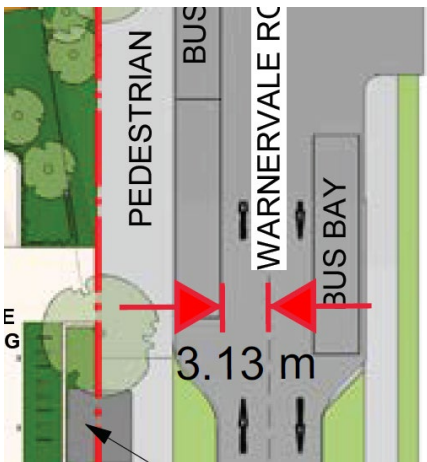
| Item No. | Location | Descriptions of Findings | Design | Likelihood | Severity | Risk Rating | Designer Response |
|---|---|---|---|---|---|---|---|
| 9. | Travel lanes on Warnervale Road | The width of the travel lane on Warnervale Road appears to be 3.1m which is less than the minimum requirement of 3.25m for a bus route. | | - | - | Note only | |

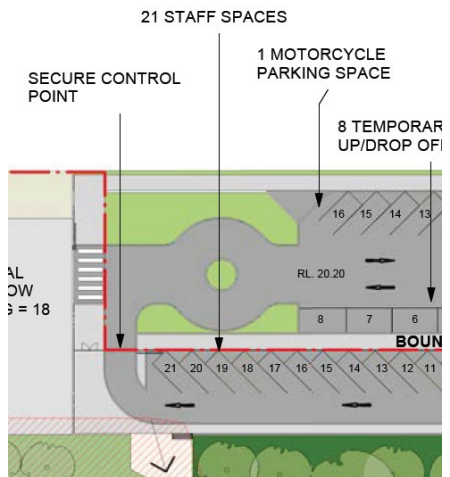
| Item No. | Location | Descriptions of Findings | Design | Likelihood | Severity | Risk Rating | Designer Response |
|---|---|---|---|---|---|---|---|
| 10. | Internal roundabout | Swept path analysis should be undertaken to confirm a B-99 passenger vehicle can turn-around within the proposed roundabout. | | - | - | Note only | |

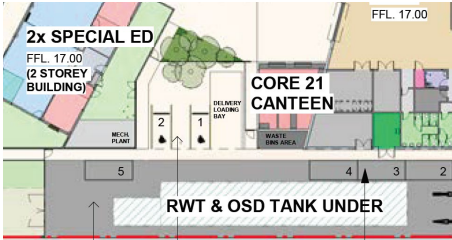
| Item No. | Location | Descriptions of Findings | Design | Likelihood | Severity | Risk Rating | Designer Response |
|---|--|---|---|---|---|---|---|
| 11. | Internal roundabout | Swept path analysis should be undertaken to confirm that the largest service vehicle can enter and exit the school in a forward direction. | | - | - | Note only | |

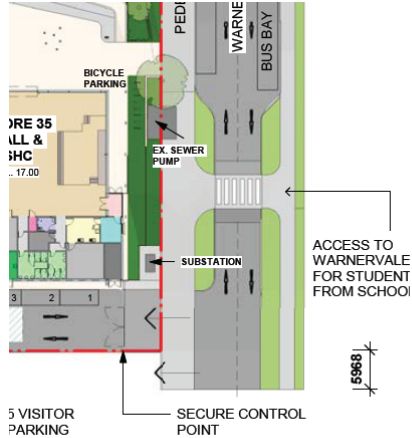
| Item No. | Location | Descriptions of Findings | Design | Likelihood | Severity | Risk Rating | Designer Response |
|---|---|--|---|---|---|---|---|
| 13. | Bicycle parking | Bicycle parking is proposed within the proposed new school. However, no dedicated cycle facilities are provided for teachers who cycle to/ from school along Warnervale Road. | | - | - | Note only | |

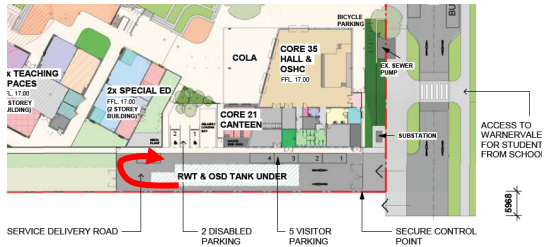
| Item No. | Location | Descriptions of Findings | Design | Likelihood | Severity | Risk Rating | Designer Response |
|---|---|--|---|---|---|---|---|
| 14. | Eastern school car park. | The eastern school car park does not provide any turnaround facilities within the car park. | | - | - | Note only | |

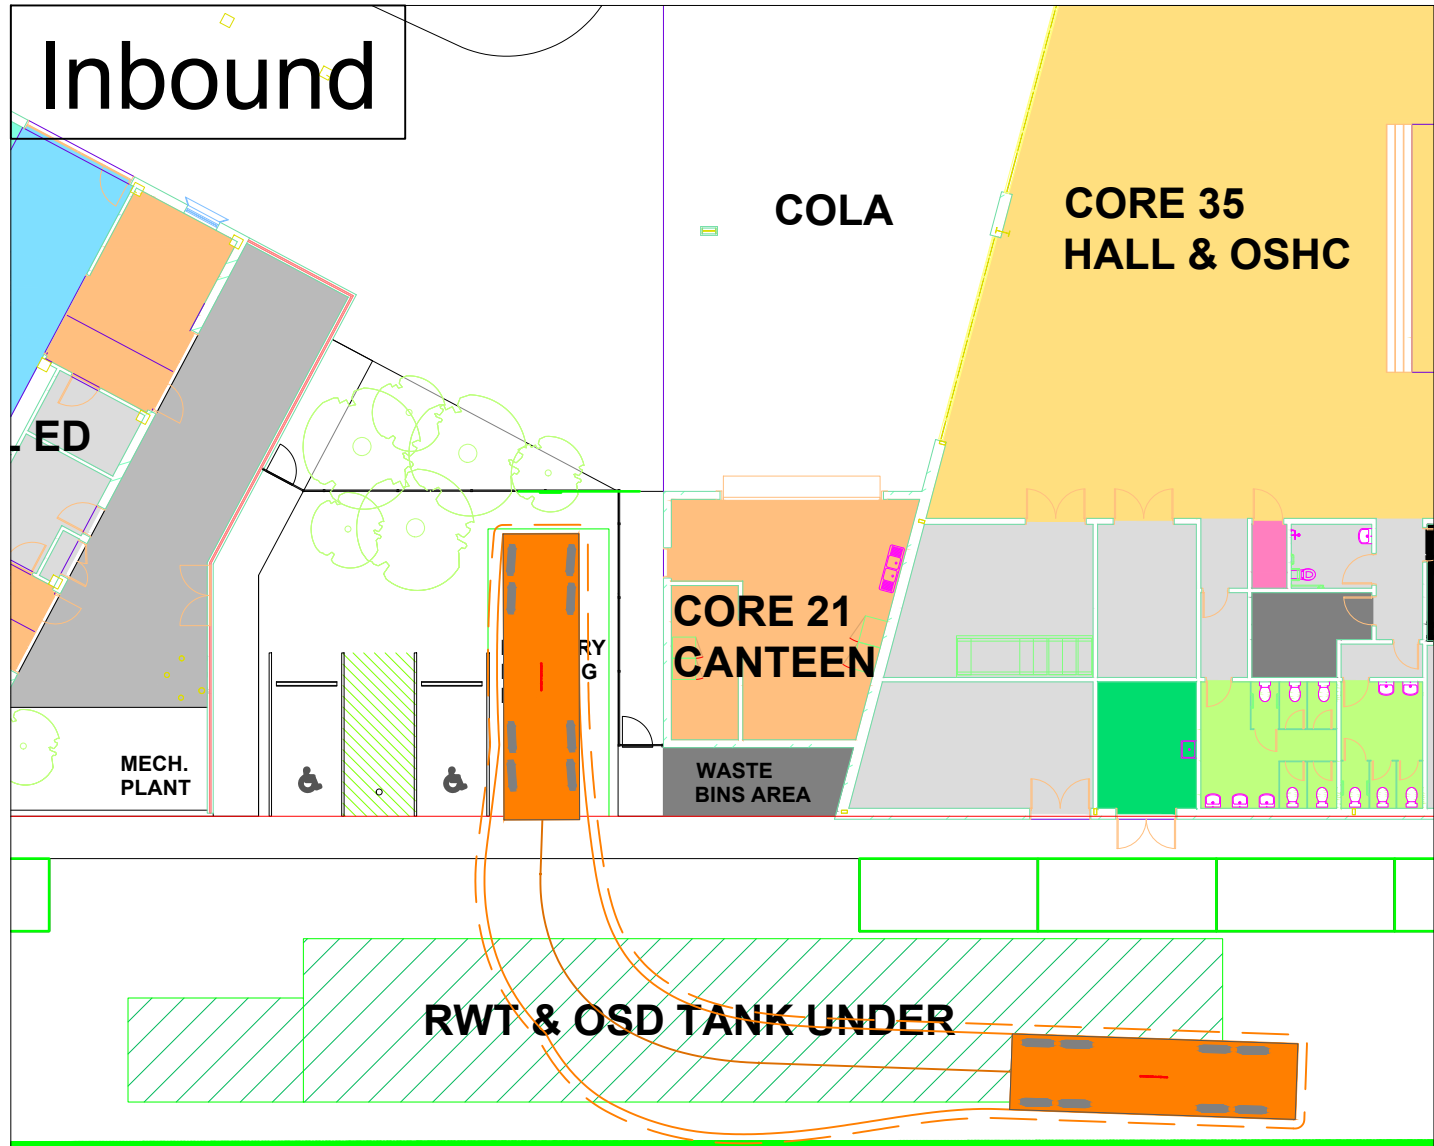
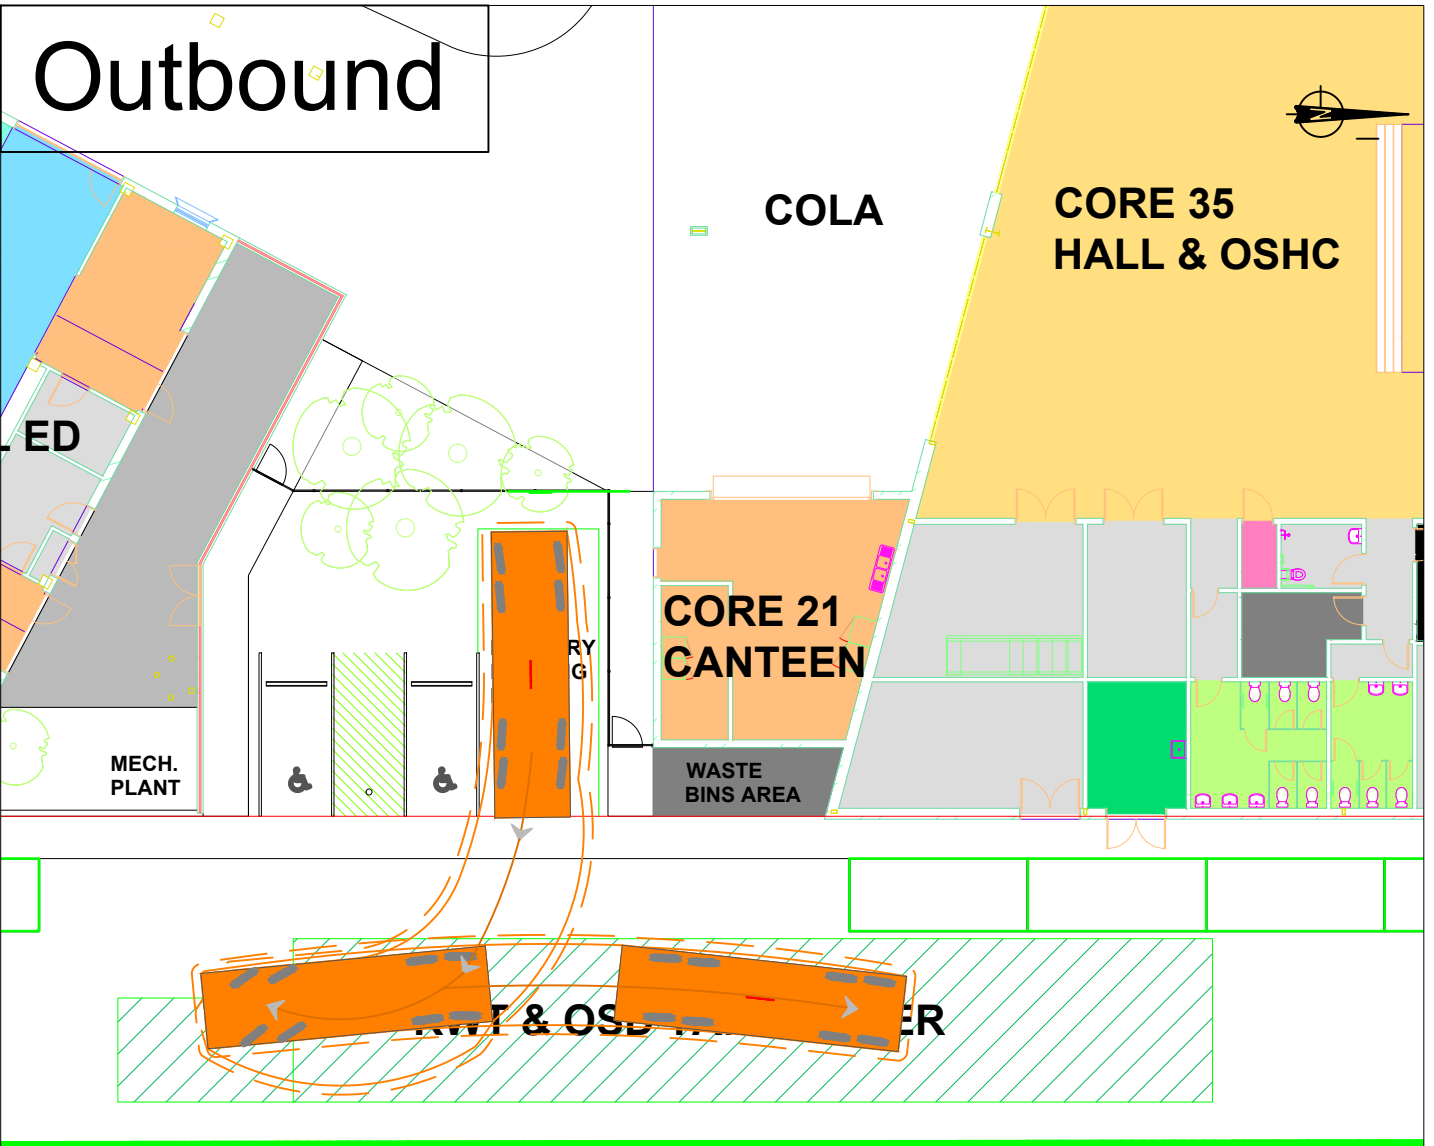
Warnervale Public School
Swept Path Assessment
9.45 metres Front Loader (Waste Collection Truck)

9.45 Front Lifting Truck

Width : 2500
Track : 2220
Lock to Lock Time : 6.0
Steering Angle : 28.0
