# **Stage 1 Soil Supplemented Preliminary Environmental Site Assessment**

**151 Tallawong Road  
Rouse Hill NSW 2155  
Lot 42 DP 30186**

**DL3280\_S001502**

**March 2014**

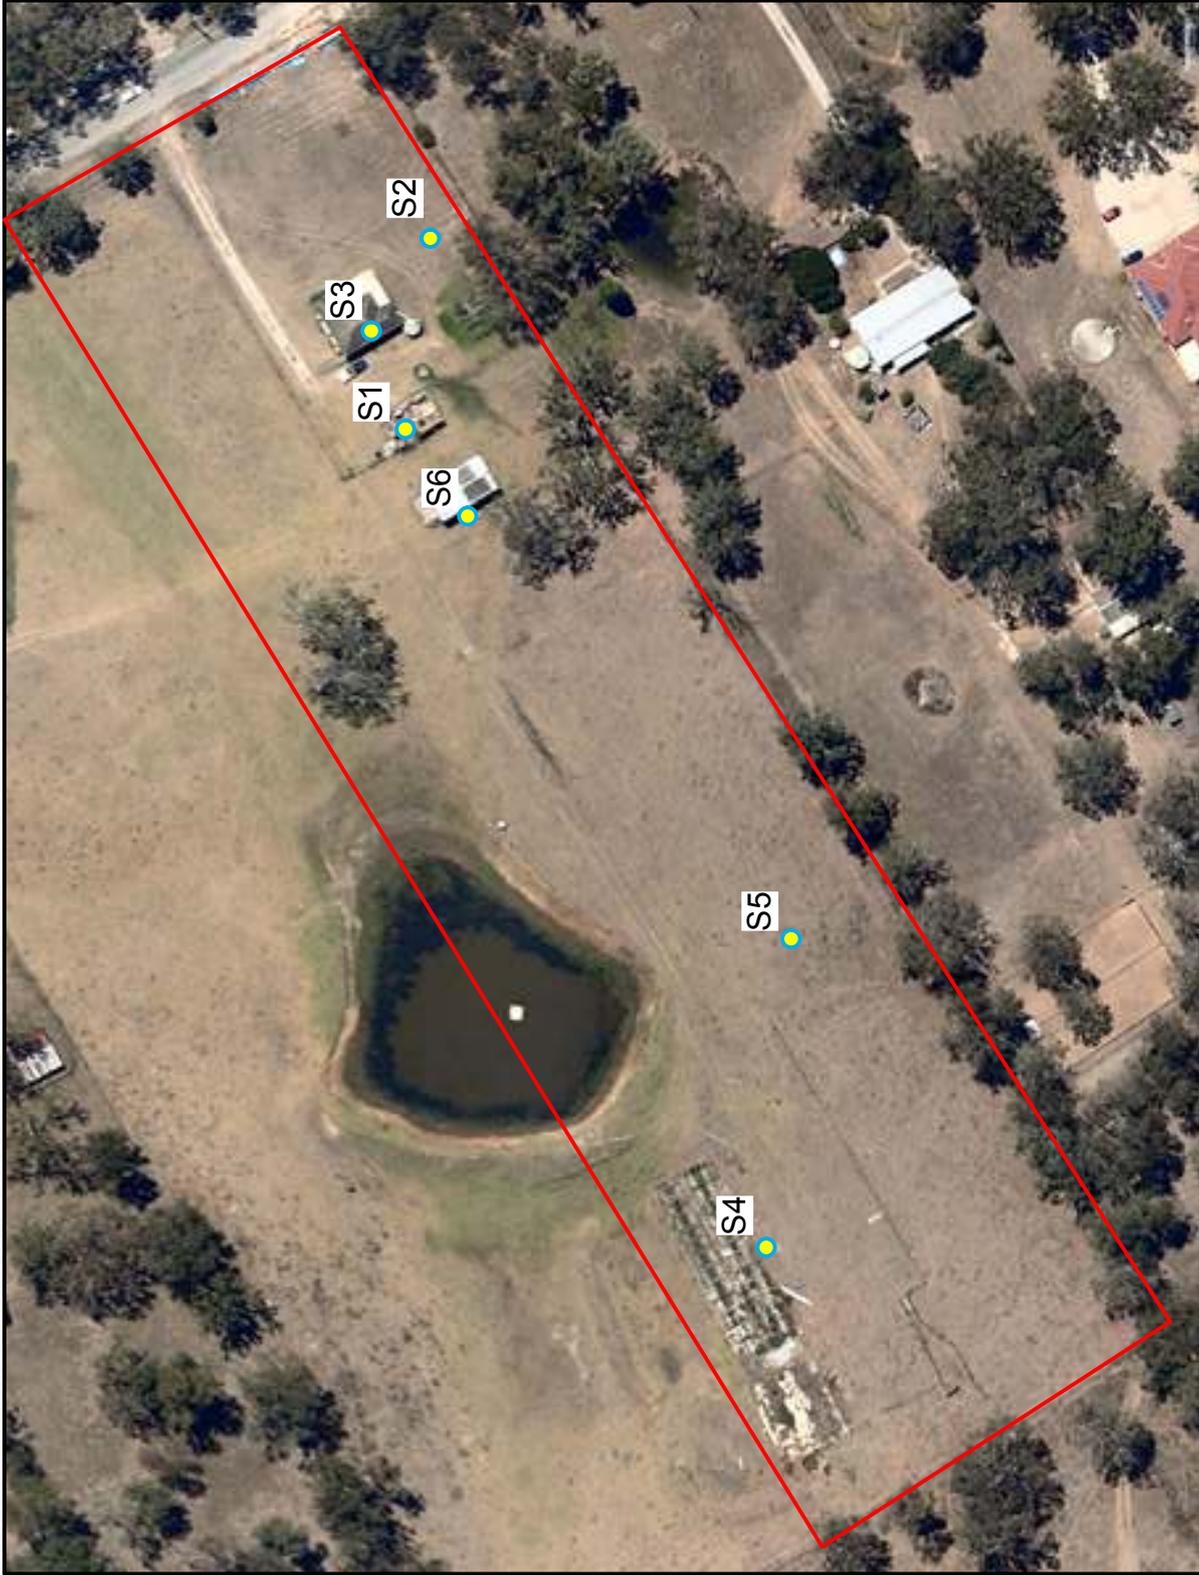
151 Tallawong Road,  
Rouse Hill, NSW

Figure modified from [www.nearmaps.com.au](http://www.nearmaps.com.au)  
22.9.2013 air photo
