Honeysuckle City Campus Development (HCCD) **Project**

Remedial Action Plan, University of Newcastle HCCD, Site 1

5 March 2019

754-NTLEN213887 - R01

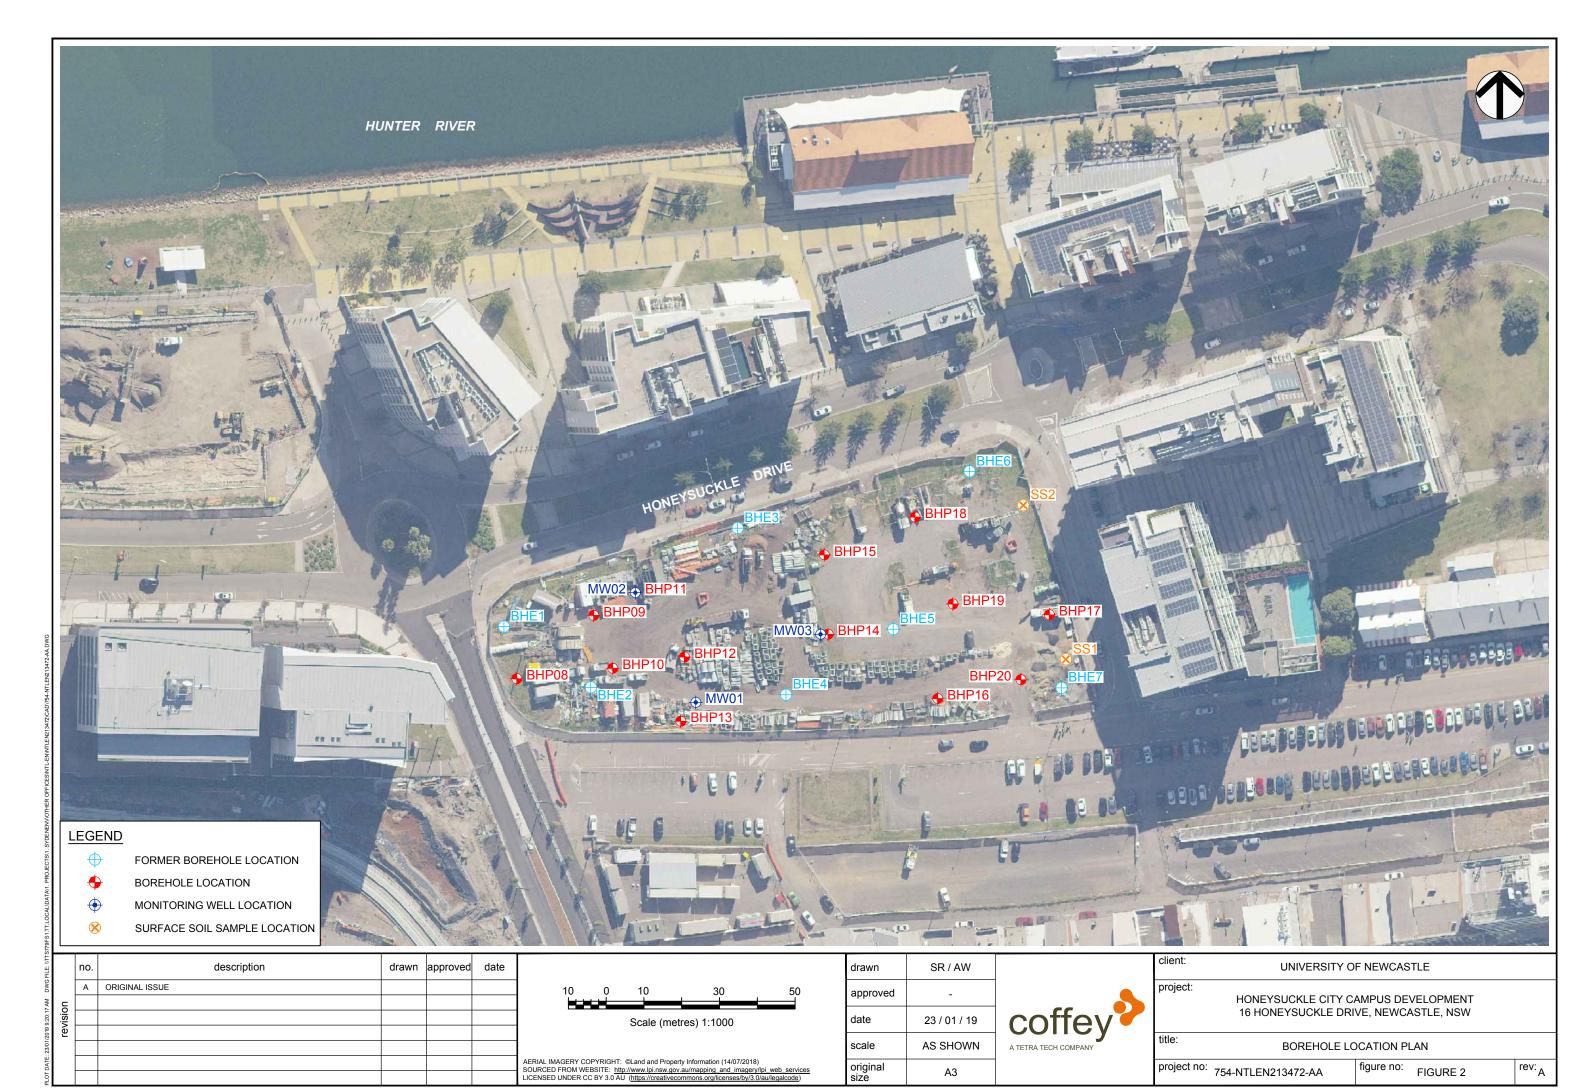
Soil analytical results from BHP08 – BHP20 (minus BHP17 due to Aboriginal Heritage issues) and two surface soil samples (SS1 and SS2) were compared to the site assessment and waste classification criteria. The soil results have been combined with the results of seven (7) locations previously sampled during the Coffey (2004) Waste Classification Assessment of Lot 3 (BHE1, BHE2, BHE3, BHE4, BHE5, BHE6 and BHE7). Sampling locations have been provided in Appendix A, Figure 2.
