## **SOIL SURVEY REPORT**

## **YANCO SOLAR FARM**

**FEBRUARY 2019**

**DM McMahon Pty Ltd**

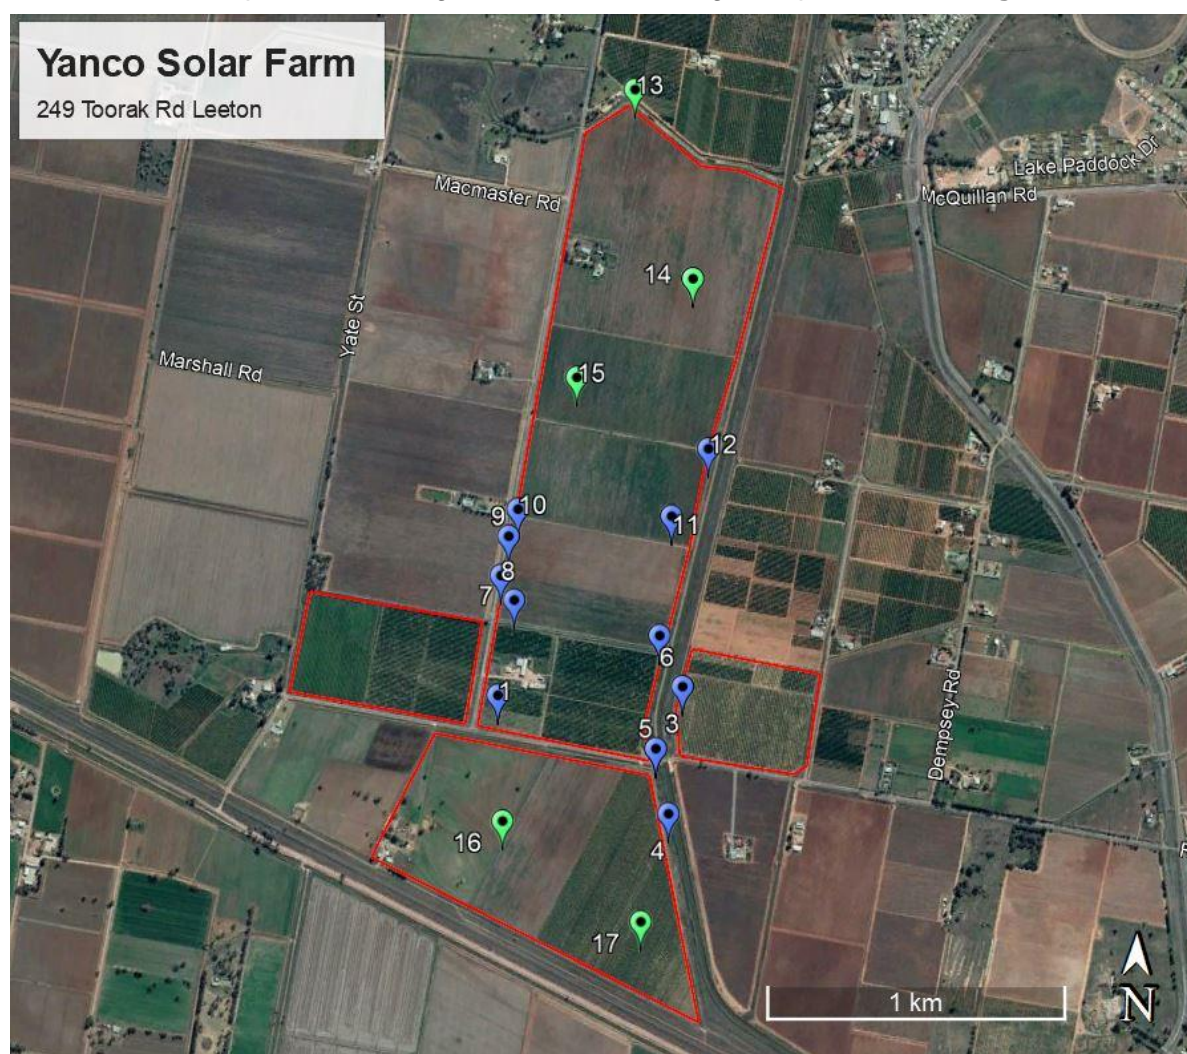
**Figure 1:** Soil survey investigation locations

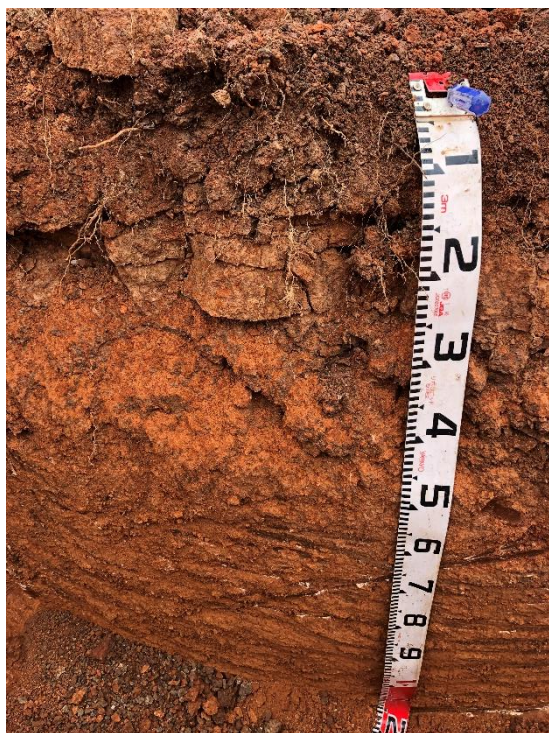
Chromosols have a strong texture contrast between A and B horizons (however, on this site the topsoil layer providing a strong texture contrast between the horizons had been removed). There is a clear or abrupt textural B horizon in which the upper portion of the horizon (0.2m) is not strongly acid and not sodic. These soils are the most commonly encountered soils under agricultural use in Australia.

Brown sandy clay loams, moderately well-structured to well-structured with sub-angular blocky peds. pH (1:5 soil/water) 4.8 to 7.1 in the A horizon; to 20-40cm depth. Clear boundary to-

Weakly to moderately structured with sub-angular blocky peds. Hues vary from reddish-brown to brownish-red in B horizon and brownish-yellow in B2 and C horizon (where present). Light to medium clays in B horizon and extremely weathered rock in C horizon.

In some locations, soft nodules of calcium carbonate begin to appear at about 90cm depth. pH (1:5 soil/water) 5.6 to 7.5.

**Figure 2:** Typical soil profile with A and B horizons, showing carbonate in the B Horizon.

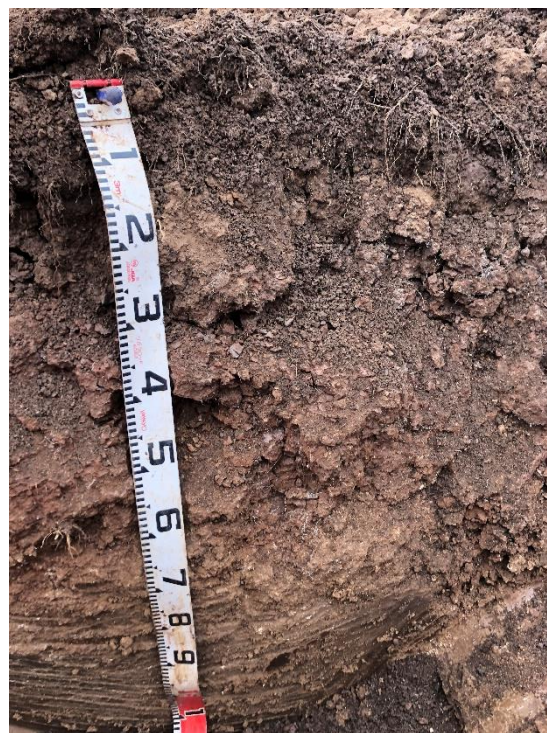
**Figure 3:** Typical soil profile with A and B horizons.

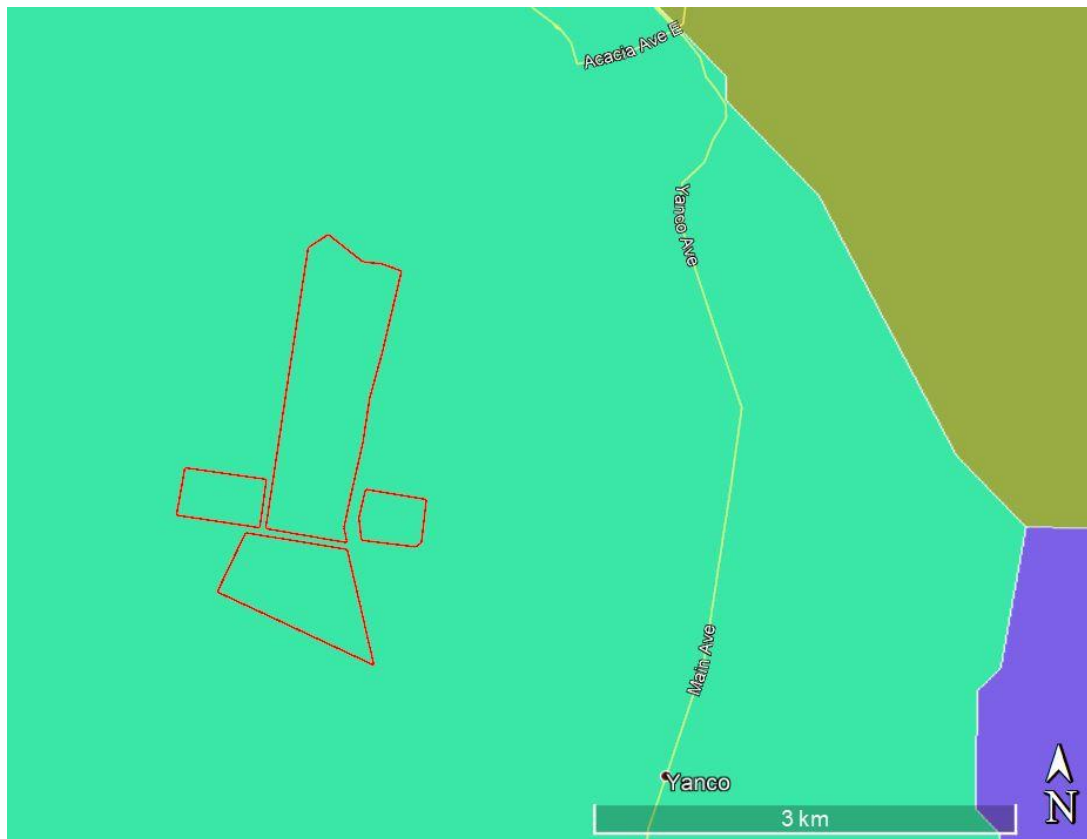
As follows is the soil landscape map (Digital Atlas of Australian Soils) that has been generally validated by the soil survey through laboratory and field techniques. As such, management practices can be grouped into management classes of Australian Soil Classification (ASC) units with Chromosols being represented across the majority of the property in the Oc3 soil landscape, **Figure 4**. This report identifies management practices for ASC units in Section 6.5 below.

**Figure 2:** Digital Atlas of Australian Soils mapping units with site overlay (Oc3, Oc5 and Qb9).
