Mamre Road South Precinct – Proposed Industrial Subdivision
Assessment of Riparian and Groundwater Dependent Ecosystems
Prepared for ALTIS Property Partners Pty Ltd
October 2018

Project	Mamre Road South Precinct – Proposed Industrial Subdivision. Assessment of Riparian and Groundwater Dependent Ecosystems
Prepared For	ALTIS Property Group
Author/s	Carl Tippler, Ben Green (CTENVIRONMENTAL)
Reviewed by	Lucas McKinnon (Ecoplaning)
Approved by	Stephen O'Connor (Altis Property Partners)
Version	FINAL

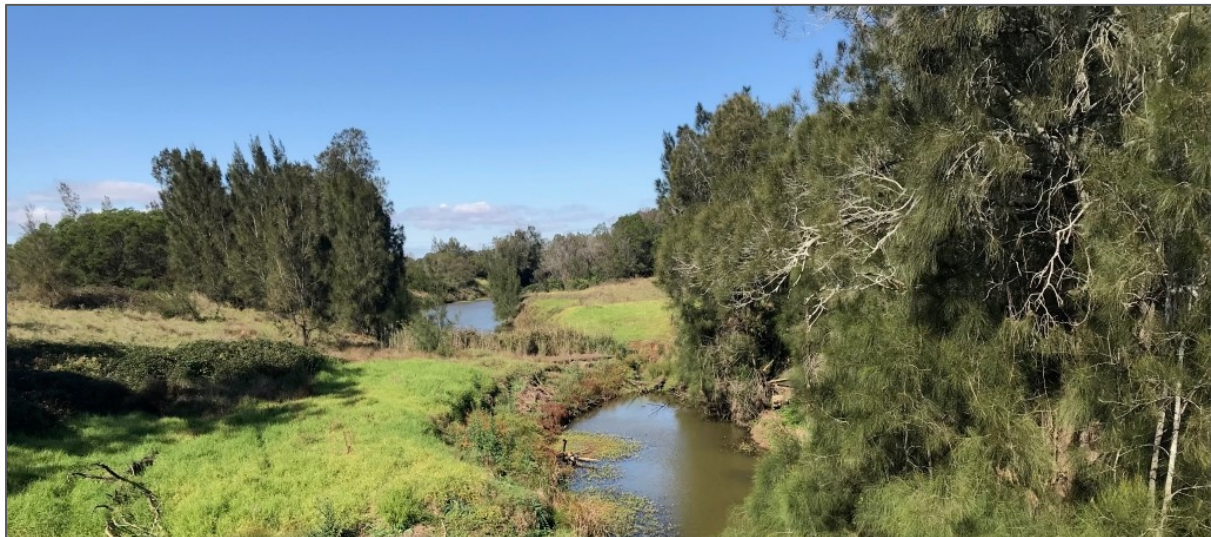
At the time of survey, flow in South Creek was not flowing around/under a historic weir/crossing point on South Creek. Under these flow conditions this structure provides a barrier to fish passage and is maintaining a deep weir pool on its upstream side (Figure 3).

Figure 3: South Creek at the subject land. Historical weir/crossing can be seen mid-image with upstream weir pool.

The bed and bank of all assessment reaches appeared to be stable with only one significant erosion feature observed which was the bank slump recorded at Site 1. The historical weir/crossing located at Site 1 is likely to provide protection by regulating flow velocity and therefore mitigating against bed and bank erosion.

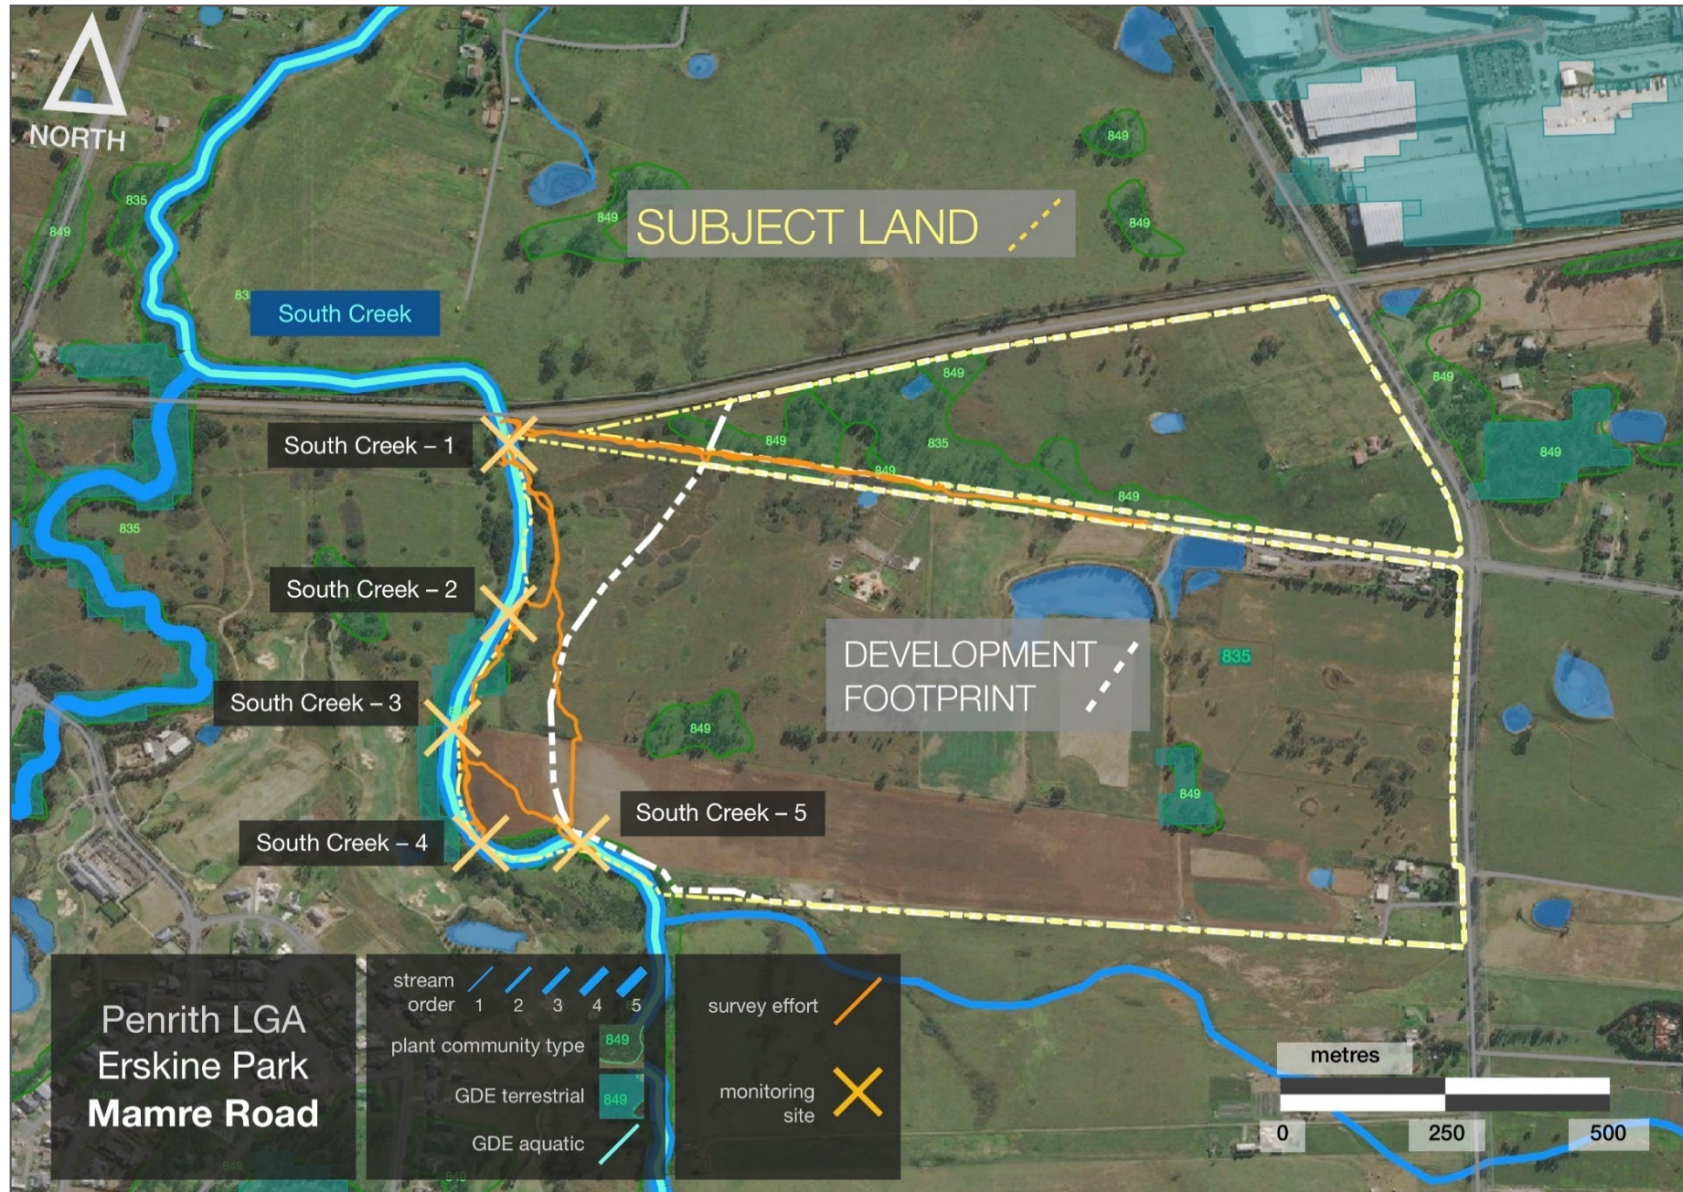
Field survey was undertaken on April 30, 2018. A site walkover was undertaken which included assessment of KFH and field validation of mapped GDE's and native vegetation. An assessment of riparian vegetation and creek channel condition was undertaken at five sites along South Creek within the subject land (Figure 4).

Figure 4: Field survey effort and location of riparian vegetation and creek channel condition assessment sites.

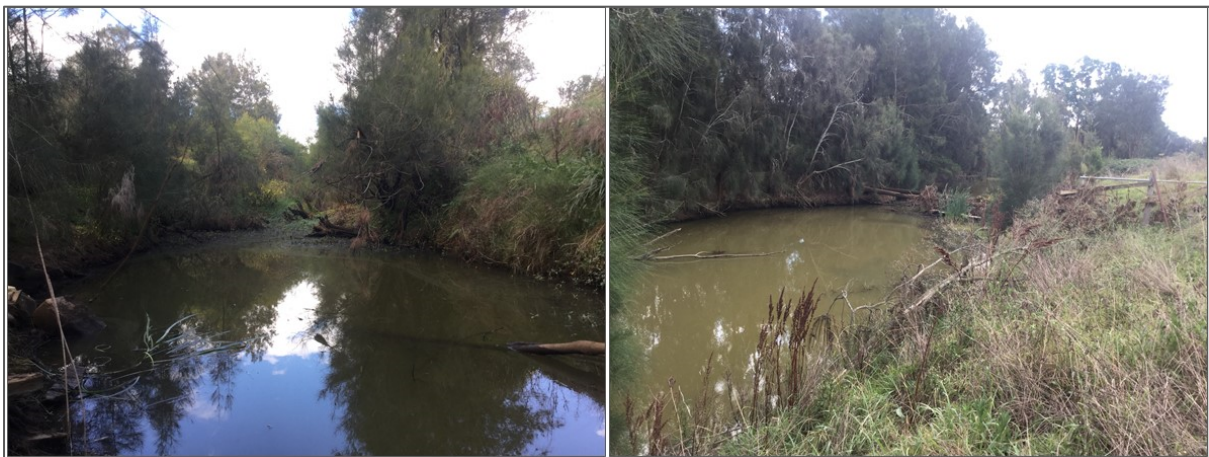
Classification as Type 1 – highly sensitive fish habitat is due to the presence of instream large woody debris > 300 mm diameter and > 3 m in length and presence of native macrophytes in some areas. The determination of Class 2 – moderate key fish habitat is due to the intermittent flow observed at the time of survey and the presence of a clearly defined creek bed and banks with semi-permanent to permanent waters in pools (Figure 6).

Figure 6: Photographs showing Type 1, Class 2 KFH attributes for South Creek (right) within the subject land.

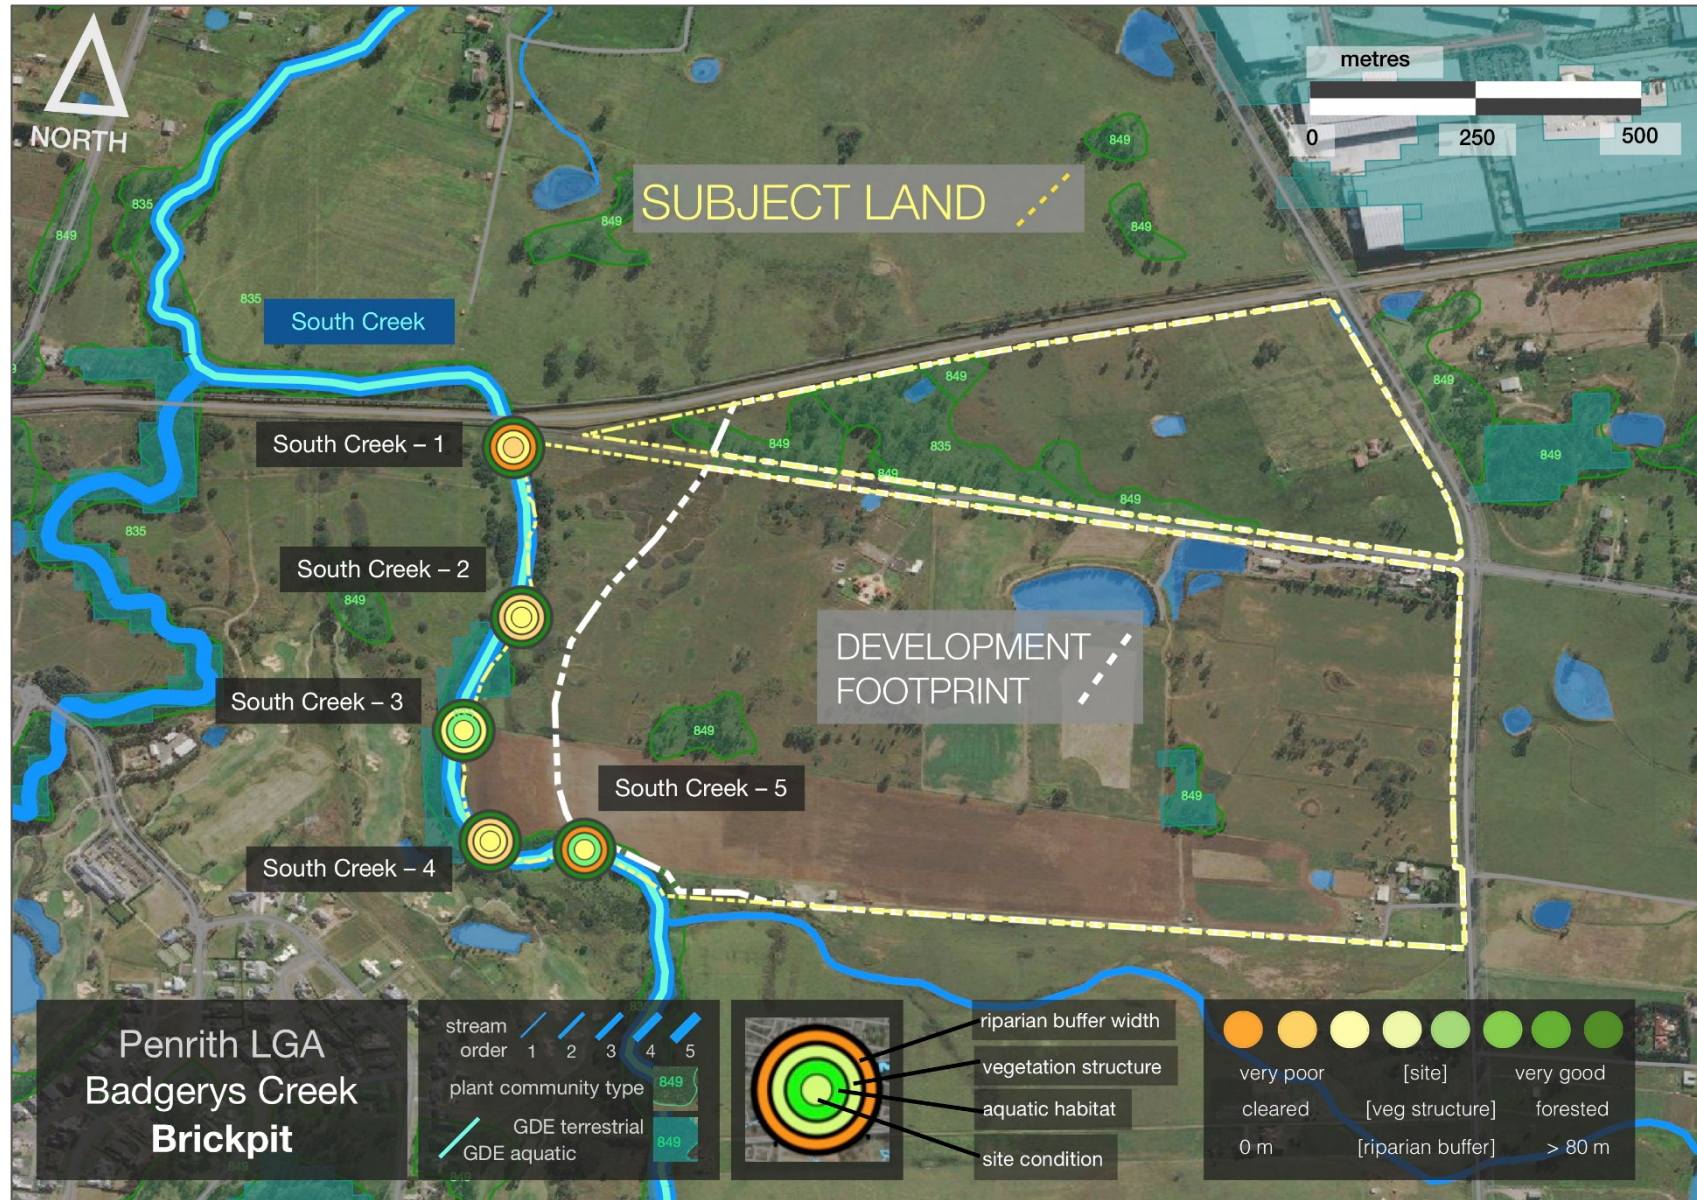
Results of the assessment of riparian vegetation and creek channel condition using the Rapid Riparian Appraisal (Findlay et al 2011) show the condition of assessment sites within the reach of South Creek in the subject land ranged from 'poor' to 'fair' (Table 3, Figure 7).

Site 1 was found to be in poor condition (Table 3, Figure 7), a result which reflects the surrounding landuse which is primarily pasture/grazing. The vegetation community within the 50 m assessment radius is dominated by exotic species with only a thin and scattered band of native vegetation present. A high degree of litter was recorded at the site and a significant bank slump was observed on the western bank which, if left unmanaged will increase in size and potentially threaten future infrastructure.

Sites 2 – 5 were found to be in fair condition (Table 3, Figure 7) which when compared to Site 1 reflects a more complex riparian vegetation matrix and a lesser degree of bank erosion. Although pasture/grazing land use was typical along the entire assessment reach, the percentage of the assessment area covered by this land use varied and contained a greater percentage of remnant native vegetation, less litter and less erosion.

Figure 7: Results of riparian vegetation and creek channel assessment using Rapid Riparian Appraisal (Findlay et al 2011).

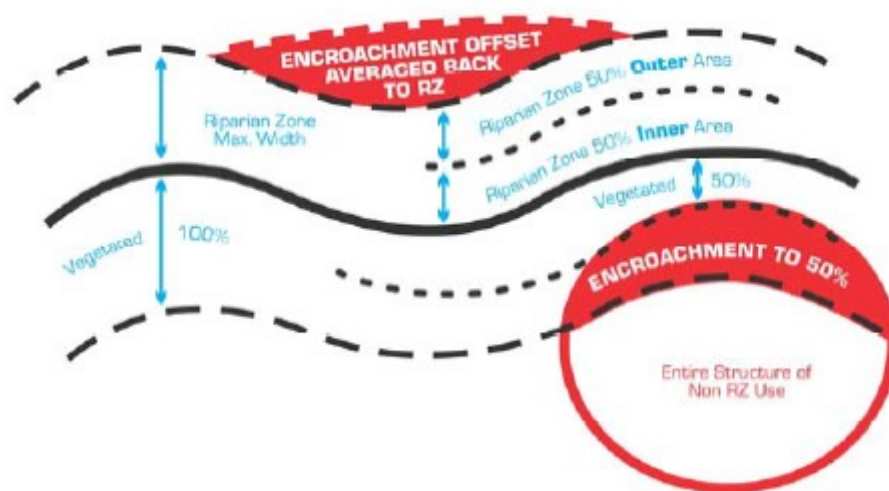
For example, the required VRZ for South Creek is 40 m from top of bank, however, development may encroach into the VRZ by up to 20 m so long as the area consumed by the encroachment is offset in another section of the VRZ. However, the area of encroachment must already be cleared land. See Figure 8 for interpretation.

Application of the averaging rule can potentially be applied to the proposed development footprint by permitting up to 20 m encroachment into the VRZ of the south-west corner and offsetting this in the north-west corner where there is an existing 150 m of vegetated riparian corridor however this will require liaison with and consent by the NSW Office of Water

Figure 8: Image interpreting the WMA 2000 averaging rule for vegetated riparian zones (RZ).

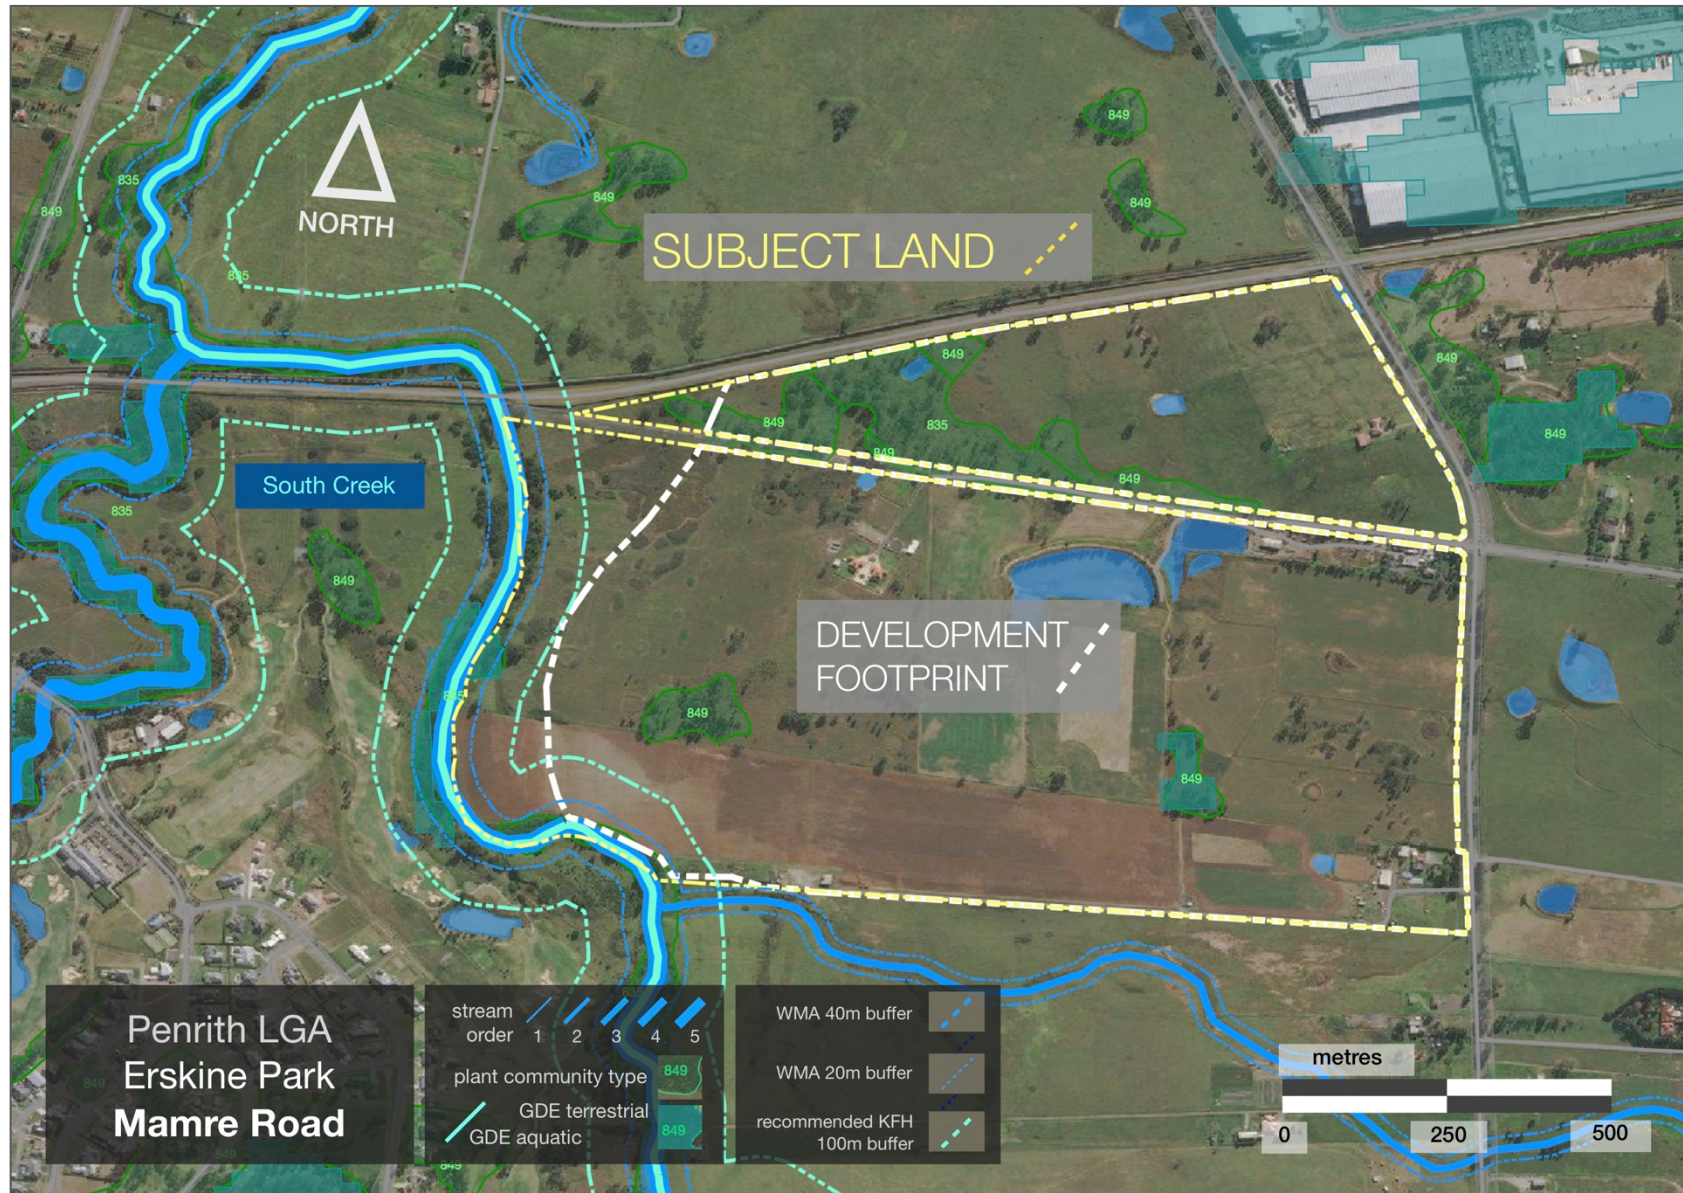
Due to South Creek being assessed as Type 1 – highly sensitive fish habitat, a 100 m VRZ is recommended to protect aquatic habitats in South Creek (Figure 9).

Figure 9: Required VRZ as per NSW Water Management Act (2000) and recommended Key Fish Habitat VRZ as per NSW DPI (2013). Note buffers on this map are measured from the centre of the creek channel as top of bank was not surveyed as part of this study. Therefore, it is likely the official VRZ as measured from top of bank will extend further into the study area.

1. Establish appropriate Vegetated Riparian Zones (VRZ). To protect GDE's, KFH and riparian vegetation it is recommended appropriate VRZ's are established along South Creek corridor. Under

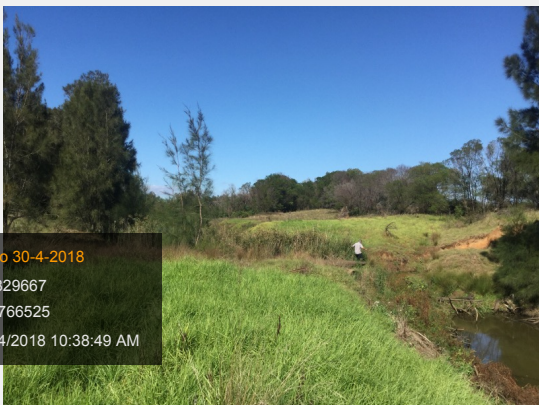
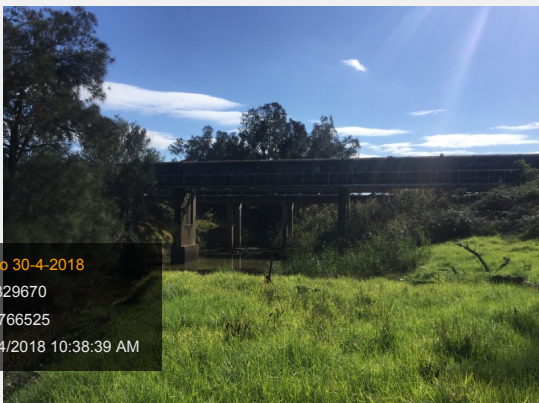
The site is in poor condition, with a score of -2.1 overall. The bed type is natural bed clay - Nvc. The bank type is natural vegetation - Nveg. Assessment point approx 50 upstream of SW pipeline. Weir/ old crossing obstructing creek and fish passage. Bank slump.

Within the 50 metre assessment radius, left bank vegetation structure is 80% pasture grassland, 20% derived native shrubland, approximately. Right bank vegetation structure is 10% forest/woodland, 60% pasture grassland, 30% weed/exotic, approximately. This is reflected in the vegetation structure subtotal.

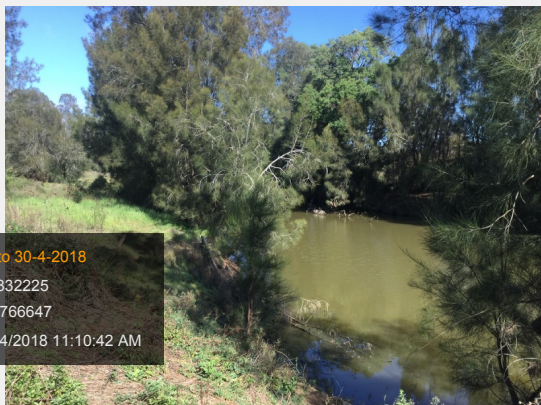
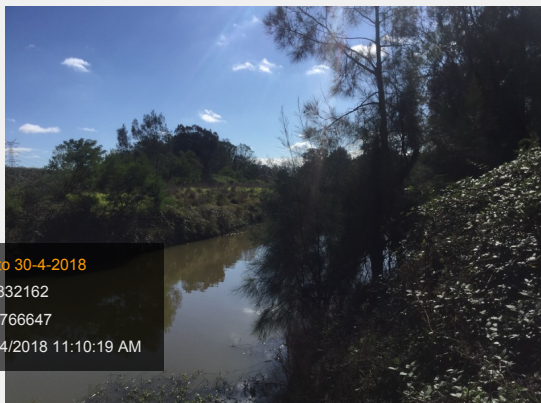
The site is in fair condition, with a score of 12.45 overall. The bed type is natural bed clay - Nvc. The bank type is natural vegetation - Nveg. Observed: Carp and Goldfish.

Within the 50 metre assessment radius, left bank vegetation structure is 10% forest/woodland, 90% pasture grassland, approximately. Right bank vegetation structure is 10% forest/woodland, 20% derived native shrubland, 70% pasture grassland, approximately. This is reflected in the vegetation structure subtotal.

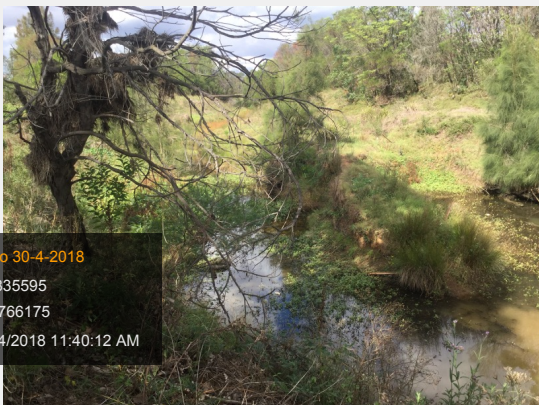
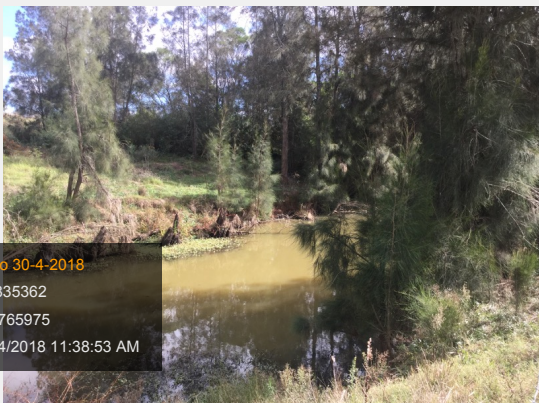
The site is in fair condition, with a score of 11.7 overall. The bed type is natural bed clay - Nvc. The bank type is natural vegetation - Nveg. Carp observed.

Within the 50 metre assessment radius, left bank vegetation structure is 20% forest/woodland, 50% pasture grassland, 10% derived native shrubland, 20% weed/exotic, approximately. Right bank vegetation structure is 10% forest/woodland, 20% derived native shrubland, 60% pasture grassland, 10% weed/exotic, approximately. This is reflected in the vegetation structure subtotal.

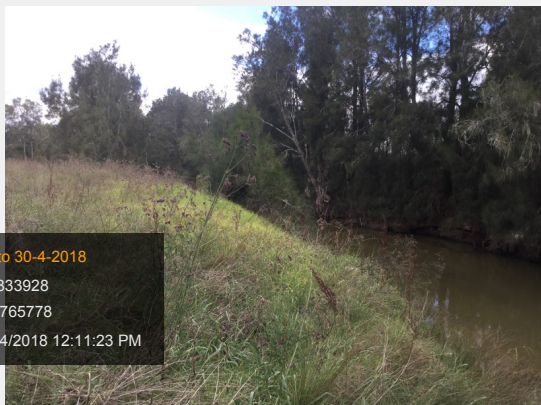
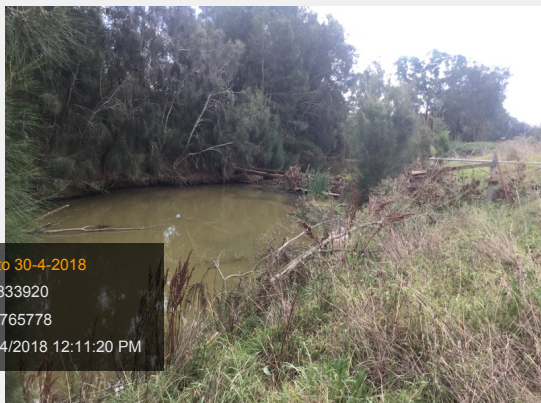
The site is in fair condition, with a score of 25.1 overall. The bed type is natural bed clay - Nvc. The bank type is natural vegetation - Nveg. Old informal crossing.

Within the 50 metre assessment radius, left bank vegetation structure is 40% forest/woodland, 40% pasture grassland, 10% weed/exotic, 10% derived native shrubland, approximately. Right bank vegetation structure is 10% derived native shrubland, 70% pasture grassland, 20% weed/exotic, approximately. This is reflected in the vegetation structure subtotal.

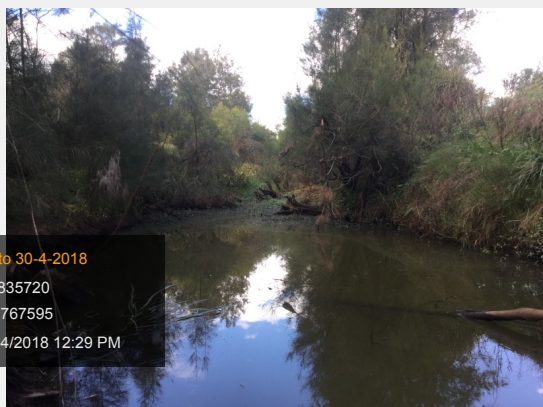
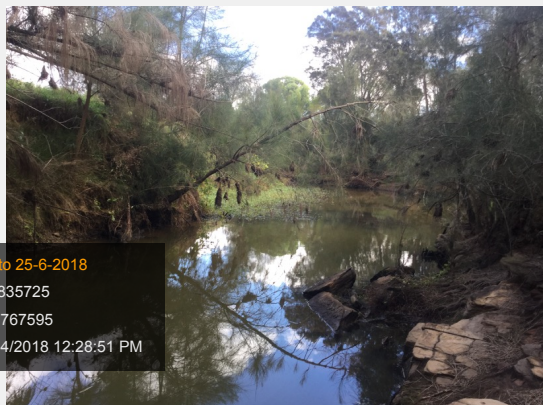
The site is in fair condition, with a score of 16 overall. The bed type is natural bed clay - Nvc. The bank type is natural vegetation - Nveg.

Within the 50 metre assessment radius, left bank vegetation structure is 10% derived native shrubland, 90% pasture grassland, approximately. Right bank vegetation structure is 10% forest/ woodland, 10% derived native shrubland, 80% pasture grassland, approximately. This is reflected in the vegetation structure subtotal.
