Wyong Hospital Expansion - Geotechnical and Pavement Design Report

Prepared for
Taylor Thomson Whitting (NSW) Pty Ltd

Prepared by
Coffey Services Australia Pty Ltd
19 Warabrook Boulevard
Warabrook
NSW 2304 Australia
t: +61 2 4016 2300
ABN 55 139 460 521

754-NTLGE222494-AB.Rev1

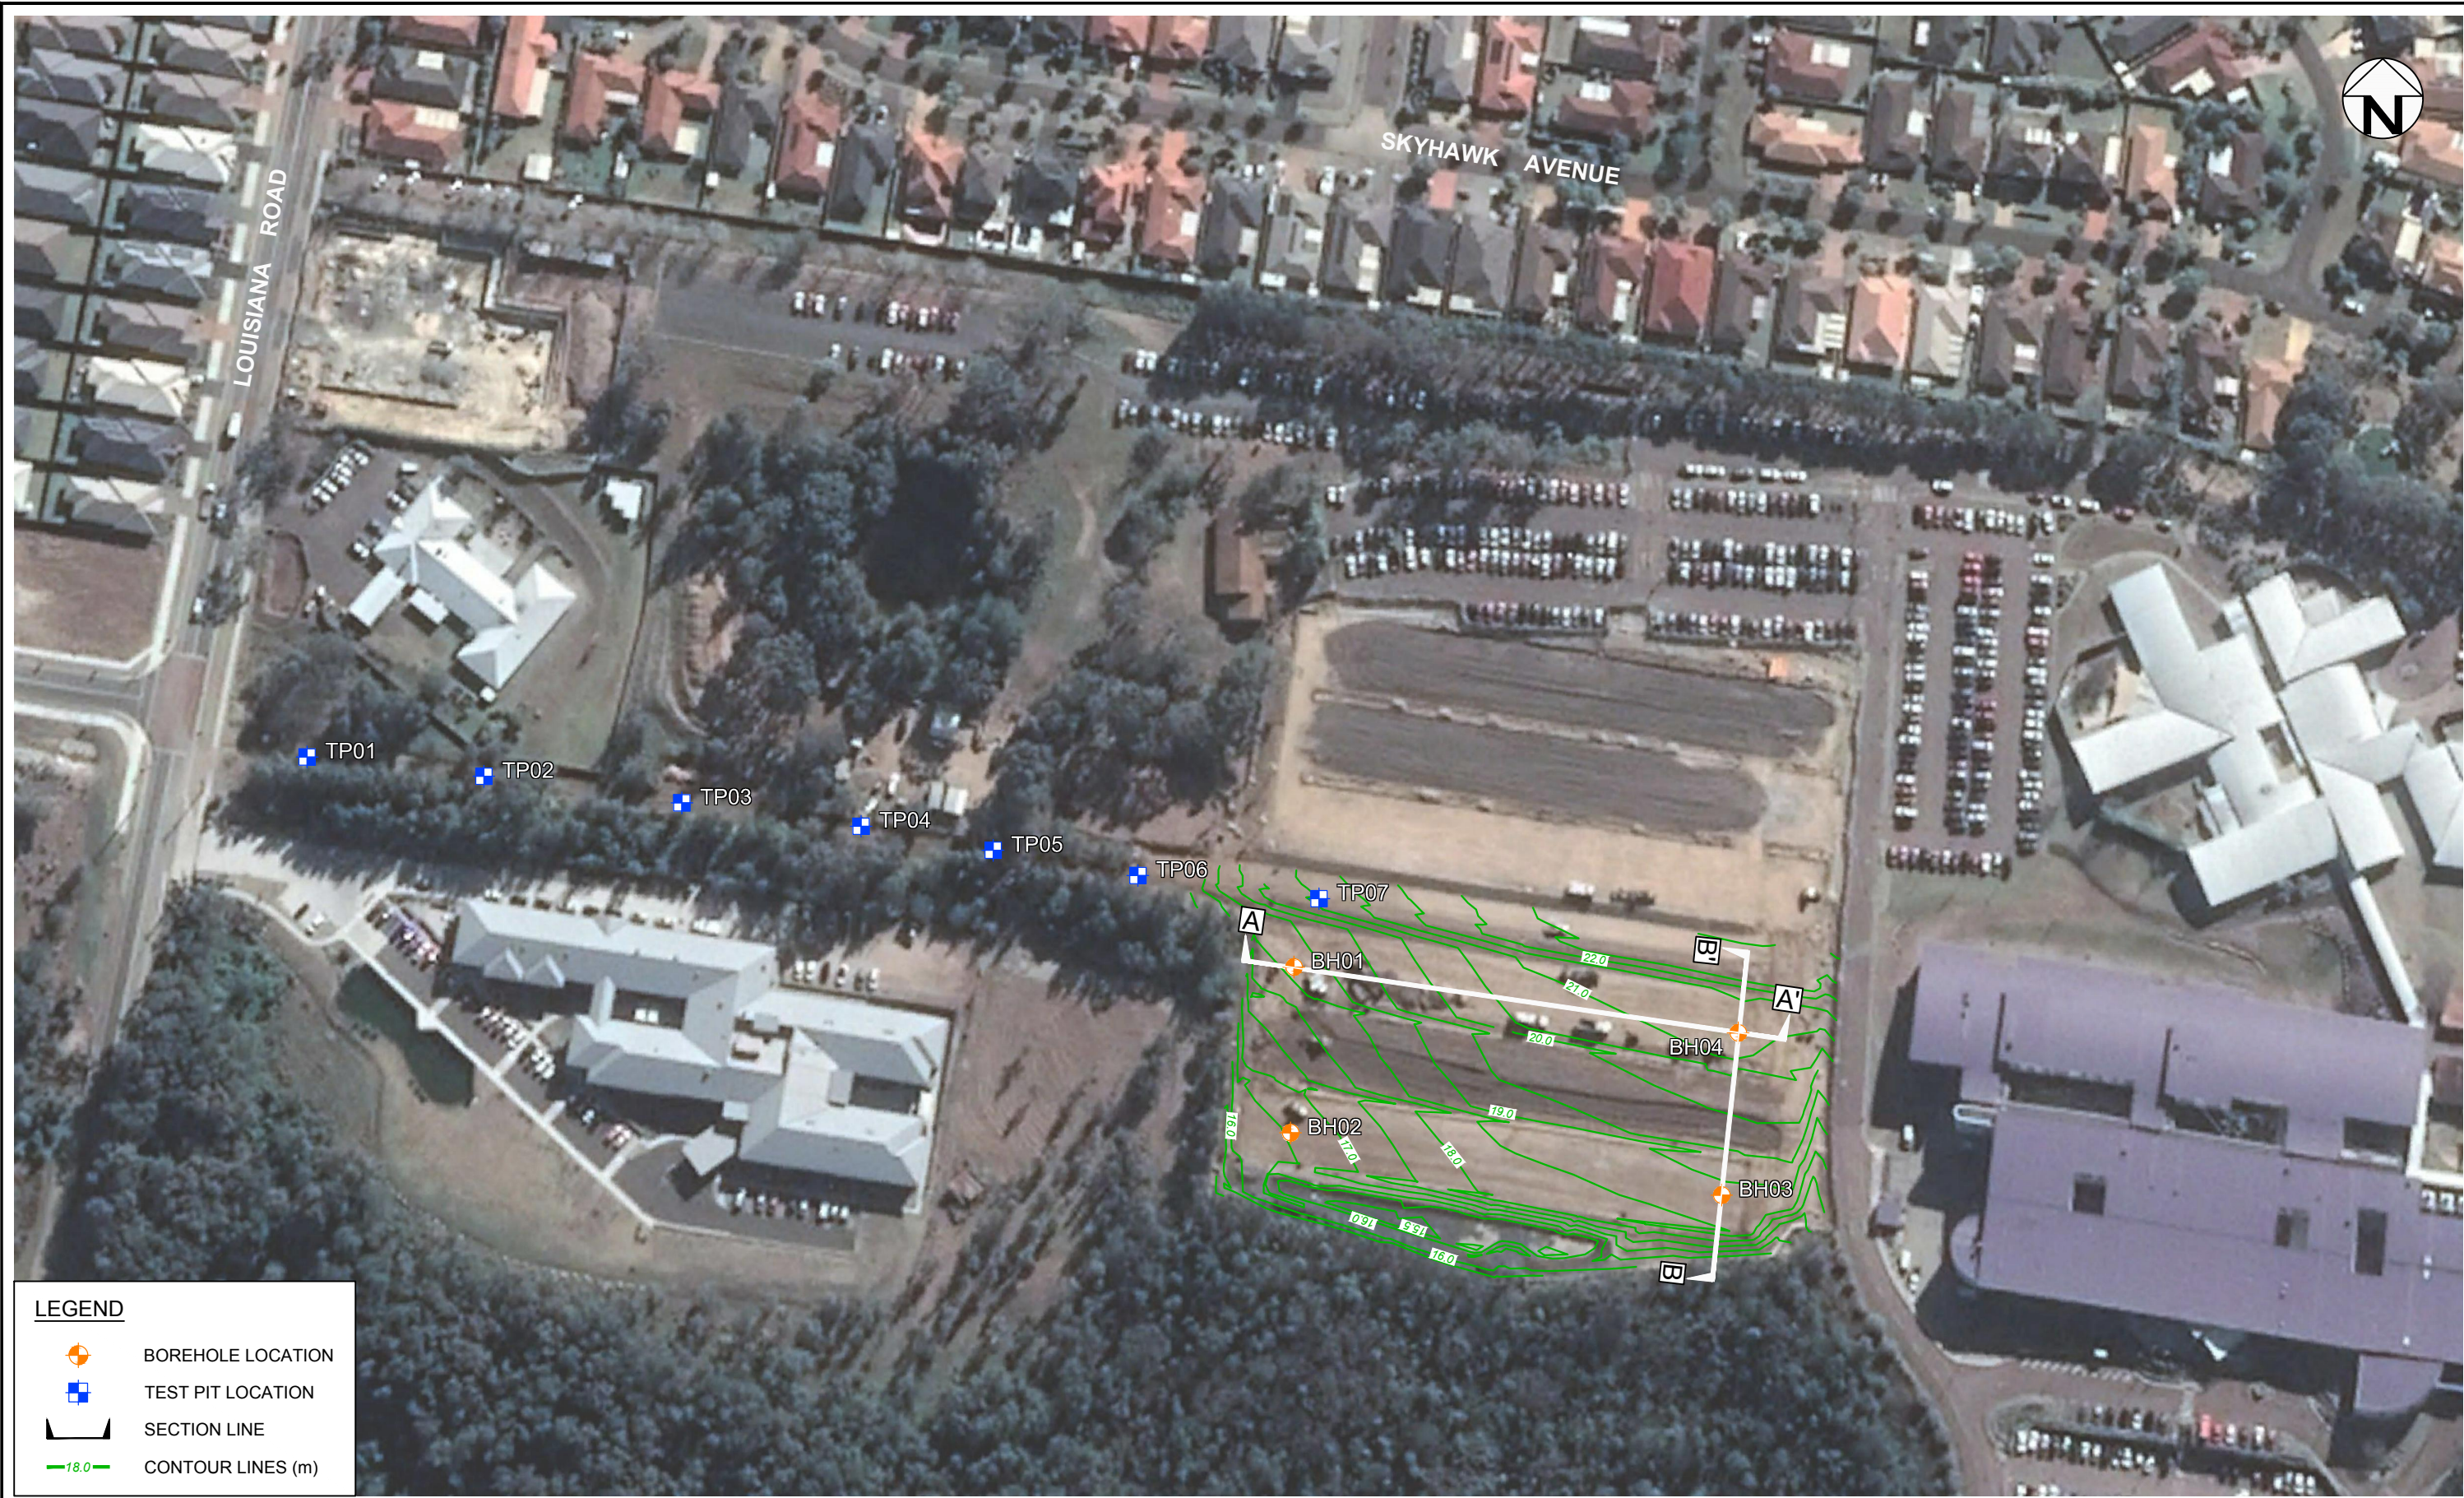
client: COLLIERS INTERNATIONAL PTY LTD	
project: WYONG HOSPITAL EXPANSION PACIFIC HIGHWAY, HAMLYN TERRACE, NSW	
title: INVESTIGATION LOCATION PLAN	
project no: 754-NTLGE222494	figure no: FIGURE 1
rev: A

- BOREHOLE LOCATION
- TEST PIT LOCATION
- SECTION LINE
- CONTOUR LINES (m)
