Environmental Impact Statement Glenellen Solar Farm

Appendix H: Traffic Assessment and Road Safety Audit

Traffic Impact Assessment

Glenellen Solar Farm, Glenellen NSW
Road Safety Audit

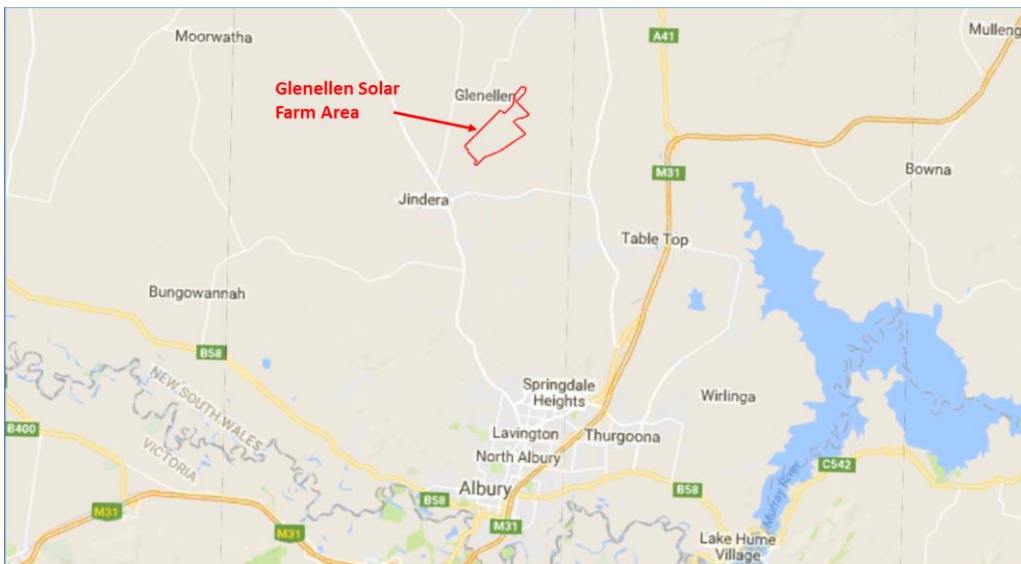
Figure 1-1: Site location map view

The site is located approximately 20km north of Albury NSW. The site location is shown in Figure 1.1. Access to the site is via Ortlipp Road (see Figure 1-2). A TransGrid substation is located adjacent to the site on Ortlipp Road which will serve as the grid connection point.

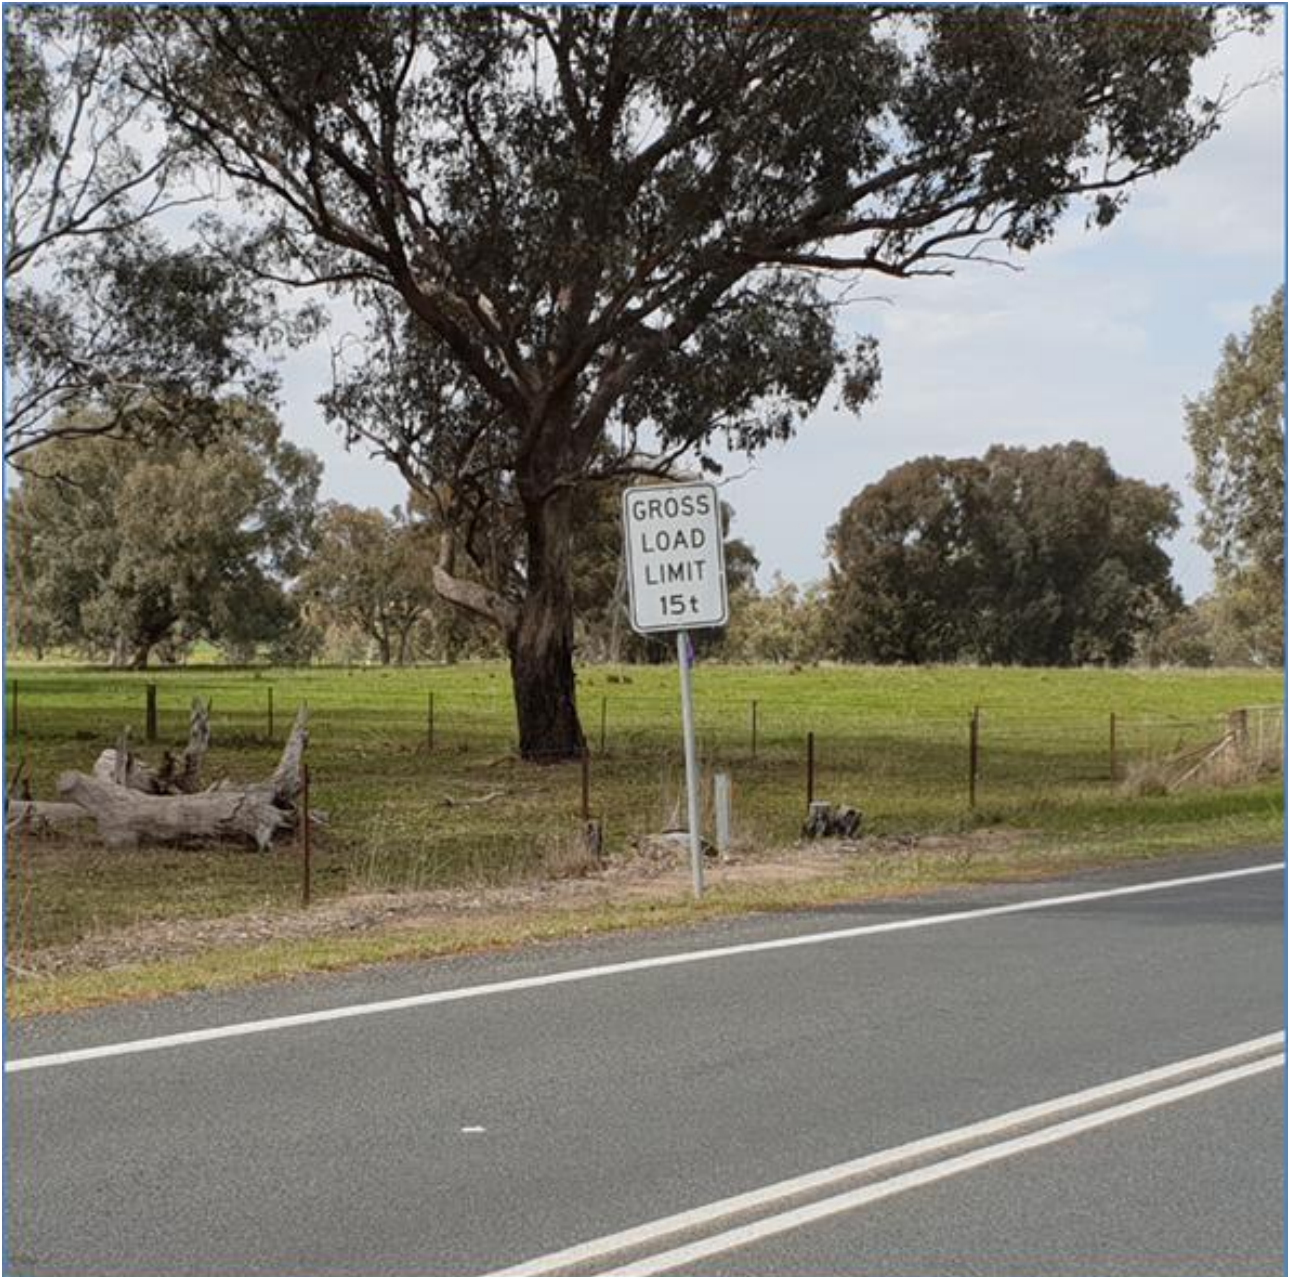
Figure 2-3: Load limit restriction on Gerogery Road

There is another possible access route to the site from Hume Highway and Wagga Road, then onto Gerogery Road. Gerogery Road has a 15 tonne limit restriction for vehicles as shown in Figure 2-3. This route could be used for staff vehicles, buses, and small construction vehicles but not for large laden trucks.

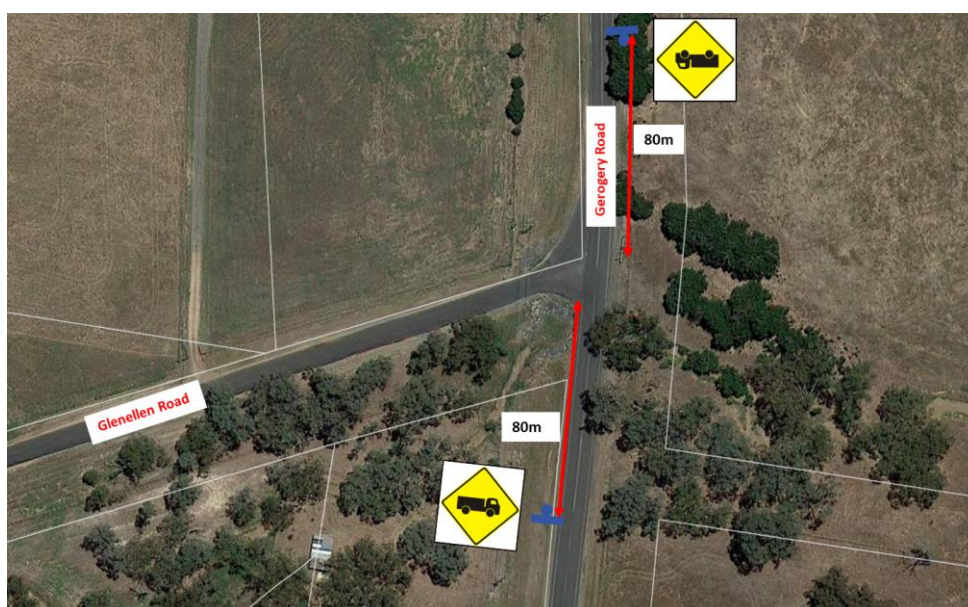
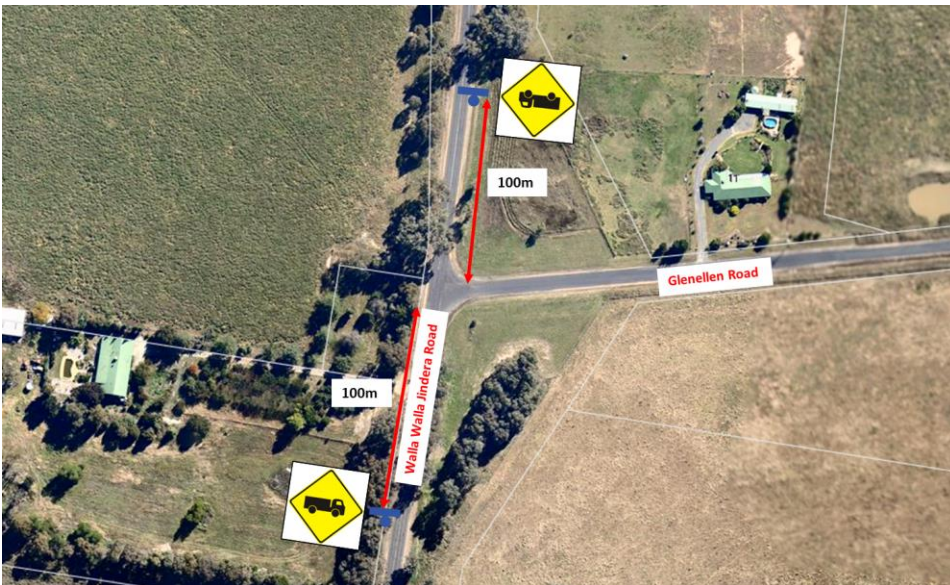
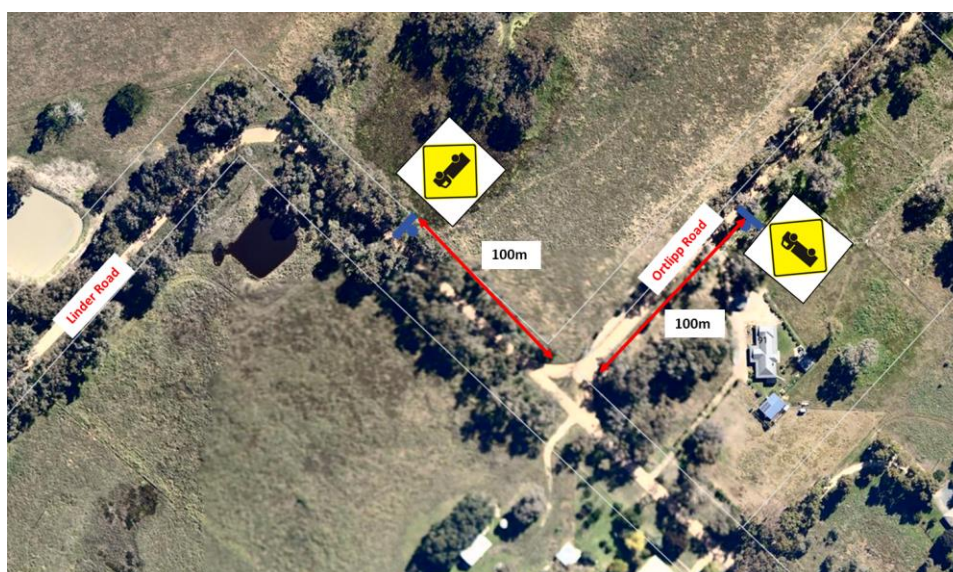
Figure 5-1: Truck crossing signs at the intersection of Olympic Highway and Main Street

Figure 5-2: Truck crossing signs at the intersection of Gerogery Road and Glenellen Road

Figure 5-3: Truck crossing signs at the intersection of Glenellen Road and Ortlipp Road

Figure 5-4: Truck crossing signs at the intersection of Glenellen Road and Walla Walla Jindera Road

Figure 5-6: Truck crossing signs at the intersection of Lindner Road and Ortlipp Road

Truck crossing signs (W5-22) for truck crossing or entering are recommended to be installed throughout the intersections along the route during the construction period (see Figure 5-1 to Figure 5-6).

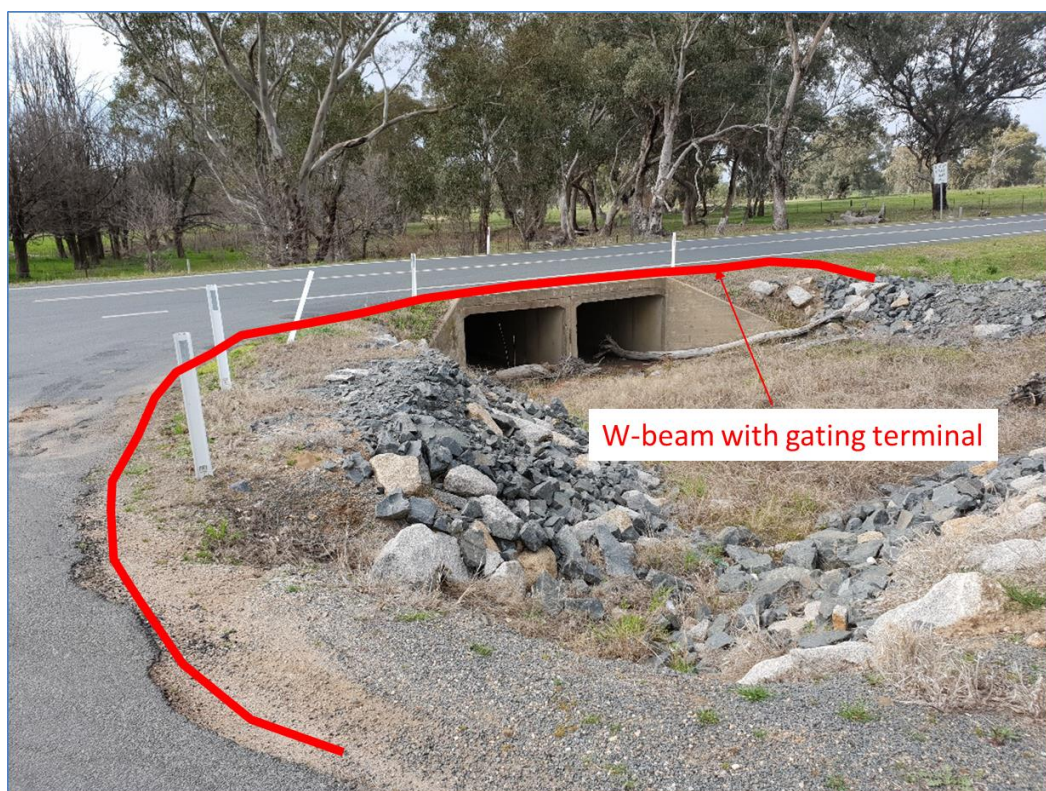
Figure 5-7: Recommended guardrail at the intersection of Gerogery Road and Glenellen Road

A guardrail is recommended to be installed at the intersection of Gerogery Road and Glenellen Road (see Figure 5-7). The design guidance can be referred to AUSTROADS Guide to Road Design - Part 6 Roadside Design, Safety and Barriers. The delineator is recommended to be installed at the ends of the guardrail.

1. Installation of a guardrail at the intersection of Gerogery Road and Glenellen Road (on the left turn lane from Gerogery Road to Glenellen Road).
2. Consideration of the installation of W-beam guardrails with delineators at both sides of the culvert on Glenellen Road near the intersection of Glenellen Road and Ortlipp Road.
3. Installation of frangible hazard marker posts along the bends on Lindner Road.
4. Upgrade of the site access point off Ortlipp Road.

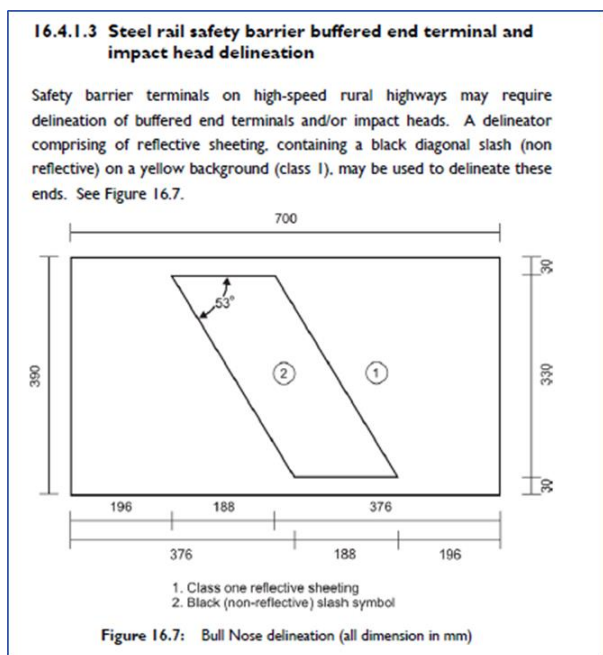
A design from RMS guidelines for delineators is provided below².

² from page 16-13 of NSW RTA Delineation Guidelines Section 16 Guide posts and delineation of safety barriers (Version 1.0 Feb 10)

It is our advice that this issue should be reviewed and addressed by Council. Delineators are recommended to be installed at the ends of the guardrails.

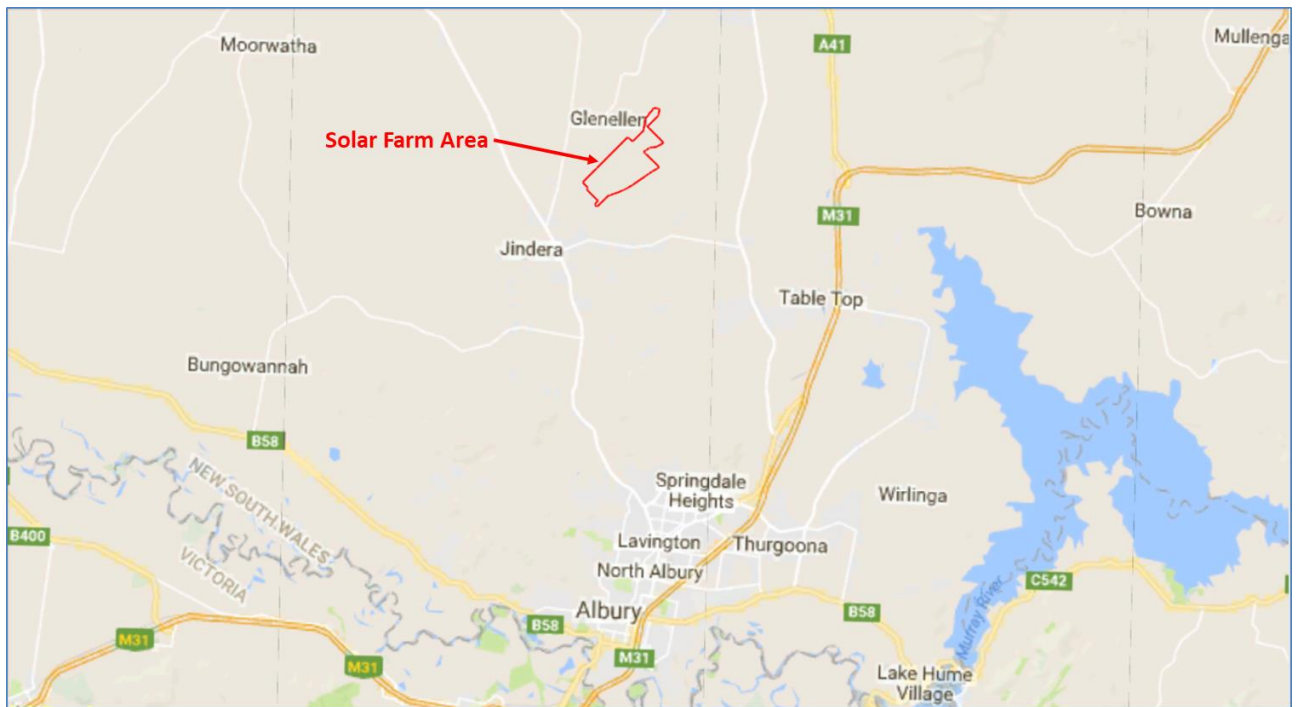
Figure 1.1 Solar farm location with surrounding areas

The location of the proposed solar farm is 20 kilometre north of Albury, NSW. Albury is a small city which sits on the border of New South Wales and Victoria. The location of the solar farm in terms of nearby areas is shown in Figure 1.1. The location of the solar farm in terms of surrounding roads is shown in Figure 1.2. Figure 1.3 show the roads in the immediate vicinity of the site.

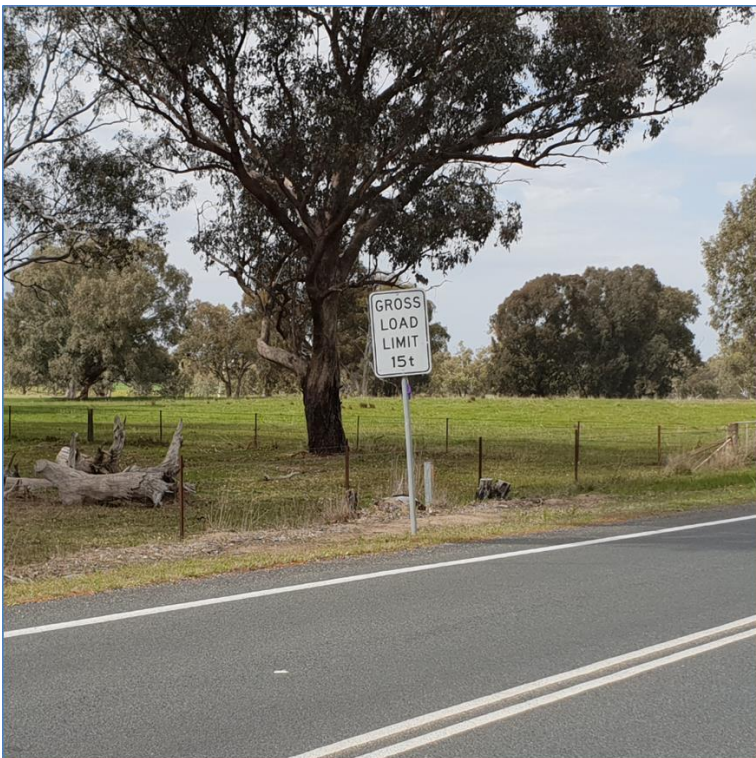
Figure 2.1 Load limit on Gerogery Road

During the road safety audit site visit it was observed that the route from Wagga Road to Gerogery Road has 15 tonne limit for vehicles as shown in Figure 2.1. The route is shown in NSW combined higher mass limits and restricted access vehicles map Figure 2.3. The route is shown with a black line as approved route with travel conditions.

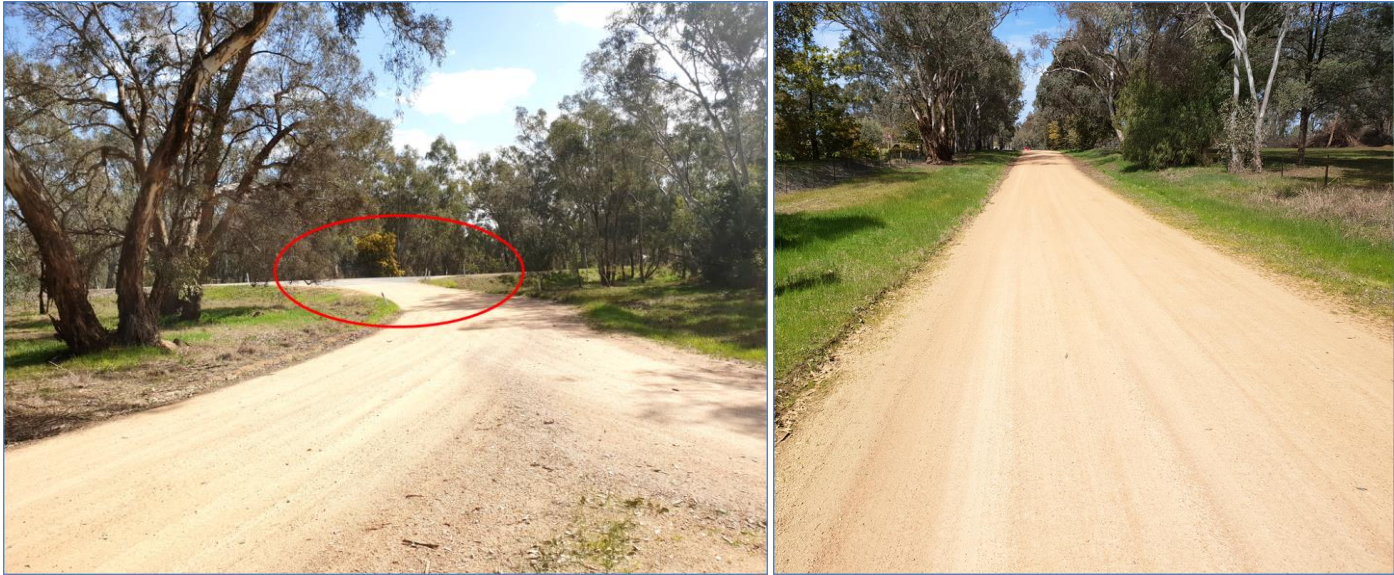
Item	Audit Findings/Recommendations	Rankings
5	<p>The intersection of Glenellen Road and Ortlipp Road may be used by heavy and staff vehicles. There is a risk that the intersection is not wide enough to pass a vehicle waiting to turn or an approaching vehicle on Ortlipp Road.</p> <p>The width of Ortlipp Road may not be wide enough and pose difficulty for passage of heavy vehicles. There is a risk of side swipe crash which may result in injury.</p> <p>There is slight grade when approaching the intersection from Ortlipp Road. Vehicles waiting to turn may roll back in to vehicle behind and large trucks will take longer to exit as starting on an uphill grade. The insufficient width of the intersection may result in vehicles having a side swipe crash causing serious injury.</p> <p>Vehicles rolling back may result in a rear end crash.</p> <div data-bbox="239 687 1628 1264">

</div> <p>Consideration could be given to conducting construction vehicle swept path at the intersection and localised widening to accommodate increased construction and heavy vehicles traffic.</p>	Medium

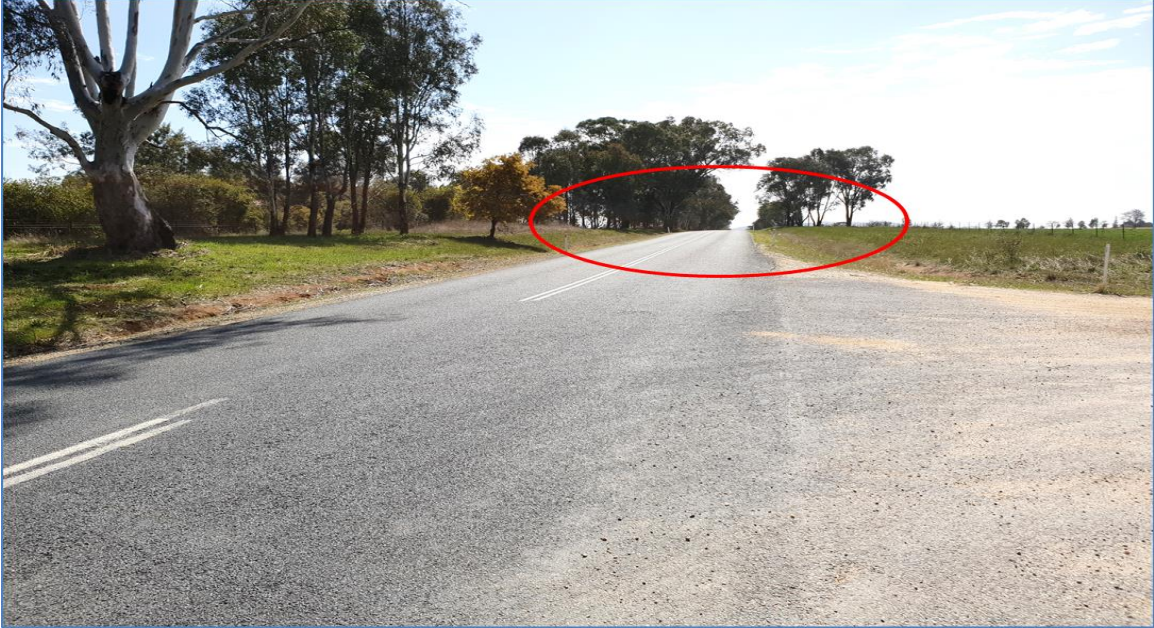
Item	Audit Findings/Recommendations	Rankings
6	<p>The intersection of Walla Walla Jindera Road and Lindner Road will be used by all construction vehicles and workers vehicles, as the main access to the solar farm. The main movements will be left turn from Walla Walla Jindera Road to Lindner Road and right turn from Linder Road to Walla Walla Jindera Road.</p> <p>There is some restricted sight distance from Lindner Road to the north (192m due to the brow of the hill). There is a risk that driver will enter or exit Lindner Road when there is insufficient sight distance to oncoming vehicles. This can result in a T-bone crash at this location leading to serious injury.</p>

<p>Consideration could be given to installation of advance warning sign or truck crossing signs.</p>	Medium

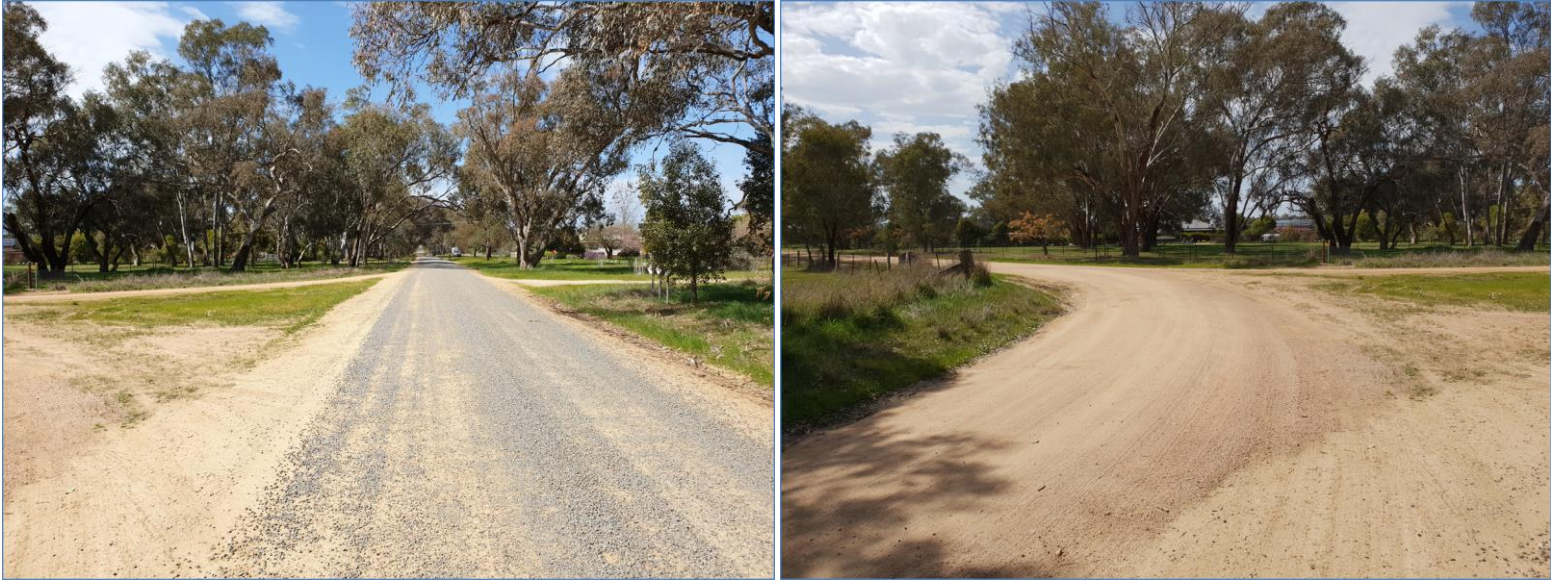
Item	Audit Findings/Recommendations	Rankings
7	<p>Construction vehicles will be accessing the solar farm site from Lindner Road and Ortlipp Road intersection. The road surface of Lindner Road and Ortlipp Road has loose gravel, overgrown grass and is not completely sealed. There is an increased risk for vehicles turning right out on to Linder Road to skid on the surface especially when it is wet. The condition of the intersection may further deteriorate due to the passage of heavy and light vehicles. This can result in vehicles skidding out of control, resulting in a T-bone crash causing serious injury.</p> <div data-bbox="237 616 1783 1198">

A maintenance plan is recommended to maintain the road conditions to a level suitable for the proposed access and for all vehicle types. A dilapidation survey should be conducted periodically to review the condition of the road.

</div> <p>Consideration should be given to the development of a maintenance plan to maintain road conditions to a level suitable for the proposed access and for all vehicle types.</p>	Medium

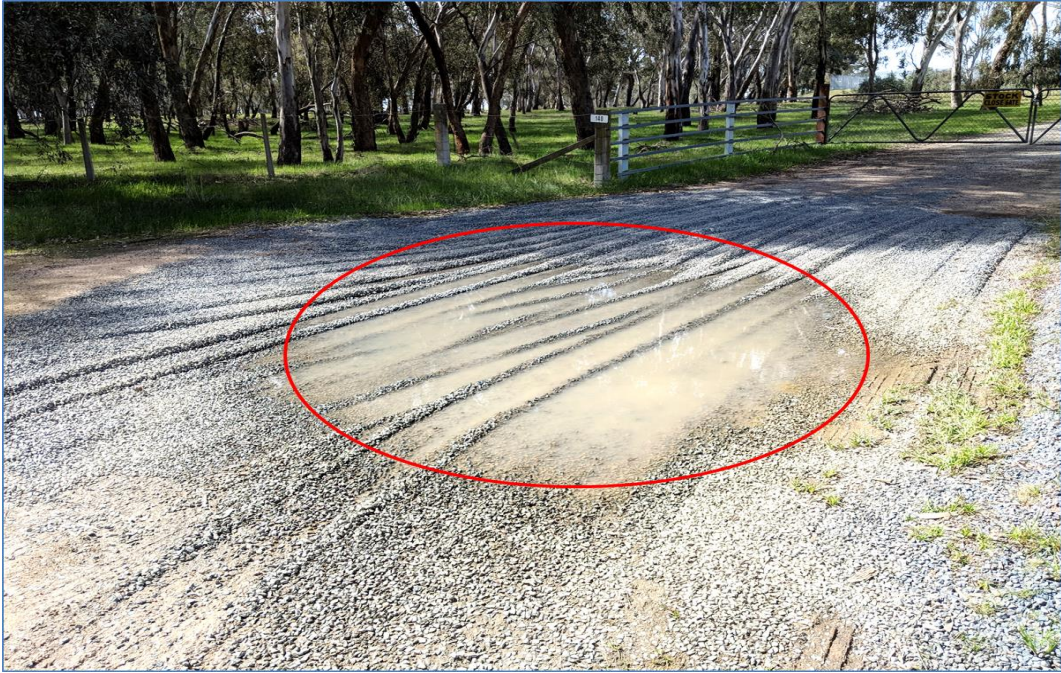
Item	Audit Findings/Recommendations	Rankings
9	<p>The solar farm only has one access point which is from Ortlipp Road. The access point to the site has uneven surface with loose gravel and areas of ponding. There is a risk that a worker's car or motorcycle could lose control of their vehicles when driving over this rough surface / pond or when swerving to avoid them. There is an increased risk that this would result in a side swipe crash at this location causing injury.</p>

The access point off Ortlipp Road will need to be upgraded to accommodate the heavy vehicles. Improved surface pavement / grading and drainage, with periodical maintenance is recommended.

<p>Consideration could be given to maintaining the road surface to a level suitable to the proposed access and all vehicle types.</p>	Medium
