# Tweed Valley Hospital

## Historical Heritage Assessment

**Prepared for NSW Health Infrastructure**

**19 October 2018**

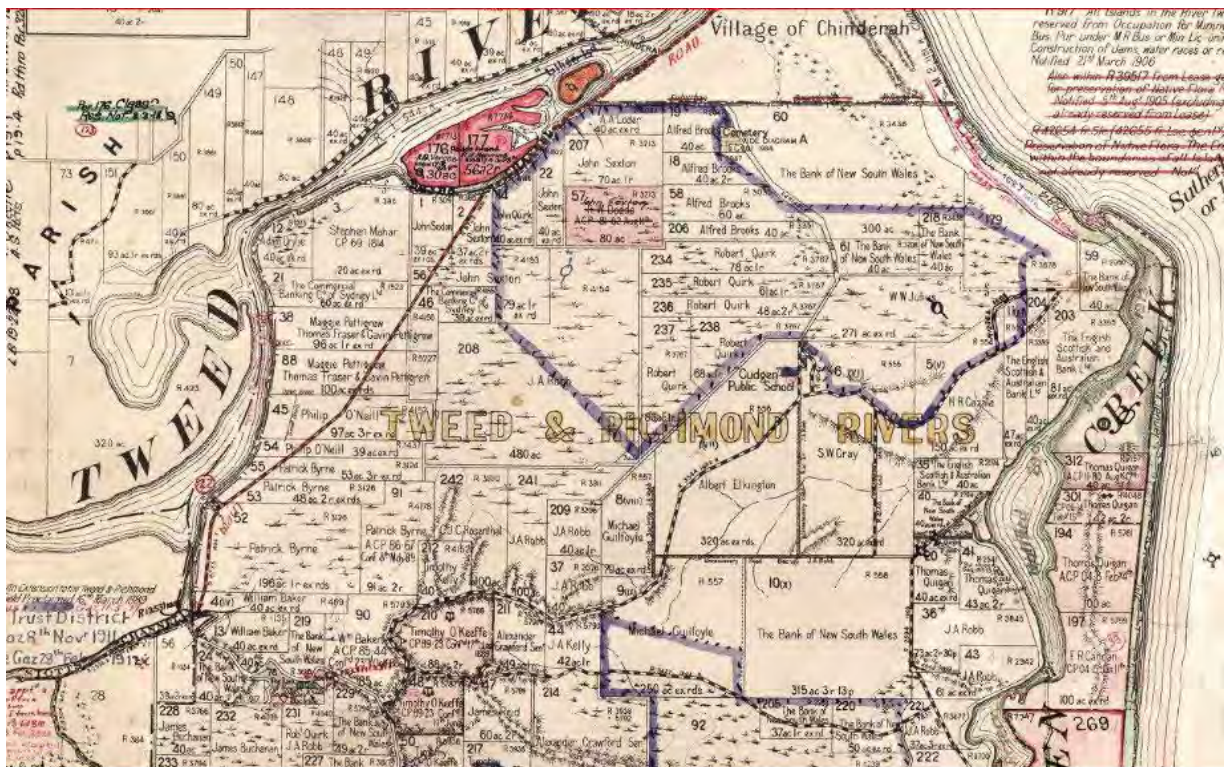
**Figure 4. Map of the Cudgen area, 1913 (NSW Land Registry Office, Historical Lands Records Viewer, Parish of Cudgen, 1913, edition 7, sheet reference 1, CD PMAPGF09).**

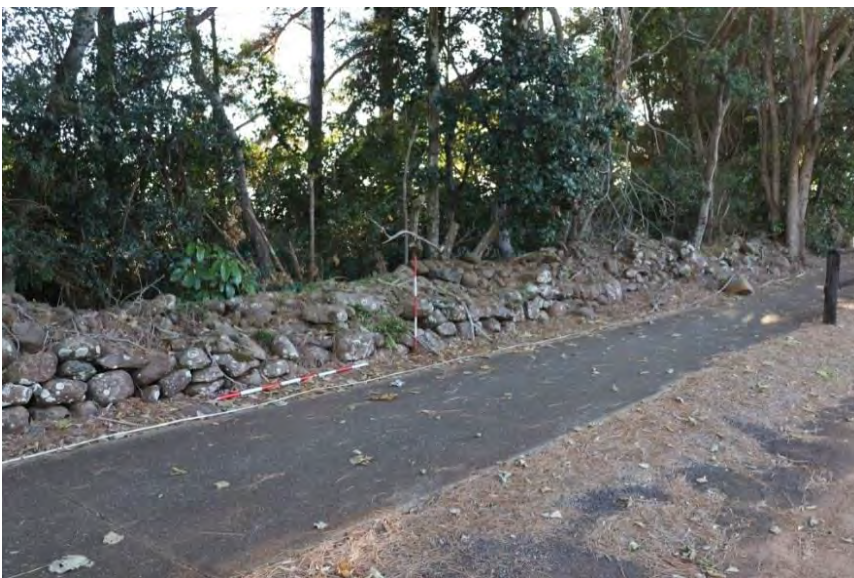
**Plate 2. Wall 1, view northeast.**

Wall 1 is a dry-stone wall approximately 64 m in length and is located adjacent to Cudgen Road, within the road reserve. The wall is constructed with large volcanic cobbles 3-5 courses high, with a rock rubble infill. The wall varies in width between 1-3 m. From the western end for around 20m the wall is low (single course) and partially collapsed. Between 20m and 34m the wall is in good condition and uniform in construction. Over the remaining 30 m of its extent the wall deteriorates and collapses in sections and is overtaken by ground cover. Vegetation and tree growth is intermingled with the wall along its extent. This relationship is both beneficial and deleterious, with tree roots holding together as well as tearing apart sections of the wall.

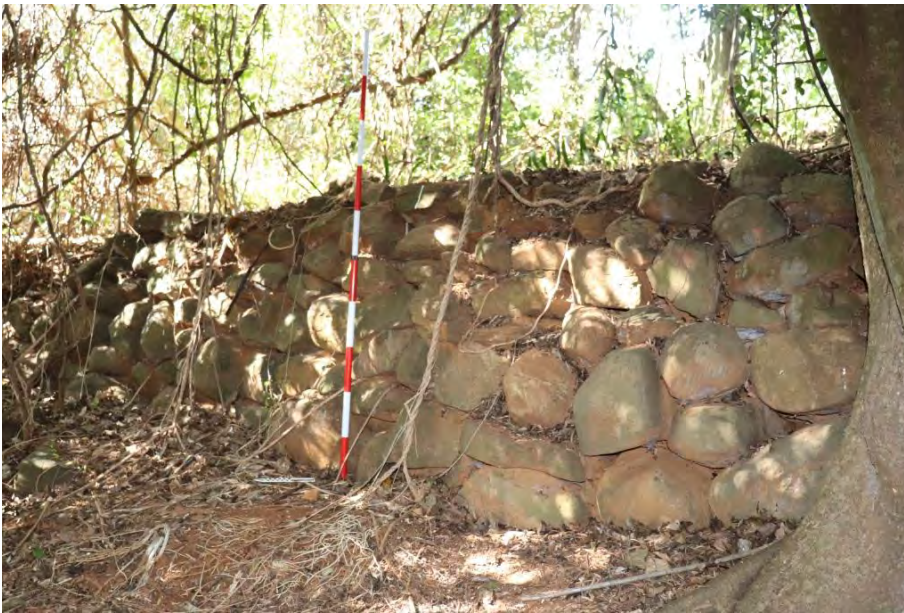
**Plate 3. Wall 2, northern boundary section, view southeast.**

Wall 2 is an extensive wall which runs along much of the western and northern boundaries of Lot 102 DP870722. Wall 2 is inclusive of both Wall 2 and Wall 3 identified in Niche (2018a). Wall 2 is a very well-constructed dry-stone wall of 6-8 courses of large volcanic cobbles. The sections of wall examined were in excellent condition although the encroachment of vegetation was apparent, and at its eastern end its height reduces and it forms more of a rubble batter than an upright wall. Thick vegetation prevented the full extent and condition of the wall from being assessed during the survey, and it is likely to be more extensive than shown in this report. Sections of the wall have been impacted by later developments including track construction to the creek on the western side (i.e. the former Wall 3 [Niche 2018]). Wall 2 appears to be a retaining wall designed to protect the ploughed fields upslope from the erosion and flooding from the creek in the west and swamp to the north.

- **Wall 2 and 5.** Although these features sit outside the impact zone, future vegetation management might have a detrimental impact. Therefore it is recommended that heritage considerations be incorporated into a vegetation management plan. Avoid removing trees and vegetation which may be supporting the walls.

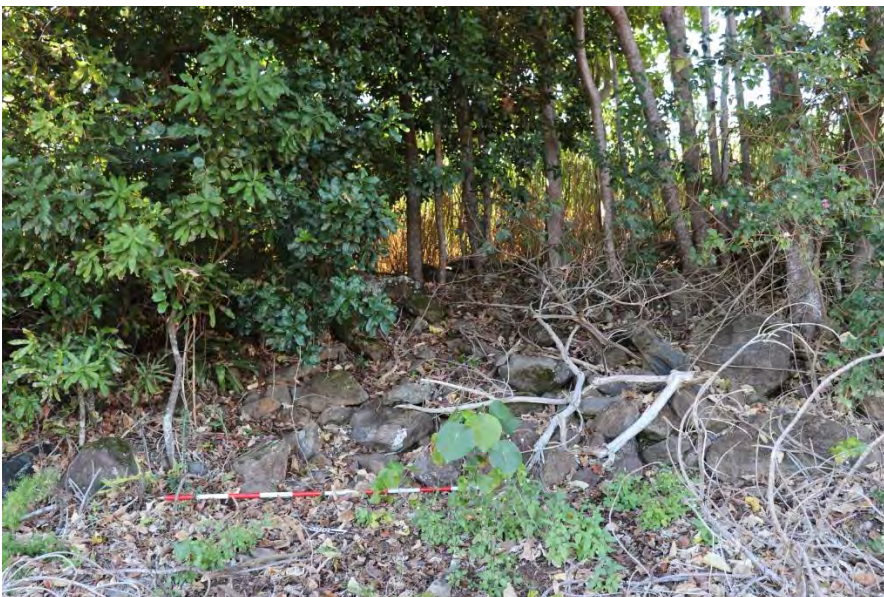
**Plate 4. Wall 3, view east towards upper paddock.**

Wall 3 is a dry-stone wall of variable height located mid-slope on the western side of Lot 102 DP870722. The wall is oriented north-south within a row trees and runs for approximately 46 m. The wall varies in height and condition, however the majority of the wall is high (4-5 courses of volcanic cobbles) and well formed. This wall is overgrown with vegetation which prevented its full extent from being defined and contributes to its deterioration. Included in this vegetation is a very old macadamia tree.

- **Wall 3.** This feature also sits mostly outside the impact zone, but could potentially be clipped at its northern end by an internal road. It may also be inadvertently damaged by machinery during construction of the hospital or through later vegetation and site management. If possible, impact should be avoided through a redesign of the road that shifts it further north to avoid the wall. The wall should be temporarily barricaded during construction works and considered in future management policies. If impacts are unavoidable, the features should have an archival recorded prepared prior to

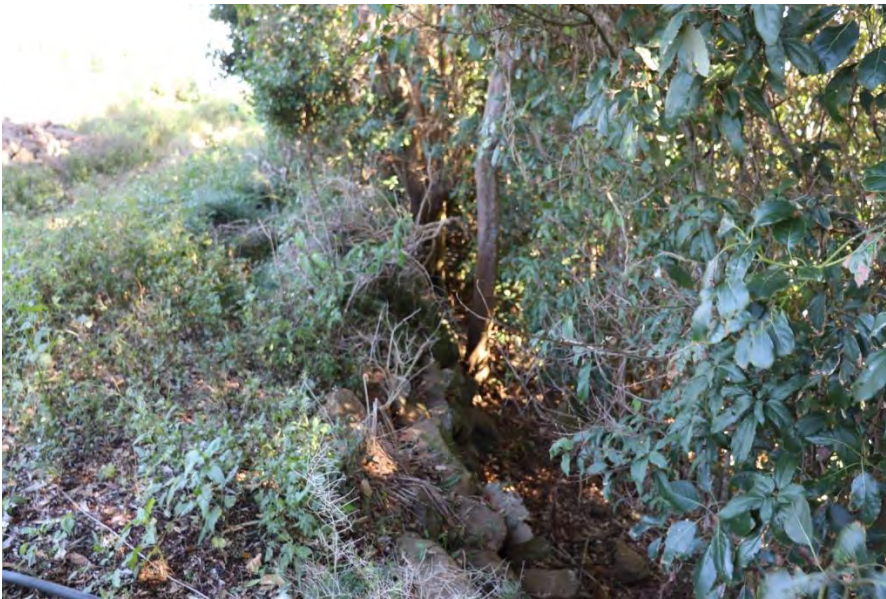
**Plate 5. Wall 4, view west from top of wall and terrace.**

Wall 4 is a dry-stone wall of 4-6 courses of large volcanic cobbles. This wall is approximately 60 m long and contained within a hedgerow mid-slope. This wall appears to act as a terrace, supporting the upslope fields, although it could also be the remains of a culvert or retaining wall associated with the tramway that was

roughly in this location. This wall is heavily concealed by the trees and vegetation of the hedgerow. It was only viewed and photographed from above as it was too difficult to access it from its base. This wall appears to be in good condition and remains in situ.

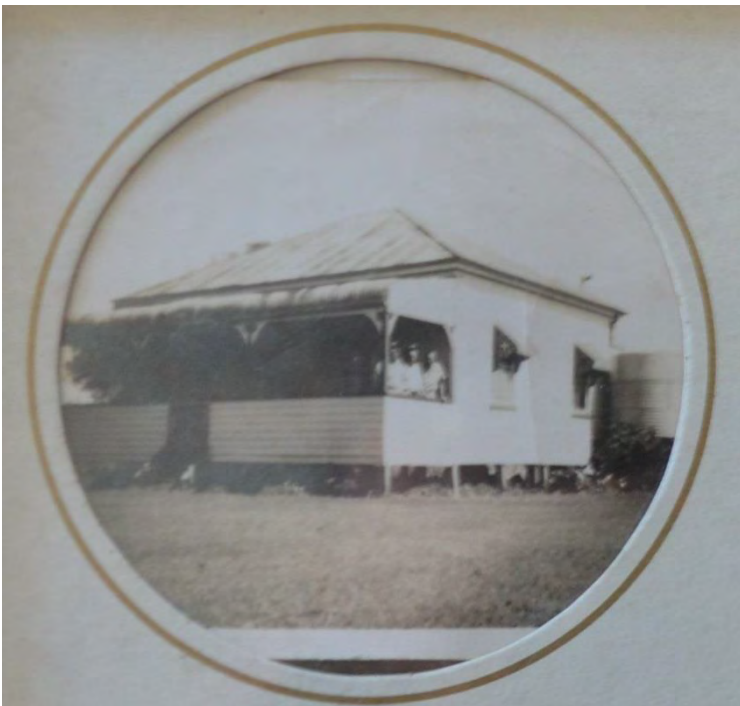
**Plate 6. Image of the original house, ca. 1920s-50s, looking from the southeast (image supplied by property resident).**

Stylistically the existing house is a circa 1890-1900 weatherboard cottage on low stumps with iron roof. Originally it had a front, bullnose verandah facing Cudgen Rd (Plate 6). Anecdotal evidence from the current occupier is that her family bought or moved onto the farm around 1916 and the house was present at that time. It therefore post-dates the heyday of the plantation system and most likely is linked to the period of ownership of the Cornwell family. It may or may not have been the principal family residence as there are

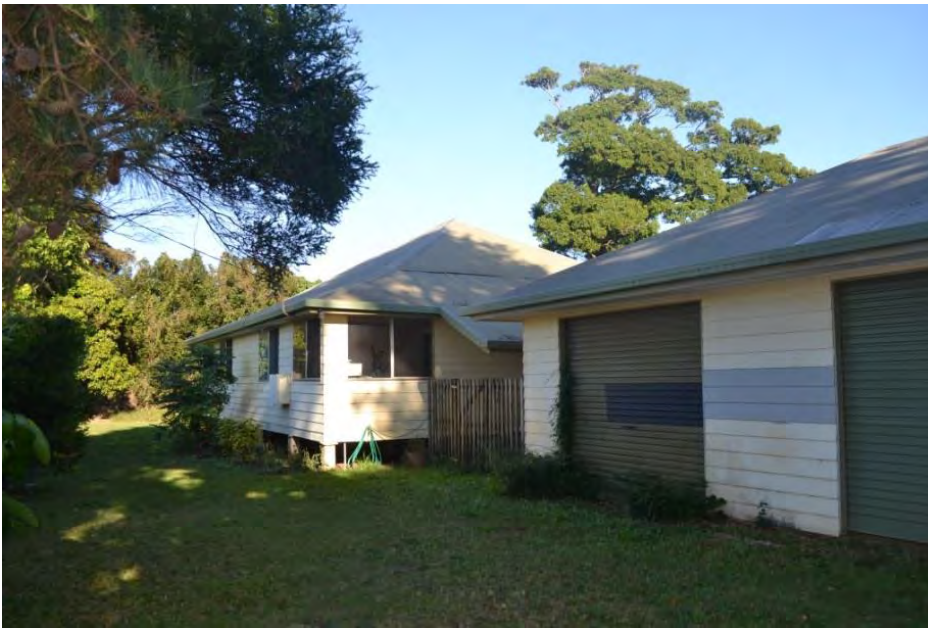
In the nature of many farmhouses, the building has been extensively modified in response to changing family needs. Almost all original features have been removed or obscured except for an internal wall with a fretwork arch, one door and some VJ walls and ceiling. The roof has been re-profiled and extended on all sides to create a wrap-around verandah that is now enclosed by Hardieplank and aluminium windows for extra living space. The original corrugated iron of the roof has been replaced with Colorbond sheeting.

These major alterations greatly diminish the house's heritage values.

**Plate 7. House as it is today, with garage to right, looking from southeast.**

- House – the house will be removed during Preliminary works on the site.
- Trees – pine trees on the southern boundary will be removed, mostly along the main frontage to the hospital, but there are also a small number requiring removal to the east and west where there are proposed vehicle entrances. Of the three mature trees within the existing house area, the Poinciana and western fig will need to be removed for a carpark road. The east fig will be retained and incorporated in the new design.

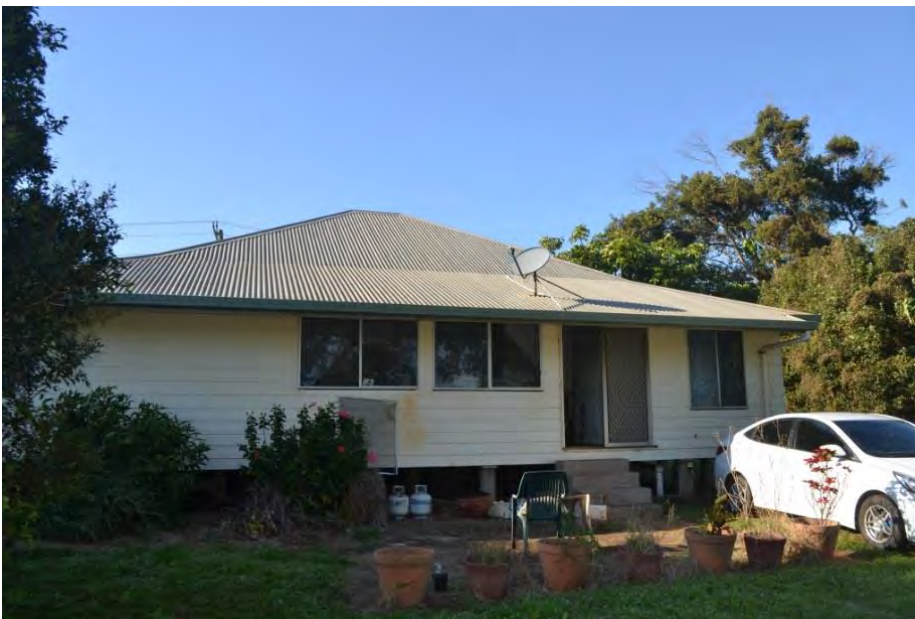
**Plate 8. Rear of the house, now the main entry.**

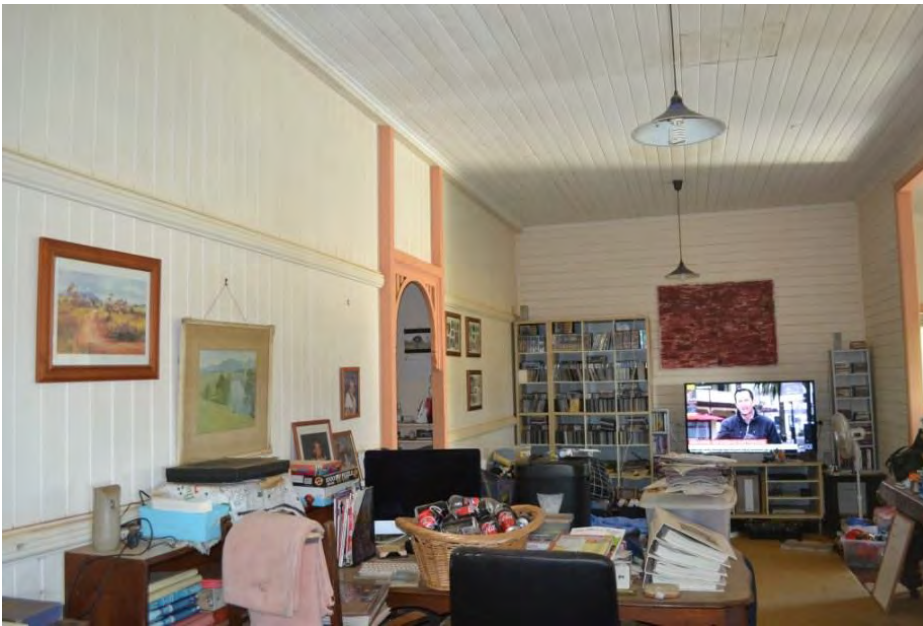
**Plate 9. Interior of house showing main living room with VJ ceiling, wall and hallway arch.**

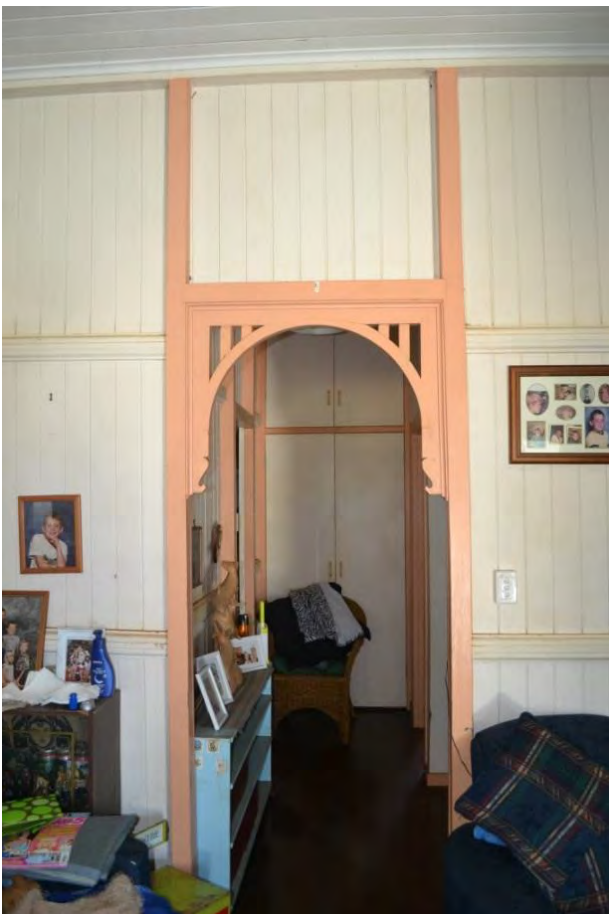
**Plate 10. Detail of fretwork hallway arch. Hallway is now enclosed by a cupboard, visible to rear.**

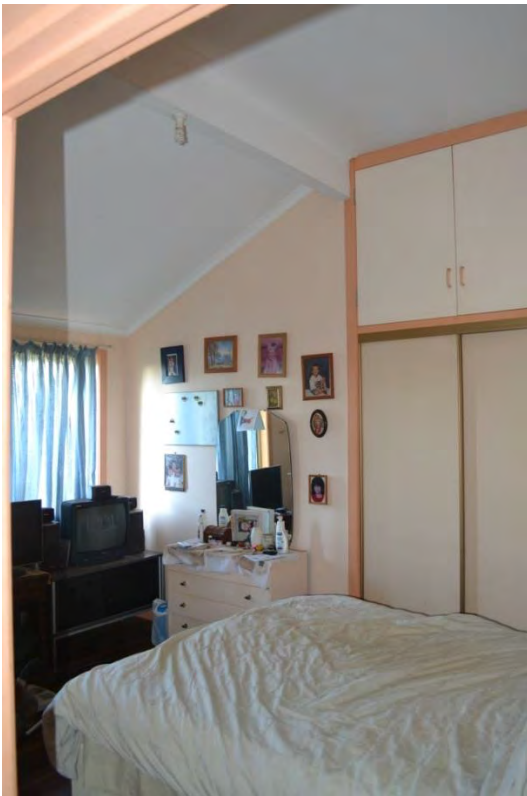
**Plate 11. Southwest bedroom showing opening into the now enclosed verandah.**

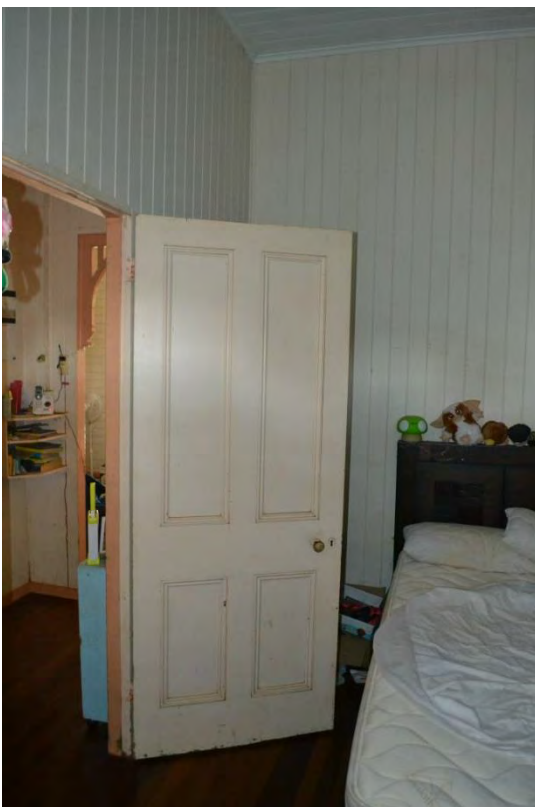
**Plate 12. Southeast bedroom showing an original door.**

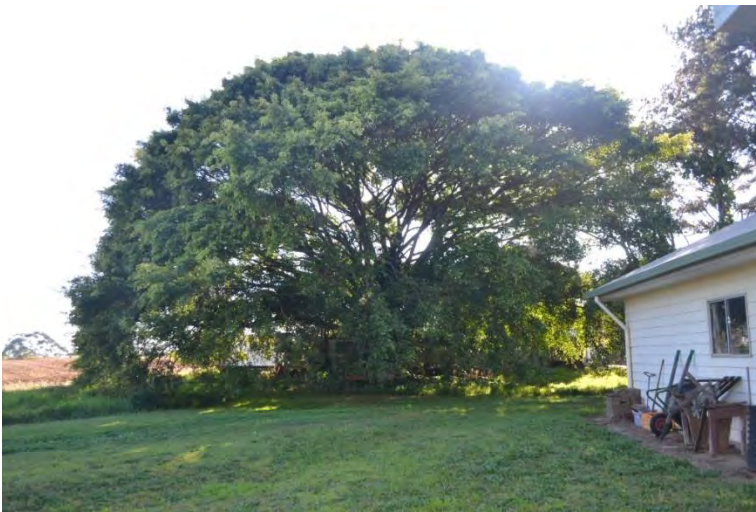
**Plate 13. Spreading fig tree on northeast side of house, view east.**

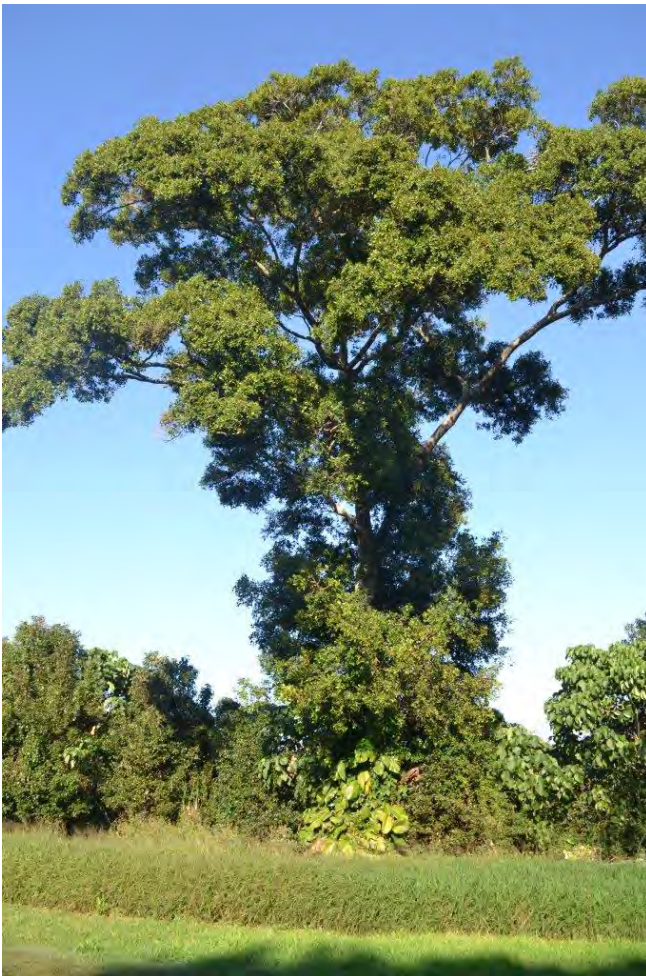
**Plate 14. Tall fig tree on northwest side of house, view west.**

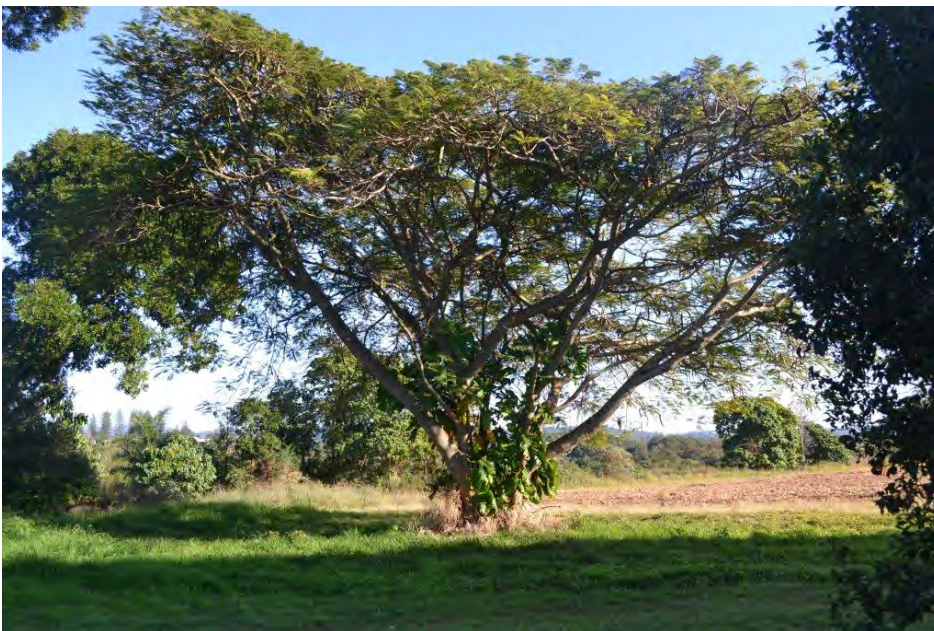
**Plate 15. Poinciana, view north.**

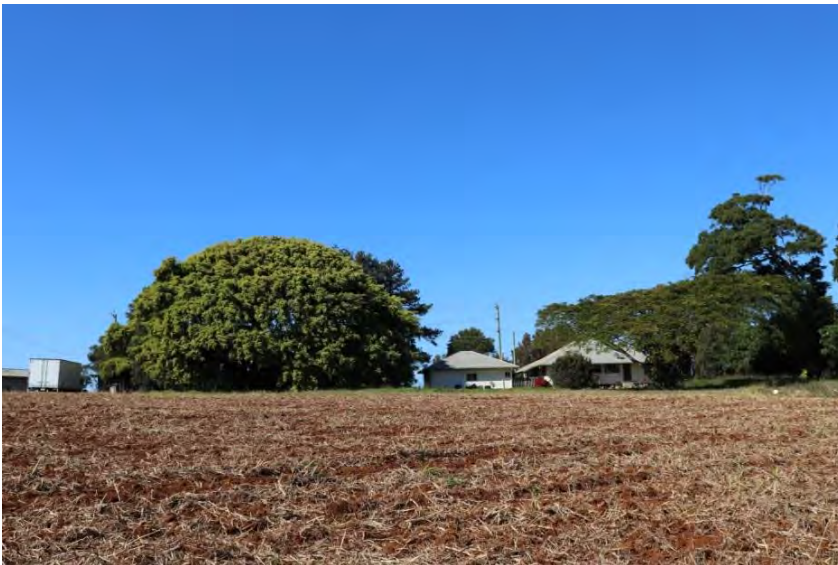
**Plate 16. Rear of house area, looking southeast showing the three trees.**

Owing to the high growth rate of trees in this area, supported by rich soil and high rainfall, these trees may not be very old (possibly 40-60 years). This assessment is based on their size but would need to be confirmed by a trained arborist and/or historical aerial photo analysis. Historic aerial images that could help indicate the age of the trees were sought from LPI but were not obtainable within the necessary timeframe.

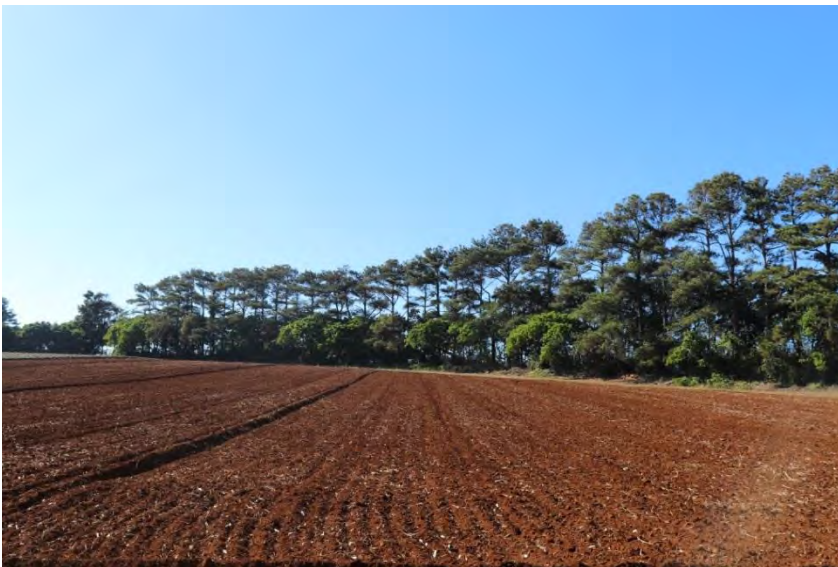
**Plate 17. Boundary planting of pine trees, looking east from across field.**

Along the southern (Cudgen Road) boundary is a line of mature exotic pines (probably *Pinus radiata*) mixed with regrowth rainforest species such as tuckeroo (*Cupaniopsis anacardioides*) and macaranga (*Macaranga tanarius*). The pine trees probably date from the 1930s onwards when the McPhail family established the current farm boundaries.

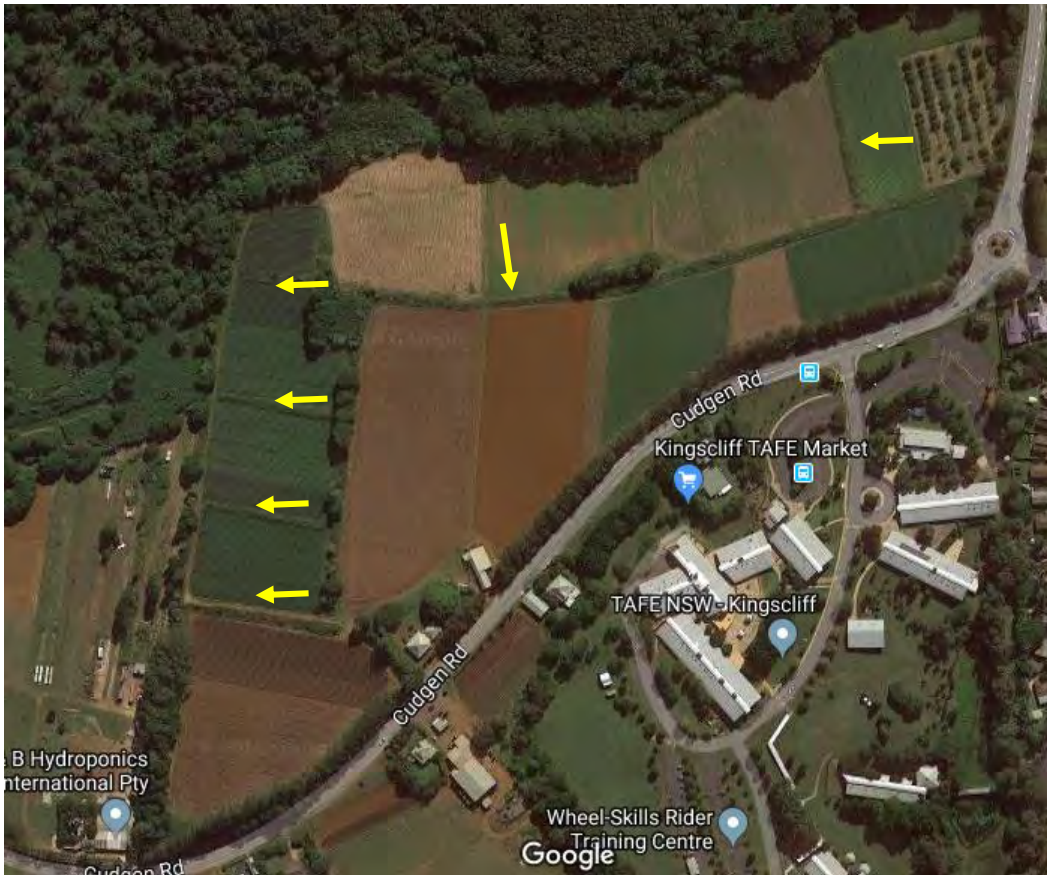
The property is divided into individual paddocks by six major hedgerows formed by the collection and piling of boulders from the surrounding fields. These are becoming overgrown by grass, weeds and rainforest trees, but do not exhibit the same maturity of regrowth or level of weathering or lichen colonisation as the stone walls, suggesting they are of more recent origin.

**Plate 18. Aerial image of Project Site showing main rock hedgerows (yellow arrows) (Google Earth 2018).**

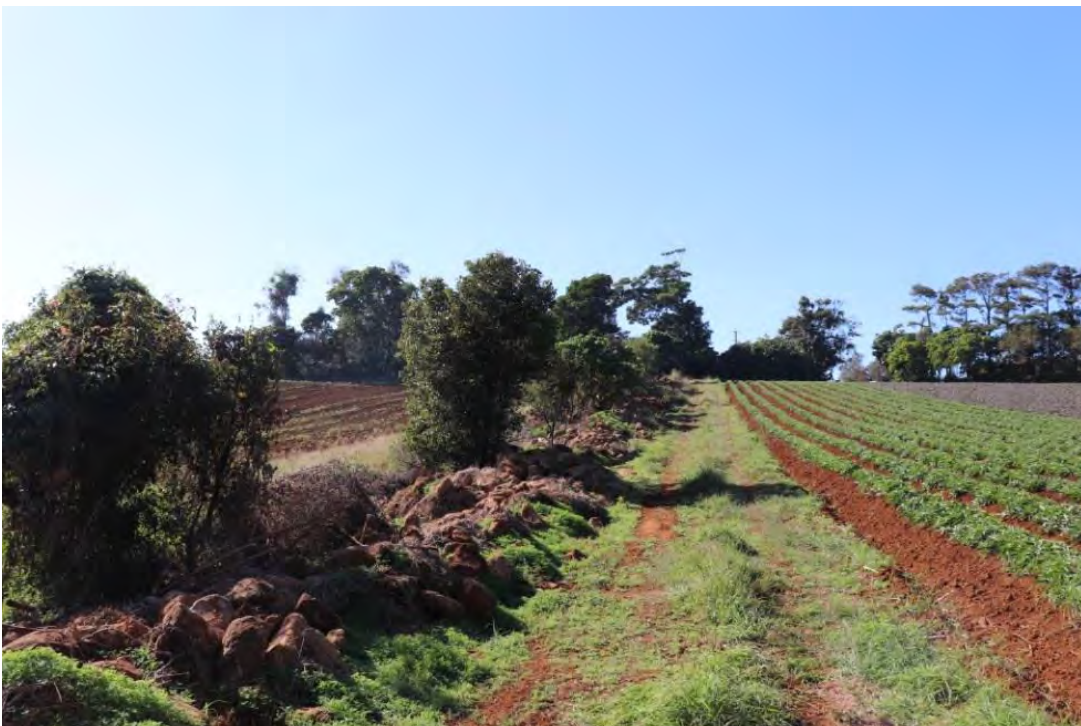
**Plate 19. Rock hedgerow, view east.**

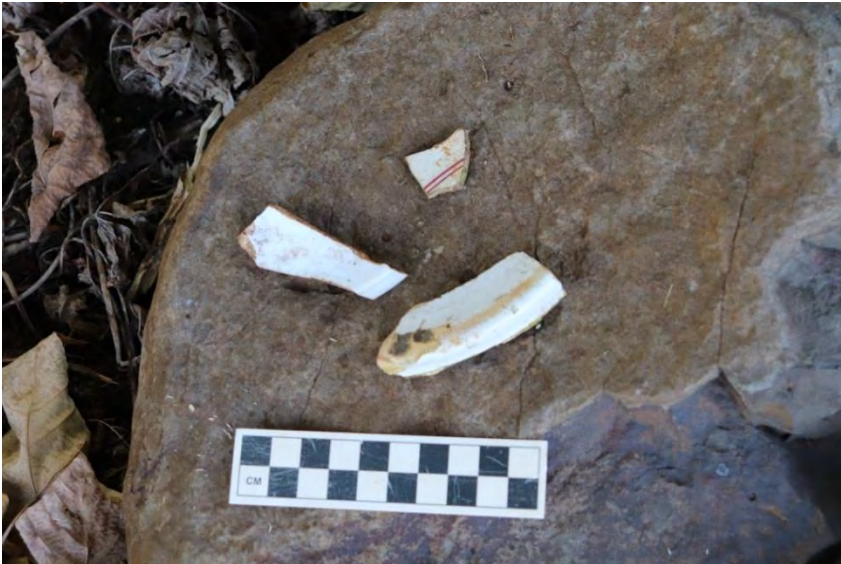
Across the site three rubbish deposits were identified. A small scatter of fragmented ceramics were identified amongst the volcanic cobbles of Wall 3. These ceramics were utilitarian 19<sup>th</sup> century or early 20<sup>th</sup> century domestic-ware. Two other, larger rubbished deposits were identified in the north-west corner of the site. These two rubbish deposits contained a range of material including evidence of the old tramway in the form of rail track, as well as other cast-iron, a Schultz Engineering and Manufacturing Co. ferrous metal container (post-1961) and demolition debris. Initial inspection indicated some of the material may be 19<sup>th</sup> or early 20<sup>th</sup> century, while other material is more recent.

**Plate 20. Ceramics at Wall 3.**

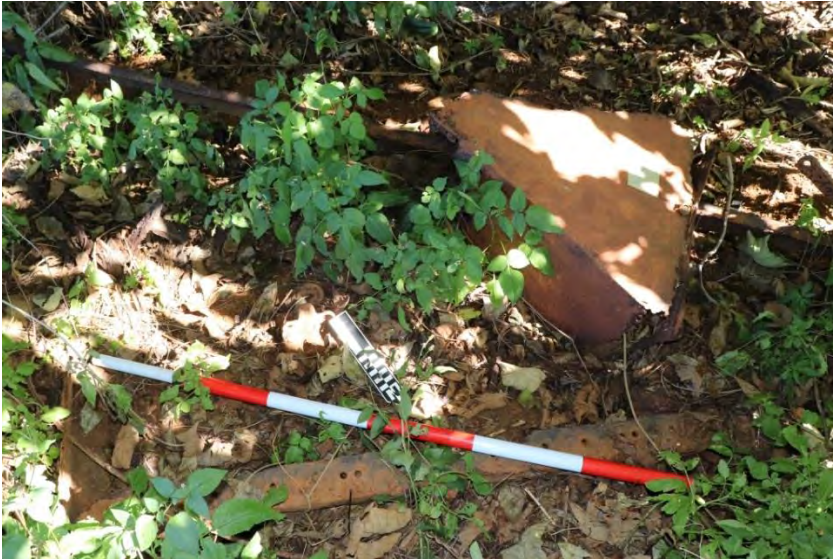
**Plate 22. Rubbish dump including rail track and machinery**
