Remedial Action Plan Addendum – Residential house

771 Cudgen Road,
Cudgen, NSW

January 2019, Ref. 18084 R02 V3

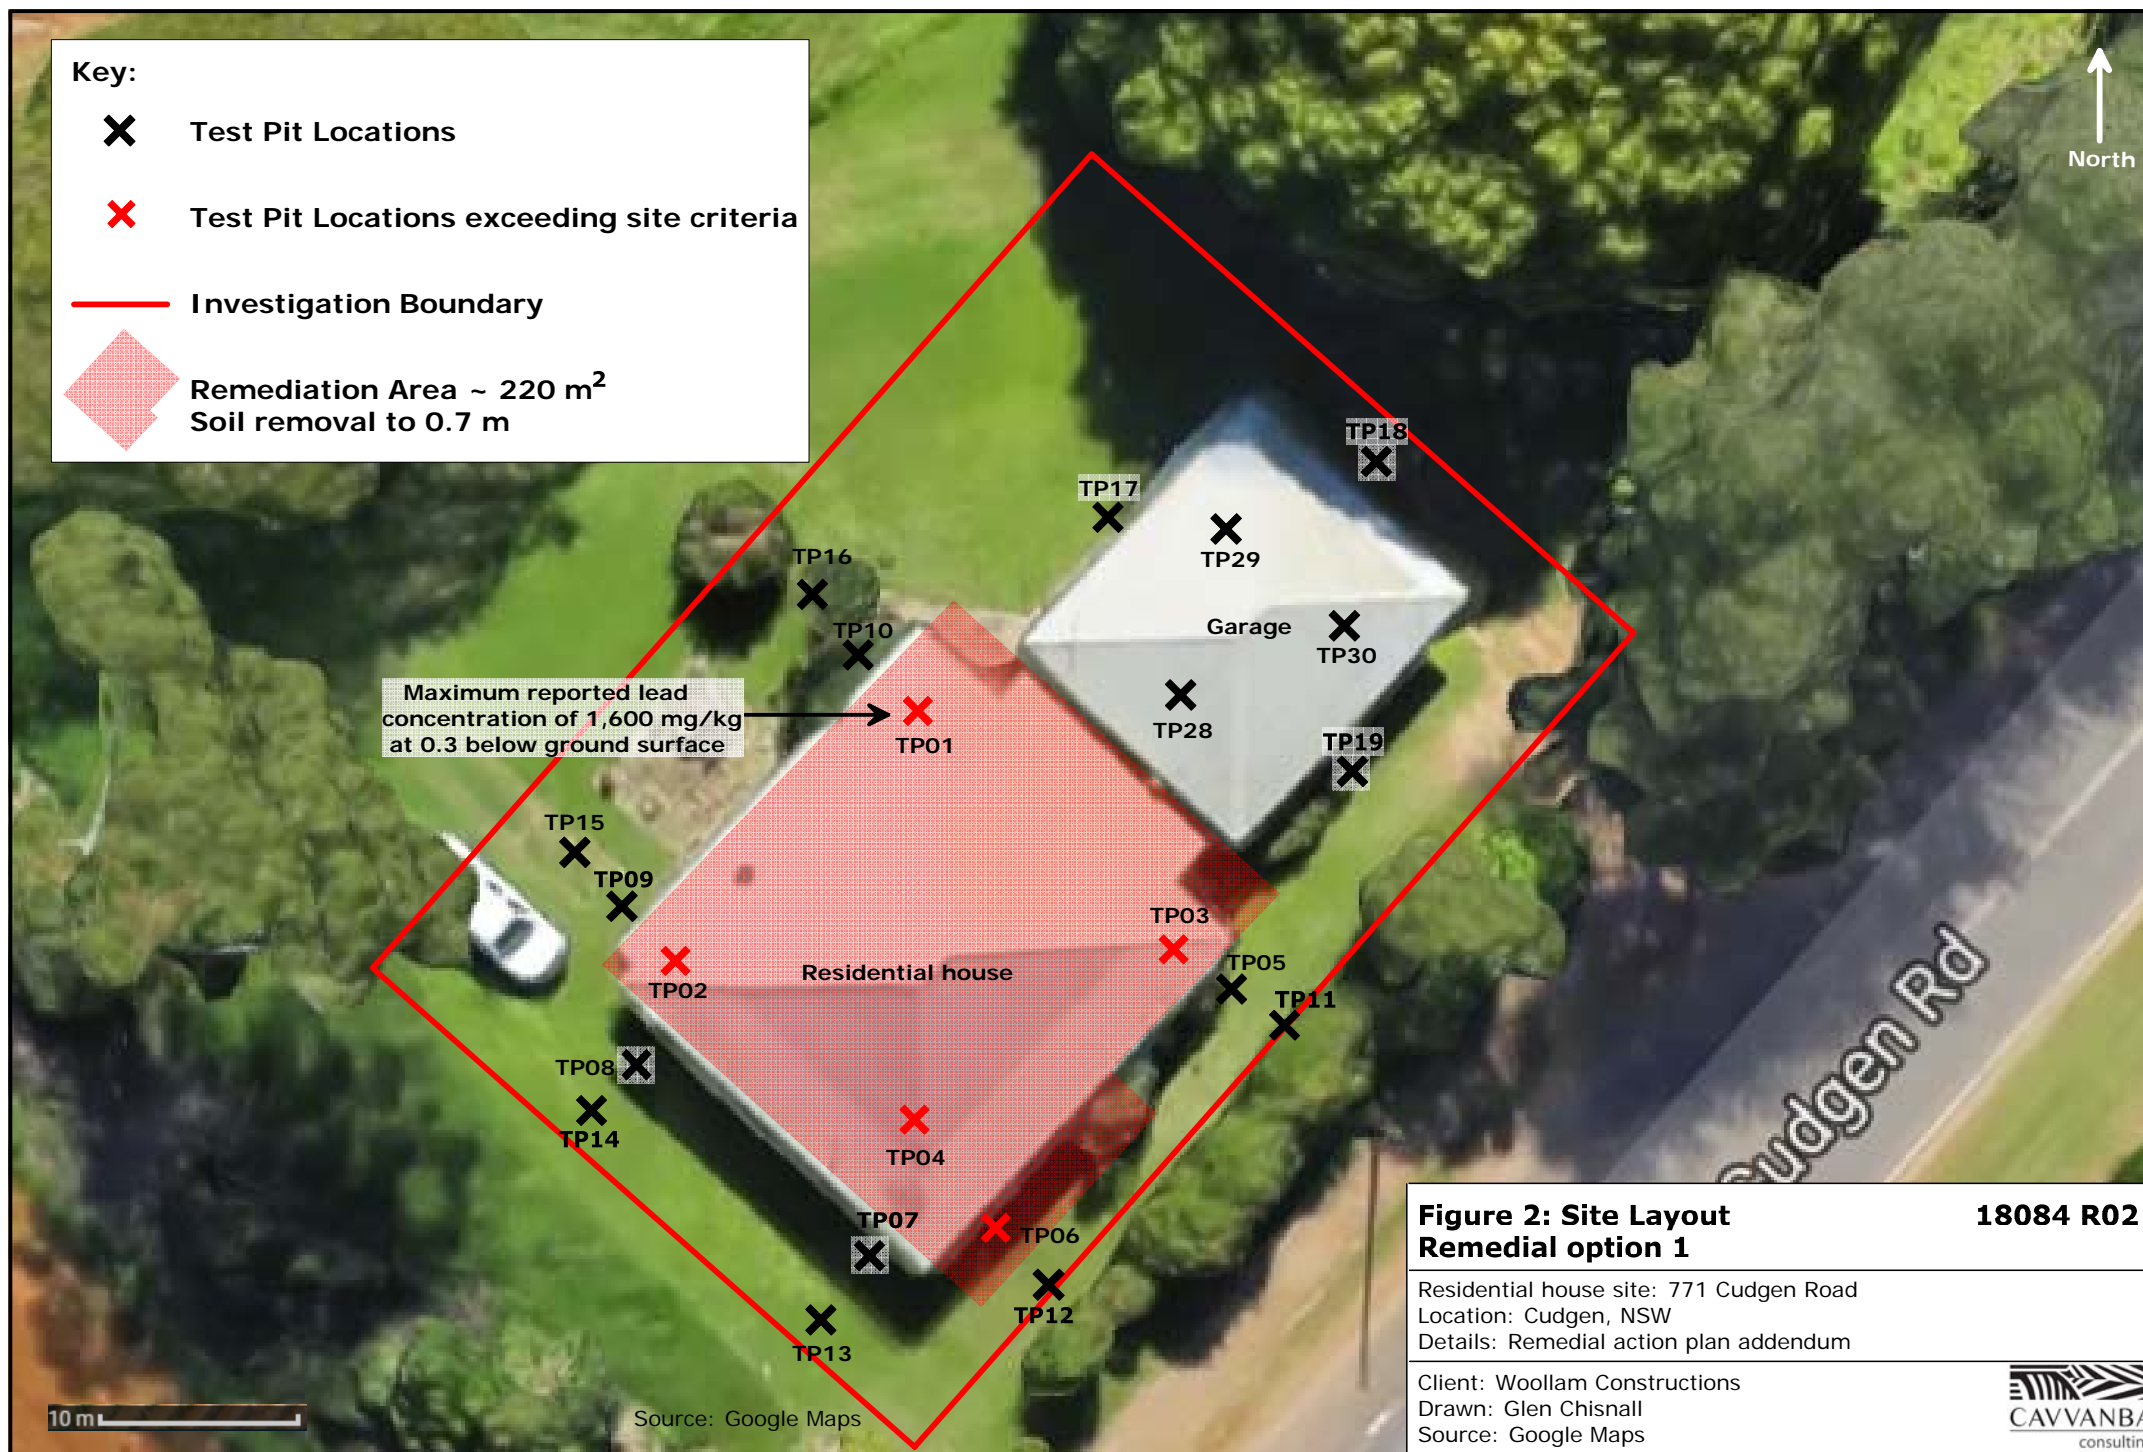
**Figure 2: Site Layout
Remedial option 1**

Remediation Area ~ 220 m²
Soil removal to 0.7 m

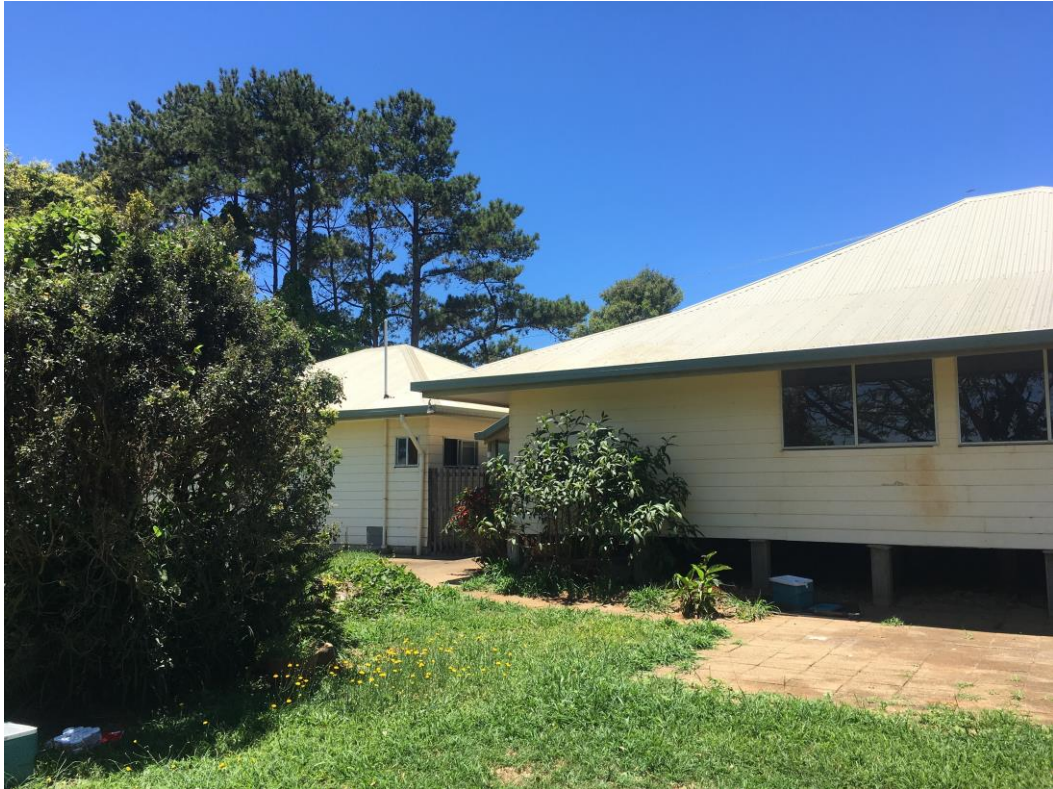
Photograph 1.

View east of investigation area, garage to the left and the residential house on the right. All photographs taken on 30 November; 11 and 12 December 2018.

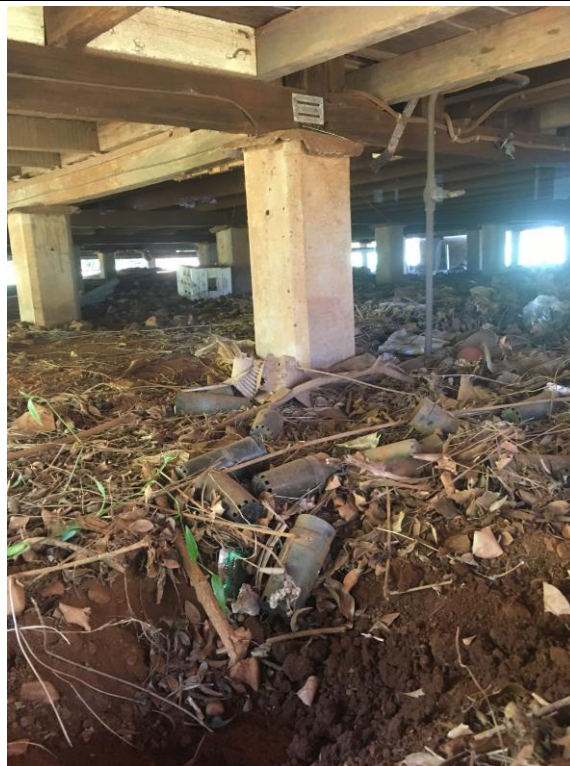
Photograph 2.

View of TP02; located underneath the south-western section of the former residential house. Anthropogenic materials consisting of plastic and glass scattered around the test pit location.

- TP02_0.1 = 1,070 mg/kg;
- TP02_0.3 = 838 mg/kg; and
- TP02_0.6 = 324 mg/kg.

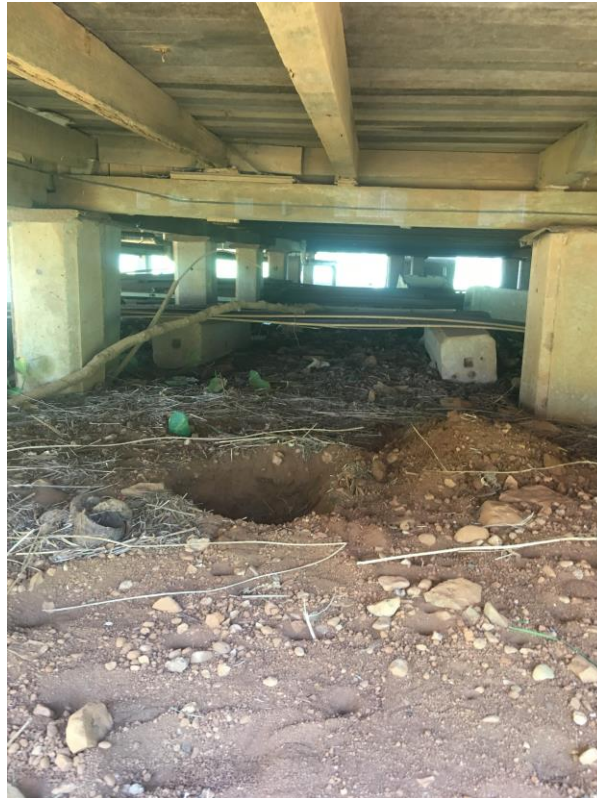
Photograph 3.

View of test pit location TP04; located underneath southeast portion of the house, in the southeast portion.

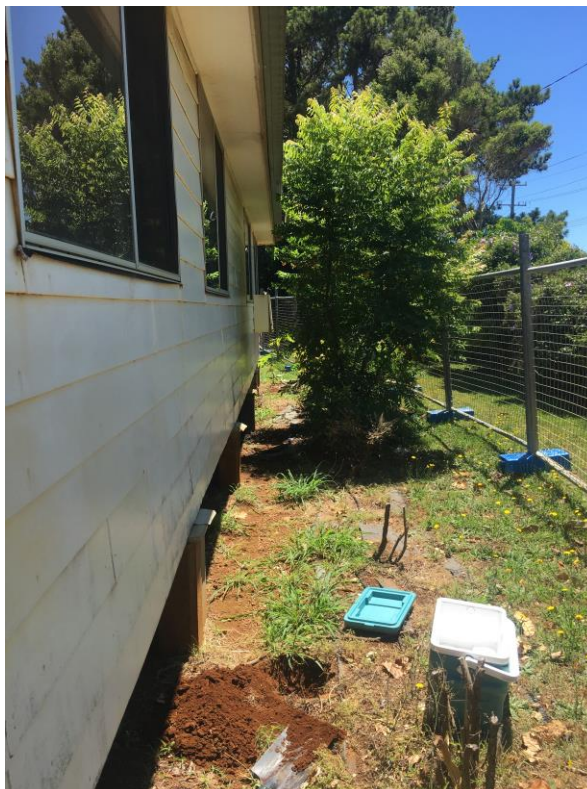
Photograph 4.

Test pit location TP06, located ~ 1 m from the eastern wall of the former residential house.

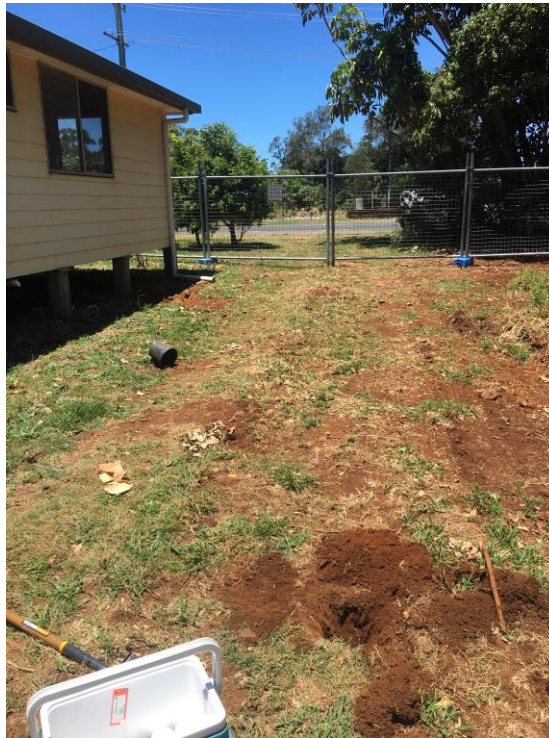
Photograph 5.

*View of test pit location TP14, sampled ~ 5 m to the south of the residential house.
Anthropogenic inclusions of glass and tiles were identified within this location.*

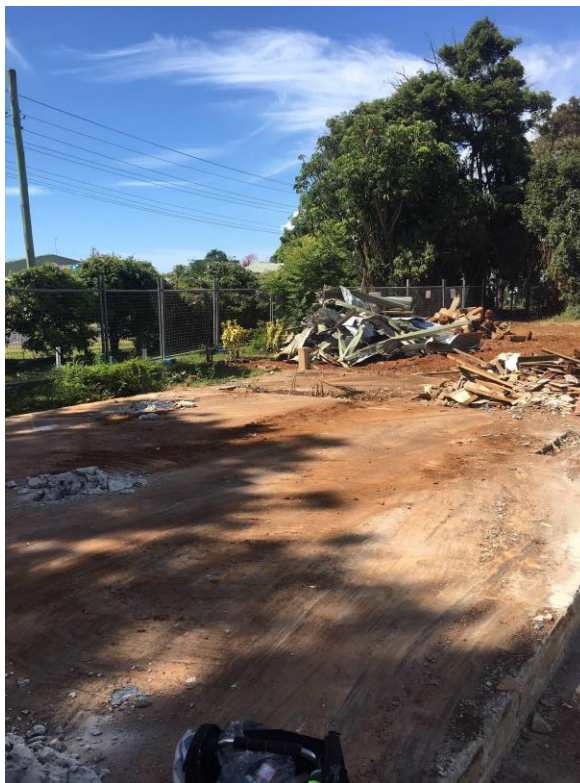
Photograph 6.

*View over garage slab. Test pit locations TP28 and TP30 visible in foreground followed by
demolition waste from the former residential house.*
