## **REMEDIATION ACTION PLAN**

**TWEED VALLEY HOSPITAL SITE  
771 CUDGEN ROAD, CUDGEN,  
NSW**

Prepared For: NSW Health Infrastructure c/o – TSA Management

Date: 1 February 2019

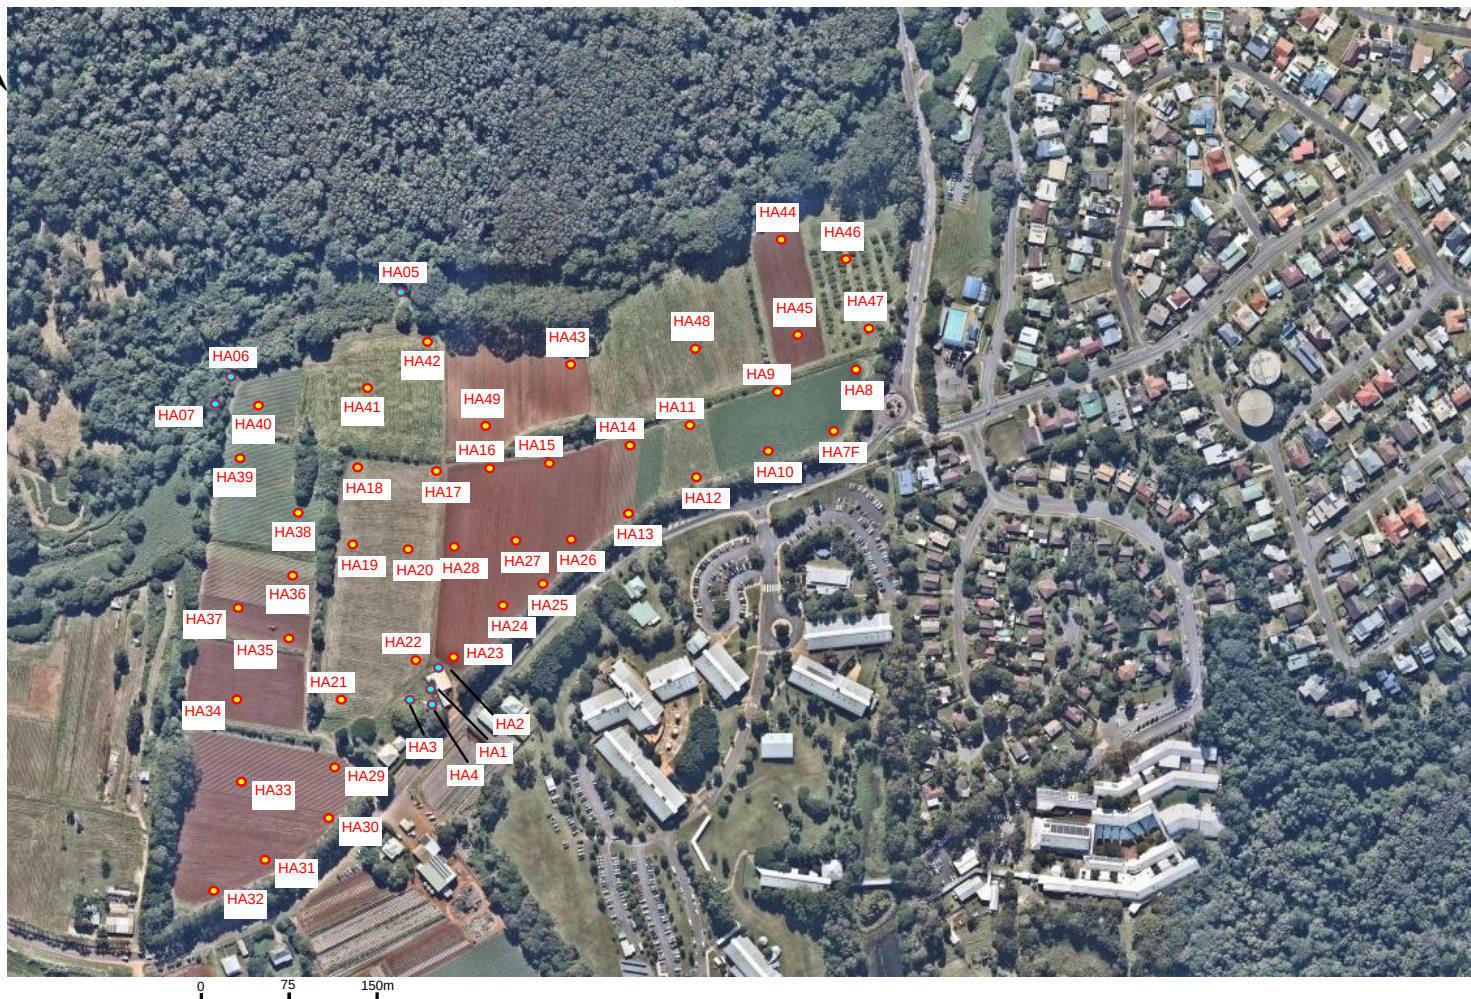
| | | DRAWING No: | 2 |

Hand Auger  
location

| DRAWING TITLE: | DSI Sampling Locations | JOB No: | J8961 |

During the Stage 2 Detailed Site Investigation, the following subsurface conditions were encountered (Borehole locations provided on Figure 2, Appendix A):

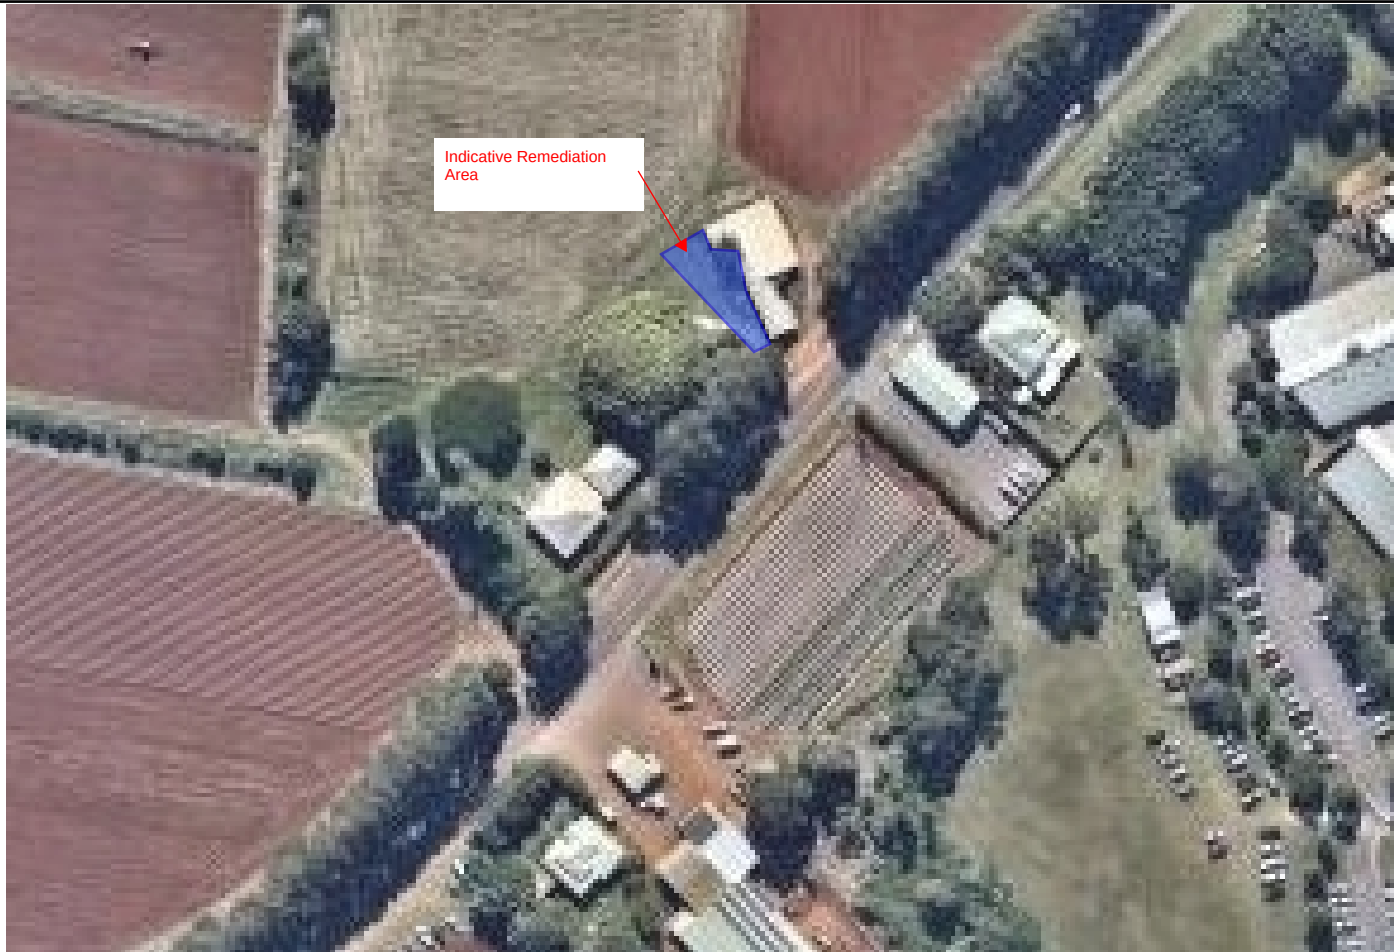
| | | DRAWING No: | 3 |

| DRAWING TITLE: | Remediation Area | JOB No: | J8961 |

The WA DoH (2009) guidelines recommend the removal of an additional 1m laterally in all directions beyond the contaminated area. Based on site observations and sample locations the remediation area is shown in Figure 3 covering an area of approximately 230m<sup>2</sup>, which extends from 1m to the east of the western wall of the shed to 6m west of the north west corner and 2m west of the southwest corner.

The WA DoH (2009) guidelines recommend the removal of an additional 1m laterally in all directions beyond the contaminated area. Based on site observations and sample locations the remediation area is shown in Figure 3 covering an area of approximately 230m<sup>2</sup> extending from 1m east of the former western wall of the shed to 6m west of the north west corner of the former shed and 2m west of the southwest corner.
