Site Audit Statement

Site audit statement no. **0503-1901**

Address **771 Cudgen Road**

**TWEED VALLEY HOSPITAL SITE
771 CUDGEN ROAD, CUDGEN,
NSW**

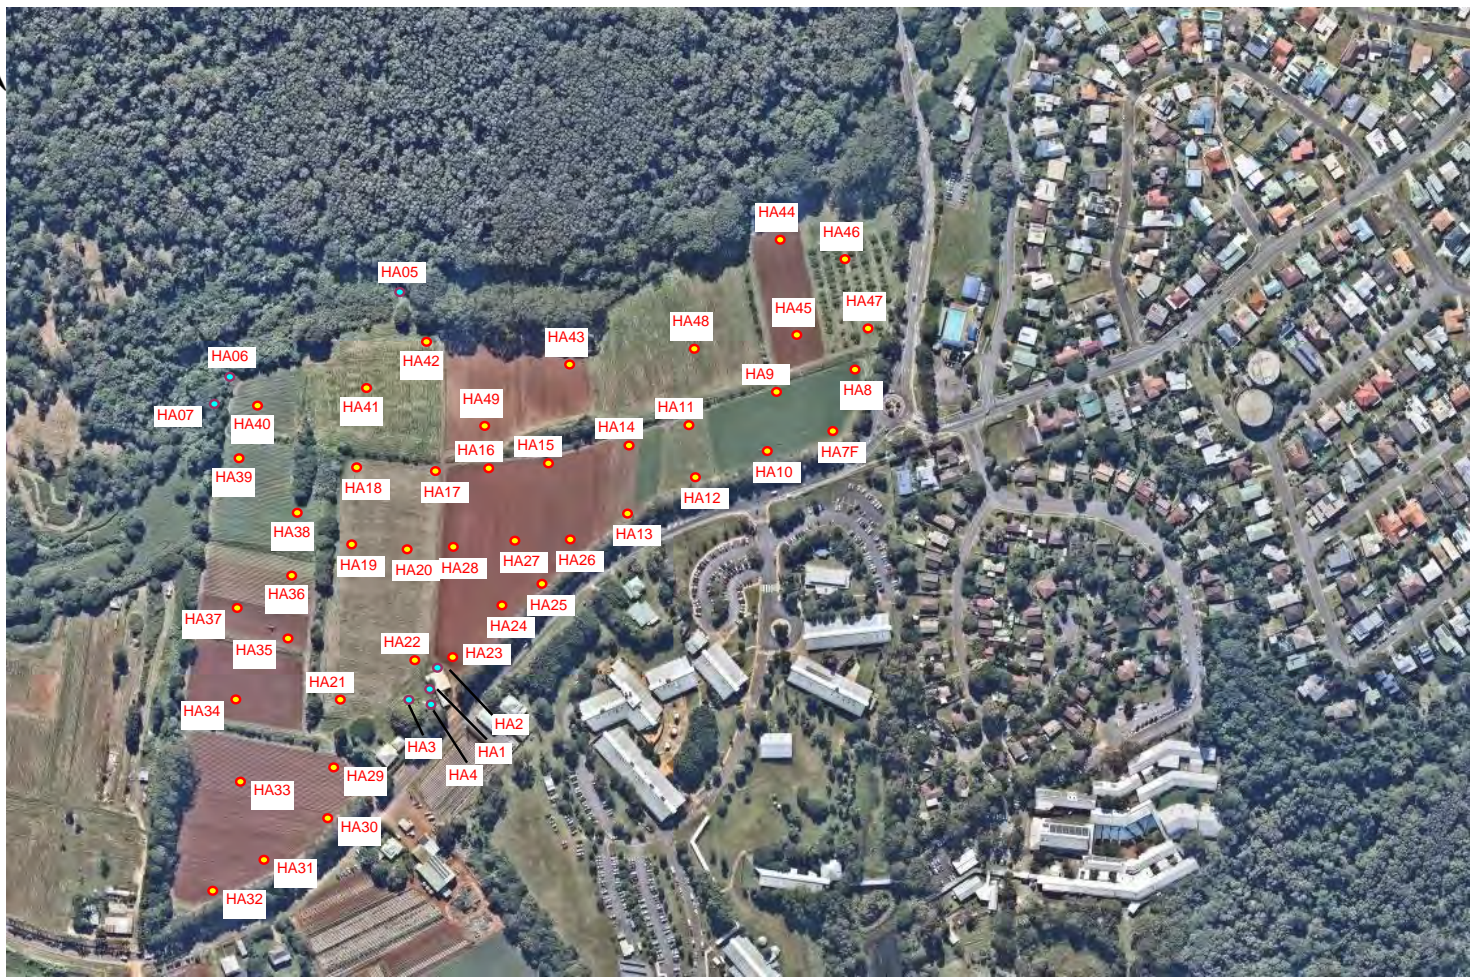
CLIENT:	Health Infrastructure NSW	DESIGNED:	DRAWN:
PROJECT TITLE:	Tweed Hospital RAP	CHECKED:	No. SHEETS:
SITE ADDRESS:	771 Cudgen Road, Cudgen	SCALE:	DATE STARTED:
DRAWING TITLE:	DSI Sampling Locations	JOB No:	J8961
		DRAWING No:	2

During the Stage 2 Detailed Site Investigation, the following subsurface conditions were encountered (Borehole locations provided on Figure 2, Appendix A):

HA37

Hand Auger
location

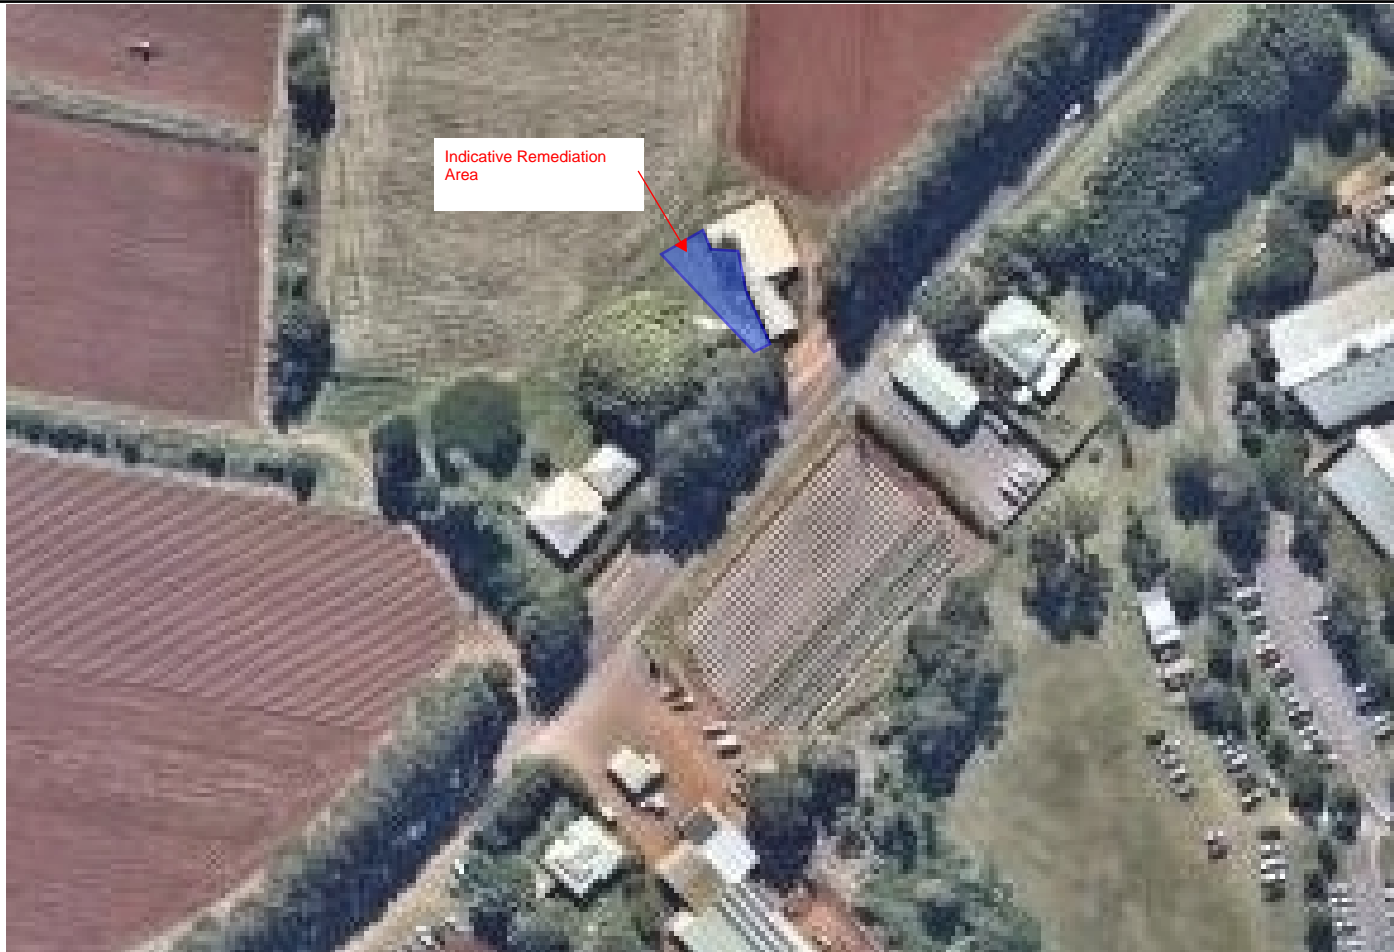
CLIENT:	Health Infrastructure NSW	DESIGNED:	DRAWN:
PROJECT TITLE:	Tweed Hospital RAP	CHECKED:	No. SHEETS:
SITE ADDRESS:	771 Cudgen Road, Cudgen	SCALE:	DATE STARTED:
DRAWING TITLE:	Remediation Area	JOB No:	J8961
		DRAWING No:	3

The WA DoH (2009) guidelines recommend the removal of an additional 1m laterally in all directions beyond the contaminated area. Based on site observations and sample locations the remediation area is shown in Figure 3 covering an area of approximately 230m², which extends from 1m to the east of the western wall of the shed to 6m west of the north west corner and 2m west of the southwest corner.

The WA DoH (2009) guidelines recommend the removal of an additional 1m laterally in all directions beyond the contaminated area. Based on site observations and sample locations the remediation area is shown in Figure 3 covering an area of approximately 230m² extending from 1m east of the former western wall of the shed to 6m west of the north west corner of the former shed and 2m west of the southwest corner.

The WA DoH (2009) guidelines recommend the boundaries of excavation works include an additional 30cm depth to account for uncertainty in the contamination delineation and removal process and therefore the below process should be undertaken for excavation and validation of ACM and asbestos impacted soils.

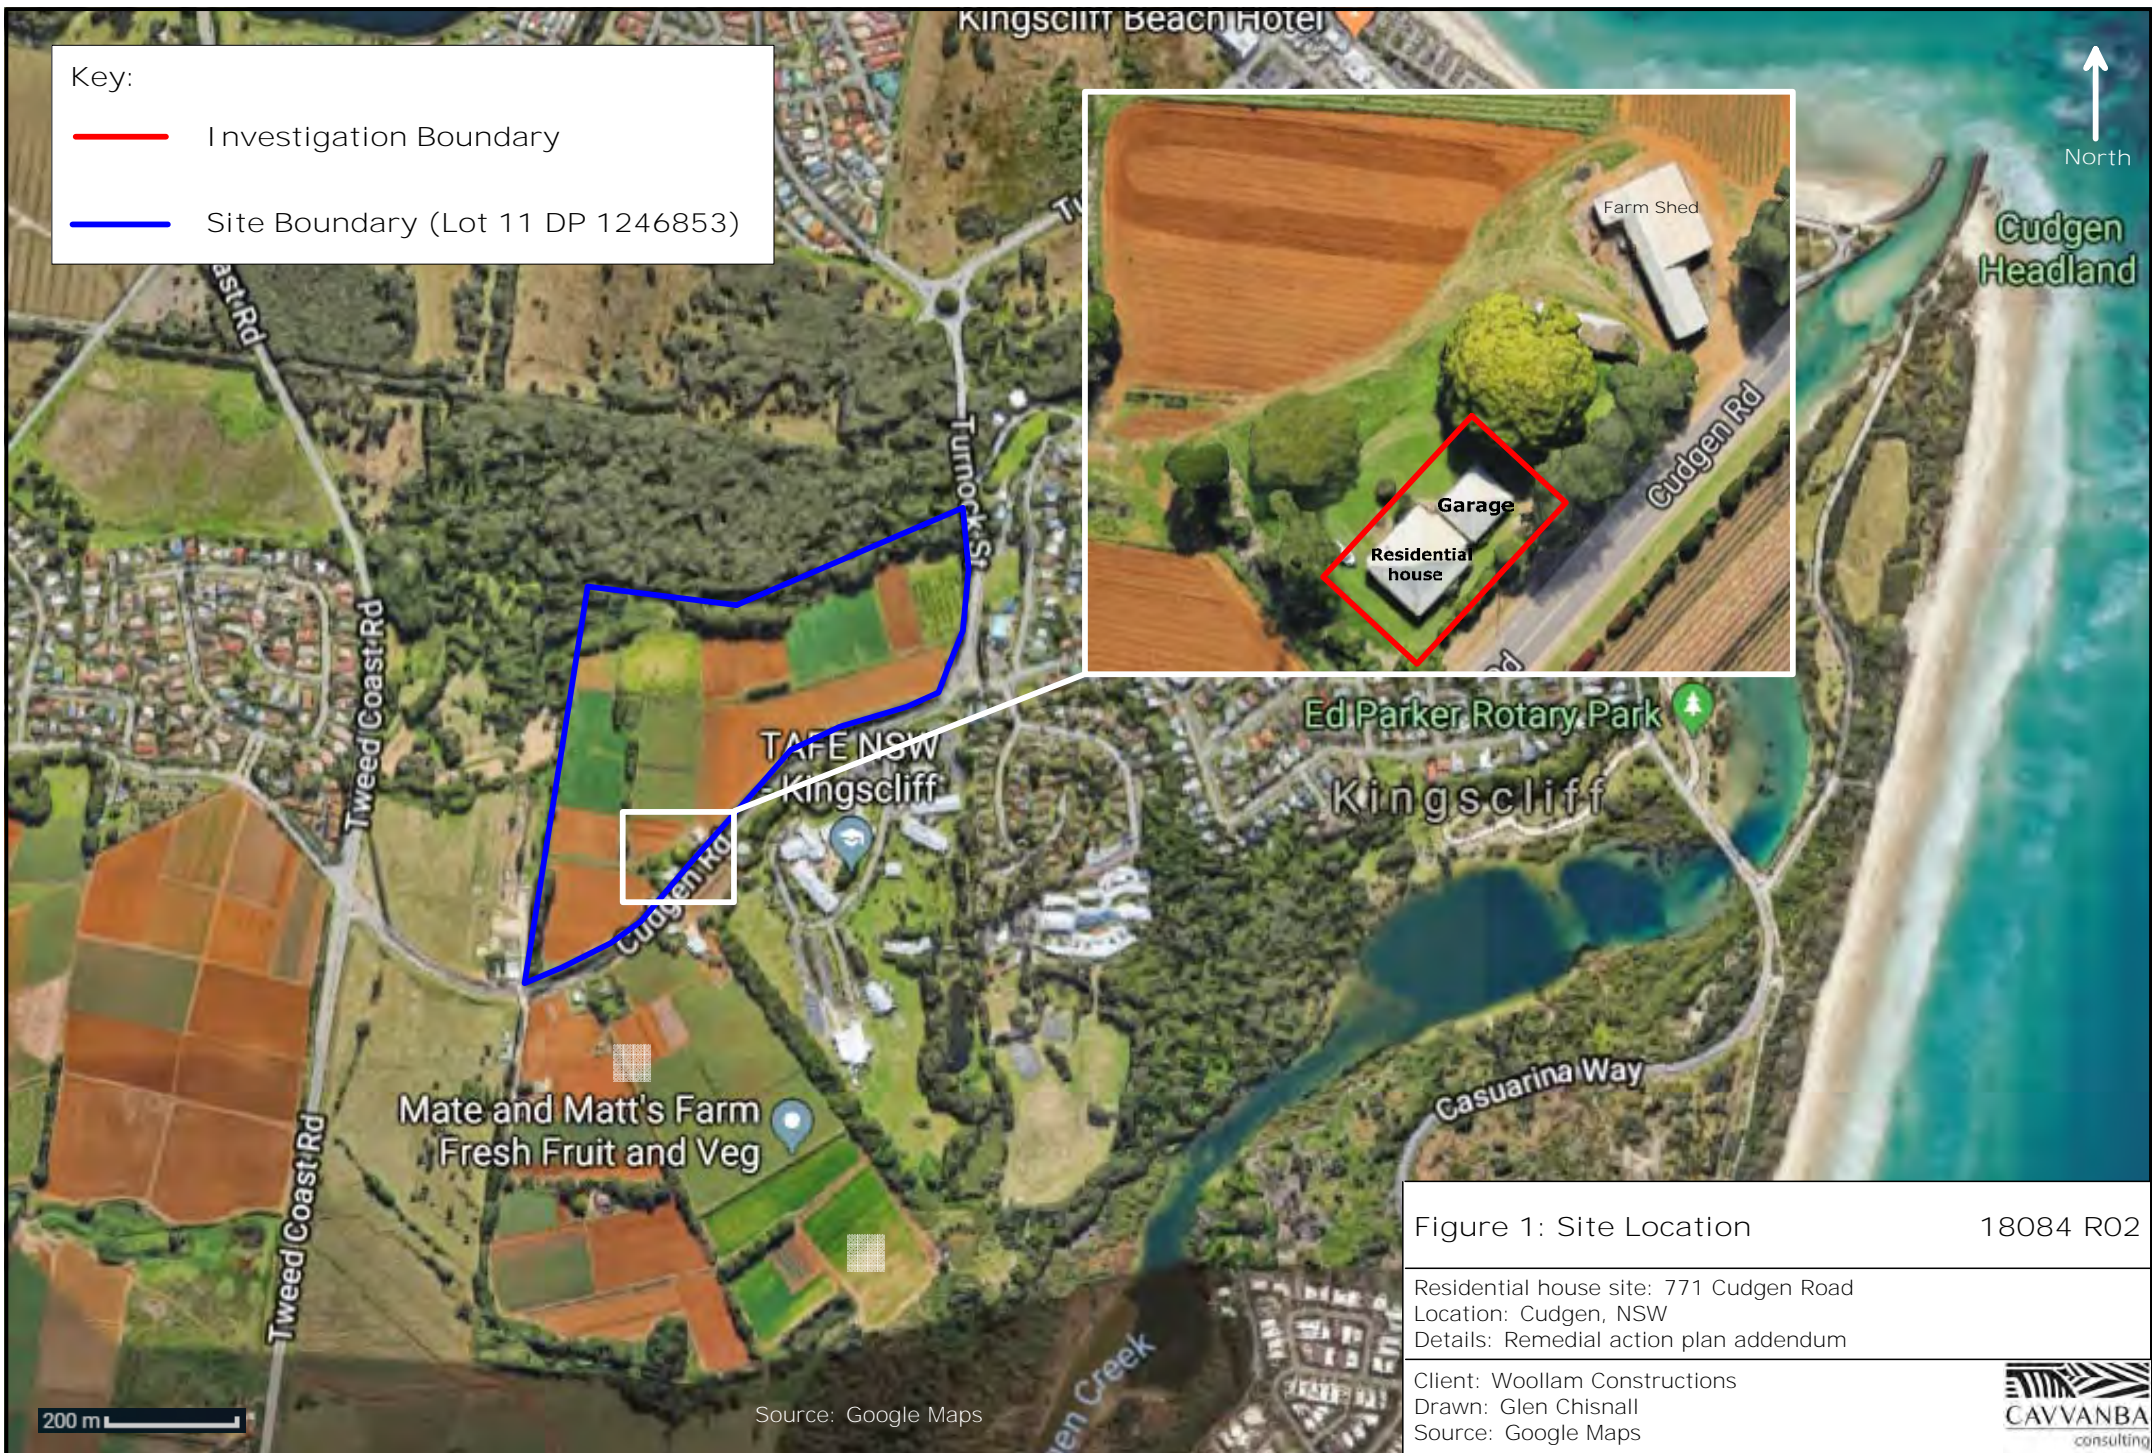
Figure 1: Site Location

The previous investigation delineated the impact vertically and laterally as described in Section 2.5.4 and determined that approximately 132 m³ of soil required disposal off-site, depending on the level of certainty required. Considering the concentrations of lead and the volume of waste present, removal is considered appropriate. Two remedial options for removal have provided as Figure 1 and Figure 2:

- The Figure 1 strategy is to excavate and remove 0.7 m of soil across the entire remediation area; and
- The Figure 2 strategy is to remove 0.4 m of soil in the shallower contaminated areas (TP01, TP03, TP04, TP06) and to remove 0.7 m of soil in the vicinity of TP02 where contamination extended beyond 0.4 m depth.

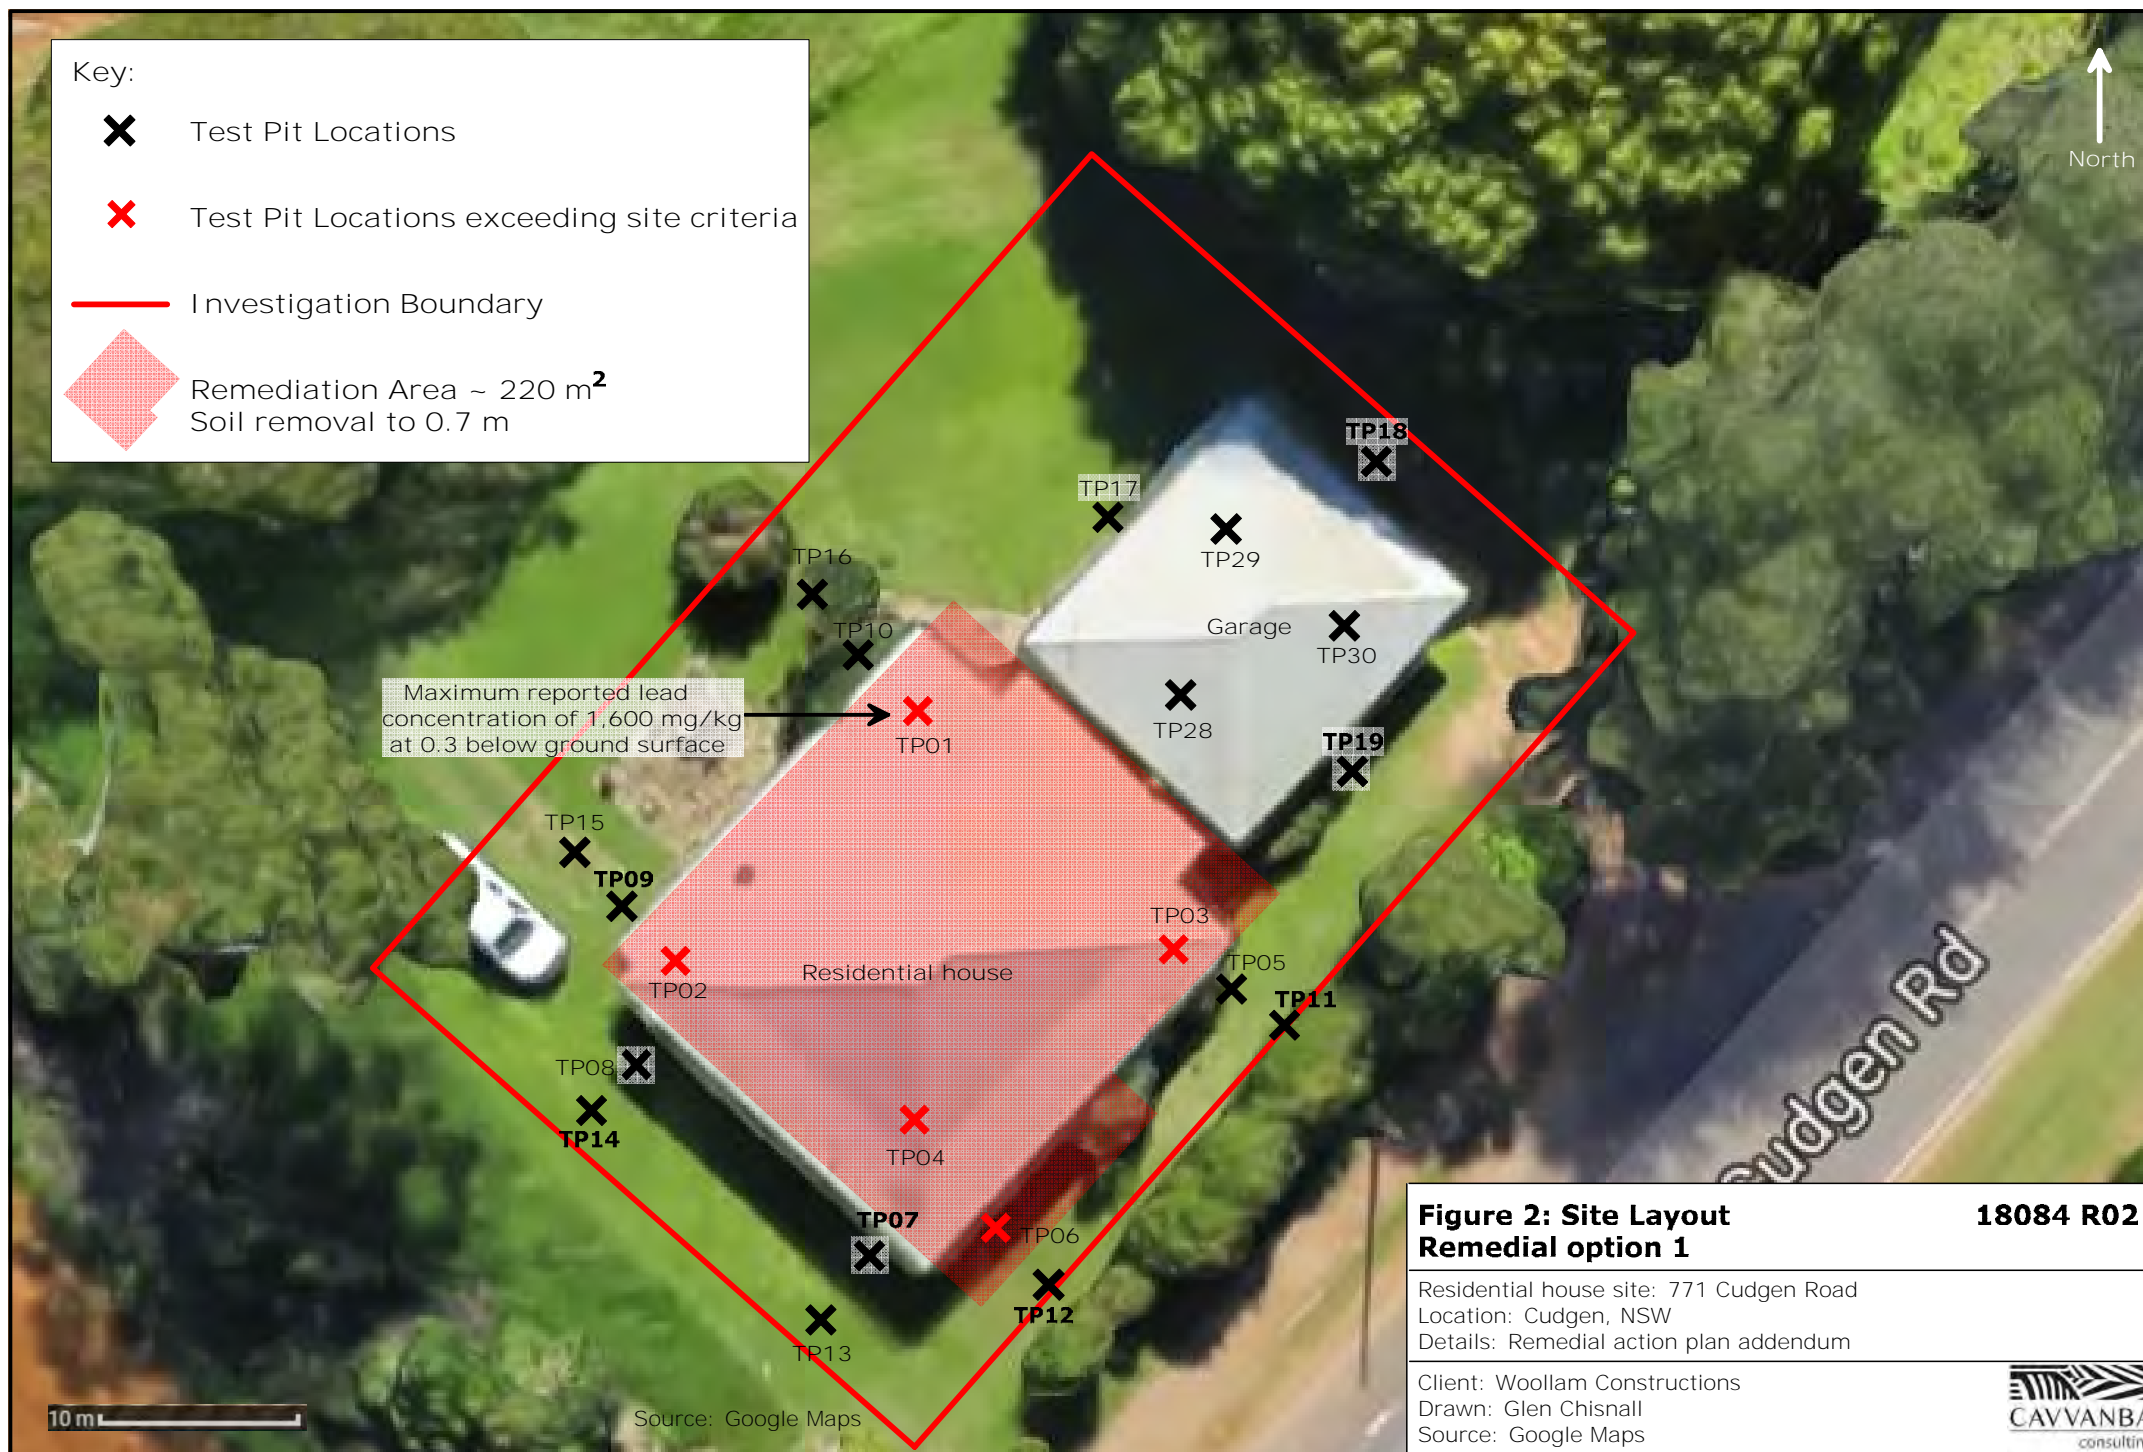
**Figure 2: Site Layout
Remedial option 1**

Remediation Area ~ 220 m²
Soil removal to 0.7 m

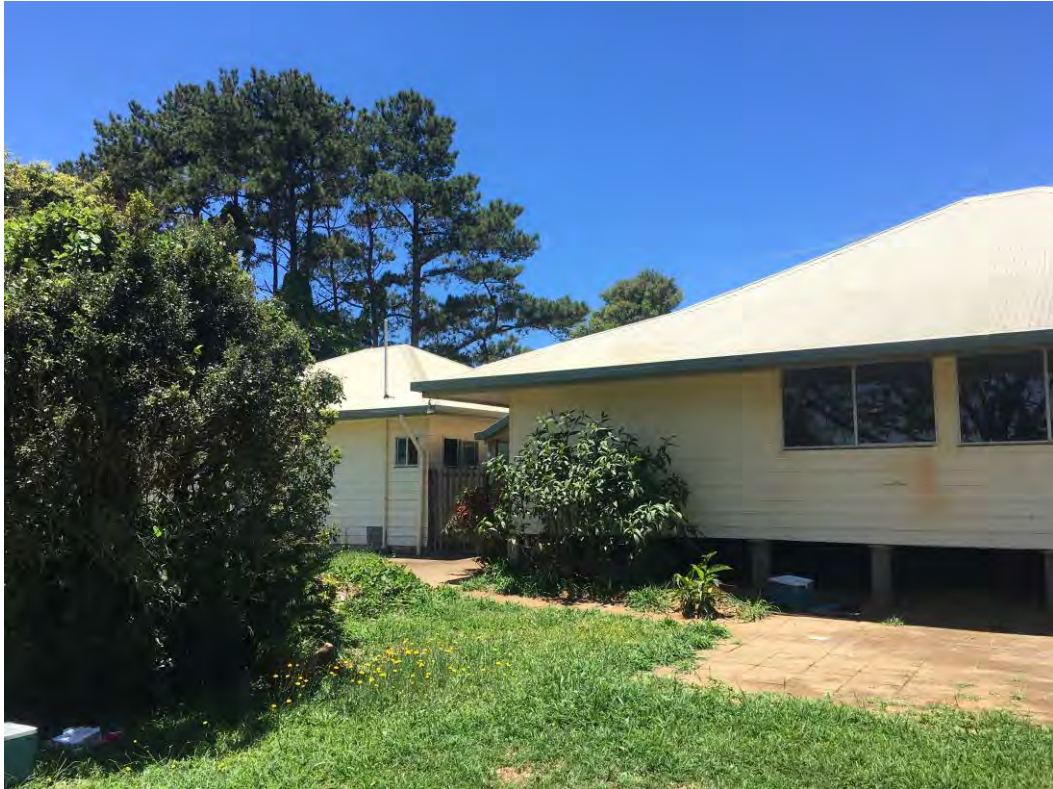
Photograph 1.

View east of investigation area, garage to the left and the residential house on the right. All photographs taken on 30 November; 11 and 12 December 2018.

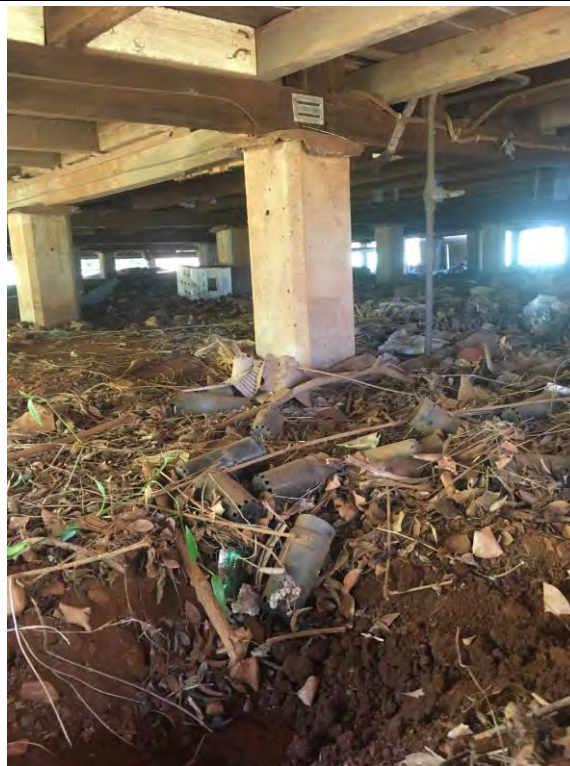
Photograph 2.

View of TP02; located underneath the south-western section of the former residential house. Anthropogenic materials consisting of plastic and glass scattered around the test pit location.

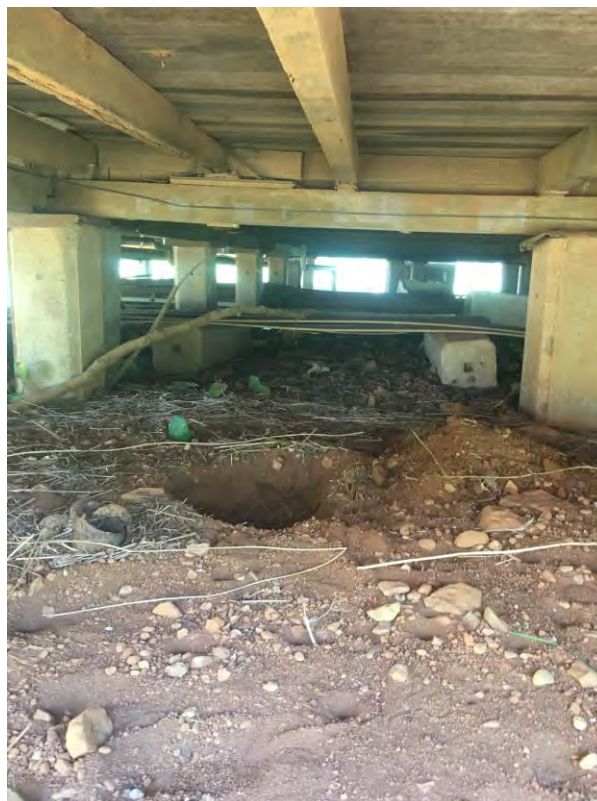
Photograph 3.
View of test pit location TP04; located underneath southeast portion of the house, in the southeast portion.

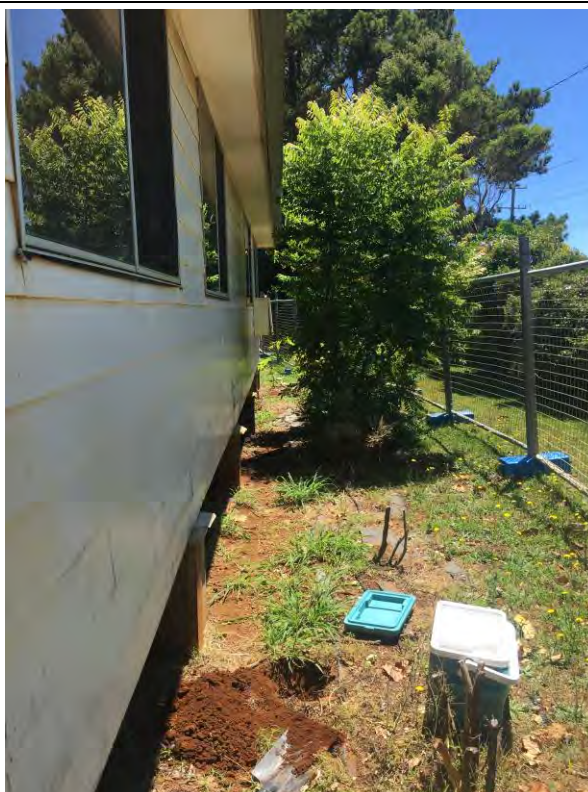
Photograph 4.
Test pit location TP06, located ~ 1 m from the eastern wall of the former residential house.

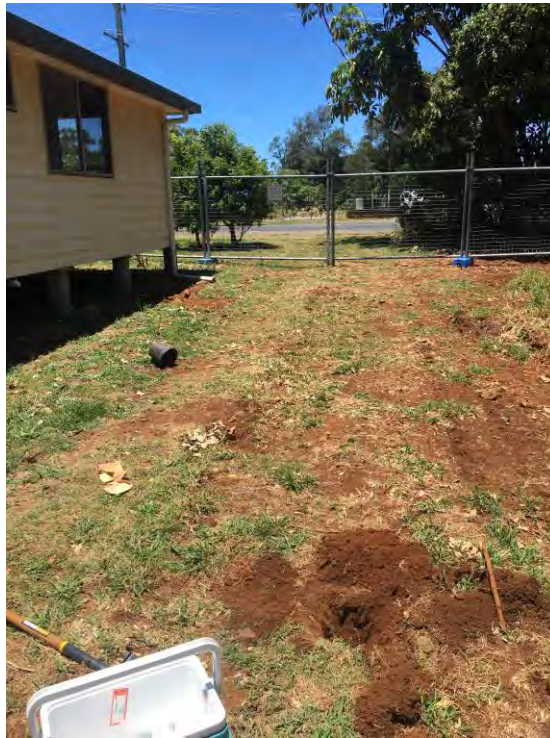
Photograph 5.

*View of test pit location TP14, sampled ~ 5 m to the south of the residential house.
Anthropogenic inclusions of glass and tiles were identified within this location.*

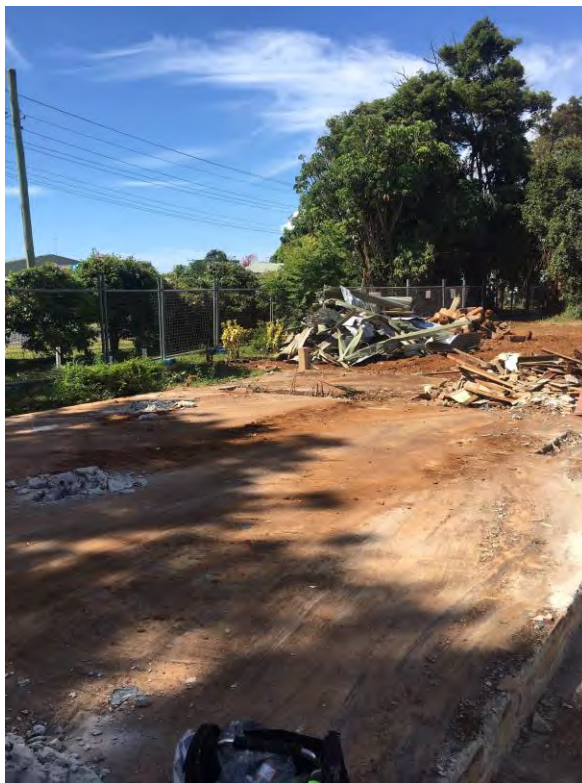
Photograph 6.

*View over garage slab. Test pit locations TP28 and TP30 visible in foreground followed by
demolition waste from the former residential house.*
