Site Audit Report
0503-1901

771 Cudgen Road
Cudgen NSW

4 February 2019

JBS&G Australia Pty Ltd

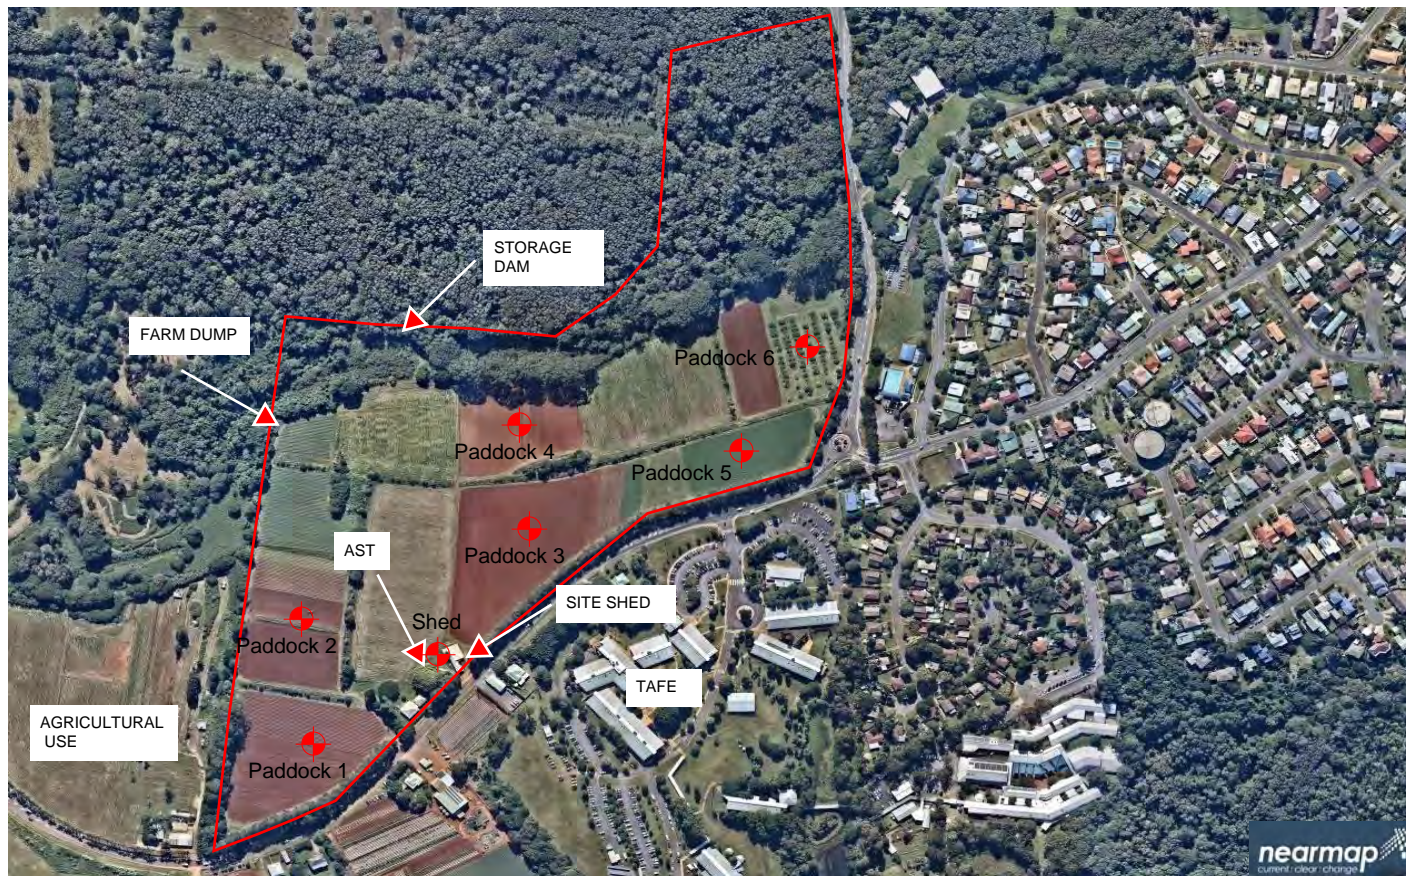
HA37
Hand Auger
location -
Discrete
Sample

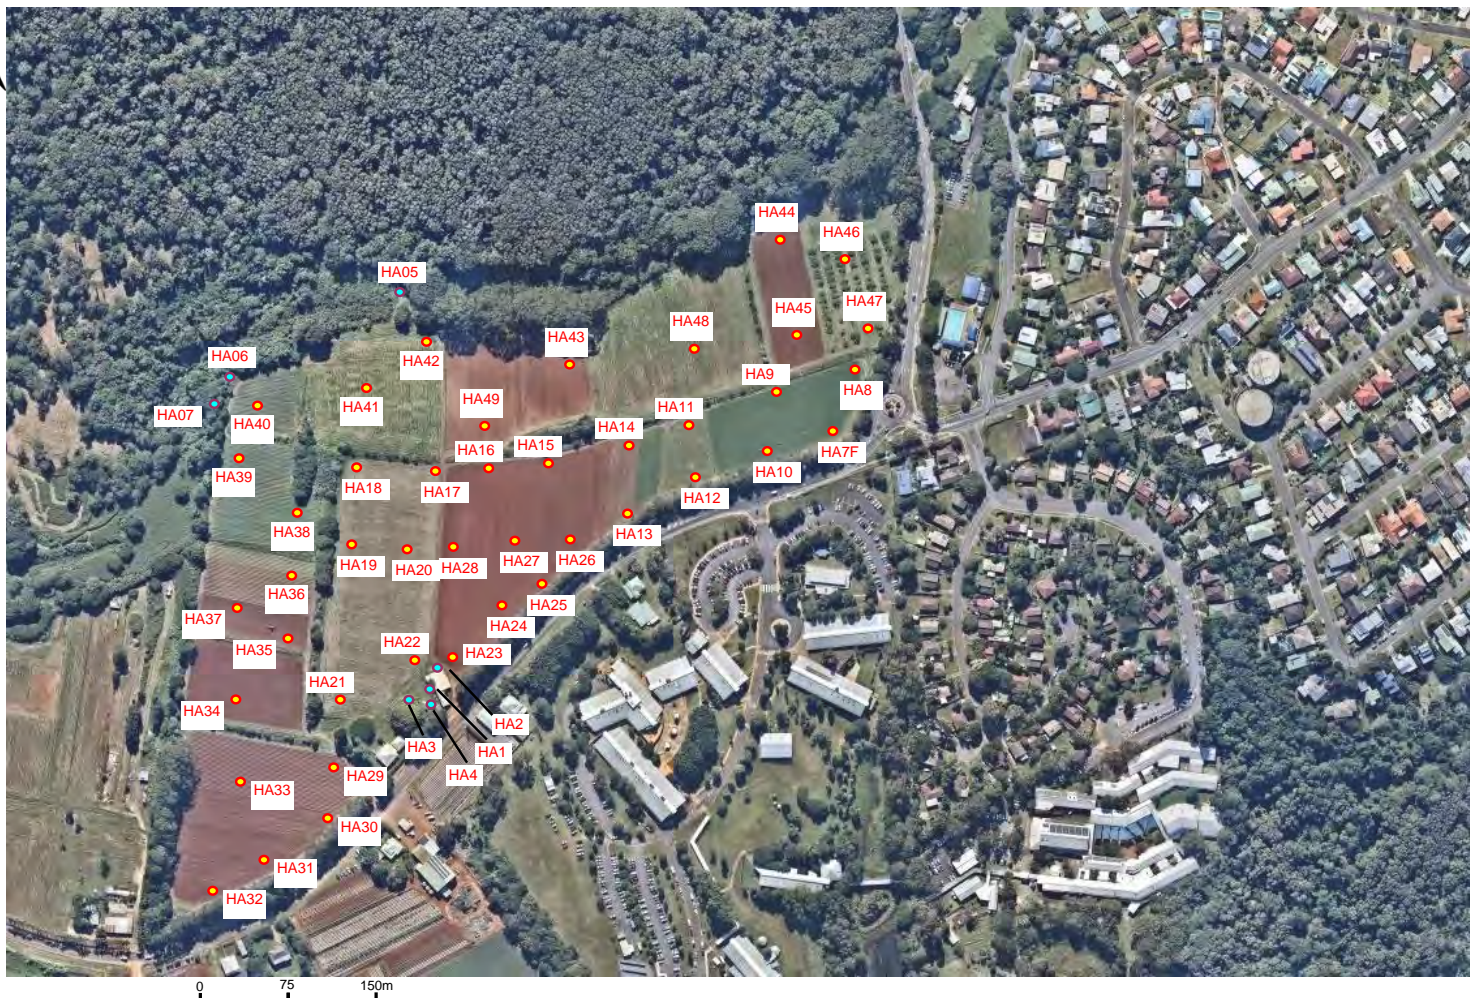
CLIENT:	Health Infrastructure NSW	DESIGNED:	DRA/WR:
PROJECT TITLE:	Tweed Hospital RAP	CHECKED:	No. SHEETS:
SITE ADDRESS:	771 Cudgen Road, Cudgen	SCALE:	DATE STARTED:
DRAWING TITLE:	DSI Sampling Locations	JOB No:	J8961
		DRAWING No:	2

Hand Auger
location

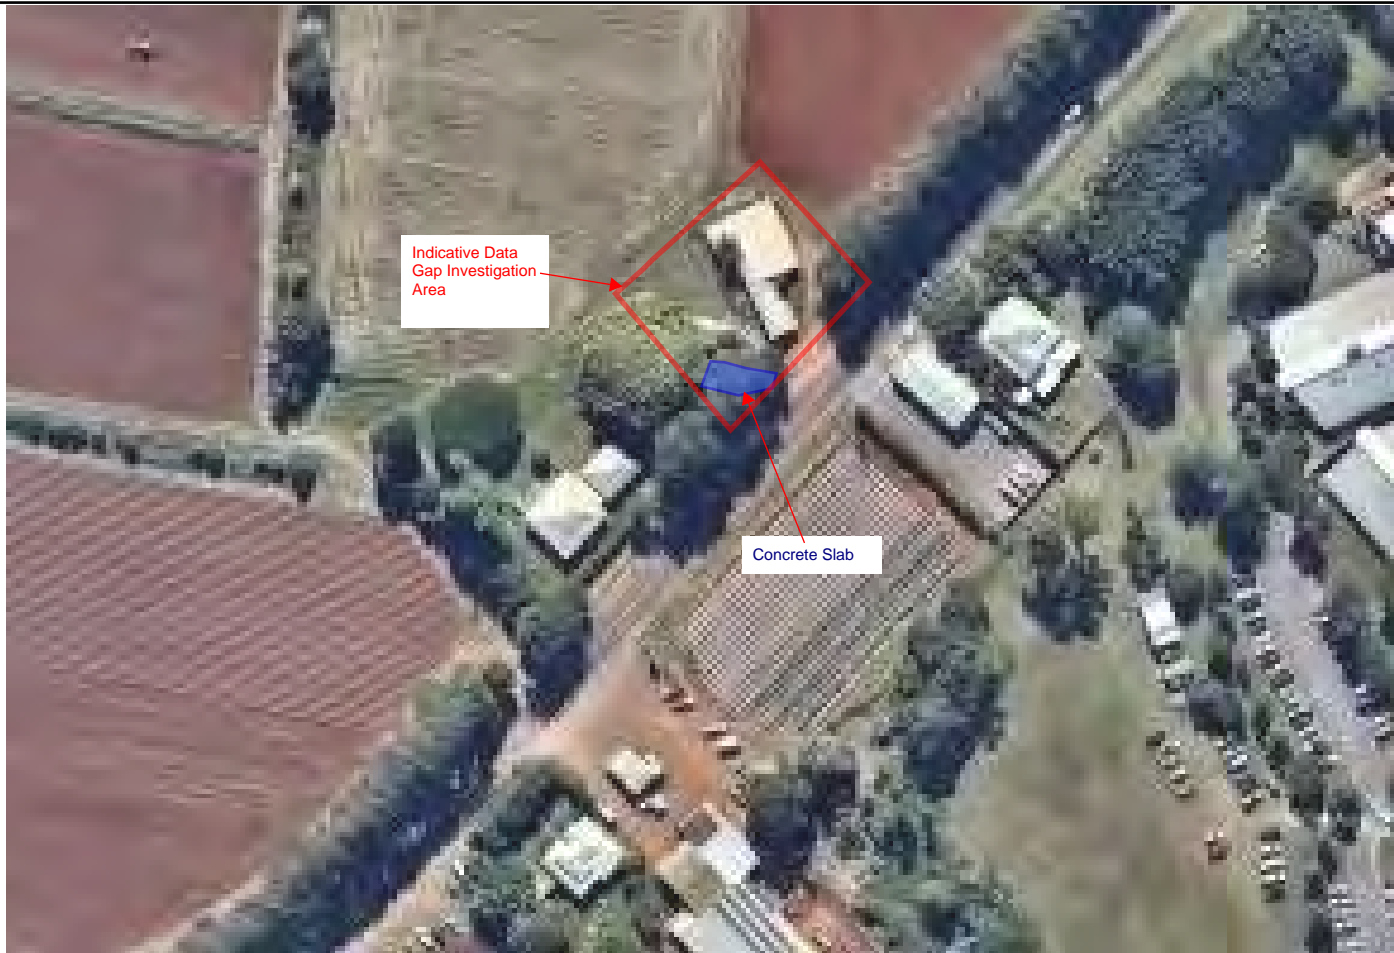
CLIENT:	Health Infrastructure NSW	DESIGNED:	DRAWN:
PROJECT TITLE:	Tweed Hospital RAP	CHECKED:	No. SHEETS:
SITE ADDRESS:	771 Cudgen Road, Cudgen	SCALE:	DATE STARTED:
DRAWING TITLE:	Indicative Data Gap Investigation Area	JOB No:	J8961
		DRAWING No:	4

Indicative Data
Gap Investigation
Area

Concrete Slab

Due to the absence of any documentation regarding the location of the potential dip, test pitting across the identified area following the removal of surface infrastructure and concrete slabs was required to enable characterisation of the area. The consultant (OCTIEF 2019) noted that test pits will be undertaken at an equivalent density of 1 per 100 m².

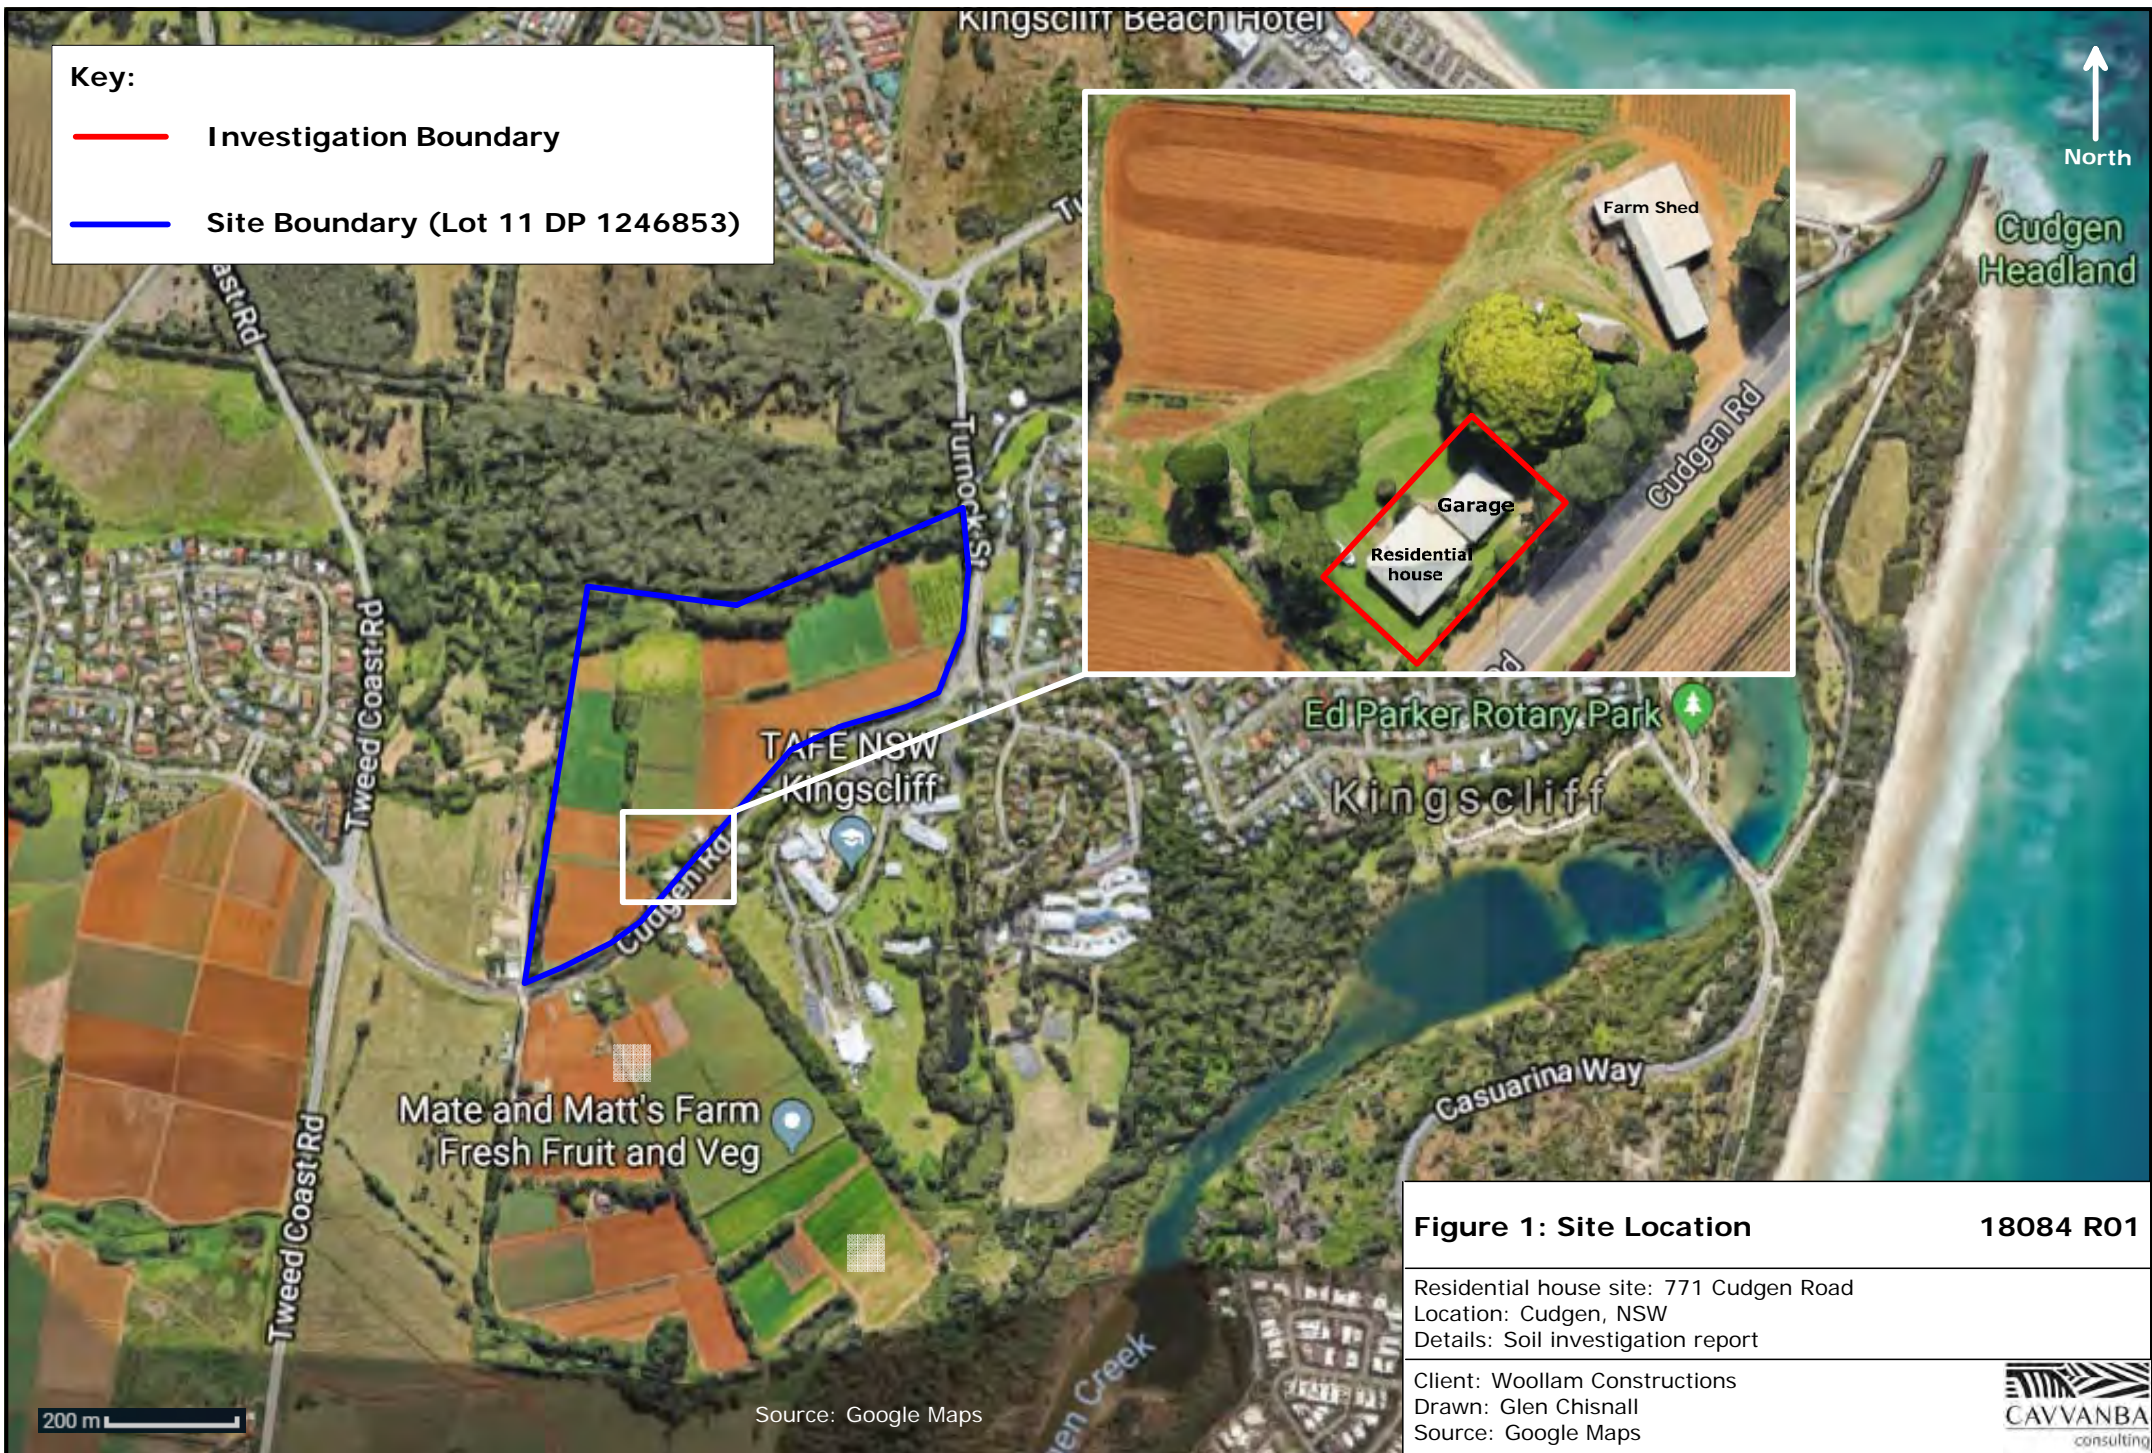
Test Pit Locations exceeding site criteria

Investigation Boundary

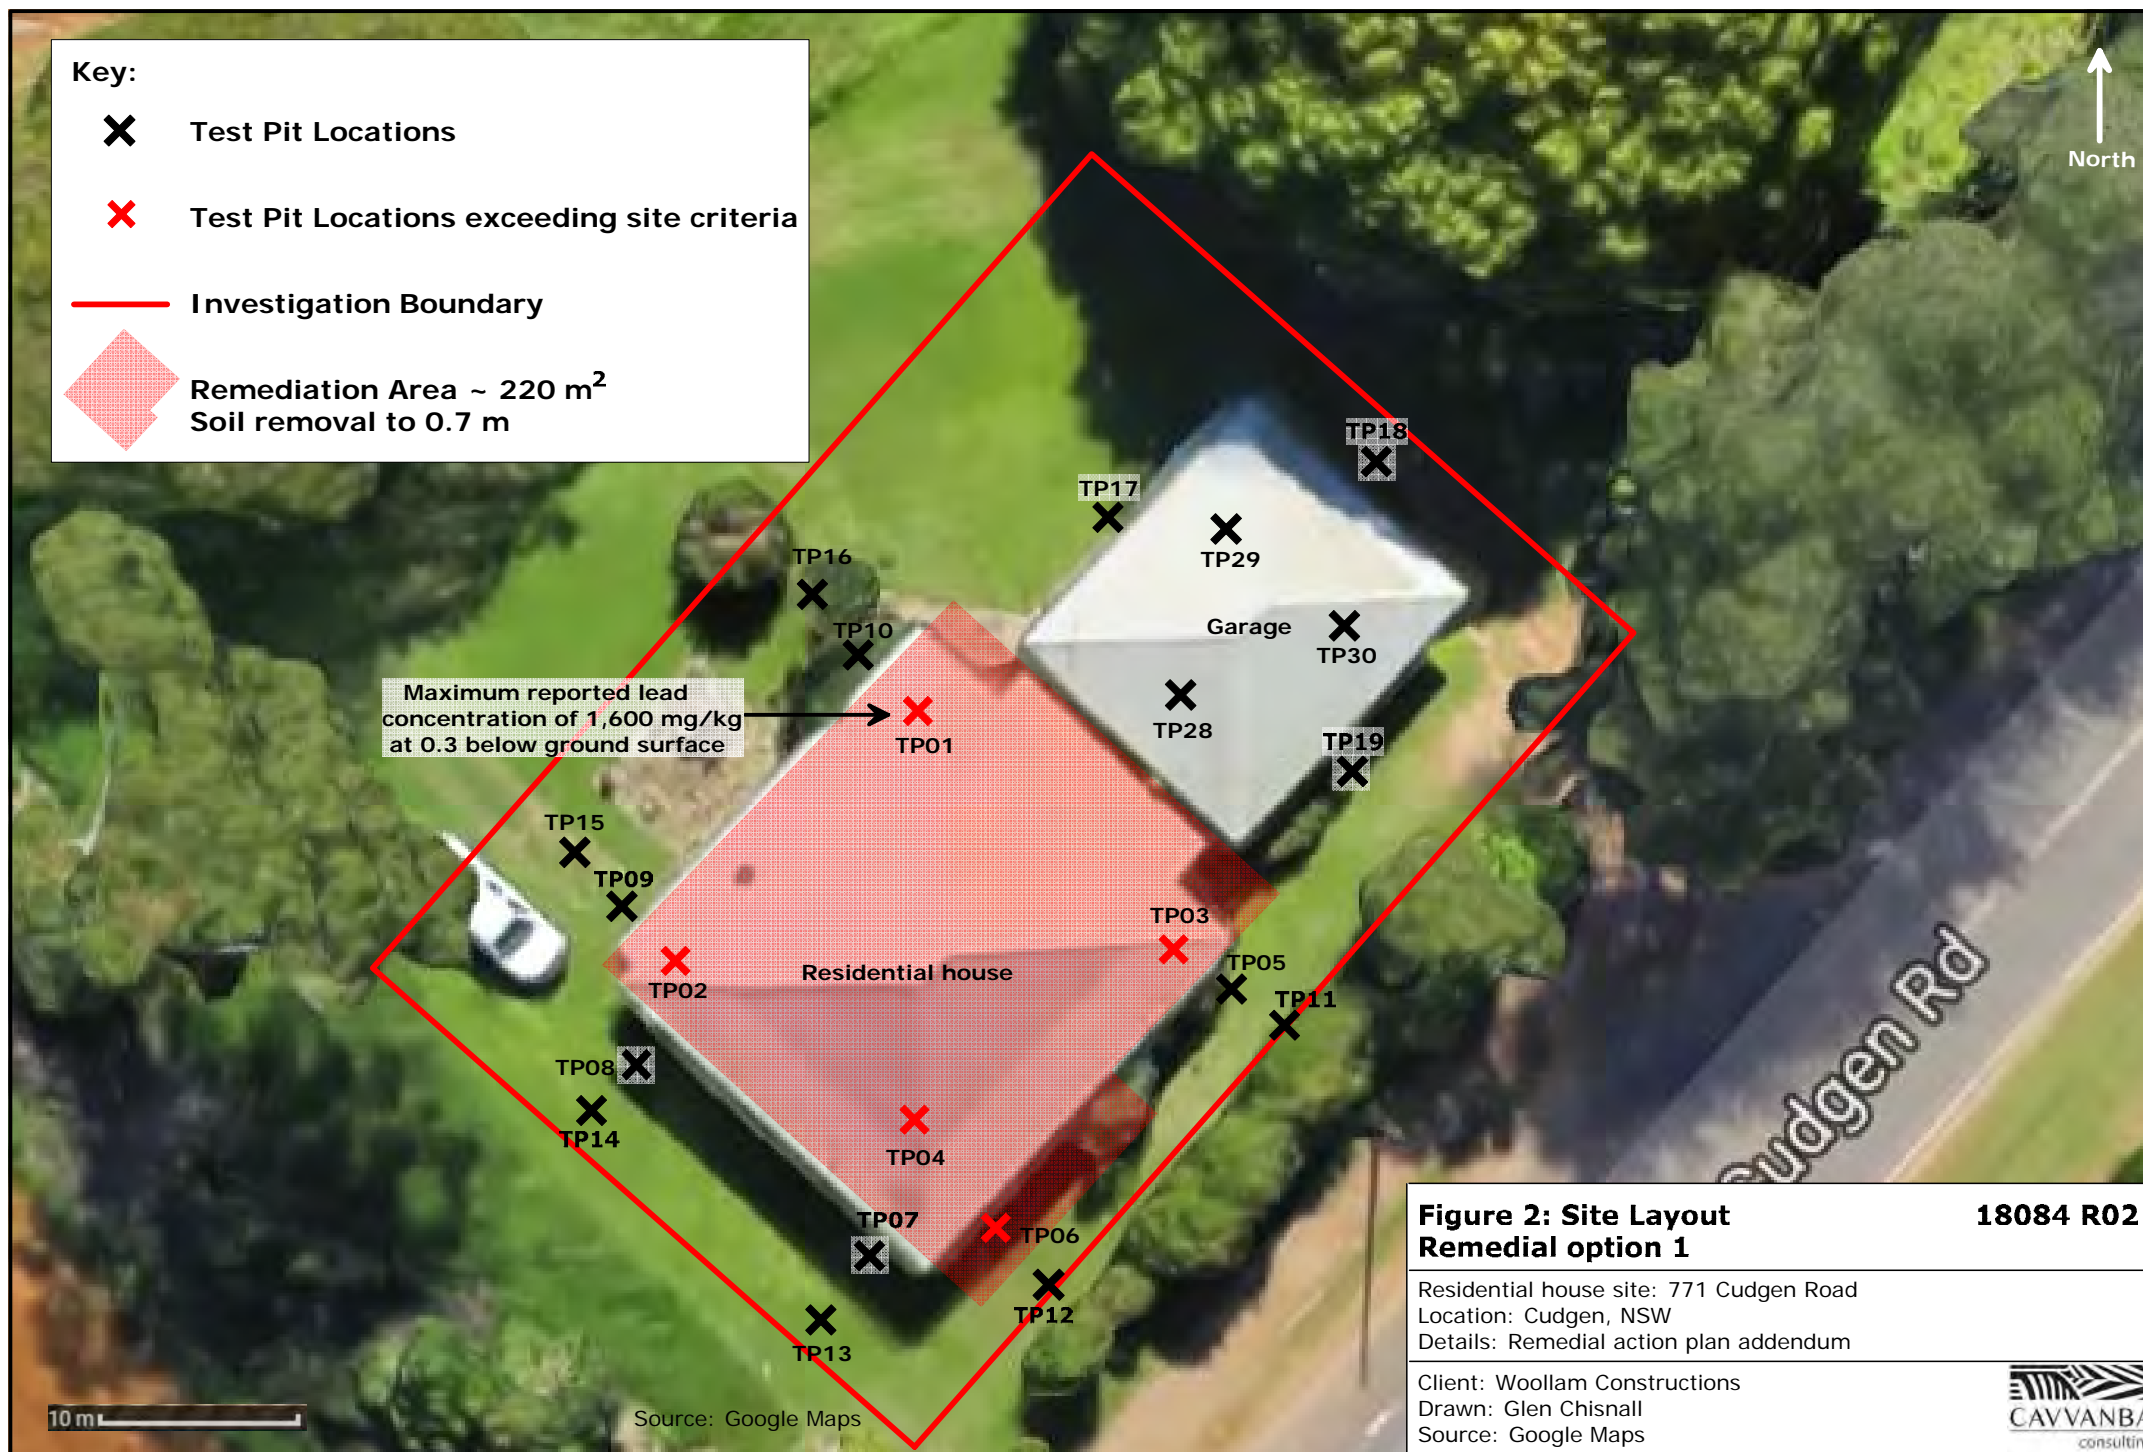
**Figure 2: Site Layout
Remedial option 1**

Remediation Area ~ 220 m²
Soil removal to 0.7 m
