Report on
Preliminary Geotechnical Investigation

Proposed UNSW D14 Building
High Street, Kensington

Prepared for
University of New South Wales
(Developer and Applicant)

Project No.	86457.00	Document No.	R.002.Rev1
Document title	Report on Preliminary Geotechnical Investigation Proposed UNSW D14 Building		
Site address	High Street, Kensington		
Report prepared for	University of New South Wales		
File name	86457.00.R.002.Rev1

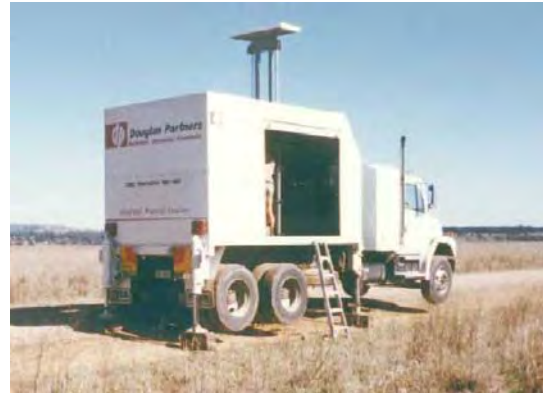
Figure 2: Purpose built CPT rig

The cone is thrust into the ground at a steady rate of about 20 mm/sec, usually using the hydraulic rams of a purpose built CPT rig, or a drilling rig. The testing is carried out in accordance with the Australian Standard AS1289 Test 6.5.1.

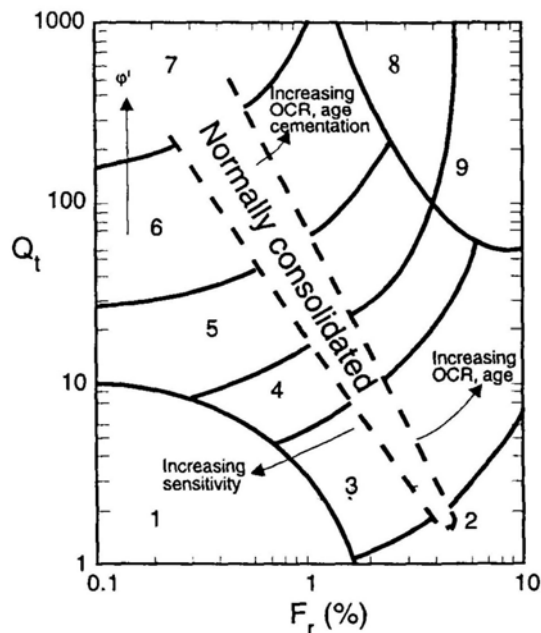
Figure 3: Soil Classification Chart

The CPT parameters can be used to infer the Soil Behaviour Type (SBT), based on normalised values of cone resistance (Q_t) and friction ratio (Fr). These are used in conjunction with soil classification charts, such as the one below (after Robertson 1990)

DP's in-house CPT software provides computer aided interpretation of soil strata, generating soil descriptions and strengths for each layer. The software can also produce plots of estimated soil parameters, including modulus, friction angle, relative density, shear strength and over consolidation ratio.

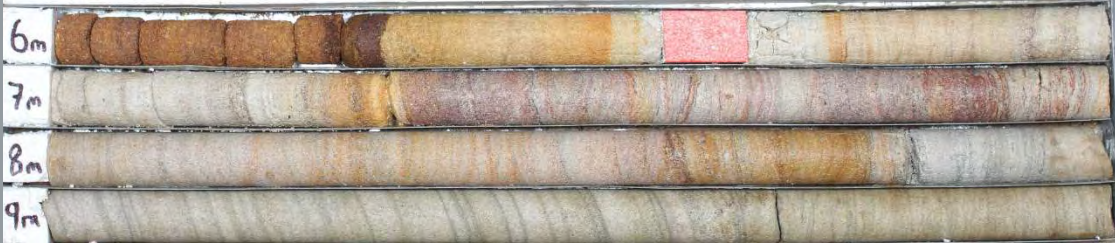
6.0 - 10.0 m

86457.00 UNSW 25/7/18 BH6 START CORING 6.00m

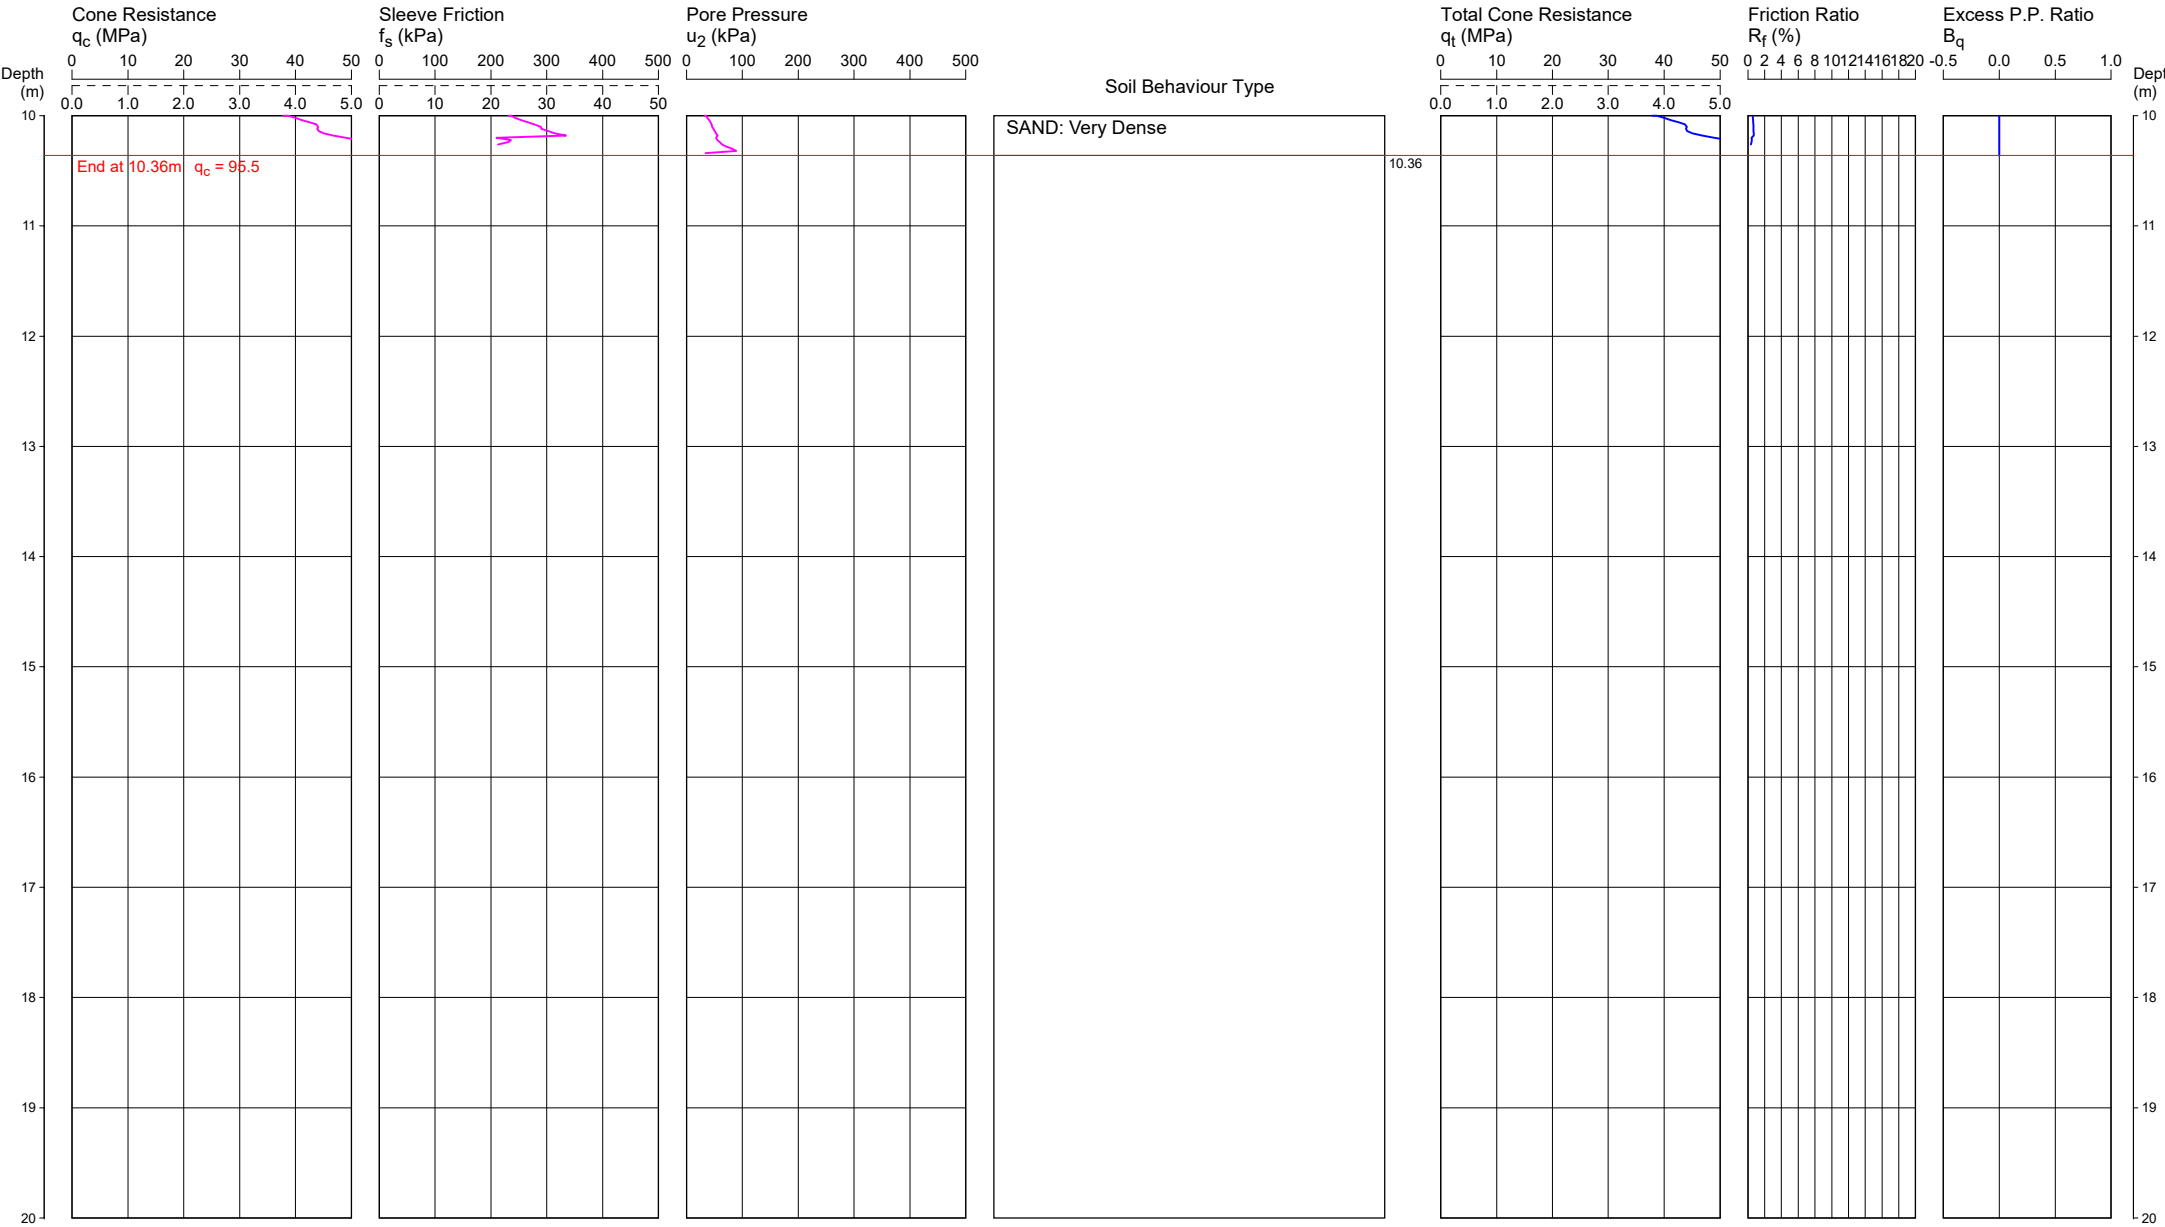
REMARKS: TEST DISCONTINUED DUE CONE TIP REFUSAL. HOLE COLLAPSE AT 7.2 m AFTER WITHDRAWAL OF RODS. File: P:\86457.00 - KENSINGTON UNSW, D14 UNSW HALL\4.0 Field Work\4.2 Testing\CPT\CPT4 Interpreted.CP5 Cone ID: 140913 Type: I-CFXYP20-10
