<b>Client</b>	Lend Lease
<b>Location</b>	UNSW D14 Precinct, UNSW Kensington Campus
<b>Document Type</b>	Arboricultural Impact Assessment, Tree Protection Plan & Tree Protection Specification
<b>Date</b>	5 <sup>th</sup> November 2018

# The Ents Tree Consultancy

Development Reports | Hazard Assessments | Tree Management

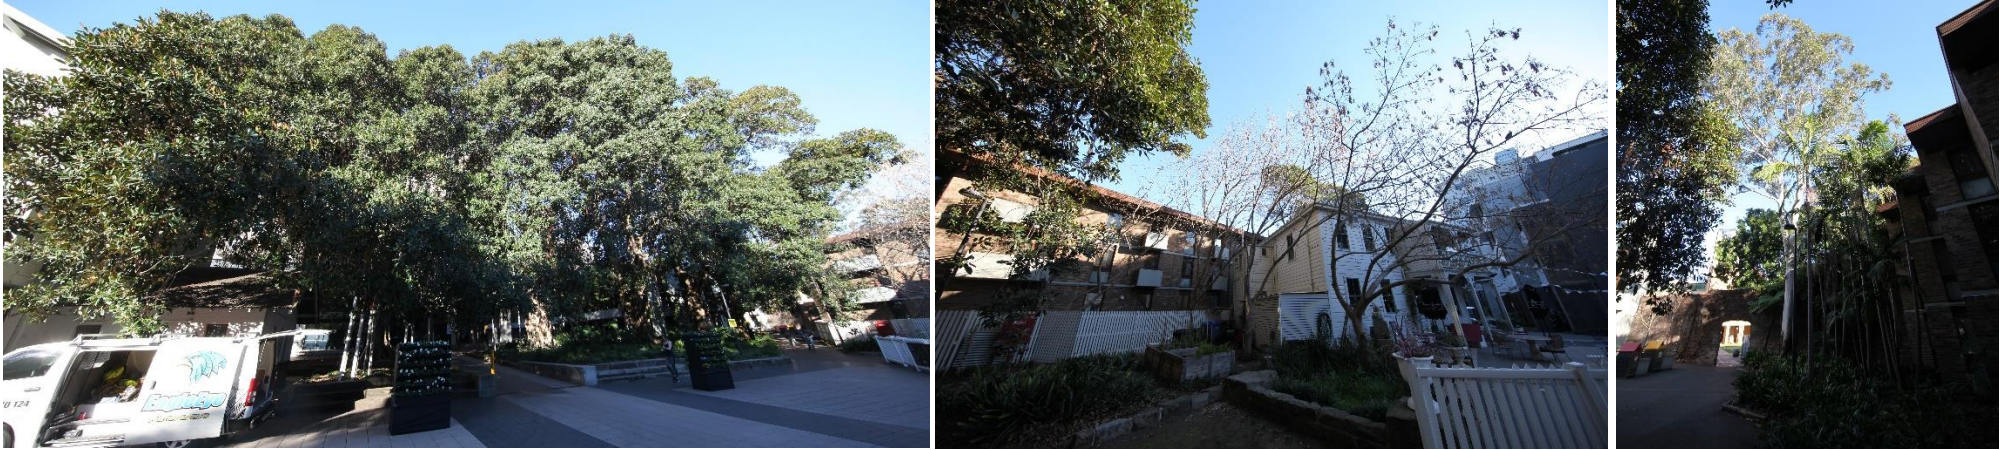
Image 1 above left shows the significant stand of trees along fig tree lane which should be retained with minimal disturbance. Image 2 above centre shows trees 1219, 1219a, 1219b & tree 1220. Image 3 above right shows the significant Gum tree 402. Image 4 below left shows trees 480 & 481. Image 5 below centre shows trees 464 to 461. Image 17 shows tree 411 to the north of the proposed works site. This tree should not be disturbed.
