## Appendix E

### Detailed Dwelling Assessments

# E1. NAD\_1 Dwelling Assessment

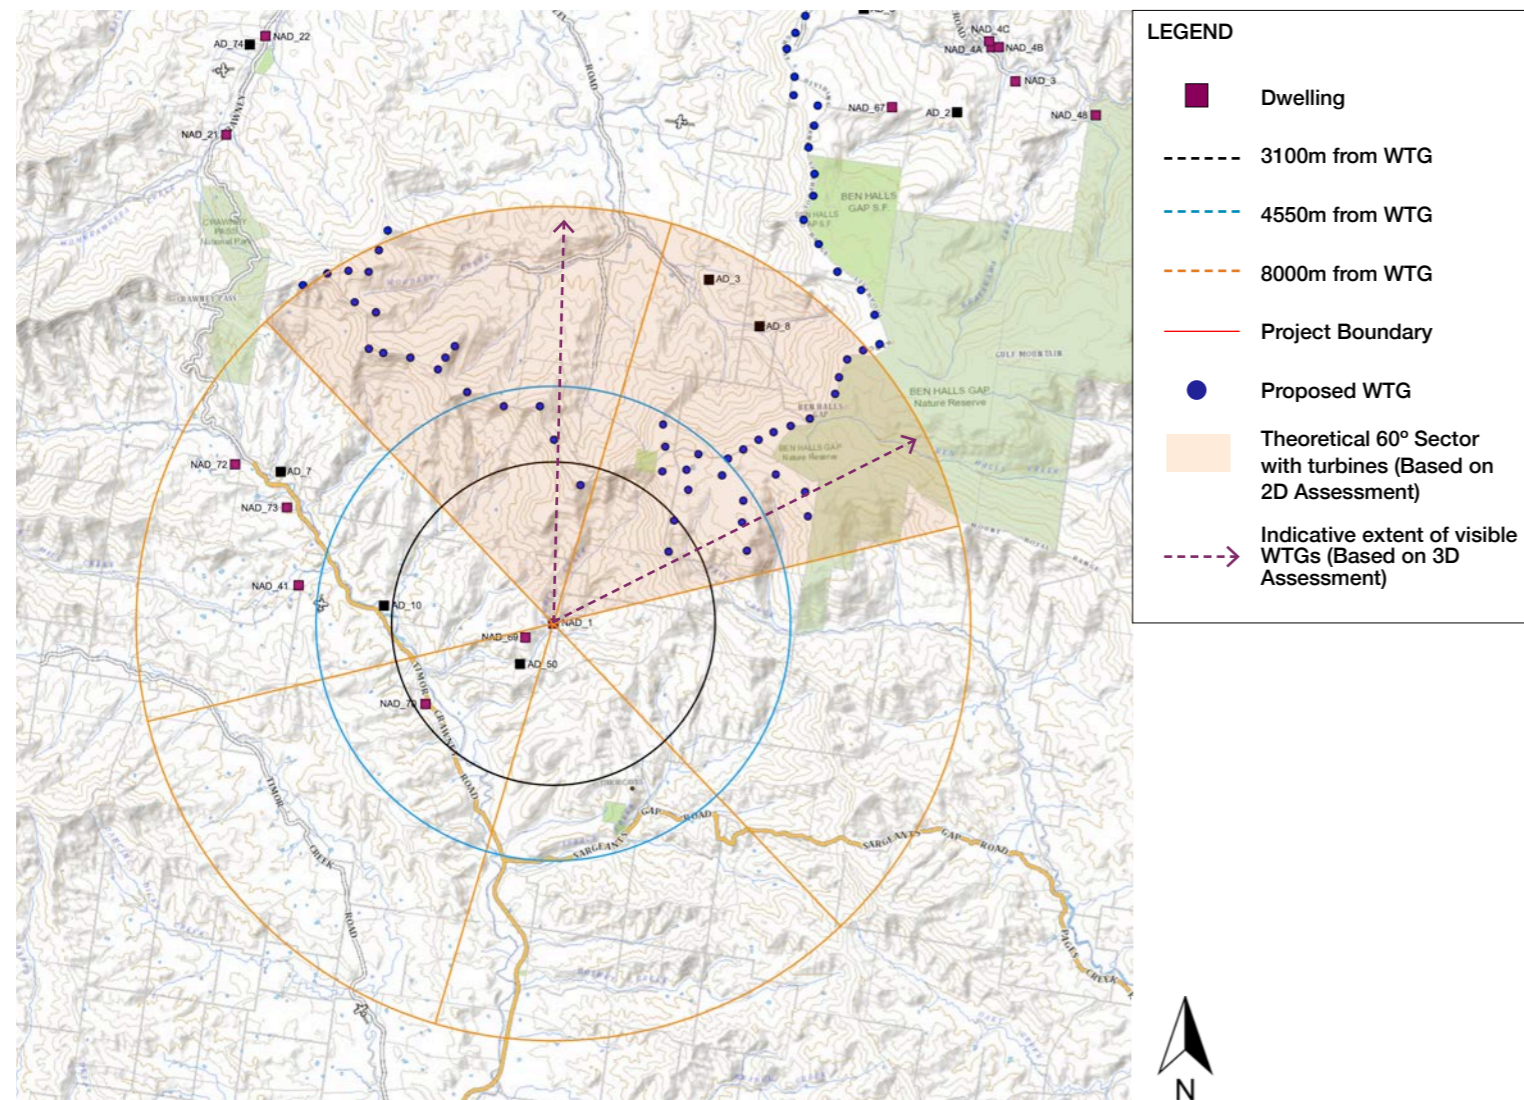
Figure E1a Preliminary Assessment Tool: NAD\_1

**Visual Magnitude:** Three (3) visible turbines are located within the 'black line' of visual magnitude. It is likely views to these turbines would be limited due to intervening vegetation.

**Multiple Wind Turbine Effects:** The Project will be visible in up to one 60° sector (based on topography alone). This is deemed acceptable for a Level 2: Viewer (Rural Dwelling).

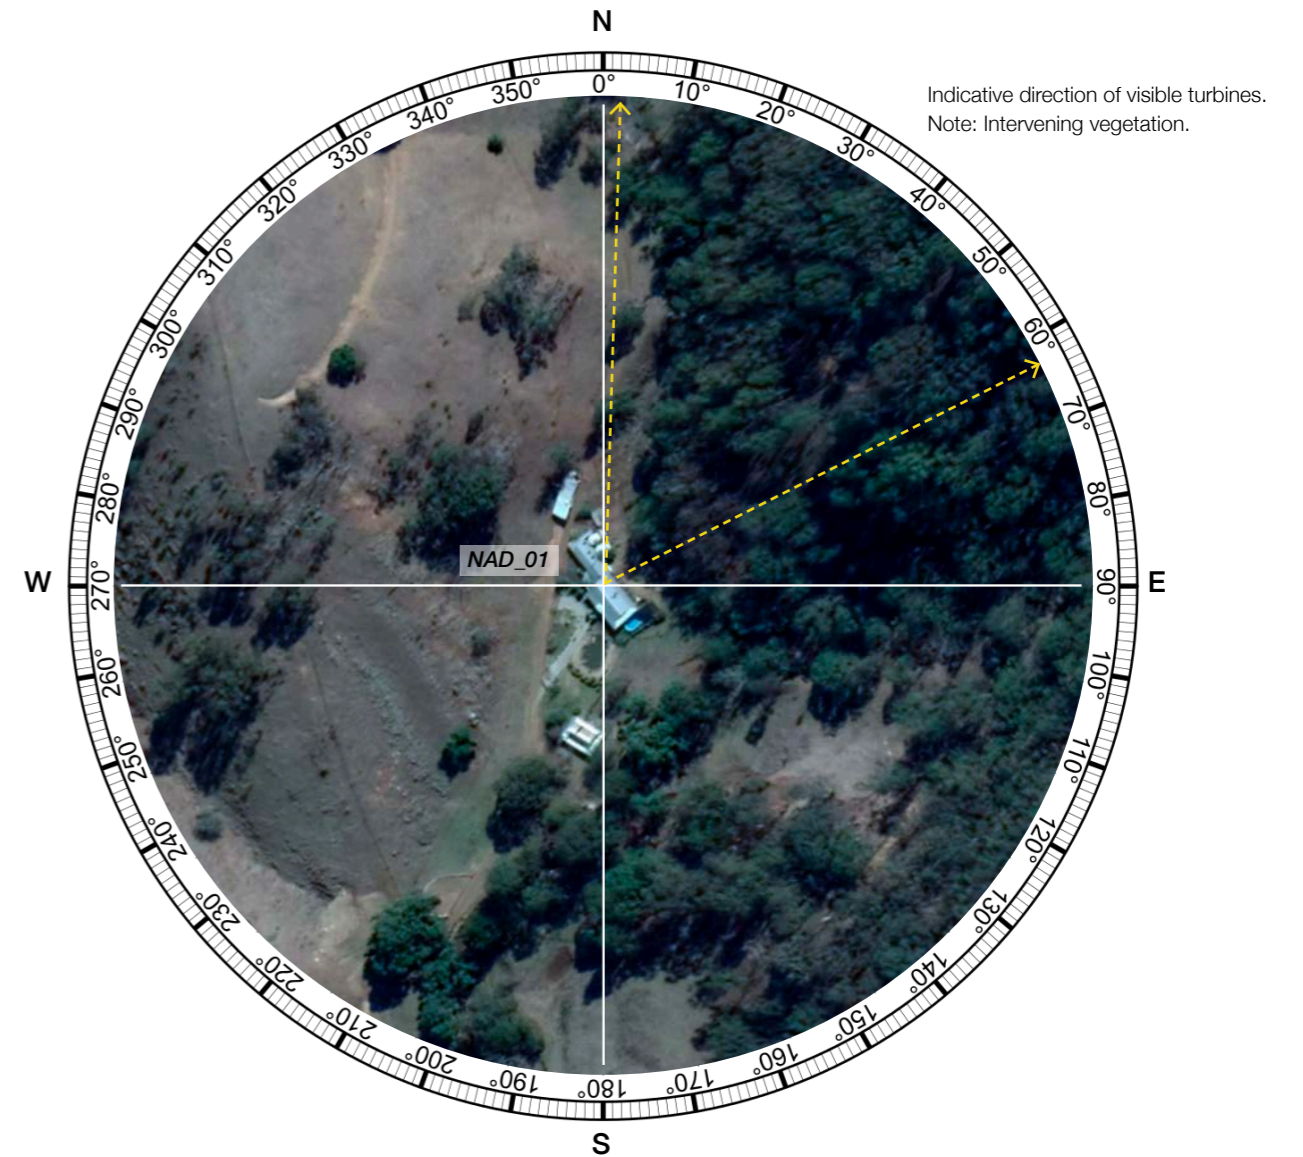
Figure E1b Aerial Image - Dwelling NAD\_1 (Aerial Image Source: Google Earth Image Date: 21.08.2018)

Based on a desktop assessment, the dwelling is sited at the northern most end of Mountain View Road, in a small valley associated with Perrys Creek. Views surrounding the property are largely contained by steep topography and vegetation. 3D Assessment based on topography alone identified up to 10 WTGs would be visible to the NNE. Three (3) visible turbines are within 3100m. Aerial imagery indicates intervening vegetation between the dwelling and the direction of the visible turbines which is likely to reduce the potential number of visible turbines.

Consider supplementary planting if deemed necessary to further reduce any potential visual impacts in consultation with landowner.

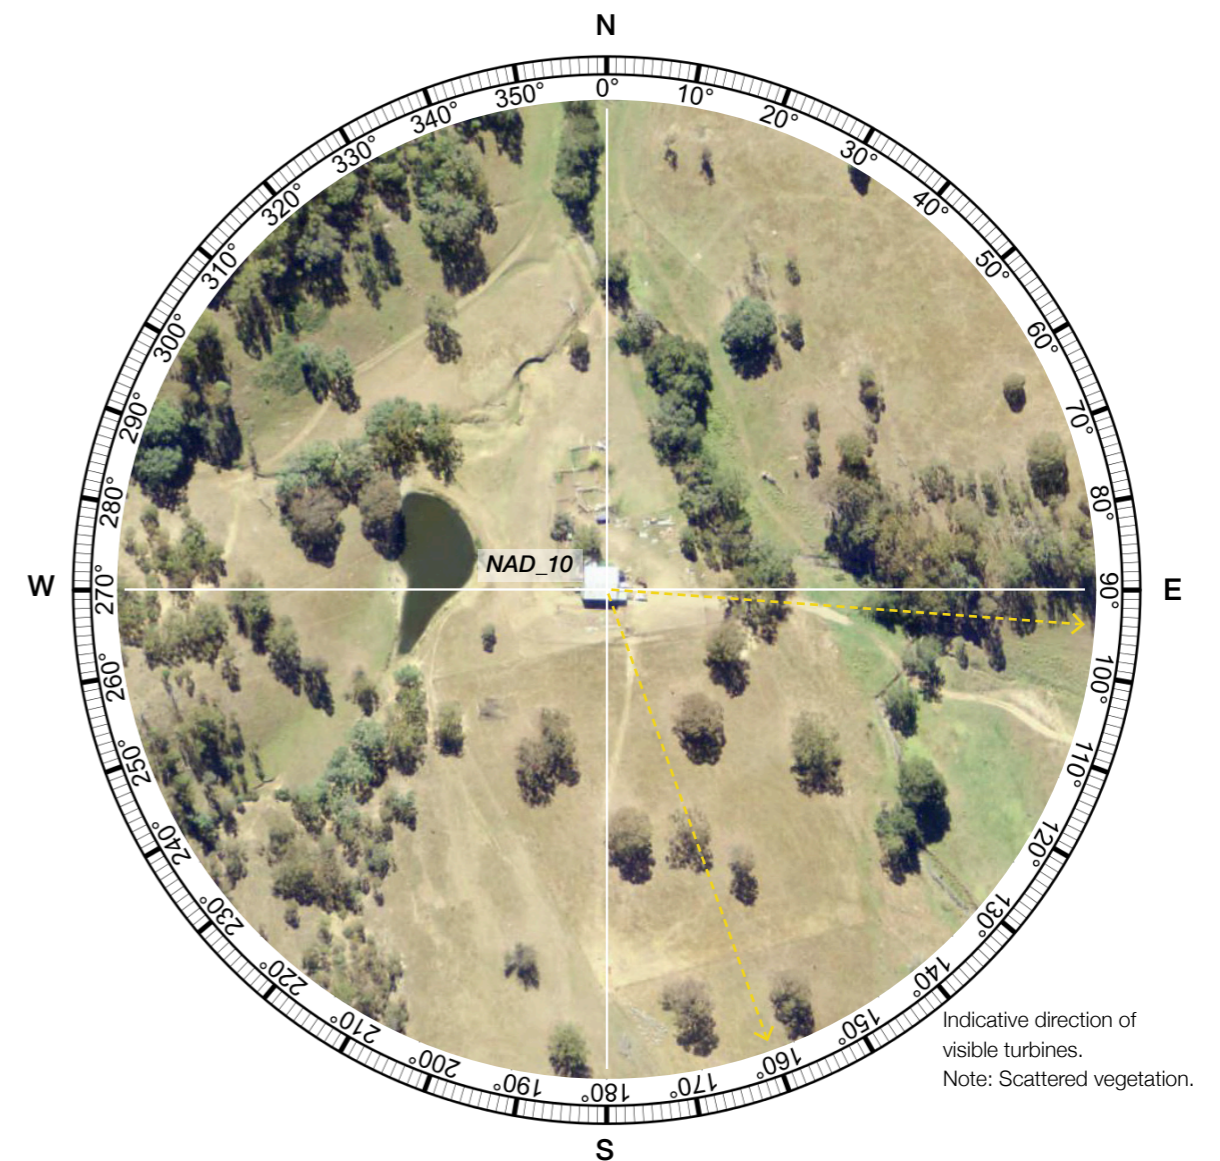
Figure E8b Aerial Image - Dwelling NAD\_10 (Aerial Image Source: Google Earth Image Date: 05.08.2019)

Indicative direction of visible turbines.  
Note: Scattered vegetation.

Screen planting close to the eastern side of the dwelling would be an acceptable form of mitigation to reduce the visibility of turbines to the south east. Desirable views to the north would be maintained. This is a long-term solution which would require consultation with the landowner.

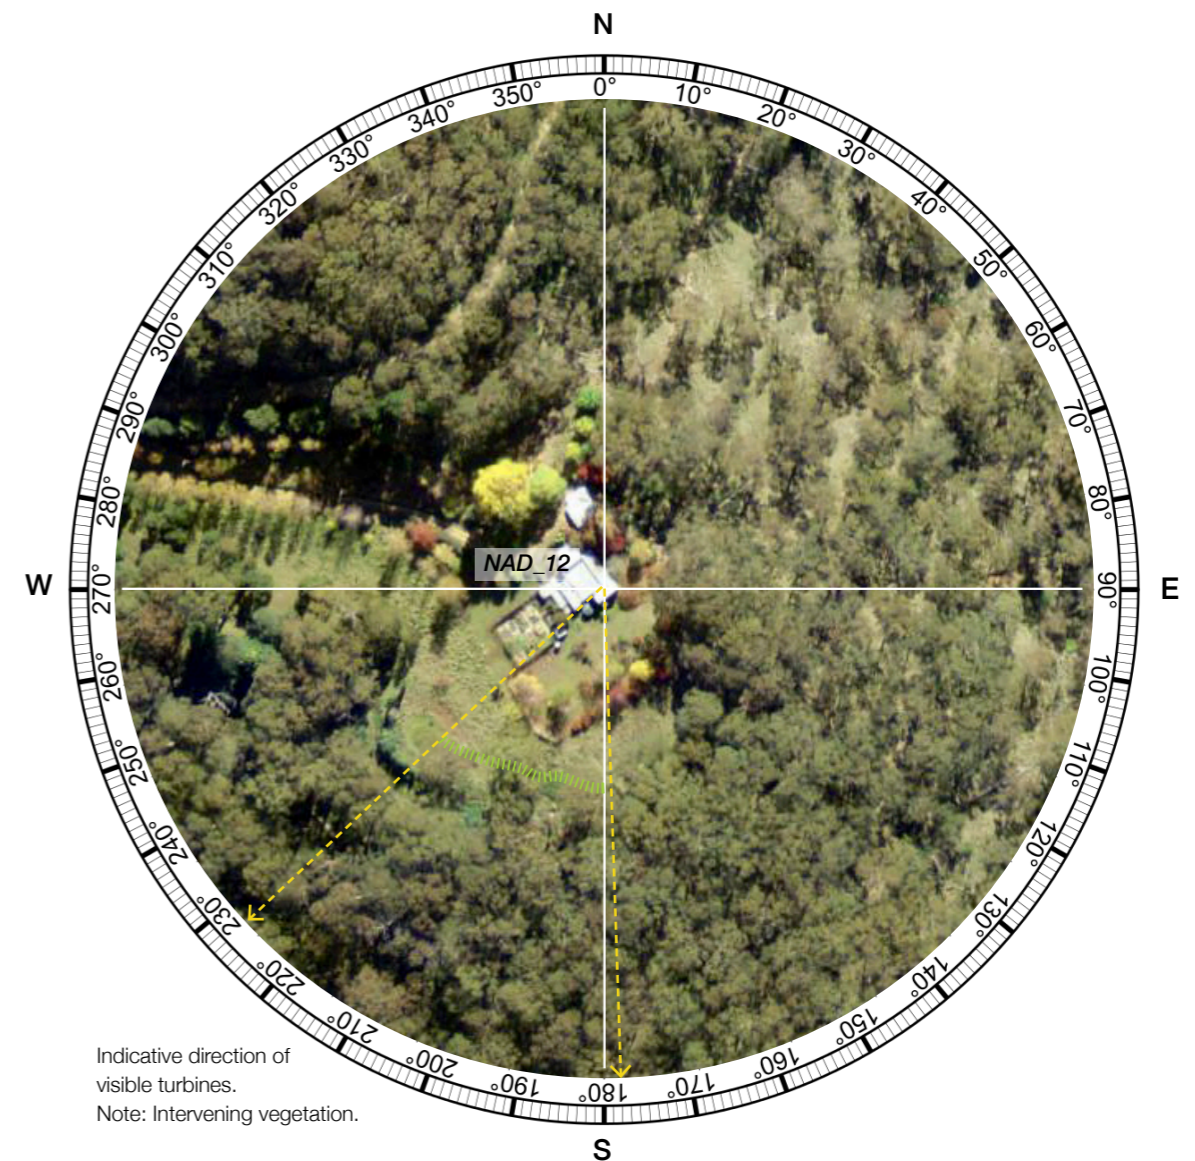
Figure E11b Aerial Image - Dwelling NAD\_12 (Aerial Image Source: Google Earth Image Date: 05.08.2019)

**Landscape Scenic Integrity:** The proposed turbines will not cause significant modification of the visual catchment from this viewpoint.

If deemed necessary supplementary planting could be considered along the northern edge of existing vegetation in the direction of the Project (as shown as a green dashed line on Figure E11b) to ensure views to the Project are screened in the long-term.
