ENVIRONMENTAL INVESTIGATION SERVICES

ACID SULFATE SOIL

PROPOSED ALTERATIONS AND ADDITIONS – MERIDEN SCHOOL

16 MARGARET STREET, STRATHFIELD

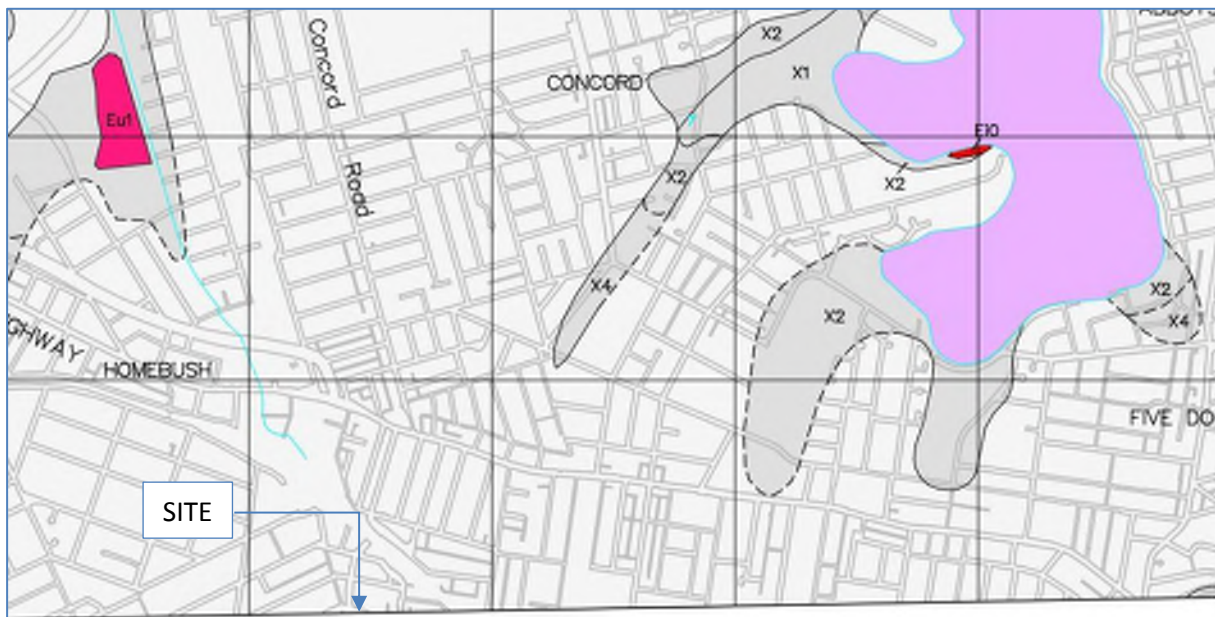
A review of the ASS risk maps prepared by Department of Land and Water Conservation (1997)⁴ indicates that the site is located in an area classed as no known occurrence of acid sulfate soil. A section of the map is reproduced below. EIS note that the initial report stated that the site was located in a low risk area.

Based on the risk maps there do not appear to be any risk areas within 500m of the site. There is a creek source (Powells Creek) approximately 550m to the north of the site. The acid sulfate soil risk map does include a notation that river and creek sediments may contain acid sulfate soil. However EIS note that the sections of creek closest to the site are concrete lined. This area does not show up as Class 1, 2, 3, or 4 area on the Strathfield LEP 2012.
