**REPORT TO
MERIDEN SCHOOL**

**ON
REMEDiation ACTION PLAN (RAP)**

**FOR
PROPOSED ADMINISTRATION AND
STUDENT CENTRE OF MERIDEN SCHOOL**

**AT
16 MARGARET STREET, STRATHFIELD,
NSW 2135**

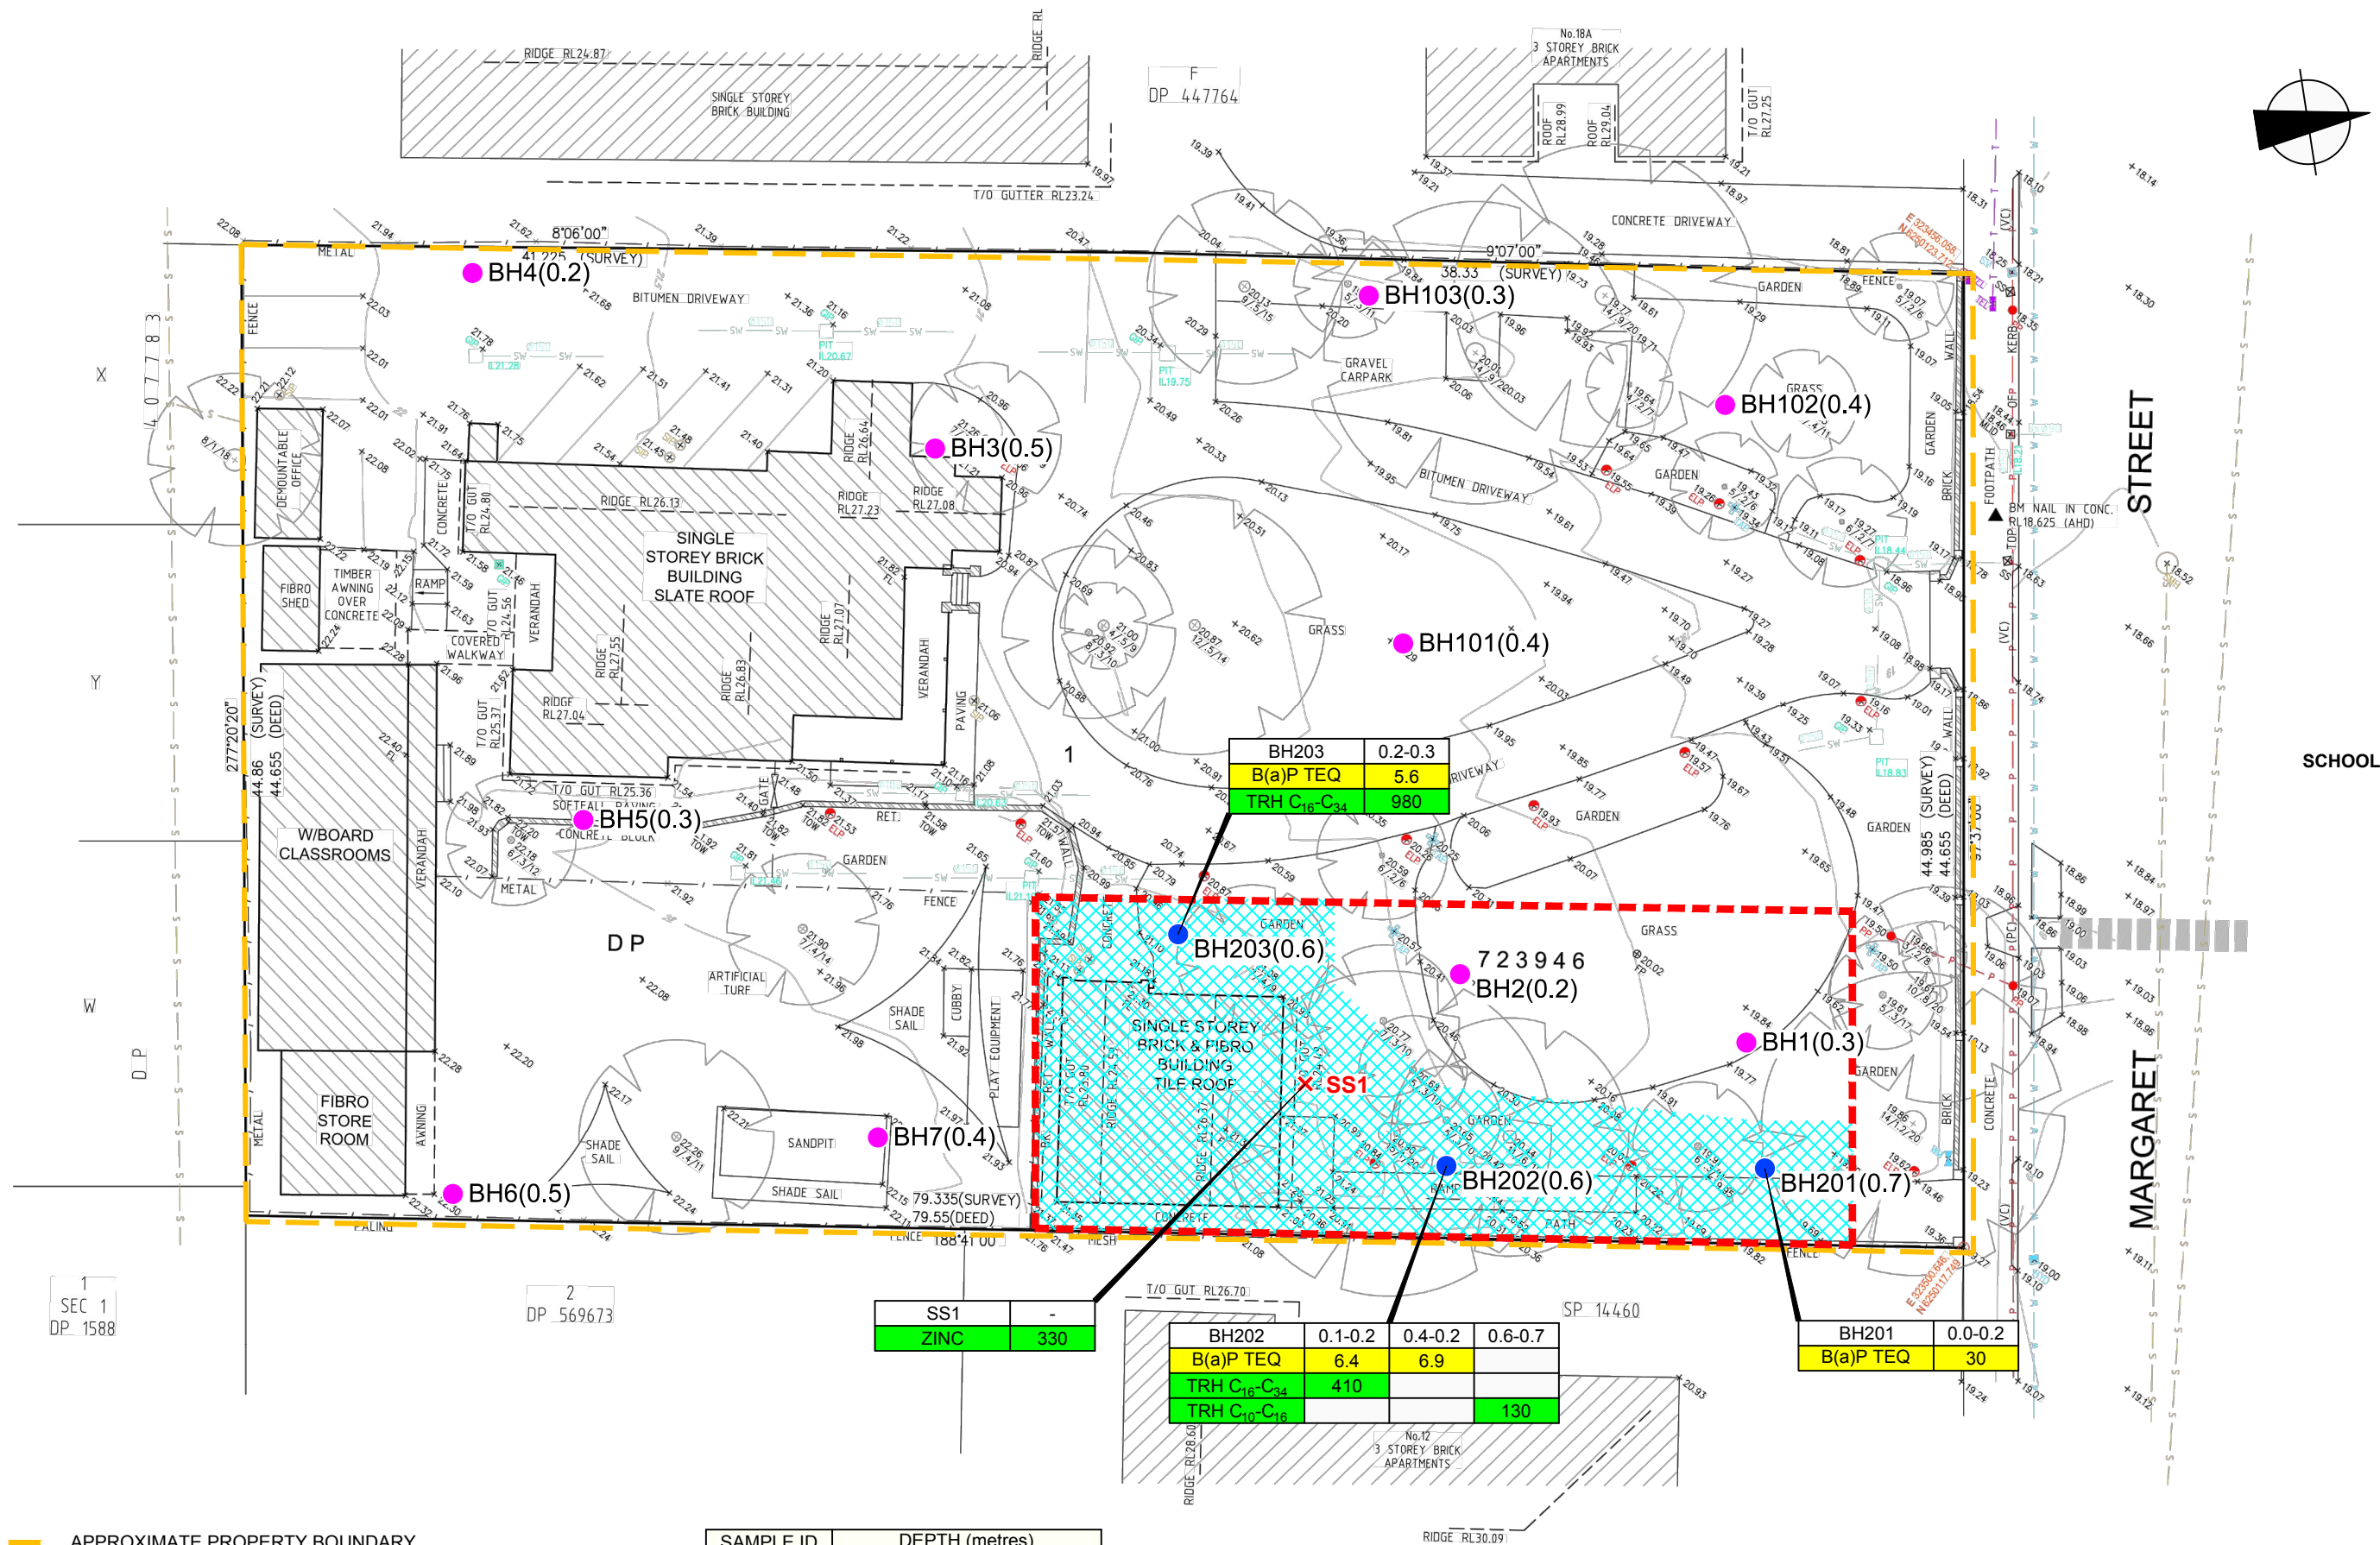
Title: REMEDATION PLAN (2019)	
Location: 16 MARGARET STREET STRATHFIELD, NSW	
Report No: E30910KG	Figure No: 3
JKEnvironments

This plan should be read in conjunction with the Environmental report.
