# **Bayswater Water and Other Associated Operational Works Project**

## **Appendix I – Non-Aboriginal Heritage Assessment**

## Non-Aboriginal Heritage Assessment

21 October 2019

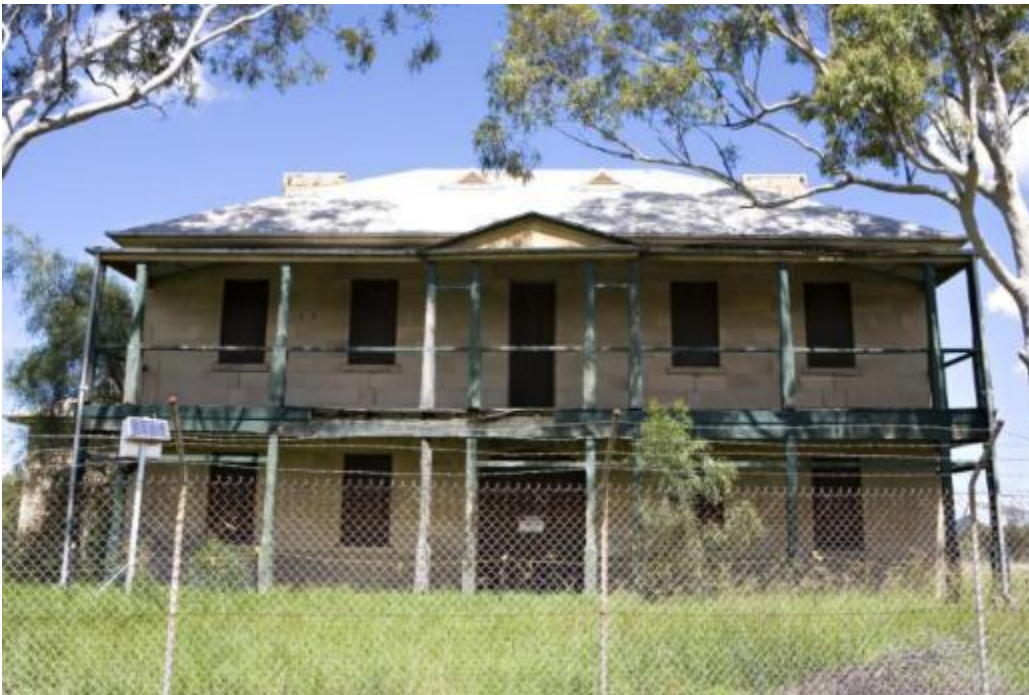
Figure 4-2: Chain of Ponds Inn, Liddell (Courtesy: EJE Heritage, 2013:1).

The Chain of Ponds Inn was constructed in the 1840s by Henry Rowland as a coaching inn for traffic on the main road from Morpeth to Tamworth (Umwelt 2014:3.20) (Figure 4-2). The inn was convict built, and one of the structures was a stone lock-up to house convicts being transported to the north (Thorp 1990).

The Inn has been known by several names since its construction including the Lady Mary Fitzroy, the Coach and Horses Inn, the Star of the North Inn, the Travellers Inn and the Liddell House when it was used as a private residence in the late 19<sup>th</sup> century. It also operated as a post office from 1890 until 1920 (EJE Heritage 2013:10).

The former Chain of Ponds Inn and its outbuildings, comprising a police lock-up and stables, were listed on the State Heritage Register in 1999. It is located approximately 500 metres outside of the study area, on the north-eastern side of Bayswater Creek. It is therefore unlikely to be impacted by the proposal.

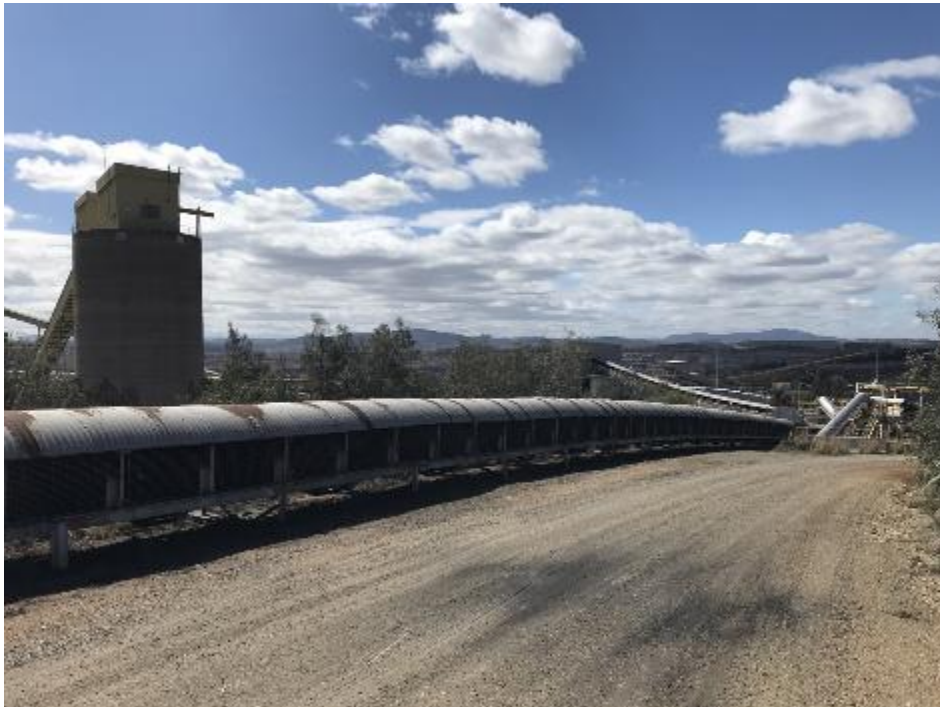
Existing above-ground pipelines and conveyors run along the entire length of the ash line corridor (Figure 5-1). Graded vehicle tracks run alongside the existing pipeline for most of the length of the ash-line corridor. These vehicle tracks and the ground immediately adjacent to them are highly disturbed by the grading, drain excavation, capping, and other earthworks required to construct the tracks. Various localised areas of disturbance occur along the ash line corridor, where it is crossed by road bridges and conveyors; and where graded and gravel-capped laydown yards have been constructed. As a result, remnant intact areas of ground that appear to be free of prior disturbance make up only a minority of the ash line corridor. No historical heritage or potential for subsurface archaeology was observed in this area.

Figure 5-1: Vehicle track and working coal conveyor (ash line out of frame to right) (Source: Jacobs 2019)

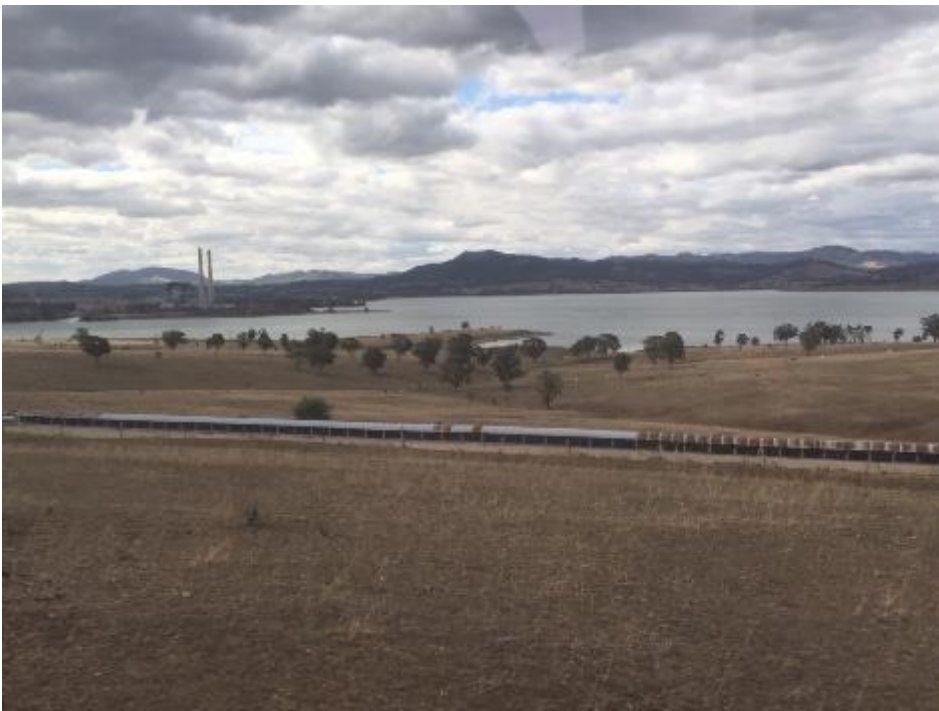
There are various visible signs of prior disturbance to the ground surface in the western section. Various vehicle tracks run through the section. Artificial ponds have been constructed, and signs of water ponding against the western edge of the ash dam are identifiable. Ponding of water in this section is probably the result of rainwater runoff from the ground to the west, which ponds against the artificially raised ground along the western edge of the ash dam. High voltage powerlines also run through this section. The ground is patterned with linear plough lines and furrows, indicating that the entire area has probably been subject to the low-level disturbance of ground ploughing and perhaps contour bank formation in the recent past.

No historical heritage or potential for archaeological relics were observed in this area.

Figure 5-2: Open fields to the south of the ash dam, looking north-west (Source: Jacobs 2019)

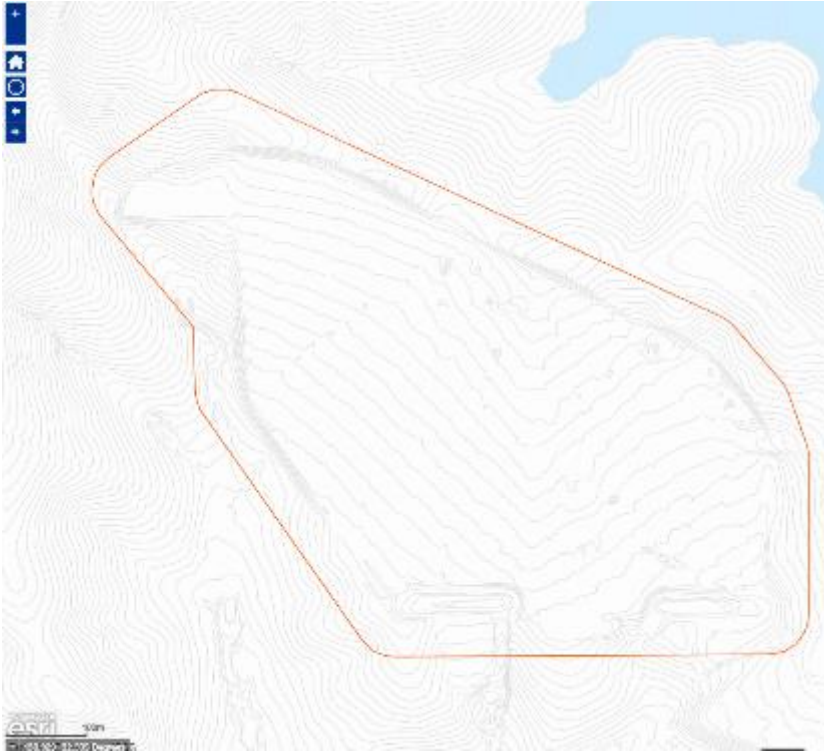
The salt cake landfill area has been cut into the surrounding landscape of low rolling hills, drastically modifying its topography (Figure 5-3 and Figure 5-4). It is currently divided into small segments of land with surrounding

Figure 5-3: Mapping of salt cake landfill area overlaid with 1 m contour lines (Source: Jacobs 2019)

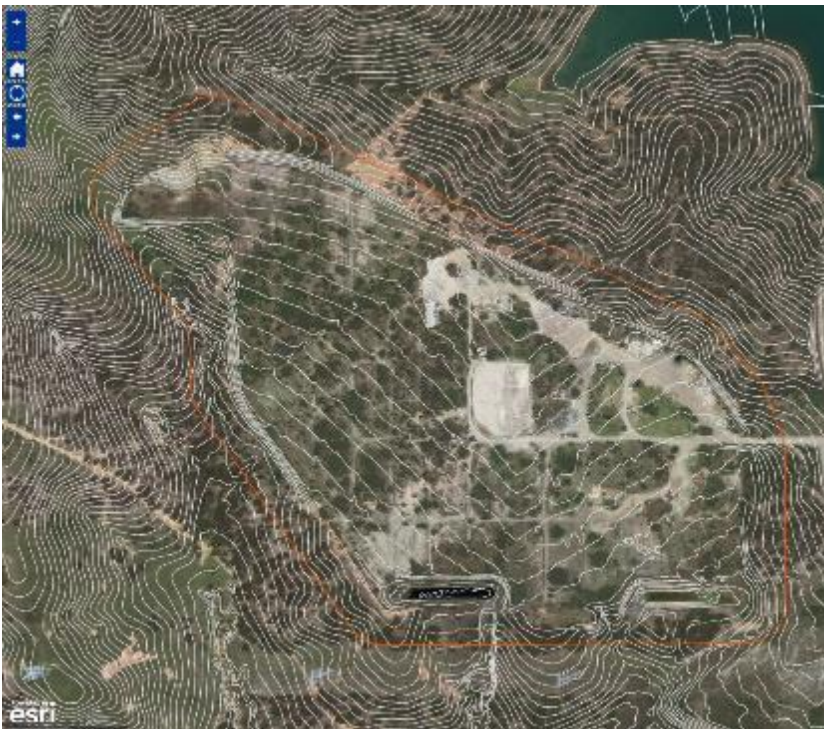
Figure 5-4: Salt cake landfill area with aerial base map (Source: Jacobs 2019)

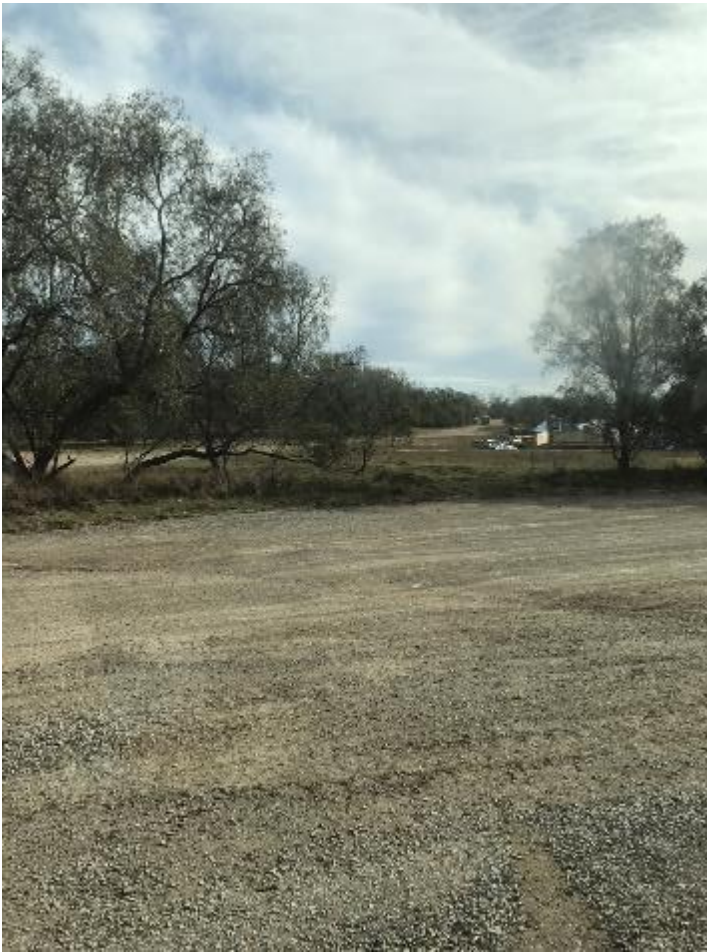
Figure 5-5: View from the entrance of the landfill area, looking south-west (Source: Jacobs 2019)

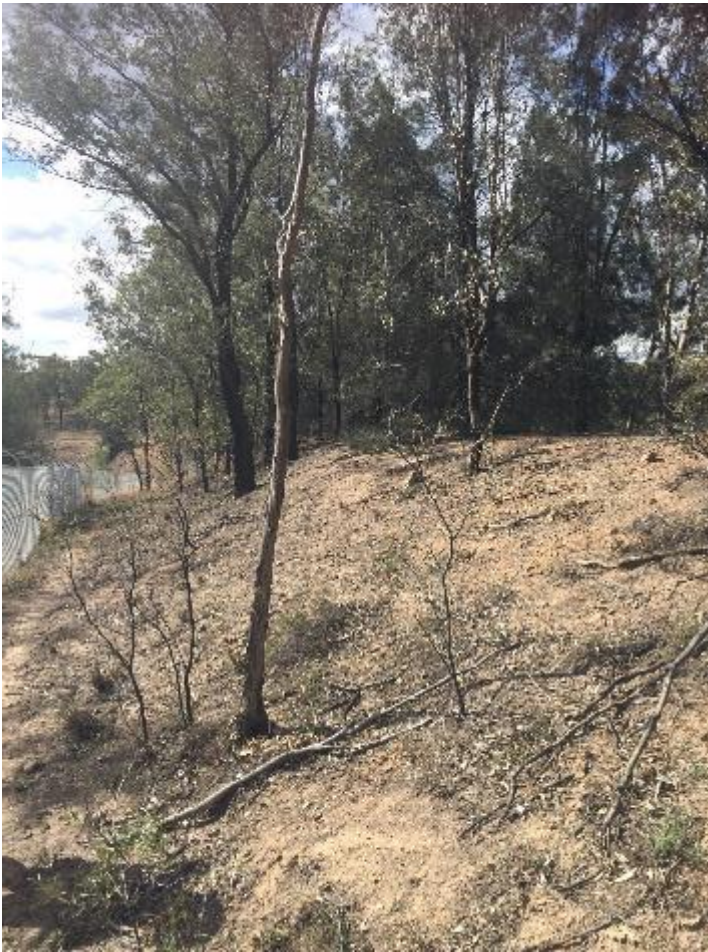
An encircling chain-link fence has been placed around the coal stockpile, on the ground surface above and adjacent to the vertical excavation face. The ground surface adjacent to this fence shows signs of earthworks associated with its construction, in the form of graded or flattened ground, and incised drainage channels diverting water runoff away from the fence and the coal stockpile within it. The margin around the chain-link fence is currently regrowth native vegetation with Eucalypt saplings and casuarinas (Figure 5-6). No historical heritage or potential for subsurface archaeology was observed.

Figure 5-6: Regrowth vegetation on the outer margin of the CHP (Source: Jacobs 2019)

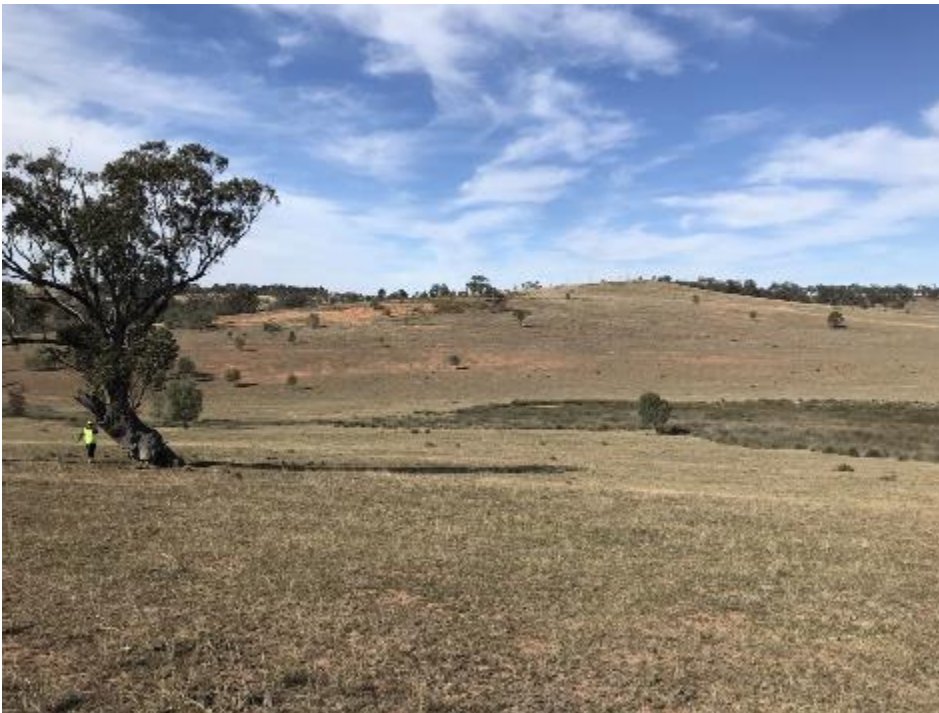
This area consists of low rolling hills, and flat-floored valleys. The ground surface rises upward to the north, toward the hilltops bordering the ash dam. To the south the ground surface slopes downward into a flat-floored valley running east-west along the area's southern border. Some small farm dams have been constructed along drainage lines within the area and it is probable that this creek incorporated ponds and swampy areas prior to European land clearing. Although signs of grazing stock were observed, the infrastructure all appeared to be recent, and no items of potential heritage significance were observed.

Figure 5-7: Borrow pit 1 - View down into the valley, looking south-east (Source: Jacobs 2019)

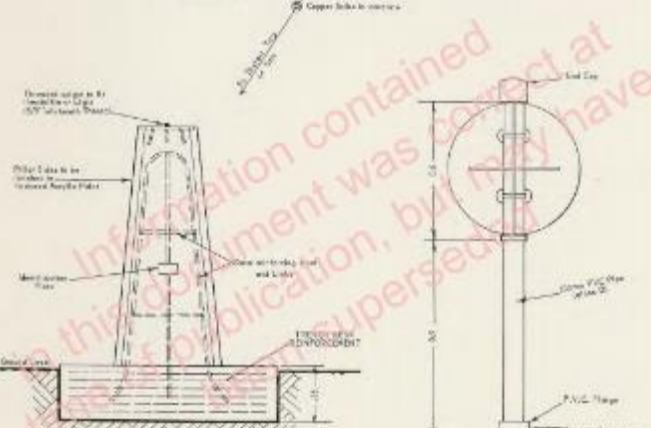
It is a concrete pillar trig station of a common design which rose to prominence in the mid-1970s (Figure 5-8). It has a concrete pillar of approximately 1.3 metres tall with a metal mast and circular vane mounted using a P.V.C. flange (this flange is broken on TS Glendower, which has allowed the mast to be dislodged). The mast is designed to be removable in order to access a threaded spigot which provides a mount for a theodolite or prism.

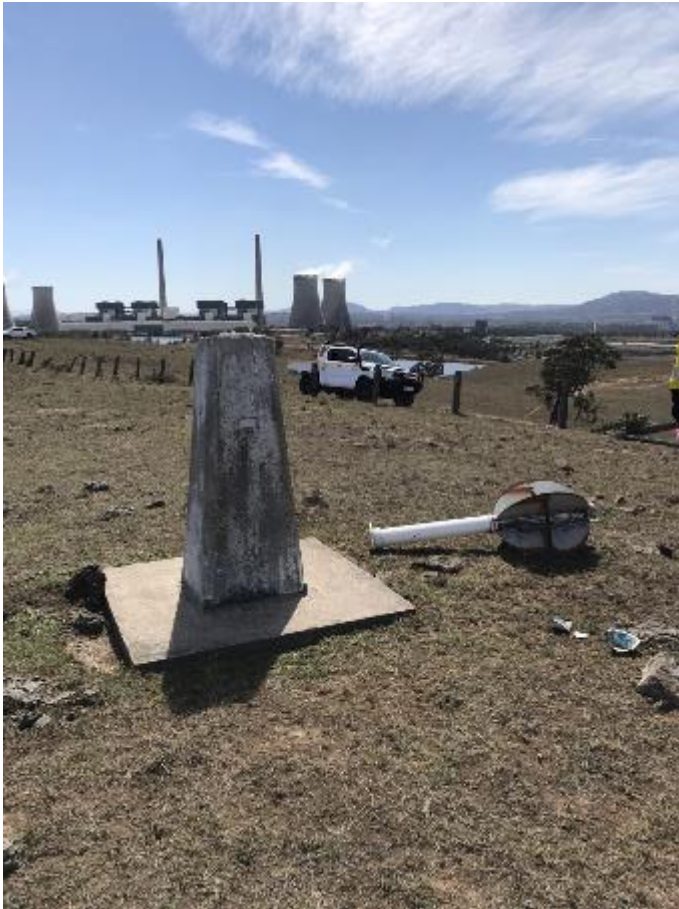
The highest elevation of the crest has a broken trigonometrical (trig) station (Figure 5-9), marked 'T.S. Glendower' (Figure 5-10), adjacent to a wooden post and wire fence.

Figure 5-9: Derelict trig station (mast and vanes broken off and lying on the ground; Bayswater at rear of frame), looking north (Source: Jacobs 2019)

An application for authorisation to remove or replace a permanent survey mark (TS Glendower) must be made in accordance with clause 90 of the *Surveying and Spatial Information Regulation 2017* at least 30 business days before the proposed removal or replacement. It is recommended that consultation with the NSW Government Spatial Services and/or the Surveyor-General be started as soon as practicable, to seek advice on the management of TS Glendower and to avoid any subsequent delays to the Project.

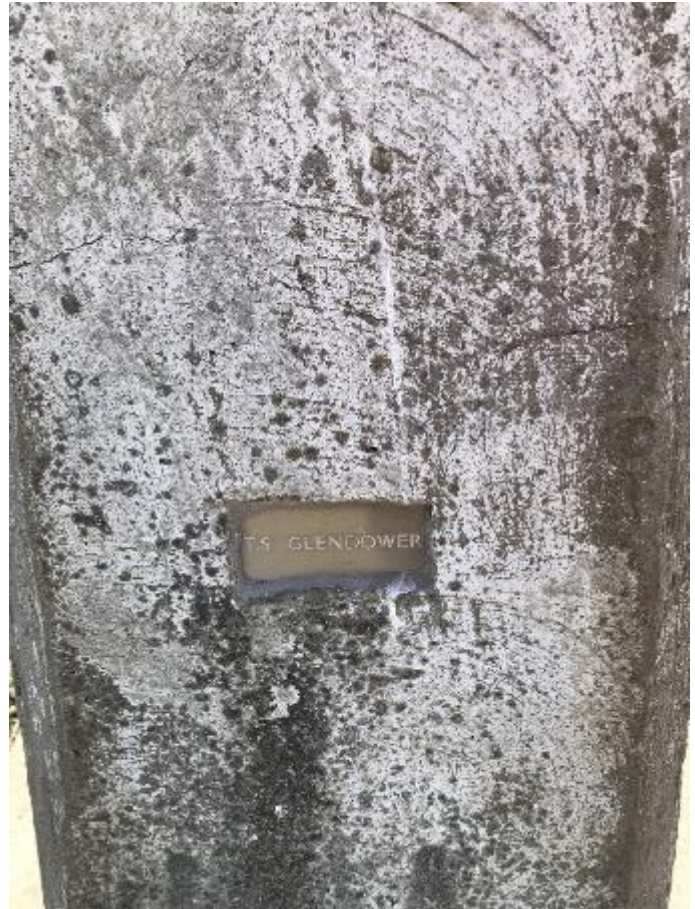
Figure 5-10: Survey marker plaque 'T.S. Glendower' (Source: Jacobs 2019)

The trig station in Borrow Pit 2 (TS Glendower, #TS10176) is an integral part of a key spatial network dating from the mid-nineteenth century and represents its continuing development through time with advancements in technology and spatial services. The next closest trig stations are TS Shepard (#TS10925), 5 kilometres to the south-east, which may have been removed by the Ravensworth open-cut pit, and TS Savoy (#TS5333), 5.7 kilometres to the north-west which is still in operation.

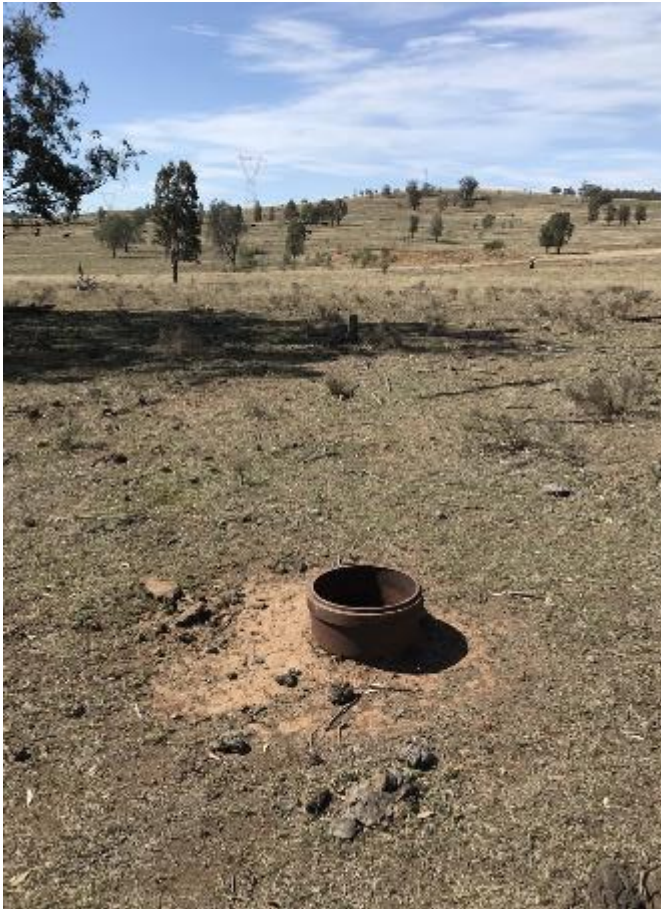
To the south of the creek line, a circle of trees with a central clearing showed signs of past camp activity, with a metal tub likely used as a hearth or small stock-feeding tub (Figure 5-11), and a wooden structure of indeterminate purpose (Figure 5-12). The wooden structure was constructed using modern Phillips head screws as well as older metal bolts, and although evidence of land use and past human activity, the features appear relatively modern and neither feature is considered to be of heritage significance.

Figure 5-11: Metal tub, likely either a hearth or feeding tub, looking north-east (Source: Jacobs 2019)

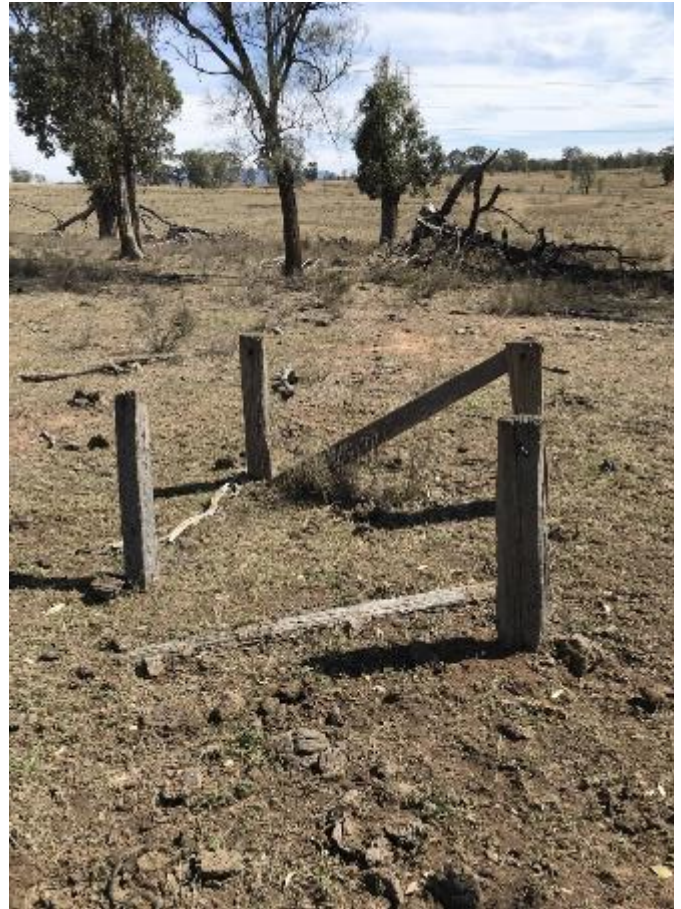
Figure 5-12: Indeterminate wooden feature, likely livestock related, looking south-west (Source: Jacobs 2019)

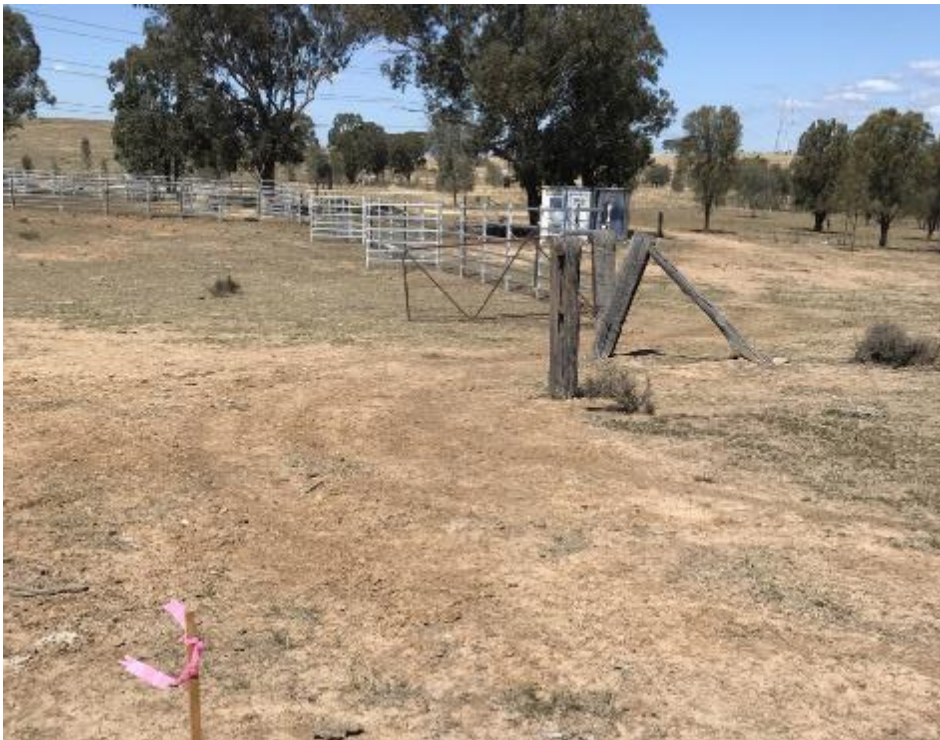
A series of cattle yards and modern metal run fencing has been installed at the entrance to this borrow pit area (Figure 5-13). The fencing material, gates and shipping container present all appear to be relatively recent.

Figure 5-13: Fences, gate and stock run at the entrance to Borrow pit 4, looking south-east (Source: Jacobs 2019)
