Report on  
Geotechnical Investigation

Proposed Data Centre  
1 Sirius Road, Lane Cove West

Prepared for  
Greenbox Architecture Pty Ltd

Project 86621.00  
December 2018

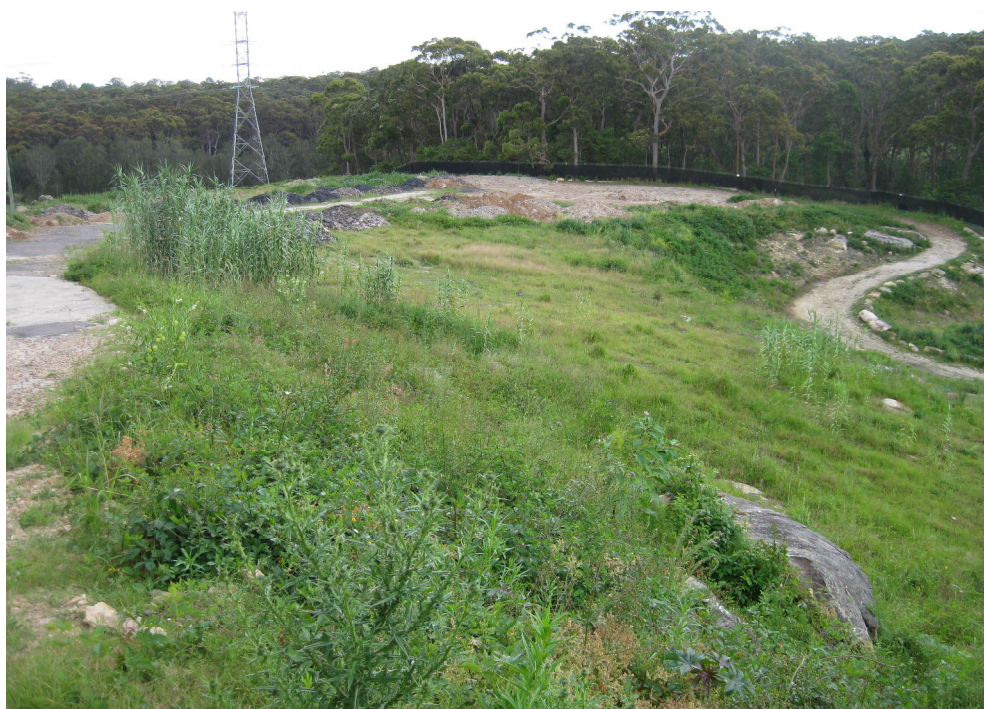
Photo 1 – View north-west over the broad, slightly sloped central area of the site, with some soil stockpiles.

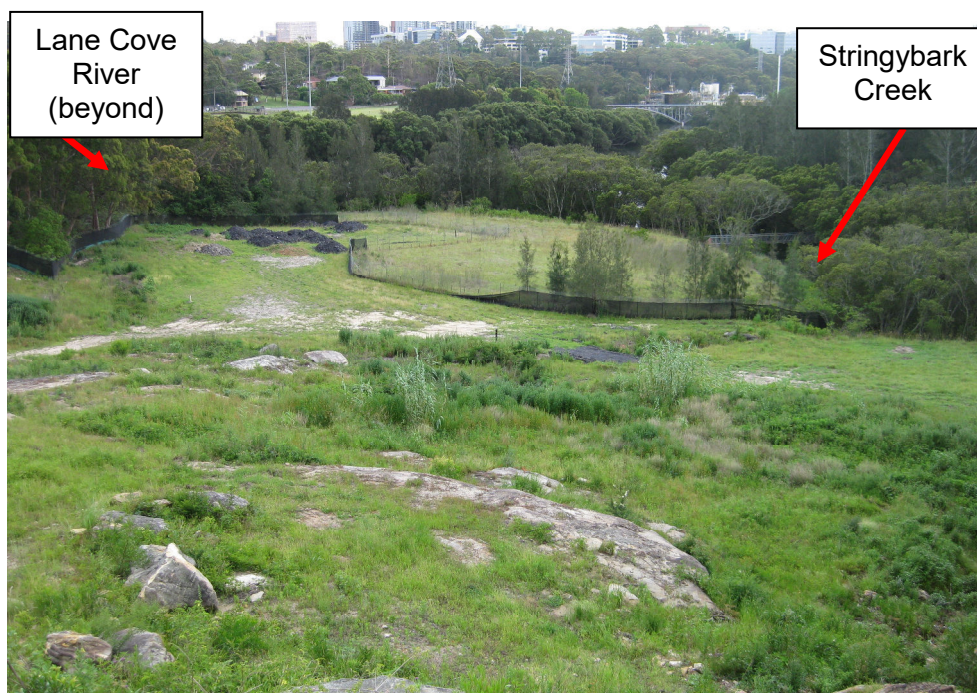
Photo 2 – View north towards Stringybark Creek and the Lane Cove River. The site slopes down to the north-east, towards a filled and levelled area.

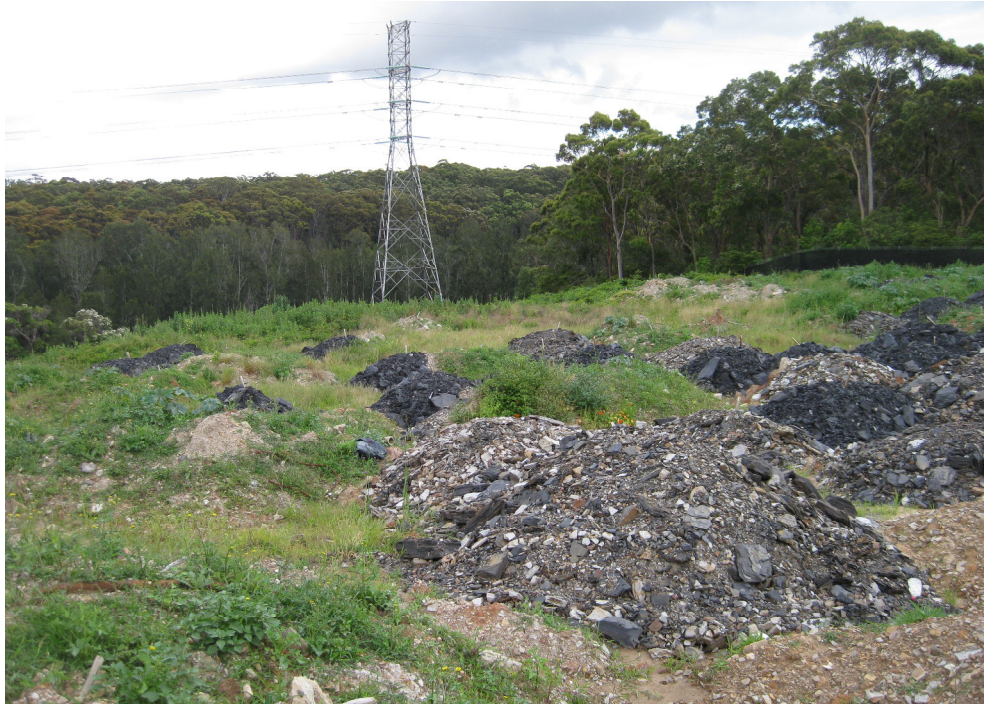
Photo 3 – View west towards the western property boundary from an access track. The site slopes down to the south-west.

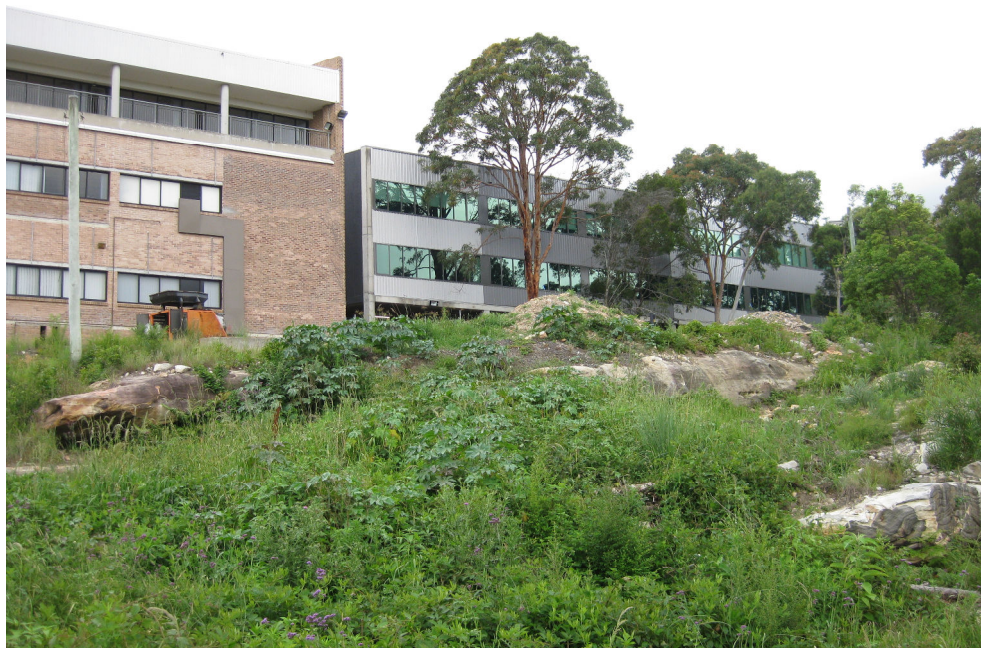
Photo 4 – View south towards neighbouring multi-storey industrial developments.

The neighbouring multi-storey industrial developments appear to be constructed without basement levels, and are probably constructed with shallow footings founding within the near-surface sandstone.

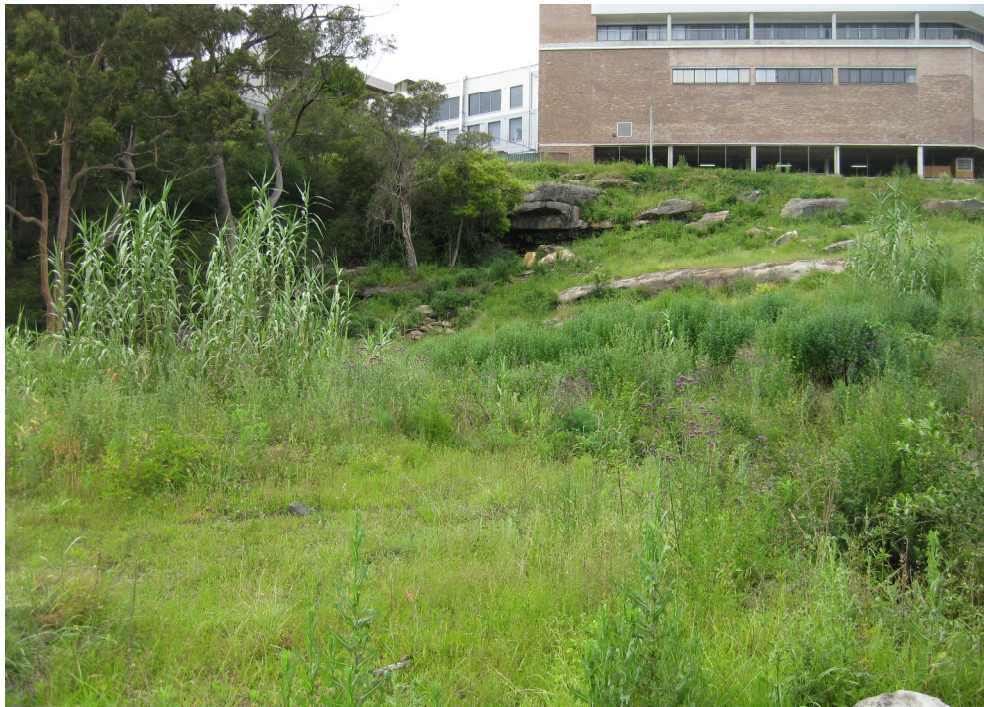
Photo 5 – View south towards a cliffline and rock overhangs adjacent to an access track leading from Sirius Road.

Based upon the preliminary architectural drawings, excavations within soil and rock are proposed within about 15 m of the southern property boundary (to a depth of 13 m: including within soils, and close to cliffs with overhangs), and within 10 m of the western property boundary (to about 4 m depth). There is likely to be sufficient space adjacent to the proposed excavation footprint to form temporary batters or benches, within the soil and extremely low to very low strength rock. It is noted that pavements are proposed to be constructed within the footprint of the temporary slope batters and near to the buildings, therefore filling over the temporary batters and benches will be required to construct the pavements.

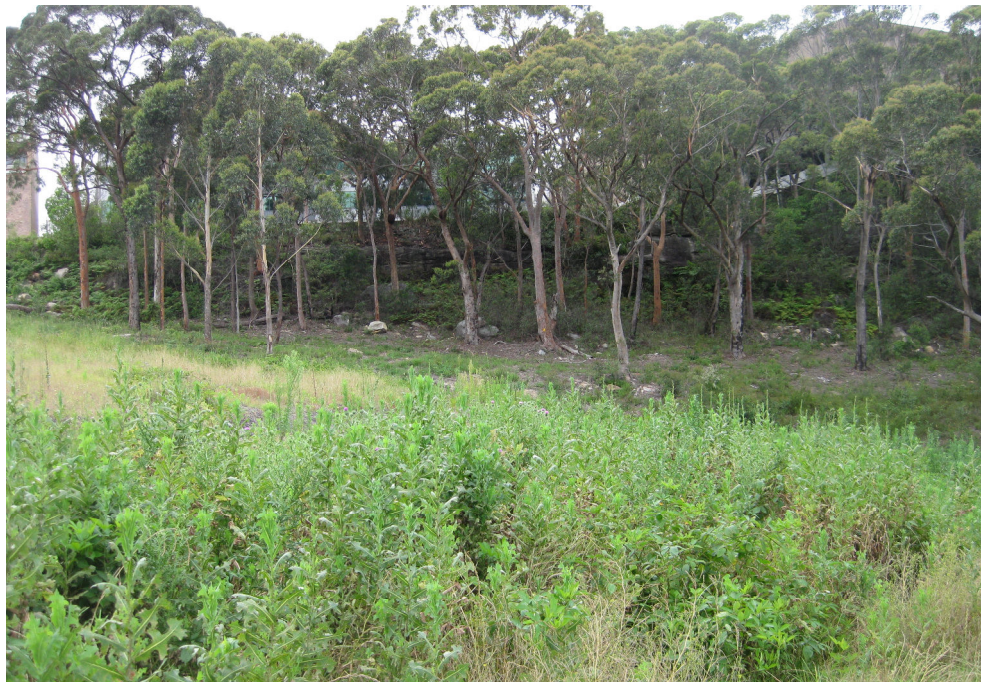
Photo 6 – View south-east towards a colluvial slope and cliffline, with cobbles and boulders at the ground surface.

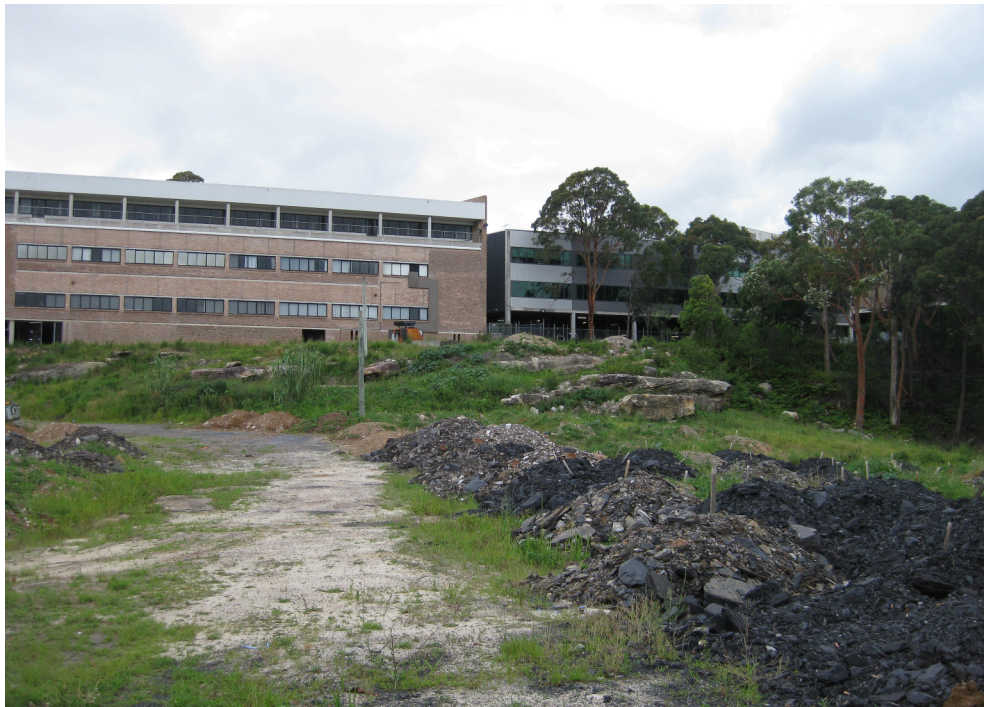
Photo 7 – View south-east towards the southern property boundary and neighbouring developments, across stockpiles of soil and excavation rubble within the central part of the site.

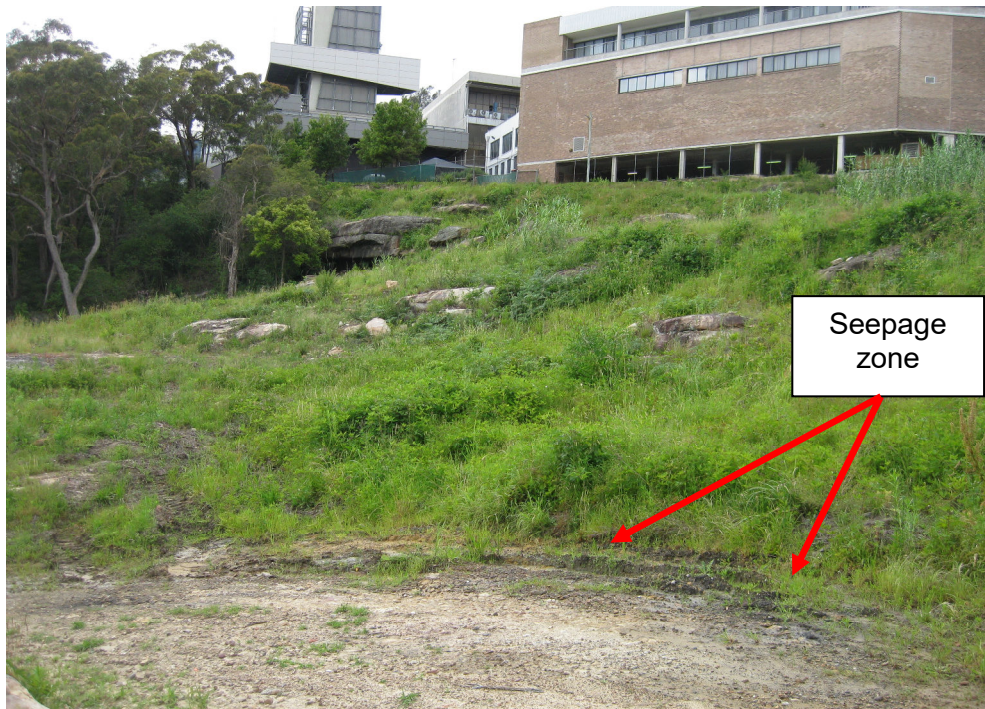
Photo 9 – View south-east from the winding access track, towards a zone of seepage onto the access track as indicated.

Observation of seepage within the access track at an elevation of about RL11 m, indicates a perched water table is present within elevated areas of the site, at the soil-rock interface. Groundwater levels are potentially transient, and affected by the prevailing weather conditions and downslope drainage conditions.

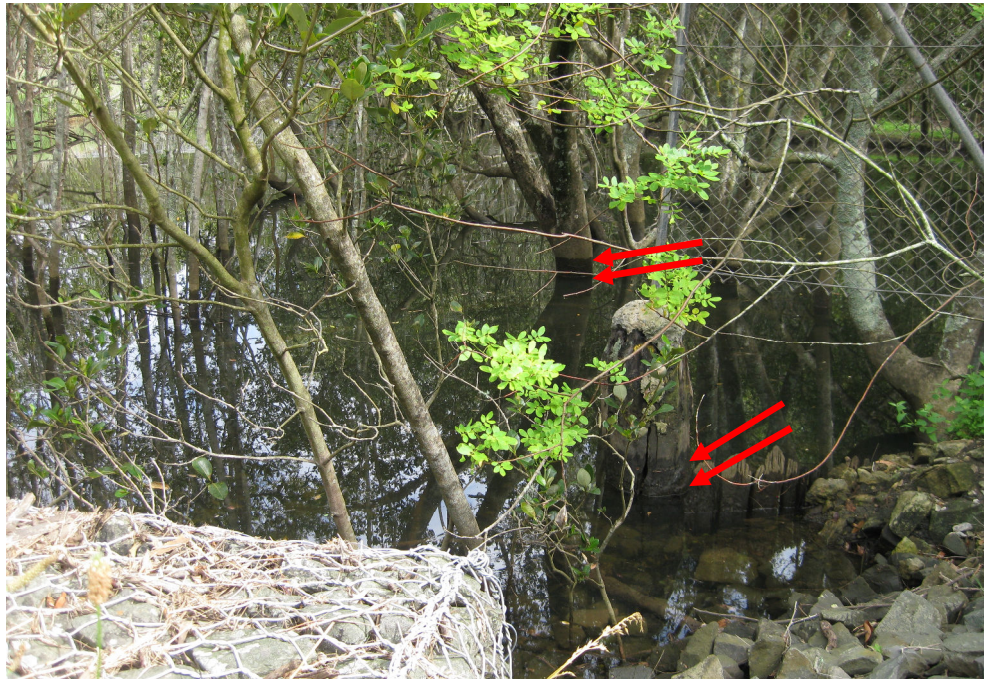
Photo 10 – View north-west from the southern bank of Stringybark Creek, with wet sections of partly submerged features within the creek (as shown with arrows) indicating the water level in the creek has recently gone down (i.e. falling tidal level).

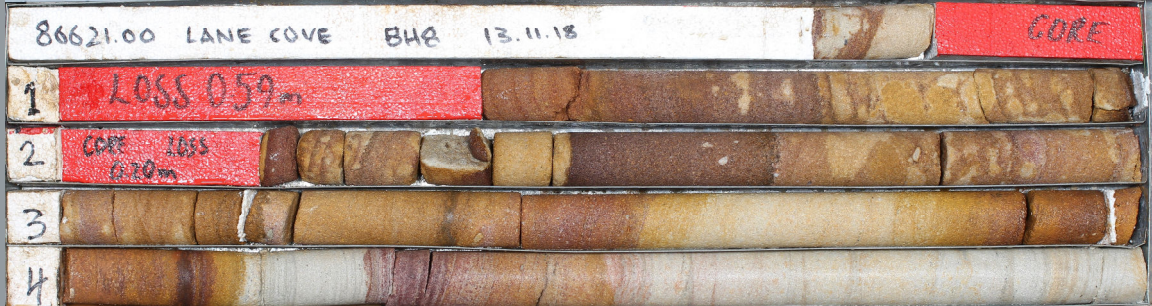
0.74m - 5m

Project No: 86621.00  
BH ID: BH1  
Depth: 0.74 - 5.00m  
Core Box No.: 1/3

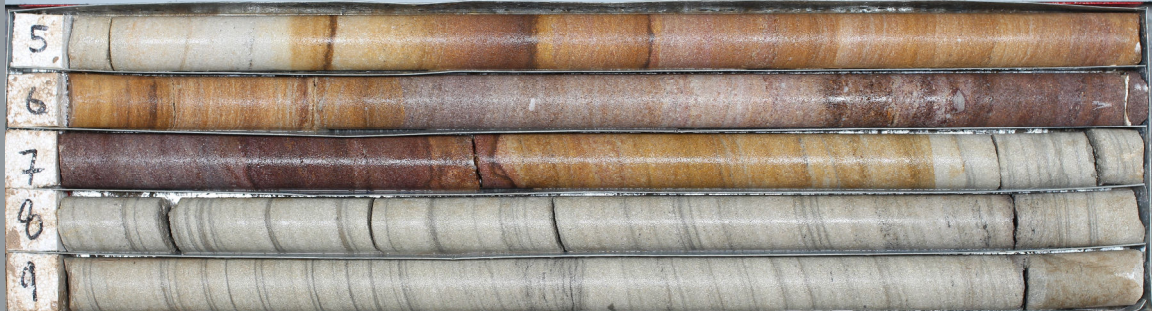
5m - 10m

Project No: 86621.00  
BH ID: BH1  
Depth: 5.00 - 10.00m  
Core Box No.: 2/3

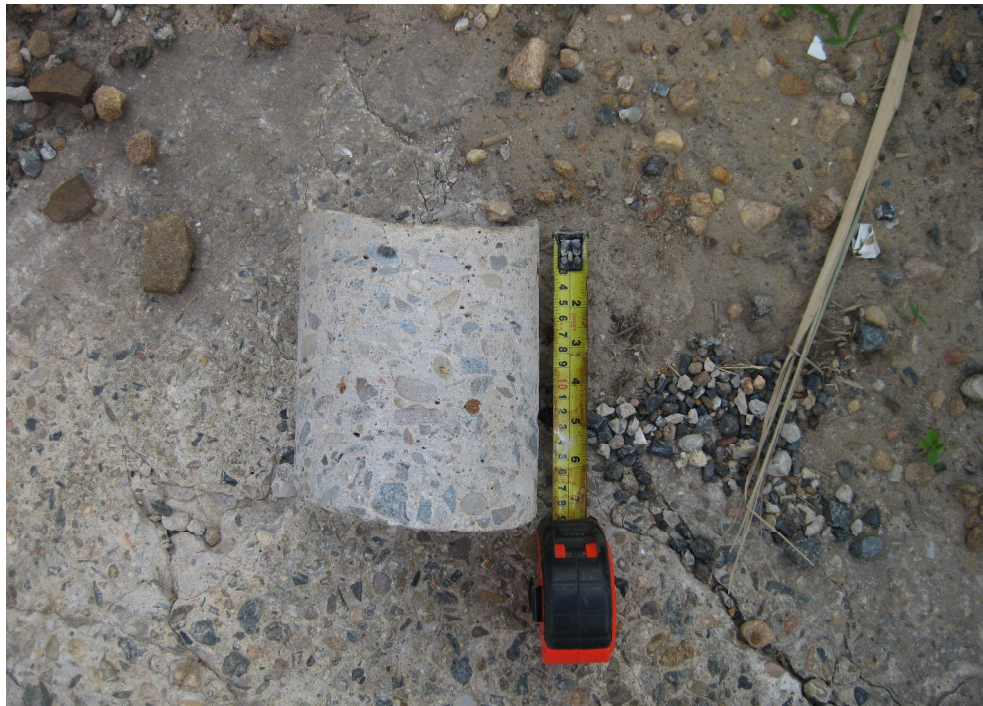
Photo D1 – View of concrete core obtained from 0.2 m depth, within Borehole BH2.

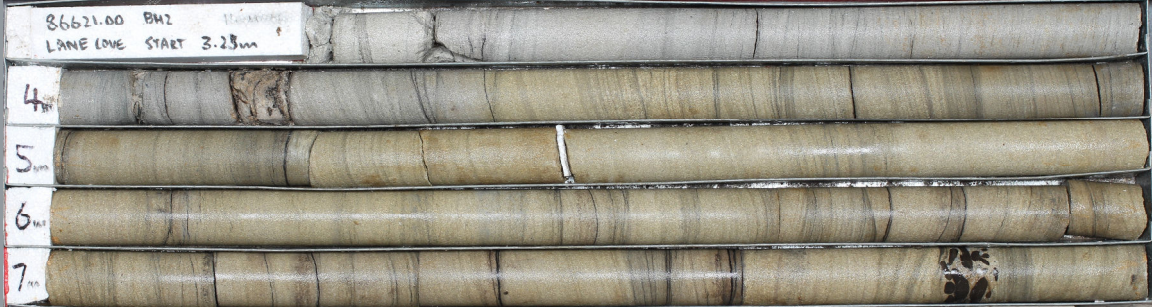
3.23m - 8m

Project No: 86621-00  
BH ID: BH2  
Depth: 3.23 - 8.00m  
Core Box No.: 1/2

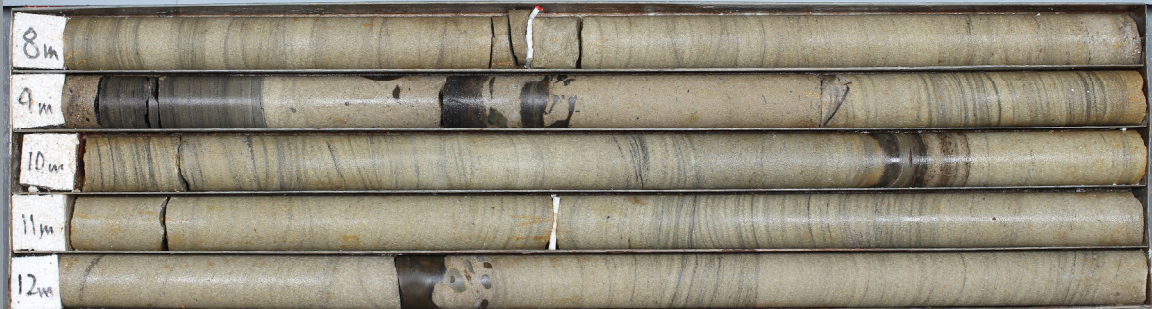
8m - 13m

Project No: 86621-00  
BH ID: BH2  
Depth: 8.00 - 13.00  
Core Box No.: 2/3

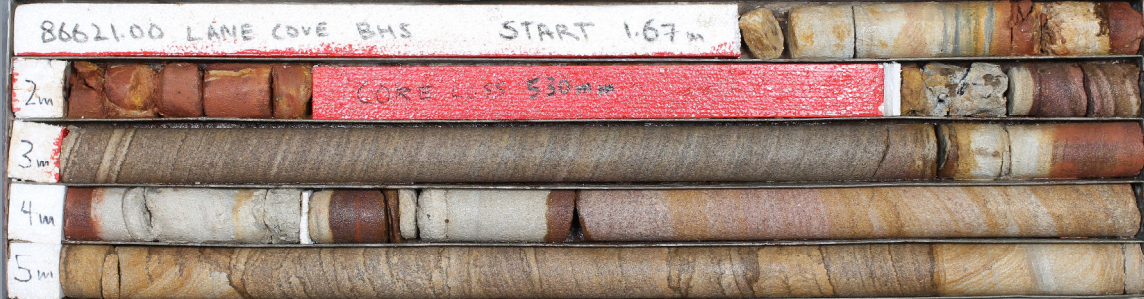
1.67m - 6m

Project No: 86621.00  
BH ID: BH5  
Depth: 1.67 - 6.00m  
Core Box No.: 1/2

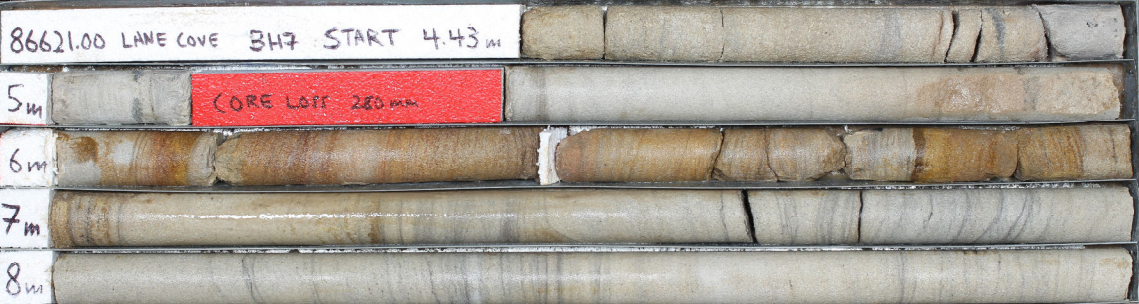
4.43m - 9m

Project No: 86621.00  
BH ID: BH7  
Depth: 4.43 - 9.00m  
Core Box No.: 1/2

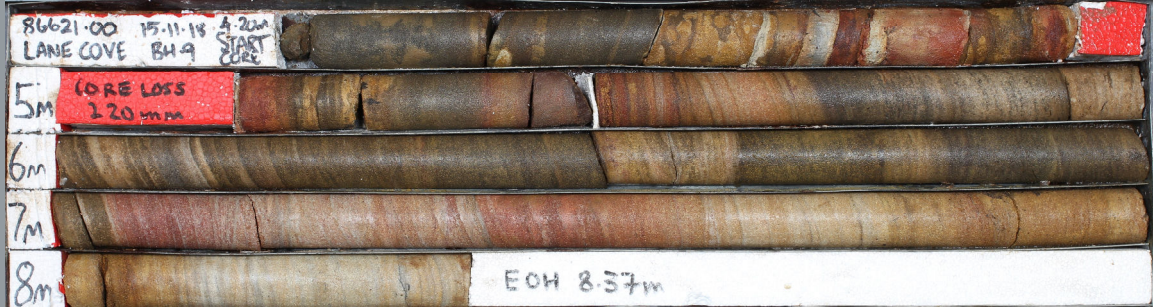
4.2m - 8.37m

Project No: 86621.00  
BH ID: BH9  
Depth: 4.20 - 8.37 m  
Core Box No.: 9/1

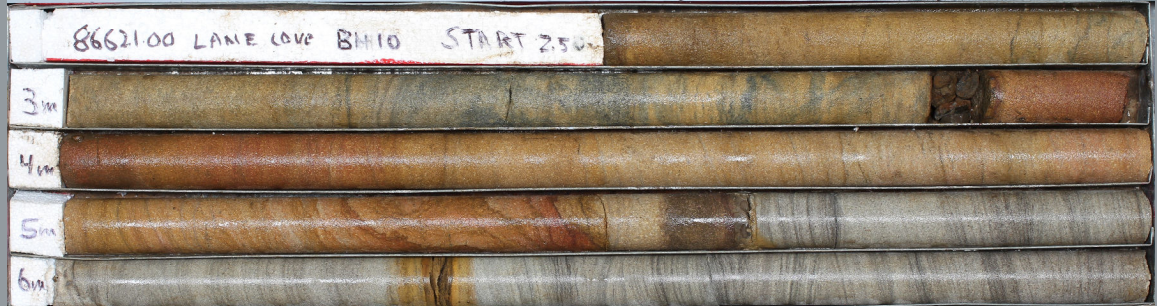
2.5m - 7m

Project No: 86621.00  
BH ID: BH10  
Depth: 2.56 - 7.00 m  
Core Box No.: 1/2
