29 March 2019

**Contamination Assessment, Proposed Santa Sophia Catholic College, The Gables Town Centre, Box Hill North**

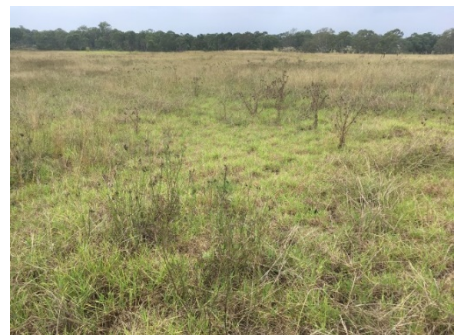
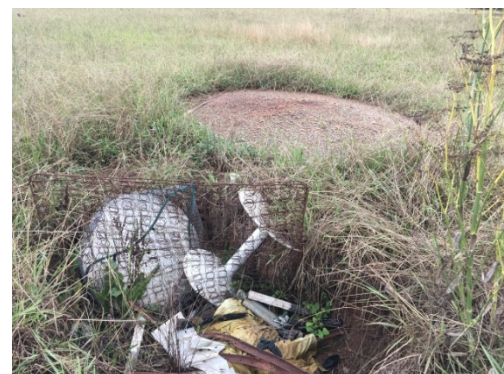
A small circular area of bare ground and gravel adjacent a small depression approximately 2 m long by 0.5 m wide and 0.5 m below the surrounding ground level, was observed in the northeast corner of the site. The depression contained a small amount of general rubbish including steel fence pickets, steel mattress springs and plastic. No asbestos or chemical containers were observed, and there were no odours or staining noted in this area, or elsewhere within the site.

Celestino has been completing remediation where required for development/earthworks stages across the Gables development precincts, and JBS&G has been completing validation of remediation and unexpected finds to confirm the land use suitability as required by consent conditions for each stage. This process will continue for the Town Centre precinct which includes the SSCC site. This will include removal of minor surface waste where observed.

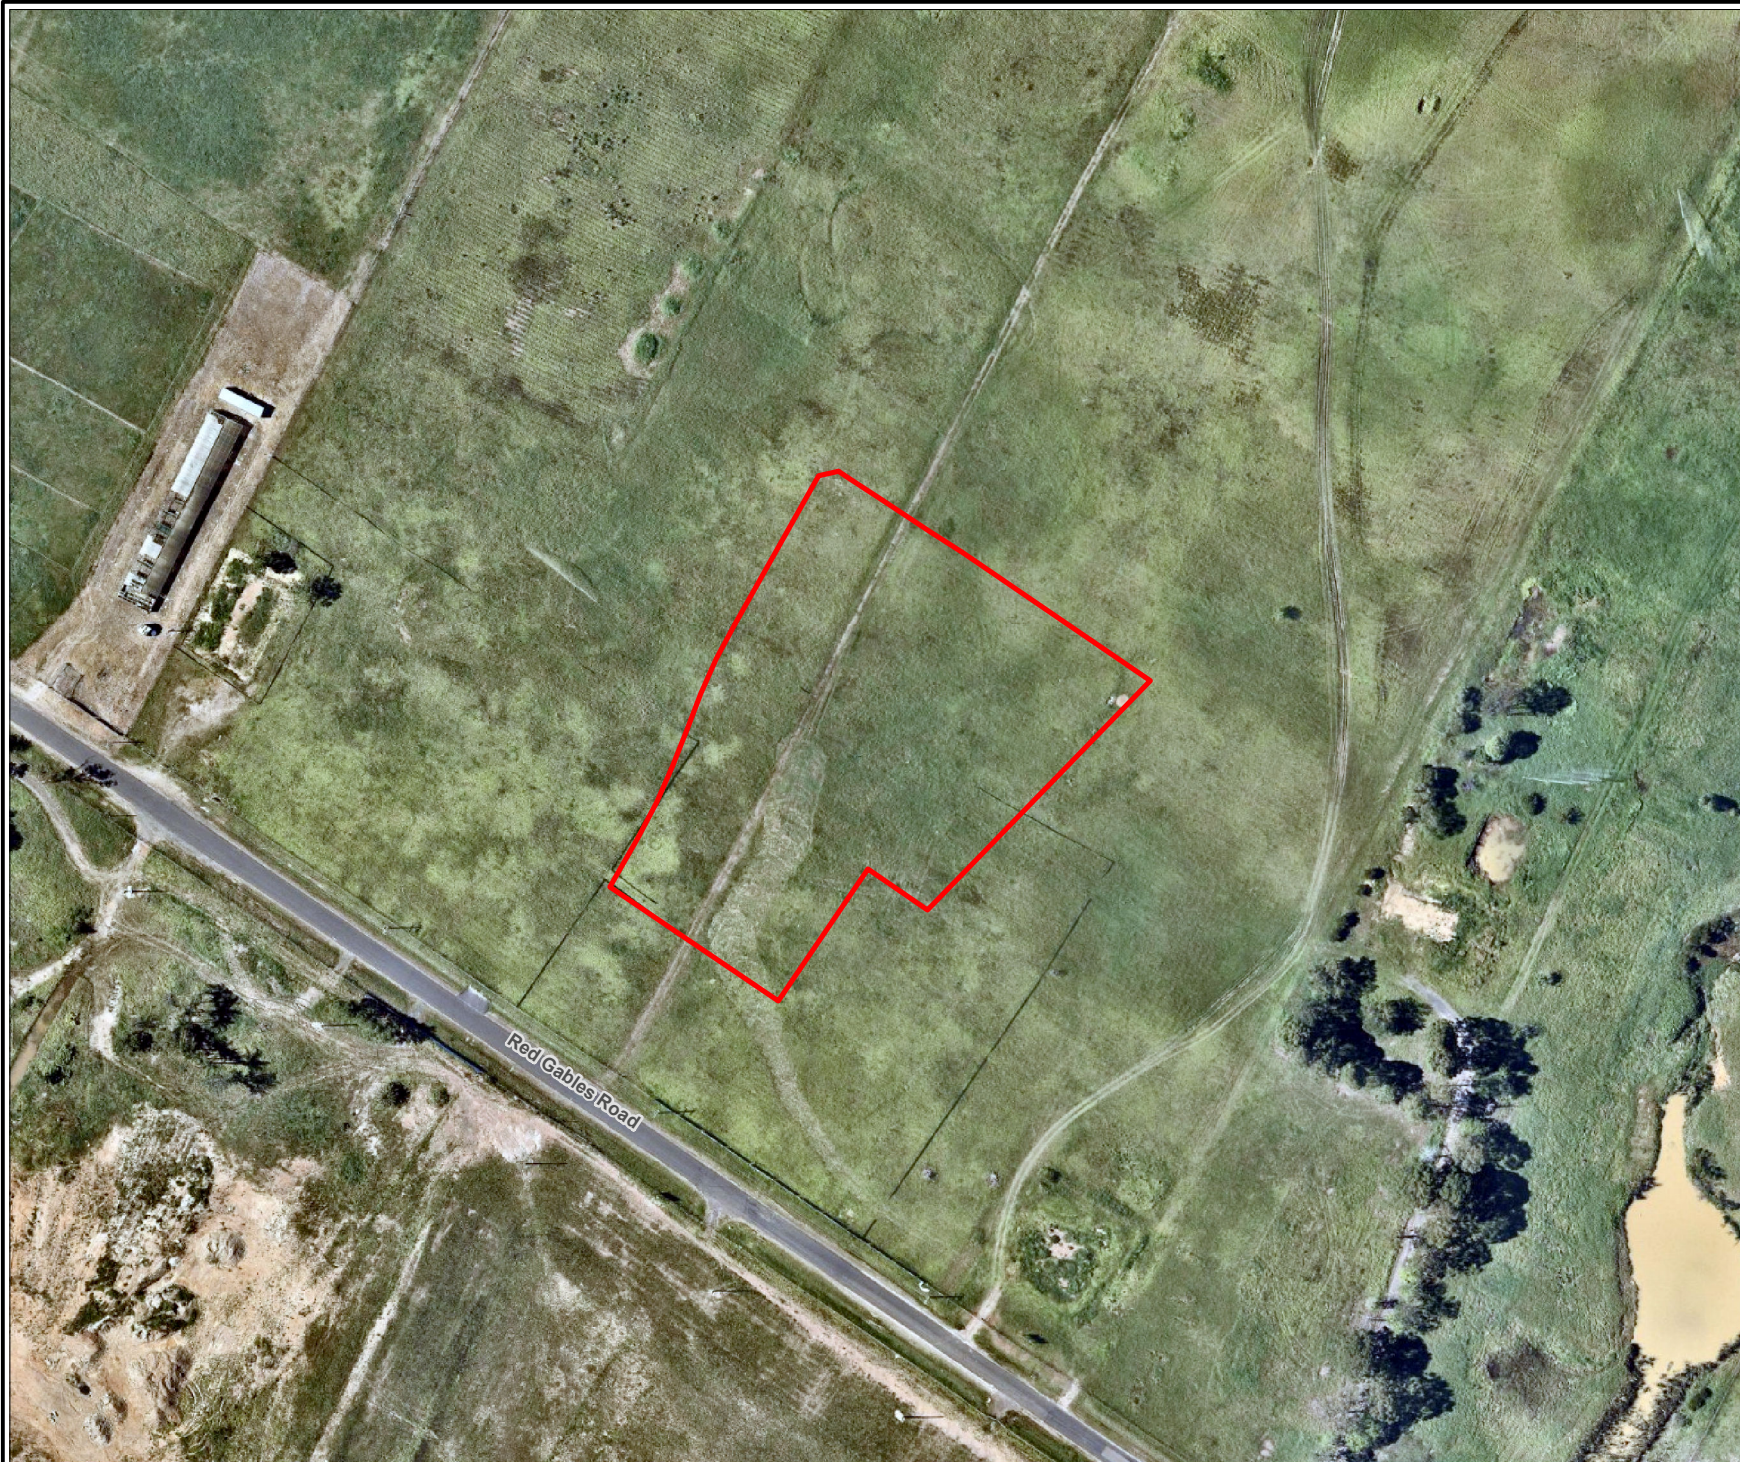
**FIGURE 2**

The SSCC site is situated north of Red Gables Road within the Box Hill North Town Centre precinct within The Gables mixed use development by Celestino. The site has an area of approximately 10,000 square metres, or 1 hectare. The site is currently part of Lot 26 in Deposited Plan (DP) 255616, being 12 Red Gables Road, and may include a small portion of adjoining Lot 25 DP 255616 being 10 Red Gables Road. The site location and boundaries are provided on **Figures 1 and 2** attached.

**SITE LAYOUT**
