Report on
Geotechnical Investigation

Proposed Santa Sophia Catholic College
Precinct E.5 - Red Gables Road, Box Hill

Prepared for
Catholic Education Diocese of Parramatta

Project 94526.00
March 2019

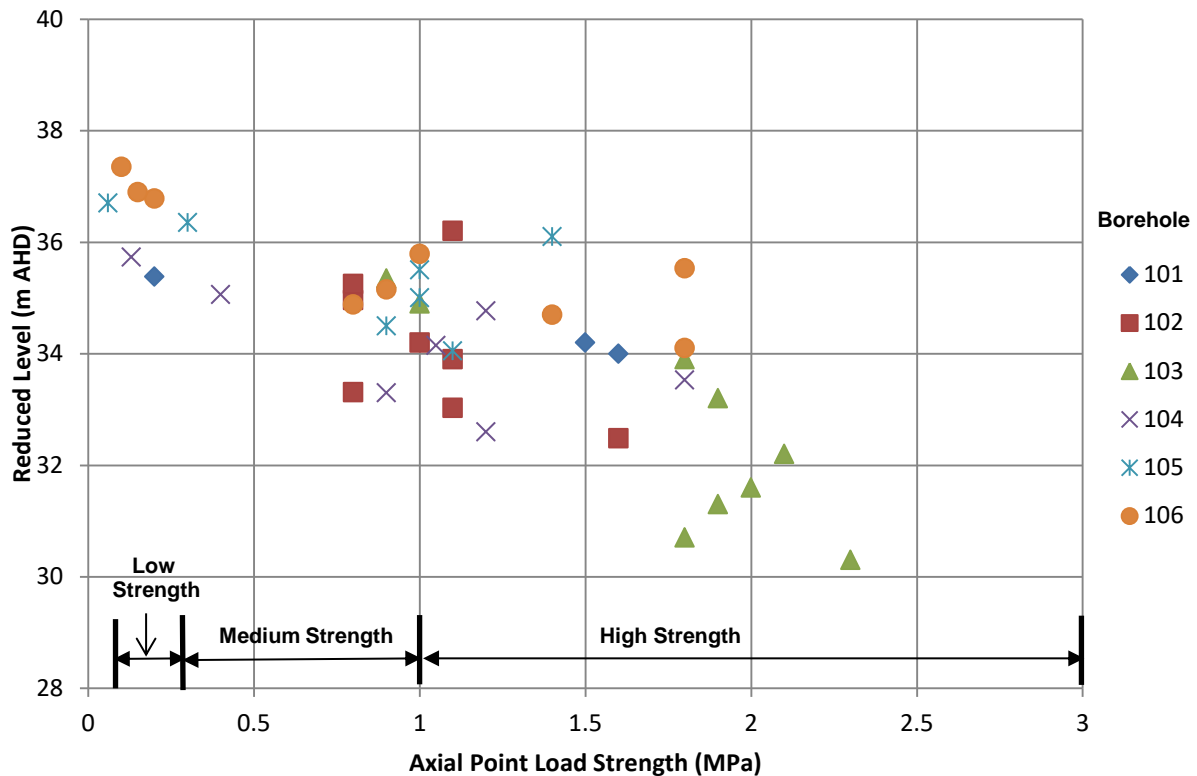
Figure 1: Results of Axial Point Load Tests

Point Load Strength Index (Is_{50}) testing was carried out on selected rock core specimens. The results of the tests are given on the borehole logs at the appropriate depths. Figure 1 below shows the range of Is_{50} results at the various depths (shown as Reduced Levels relative to AHD).

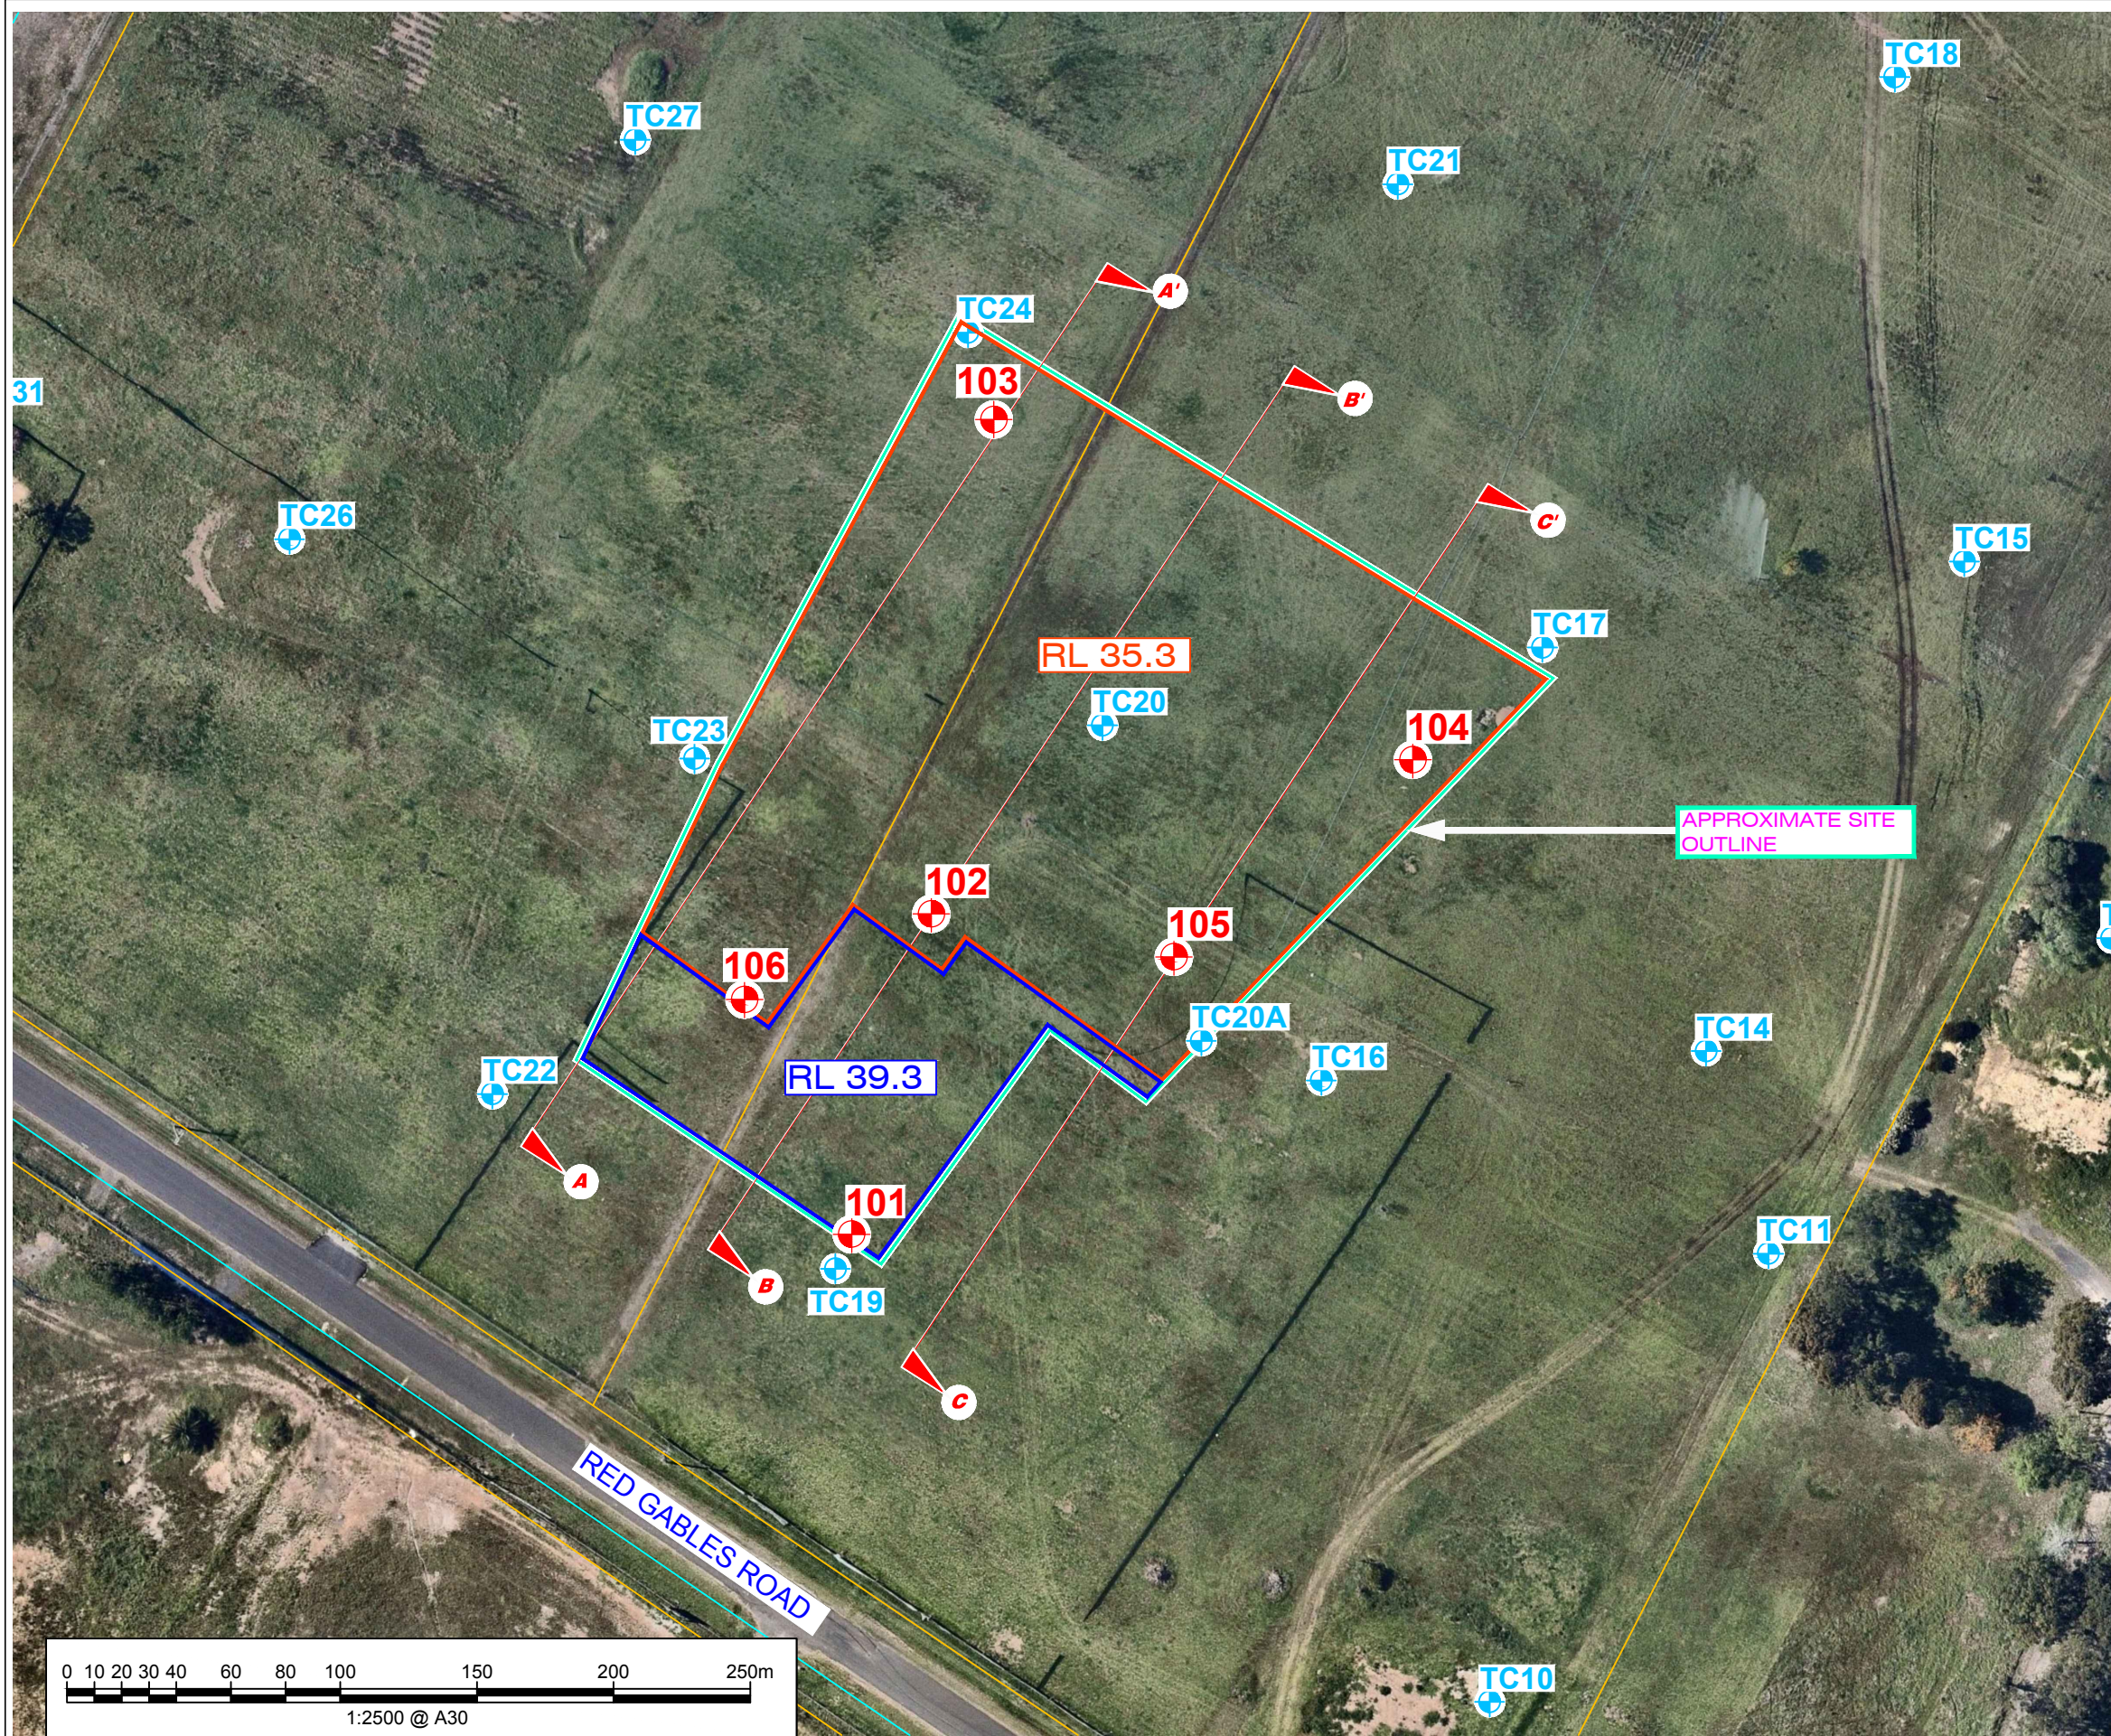
Locality Plan

NOTE:
1: Base image from Nearmap.com
(Dated 13.11.2018)
2: Test locations are approximate only and
are shown with reference to existing features.

- JK bore location
- DP bore location
- RL 35.3 Finished floor slab level
- Geotechnical Cross Section A-A'

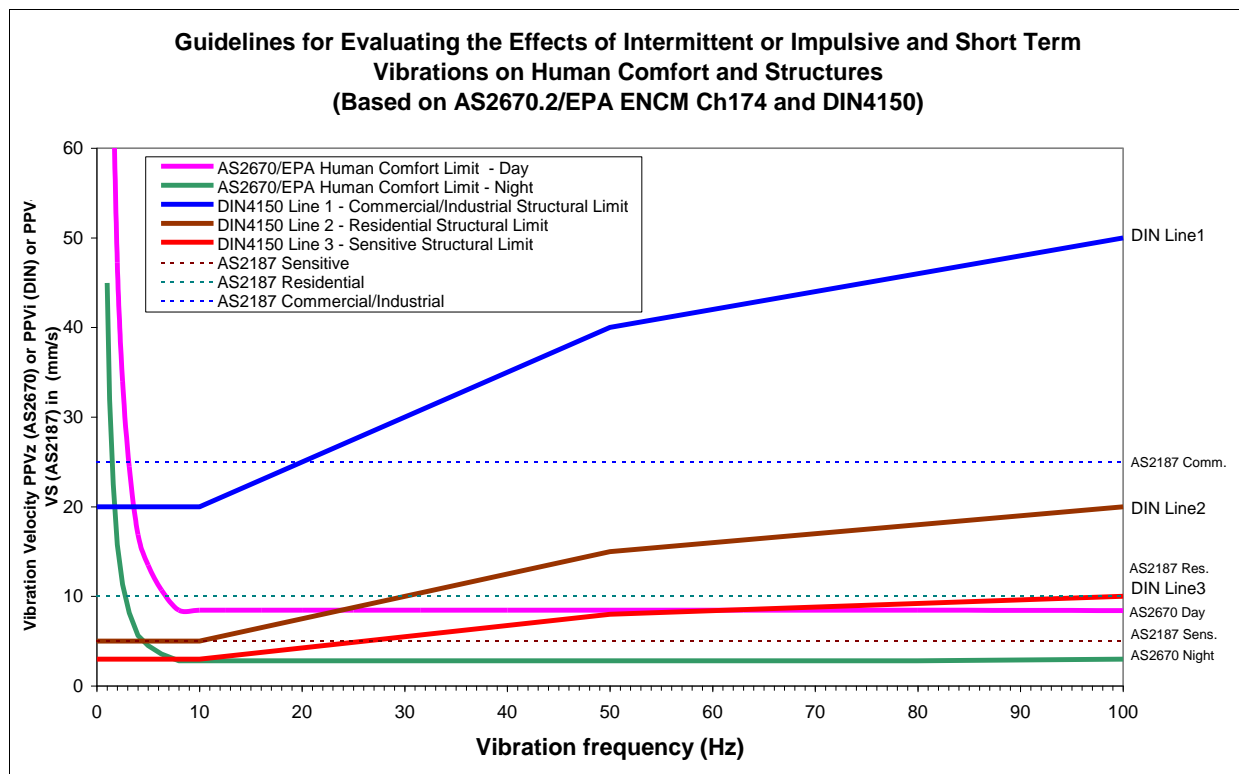
The German Standard DIN4150-3-1999 “Structural vibration – effects of vibrations on structures”, recommends that ground vibration at foundation level of residential buildings, in good condition bearing on sound rock foundations, be limited to 5 - 15 - 20 mm/s PPV_i (at vibration frequencies of 10-50-100 Hz typical of excavation plant), in order to reduce the potential for structural damage. Higher limits (20-40-50 mm/s PPV_i) and lower limits (3-8-10 mm/s PPV_i) are recommended for commercial/industrial and sensitive buildings respectively. From DP experience where buildings are bearing on loose sand, maximum vibration levels should be significantly reduced to the order of 5 to 7 mm/s VSPPV to reduce the risk of vibration-induced sand densification and settlement.

It has been found from experience that even with buildings bearing on rock, vibration levels as low as 10 mm/s VSPPV may cause minor defects such as cracks through rendering, cornices and skirtings. Management of vibration may require a lowering of structural damage criteria to this architectural damage criterion, or negotiations with owners of affected buildings.
