Report on Geotechnical Investigation

Newcastle Courthouse Redevelopment

81019007-002.0

20 December 2018

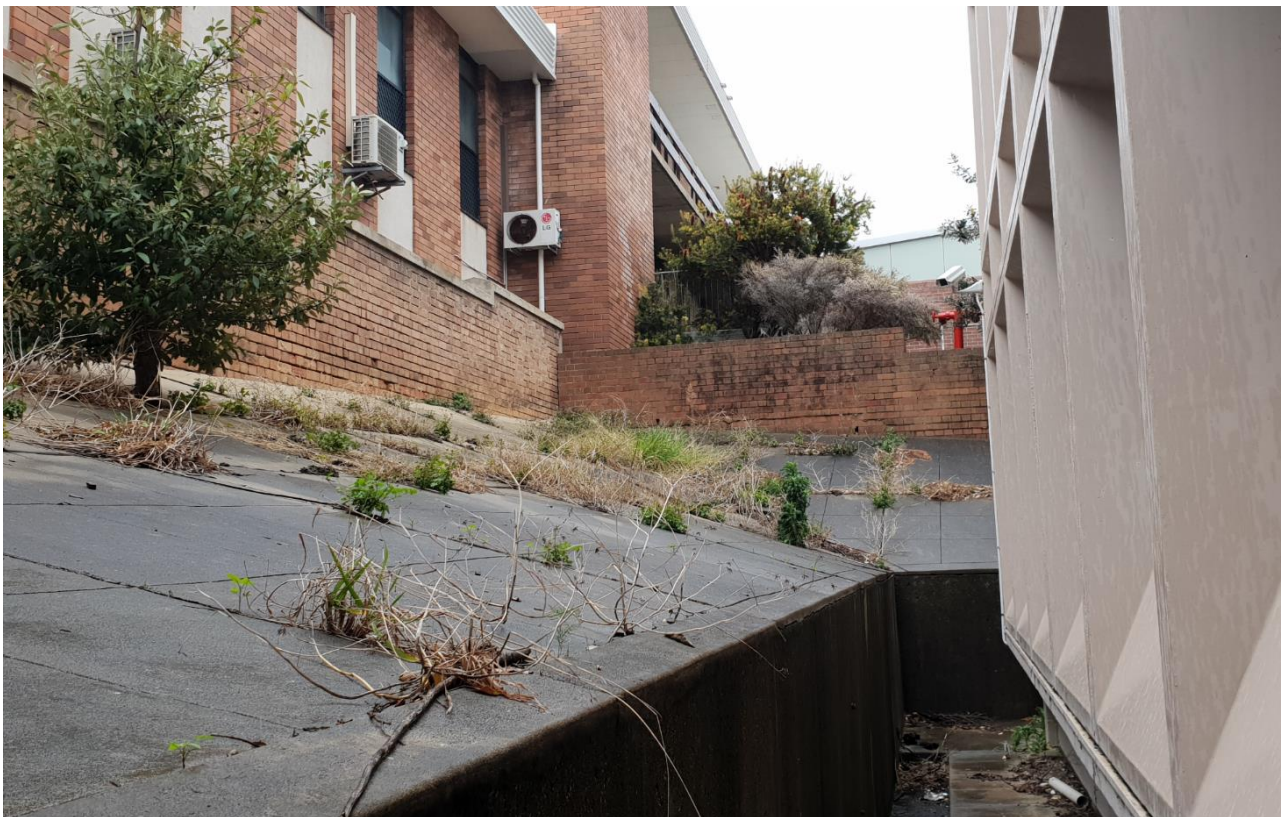
Figure 2-2 Existing retaining structure and brick retaining wall observed in the south west corner of the site

- > Structures were noted adjoining the brick retaining walls within the south western site corner (refer Figure 2-2 below) that appear to be earth fill supported by a vertical concrete wall at the toe, and the earth fill surface covered in thin concrete slabs. The vertical toe wall was approximately 1.5 m high, and the total (assumed) earth fill height approximately up to 4 m. The structures could be acting as a buttress for the existing heritage brick retaining wall.

As mentioned in Section 2, at the time of fieldwork a heritage brick retaining wall structure was noted along the southern and western boundaries of the site as well as a concrete structure in the south western corner.

- > Excavations and construction in close proximity to the existing retaining structure could potentially effect the integrity of the wall with potential for failure; and
- > It is likely that the existing concrete structure in the southwest portion of the site is acting as a buttress and providing support for the existing retaining wall. Removal of the concrete structure could lead to structural failure.

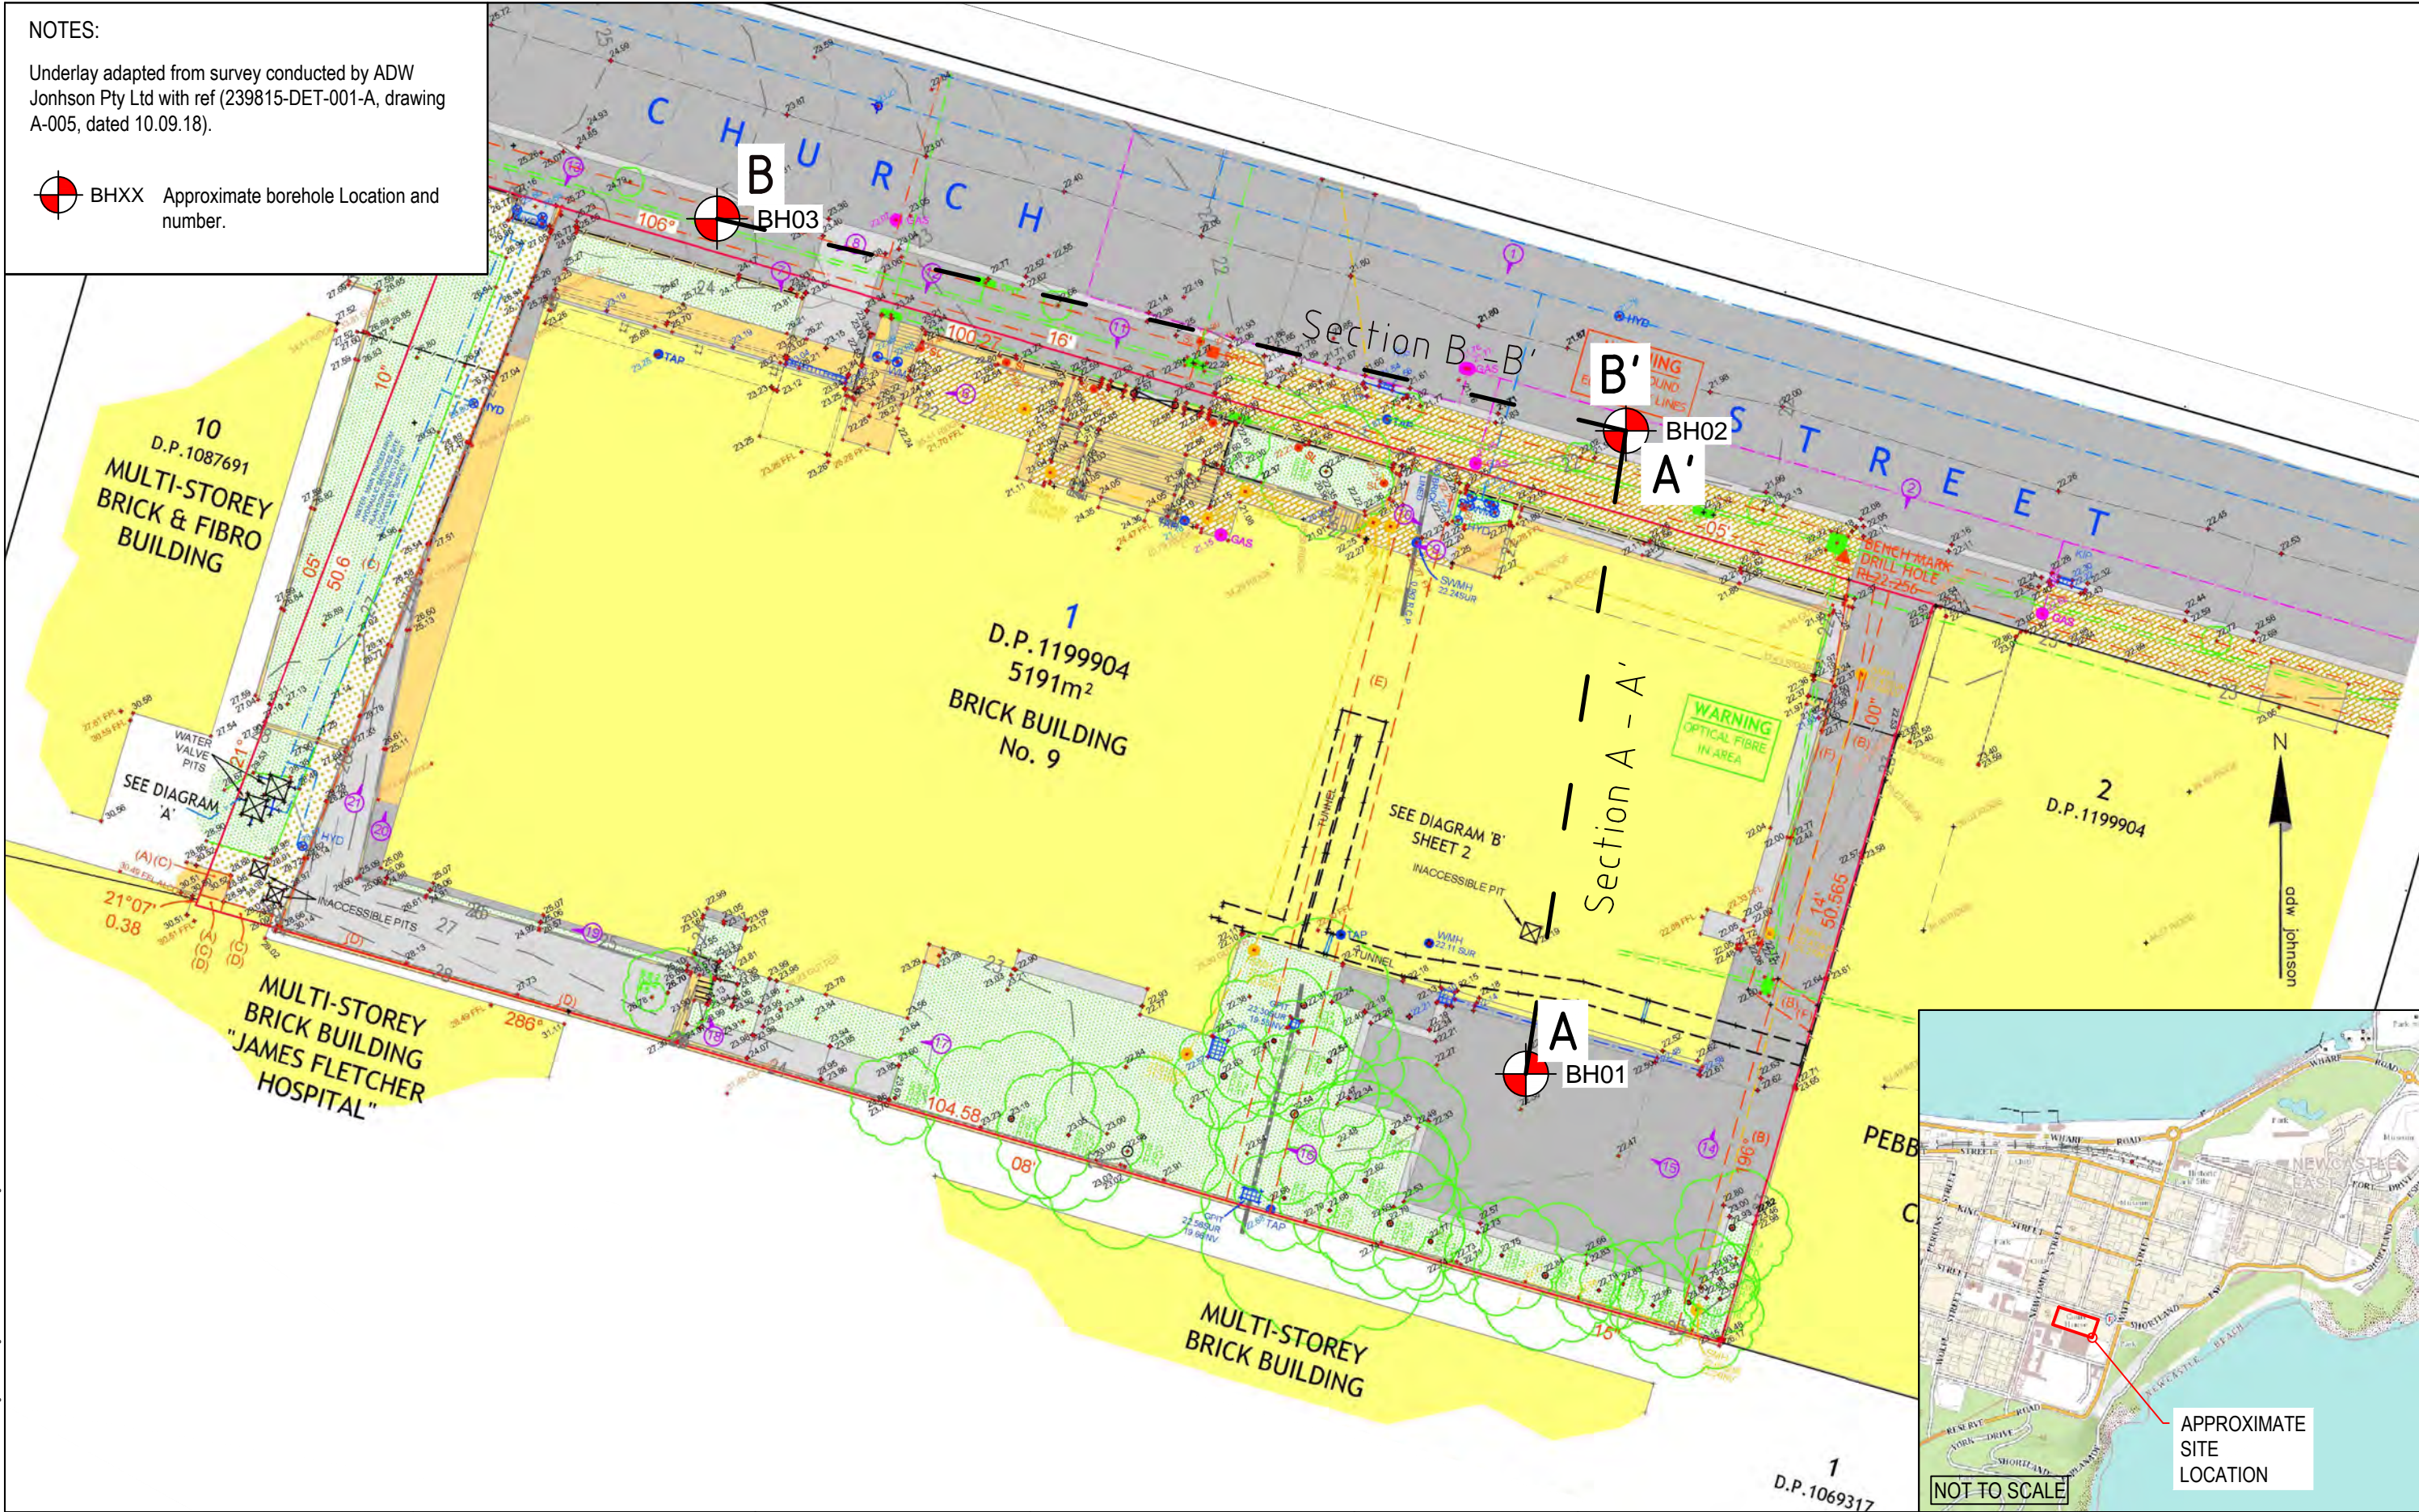
BHXX Approximate borehole Location and
number.

All fieldwork including logging of subsurface profiles and collection of samples was carried out by a geotechnical engineer from Cardno. Borehole locations are shown on Figure 1 to Figure 3 attached in Appendix A. Subsurface conditions are summarised in Section 5.2 below and detailed in the engineering logs in Appendix B together with explanatory notes and photos of recovered core samples.

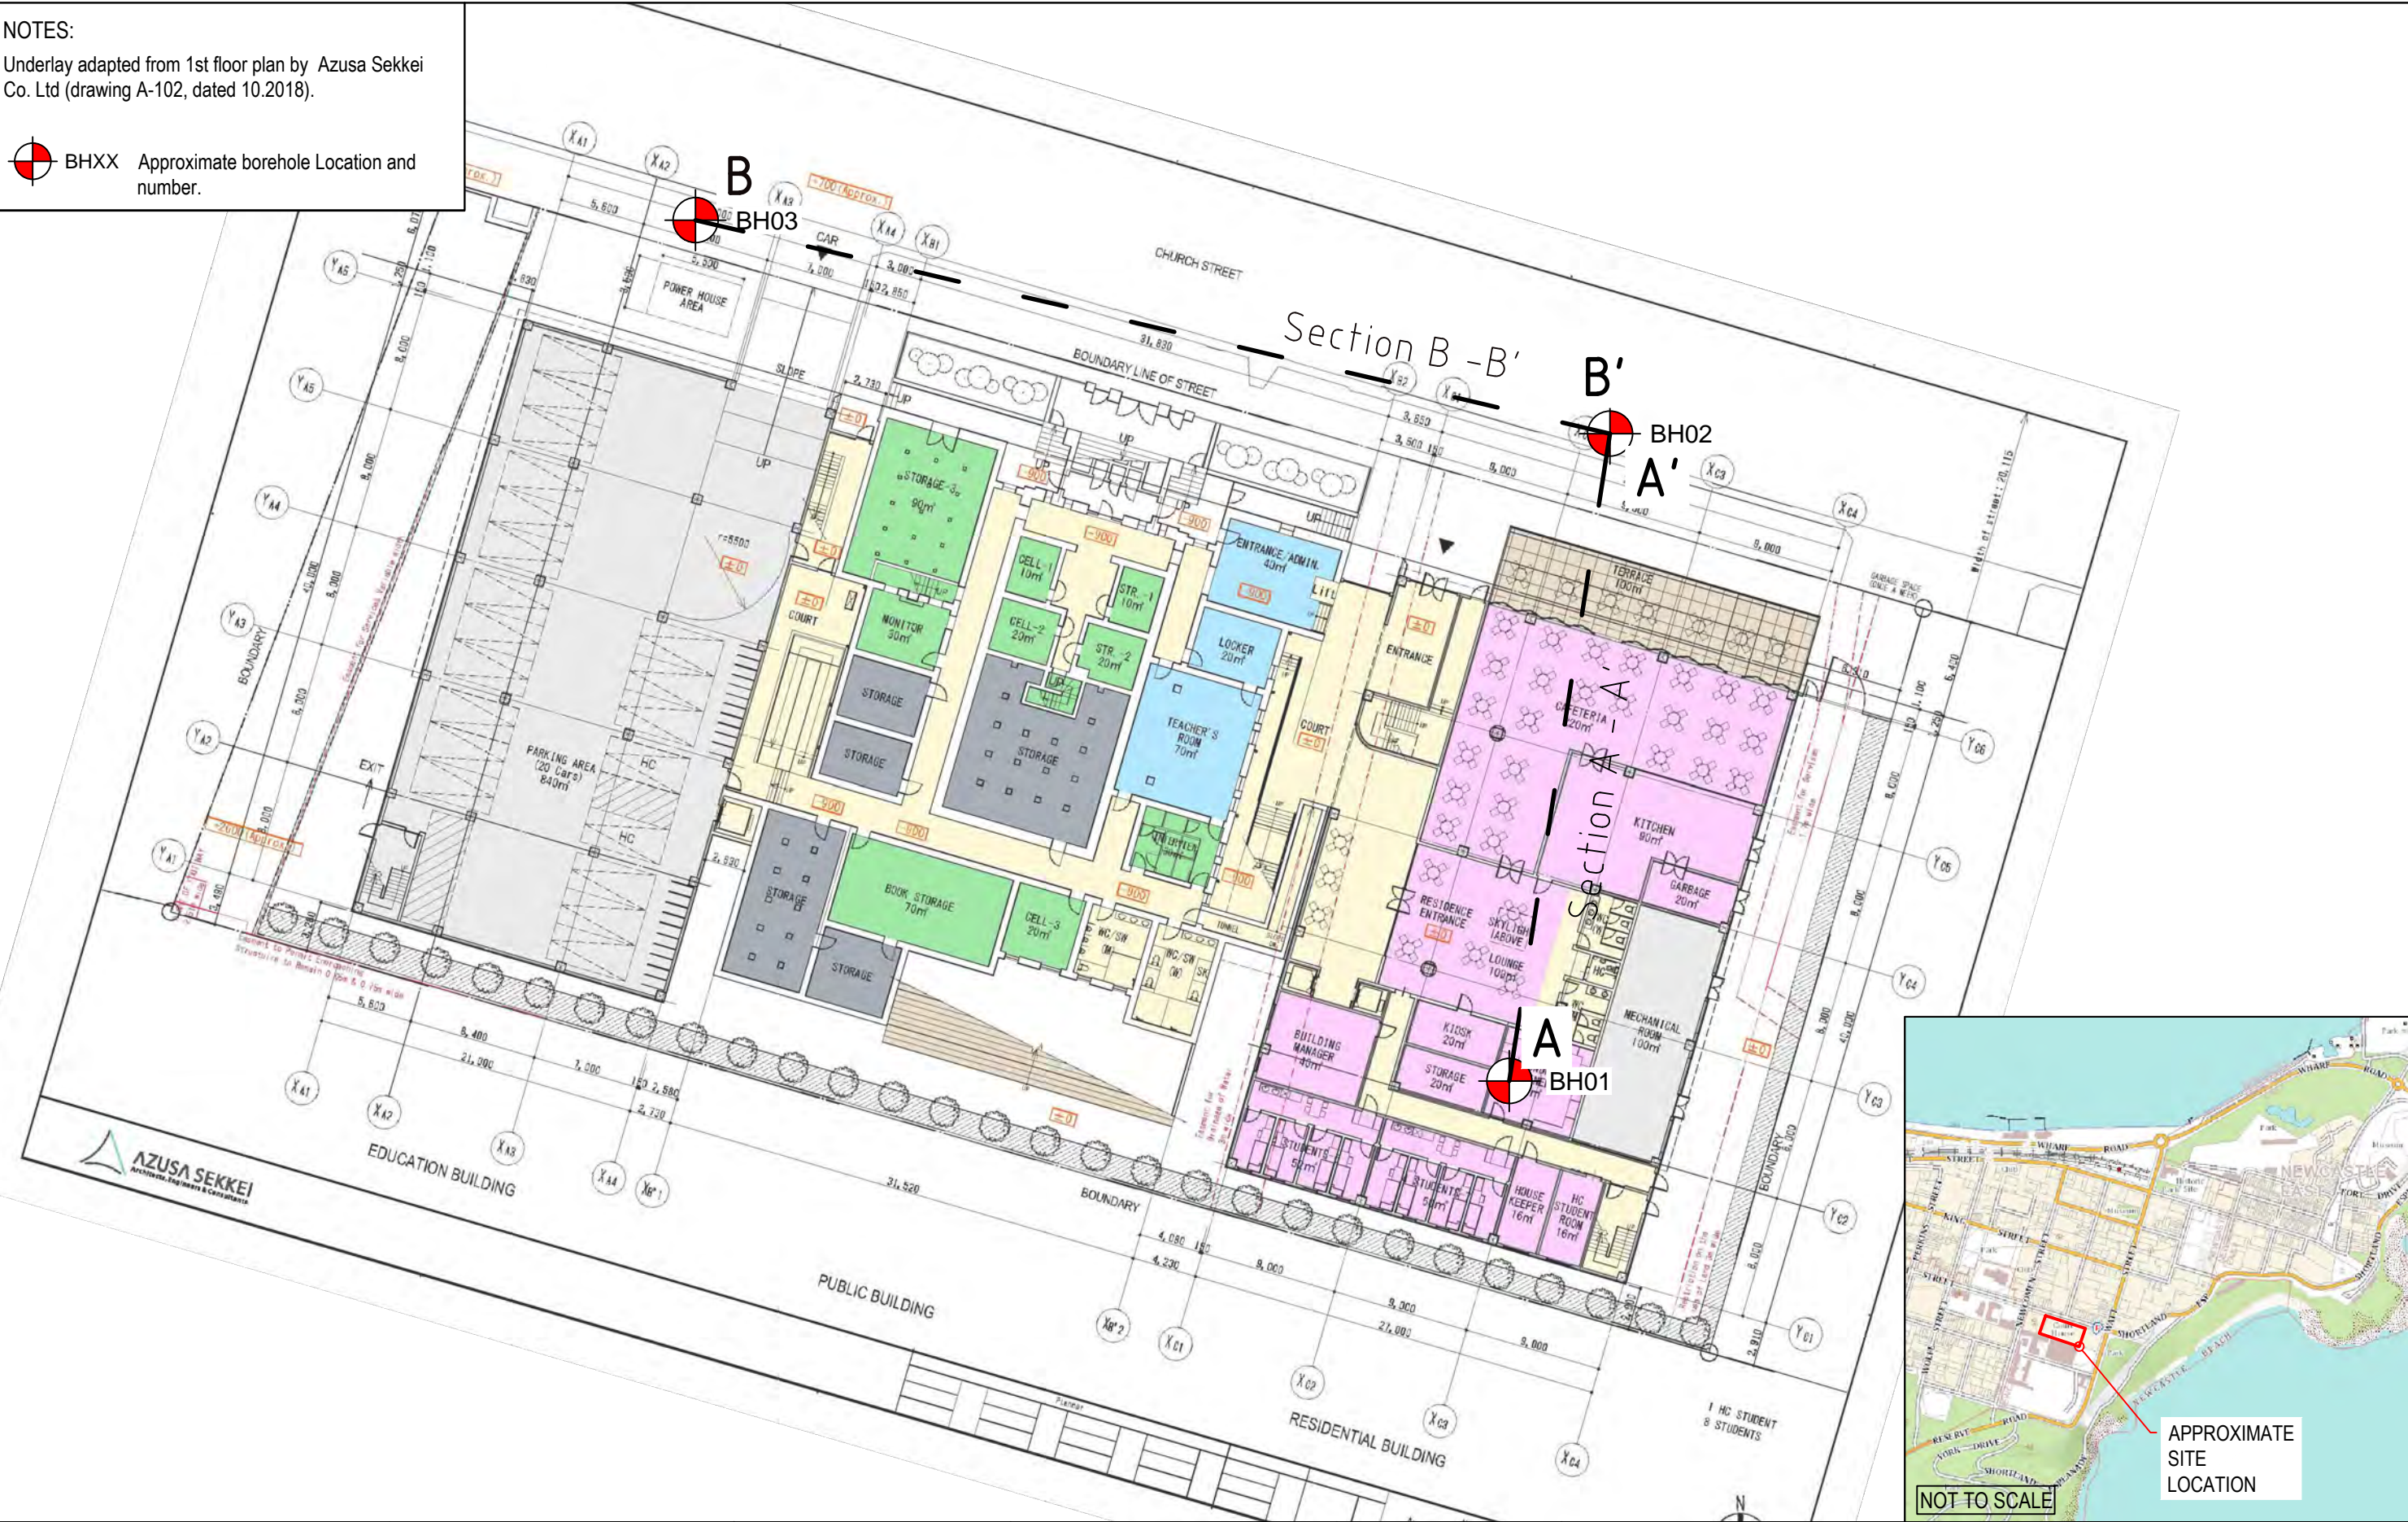
NOTES:
Underlay adapted from 1st floor plan by Azusa Sekkei Co. Ltd (drawing A-102, dated 10.2018).

BHXX Approximate borehole Location and number.

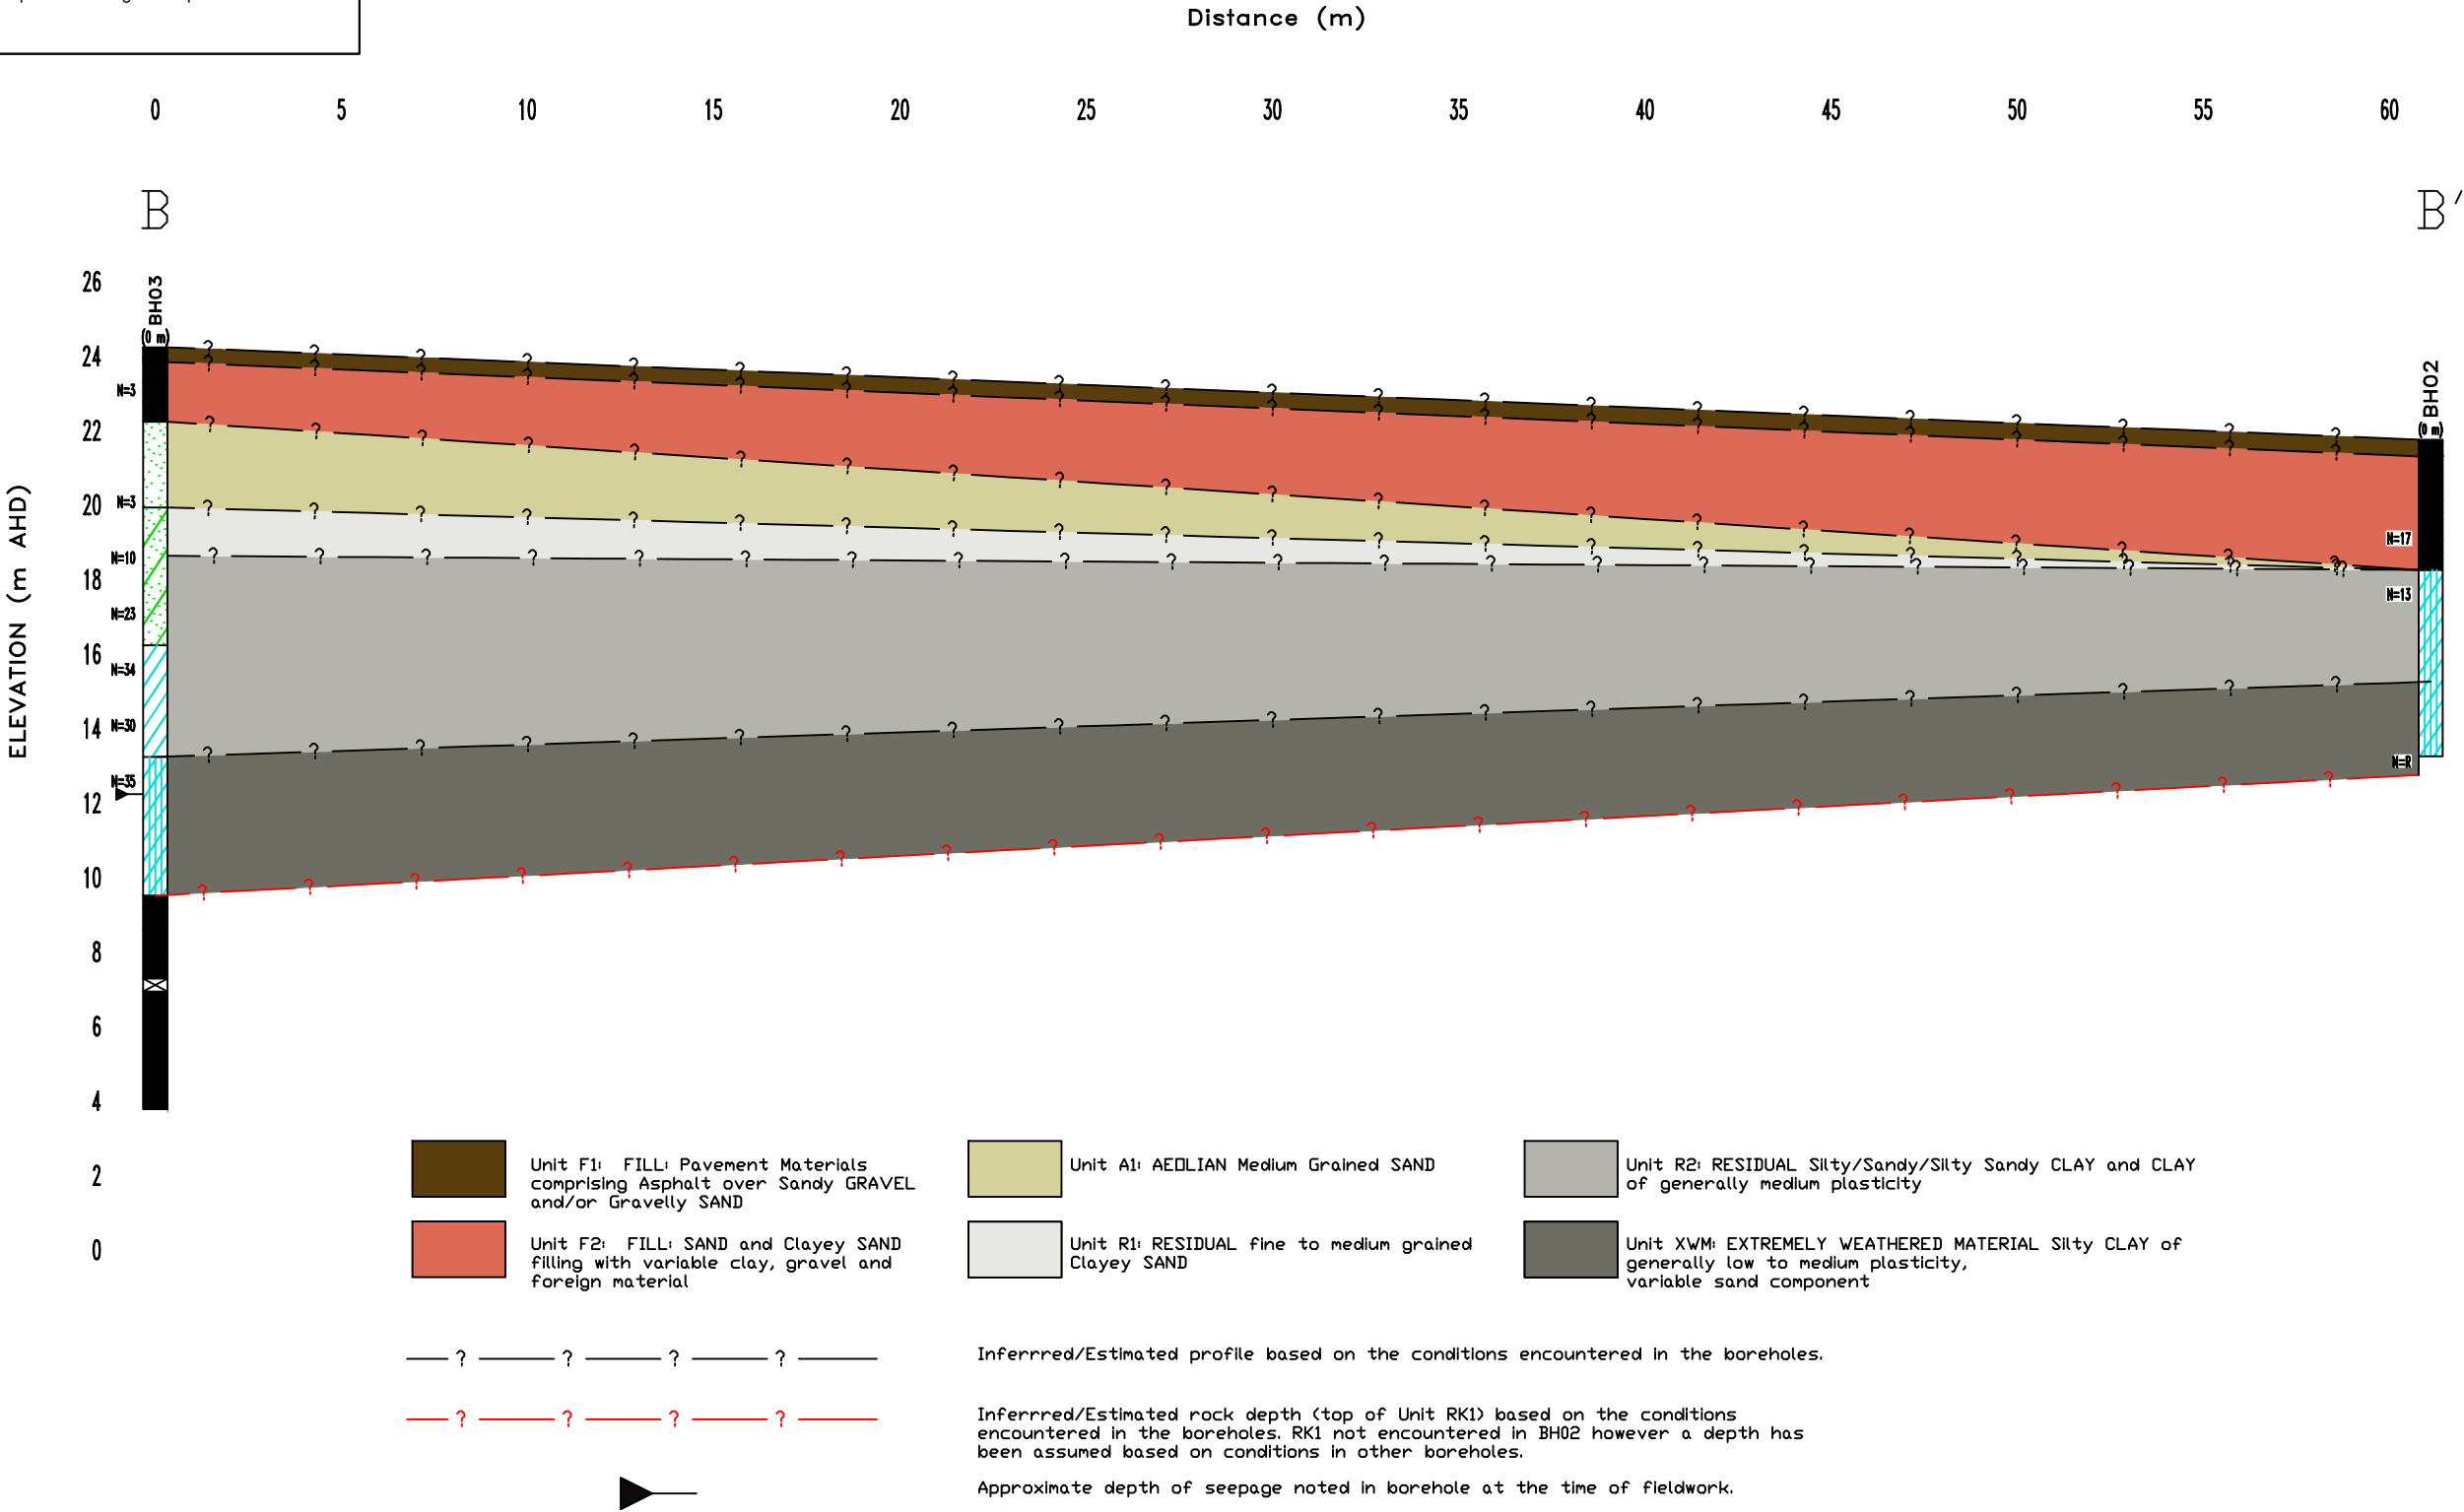
The ground surface between boreholes has been assumed linear in the absence of any dwg survey file.

The conditions between borehole locations are unknown and have been inferred/assumed. Rock depth may vary between borehole locations, and conditions below the investigated depth are unknown. Further geotechnical investigation following demolition of existing structures is recommended to confirm conditions within the proposed building envelope.

The geological profile across the site has also been interpreted and estimated in the form of cross-sections between boreholes in an attempt to graphically depict the subsurface conditions. It is worth noting that there is significant uncertainty of conditions between boreholes due to the presence of existing structures and limited site access. The geological profile based on the conditions encountered in the boreholes, suggest rock depths may dip to the northwest in the order of 2-4°. The sections Figure 4 and Figure 5 are contained within Appendix A.
