# Soil Survey

MAXWELL SOLAR FARM

Maxwell Solar Farm

Project Number: 19-069

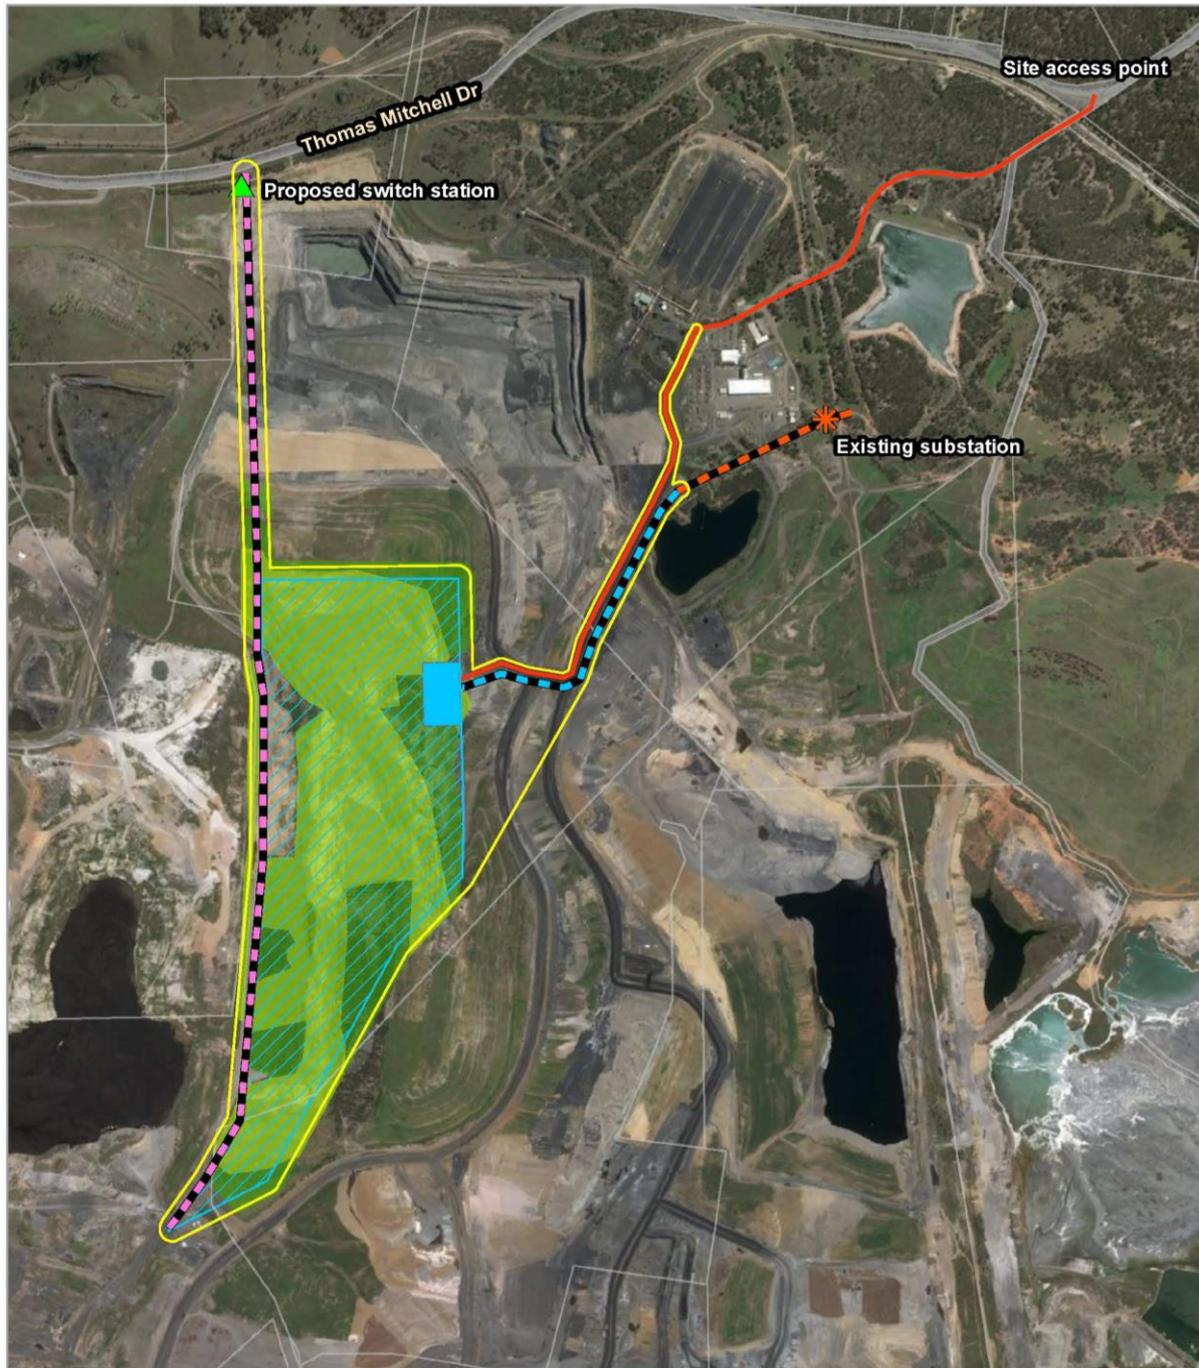
Figure 1-1 Maxwell Solar Farm proposed design and constraints

The Maxwell Solar project, as presented in Figure 1-1, includes a project boundary of about 145 hectares including a solar array/pad of about 105 hectares (ha) and about 1.2 kilometres (km) of above ground linear infrastructure. The linear infrastructure includes above ground transmission line easements to connect to

the existing Maxwell Infrastructure (nee Drayton Mine) substation (33 kilovolt (kV) option) or proposed switchyard (66kV option).

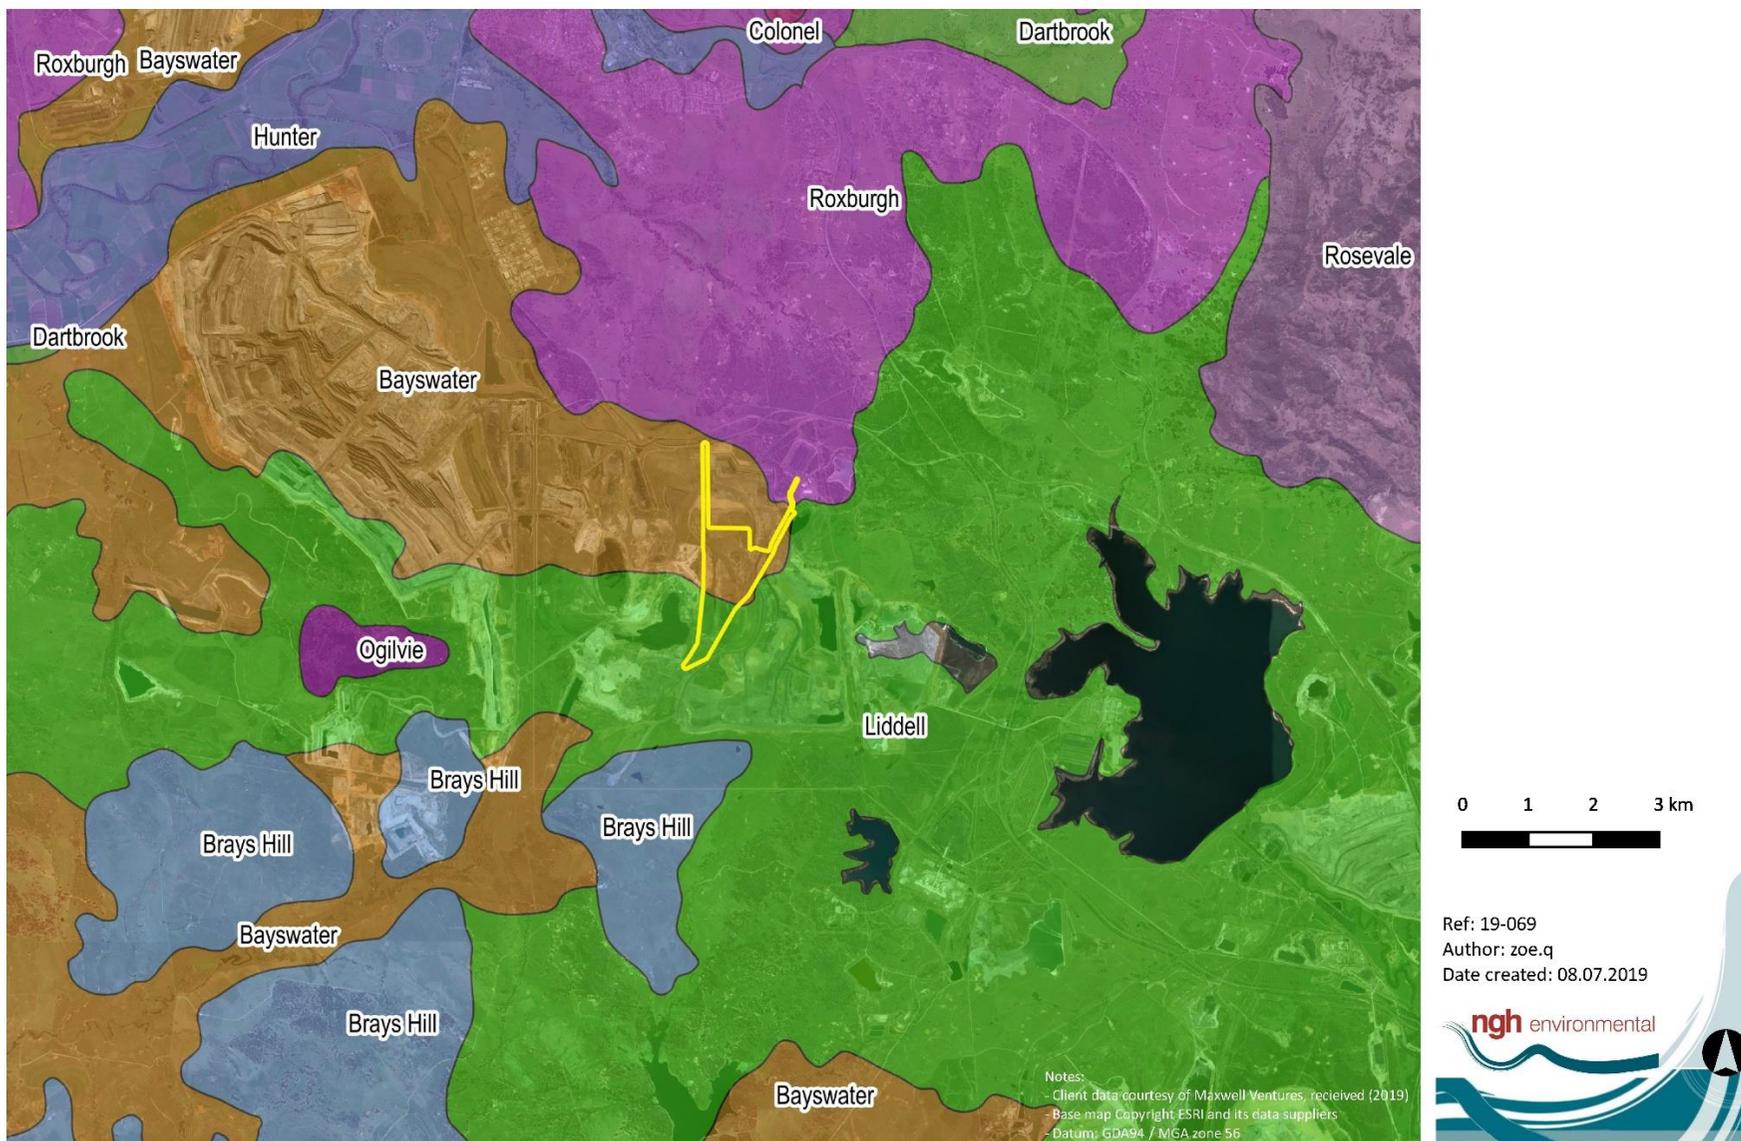
Figure 2-1 Pre-mining soil landscapes (The Proposal site is shown in yellow) (Source: OEH, 2017 and eSpade, 2019)

The pre-mining regional soil landscapes are presented on Figure 2-1. The soil landscape maps are managed by the The Department of Planning, Industry and Environment (formally OEH) and describe the properties of soils and the landscapes in which they occur. Descriptions of these soil landscapes are attached as Appendix A and key points are summarised in Table 2-1 below.

Overburden used at the Proposal site is likely to have been sourced from the Bayswater and / or Liddell soil landscapes (refer to Figure 2-1). The overburden may also include a small proportion of the Roxburgh soil landscape.

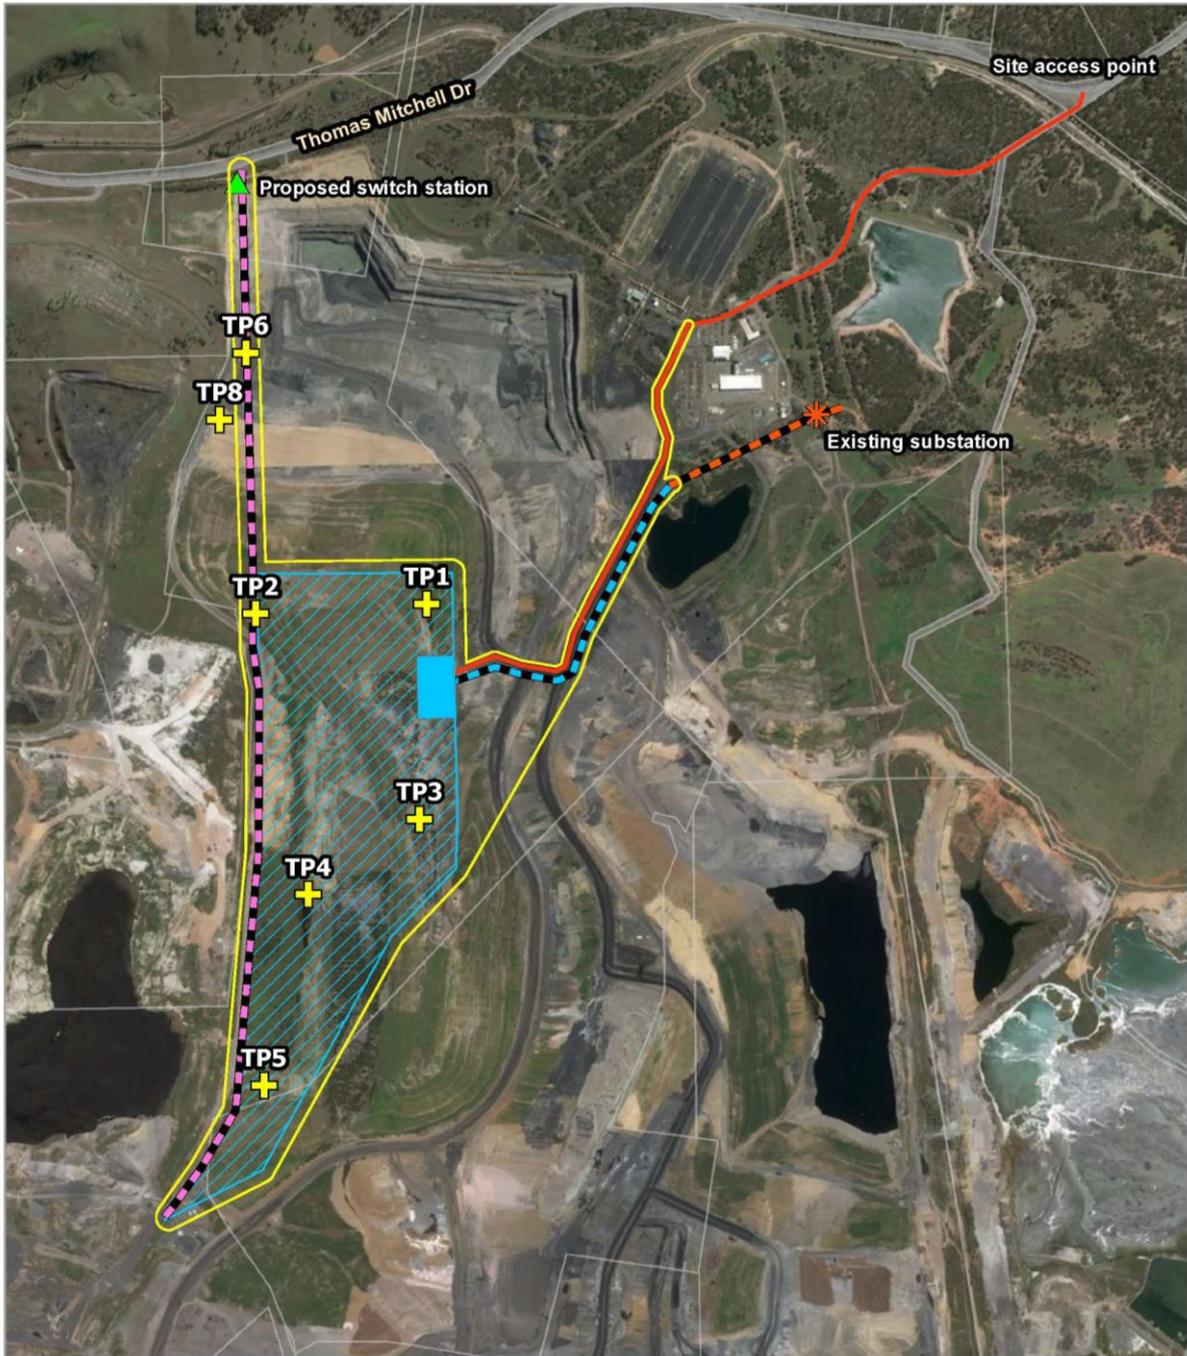
Figure 2-2 Test pit locations

The soil investigation included a test pitting program utilising an excavator supplied by Maxwell Solar Pty Ltd. The program included eight test pits (TP1 to TP8) Figure 2-2 (TP7 was not undertaken as it was located on an active internal road and the proposed work in this area would be the overhead transmission lines and so unlikely to disturb soils).

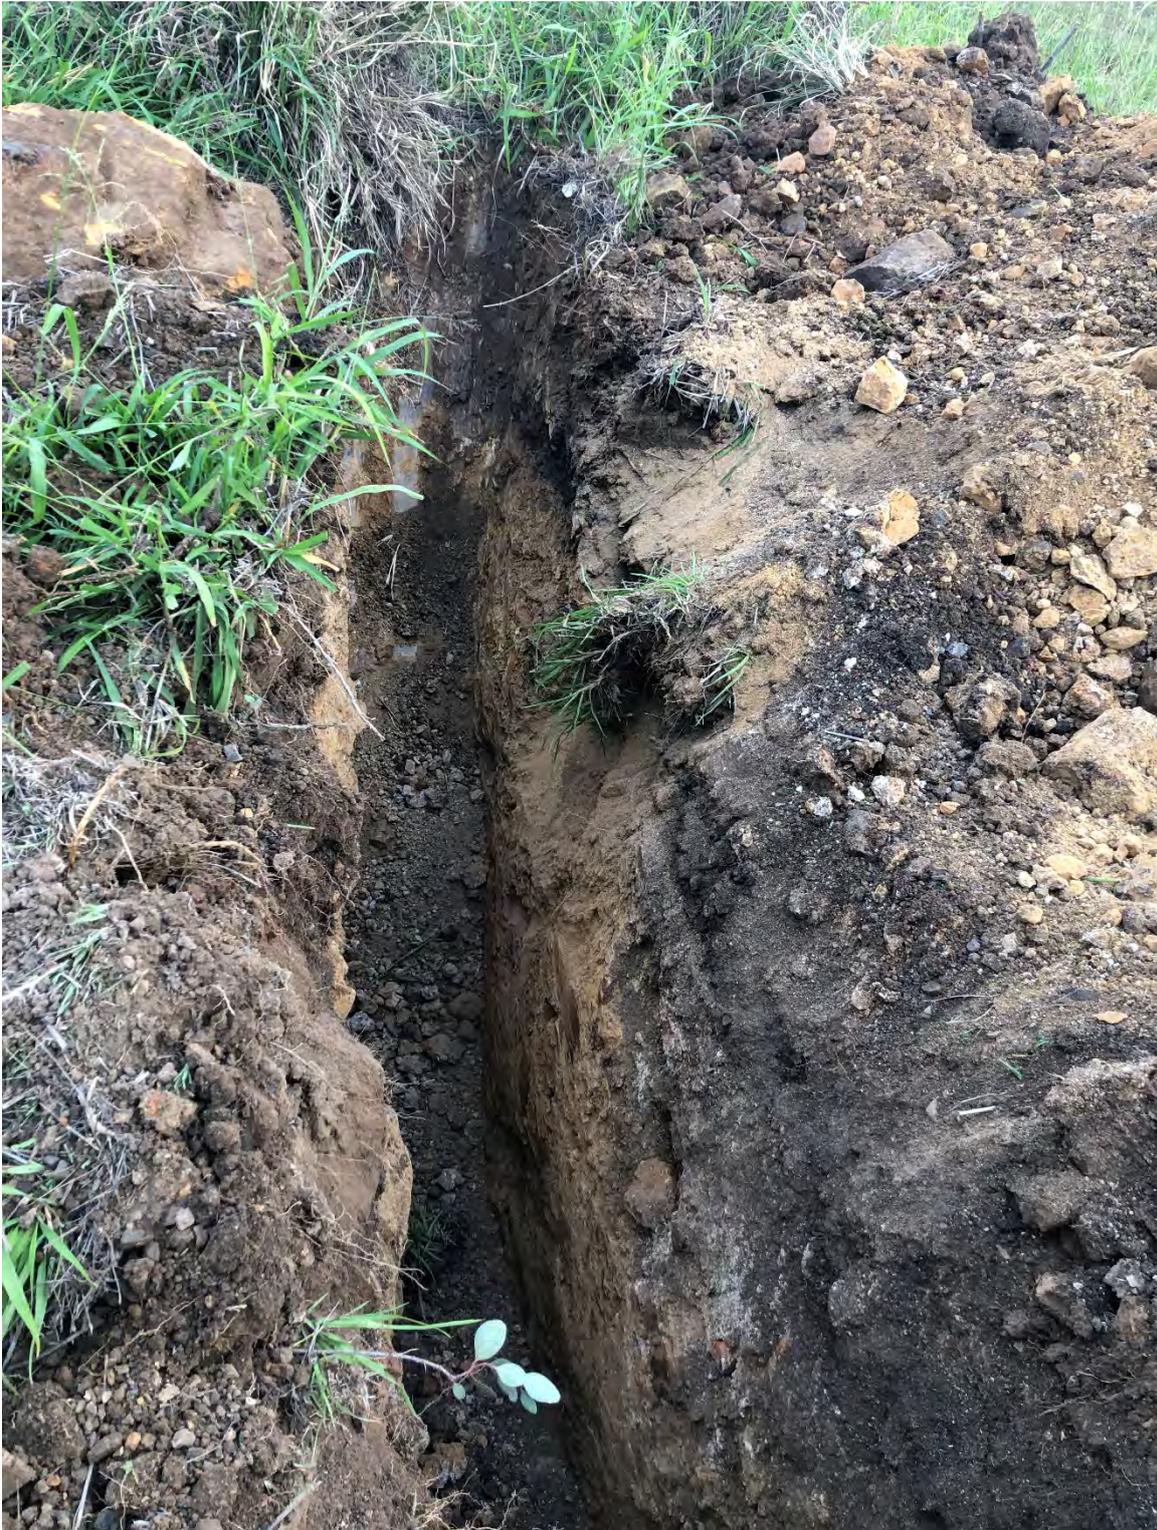
TP1

Test pit	Depth (m)	Material
1	0.3 – 1.5	FILL, Silty CLAY, medium to high plasticity, brown with mottled grey, with sand, gravel and boulders
2	0.2 – 1.4	FILL, Silty CLAY, low to medium plasticity, brown with mottled grey, yellow and red, with fine to medium grained sand, some boulders and cobbles
3	0.0 – 0.5	FILL, Gravelly Sandy CLAY, medium plasticity, brown, with roots to 0.2 m

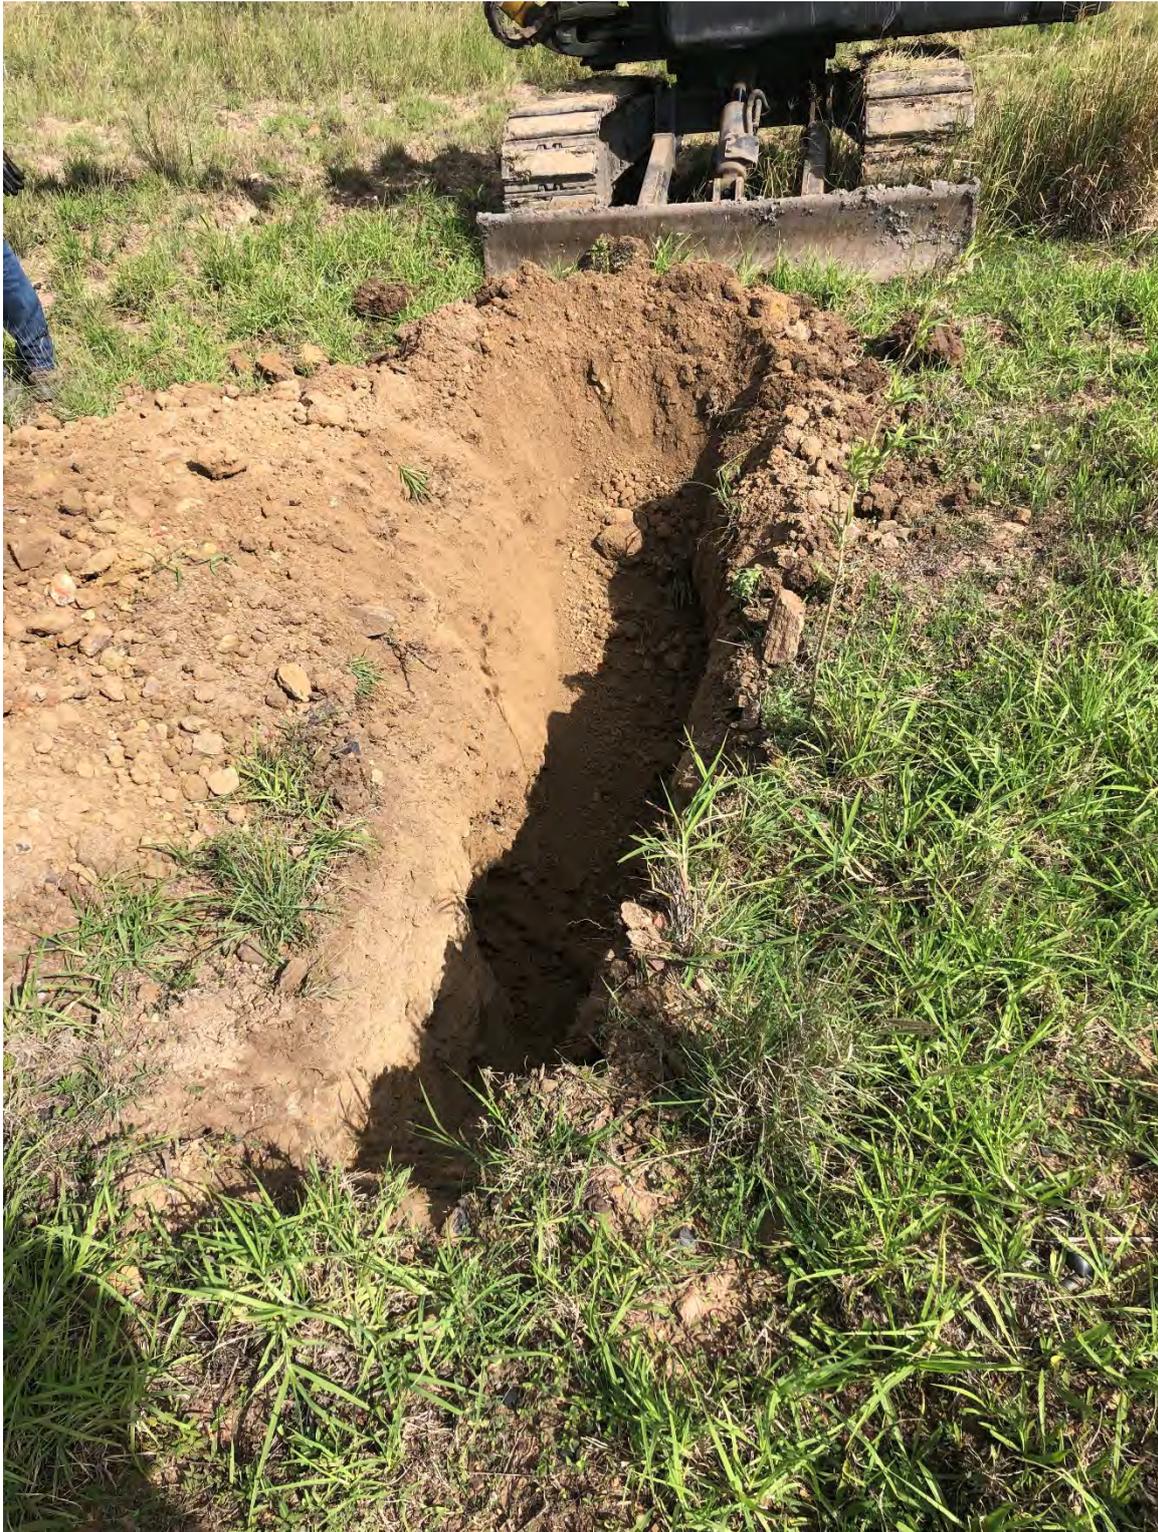
TP2

Depth (m)	Samples	Graphic Log	Material Description	Additional Observations
0.5	DS 0.0 - 0.2		TOPSOIL, Silty SAND, fine to medium grained, dark brown, with roots	TOPSOIL with cobbles and boulders observed at the surface
	DS 0.3-0.4		FILL, Silty CLAY, low to medium plasticity, brown with mottled grey, yellow and red, with fine to medium grained sand, some boulders and cobbles	
1.5			Discontinued at 1.4 m

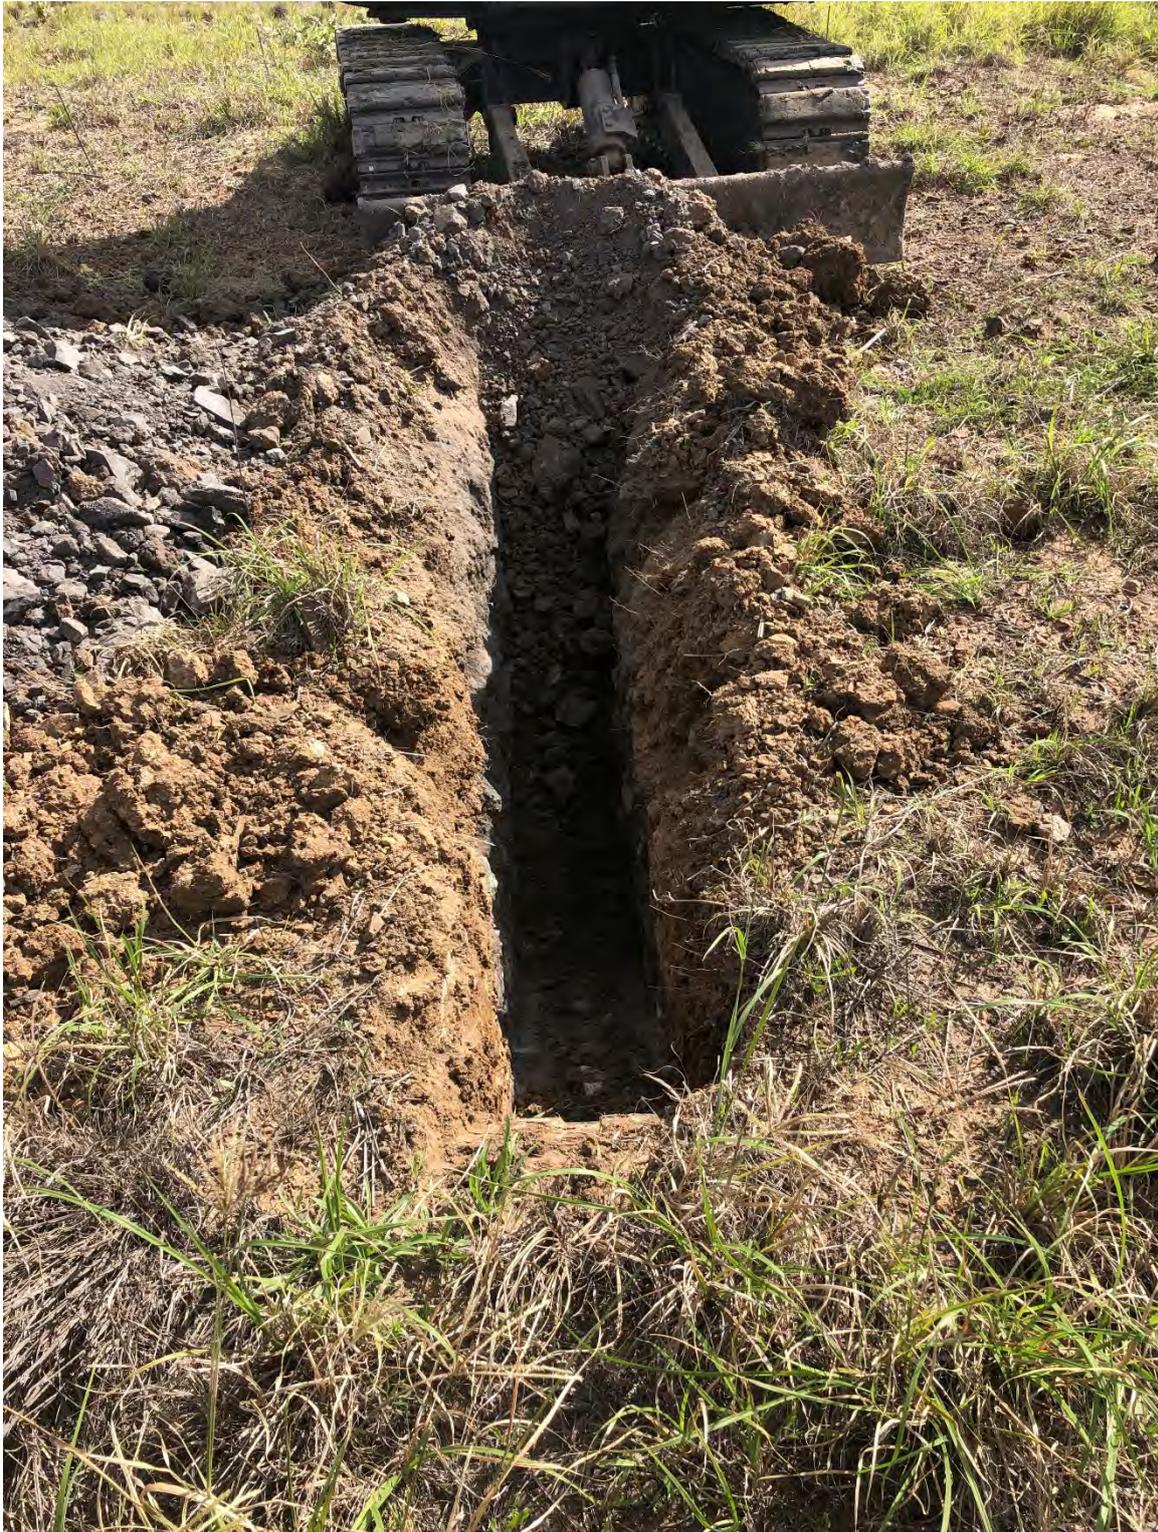
TP3

Test pits TP1, TP2, TP4 and TP8 had topsoil ranging from 50 millimetre (mm) to 300mm depth. The topsoil was underlain by fill consisting of clay (with silt or sand) or gravel (with sand and/or silt) to the maximum depth of the test pit investigation. Topsoil was described as well graded silty sand. Little topsoil was observed in three test pits (TP3, TP5 and TP6).

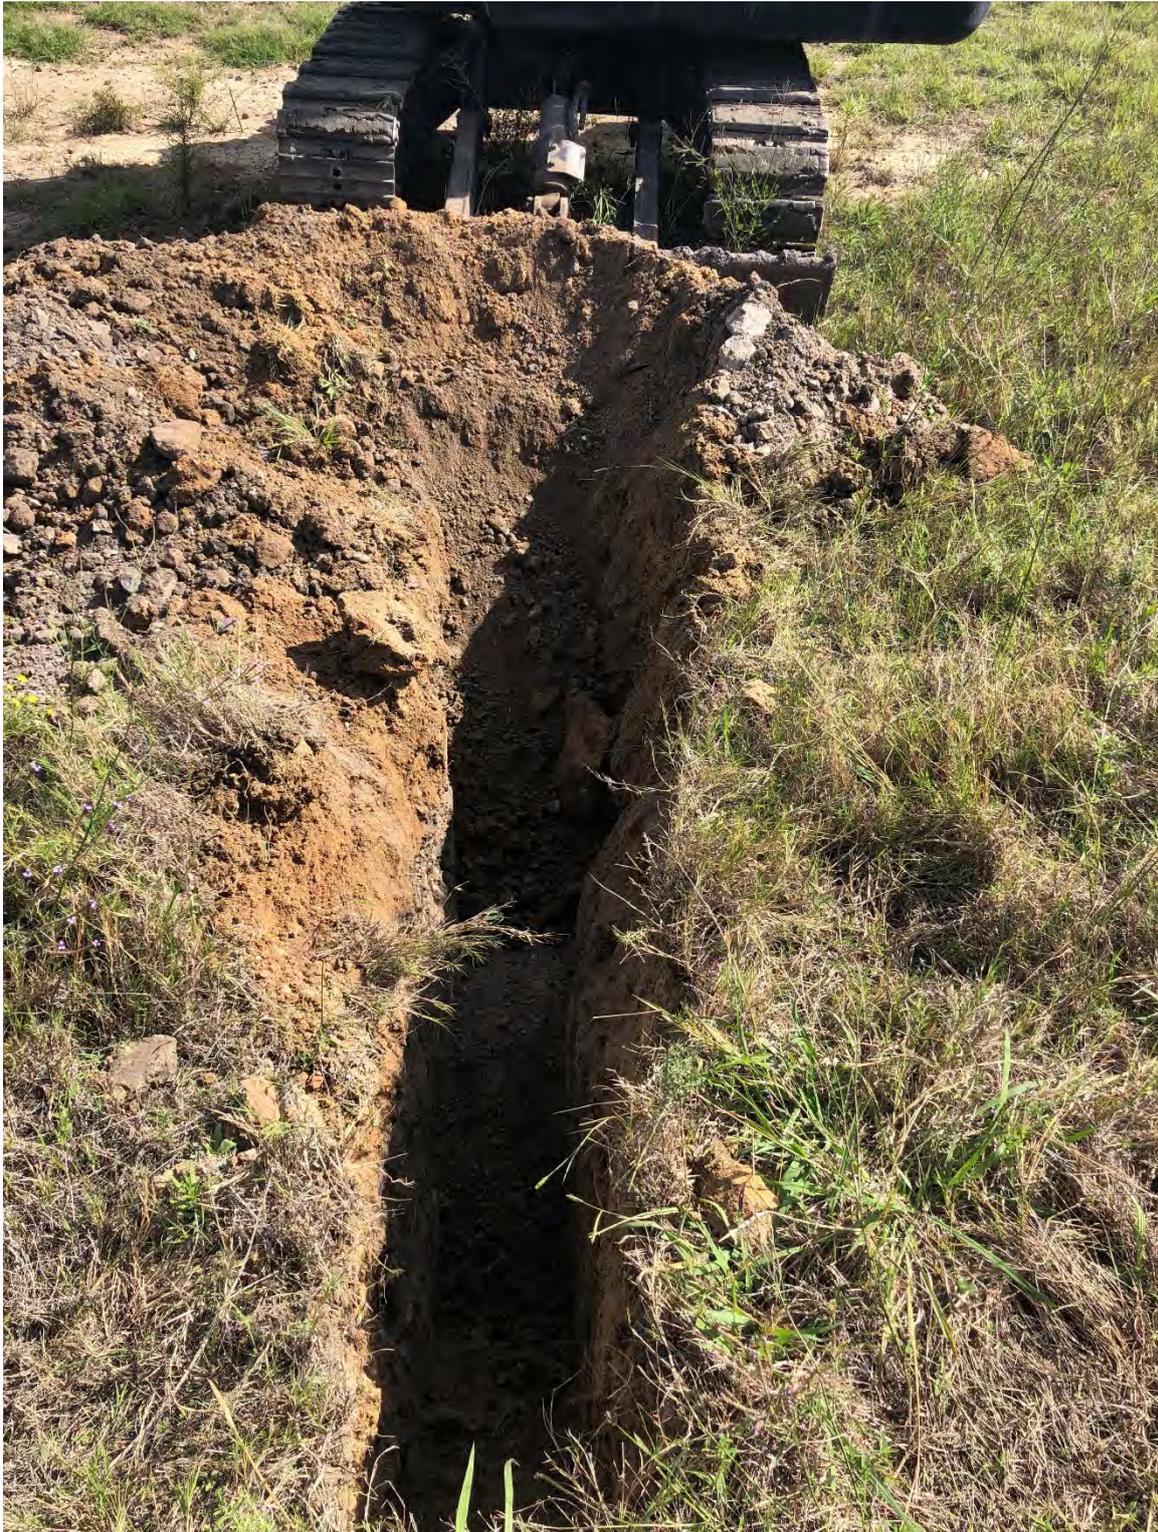
TP4

0.5 – 1.4	FILL, Sandy GRAVEL, coarse grained, grey, fine to coarse sand
4	0.05 – 0.5	FILL, Sandy CLAY, low to medium plasticity, brown with mottled grey, dark grey and yellow

0.5 – 1.4	FILL, Sandy CLAY, low plasticity, dark grey and grey, some coal and boulders
5	0.0 – 1.3	FILL, Silty Sandy GRAVEL, coarse grained gravel, fine to medium grained sand, light brown and brown, with cobbles
6	0.0 – 1.25	FILL, Silty Sandy GRAVEL, fine to coarse gravel, fine to coarse sand, dark grey, with coal fragments, cobbles and boulders
8	0.3 – 1.3	FILL, Silty CLAY, low to medium plasticity, mottled grey, brown and red
