Reflectivity Analysis

Western Sydney University - Bankstown

Doc. No: 7830-RPT-ES0001 Date: 2019-07-12 Revision: 01

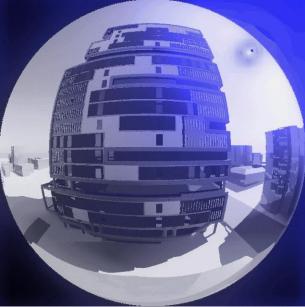
Figure 4: Example of fisheye image (left) and output from Evalglare (right)

An example fisheye image and Evalglare output is included in Figure 4 below. No direct solar glare is identified in this environment however reflected glare due to the building façade is present, represented as a blue dot in the Evalglare image.

The glare result above was analysed on the 21st of July at 3pm. The viewpoint has been arbitrarily located on the façade of the council building to the east of the proposed development, facing west. The DGI for this time and location is 39.26, translating to an intolerable level of glare. However, the intolerable glare is due to the sun and not reflected off the building façade.

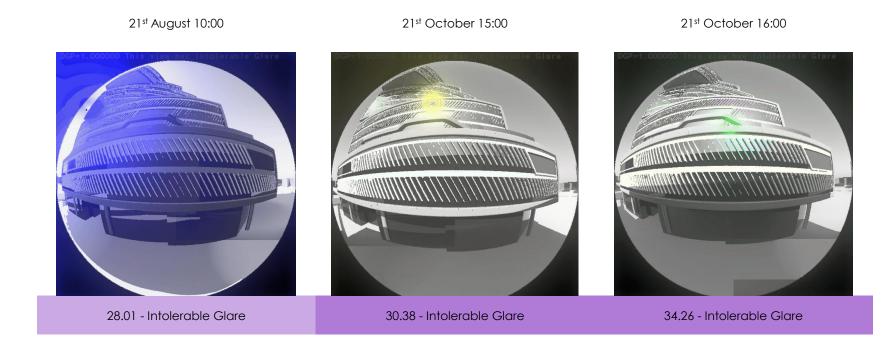
Location 4 is at an arbitrary point on the façade of the Bankstown Library and Knowledge Centre, west of the proposed development. At this location, there is intolerable glare caused by the proposed buildings west façade in the mid to late afternoon, in March, October and November.
