**REPORT TO
NSW HEALTH INFRASTRUCTURE**

**ON
REMEDIATION ACTION PLAN**

**FOR
PROPOSED GRIFFITH HOSPITAL REDEVELOPMENT**

**AT
GRIFFITH BASE HOSPITAL, NOOREBAR AVENUE,
GRIFFITH, NSW**

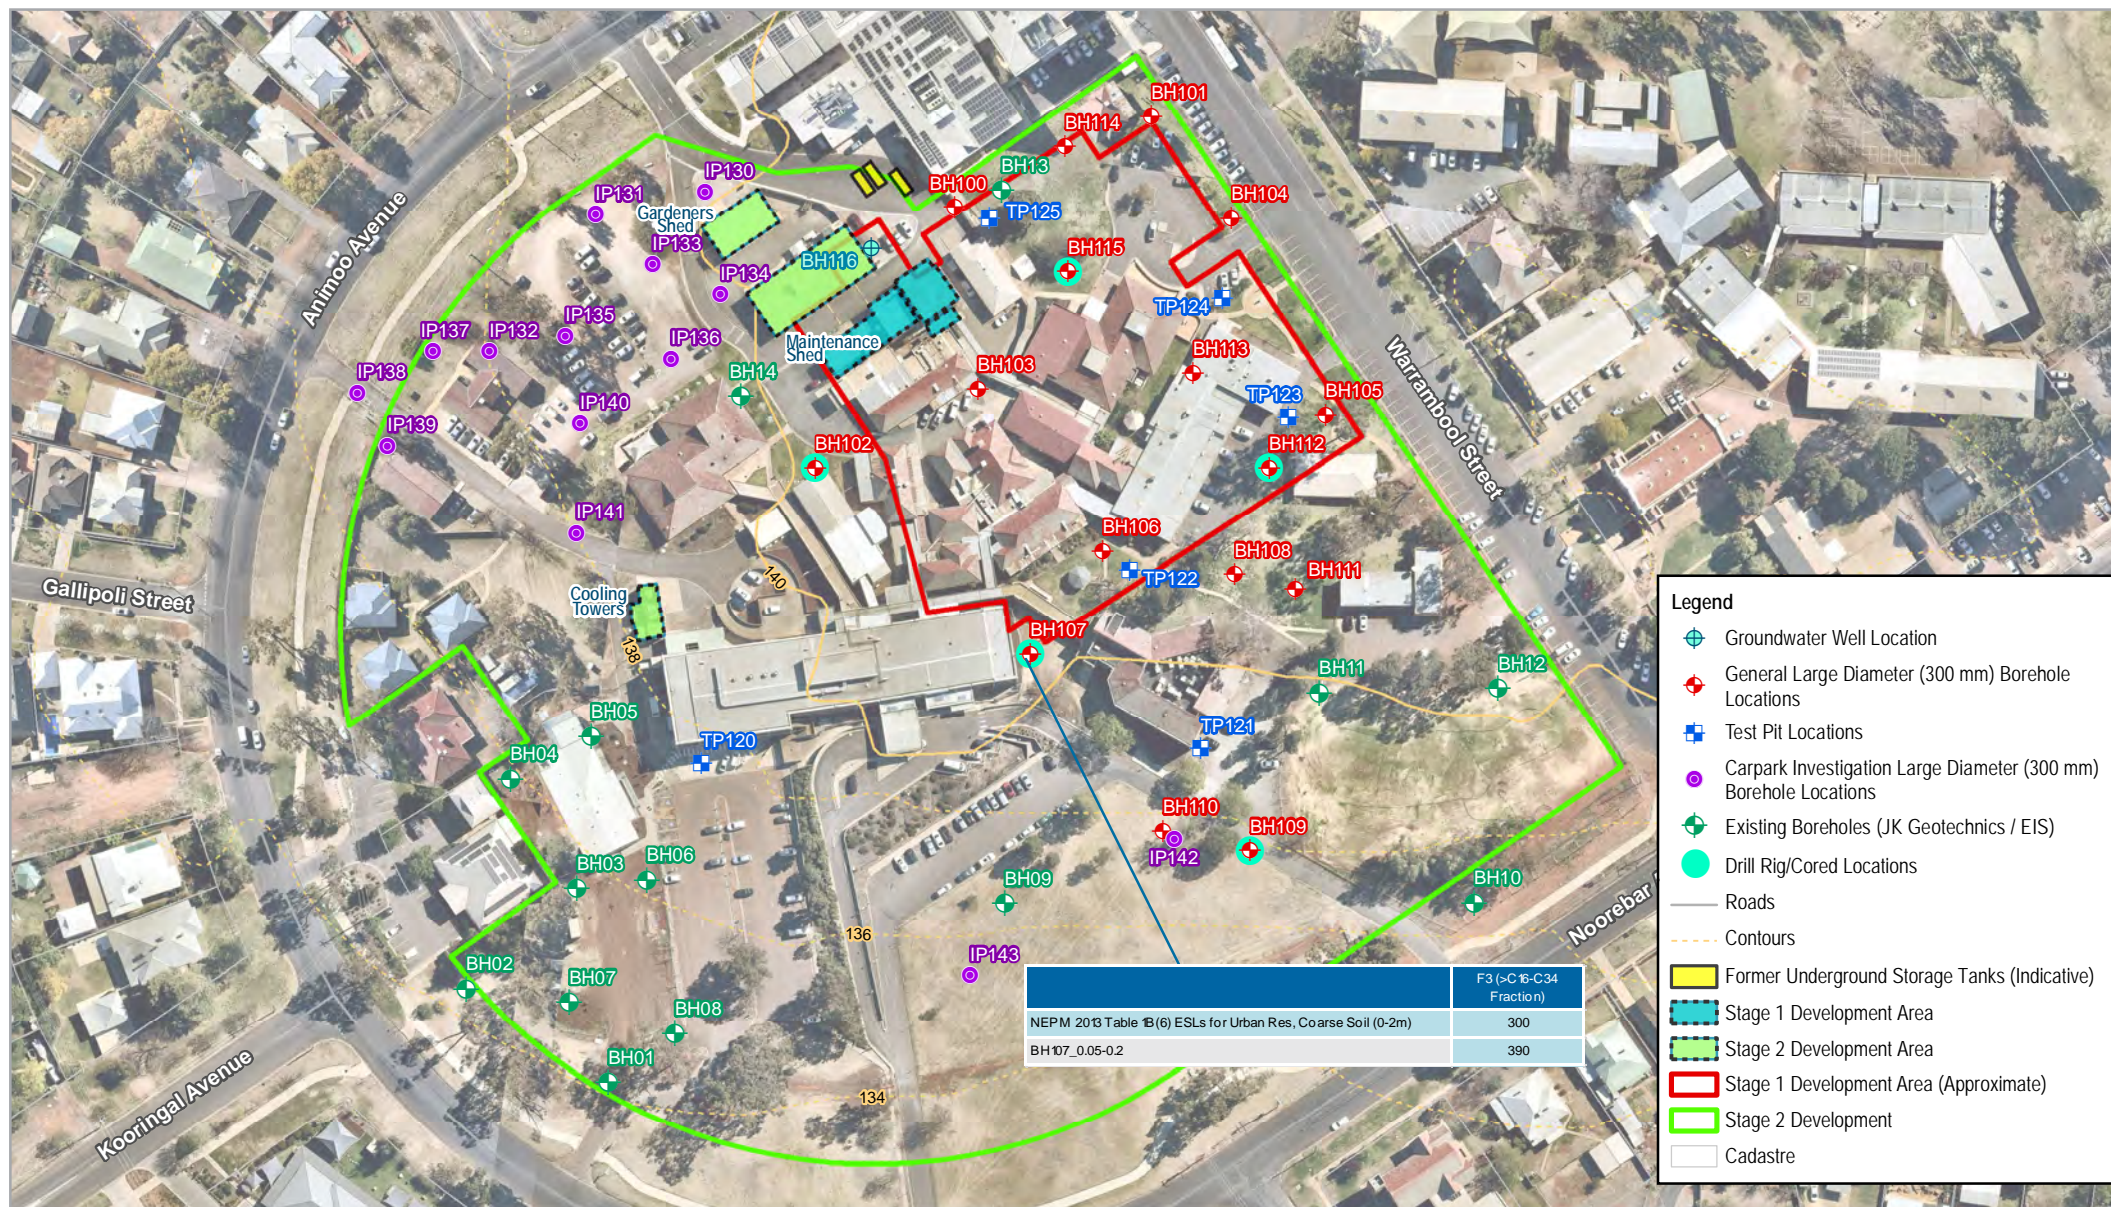
FIGURE 2

Data source: General topo - NSW LPI DTDB 2012, Cadastre - NSW LPI DCDB 2012, Aerial imagery - Nearmap (Image date: 30 Sept 2018, Extraction date: 23 November 2018), Existing borehole locations - JK Geotechnics, 2017 (Borehole Location Plan Report No. 30991L, Fig. No. 2) . Created by: kqvelasco
