**REPORT TO  
HEALTH INFRASTRUCTURE

ON  
ADDITIONAL GEOTECHNICAL INVESTIGATION

FOR  
PROPOSED HOSPITAL REDEVELOPMENT**

**AT  
GRIFFITH BASE HOSPITAL, NOOREBAR AVENUE,  
GRIFFITH, NSW**

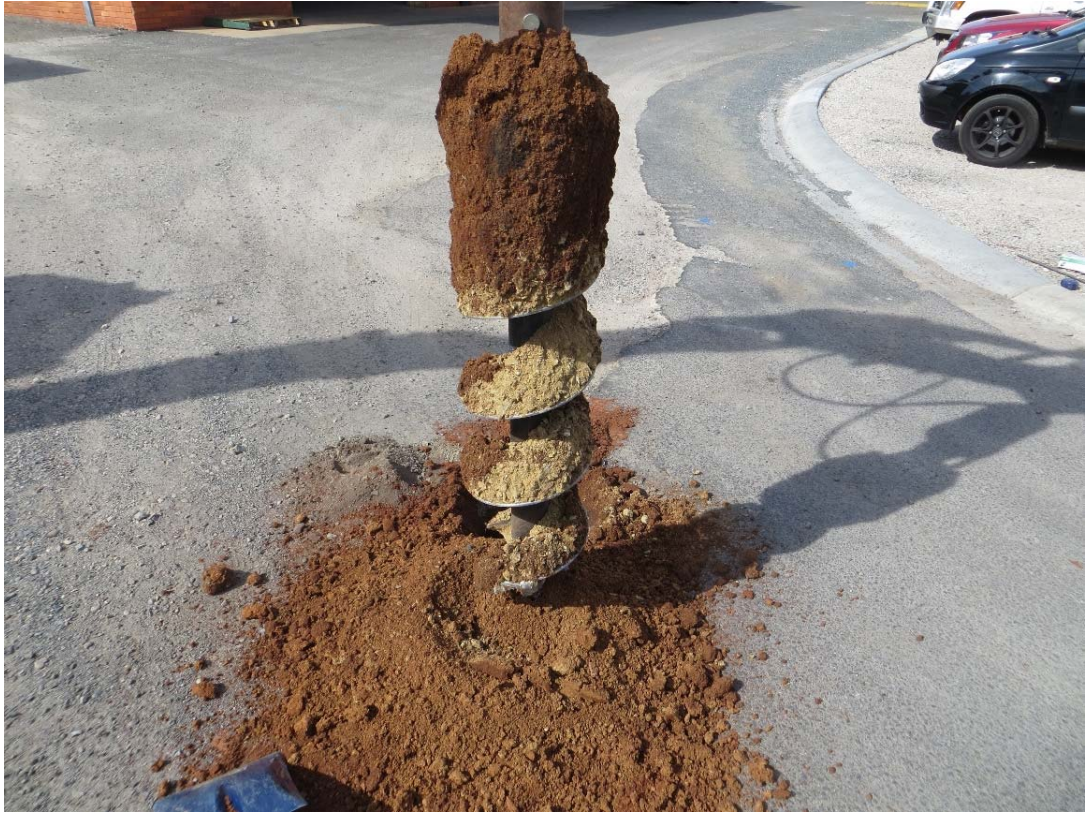
Photo 5. Soil and weathered rock profile encountered in BH100 in vicinity of Bulk Workshop

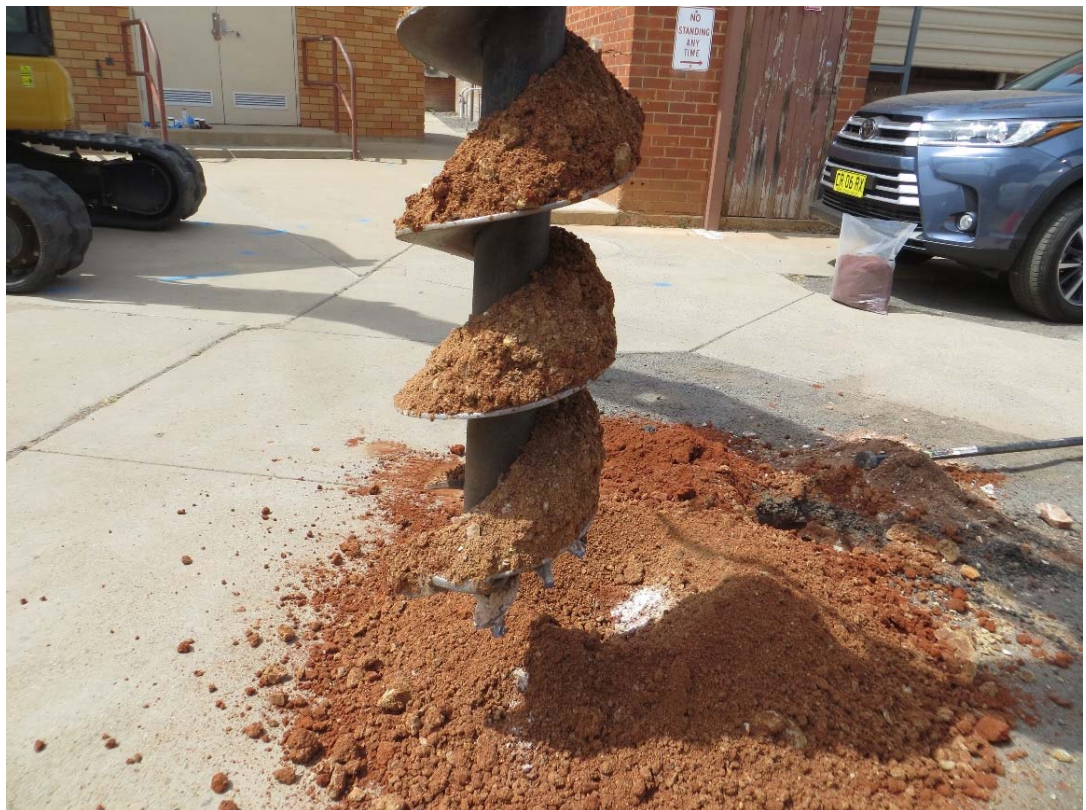
Photo 6. Soil and weathered rock profile encountered in BH103 in vicinity of Staff Dining Room and Kitchen

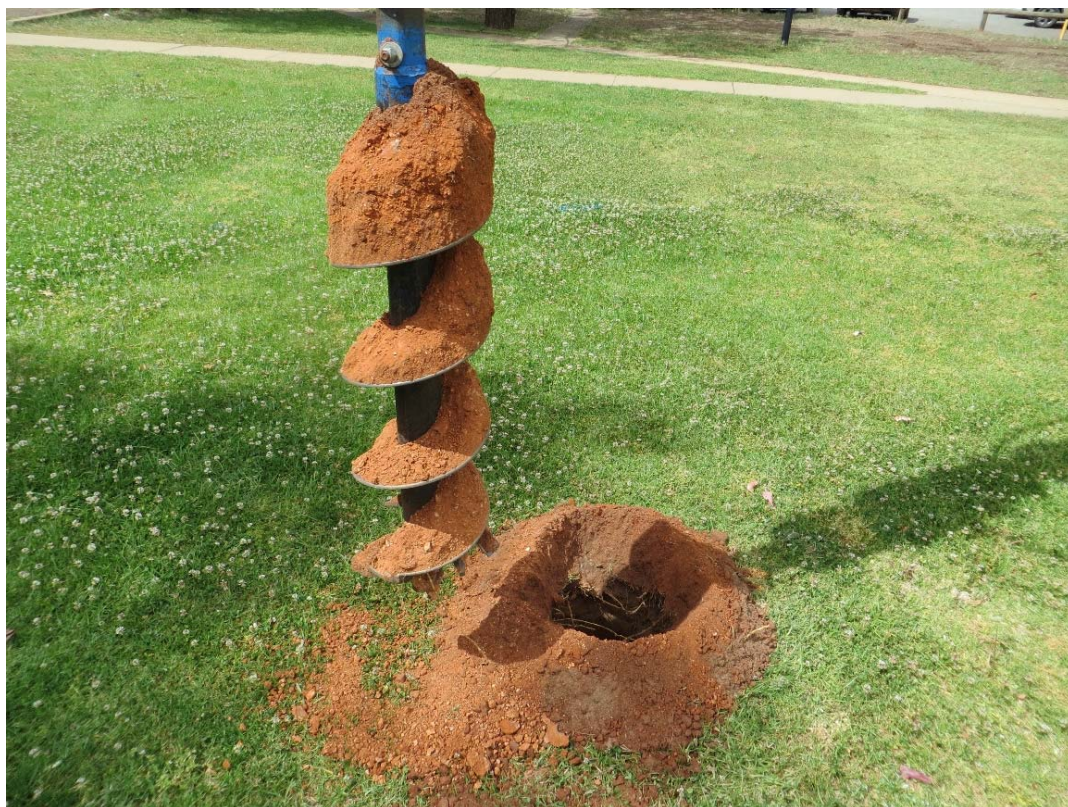
Photo 7. Soil and weathered rock profile encountered in BH111 in vicinity of Nurses Training School

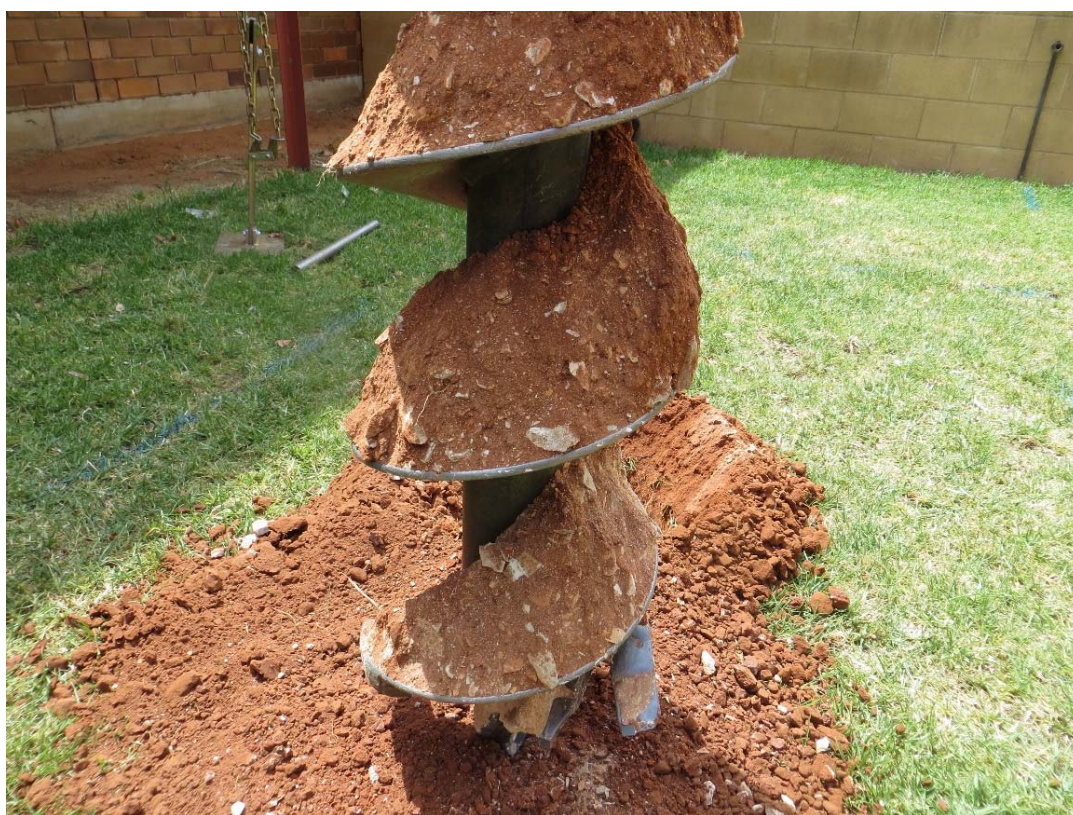
Photo 8. Soil and weathered rock profile encountered in BH113 in vicinity of Oncology and Specialist Clinic 1

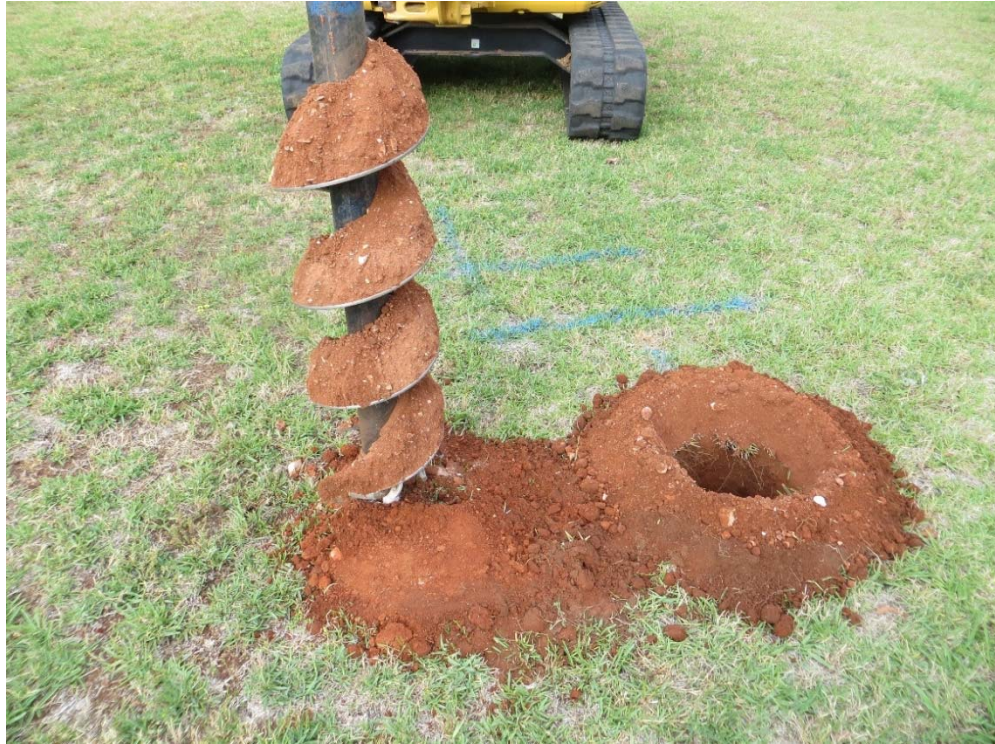
Photo 9. Soil and weathered rock profile encountered in BH114 in vicinity of RMO Accommodation

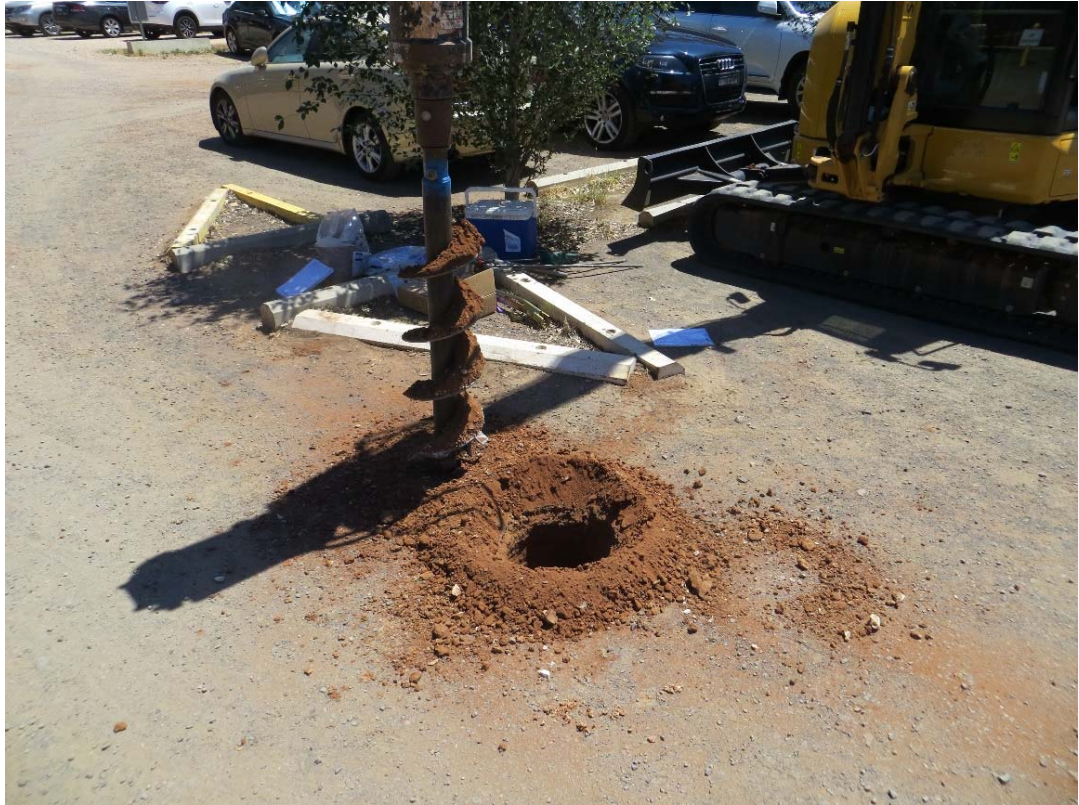
Photo 10. Soil and weathered rock profile encountered in IP136 in vicinity of Children's Ward

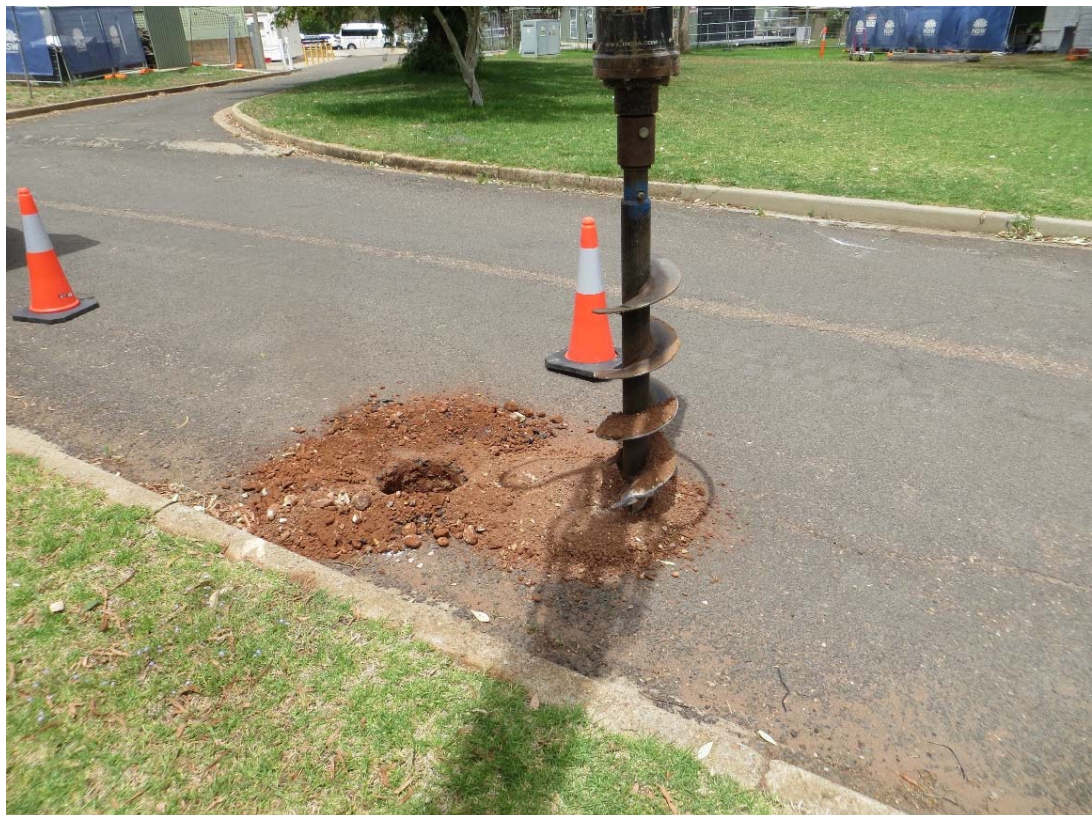
Photo 11. Soil and weathered rock profile encountered in IP141 in vicinity of Children's Ward

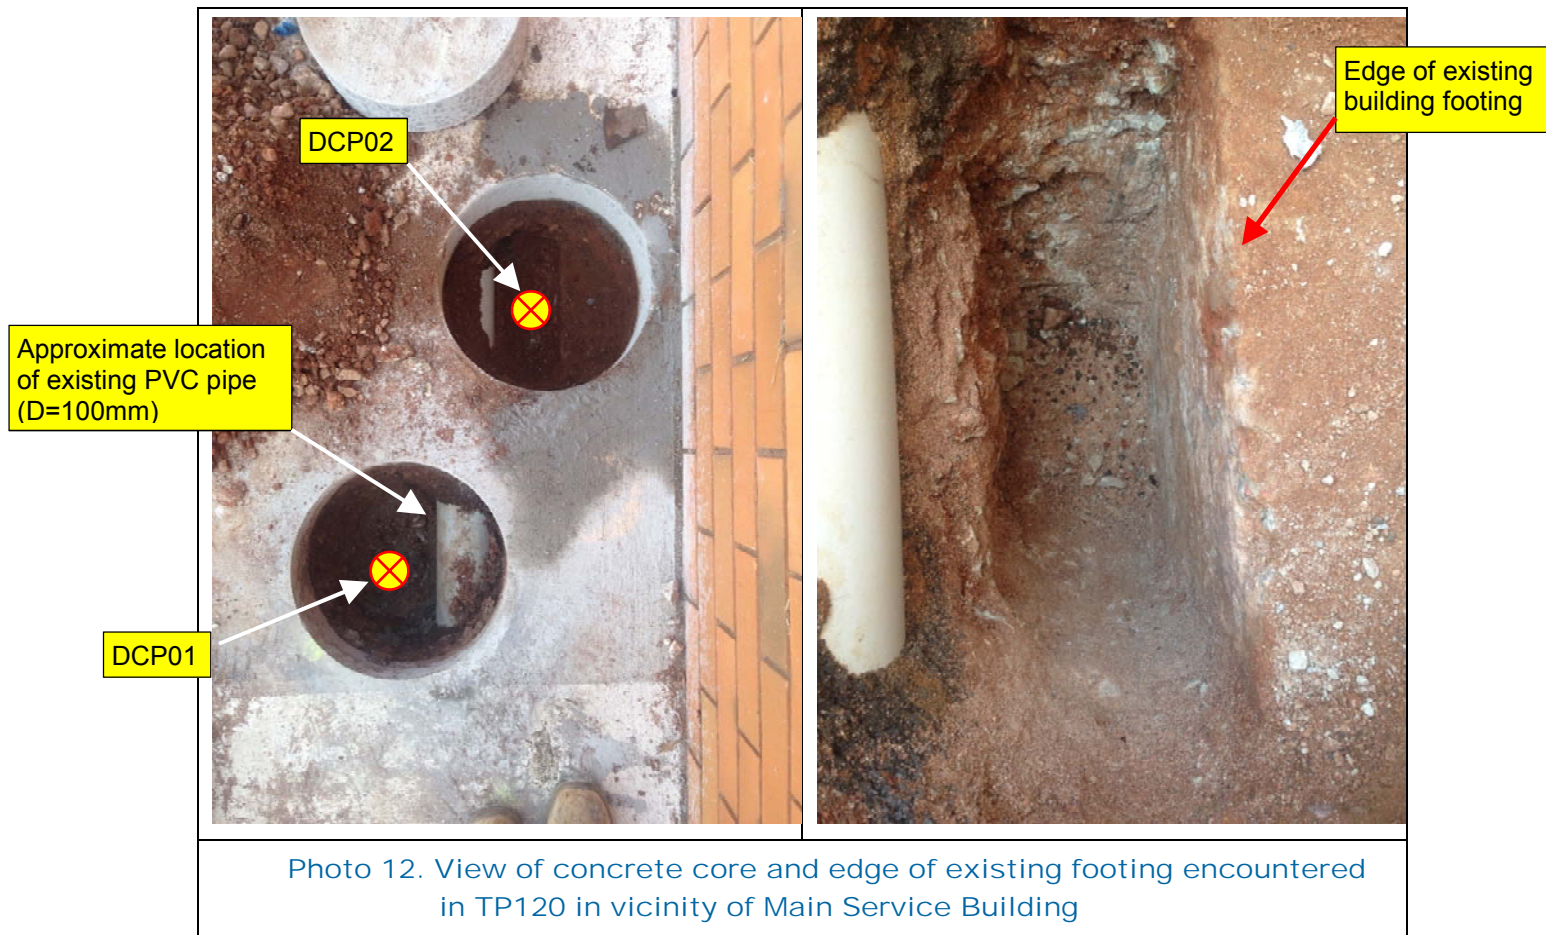
Figure 2. Schematic diagram of existing footing and adjacent to the Main Service Building

However, DCP02 was terminated at 0.6m depth from existing concrete slab. Accordingly test pit was terminated due to difficulty of excavation. Approximate footing dimensions are presented in Figure 2. Test pits were restored after completion of work.

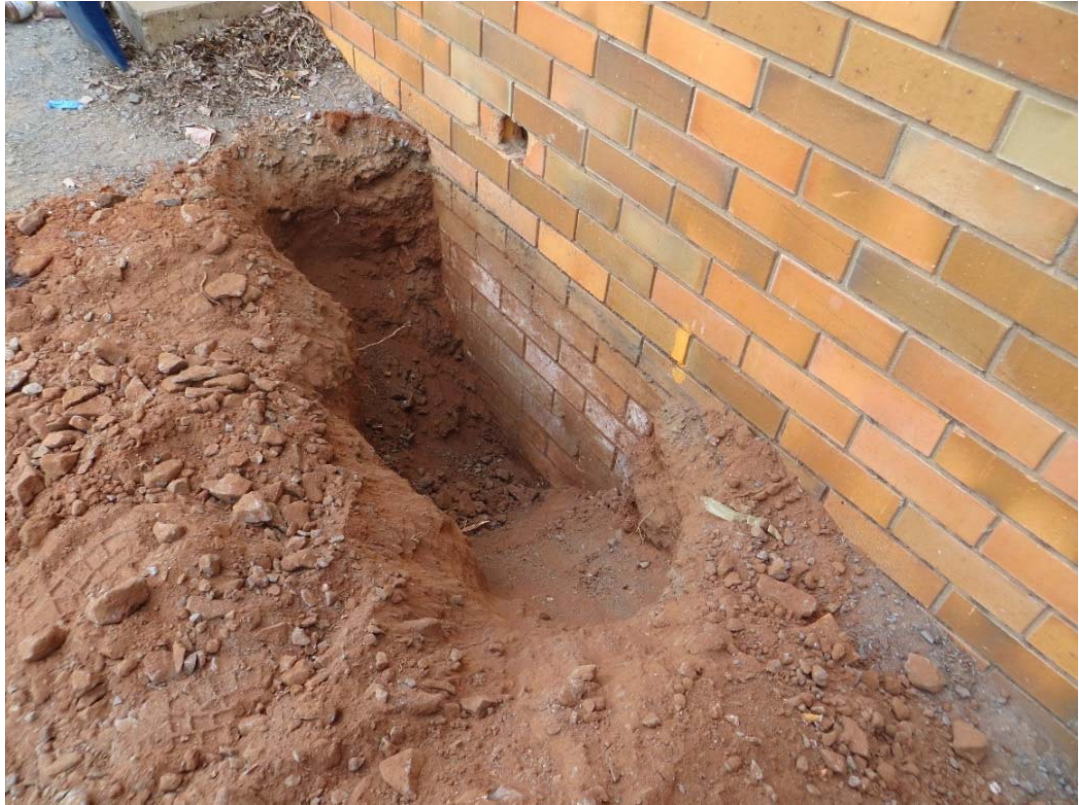
Photo 14. View of test pit (TP121) excavated adjacent to General and Medical Ward Building

Based on our observations, there are either unexcavated materials or backfilled materials in the basement against the subject building wall where the location of TP121 was nominated against. This precluded GHD's field crew from determining the footing configurations along that section of wall even from inside the basement of that building.

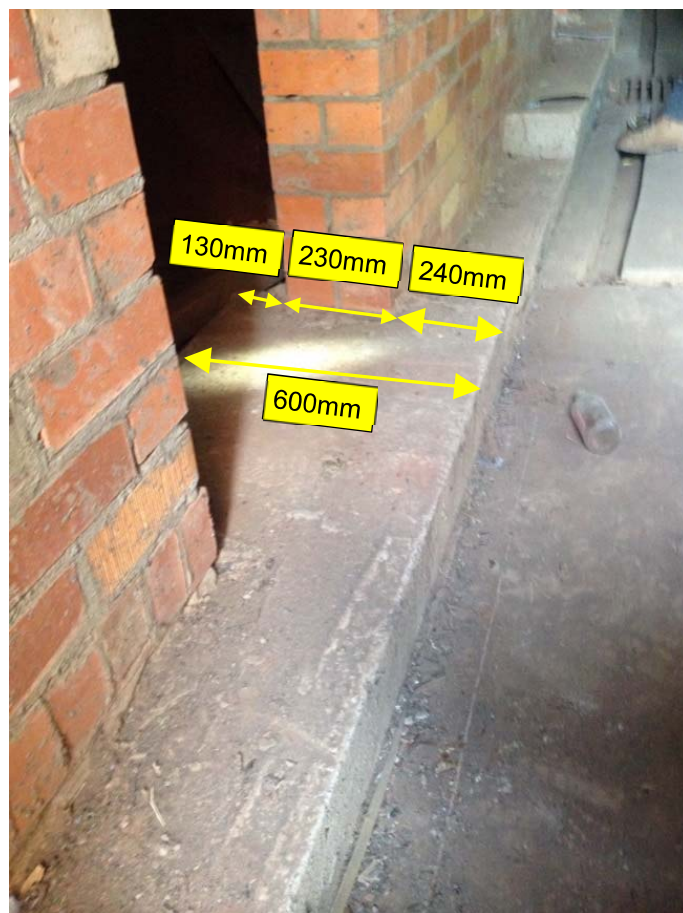
Photo 17. View of existing footing of General and Medical Ward Building

However, approximate footing dimension was assess based on exposed footing as shown in Photo 17. However, further investigation is recommended to determine founding depth of footings.

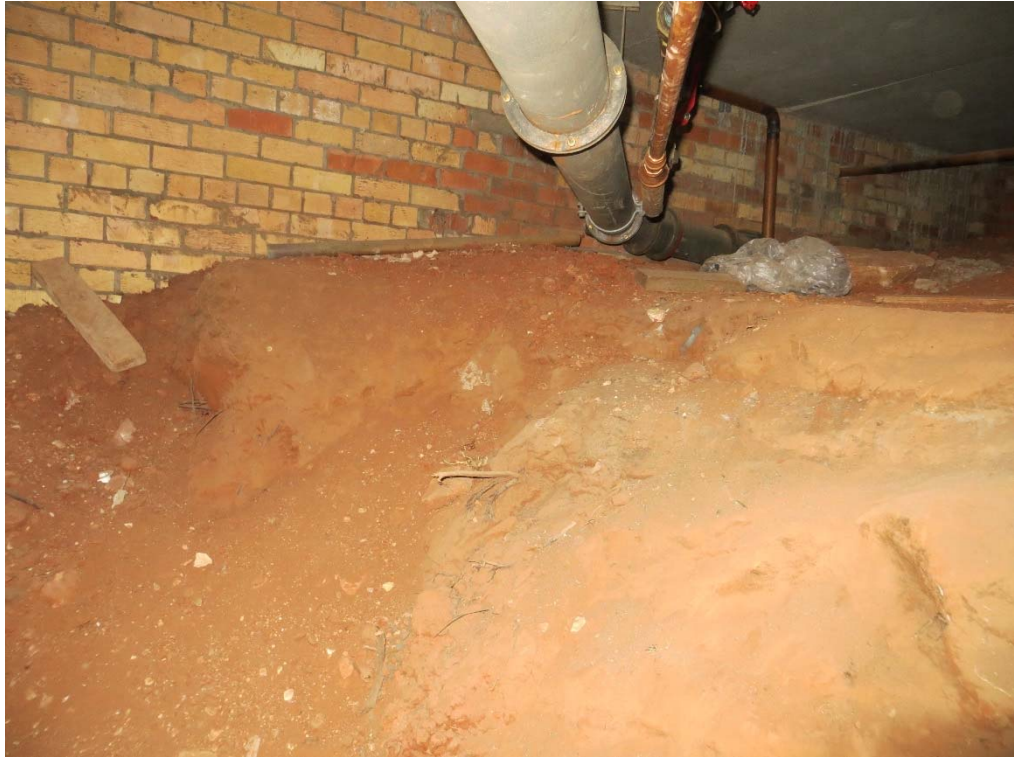
Photo 18. View of unexcavated materials or backfilled materials in the basement against the subject building wall
