**REPORT TO
HEALTH INFRASTRUCTURE**

**ON
ADDITIONAL ENVIRONMENTAL SITE ASSESSMENT**

**FOR
PROPOSED HOSPITAL REDEVELOPMENT**

**AT
GRIFFITH HEALTH SERVICES, 1 NOOREBAR
AVENUE, GRIFFITH, NSW**

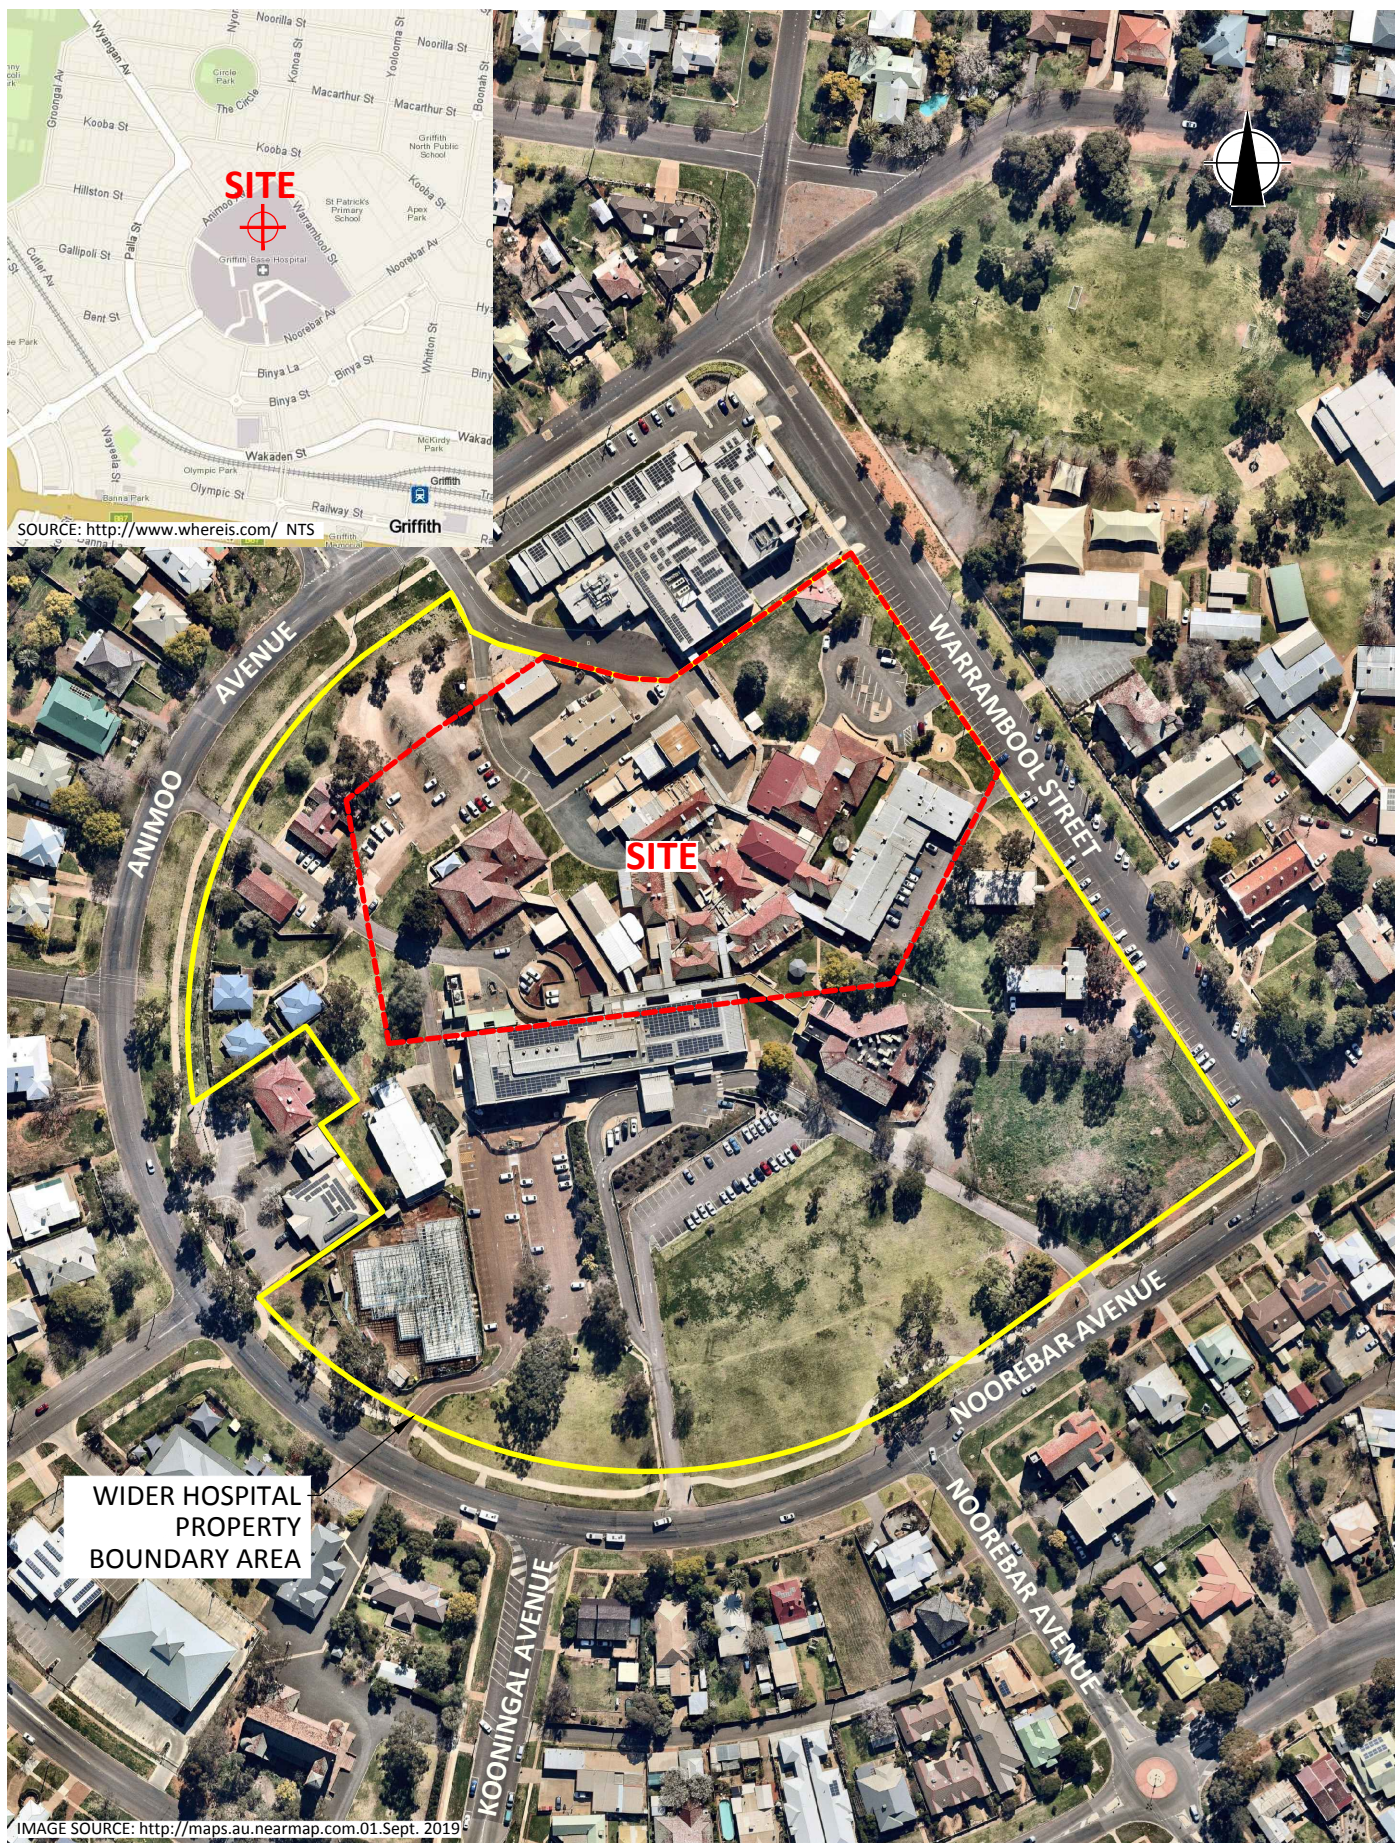
- BH201(m) BOREHOLE LOCATION, NUMBER AND DEPTH OF FILL (M) BH201 TO BH217 WERE DRILLED AS PART OF THE CURRENT JKE INVESTIGATION.
- BH101(m) BOREHOLE LOCATION, NUMBER AND DEPTH OF FILL (M) BH100 TO BH116 DRILLED AS PART OF THE 2018 GHD INVESTIGATIONS.
- BH116(m) GROUNDWATER MONITORING WELL LOCATIONS, NUMBER AND DEPTH OF FILL (M) BH116 TO DRILLED AS PART OF THE 2018 GHD INVESTIGATIONS.
- IP130(m) BOREHOLE LOCATION, NUMBER AND DEPTH OF FILL (M) IP130 TO IP142 DRILLED AS PART OF THE 2018 GHD INVESTIGATIONS.
- TP120(m) TEST PITS LOCATION, NUMBER AND DEPTH OF FILL (M) TP120 TO TP121 EXCAVATED AS PART OF THE 2018 GHD INVESTIGATIONS.
- BH1(m) BOREHOLE LOCATION, NUMBER AND DEPTH OF FILL (M) BH1 TO BH14 DRILLED AS PART OF THE NOVEMBER 2017 EIS INVESTIGATION.
