Report on
Geotechnical Investigation

Proposed Roseville College SWELL Centre
29 & 37 Bancroft Avenue, Roseville

Prepared for
Anglican Schools Corporation

Project 85310.01
October 2019

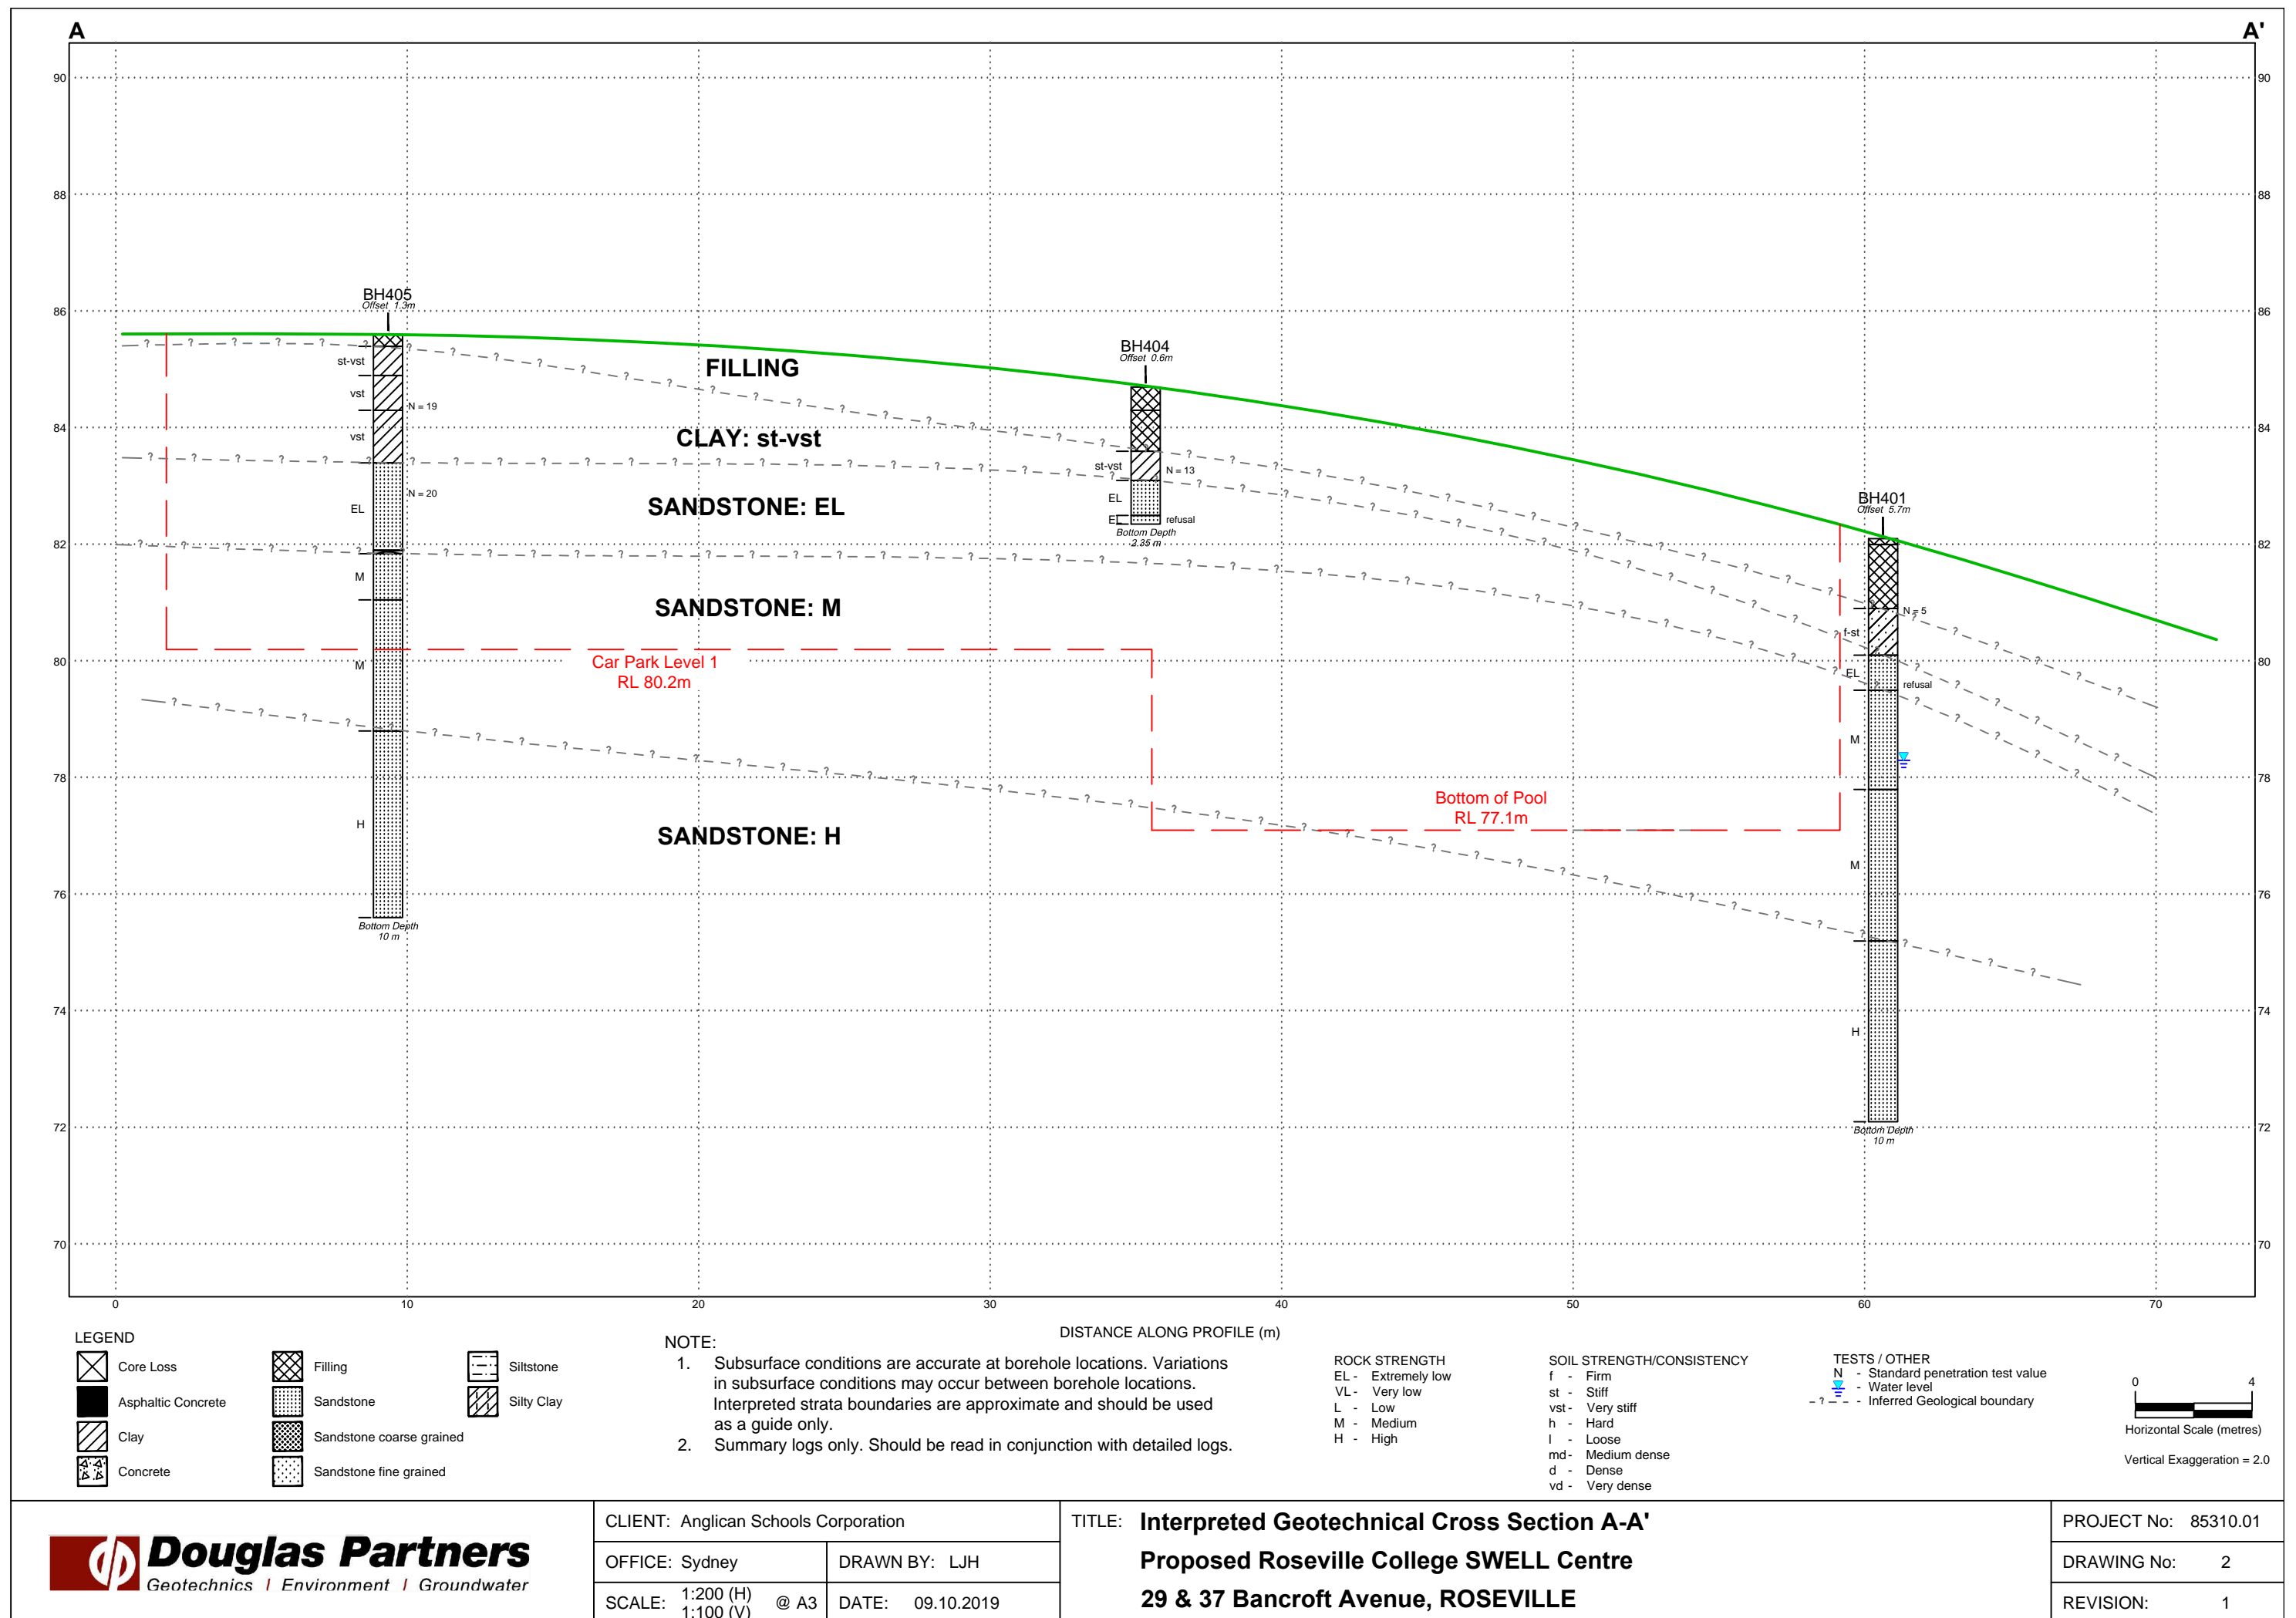
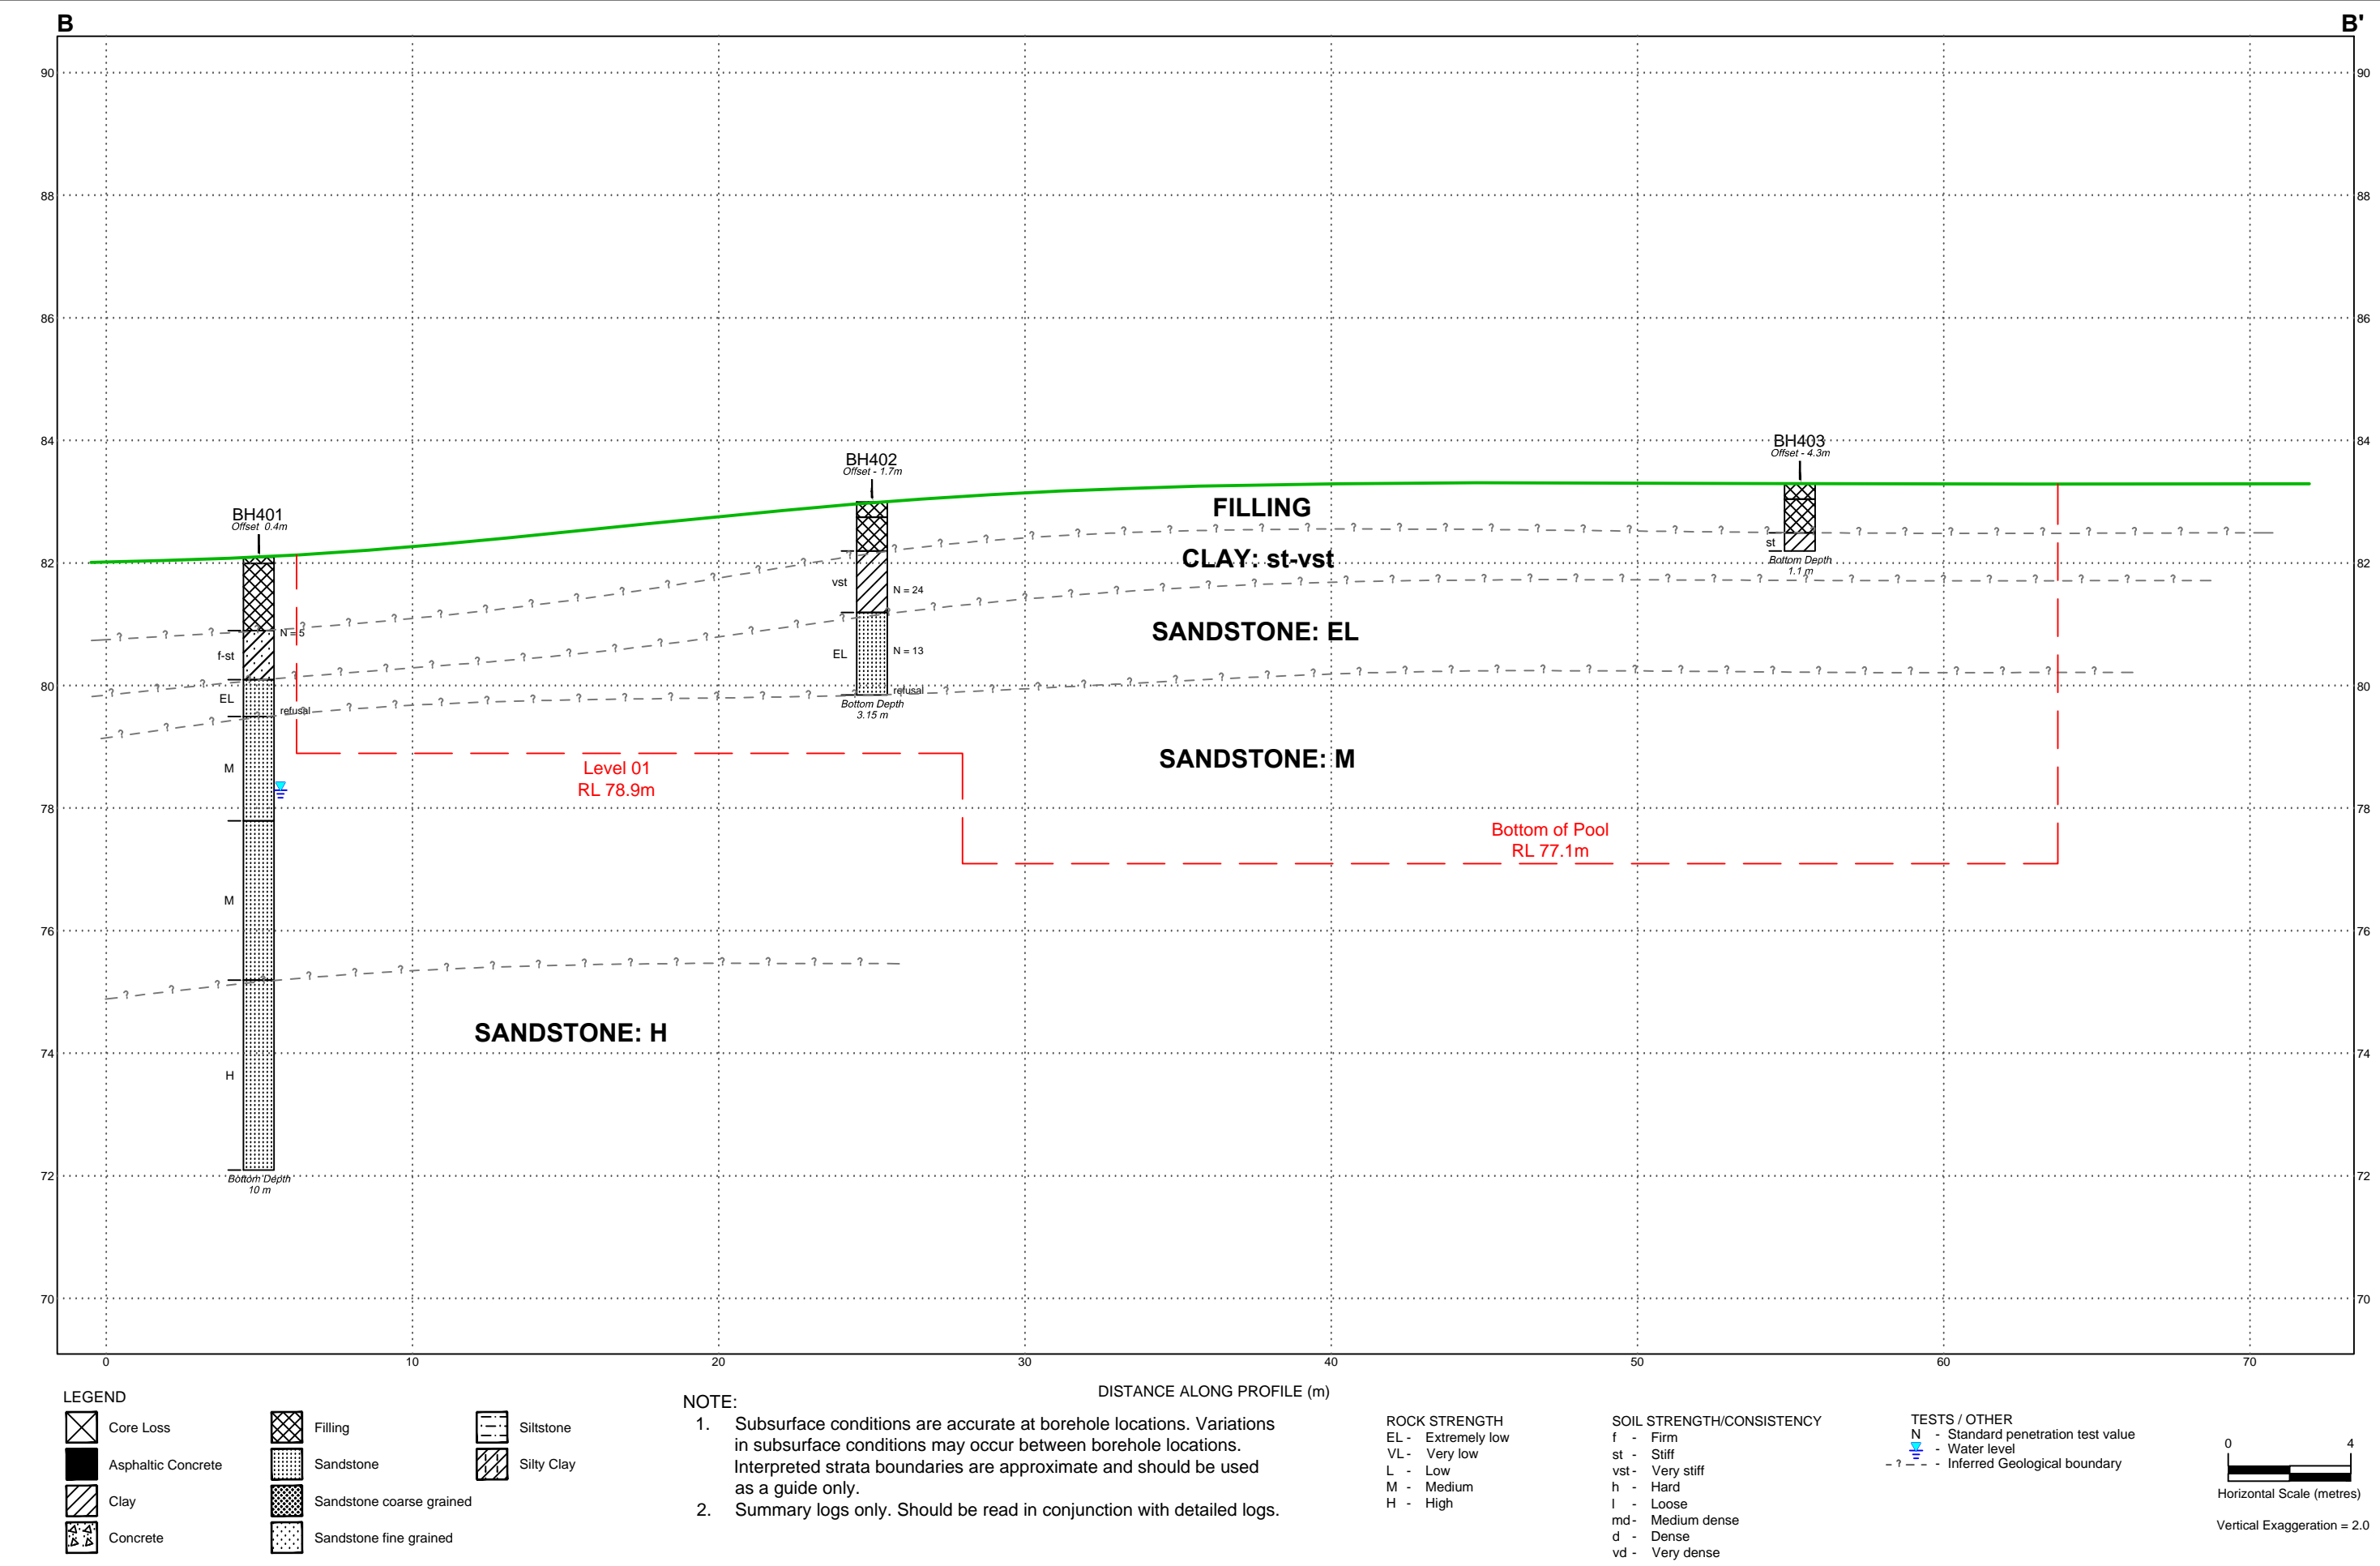
| | OFFICE: Sydney | DRAWN BY: LJH | | DRAWING No: 3 | |

| Douglas Partners <i>Geotechnics Environment Groundwater</i> | CLIENT: Anglican Schools Corporation | | TITLE: Interpreted Geotechnical Cross Section B-B' Proposed Roseville College SWELL Centre 29 & 37 Bancroft Avenue, ROSEVILLE | PROJECT No: 85310.01 | |

A summary of the subsurface conditions encountered across the proposed SWELL Centre site are shown in four interpreted geotechnical cross-sections A - A' to D - D' in Drawings 2 to 5 in Appendix B, with the proposed basement floor levels and bottom of pool shown indicatively. It should be noted that the interpreted geotechnical boundaries are shown for illustration purposes only and that the soil/rock profiles should be expected to vary in between and away from the borehole locations.

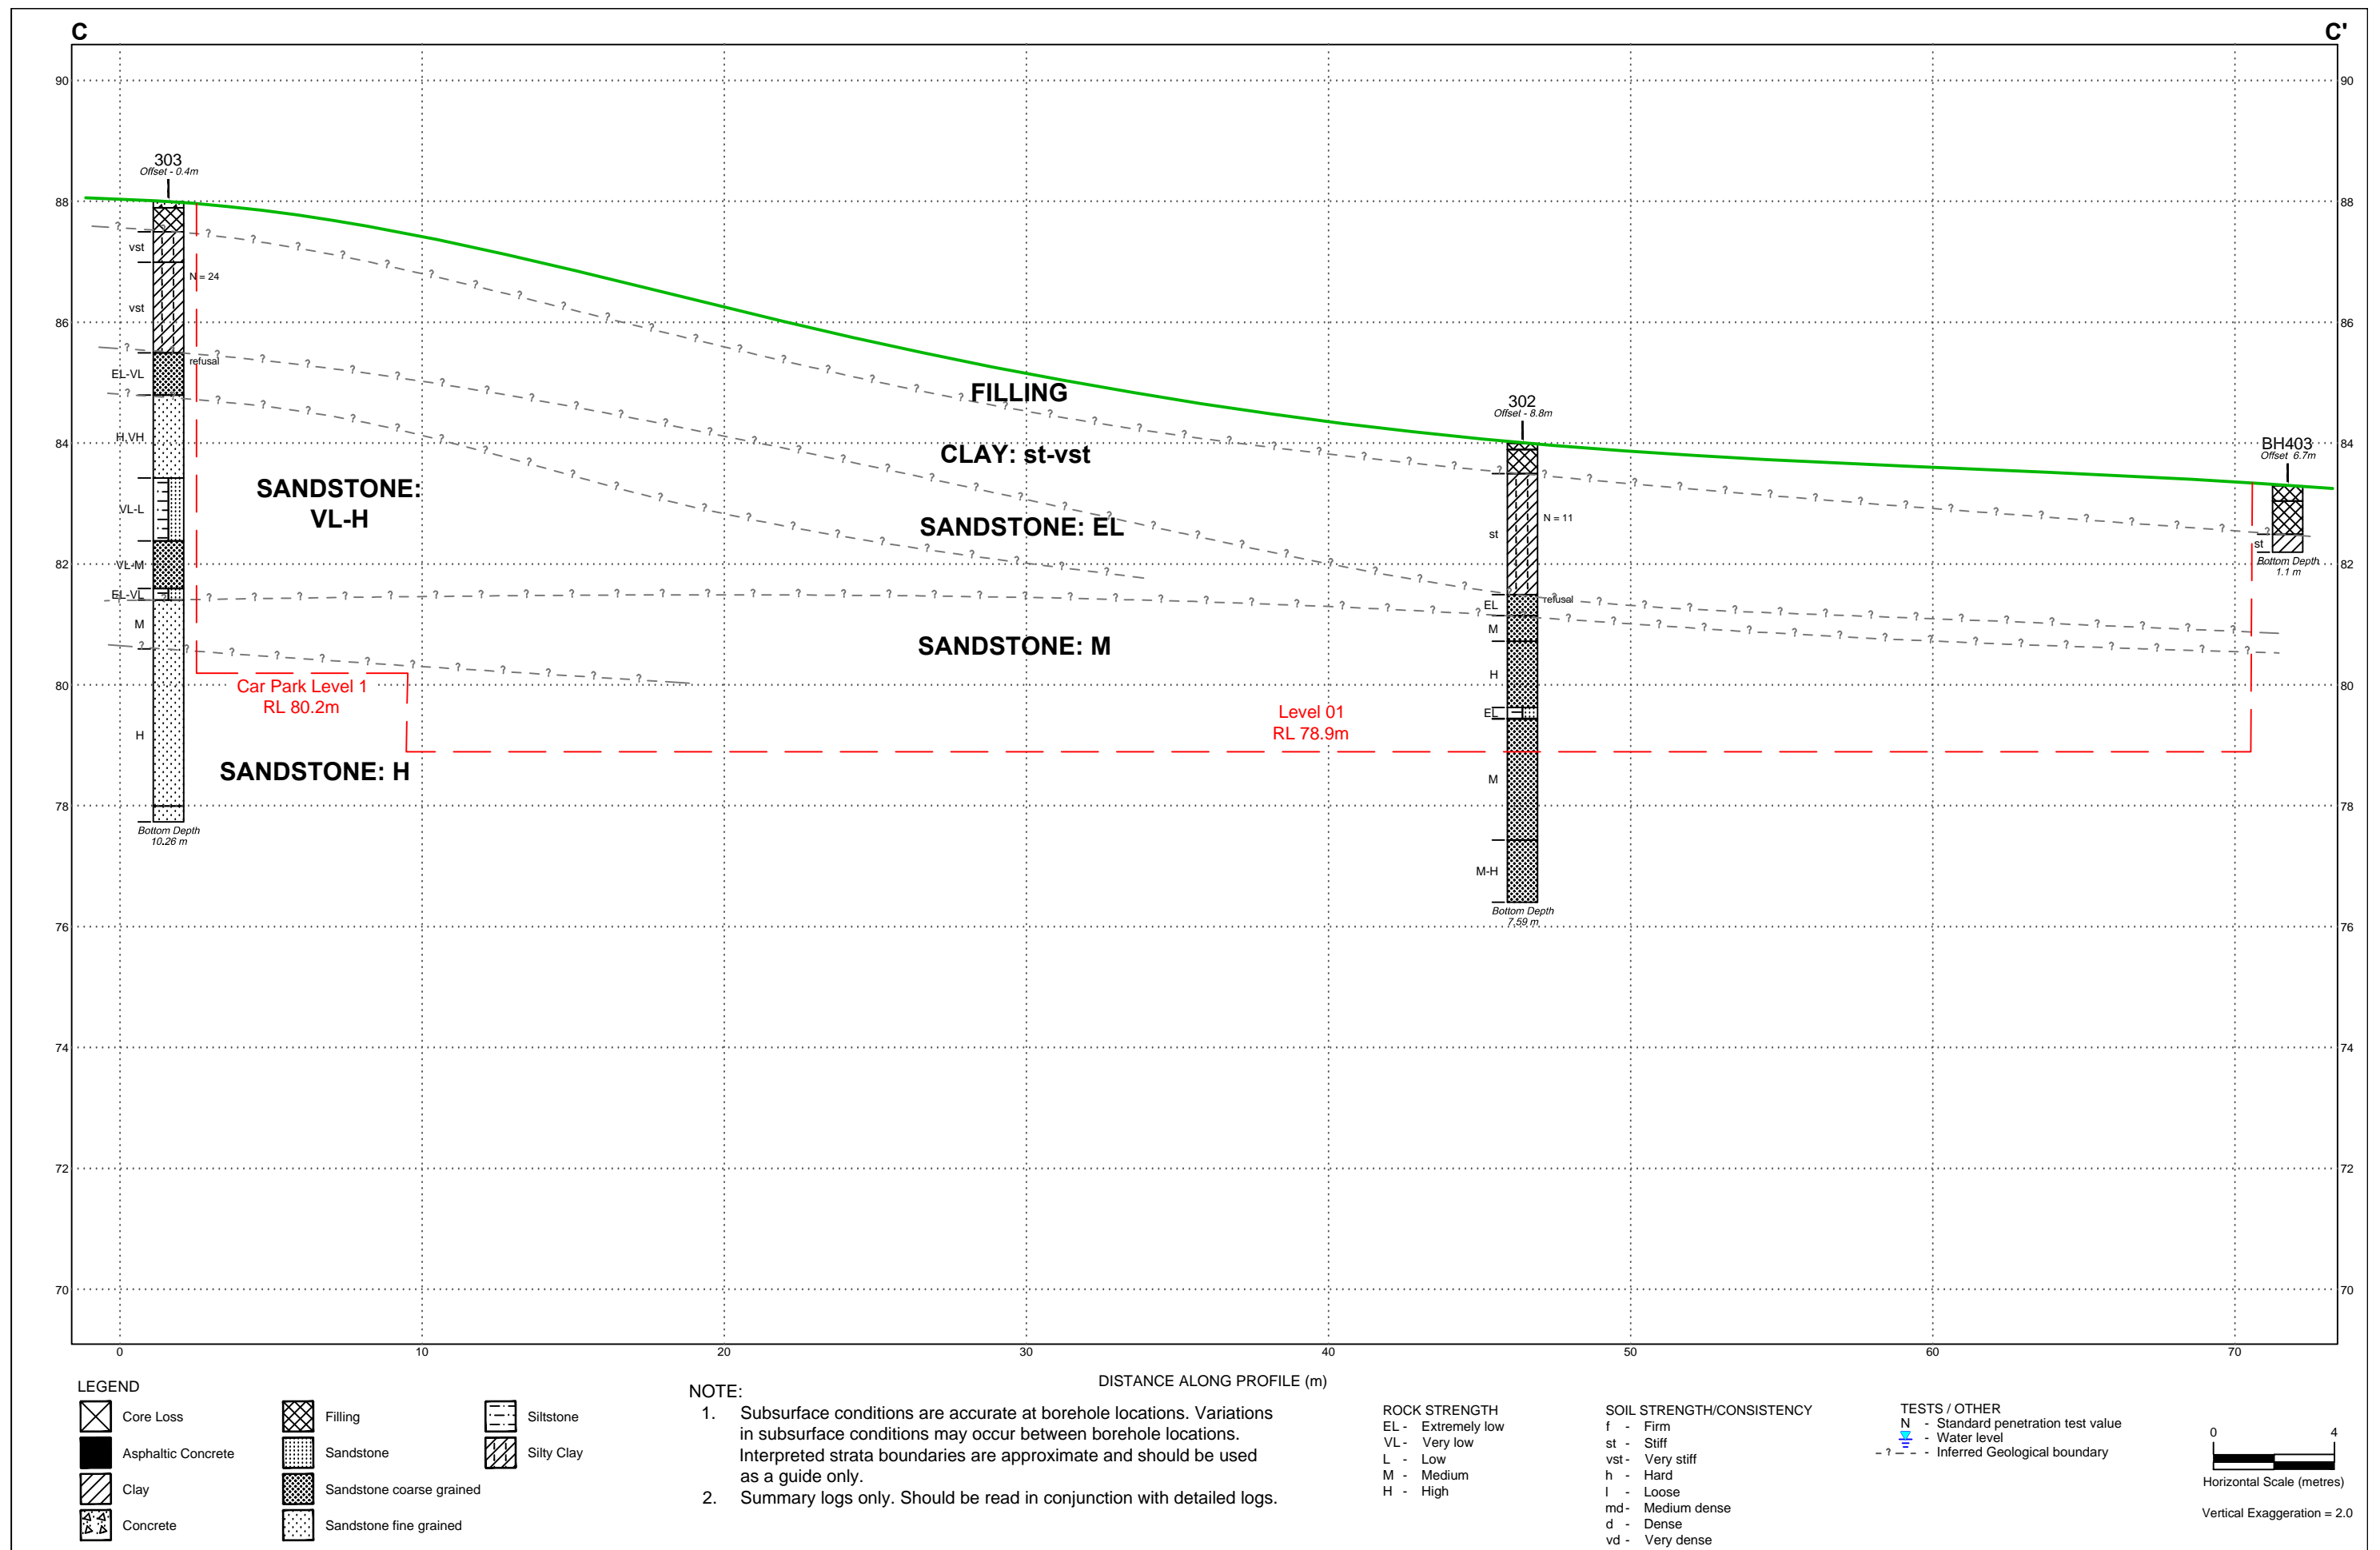
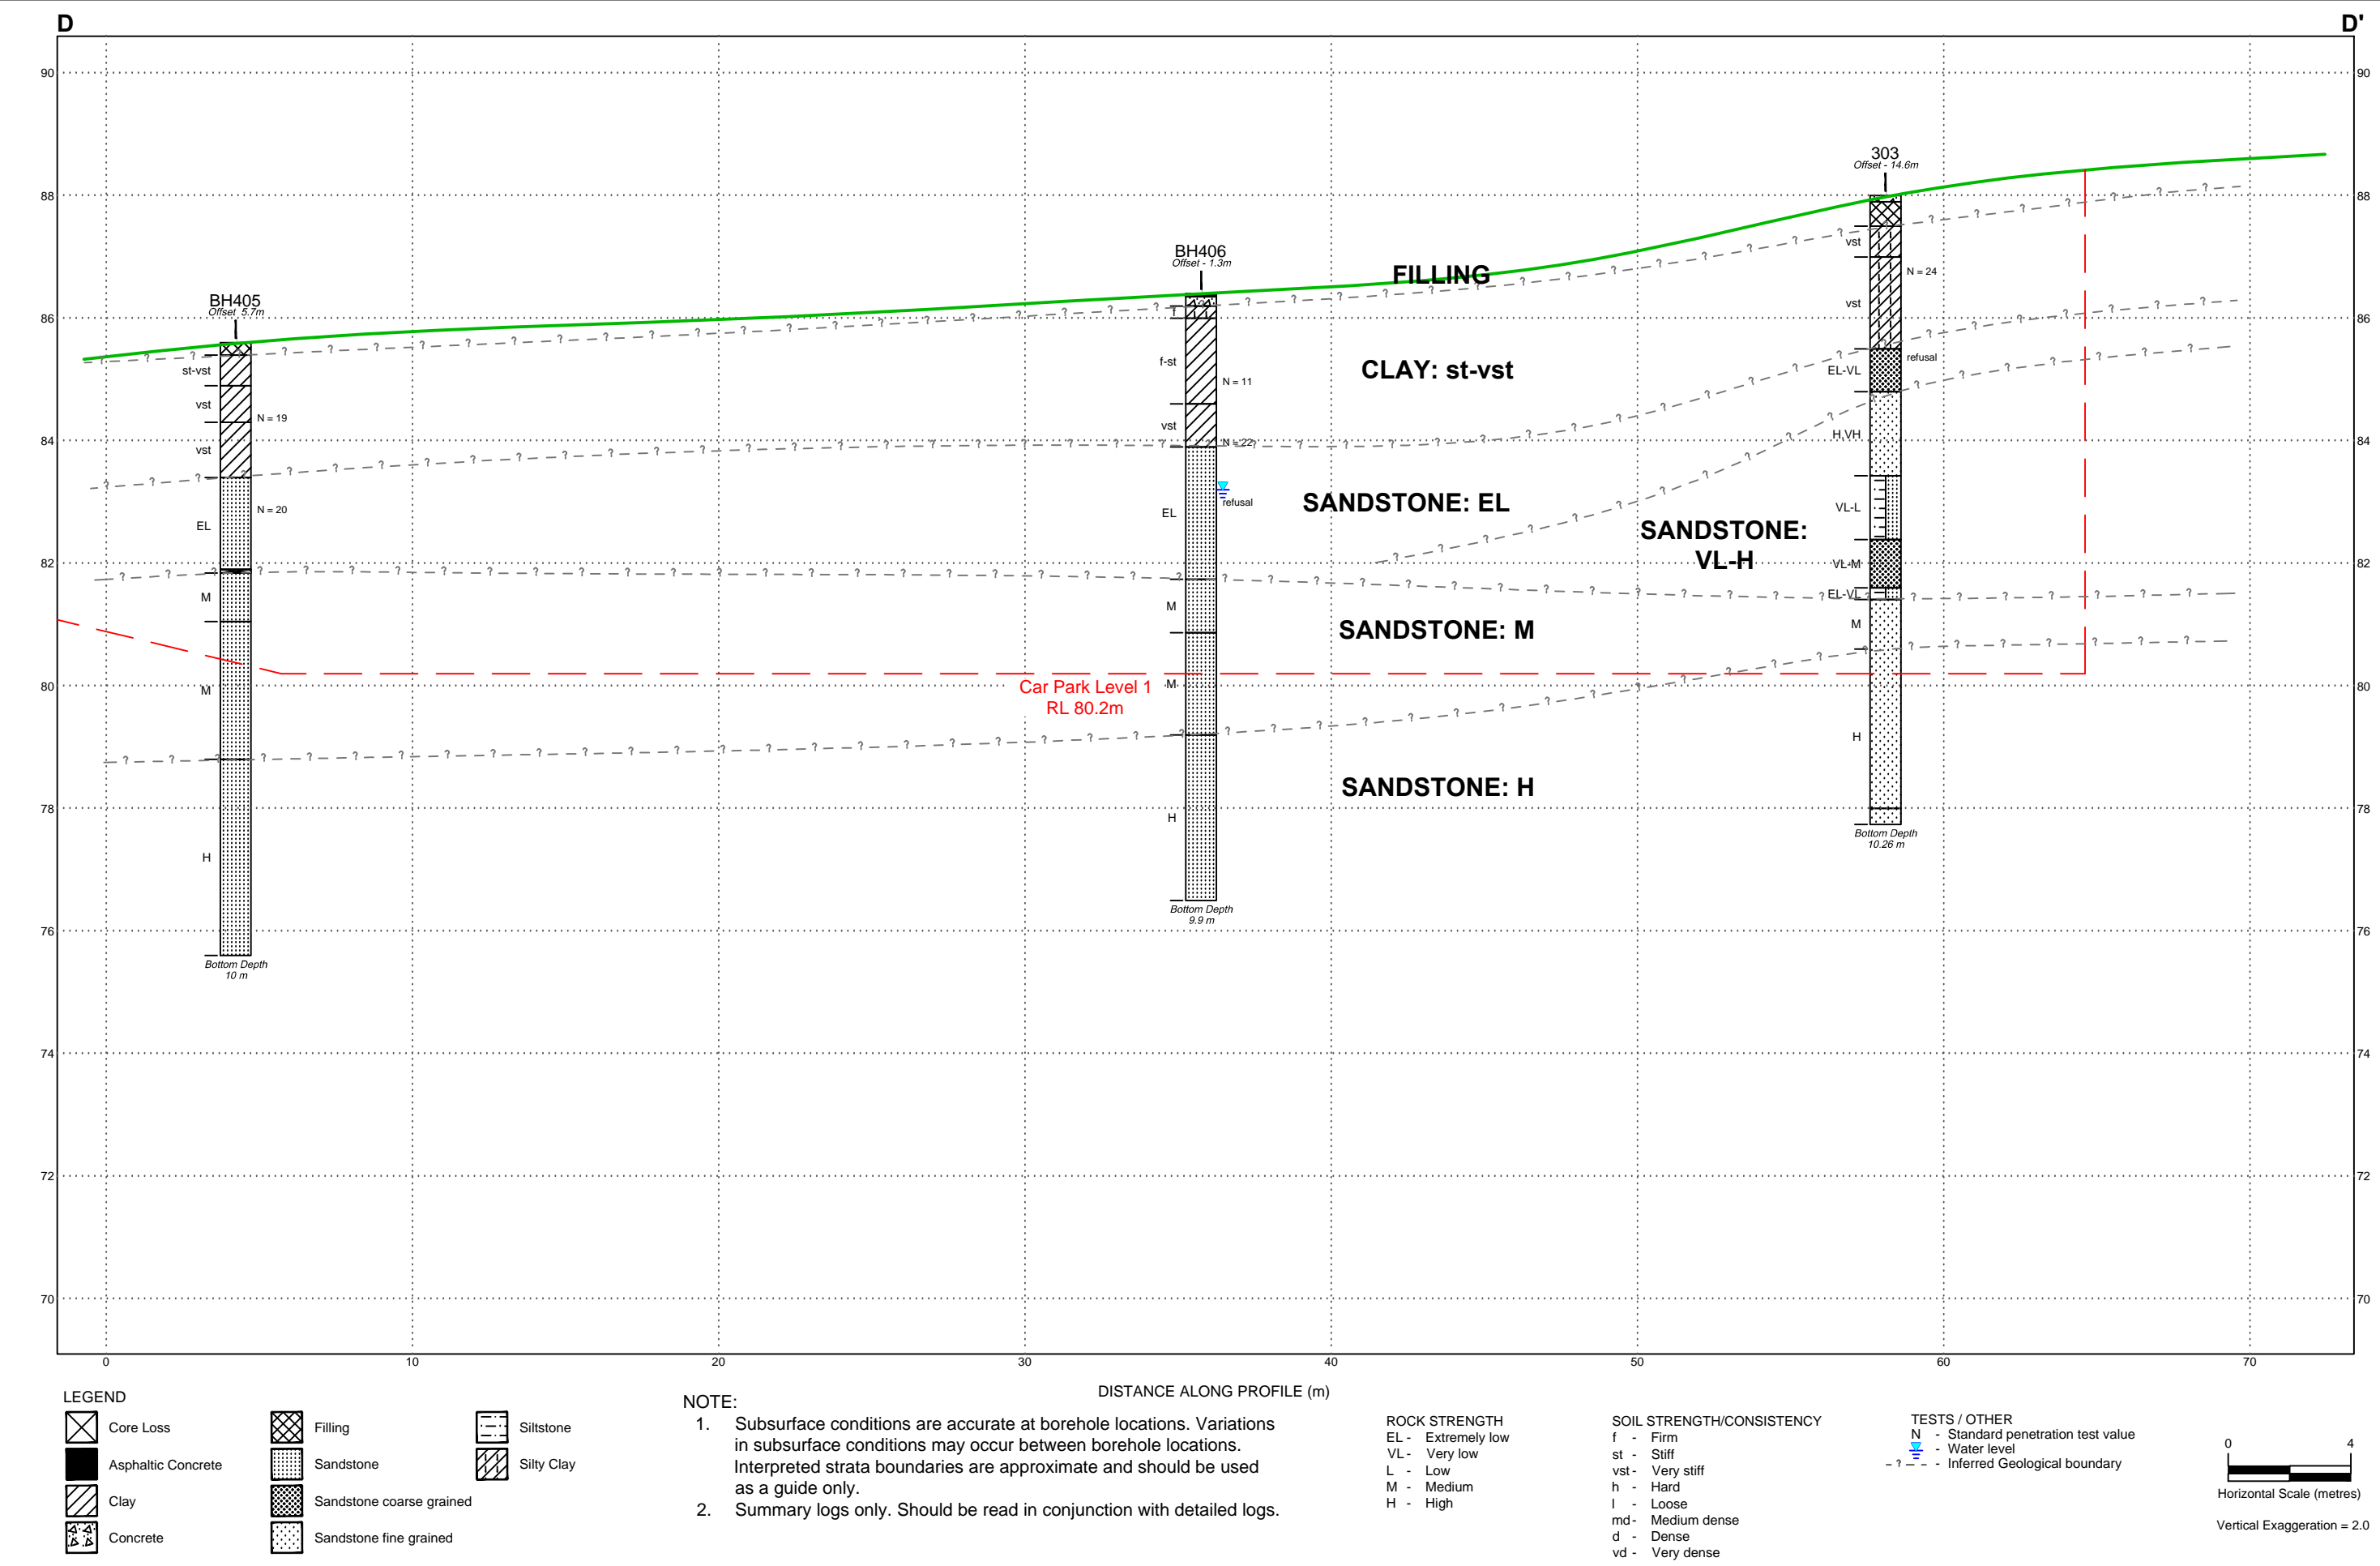
| | OFFICE: Sydney | DRAWN BY: LJH | | DRAWING No: 5 | |

| Douglas Partners <i>Geotechnics Environment Groundwater</i> | CLIENT: Anglican Schools Corporation | | TITLE: Interpreted Geotechnical Cross Section D-D' Proposed Roseville College SWELL Centre 29 & 37 Bancroft Avenue, ROSEVILLE | PROJECT No: 85310.01 | |

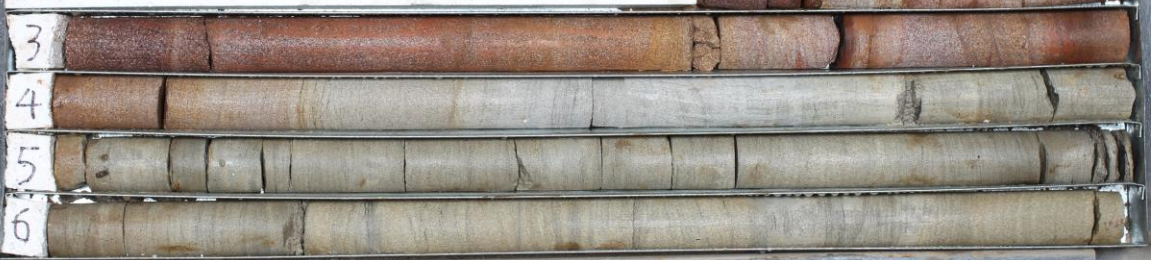
2.6 – 7.0m

B5310.01-BH401-28/6/19

Start = 2.6m

BORE: BH401

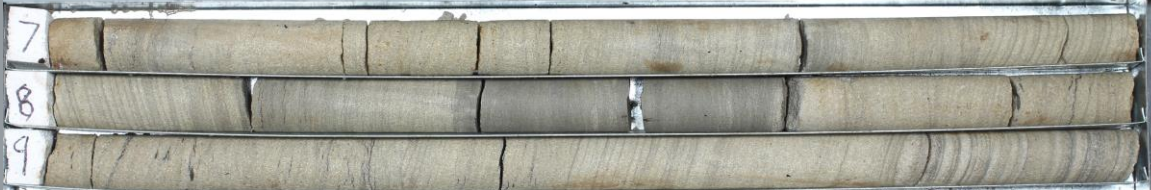
7.0 – 10.0 m

Project No: 85310.01
BH ID: BH401
Depth: 7.0-10.0
Core Box No.: 2

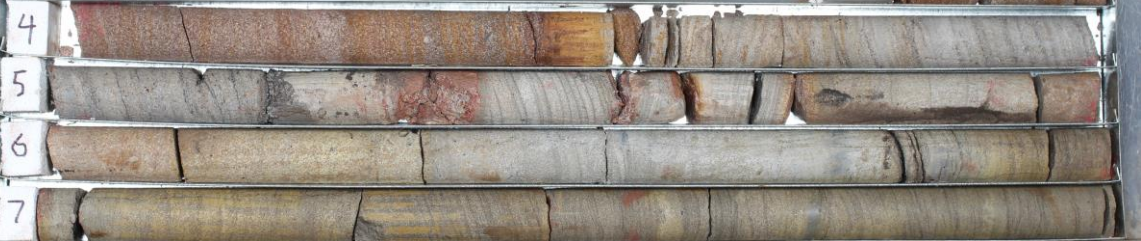
3.7 - 8.0m

B5310.01 - BH405 - Start = 3.7m
Roseville 26/6/19

BORE: BH405

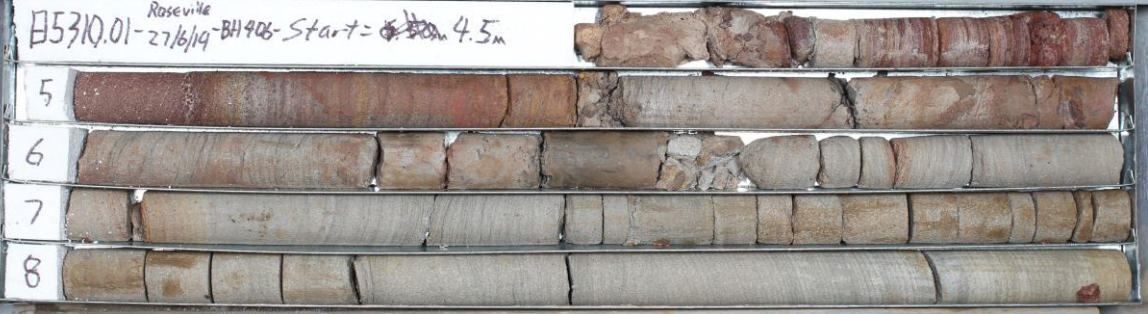
4.5 – 9.0m

B5310.01-Roseville
27/6/19-BH406-Start=~~8.50m~~ 4.5m

BORE: BH406

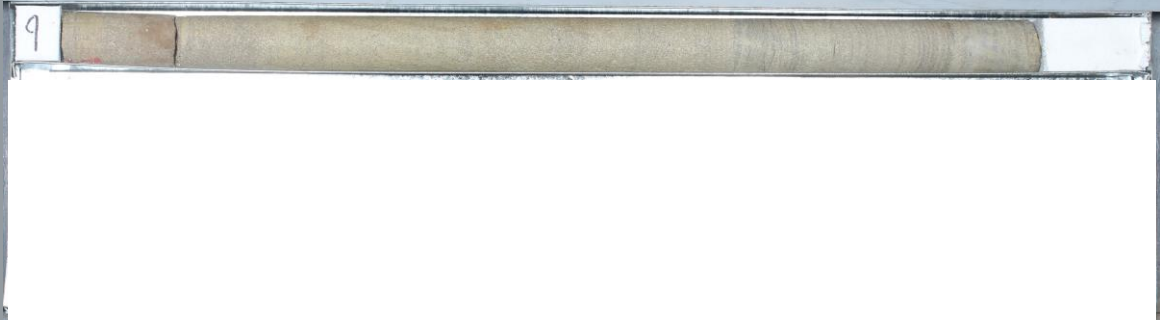
9.0 – 9.9m

Project No: 85310.01
BH ID: BH406
Depth: 9.0-9.9m
Core Box No.: 2

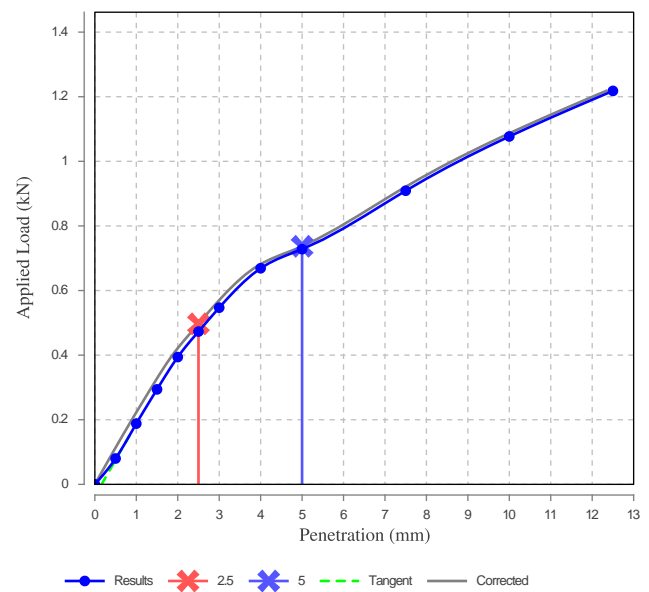
California Bearing Ratio

Report Number: 85310.01-1
Issue Number: 1
Date Issued: 24/07/2019
Client: Anglican Schools Corporation
Suite 102/9 Gloucester Road, Hurstville NSW 2220
Contact: Adam Forbes
Project Number: 85310.01
Project Name: Proposed Roseville College SWELL Centre
Project Location: 29 & 37 Bancroft Avenue, Roseville
Work Request: 4567
Sample Number: 19-4567C
Date Sampled: 28/06/2019
Dates Tested: 01/07/2019 - 08/07/2019
Sampling Method: Sampled by Engineering Department
Sample Location: BH405 (1.9-2.0m)
Material: CLAY - Red-brown clay with ironstone gravel and trace silt

Based on the laboratory test results, CBR values of 4% and 6% were indicated for the natural clay. Based on DP's experience and given the potential for variable subgrade conditions, a design CBR value of 3% is suggested for the Recreational Avenue pavement thickness design.
