# Arboricultural Impact Assessment Report

*DARLINGTON PUBLIC SCHOOL*

October 2020

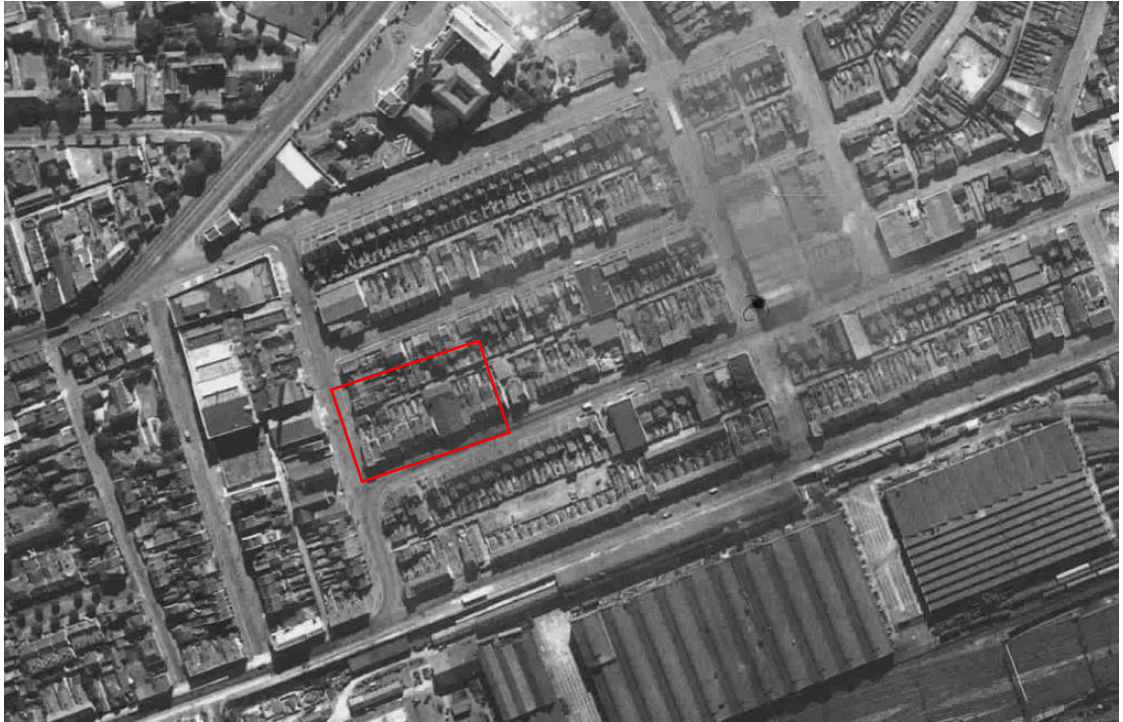
- 3.1** Darlington Public School is located in Chippendale, in Sydney. Darlington Public School is an inner city school servicing the suburbs of Chippendale, Darlington, Redfern and Waterloo. The school has been built following World War 2 (Diagram 2) however the school's trees are well established, with some being almost twenty (20) metres in height and spread.

**Diagram 2:** The site as seen in 1943, devoid of trees (RTA From the skies, 2007).

**3.10** Although this area of Sydney may be high in sand content, that would normally encourage deeper root systems, this site has an uncertain history. Based on Diagram 2, it appears that prior to the school being built, there were rows of terrace houses and warehouse structures, so subsoil conditions will be far from natural and would be highly disturbed. This will mean that old footings or foundations that may be subsurface will deflect woody roots keeping them close to the surface such as near Tree 20 (Plate 9).

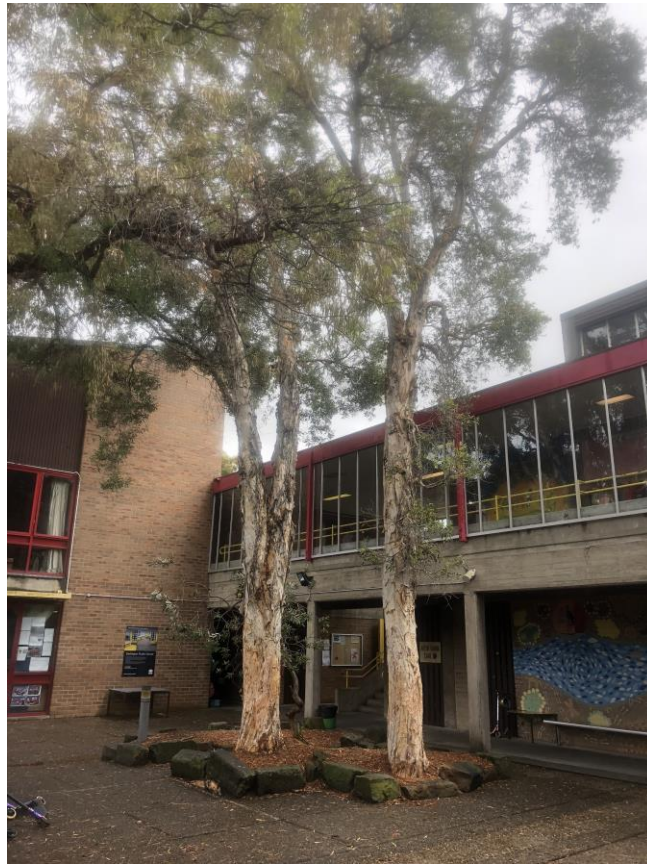
- 3.2 The Site Trees:** The site was inspected on 15<sup>th</sup> October 2018. Each tree has been given a unique number for this site and can be viewed on the Tree Impact Plan (Appendix 1).
- 3.3** The site consists of several buildings connected by covered walkways. Playground areas are located throughout the site with specimen trees located in some protected courtyard areas (Plate 1). Some of these courtyard specimens are large mature specimens that provide extensive canopy cover to the site (Plate 2).

**Plate 1:** Image showing Trees 1 and 2. Working around a mature tree such as this will be difficult in terms of canopy impacts and root disturbance. P. Vezgoff

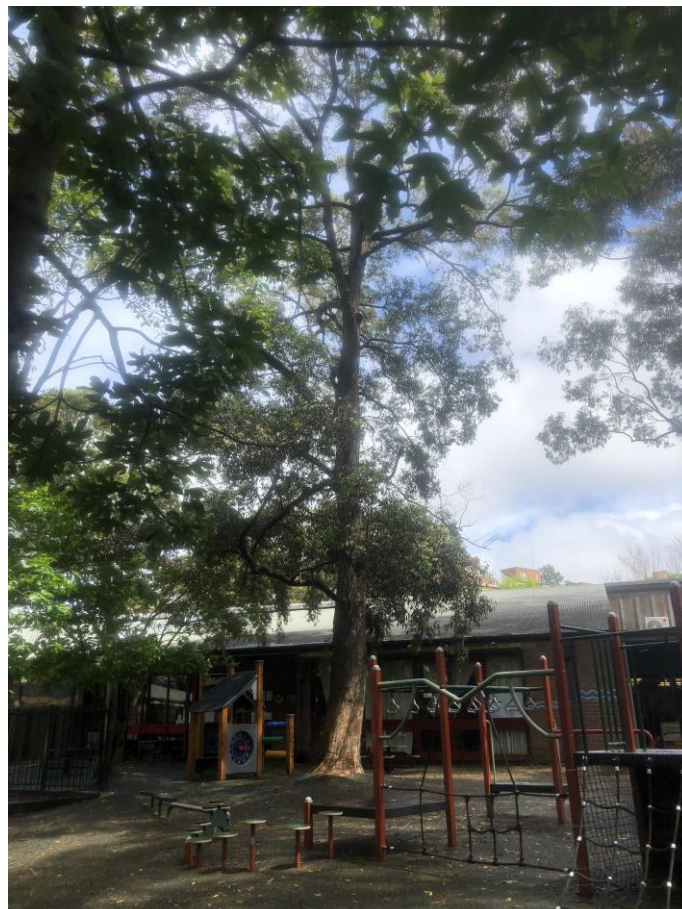
**Plate 2:** Image showing one of the larger mature specimens, Tree 53. P. Vezgoff

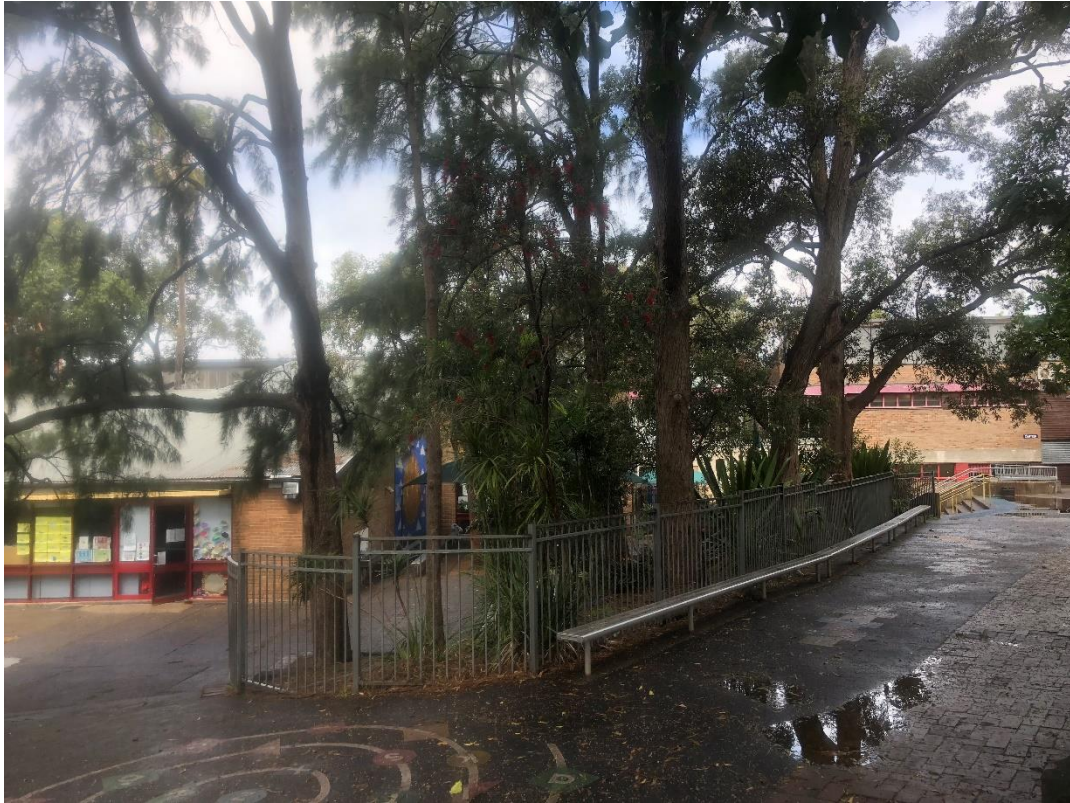
- 3.4** Trees 7-15 are located within the central playground area (Plate 3). Although not great specimens individually, they do work well as a group providing canopy cover and good aesthetic value to the rear area.

**Plate 3:** Image showing Trees 7-15 central to the playground area. The area not facing the camera consists of a low retaining wall. P. Vezgoff

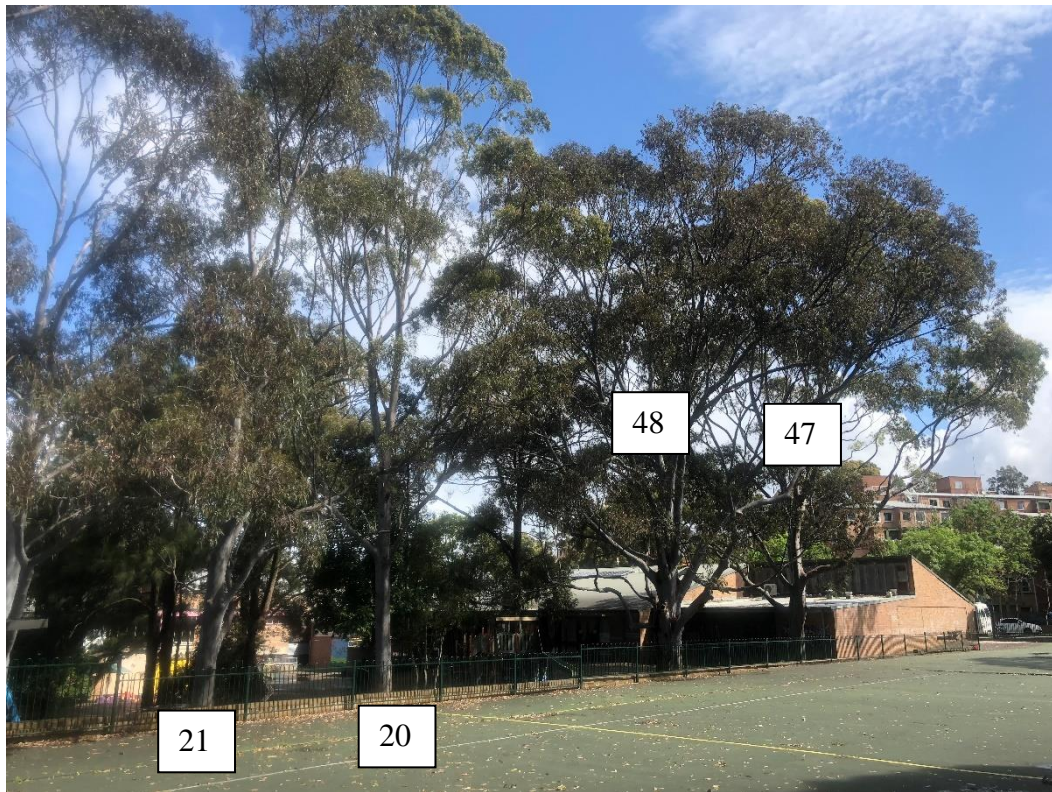
- 3.5** Trees 20, 21, 47 and 48 are some of the larger trees on site being some twenty (20) metres in height (Plate 4). The majority of the root zone of these trees is covered with hard surface. These trees have some previous failures which is to be expected from trees of this size and age. These trees were assessed as being in good health and condition. The main trunks, first and second order branches are free of any cracks, splits or fruiting bodies. New extension growth was noted. The basal area and woody root zones were free of any ground heaving, or lifting. Ideally an aerial inspection should occur to fully determine the condition of the main branch unions if they were to be retained.

**Plate 4:** Image showing Trees 21, 20. P. Vezgoff

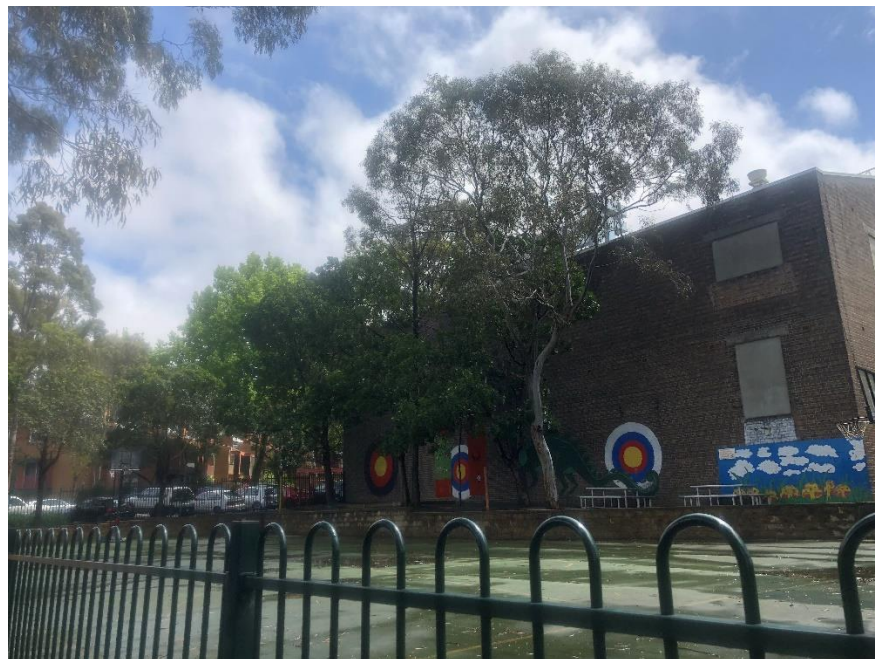
- 3.6** Trees 26-31 (Plate 5) are tightly grouped specimens that have a restricted root space and are covered with asphalt and playground rubberised matting up to the trunks. These trees are mostly in good health but could be replaced with better specimens. They would not be considered long term specimens.

**Plate 5:** Image showing Trees 26-31. P. Vezgoff

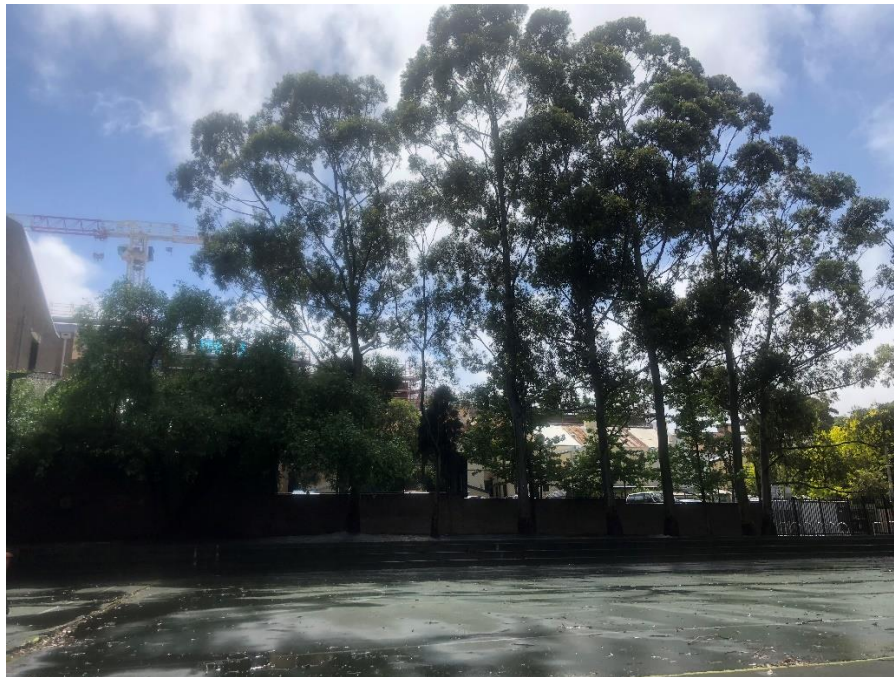
- 3.7** Trees 32-39 are growing along the northern boundary fence (Plate 6). These are a mixed group of large mature *Eucalyptus* specimens but competing with some exotic specimens (*Liquidambar*) that have been planted between and under the large *Eucalyptus* specimens. These trees are also tightly grouped specimens that have a restricted root space and are covered with asphalt and playground rubberised matting up to the trunks. Varied levels are present as these trees have been planted on a stepped area (Plate 7).
- 3.8** Under these larger more dominant native specimens are Trees 40-43 that are *Liquidambar* (*Liquidambar styraciflua*) and a single *Cupressus* specimen. These trees can be seen in Plate 7. Now suppressed, these trees will not reach maturity and as such are not long term viable specimens.

**Plate 6:** Image showing Trees 32-39. P. Vezgoff

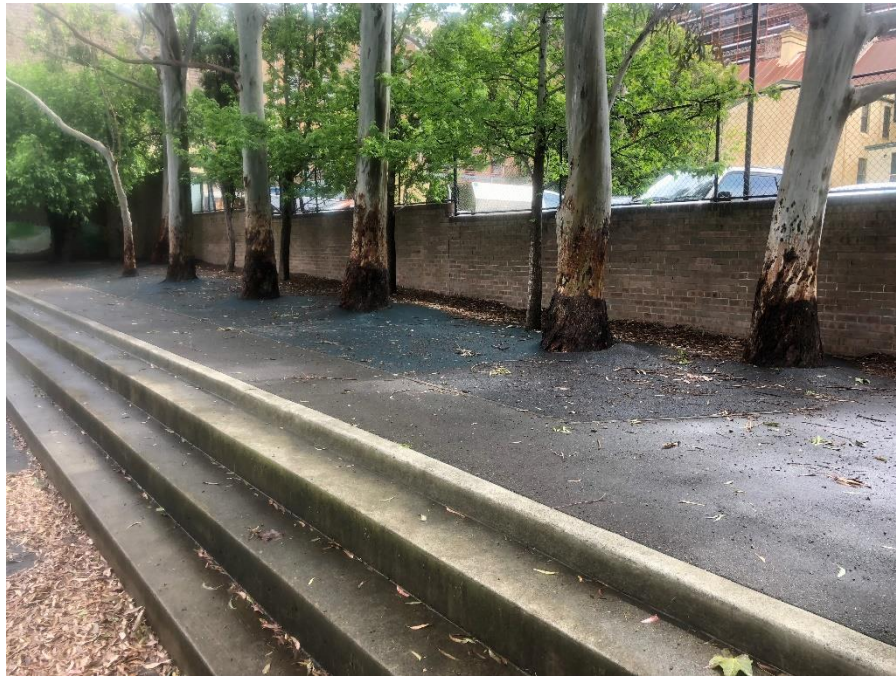
**Plate 7:** Image showing surface condition of Trees 32-39. P. Vezgoff

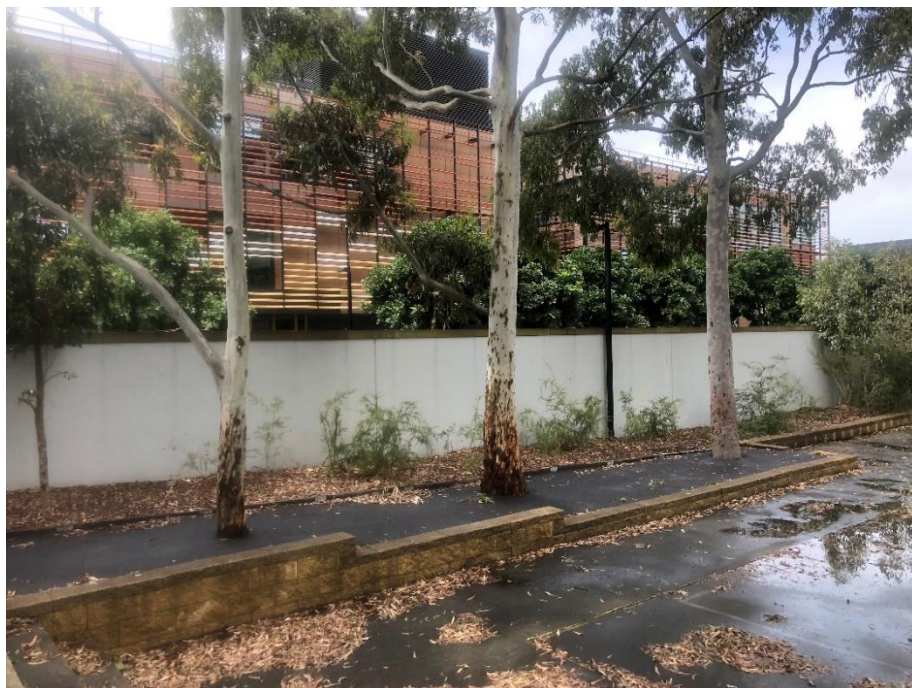
- 3.9** Trees 44-46 (Plate 8) are growing along the eastern boundary fence. These trees are younger specimens in excellent health and condition and provide a good screen between two properties. The majority of the root zones of these trees is covered with hard surface.

**Plate 8:** Image showing Trees 44-46. P. Vezgoff

**3.20.3 Hydrovac:** When undertaking hydro-vacuum excavation the water pressure shall be calibrated so as to not damage, remove bark, or sever roots over 30mm in diameter. Canopy clearance will require assessment based on the size truck that will be supplied. Depending on the location of storage bays and site sheds it may be possible to park the truck off the street provide canopy clearance is available. The truck should also be kept out of the TPZ areas and not parked within any TPZ area for the duration of the works. No roots >30mm within the SRZ are to be cut or damaged. The Project Arborist shall supervise these works. This option could be used for the decking piers below Trees 33-39 and 44-46.

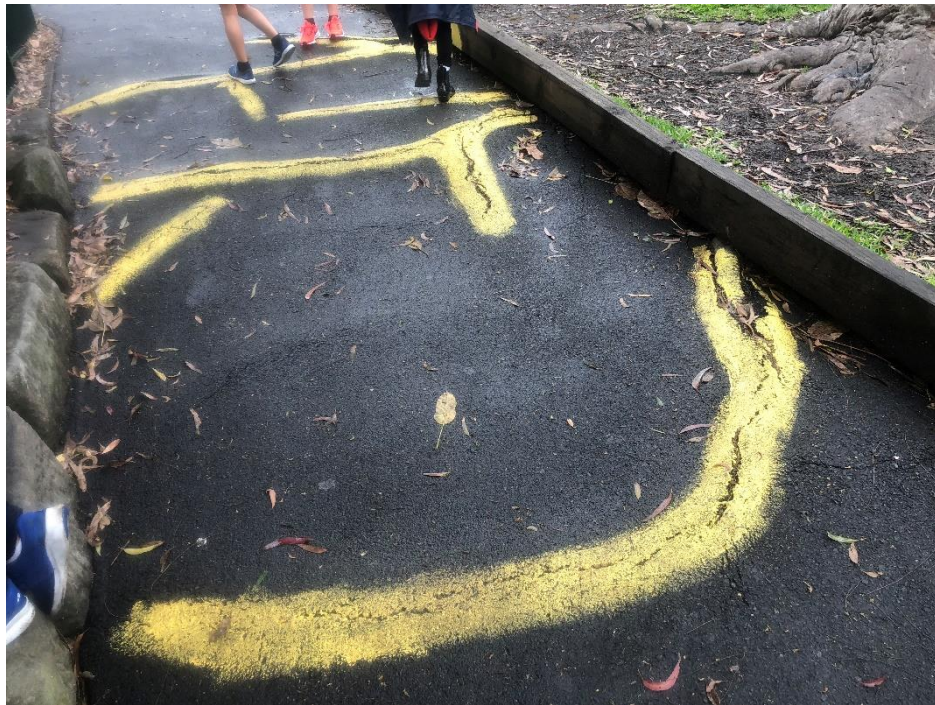
**Plate 9:** Image showing surface roots from Tree 20. P. Vezgoff

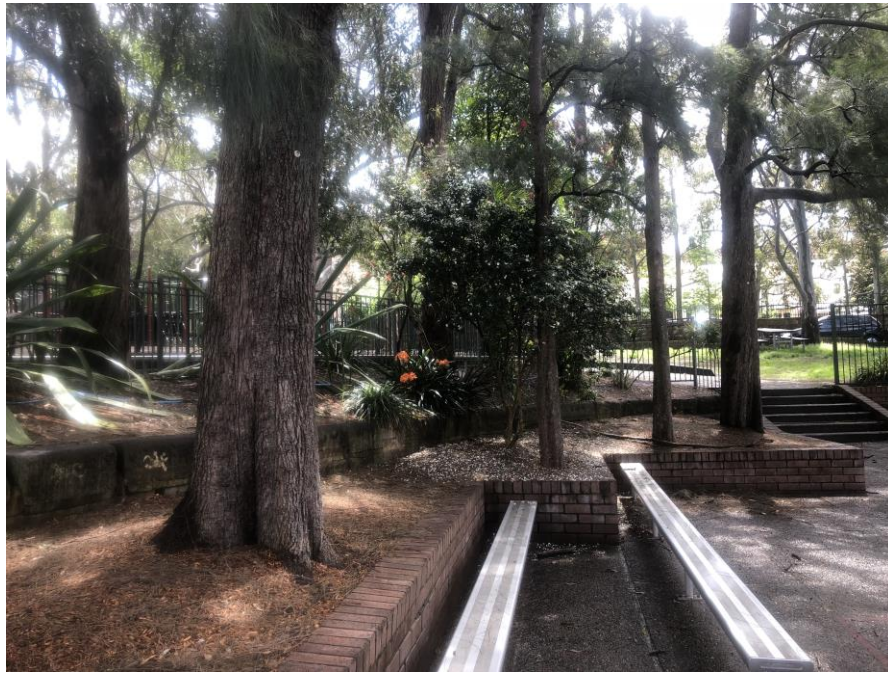
- 3.17** The design levels around Tree 12 are very tight as it is surrounded by an existing brick wall and sandstone steps (Plate 10). Any new wall around this tree is likely to require additional excavation to allow for drainage. The landscape design is working to retain existing levels and allowing for the construction of new accessible footpath however further consultation may be required in relation Trees 12-15 to achieve this.

**Plate 10:** Trees 9, 10, 11 and 12. P. Vezgoff

**3.20.2 Hand excavation:** Hand excavation will ensure that no roots within the SRZ are to be cut or damaged that are >40mm in diameter around Trees such as 6, 12, 17, 18 and 19.

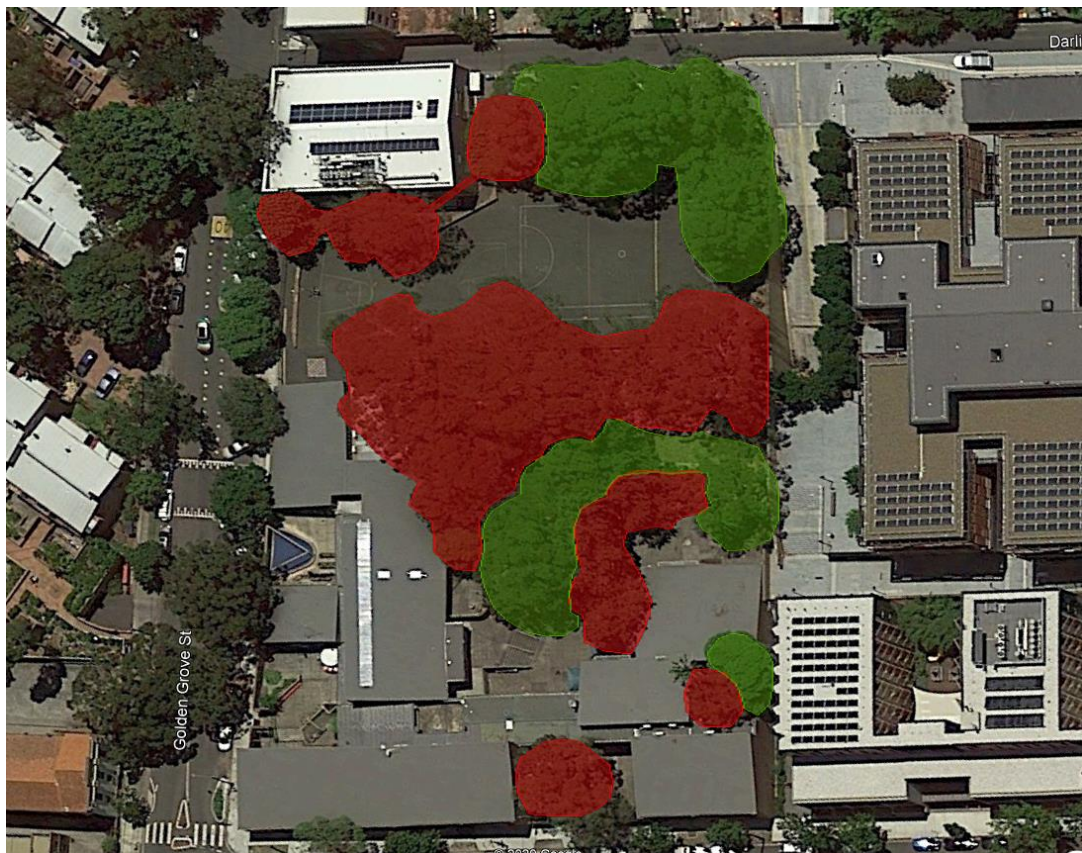
**Diagram 3:** Image showing the proposed trees to be removed (red) and the trees that will be retained (green) (Google earth 2020).
