Cockle Bay Park Redevelopment

Maritime Archaeology Statement of Heritage Impact

Darling Harbour
Sydney
NSW

October 2021

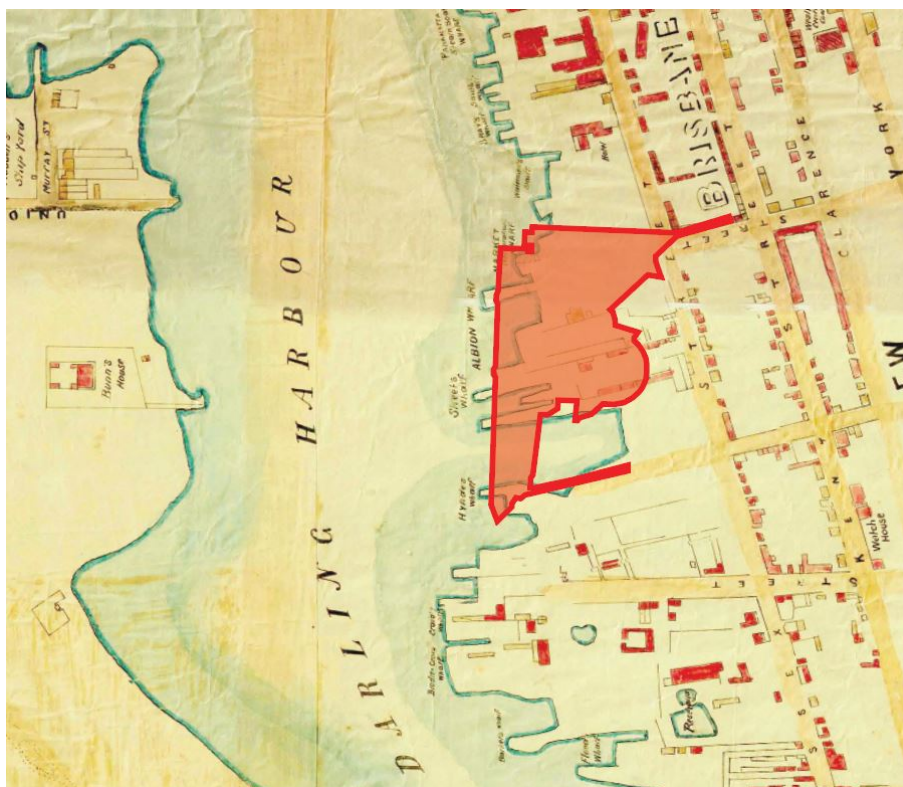
Figure 6: 1844 map of Darling Harbour showing wharves within the study area. Study area of Cockle Bay Park shown in red.¹⁴

Several episodes of private land reclamation occurred along the eastern side of Darling Harbour within the current study area during the early to mid-1840s, followed by the construction of four new wharves; including Albion Wharf just to the south of Market Street, associated with Messrs. Hughes and Hosking’s Albion Mills; a new Streets Wharf, situated between Market and Druitt Streets and seemingly replacing the previous Streets Wharf; Mr. Jaques Wharf just south of Streets Wharf, and Mr. Thomas Hyndes Wharf at the end of Druitt Street – the latter three all offering rent of wharfage and storage to coastal shipping businesses (Figure 6 and Figure 7).

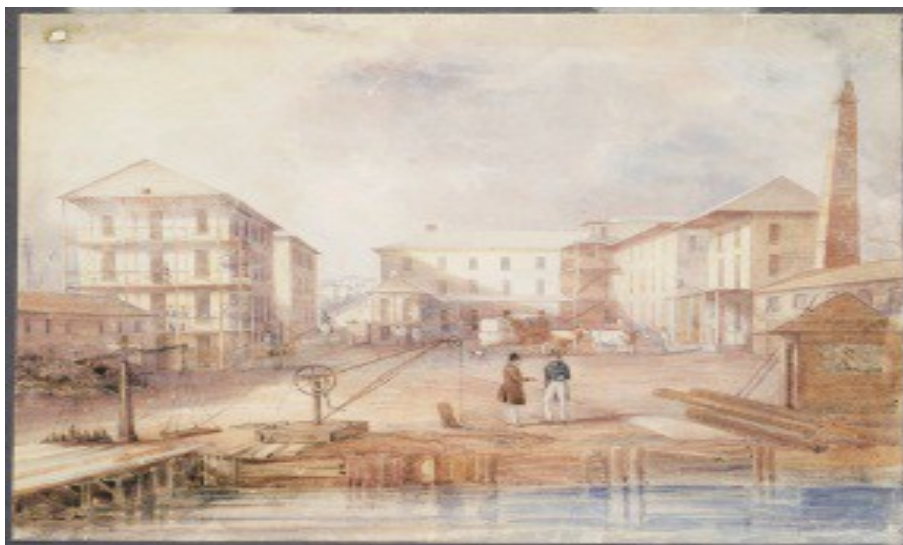
Figure 7: ca. early 1840s painting of Albion Mills with associated timber wharf visible in foreground on left-hand-side.¹⁵

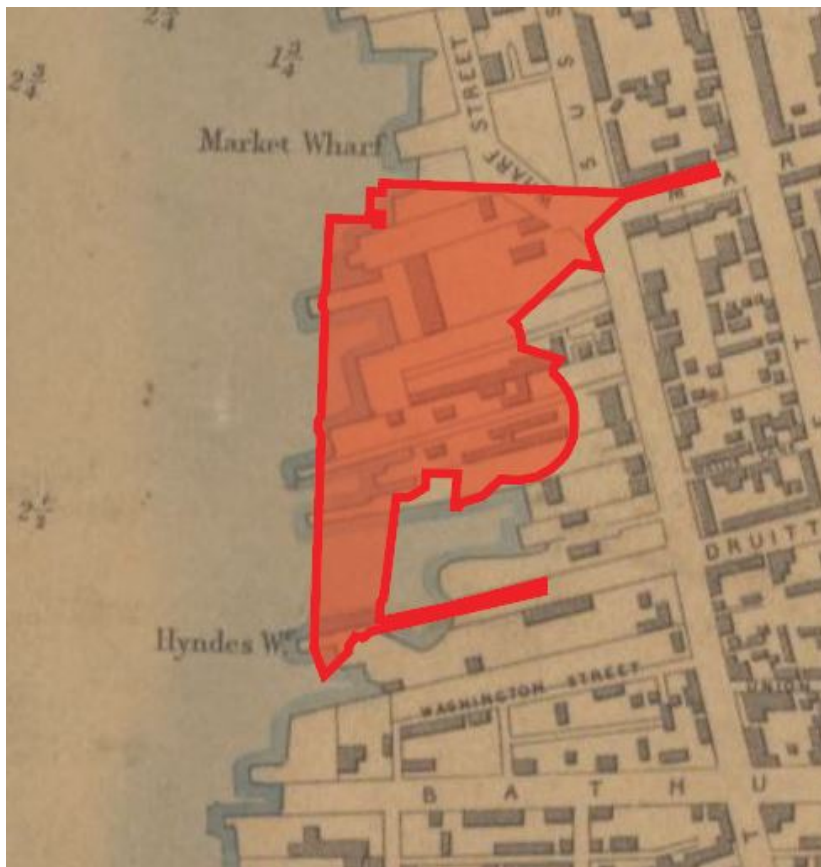
Figure 8: 1853 map of Darling Harbour showing wharves within the study area (shown in red).¹⁶

By 1853, almost the entirety of the eastern shore of Darling Harbour had been taken up. Land within the vicinity of the study area was more intensively occupied and the beginnings of additional land reclamation were being undertaken; however, no new wharves were constructed during this time (Figure 8).

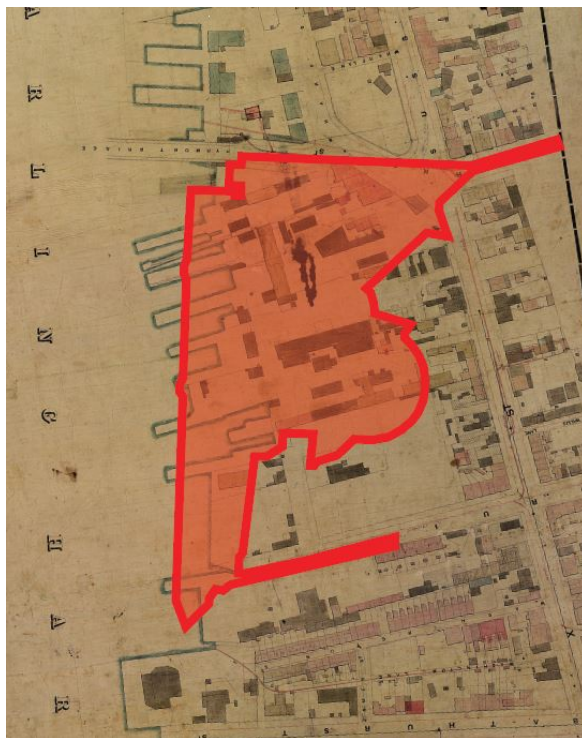
Figure 9: 1865 surveyors plans of Darling Harbour showing detail of wharves on the eastern shore. Study area of Cockle Bay Park shown in red.¹⁷

the existing Albion Wharf; a second Albion Wharf to the south of the original; Fagan Bros pair of wharves just to the north of Jaques Wharf, and the Jones Bros coaling wharf at the end of Bathurst Street. The original (northern) Albion Wharf had also been extended by this time (Figure 9 and Figure 10). By the mid-1860s, this collection of wharves and associated warehouses and shipping facilities on the eastern side of Darling Harbour between the Pyrmont Bridge and Bathurst Street catered almost exclusively to timber and coal industries.

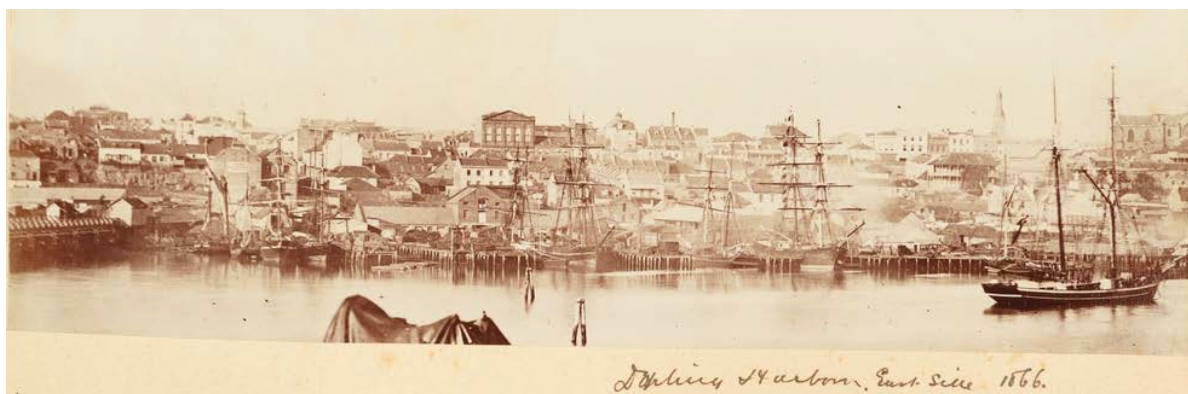
Figure 10: 1866 photograph of Darling Harbour showing wharves along the eastern shore within the study area.¹⁸

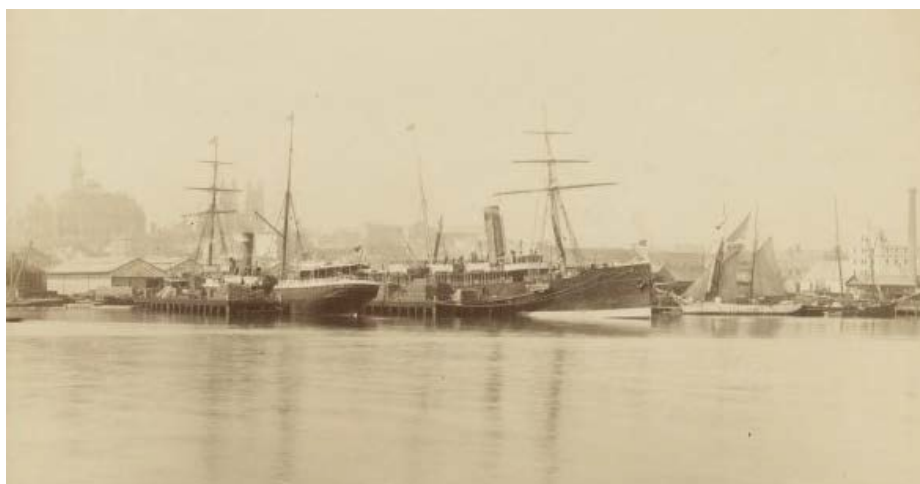
Figure 13: ca. 1890s photograph of ships at Union Wharves, Darling Harbour.²⁰

Zealand) with the existing structures demolished and a pair of two long much longer wharves built (Figure 13); Hyndes Wharf was demolished and replaced by a new long wharf for Pacific foundry; and an additional wharf was constructed along the northern side of the Jones Bros. coal wharf.

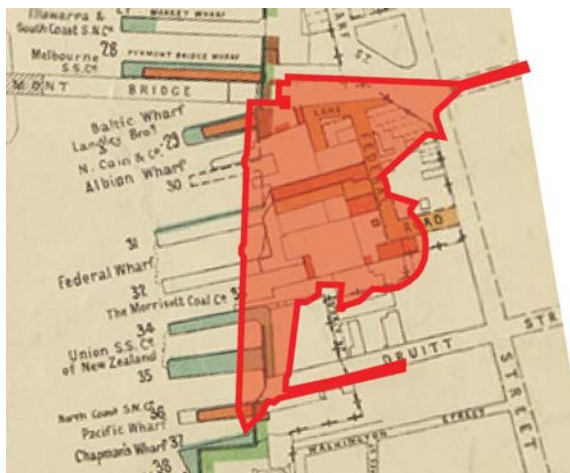
Figure 17: 1907 plan of Darling Harbour showing improvements carried out by Sydney Harbour Trust; blue-green shading denotes wharves or jetties erected, green marks the length of rat proof retaining wall erected, and orange shading signifies buildings erected / altered. The study area is outlined in red.²⁴

Federal Wharf, and additional wharfage alongside the Jones Bros coal wharf; known as Chapmans Wharf. The establishment of a rat proof sea wall within the vicinity of the current study area was first conducted along the eastern shore of the harbour, largely completed by 1907; with the southern and western shorelines rat-proofed by 1911 (Figure 17 and Figure 18).

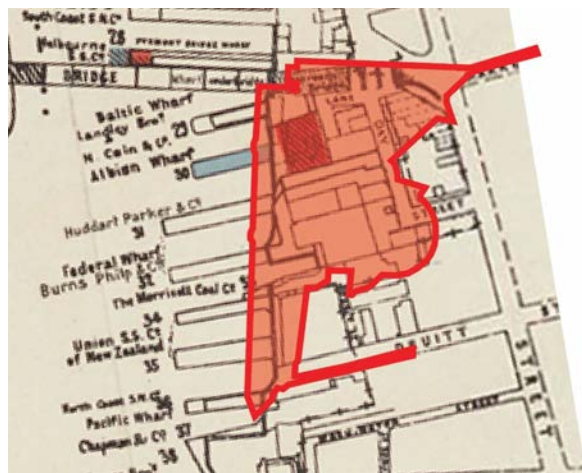
Figure 18: 1911 plan of Darling Harbour showing improvements carried out by Sydney Harbour Trust; blue shading denotes wharves or jetties erected, green marks the length of rat proof retaining wall erected, and orange shading signifies buildings erected / altered. The study area is outlined in red.²⁵

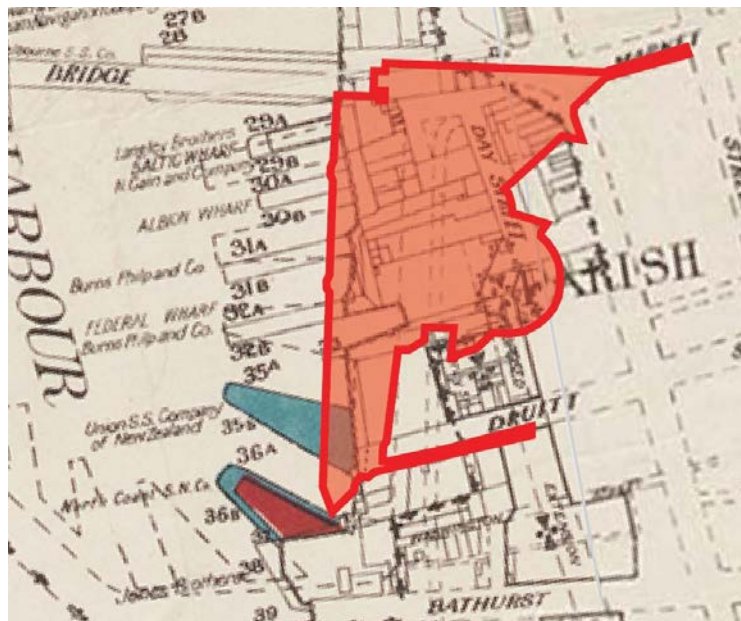
Figure 19: 1919 plan of Darling Harbour showing improvements carried out by Sydney Harbour Trust; blue shading denotes wharves or jetties erected and red shading signifies buildings erected / altered. The study area is outlined in red.²⁶

In the meantime, the Sydney Harbour Trust continued redevelopment of the wharfage on the eastern side of Darling Harbour within the current study area, including the demolition of two Union Steam Ship Co. Wharves and Pacific Wharf, strips of infill land reclamation and subsequent construction of the much larger Wharves 35 and 36 (Figure 19 to Figure 21).

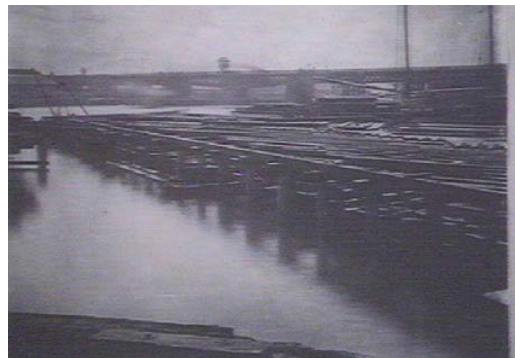
Figure 21: Wharf 35 under construction, September 1918.²⁸

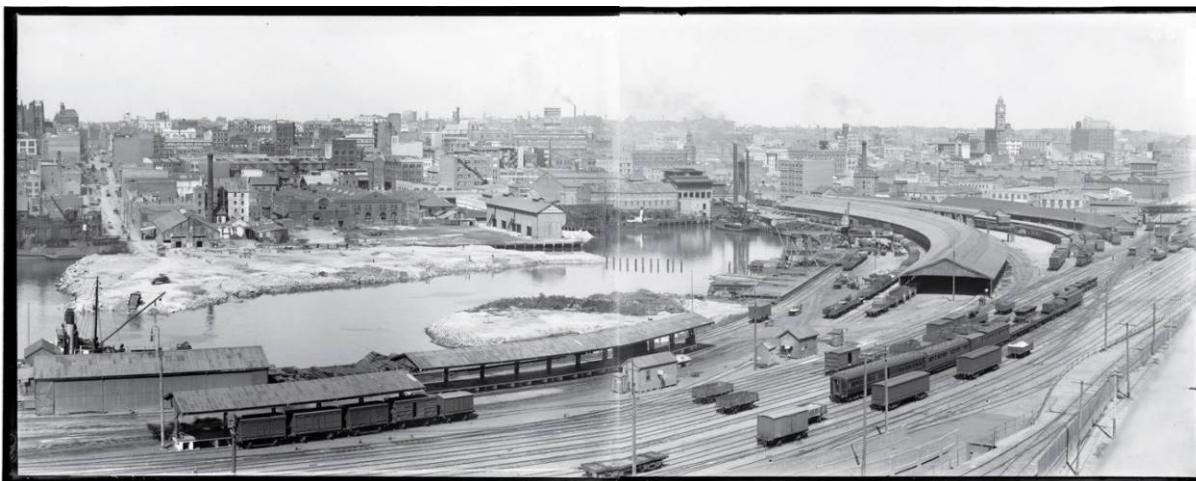
Figure 22: 1923 panorama showing commencement of reclamation works at the head of Darling Harbour.²⁹

Construction of the underground Sydney City Railway scheme finally commenced in 1923, allowing the reclamation of the head of Darling Harbour to be undertaken using the excavated spoil (Figure 22 and Figure 23). These works were completed in 1926 and over the course of the following two years, the Sydney Harbour Trust undertook the final stages of the Darling Harbour port improvement scheme; including works on the eastern side of Cockle Bay such as the extension of Wharf 36 and the demolition of the pair of Federal Wharves on the eastern shoreline to allow for the construction of Wharves 31 and 34 (Figure 22 and Figure 25).

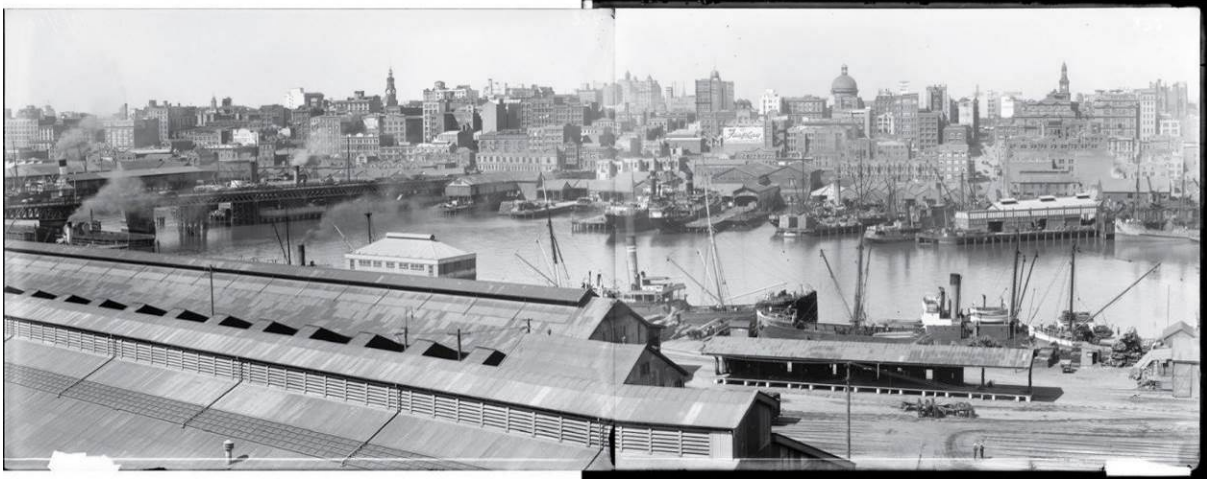
Figure 23: Continuation of 1923 panorama showing Darling Harbour railway goods yard in foreground and wharves along eastern shore in background.³⁰

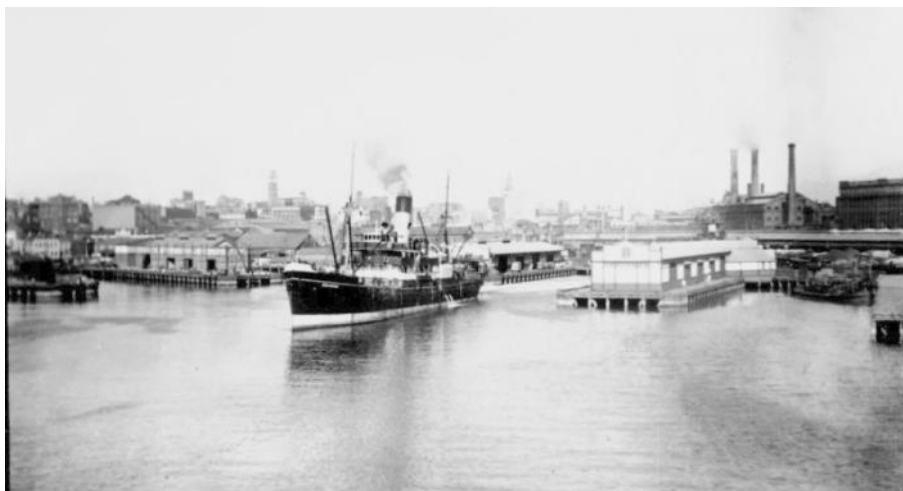
Figure 25: 1930s photograph of the head of Darling Harbour showing Wharves 34-37.³²

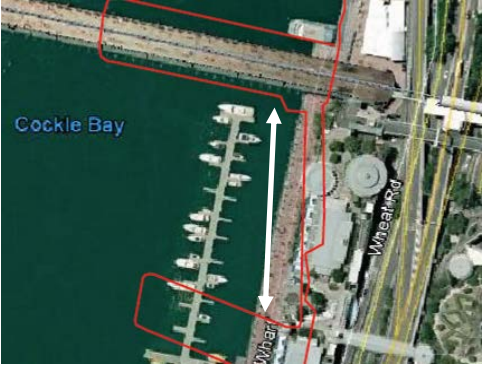
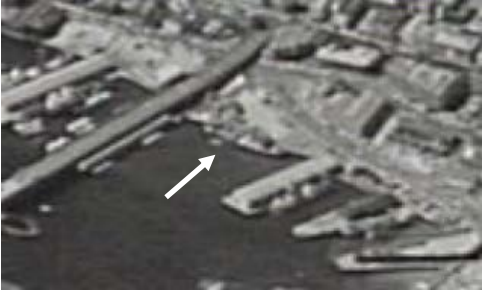
Wharf No.	History and Description	Outline Overlay and Historic Images
<p>Wharf 33 ca. 1961/1962 – mid 1980s</p>	<p>Wharf 33 was a longshore wharf built ca. 1961-1962 as part of port improvements conducted by the Maritime Services Board. These works included the demolition of Wharfs 29-31 and associated warehouses, the construction of Wharf 33 in their place, and the establishment of the Port Roadway along the eastern shore of Darling Harbour between Market and Bathurst Streets. Wharf 33 was built out from the existing ca. 1908-1911 seawall and is likely to have been constructed with a combination of timber and concrete piles, with concrete decking. Wharf 33 was demolished and / or buried under reclamation during the mid-1980s redevelopment of Cockle Bay by the Darling Harbour Authority. Previous structures within the footprint of Wharf 33 include sections of Wharves 29-31, the former Wharf 31, the former Baltic Wharf and earlier pair of Baltic Wharves, the former pair of Albion Wharves and earlier Albion Wharf, Fagans Wharves, the northern Federal Wharf and the former Streets Wharf.</p>

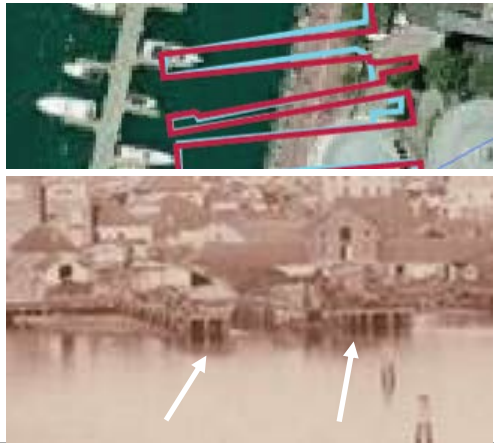
Wharf No.	History and Description	Outline Overlay and Historic Images
<p>Former Baltic Wharves (pair) ca. early 1860s – mid 1880s</p>	<p>The original Baltic Wharves were constructed as a pair in ca. early 1860s as an extension on an earlier 1840s structure (outside study area). Both wharves were quite narrow, open wharves, built of timber piles and decking. The southern of the pair had a narrow gauge rail / trolley track running along its length. These wharves were either demolished or converted into the larger single Baltic Wharf (see above) in ca. mid 1880s. No previous structures occur in the footprint of this pair of Baltic Wharves.</p>

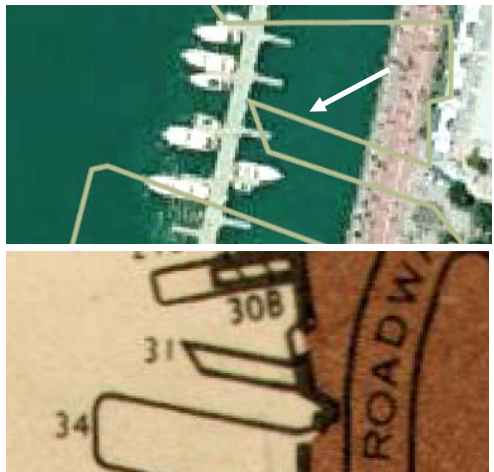
<p>Wharf 31 ca. 1956/1958 – 1963</p>	<p>Wharf 31 was constructed ca. 1956-1958 by the Maritime Services Board as part of improvement works to Darling Harbour. The wharf either replaced or involved the reconstruction of an earlier Wharf 31, and seems to represent a short lived attempt to improve wharfage by changing the alignment of Wharf 31 to match that of the larger Wharf 34 to the south. Wharf 31 is likely to have been built of timber piles and decking, and was demolished altogether by 1963. Previous structures in the footprint of Wharf 31 include part of the former Wharf 31, the northern wharf of Federal Wharves, the earlier pair of Fagans Wharves and the former Streets Wharf.</p>

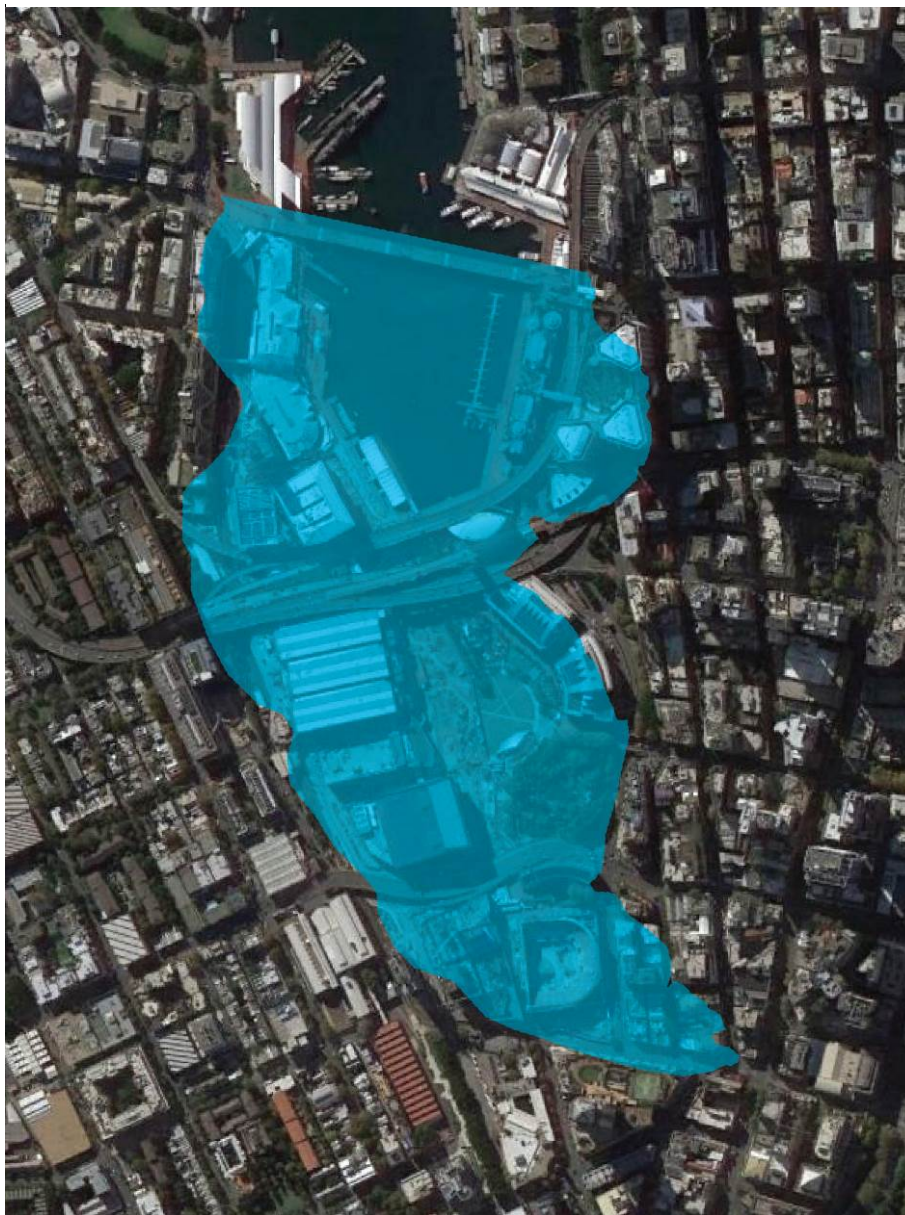
During the early years of European colonisation, the head of Darling Harbour extended as far south as Haymarket; reaching almost to Harbour Street and Sussex Street in the east and Pymont Street and Murray Street in the west (Figure 32).

Figure 32: Indicative outline of the extent of Darling Harbour south of the Pymont Bridge in the 1820s.

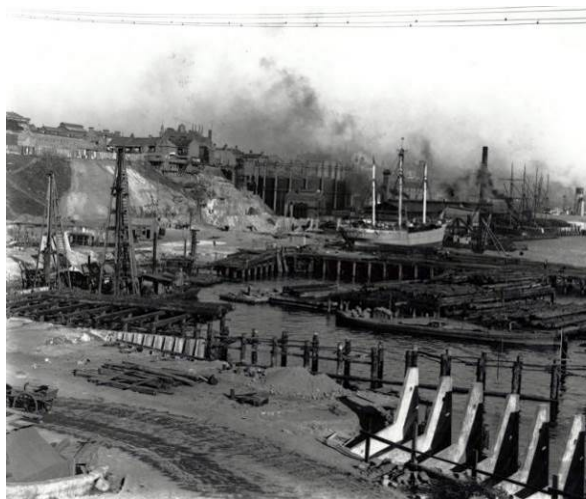
Figure 37: Example of Monier trestle seawall being constructed, Darling Harbour, 1909.⁴¹

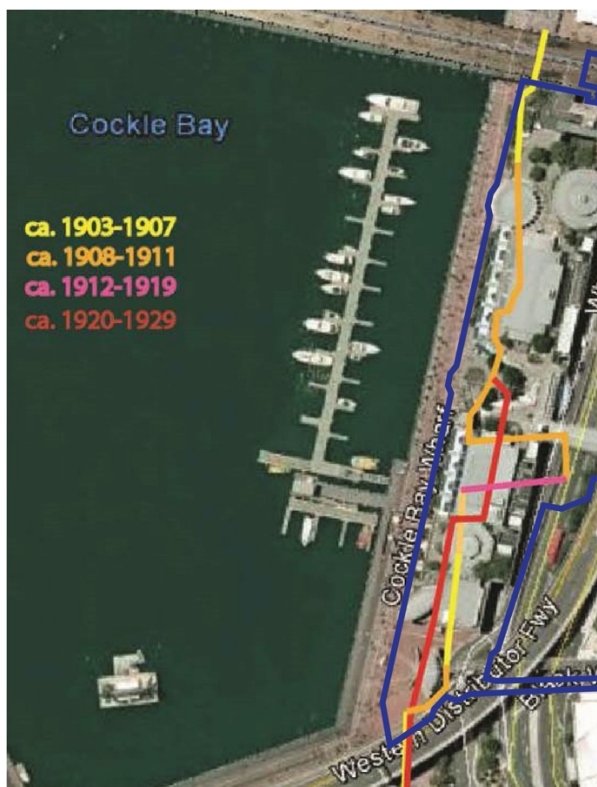
Figure 40 below provides an overlay of “rat-proofing” conducted by the Trust from ca. 1903-1930, with segments of the lines colour coded according to the general period of “rat-proofing.”

The line of wall marked as “rat proofed” in the 1920s (red line) crosses over several sections of pre-existing walls, most marked as “rat proofed” between 1903 and 1911. When viewed in comparison to historic overlays showing the wharves and reclamation in this area (Figure 41 and Figure 42), it is clear that the red line of wall runs along the base of Wharves 34 to 36 and the associated small strips of reclamation constructed by the Sydney Harbour Trust in 1918-1919 (Wharves 35 and 36) and 1927-1928 (Wharf 34). Photographs taken in 1919 during the construction of Wharves 35 and 36 indicate that this section of wall comprised timber sheet piling faced with Monier concrete plates (Figure 41 and Figure 42).

Figure 40: Overlay showing lines of “rat-proof retaining walls” established by the Sydney Harbour Trust in the 1900s-1920s. Study area shown with blue outline.

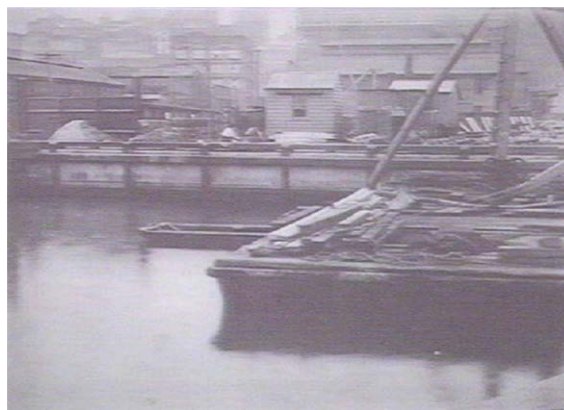
Figure 42 : Completed Monier plate facing of seawall between Wharves 35 and 36, Darling Harbour, 1919.⁴⁵

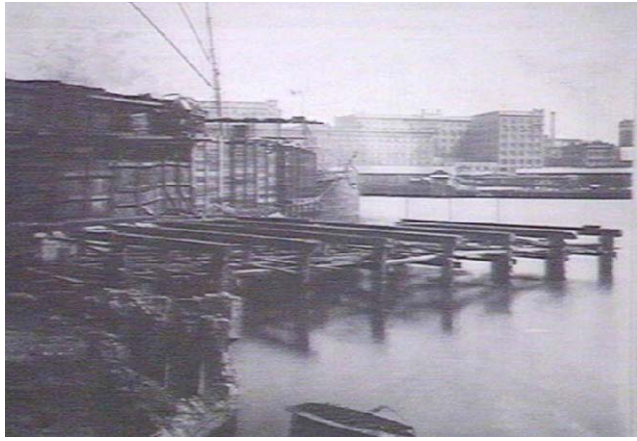
until the late 1920s. Part of this wall formed the base of Wharf 36, constructed by the Sydney Harbour Trust in 1918-1919 (Figure 43).

Figure 43 : Construction of Wharf 36, Darling Harbour, 1918, showing what appears to be a Monier plate faced seawall at the base of the wharf, fronting the northern edge of the Jones Bros. Wharf.⁴⁶

The Jones Bros. Wharf was resumed during the reclamation of the head of Darling Harbour in the 1920s and Wharf 36 was expanded southwards, backed by the newly erected Monier trestle and plate seawall fronting the reclamation. It is quite possible, however, that sections of the earlier Monier plate faced timber piling wall were actually incorporated into the expanded Wharf 36 rather than demolished altogether.

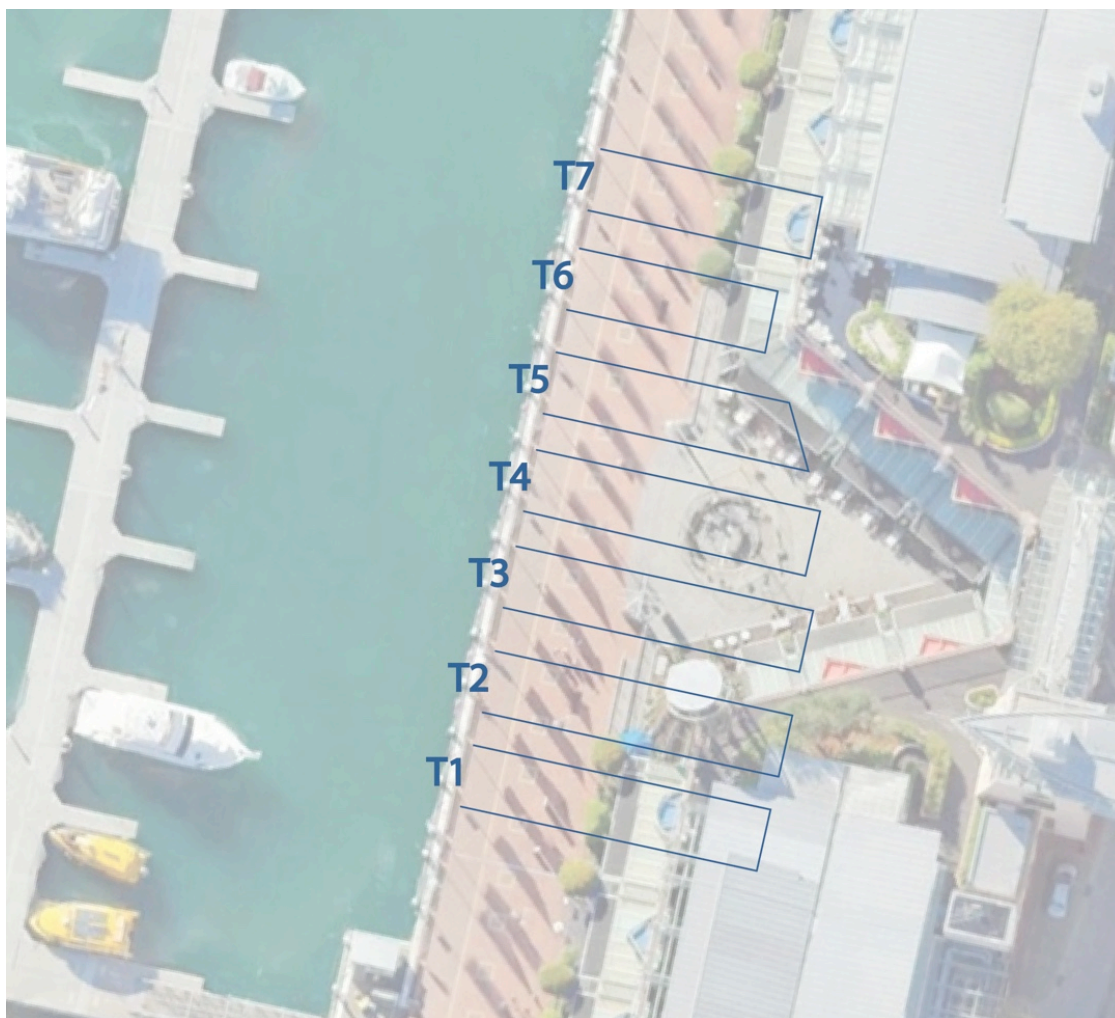
The area underneath the promenade to be impacted by piling greater than 300 mm diameter was the primary area for the survey. A total of 7 transects (T1 to T7) were conducted to cover the area, with one transect undertaken for each bent (Figure 48). The transect surveys were undertaken by the diver starting at the designated southern steel pile and then travelling east in a zig zag pattern, following the line of steel piles until they reached the seawall. The diver then moved to the northern line of steel piles and returned in a westerly direction until the edge of the promenade was reached. Video footage was captured throughout the entire survey, as well as additional observations being verbally transmitted through in-water communications to the archaeologist aboard the boat.

Distances from the edge of the wharf were estimated by relative locations to the steel piers supporting the wharf (labelled A, B, C, D consecutively towards the east).

Figure 48: Location of primary transects.

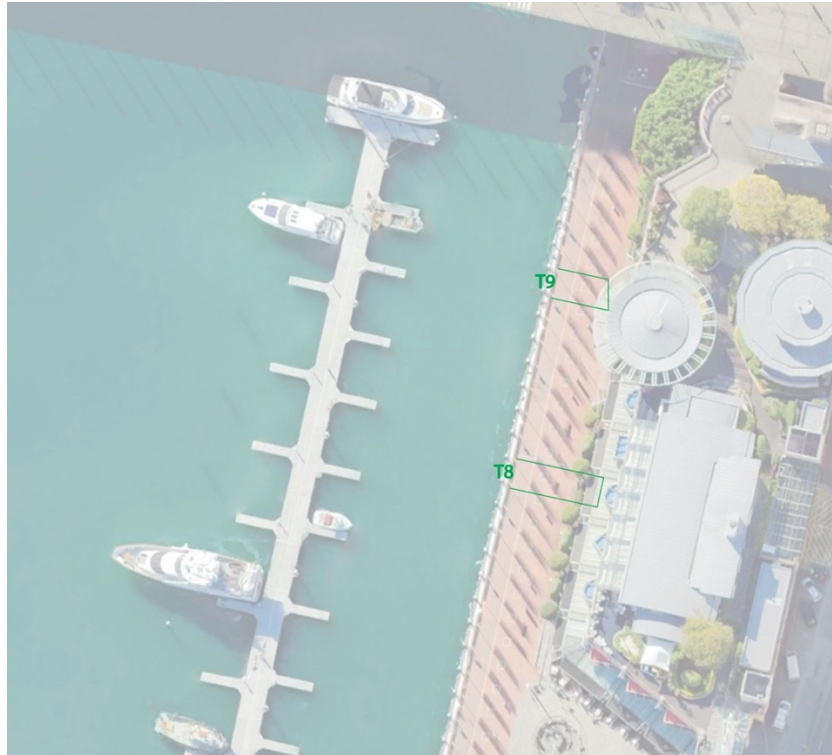
Figure 49: Location of T8 and T9 in the northern section of the study area.

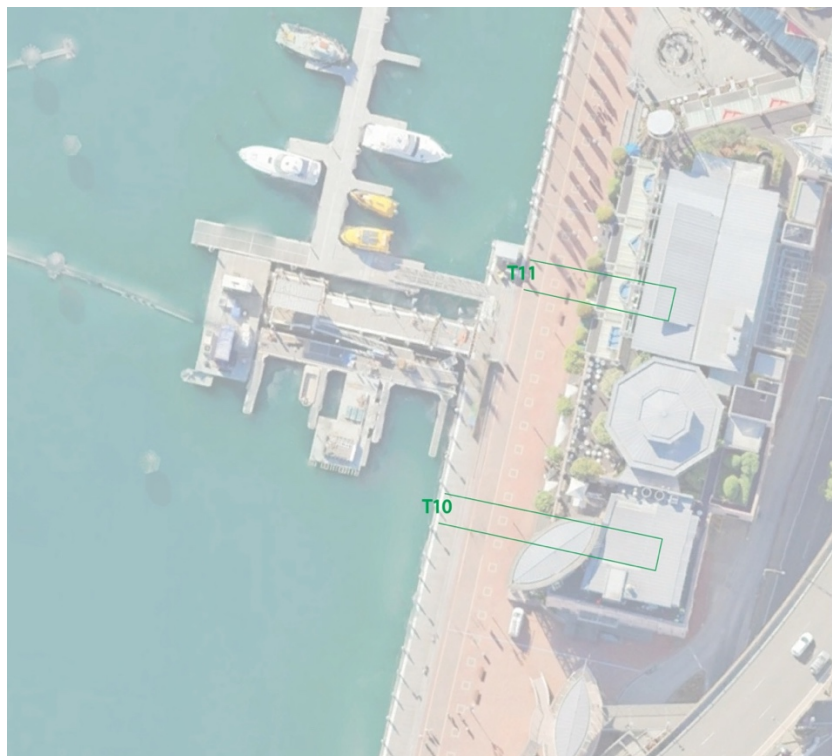
Figure 50: Location of T10 and T11 in the southern section of the study area.

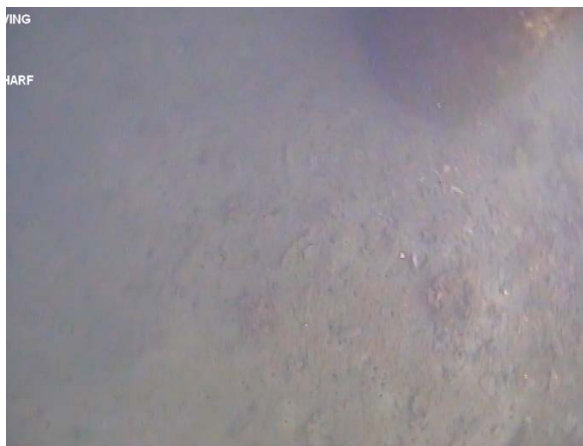
The seabed was relatively flat, silty and featureless (Figure 51). Between, and next to the 'B' and 'C' piles, a modern concrete mooring block was located, measuring 1400 mm long x 800 mm wide x 250 mm high. The block has a ferrous attachment point in the centre (Figure 52).

Figure 51: Example of silty seabed at western edge of promenade. 'A' steel pile at top of image. (Image from T1 (a) Cockle Bay 210705; 00:38).

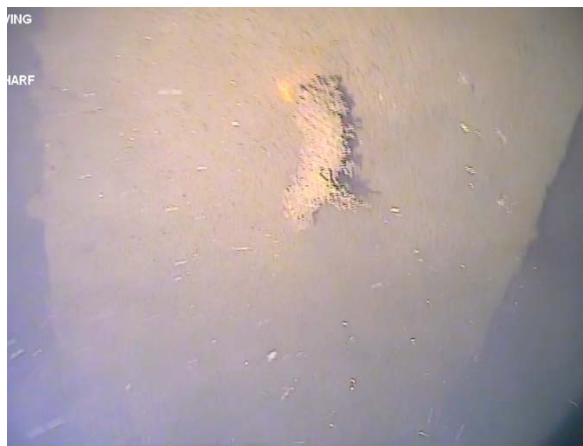
Figure 52: Modern concrete mooring block between steel piles 'B' and 'C' on the southern side of T1. (Image from T1 (a) Cockle Bay 210705; 03:38).

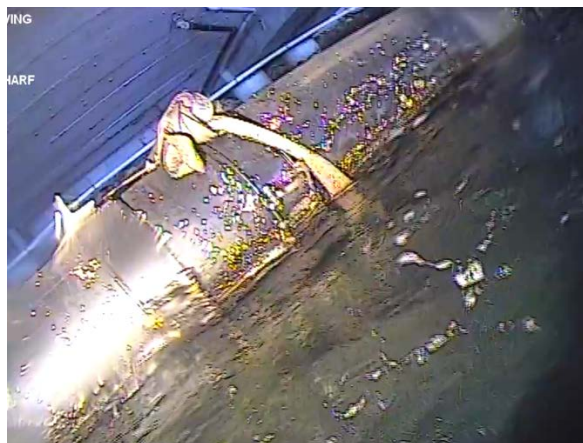
In front of the 'D' pile, what appears to be a rubbish net was located (Figure 53). This net ended at a depth of 2 m, therefore it is likely to catch floating rubbish from the storm water drains under the promenade. The seabed also began to rise at this point, probably from build-up of sediment due to the net's position. This net was attached in between two drainage pipes floating on the surface and running in an approximate north-south direction (Figure 54).

Figure 54: The rubbish net is attached to a floating drainage pipe. (Image from T1 (a) Cockle Bay 210705; 05:38).

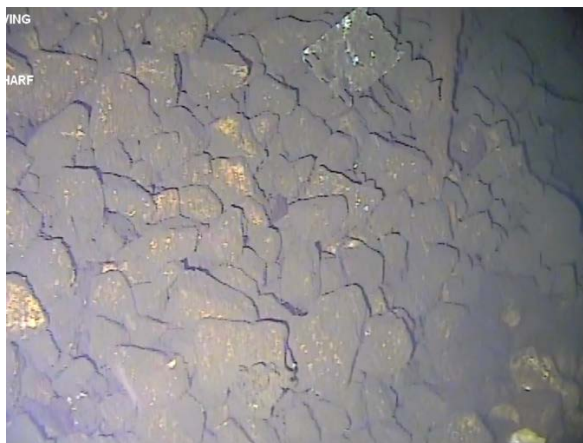
The base of the rock embankment began just after the 'D' pile, rising to an angle of 45°. The rocks in the embankment averaged 150 mm – 200 mm in size (Figure 55). The diver then travelled north following the rock embankment until the northern steel piles were reached and returned to the wharf apron to the west. No cultural features were located, other than three modern aluminium cans.

Figure 55: Example of rock embankment at western end of T1, slope of 45°. (Image from T1 (a) Cockle Bay 210705; 07:10).

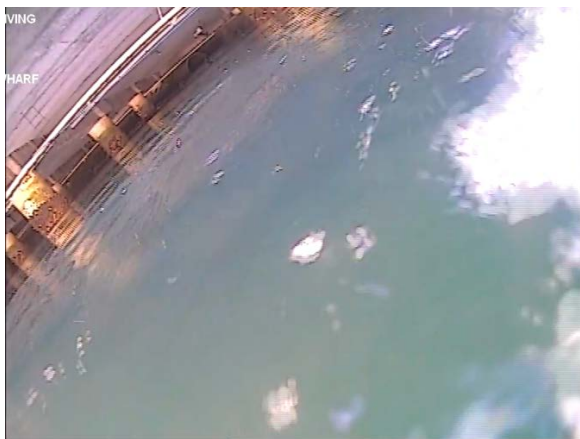
The diver started on the southern side of the bent working towards the east (Figure 56). The seabed was a relatively flat, silty bottom, and no cultural material was noted until near the 'D' pile. The rubbish net was visible in this location and just behind the net was a timber stormwater baffle (Figure 57). This structure consisted of two timber piles approximately 360 mm in diameter and 4 m tall (Figure 58). These piles were 3 m apart. Attached crossways to the piles were 8 planks measuring 100 mm thick x 300 mm wide and 3 m long (Figure 59). It appears that there were once 11 planks. This structure is in line with the stormwater drain at the eastern end of the bay. The drain appears to be held up by a concrete plinth that sits in the rock batter. There was a build-up of timber and sediment underneath the rubbish net and surrounding the timber baffle (Figure 60).

Figure 56: Start of T2, note stormwater drain at end of bay. (Image from T2 (a) Cockle Bay 210705, 00:04).

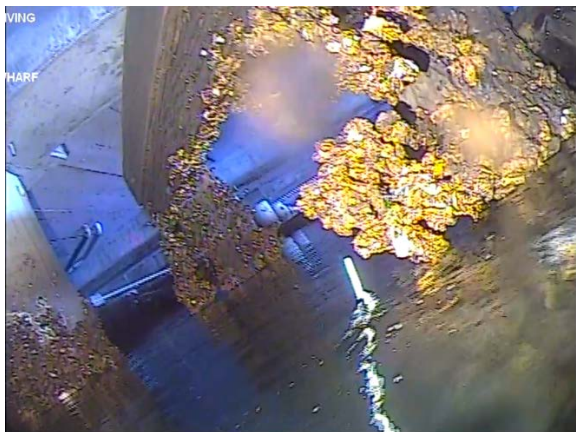
Figure 58: Timber stormwater baffle; 'D' pile to the left of image. Note large hole in net and missing timbers from baffle. (Image from T2 (a) Cockle Bay 210705, 03:57).

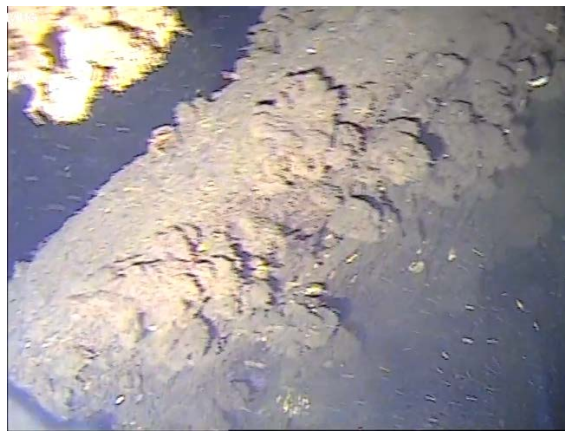
Figure 59: Example of timber planking for stormwater baffle. (Image from T2 (a) Cockle Bay 210705), 04:37).

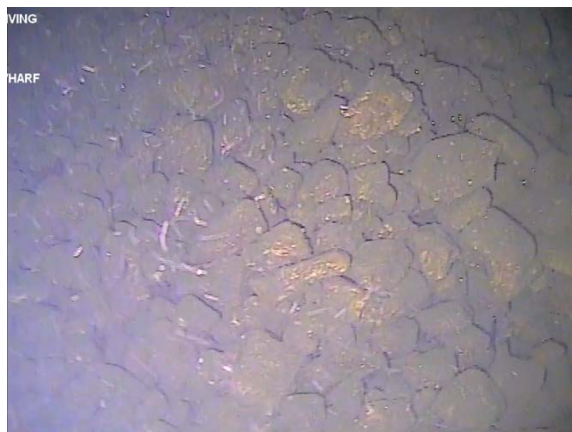
The rock batter begins at the base of the 'D' piles and is at a 45° angle, with rock size between 150 mm – 200 mm (Figure 61). The diver then travelled north following the rock embankment until the northern steel piles were reached and returned to the wharf apron to the west. A modern concrete mooring block was located on the southern side of 'B' and 'C' piles. The block was buried in the sediment with one corner exposed. Approximate measurements for the block were 1 m x 1 m and the depth could not be determined. The block had a ferrous attachment point (Figure 62). Just west of the block was a float, however it could not be determined what the float was attached to.

Figure 61: Rock embankment at eastern end of T2. (Image from T2 (a) Cockle Bay 210705, 06:39).

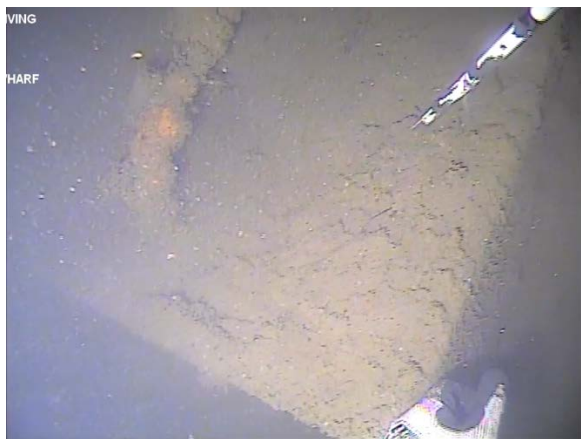
Figure 62: Mooring block northern side T2.
(Image from T2 (a) Cockle Bay 210705, 08:29).

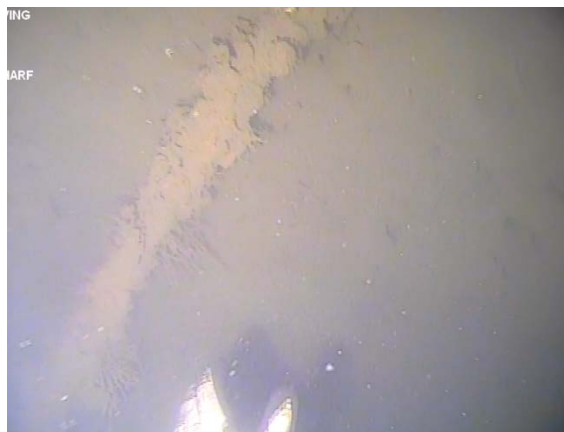
Just after steel pile ‘B’, in the centre of the bent, there was a heavily encrusted ferrous pipe with approximately 2 m of the pipe visible above the seabed and both ends penetrating the sediment. The pipe had a diameter of 60 mm and ran in a northwest to southeast direction (Figure 65).

Figure 65: Ferrous pipe running northwest to southeast across the centre of the bent. (Image from T3 (a) 210705, 03:05).

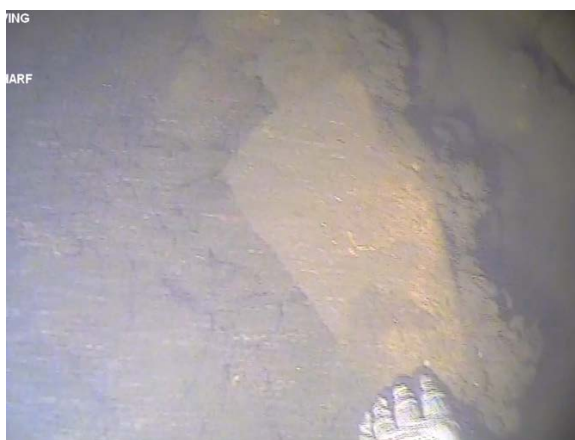
As the diver neared pile ‘C’, the seafloor began to rise and there was a build-up of predominantly plastic rubbish. The rubbish net was directly in front of pile ‘D’, where the rock batter also began. The batter was still at a 45° angle and many rocks were 150 mm – 200 mm in diameter. There were also some larger pieces of concrete amongst the rock batter (Figure 66).

Figure 66: Large piece of concrete resting on the rock batter. (Image from T3 (a) Cockle Bay 210705, 06:14).

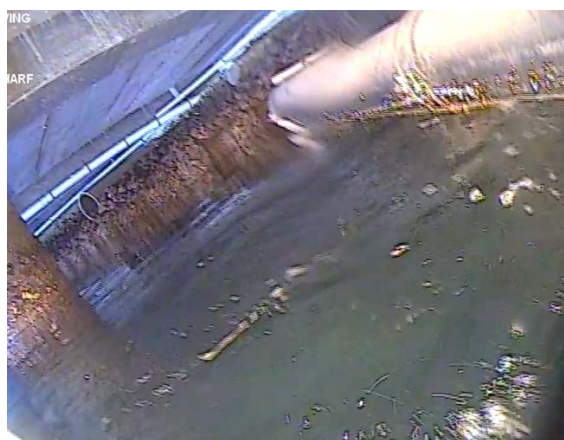
The rubbish net angled behind the northern ‘D’ pile and ended at the seawall in the next bent (Figure 67). Sheet piling began in the centre of this bent (Figure 68). At the base of the sheet pile and as the diver moved to the northern ‘D’ pile, there were pieces of scattered ferrous piping lying loose on top of the rock batter.

Figure 67: The rubbish net angles behind the northern 'D' pile (left of image) and extends towards the sea wall. (Image from T3 (a) Cockle Bay 210705, 06:45).

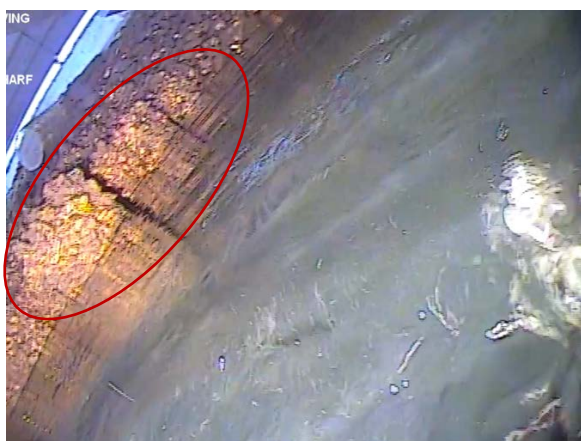
Figure 68: Sheet piling appears to start in this bent. (Image from T3 (a) Cockle Bay 210705, 07:49).

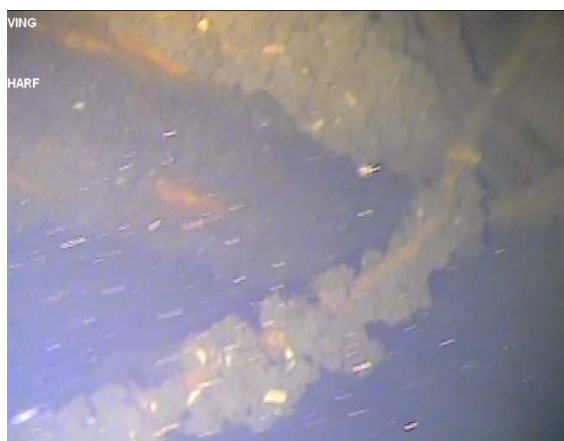
Figure 69: Sheet piling in background with loose ferrous piping in the foreground. (Image from T3 (a) Cockle Bay 210705, 07:38).

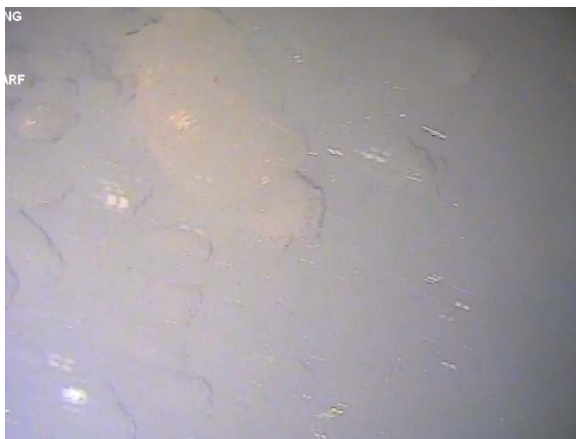
The diver then moved along the rock batter to the northern 'D' pile and continued the transect to the west, noting that the rock batter ended at the 'C' pile before the seabed returned to the relatively flat silty bottom. No other cultural material was noted.

Figure 70: Rocky batter and sediment past 'C' pile. (Image from T4 (a) Cockle Bay 210705, 04:07).

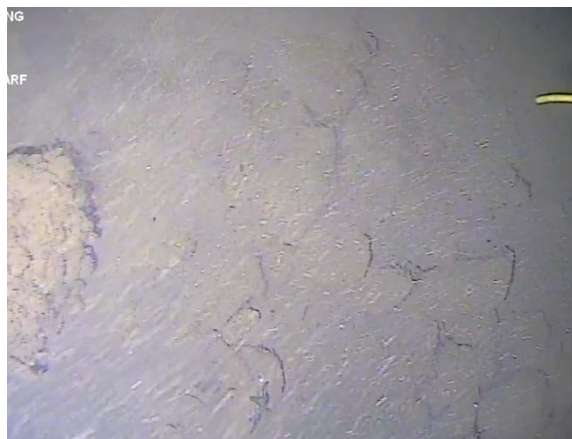
Figure 71: Increase in sediment build-up on the rock batter likely due to stormwater outflow. (Image from T4 (a) Cockle Bay 210705, 05:03).

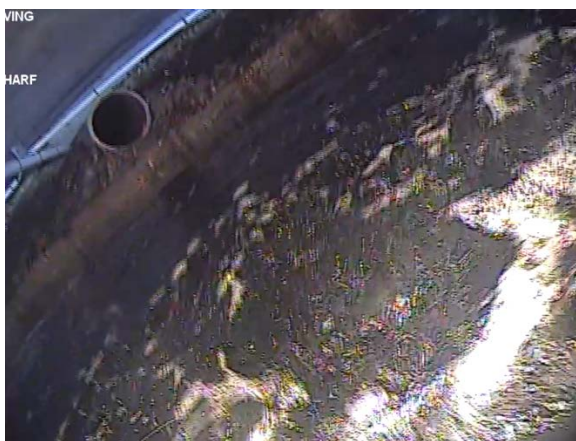
Figure 72: Stormwater at eastern end of bent. (Image from T4 (a) Cockle Bay 210705, 05:13).

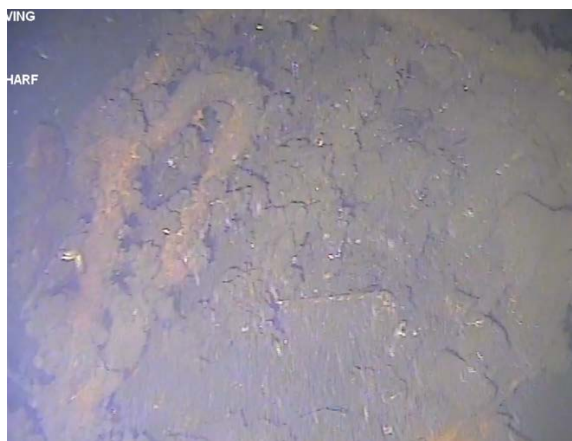
Figure 73: At the eastern end of the bent, on the rock batter, there is construction debris, consisting of ferrous pipes, possible service pipes and/or scaffolding. (Image from T4 (a) Cockle Bay 210705, 05:46).

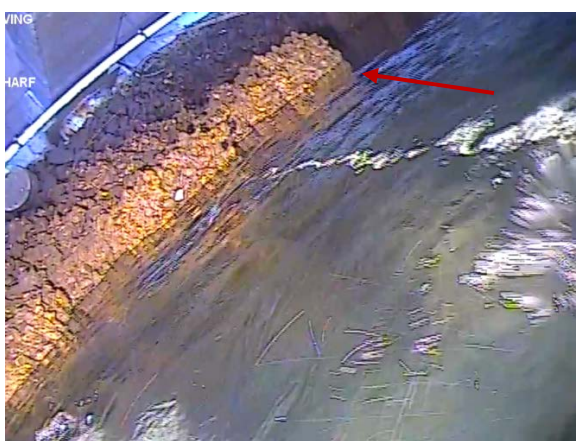
Figure 74: Sheet pile wall 1.5 m behind 'D' pile. The sheet pile returns to the east to run into the sea wall at the red arrow. (Image from T4 (a) Cockle Bay 210705, 07:06).

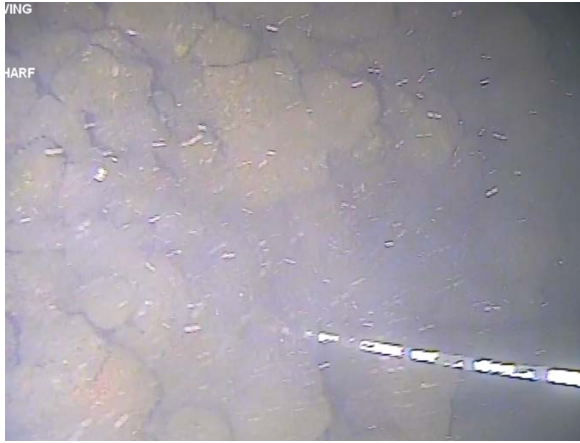
The diver started on the southern side of the bent working towards the east. Again, the seabed was silty and relatively flat. Just to the west of 'C' pile, the rock batter starts at a steep angle of approximately 45°. The rocks are between 100 mm and 200 mm in size (Figure 75). This batter rises for approximately 2 m before levelling out. There is some evidence of construction debris in this area (Figure 76). On the level section, the sediment has built up before the rock batter again rises at a 45° angle just west of the 'D' pile, ending at the sheet pile wall. On top of this second section of rock batter there is further ferrous pipes, possibly construction debris or old service pipes.

Figure 75: Example of rock batter beginning just to the west of 'C' pile. (Image from T5 (a) Cockle Bay 210705, 03:01).

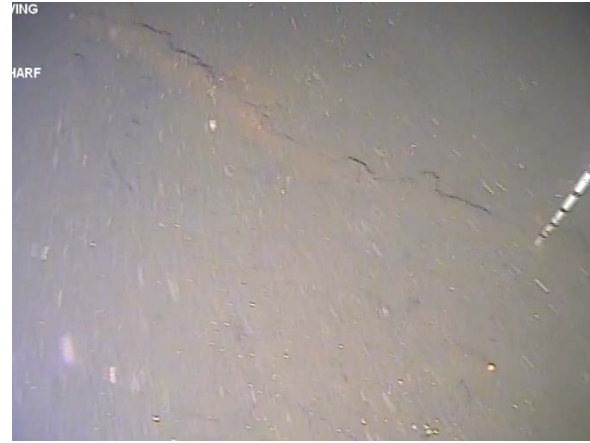
Figure 76: Where the rock batter flattens out, the seabed becomes siltier and there is scattered ferrous piping. (Image from T5 (a) Cockle Bay 210705, 03:40).

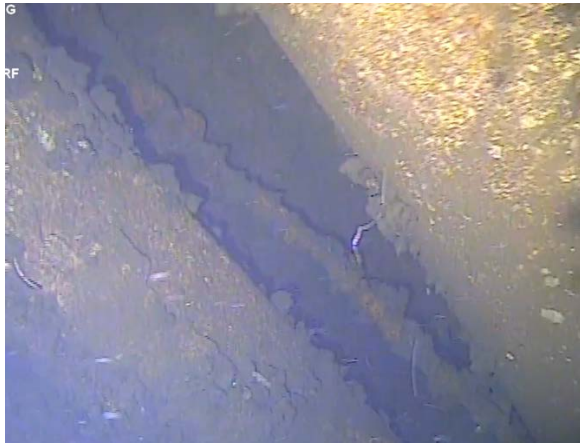
The sheet pile wall is 300 mm east of the 'D' pile (Figure 77). On the northern side of the bent, the corresponding 'D' pile is behind the sea wall and out of the water (Figure 78).

Figure 77: The southern 'D' pile (right of image) is 300 mm to the west of the sheet pile wall. (Image from T5 Cockle Bay 210507, 04:08).

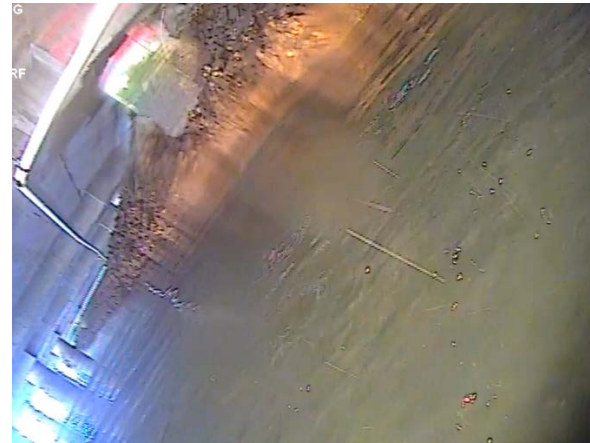
Figure 78: Northern 'D' pile is behind the sheet pile wall. (Image T5 Cockle Bay 210705; 04:59).
