Cockle Bay Park Redevelopment

Maritime Archaeology Statement of Heritage Impact

Darling Harbour
Sydney
NSW

October 2021

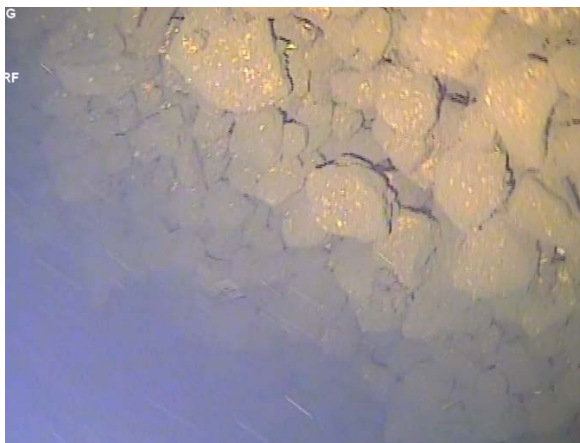
The steep rock batter extends down to the 'C' pile on the northern side (Figure 79), before flattening out into a silty seabed. No further cultural material was located on the western run of T5.

Figure 79: Example of rock batter near the 'C' pile on the northern side of the bent. (Image from T5 (a) Cockle Bay 210705; 05:35).

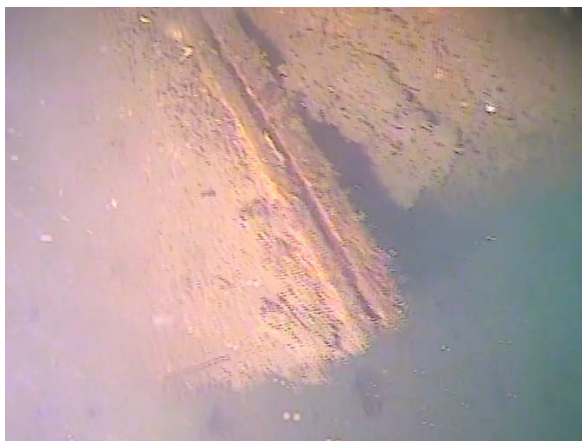
The diver started on the southern side of the bent working towards the east. Again, the seabed was silty and relatively flat. Leaning against the southern 'A' pile was what appeared to be a sandwich board or restaurant sign made of aluminium and ply, potentially from one of the restaurants in Cockle Bay (Figure 80). Immediately to the north of the sandwich board was a degraded timber. The timber stood upright 500 mm and was 120 mm in diameter (Figure 81). It did not appear to be a driven pile as the diver was able to push the timber over.

Figure 80: Sandwich or menu board resting against southern 'A' pile. (Image from T6 (a) Cockle Bay 210705; 00:36).

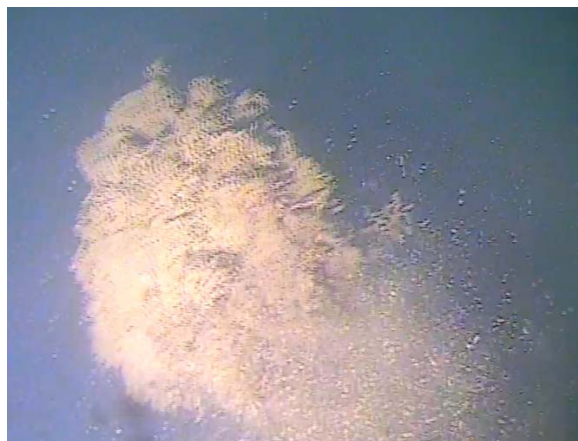
Figure 81: Degraded timber, 500 mm high and 120 mm diameter. (Image from T6 (a) Cockle Bay 210705; 00:43).

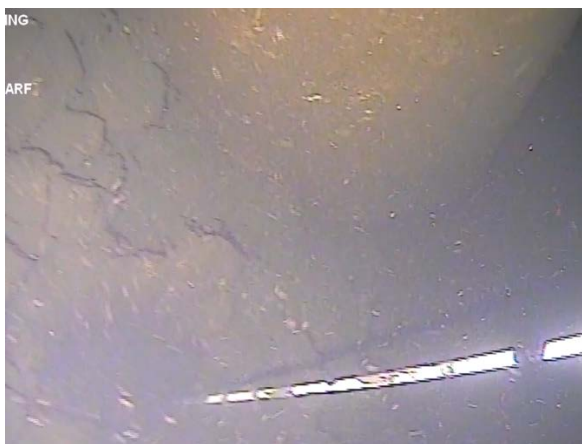
Approximately 1 m west of the southern 'C' pile, the seabed began to rise at an angle, before the rock batter started at the base of the 'C' pile (Figure 82). In the centre of the bent, adjacent to the 'C' pile, there was a 3 m section of 150 mm diameter PVC pipe running east to west. Underneath the pipe there was a 5 m section of encrusted ferrous pipe, like that seen in the previous transects. There was a large bend at one end of the pipe, both pipes were sitting loose on top of the rock batter (Figure 83).

Figure 82: The rock batter is exposed at the 'C' pile. (Image from T6 (a) Cockle Bay 210705; 04:10).

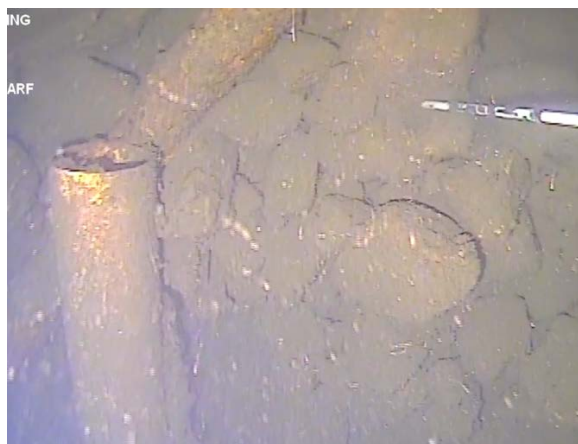
Figure 83: Section of PVC pipe with section of ferrous pipe underneath in the centre of the bent. (Image from T6 (a) Cockle Bay 210705; 04:20).

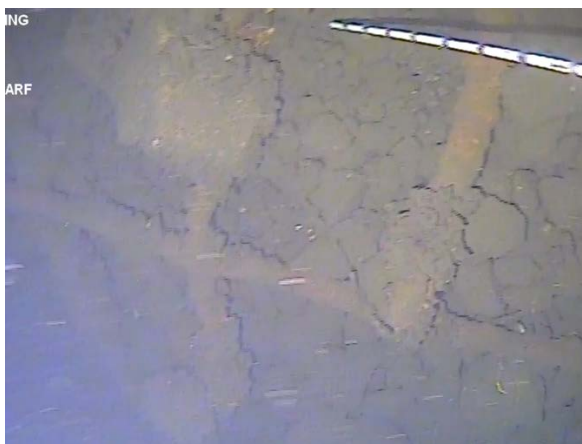
At the base of the sheet pile wall, the steep rock batter consisted of 100 – 200 mm rocks with construction debris lying loose on top (Figure 84). Both the northern and southern 'D' piles were out of the water behind the sheet pile wall.

Figure 84: Near the sheet piling there was a number of loose ferrous pipes lying on top of the rock batter. (Image from T6 (a) Cockle Bay 210705; 05:57).

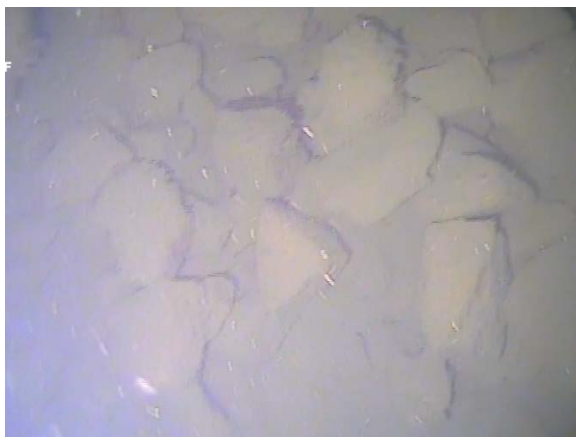
The diver started on the southern side of the bent working towards the east. Again, the seabed was silty and relatively flat. The seabed starts to rise just to the east of 'B' pile and the rock batter starts to emerge from the silty sediment (Figure 86). There were some larger rocks within this batter up to 800 mm and the batter itself was less than 45°. No cultural material was noted other than modern rubbish.

Figure 86: Rock batter emerging from the sediment to the east of the 'B' pile. (Image from T7 (b) Cockle Bay 210705; 01:12).

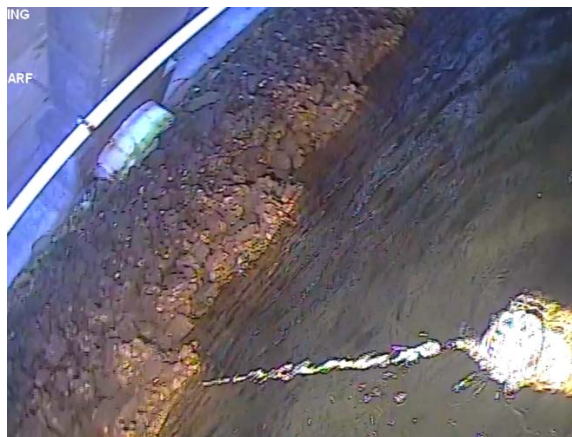
The sheet pile wall at the eastern end of the transect stood proud of the rock batter 800 mm and only just cleared the surface of the water (Figure 87). The diver then moved along the rock batter to the northern 'C' pile, noting some more ferrous pipes and possible construction debris lying on top of the batter (Figure 88).

Figure 87: Sheet pile wall at eastern end of transect holding up rock batter. (Image from T7 (b) Cockle Bay 210705; 02:17).

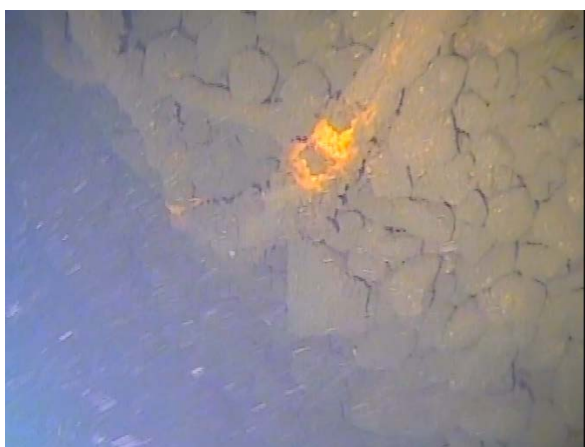
Figure 88: Construction debris resting on top of the rock batter at the eastern end of the transect. (Image from T7 (b) Cockle Bay 210705; 02:45).

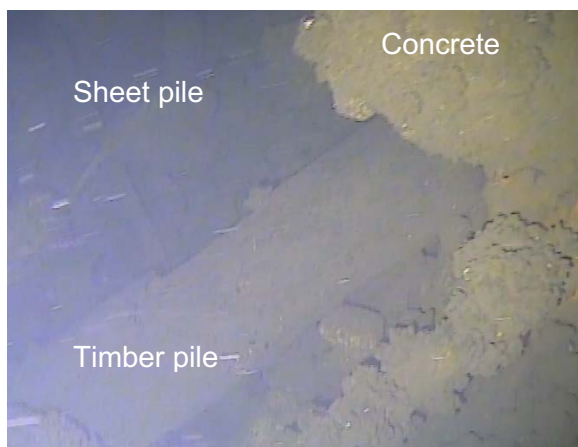
Just behind the northern 'C' pile, immediately in front of the sheet pile wall, a horizontal and a vertical timber pile were located underneath a section of concrete and other construction debris such as ferrous pipes. The diver could not get underneath the concrete section as it was not stable, so measurements of the piles are approximate. The vertical timber pile is resting directly in front (west) of the upright pile. It is heavily degraded, 700 mm diameter and 4 m long (Figure 89). The upright pile is heavily degraded, hollow in the centre and has a slightly smaller diameter of 500 mm and is standing out of the rock batter 2 m (Figure 90).

Figure 89: Horizontal timber pile on the northeast end of T7. (Image from T7 (b) Cockle Bay 210705; 03:38).

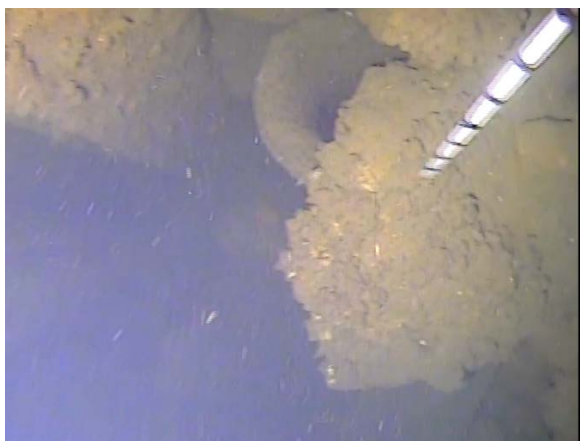
Figure 90: Degraded and hollowed out timber pile northeast end of transect 7. (Image from T7 (b) Cockle Bay 210705; 03:56).

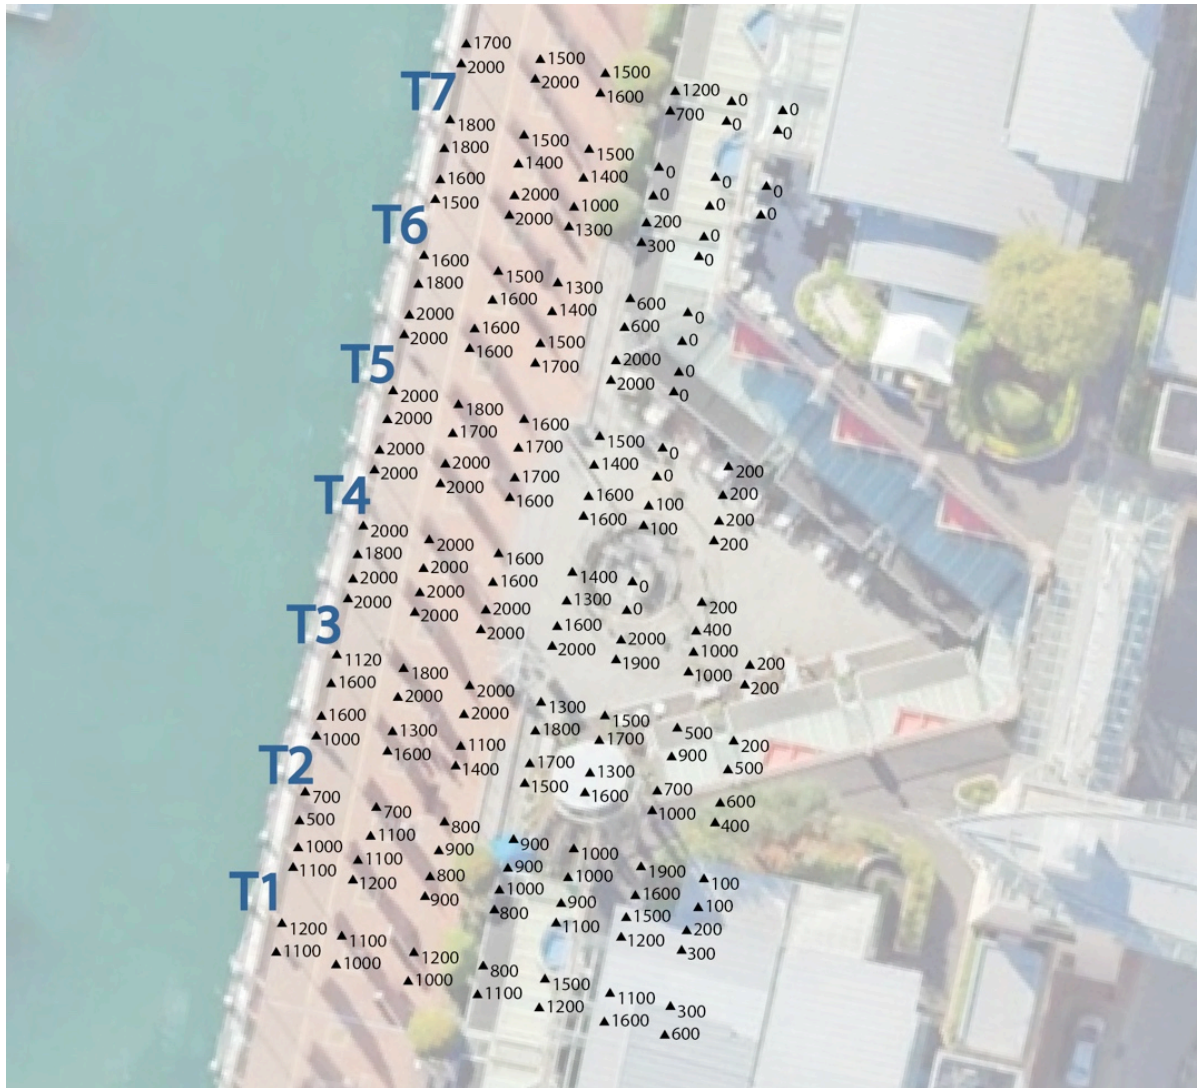
Figure 91: Overlay of probe results along transects in primary survey area. All depths are in mm.

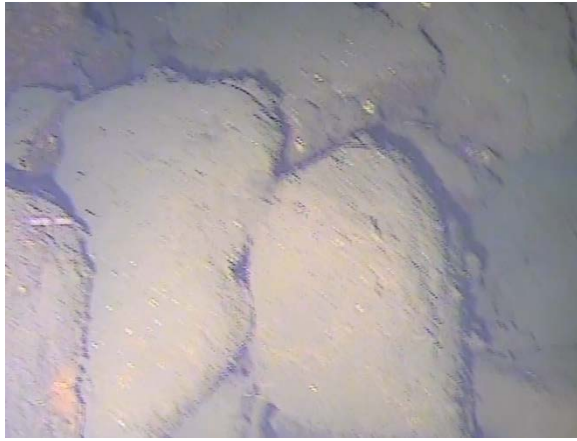
The diver started on the southern side of the bent working towards the east. Again, the seabed was silty and relatively flat. The rock batter began adjacent to the 'B' pile at a 45° angle; however, these rocks were larger, up to 1 m (Figure 92). They did not appear to be squared or shaped. There was a long ferrous pipe beginning from the northern 'B' pile running to the northeast for 5 m, similar to that found in the previous transects. At the base of the sheet pile wall, the rocks within the batter had reduced in size to 100 mm – 200 mm (Figure 93).

Figure 92: Example of rock batter at southern 'B' pile. (Image from T8 (a) Cockle Bay 210705; 03:44).

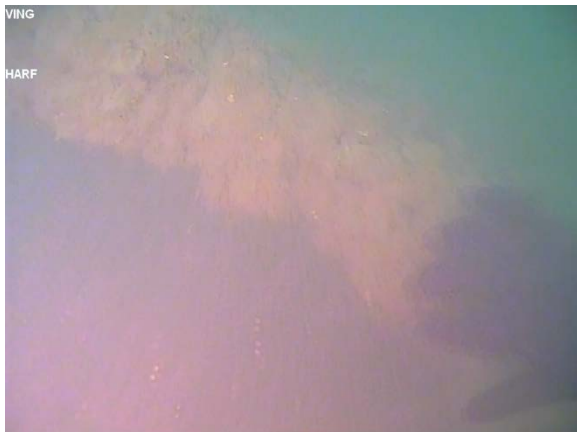
The diver then moved along the rock batter to the northern 'C' pile and continued the transect to the west. No significant cultural material was noted until the diver reached the 'A' pile. Approximately 1 m to the south of the pile, there was a timber driven at an angle into the seabed (Figure 94). The timber was 250 mm x 250 mm and there was 2 m exposed out of the seabed. The highest point was to the south at 1.5 m high. The timber could potentially be an old raker or whaler timber. No other cultural material was noted during the transect.

Figure 94: Rectangular pile on a 45° angle to the south in the centre of the bent adjacent to 'A' pile at the western end of T8. (Image from T8 (d) Cockle Bay 210705; 08:07).

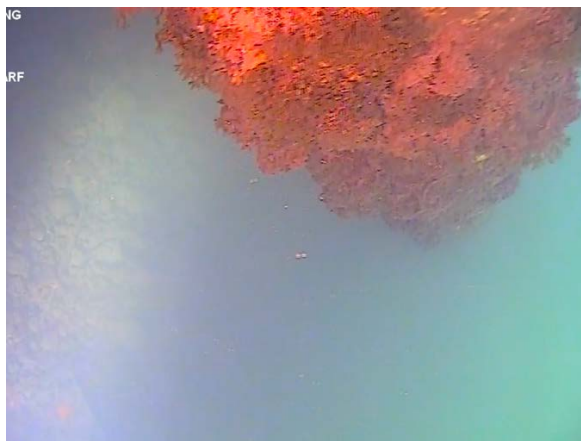
The diver started on the southern side of the bent working towards the east. Again, the seabed was silty and relatively flat but only until just to the east of 'A' pile before the rock batter began (Figure 95). The batter was quite steep, 45° and up to 60° in parts sloping to the west. There were isolated ferrous pipes scattered loosely over the batter (Figure 96). Adjacent to 'B' pile, the ferrous debris increased in volume and one single timber pile was located towards the centre of the bent (Figure 97). The degraded pile protruded 1400 mm high out of the rock batter with a diameter of 300 mm. The pile was approximately 500 mm to the west of the sheet pile wall and 2 m north of the southern 'B' pile.

Figure 95: Rock batter to the east of 'A' pile and the silty sediment to the west. Southern 'A' pile at top of image. (Image from T9 (a) Cockle Bay 210705; 00:04).

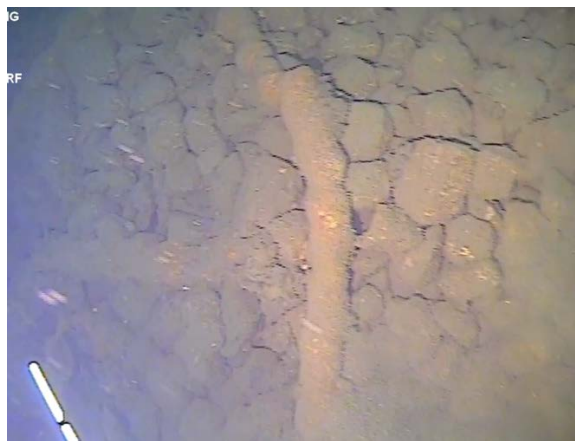
Figure 96: Scattered ferrous piping lying on top of the rock batter. Rocks measuring 100 - 300 mm in size. (Image from T9 (a) Cockle Bay 210705; 01:45).

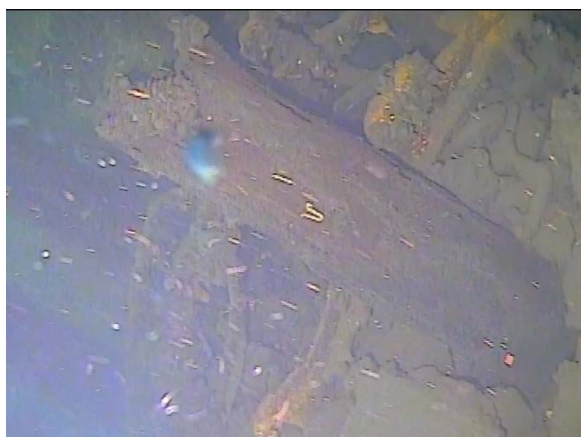
Figure 97: Timber pile adjacent to 'B' pile in centre of bent and surrounded by construction debris. (Image from T9 (a) Cockle Bay 210705; 03:06).

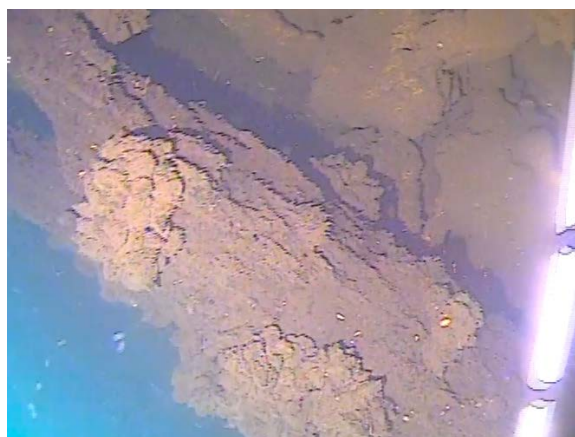
The diver then moved along the rock batter to the northern 'B' pile and continued the transect to the west. Leaning into the centre of the bent from 'B' pile was a loose, fallen pile. The pile was approximately 1.2 m from the sheet piling wall. The pile was approximately 300 mm in diameter and 2 m long (Figure 98). The rock batter ended 1 m east of the 'A' pile and the remaining transect was a silty seabed.

Figure 98: Loose fallen pile next to northern 'B' pile. (Image from T9 (a) Cockle Bay 210705; 05:22).

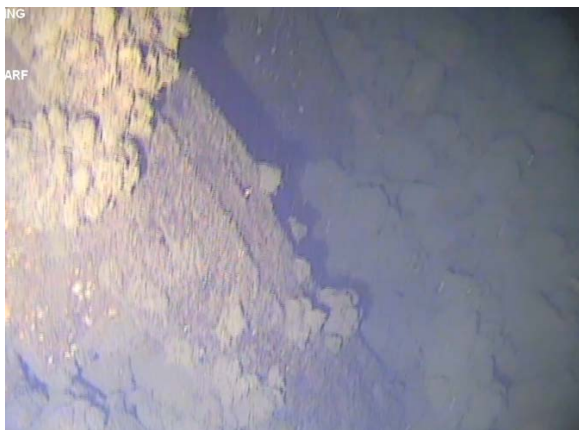
Figure 100: Two of the cut off timber piles near the southern 'E' steel pile. (Image from T10 (a) Cockle Bay 210705; 07:39).

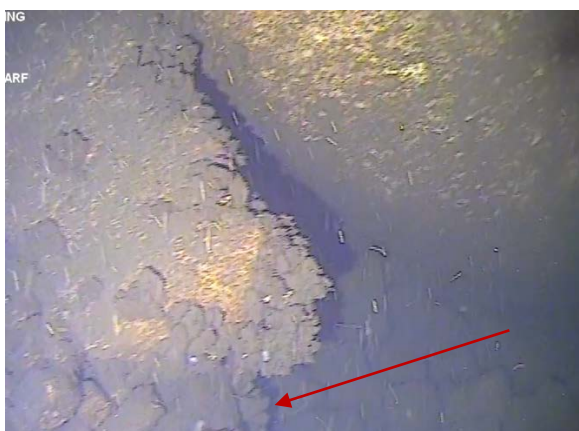
Butted against the southern 'E' pile was a large piece of possible concrete overpour approximately 1 m x 1 m. Underneath, there was a fallen timber pile, the exposed section was 1.3 m before being covered by rock batter (Figure 102).

Figure 102: Rectangular piece of concrete leaning against southern 'E' pile. Timber pile underneath indicated by red arrow. (Image from T10 (a) Cockle Bay 210705; 09:01).

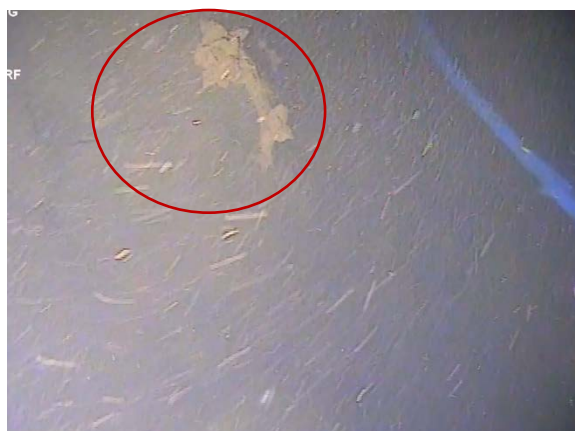
The diver then moved along the rock batter to the northern 'E' pile and continued the transect to the west. Adjacent to the northern 'E' pile there was another two cut off timber piles. The first was heavily degraded with only the outside still present. The pile was 1.5 m high with an estimated diameter of 300 mm. The next pile was 1.5 m to the south of the first and measured 2 m high out of the rock batter and was also heavily degraded (Figure 103 and Figure 104). Immediately next to the second pile there was another short pile that was 600 mm high out of the rock batter and heavily degraded.

Figure 103: Top of the northern cut off timber pile closest to the northern 'E' steel pile. Note heavy deterioration. (Image from T10 (b) Cockle Bay 210705; 02:52).

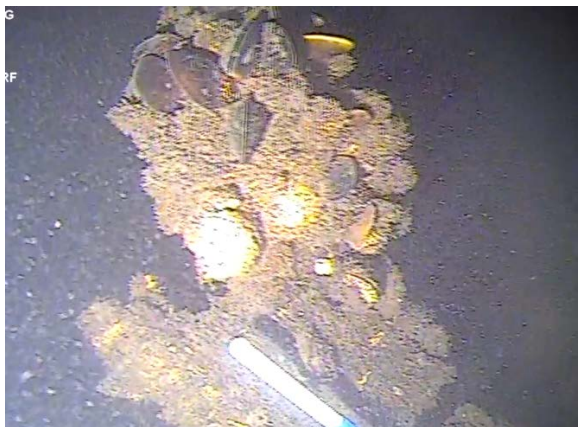
Figure 104: Heavily deteriorated cut off timber pile 1500 mm to the south of the northern 'E' pile. (Image from T10 (b) Cockle Bay 210705; 05:00).

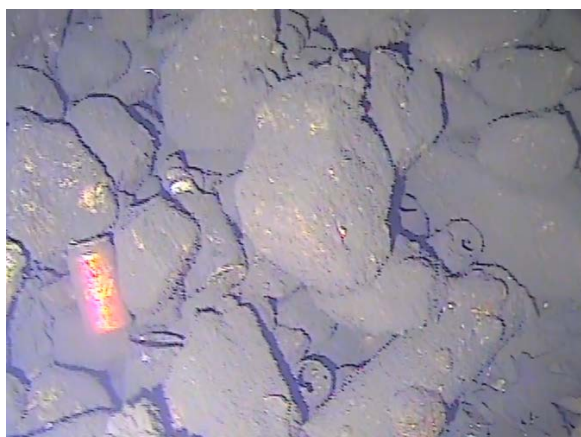
The diver started on the southern side of the bent working towards the east. The Seabed was silty and relatively flat up until the east of ‘B’ pile where the rock batter began (Figure 105). The rock batter continued on a 45° angle past ‘C’ pile. Halfway between ‘C’ and ‘D’ pile, the rock embankment becomes dry (Figure 106).

Figure 105: Example of rock batter at ‘C’ pile. (Image from T11 (a) Cockle Bay 210705; 02:42).

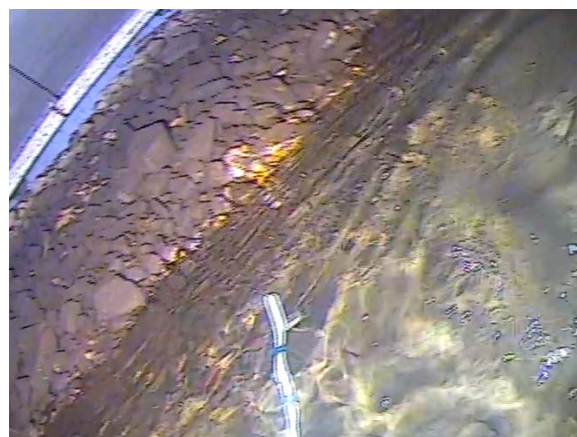
Figure 106: Rock embankment at eastern end of T11. (Image from T11 (a) Cockle Bay 210705; 03:11).
