Proposed Segment Factory

Land and Soils Assessment Report

Prepared for Snowy Hydro Limited
September 2019

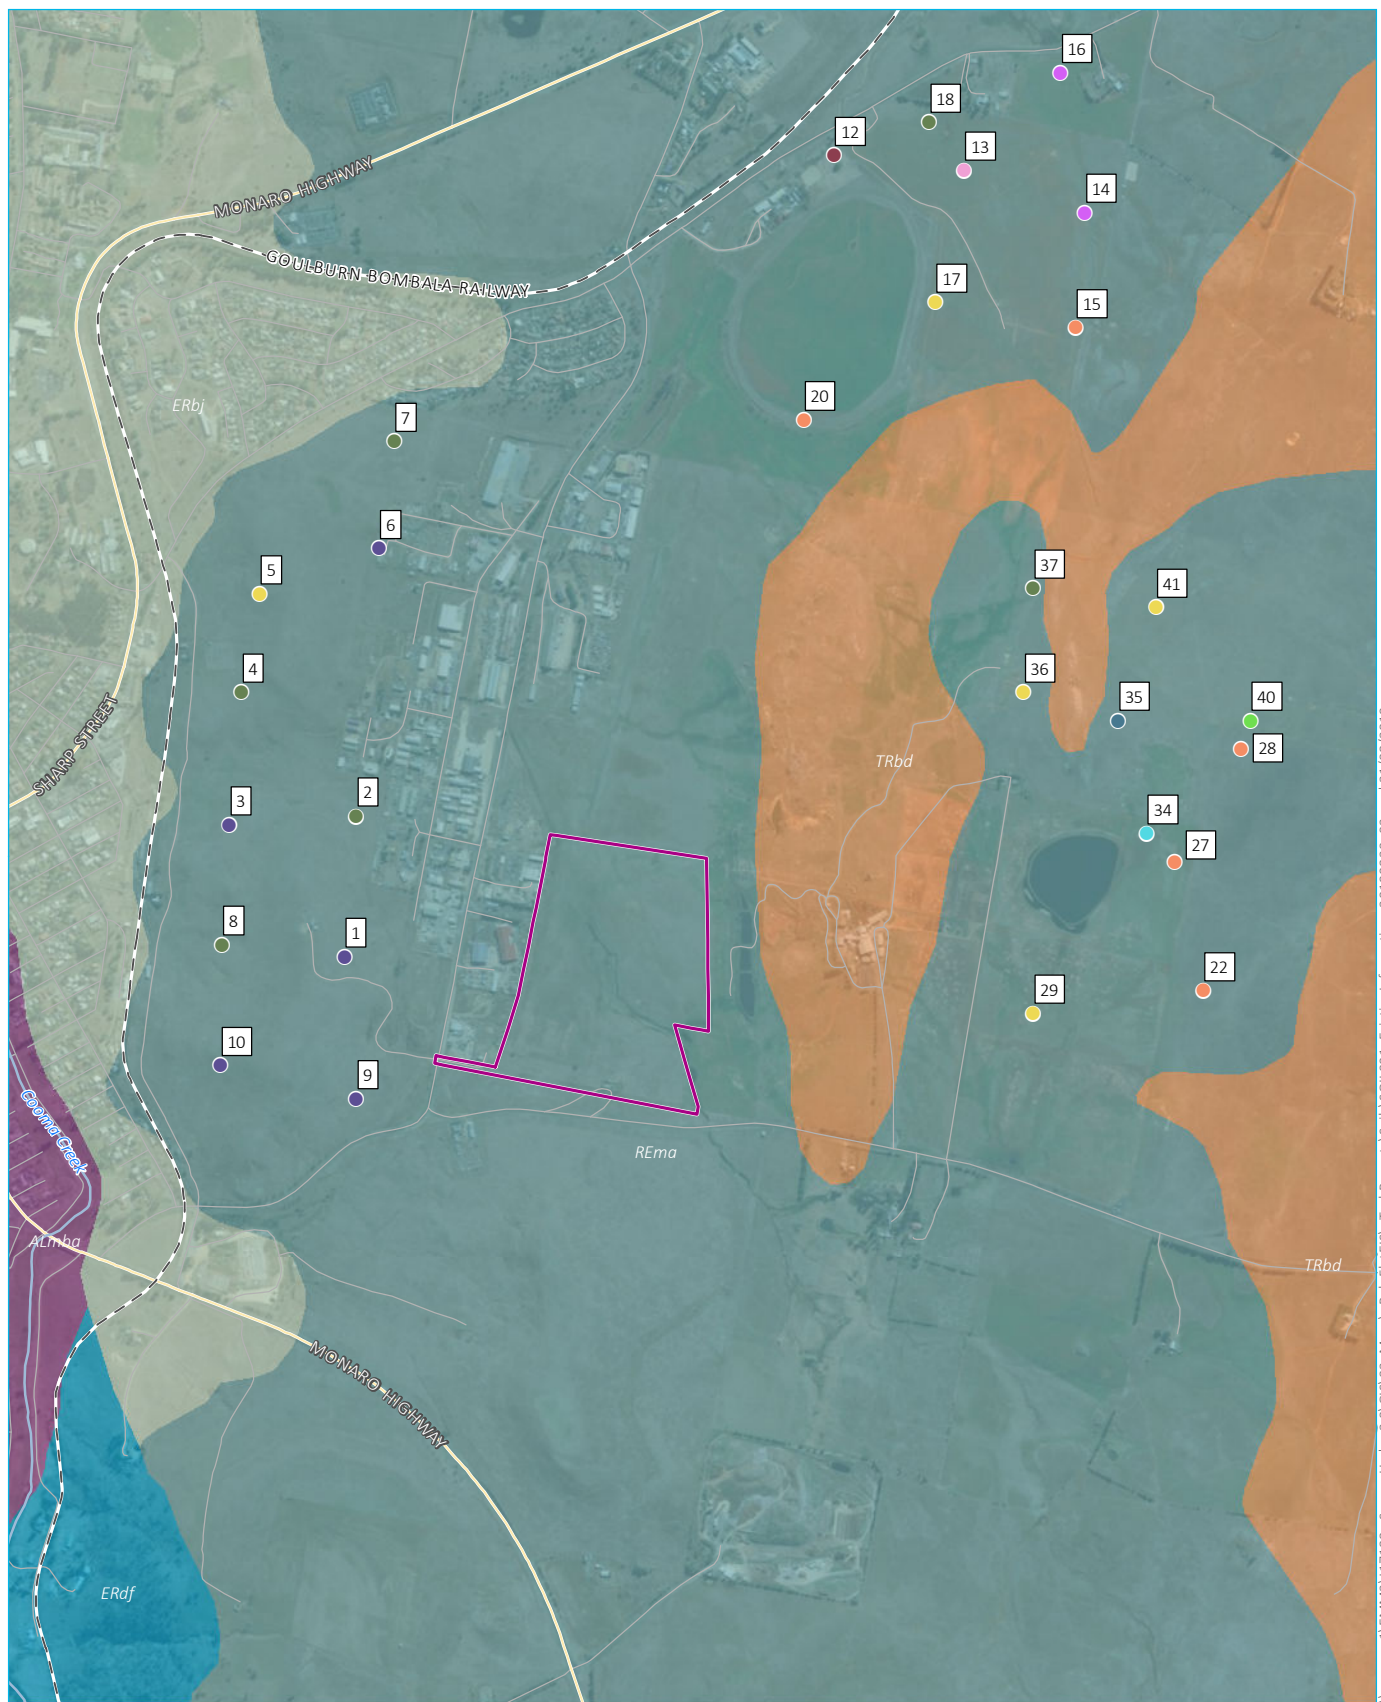
A map of the eSPADE soil profile sites and the soil landscape mapping is presented in Figure 3.1.

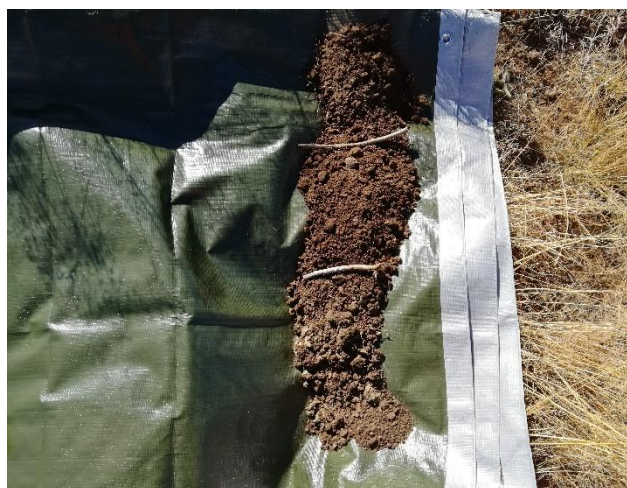
Site PF-1 soil profile, surface at top right, total depth 25 cm

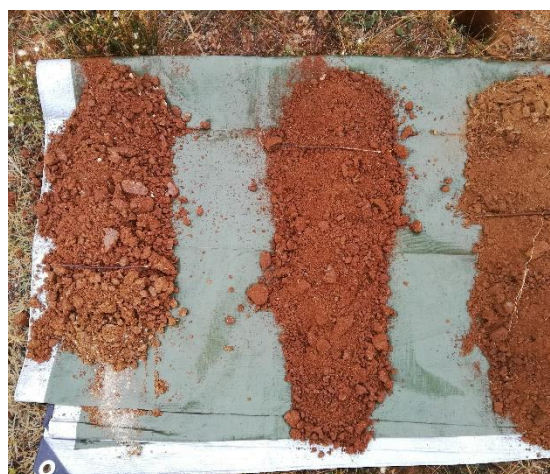
Site PF-7 soil profile, surface at top right, 30 cm rows, total depth 80c m

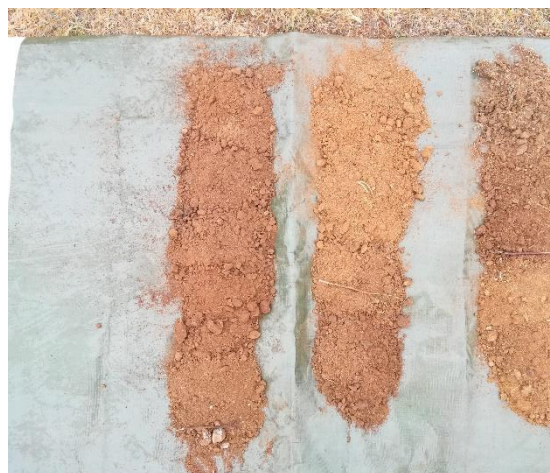
Site PF-8 soil profile, surface at top right, total depth 90 cm

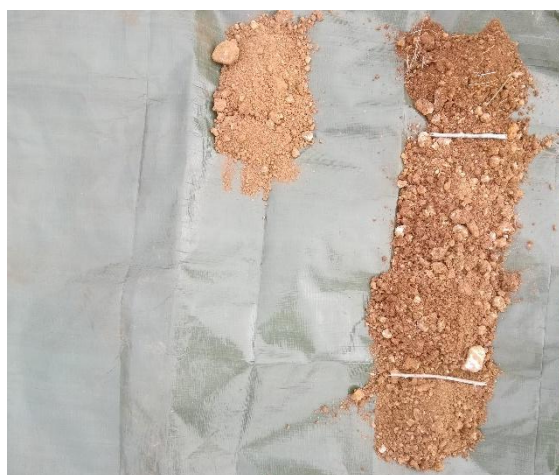
Site PF-11 soil profile, surface at top right, total depth 35 cm

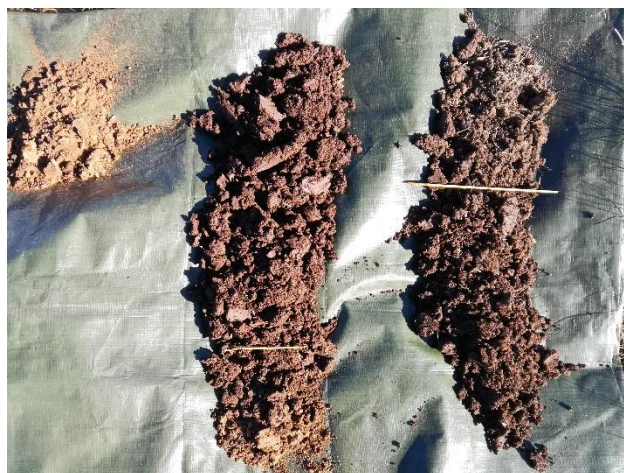
Site PF-17 soil profile, surface at top right, 30 cm rows, total depth 62 cm

SITE DESCRIPTION	Soil Unit: Ba-VE		Site: PF-17
Co-ordinates:	Easting: 693209	Northing: 5987489	Zone: 55 Datum: GDA94
ASC Soil Order:	Black Vertosol	Sampler:	J Claridge
<u>LANDFORM</u>			
Slope:	2%	Runoff:	Moderately rapid
Morphological type:	Lower-slope	Permeability:	Slowly permeable
Landform element:	Hillslope	Drainage:	Imperfectly drained
Landform pattern:	Rises	Surface condition:	Cracking and self-mulching
Relief modal class:	Very gently undulating rises	Disturbance:	Complete clearing
Coarse fragments:	Few medium basalt pebbles	Rock outcrop:	Nil
Geology:	Monaro Volcanics and Bondo Dolerite Member - basalt		
Vegetation:	Thick grass cover

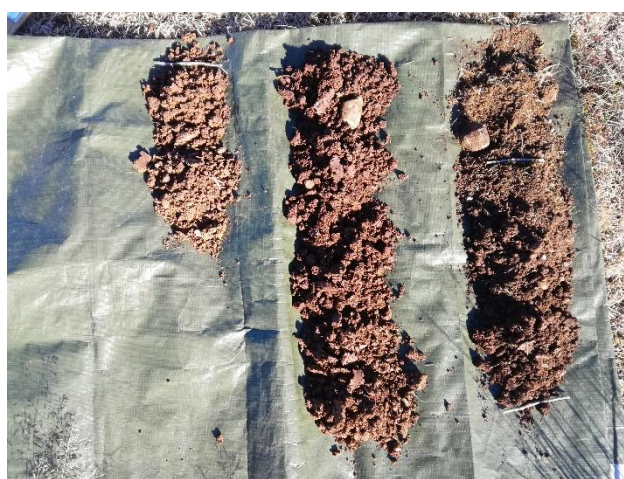
**Site PF-18 soil profile, surface at top right, 30 cm rows total depth 70 cm****SOIL DESCRIPTION**

Horizon	Depth (m)	Description
A1	0.00-0.10	Dark brown (7.5YR 3/2); light medium clay texture; moderate granular structure; very few basalt cobbles; moist weak consistence; pH 7.0; clear change to -
B21	0.10-0.30	Dark reddish brown (5YR 3/2); light medium clay texture; moderate subangular blocky 10-20 mm structure; very few large quartz pebbles; pH 7.0; clear change to -
B22	0.30-0.60	Reddish brown (2.5YR 4/3); medium clay texture; moderate angular blocky and lenticular structure; very few basalt cobbles; pH 8.5; diffuse change to -
BC	0.60-0.7
