# **Sydney International Speedway**

## **Environmental Impact Statement**

Technical Paper 8  
Contamination

Preliminary Site Investigation

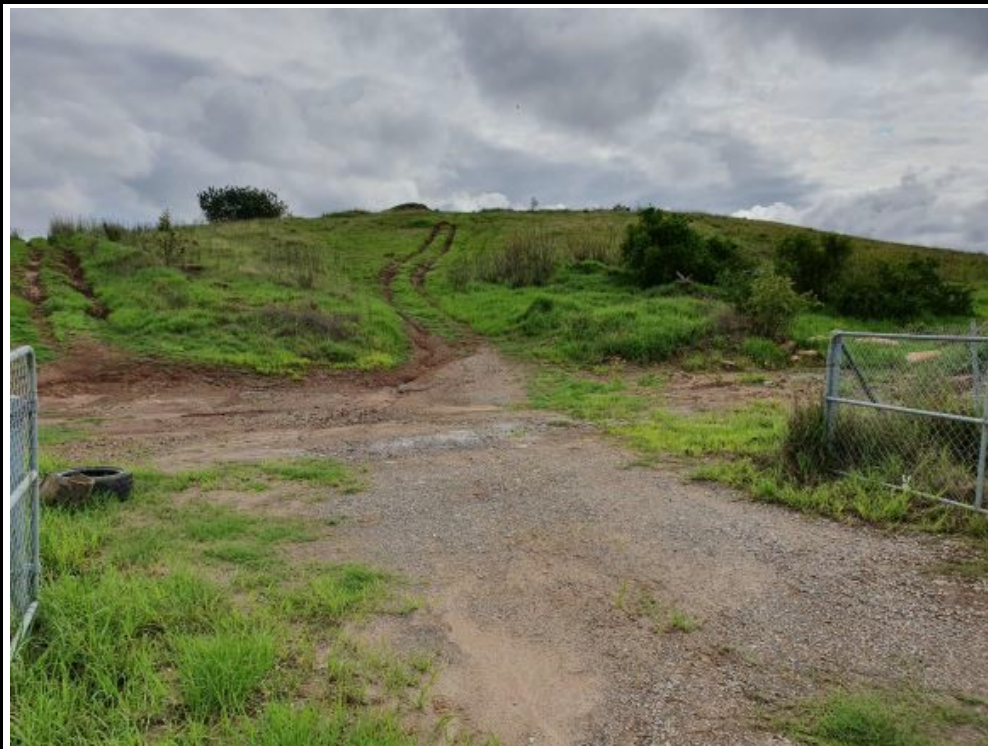
Photograph 1 – Area 1: Carpark D North and Mid Area (Facing North-West)

Feature	Observation	Reference Photo Plate*
Surfacing	Grassed with areas of bare/exposed earth.	1
Structures	Four-wheel drive training centre (mobile unit).	3, 4
Services	None observed.	-
Topography/gradient	Raised hill with peak sloping in all directions at moderate gradient	1, 8, 10
Drainage	Grassed swale along eastern boundary. No other drainage features. Ponded water in places.	-
Fill materials	Sandstone boulders formed into mound. Probable subsurface fill throughout area.	4
Waste(s)	Waste tyres, steel girders and rails, wood, cement, plastics, sheet metal roofing, intermediate bulk container (empty), vehicle trailer.	2,5,6,7,9
Above ground/underground storage tanks	None observed.	-
Asbestos	None observed.	-
Chemical and other hazard material storage	Intermediate bulk container (unlabelled and empty).	5,7
Phytotoxicity	None observed.	-
Staining and odours	None observed.	-
Incidents and complaints	None recorded.	-

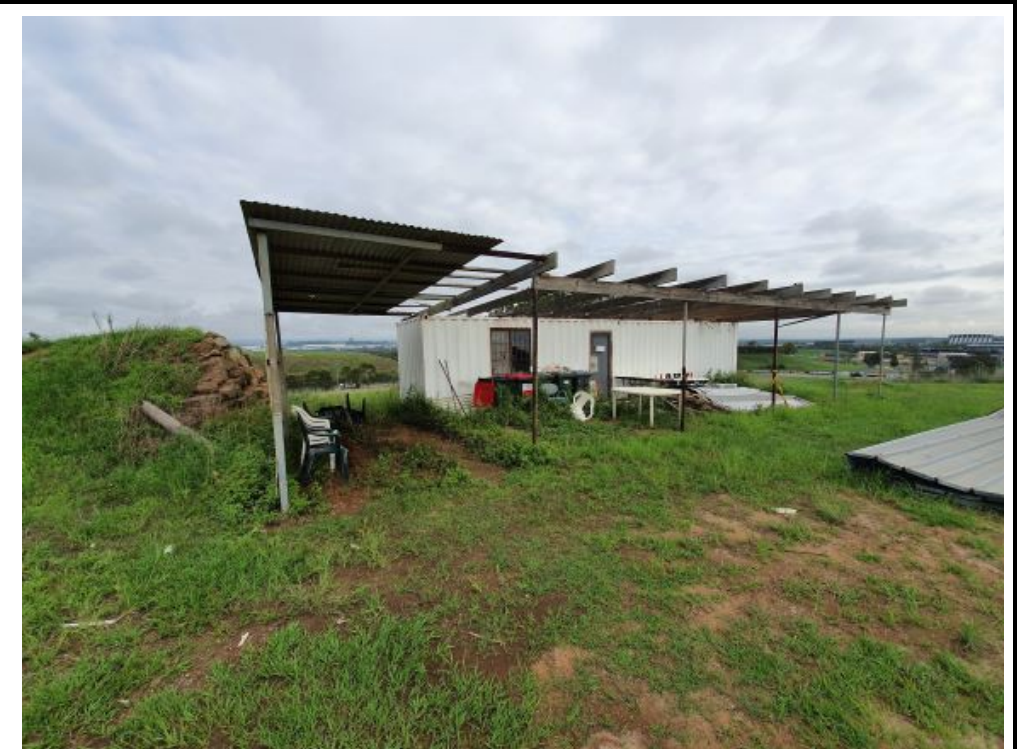
Photograph 3 – Area 1: Carpark D North Area - 4-wheel drive training unit (facing north-east)

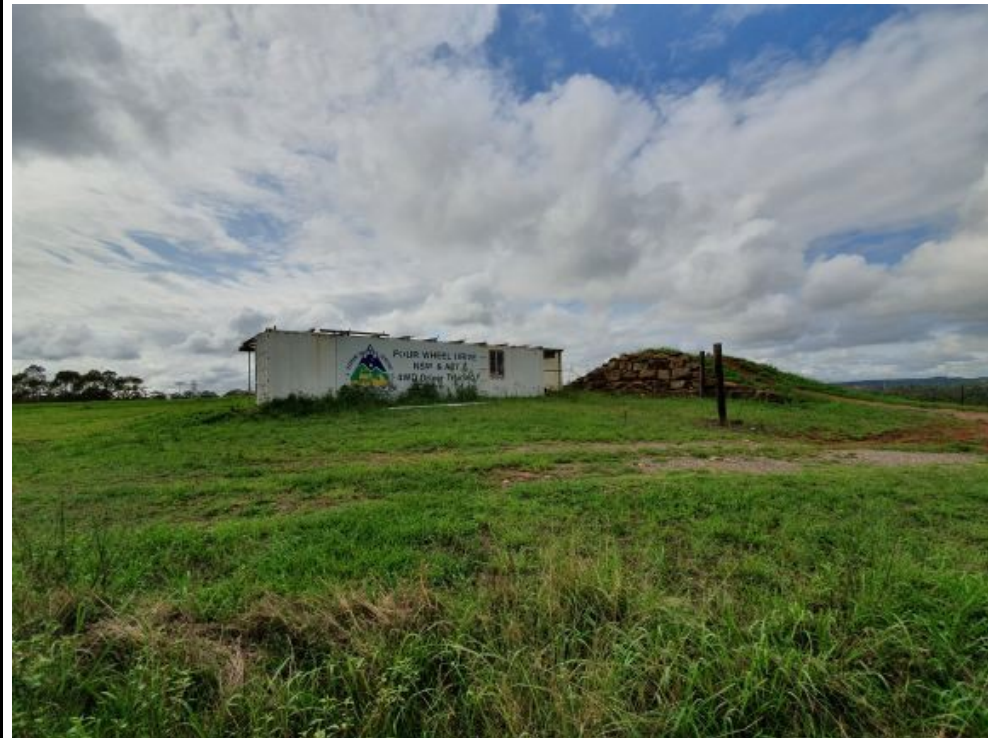
Photograph 4 – Area 1: Carpark D North Area - 4-wheel drive training unit (facing south-east)

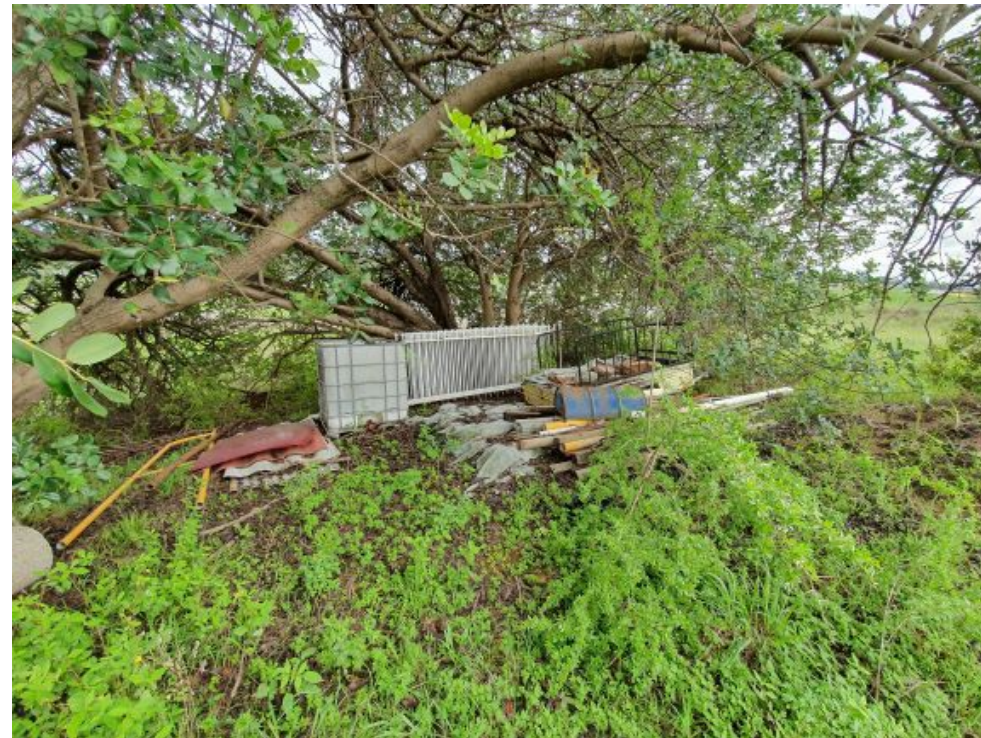
Photograph 5 – Area 1: Carpark D North Area - Waste materials located north of 4-wheel drive training unit (facing north-west)

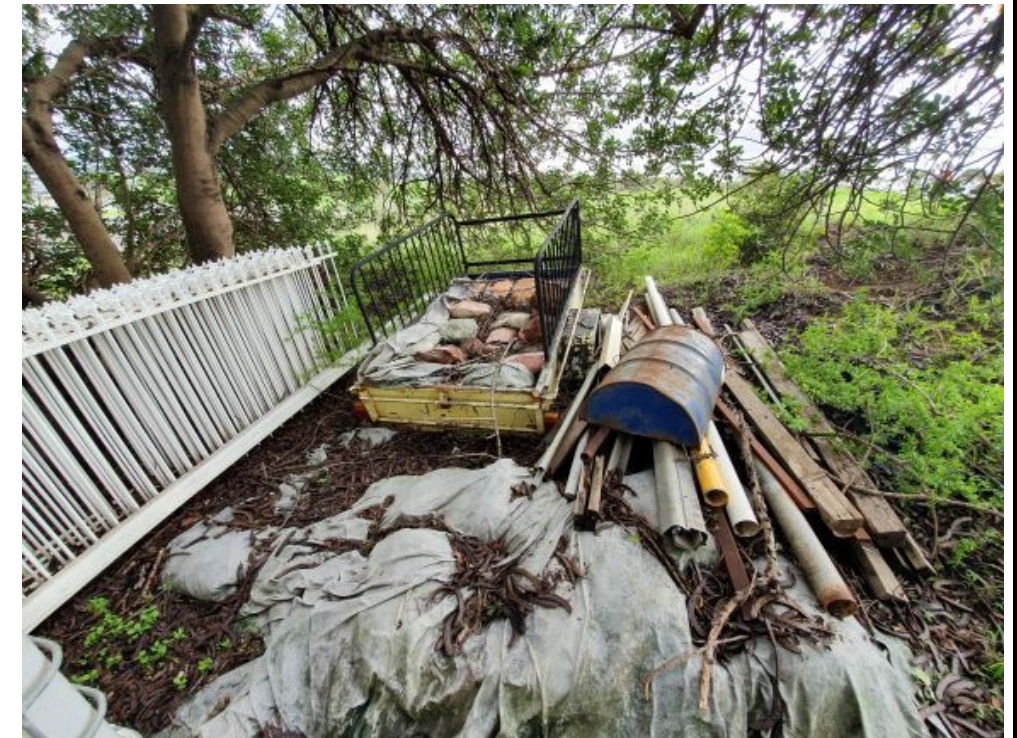
Photograph 6 – Area 1: Carpark D North Area - View of waste materials located north of 4-wheel drive training unit (facing north-east)

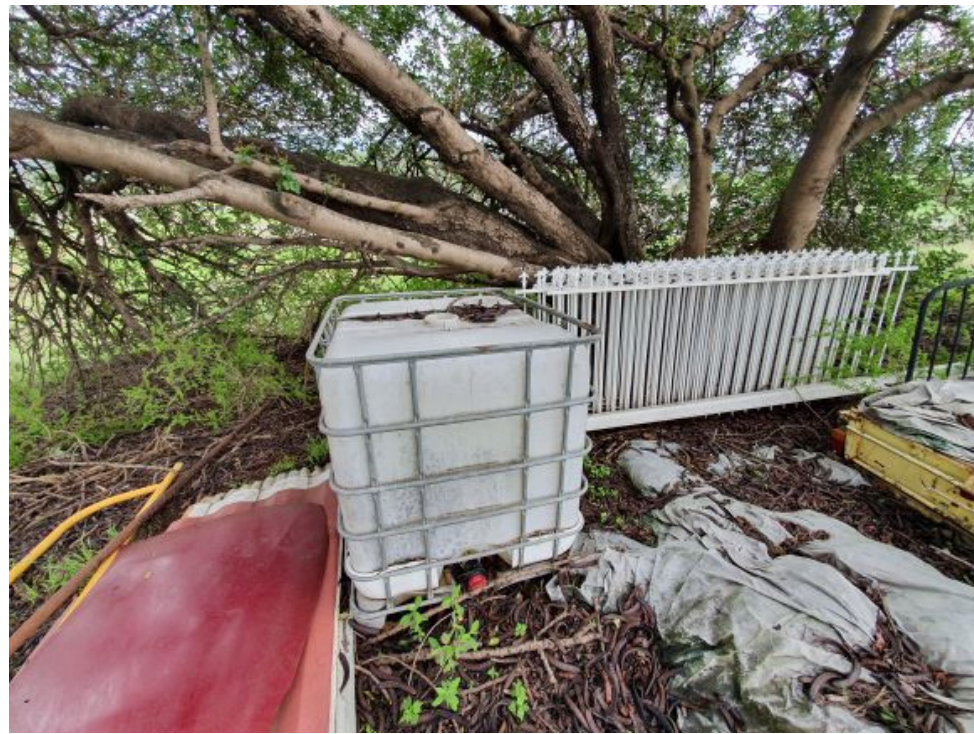
Photograph 7 – Area 1: Carpark D North Area - View of waste materials located north of 4-wheel drive training unit (facing north-west)

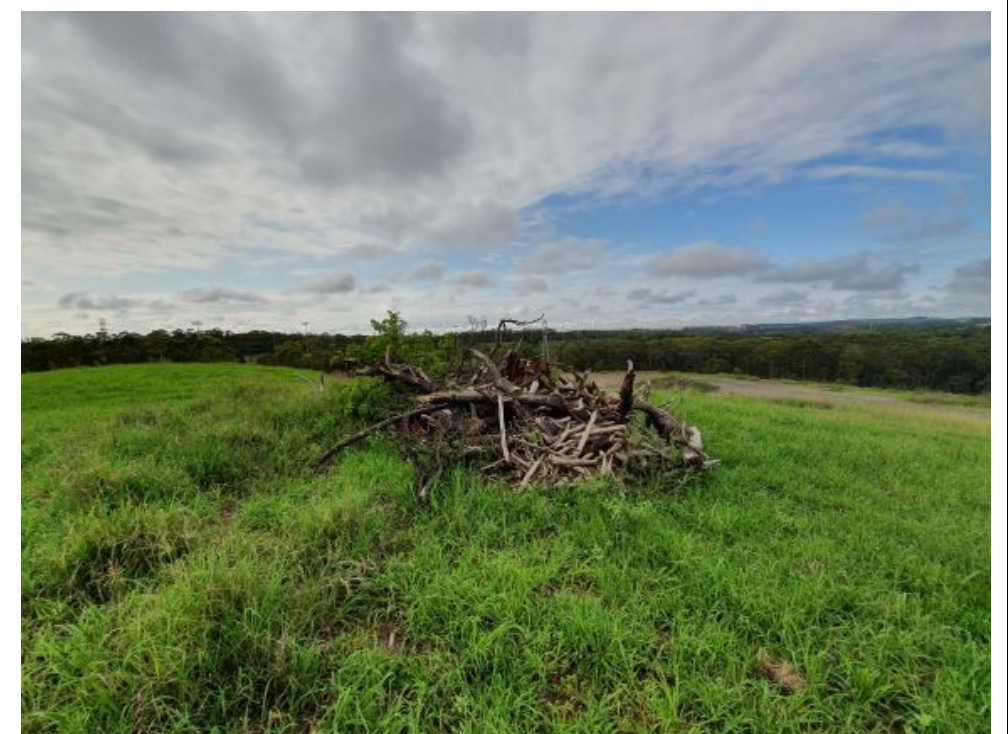
Photograph 9 – Area 1: Carpark D North and Mid Areas - woody debris

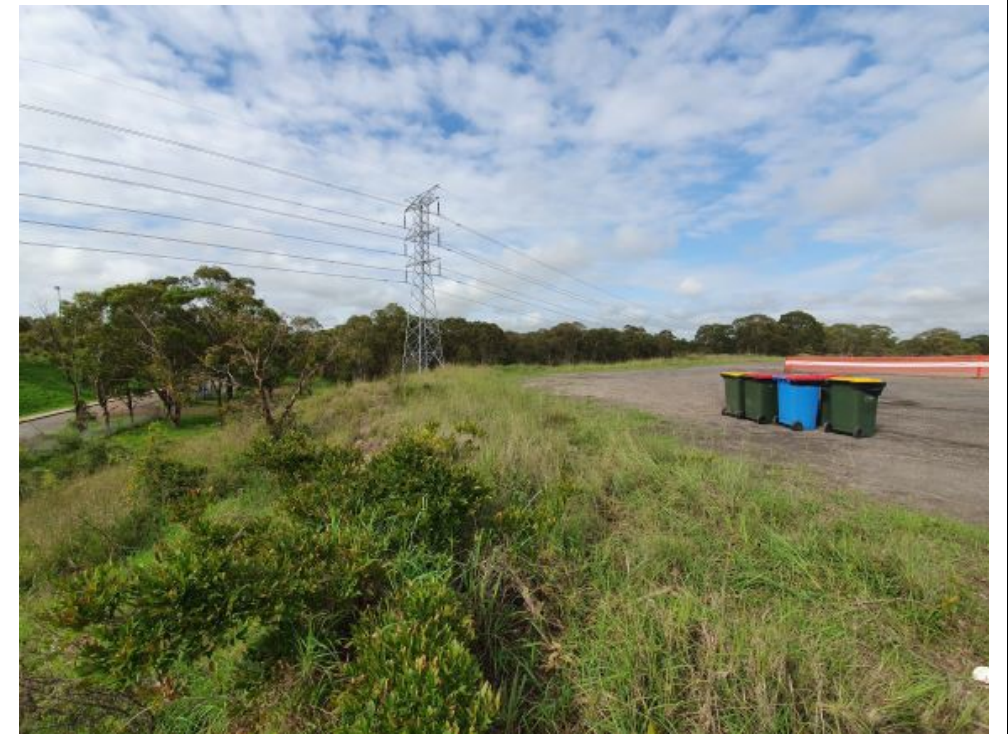
Photograph 12– Area 2: Carpark D South Area (facing south)

Feature	Observation	Reference Photo Plate*
Surfacing	Unsealed gravel with grassed areas along boundary and embankments.	11,12
Structures	Steel shipping containers within western portion of the area (contents unknown).	15,16
Services	None observed.	
Topography/gradient	Raised levelled terrain – gentle slope to south-west. Moderate to steep falling slopes along southern and eastern boundary embankments to woodland area/easement. Moderate rising slope along northern boundary to Area 1.	10,12,17
Drainage	Grassed swale along eastern boundary. Sheet flow to south. Creek and floodplain at base of southern boundary embankment.	11,12,17
Fill materials	Asphalt, concrete and brick cobbles, reworked natural materials. Probable subsurface fill throughout area.	13,17
Waste(s)	Heavy vehicle tyres, waste oil drum (empty), wooden panels, asphalt, concrete slabs.	13,14,15,16
Above ground/underground storage tanks	None observed.	-

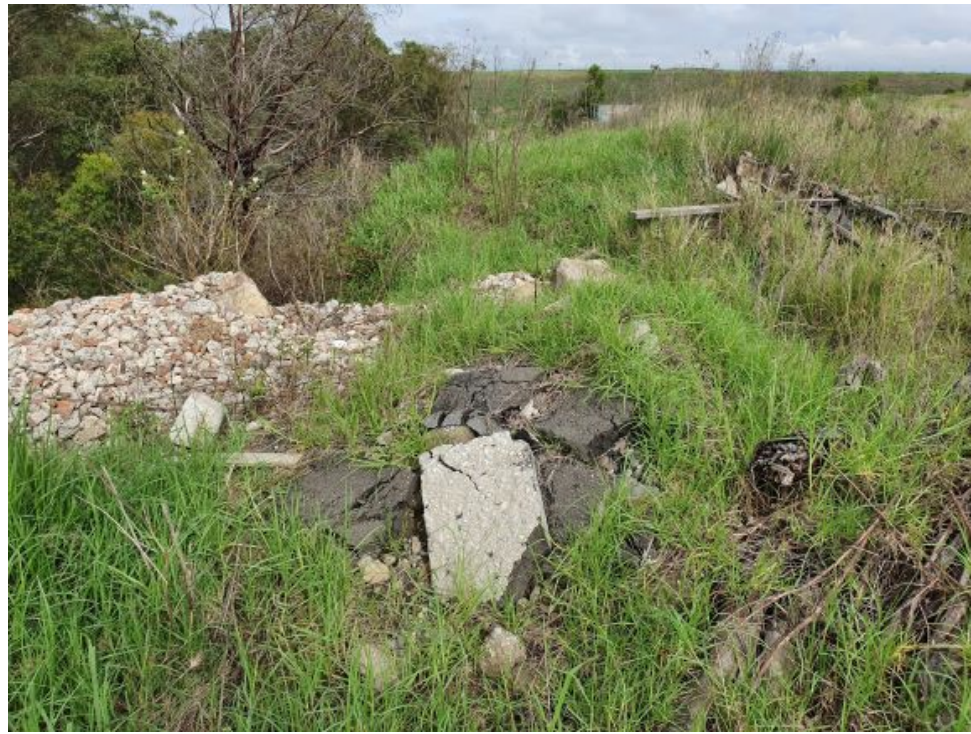
Photograph 13– Area 2: Carpark D South Area – construction / demolition waste (facing west)

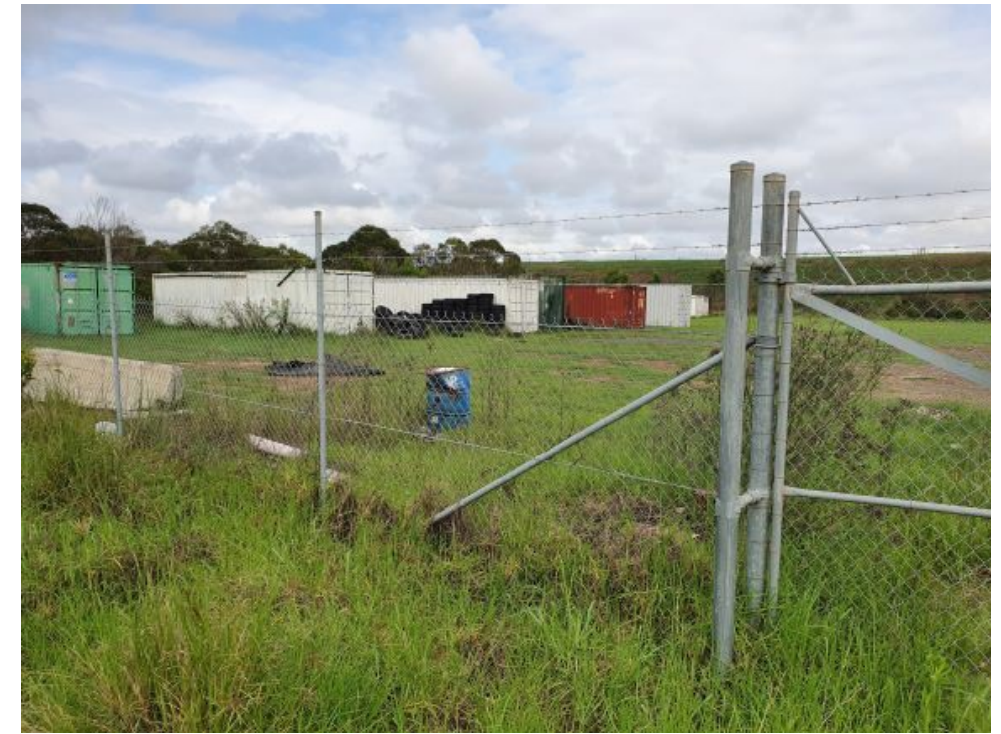
Photograph 15– Area 2: Carpark D South Area – storage containers, waste oil drum, and heavy vehicle tyres (facing west)

Asbestos	None observed.	-
Chemical and other hazard material storage	Waste oil drum (empty).	-
Phytotoxicity	None observed.	-
Staining and odours	None observed.	-
Incidents and complaints	None recorded.	-
Adjacent land uses	North: Area 1 (Carpark D)	-
	East: Access road with Sydney Dragway and Prospect Reservoir Beyond.	-
	South: Creek, floodplain, woodland and high voltage power easement.	-
	West: Ferrers Road and Eastern Creek Waste and Recycling Centre beyond.	-
Evidence of previous investigations	None observed.	-
Additional observations	Concrete and brick cobbles used as slope stabilisation measure. Contents of steel shipping containers unknown.	15,16,17

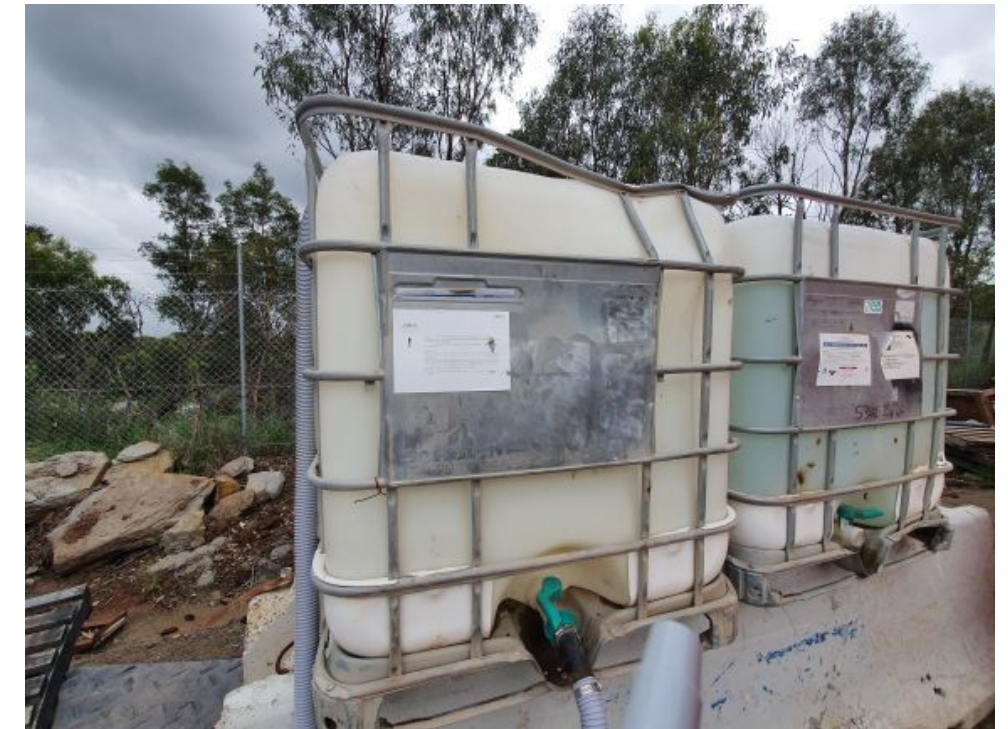
Photograph 24 – Area 4: Carpark D – Coates Hire storage area Intermediate Bulk Containers (Super Blue Sanitizer) (facing north)

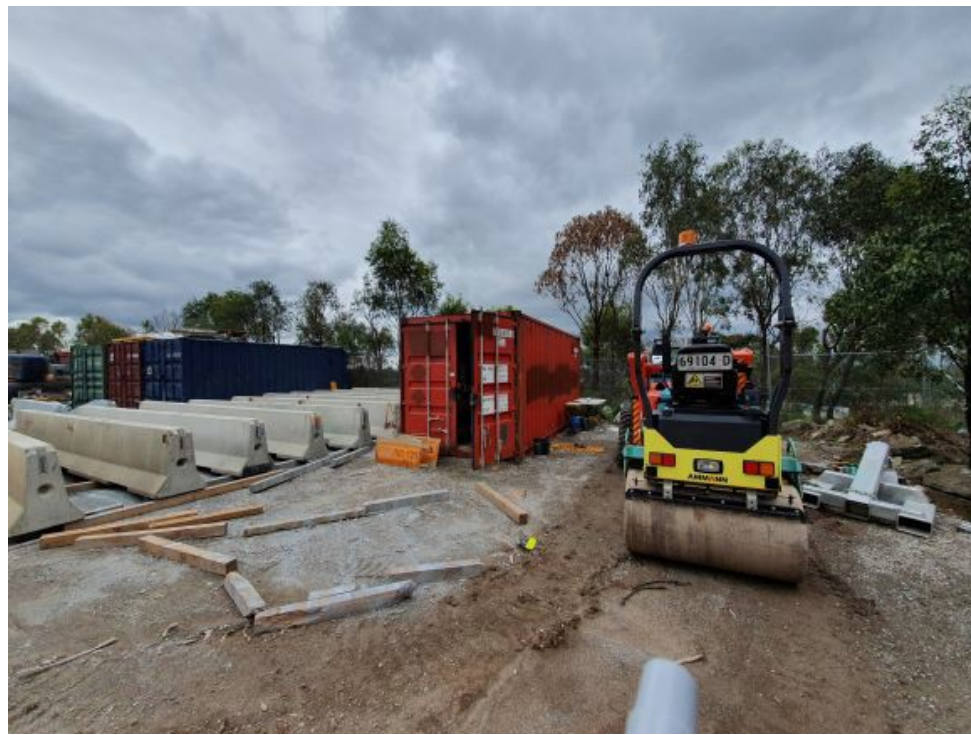
Photograph 25 – Area 4: Carpark D – Coates Hire storage area containers and machinery (facing west)

Phytotoxicity	None observed.	-
Staining and odours	None observed.	-
Incidents and complaints	None recorded.	-
Adjacent land uses	North: Access road and structures including a pad mount substation.	-
	East: Embankment with Sydney Dragway and Prospect Reservoir beyond.	-
	South: Area 5.	-
	West: Ferrers Road and Eastern Creek Waste and Recycling Centre beyond.	46,47
Evidence of previous investigations	None observed.	-
Additional observations	Plant and machinery on-site including forklifts, trailers, compacter and bobcat. Construction materials including steel fencing, wooden pallets, concrete barriers, steel beams.	25-29

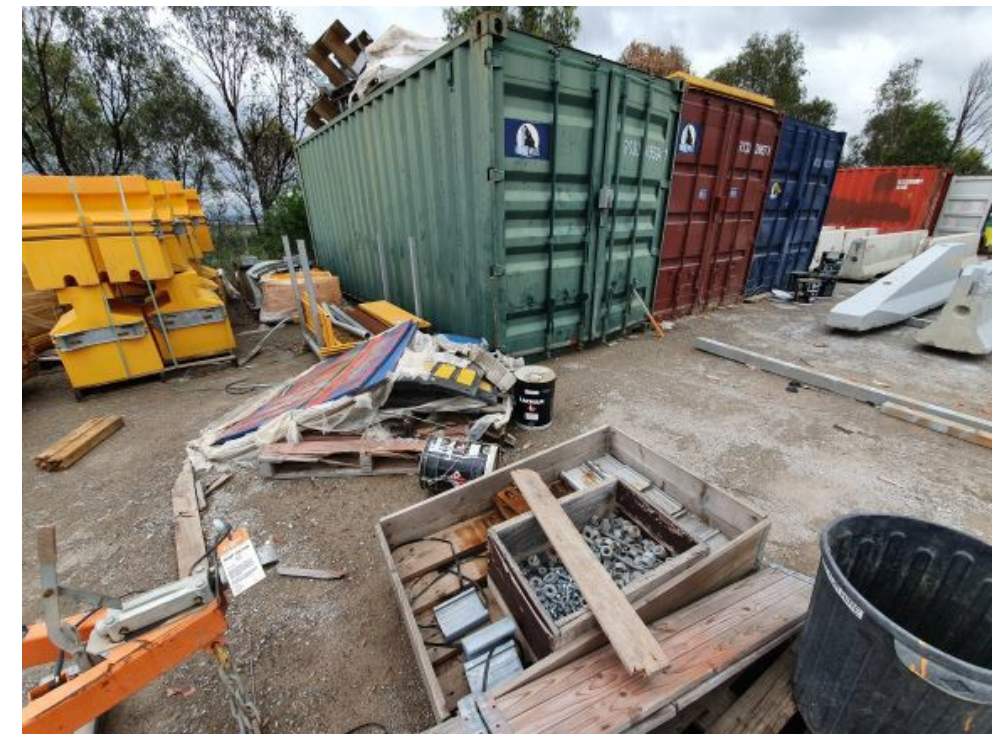
Photograph 27– Area 4: Carpark D – Coates Hire storage area containers and tools (facing west)

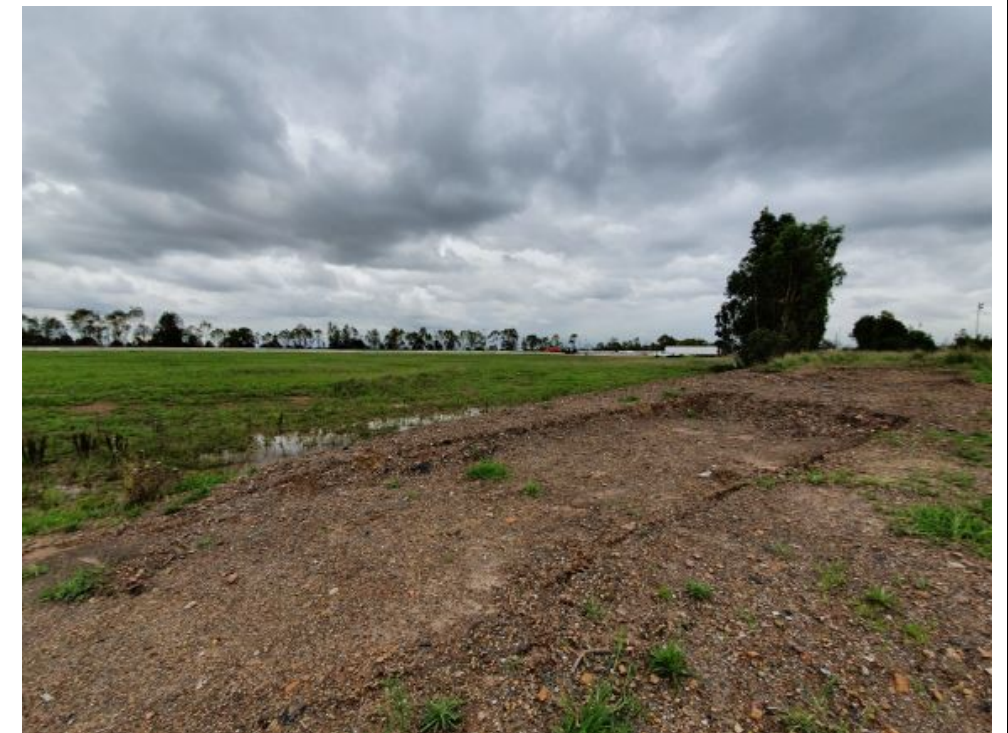
Photograph 33– Area 5: Speedway – ground cover (facing north)

Feature	Observation	Reference Photo Plate
Surfacing	Grass cover with exposed fill materials and boulders along eastern boundary.	31,33,35,36
Structures	None observed.	-
Services	None recorded.	-
Topography/gradient	Raised levelled terrain with gentle slope to south-west. Steep embankments along eastern and western boundaries.	33, 37, 46-48
Drainage	Sheet flow across area. Grassed swale to rock armoured swale along eastern boundary. Poned water present.	30-33, 35,36
Fill materials	Exposed fill materials comprising gravelly sands with concrete fragments along eastern embankment. Gravelly sand and boulders containing shales and sandstone blocks exposed by washout along western embankment.	33, 36, 47
Waste(s)	Waste tyres observed to be buried within exposed fill materials.	32, 34
Above ground/underground storage tanks	None observed.	-
Asbestos	None observed.	-
Chemical and other hazard material storage	None observed.	-

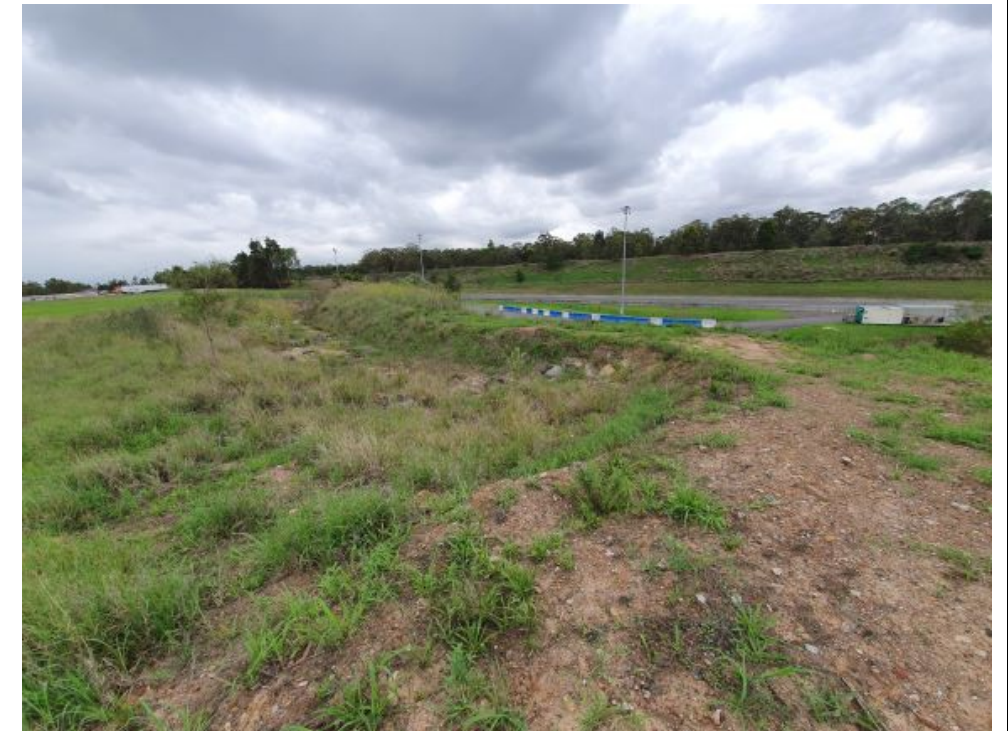
Photograph 36 – Area 5: Speedway eastern embankment – ground cover and stormwater drain (facing north-east)

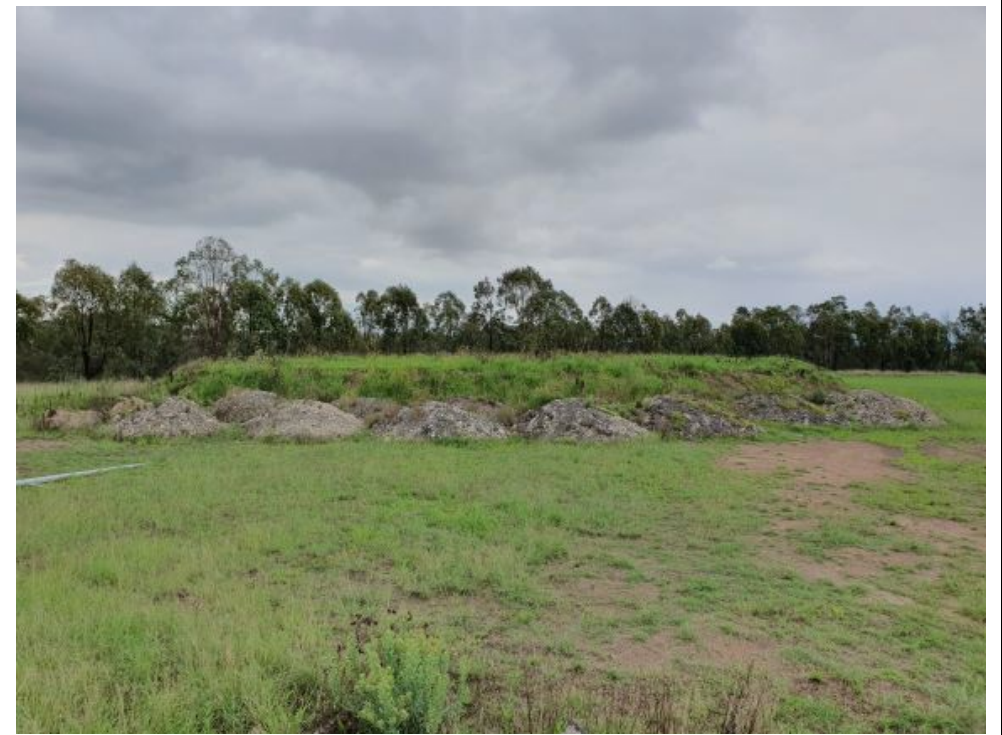
Photograph 39– Area 6: Competitor Carpark - stockpiles construction / demolition waste and ENM (facing south-west)

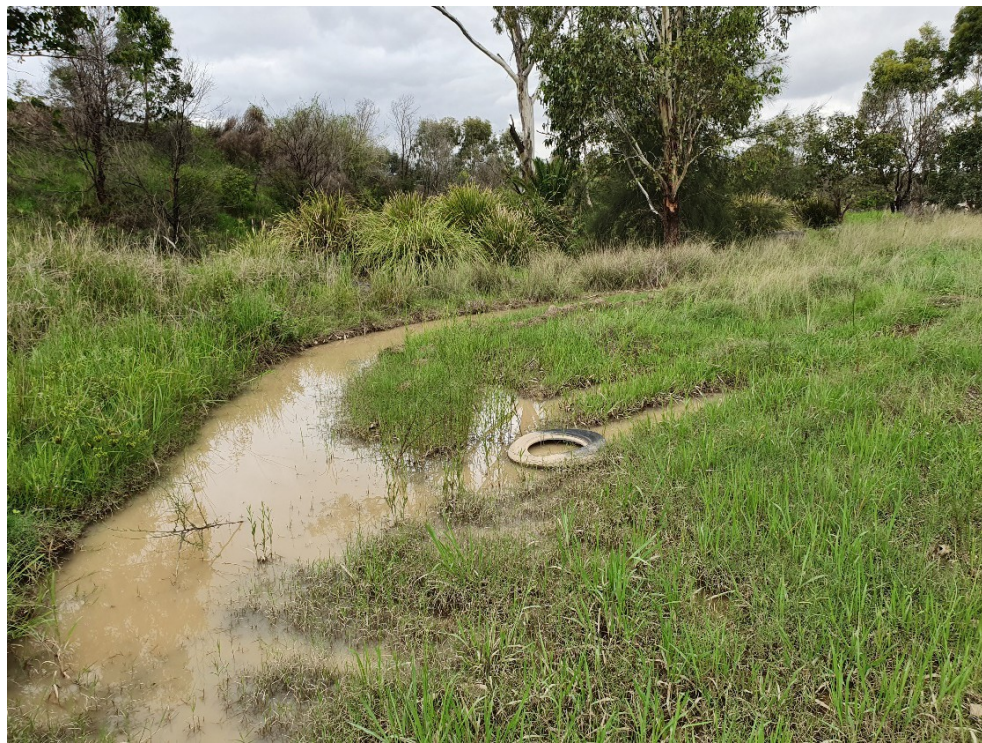
Photograph 43– Area 6: Competitor Carpark – waste tyre and ponded water (facing south)

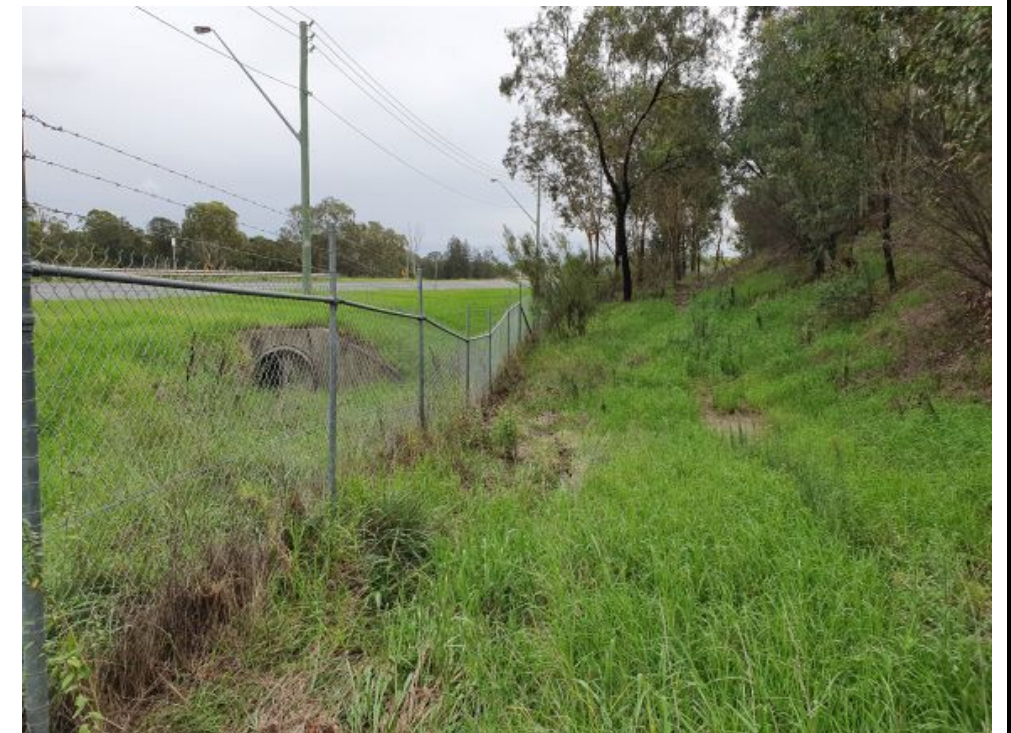
Photograph 45– Area 5/6: Speedway western boundary site drain (facing north)

Phytotoxicity	None observed.	-
Staining and odours	Discoloured ponded water with sheen within unvegetated swale along eastern boundary. Possible iron fixing bacterial sheen.	32
Incidents and complaints	None recorded.	-
Adjacent land uses	North: Area 4.	-
	East: Sydney Dragway and Prospect Reservoir beyond.	-
	South: Area 6.	-
	West: Ferrers Road and Eastern Creek Waste and Recycling Centre beyond.	-
Evidence of previous investigations	None observed.	-
Additional observations	Storm drain along eastern boundary discharges to Sydney Dragway via stormwater drain. Bio-retention basin observed within Sydney Dragway (possible stormwater treatment drain). Storm drains along western boundary discharge to adjacent property west of the project site beyond Ferrers Road via several culverts.	35,37,45

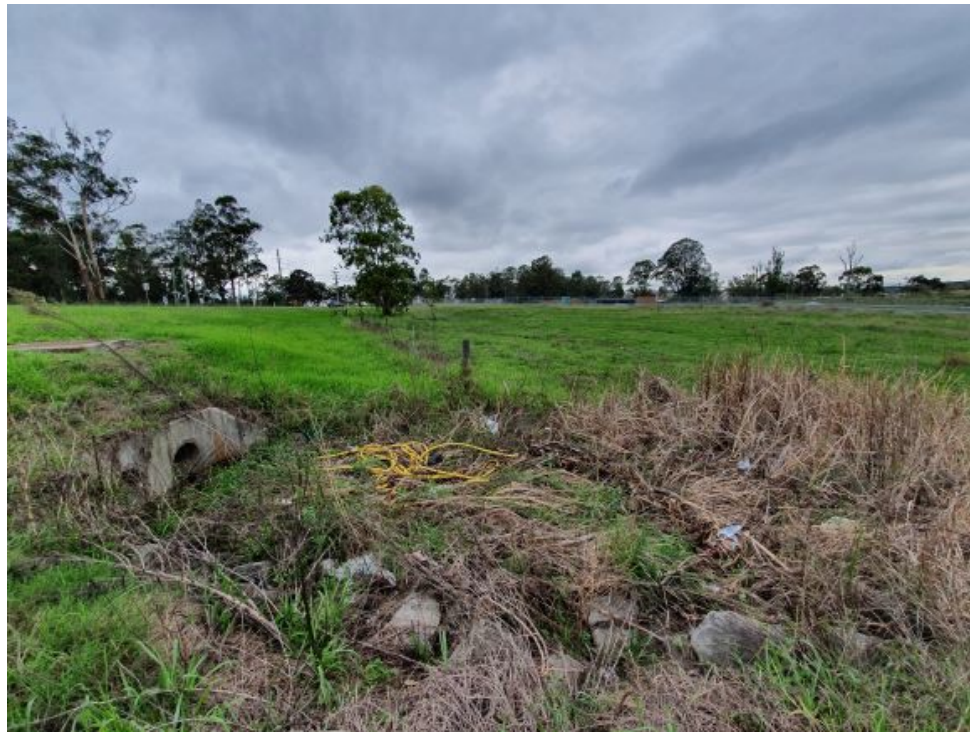
Photograph 49 – Area 7: Worksite facilities and amenities – Culvert crossing Ferrers Road from Area 6 discharging to Area 7 (facing south)

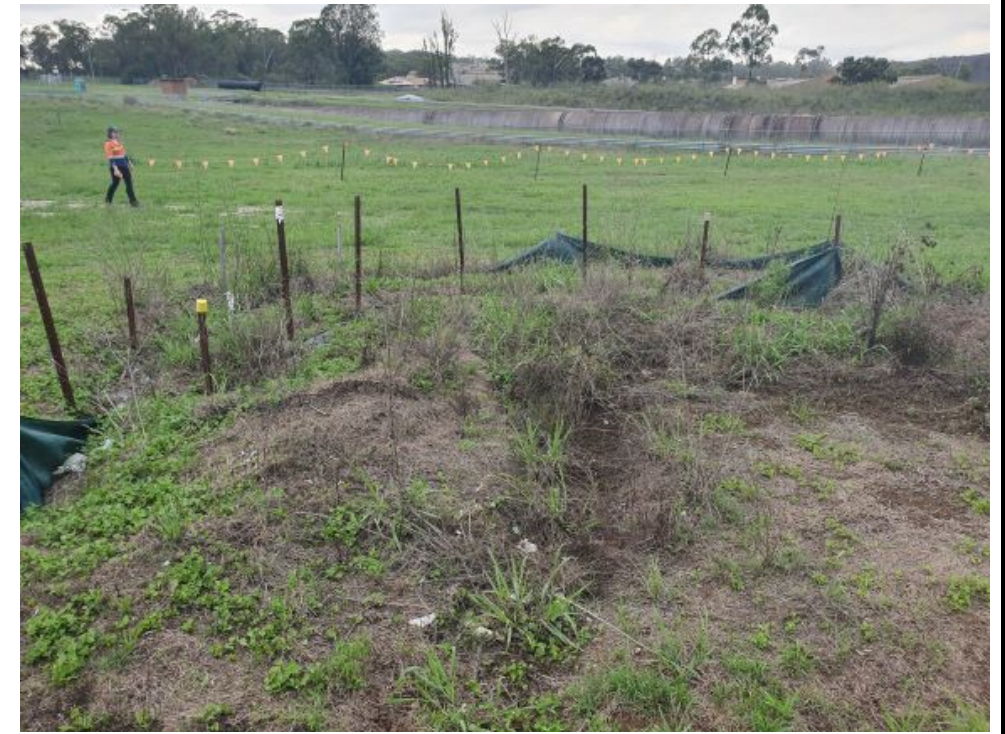
Photograph 51 – Area 7: Worksite facilities and amenities – grassed stockpile (facing south)

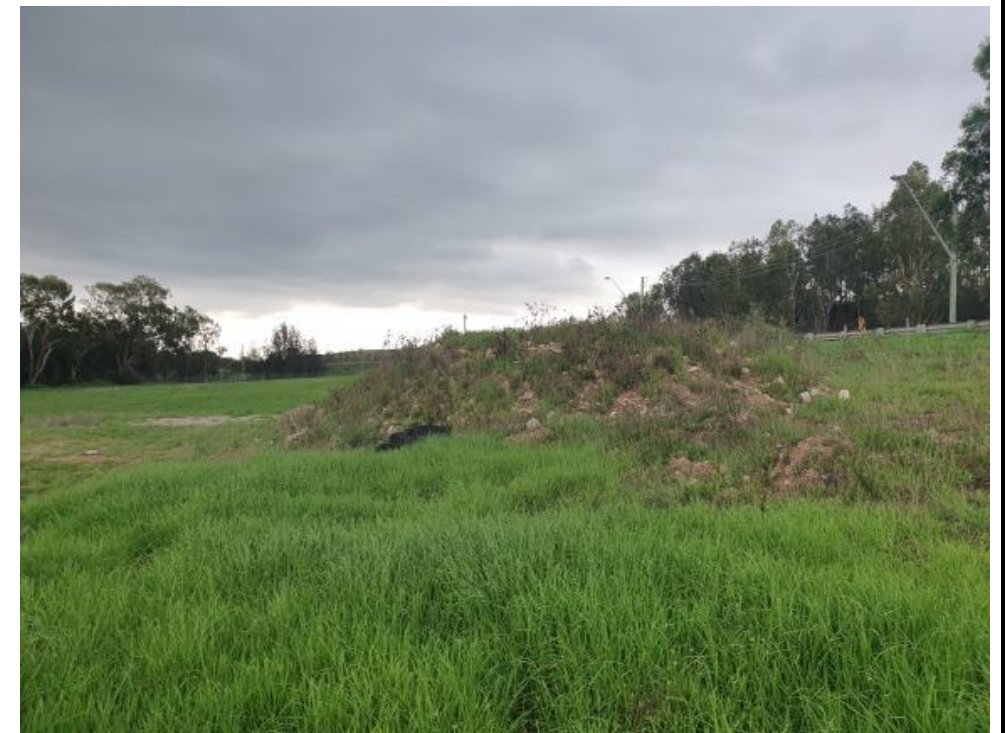
Photograph 54 – Area 7: Worksite facilities and amenities – grassed stockpile (facing north)
