Sydney Metro West – Pyrmont Station Construction Sites

Archaeological Research Design and
Excavation Methodology

Report to Sydney Metro

April 2022

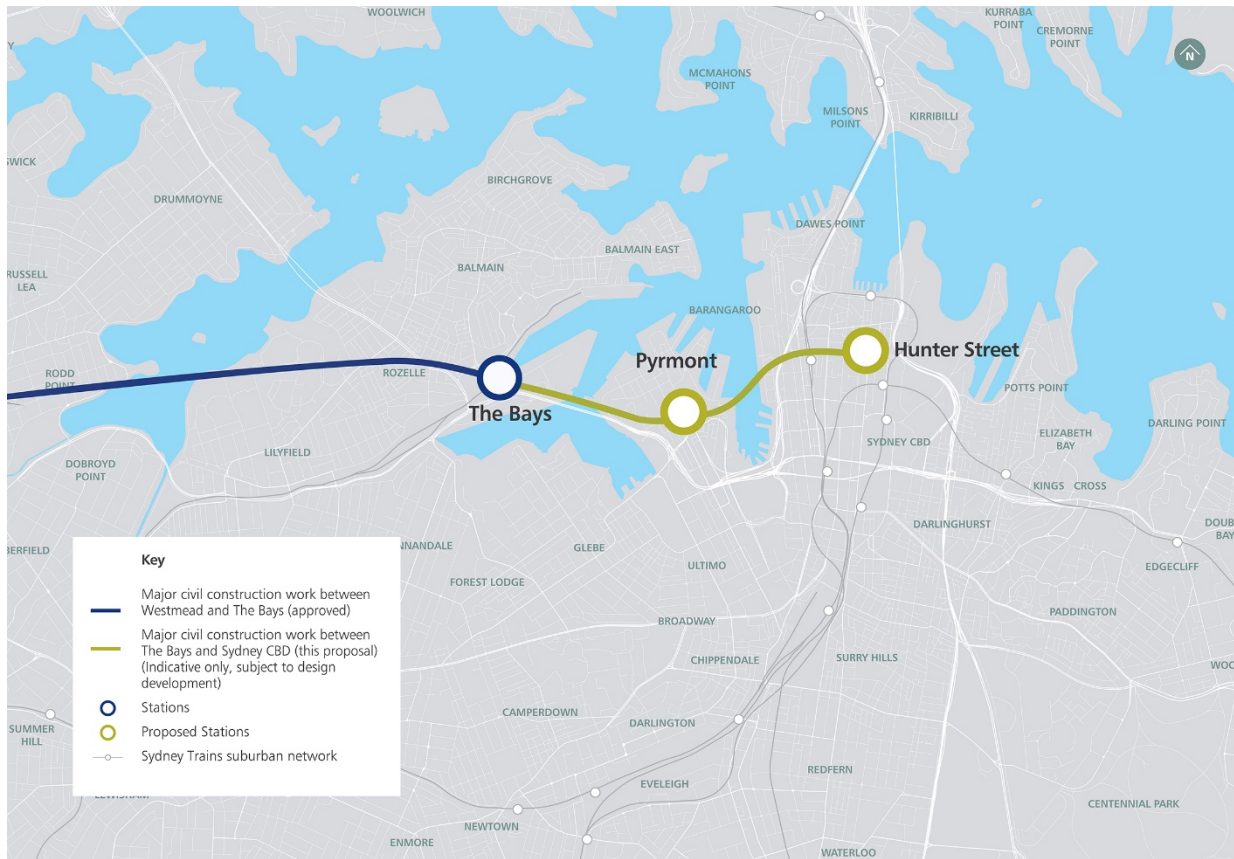
Figure 1: Overview of Sydney Metro West between The Bays and Sydney CBD

This proposal would be located largely underground in twin tunnels. Indicative locations of the proposed alignment and stations are shown in Figure 1.

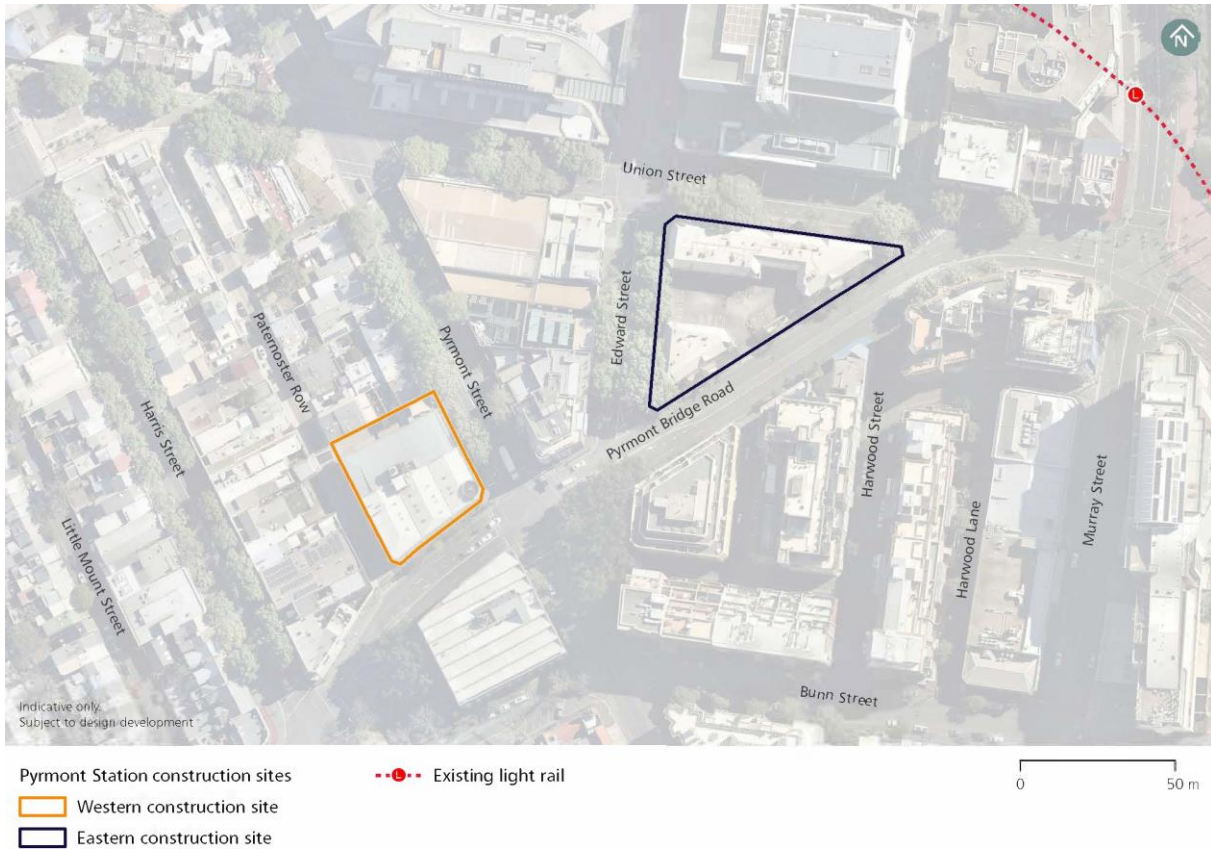
Figure 2: Pyrmont Station construction sites

The location of the Pyrmont Station construction sites is shown in Figure 2. The eastern site would be located in the block bound by Pyrmont Bridge Road, Union Street and Edward Street. The western site would be located in the block bound by Pyrmont Bridge Road, Paternoster Row and Pyrmont Street.

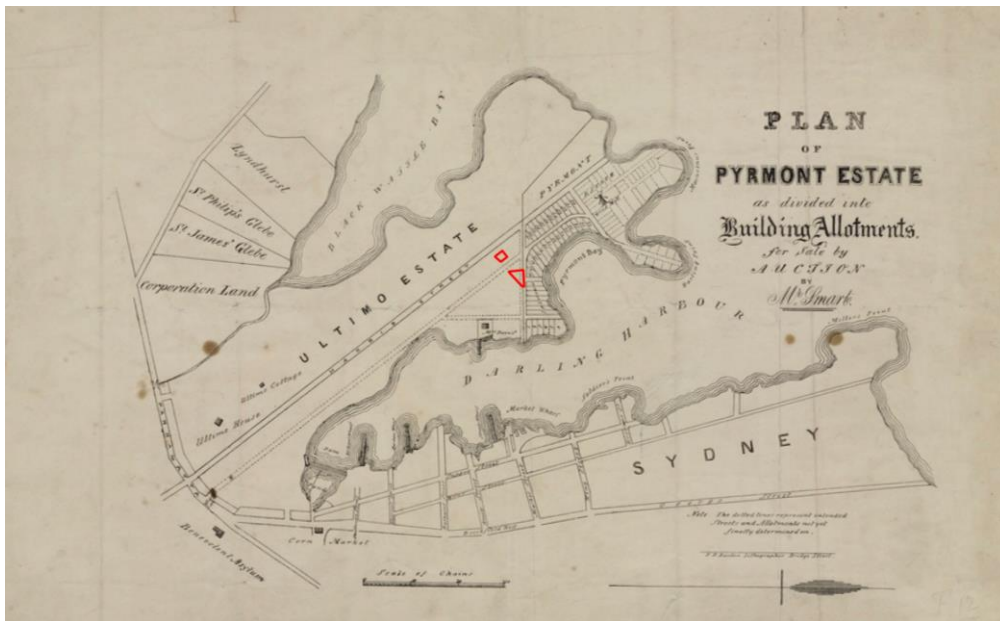
Figure 4: c1839 – Detail from ‘Plan of Pyrmont Estate (...)’, showing the subdivision of the Pyrmont Estate (Source: State Library of NSW Z/M2 811.173/1839/1, <https://collection.sl.nsw.gov.au/record/74VvM6VbD4Pd/AVRya4rQa6kQk>)

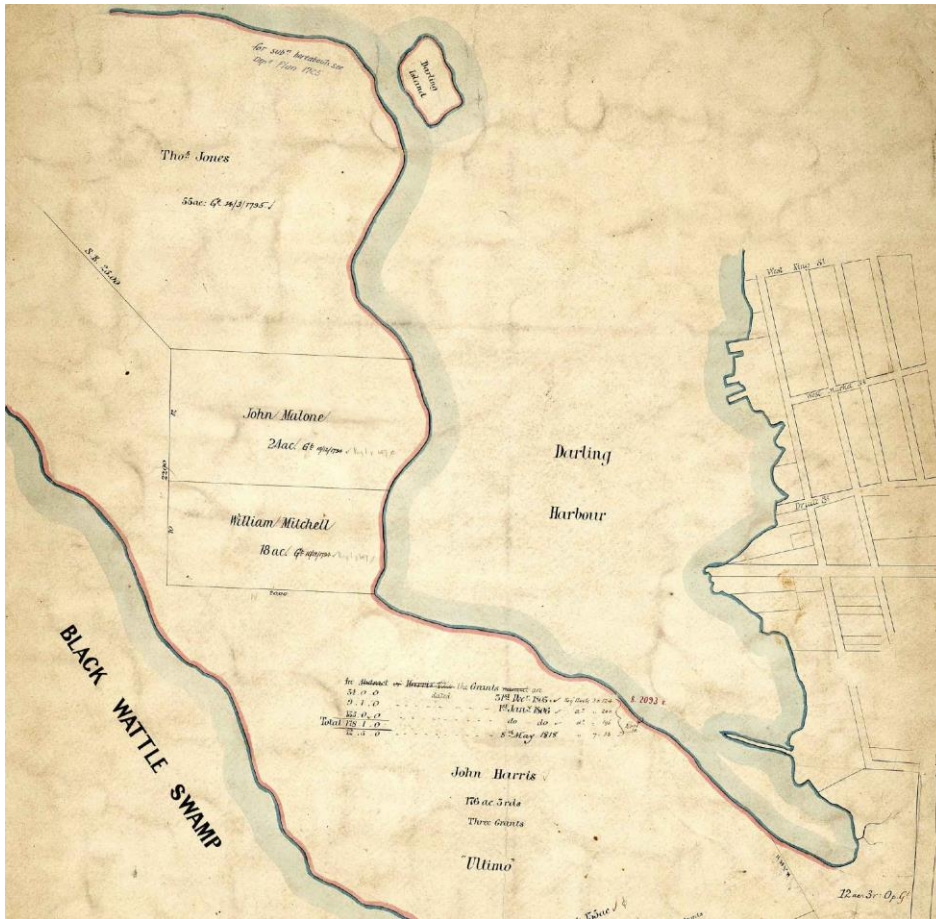
Figure 5: c1839 – Detail from Map of the Parish of St Andrew, County of Cumberland, showing the early land grants made in the Pyrmont and Ultimo areas (Source: State Library of NSW Z/M2 811.173/1839/1, <https://collection.sl.nsw.gov.au/record/74VvM6VbD4Pd/AVRya4rQa6kQk>)

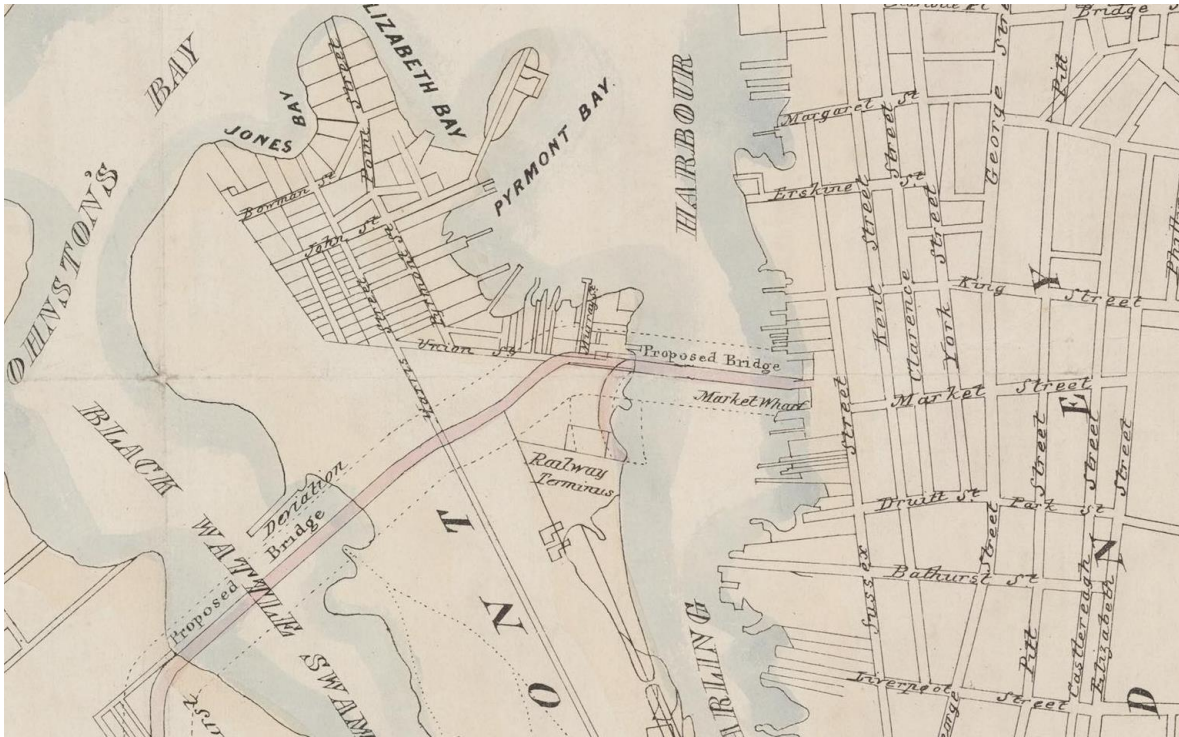
Figure 7: 1857 – Detail from ‘A plan of part of Sydney and its environs’ by Allan & Wigley, showing the development of roadways, including the proposed new Pyrmont Bridge Road, connecting the two new bridges (Source: State Library of NSW, Z/M2 811.15/1854/1, <https://collection.sl.nsw.gov.au/record/74VMbBv5kAGA>)

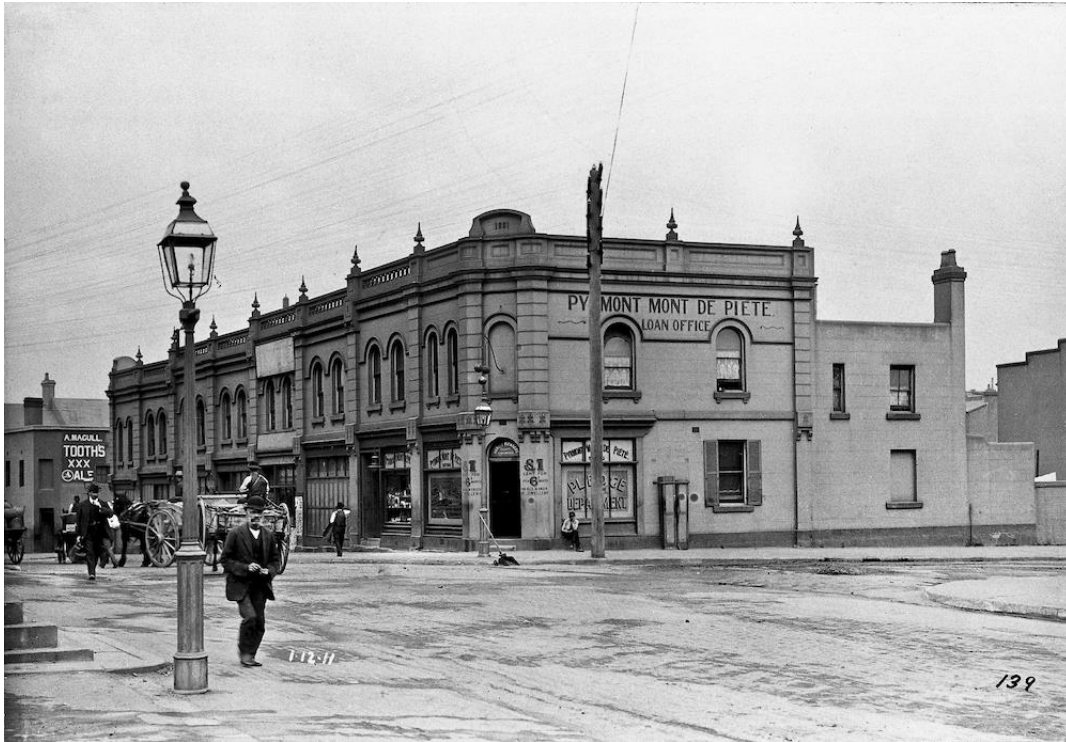
Figure 18: 1911 – Photograph of the terrace shop row on the northern side of Pyrmont Bridge Road, including the Pyrmont Mont de Piete Loan Office on the corner of Pyrmont Street. From Demolition Books. (Source: City of Sydney Archives, Pyrmont Bridge Road (01/12/1911), [A-00038946]. <https://archives.cityofsydney.nsw.gov.au/nodes/view/676872>)

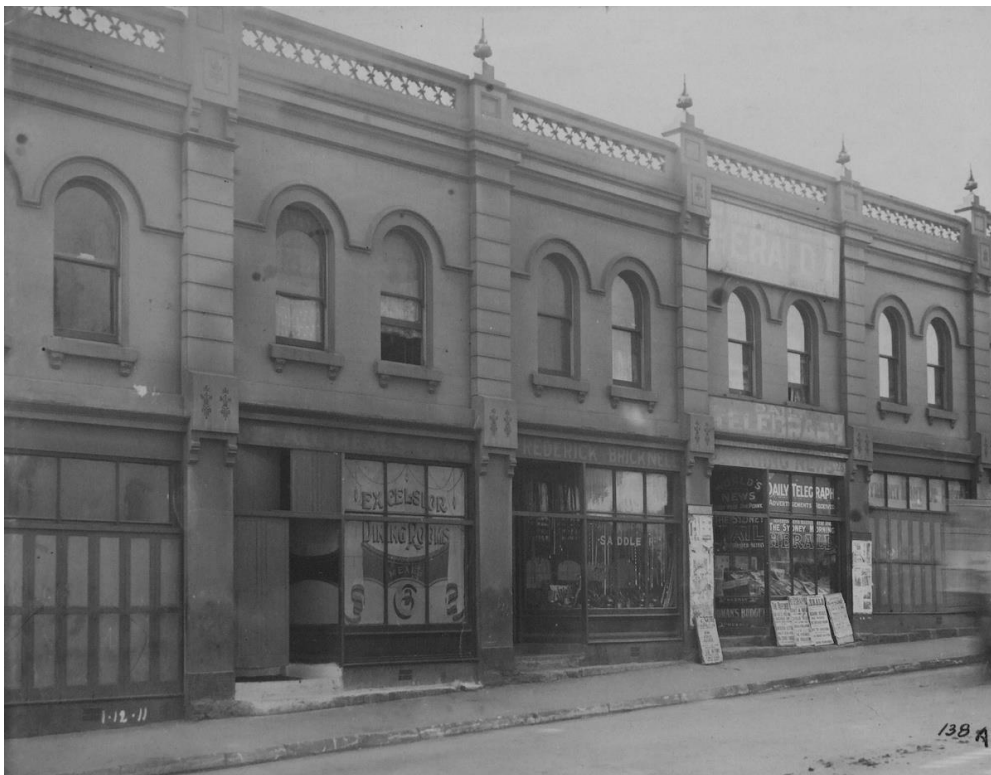
Figure 19: 1911 – Photograph of the shops on Pyrmont Bridge Road, including Excelsior Dining Rooms (No. 32), Frederick Bricknell, saddler (No. 30), and Henry Lee, newsagent (No. 28). From Demolition Books. (Source: City of Sydney Archives, Pyrmont Bridge Road (01/12/1911), [A-00038945]. <https://archives.cityofsydney.nsw.gov.au/nodes/view/676862>)

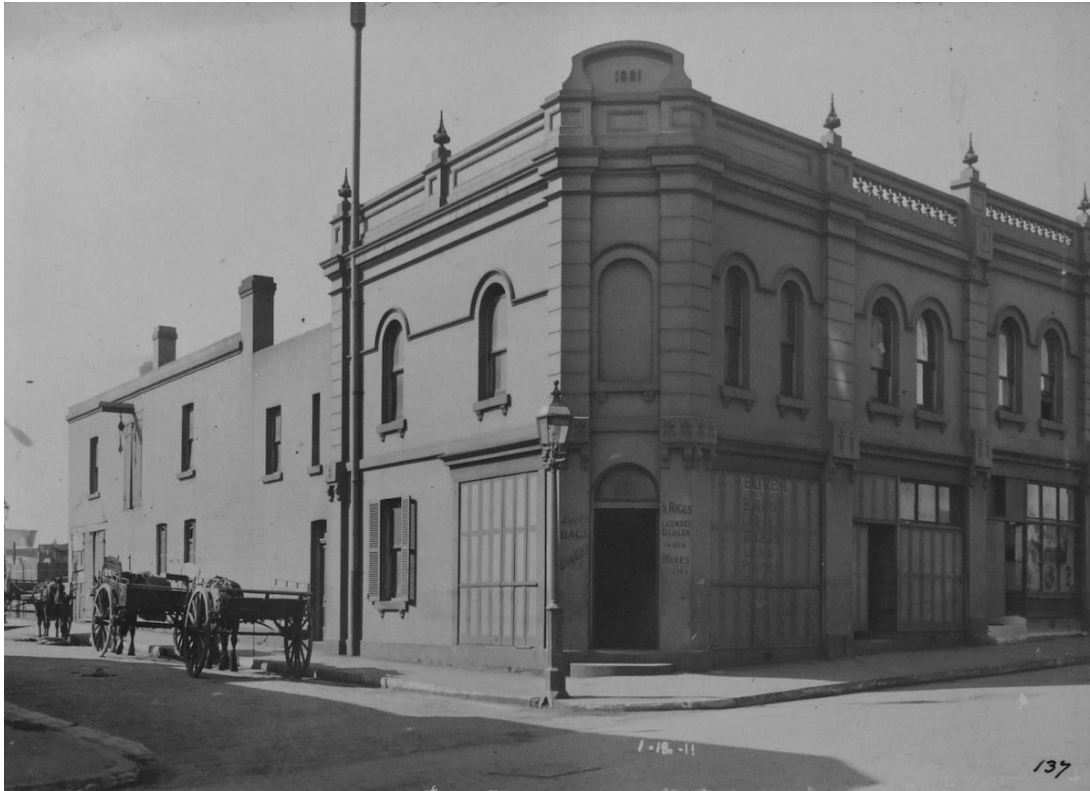
Figure 20: 1911 – Photograph of the building at the corner of Paternoster Row (on left) and Pyrmont Bridge Road. Located at 36 Pyrmont Bridge Road, this was from 1881 until the early 1900s in use as a bakery. From Demolition Books. (Source: City of Sydney Archives, Pyrmont Bridge Road (01/12/1911), [A-00038944]. <https://archives.cityofsydney.nsw.gov.au/nodes/view/676856>)

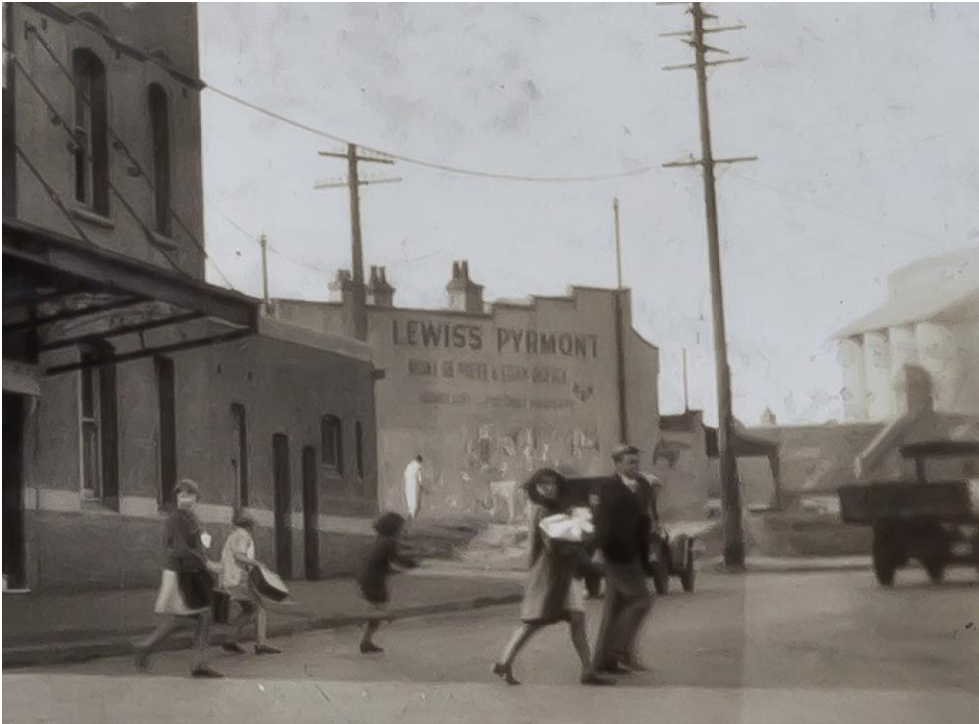
Figure 24: August 1930 – View towards the vacant site, with the Quarryman's Hotel on the left. A person appears to be standing on an elevated level, and the frontage to the street also appears to be elevated (Source: Noel Butlin Archives Centre, Tooth's Yellow Card, Quarryman's Hotel Pyrmont, Card 2 Side 2, <https://openresearch-repository.anu.edu.au/handle/1885/104550>)

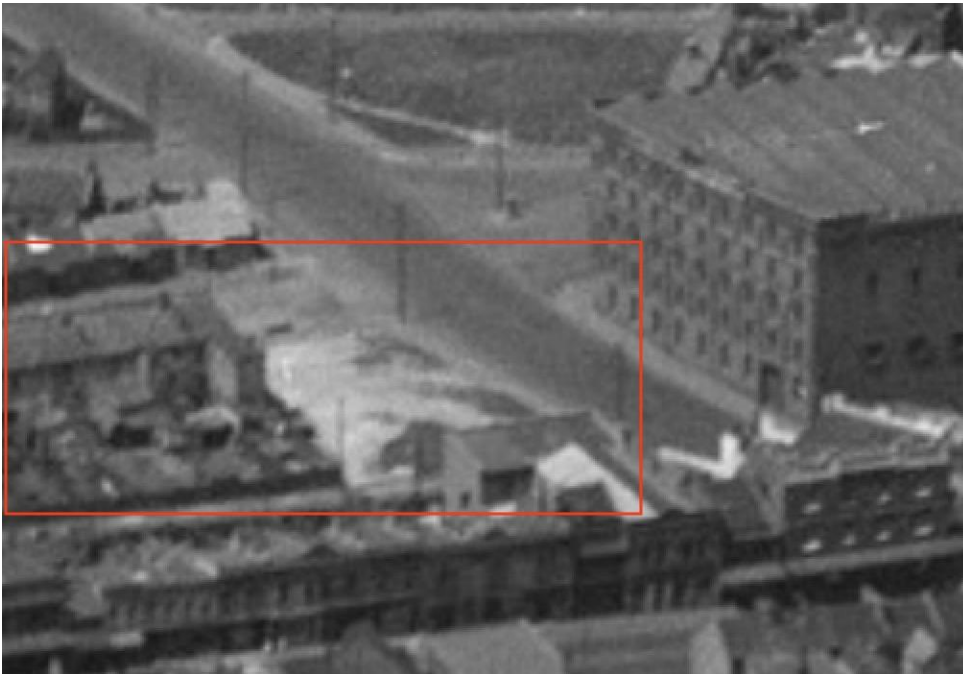
Figure 25: 1930 – Aerial view by Milton Kent, showing the vacant site as outlined (Source: SLNSW, Milton Kent aerial views of Sydney, 1932, FL8812121, <https://archival.sl.nsw.gov.au/Details/archive/110367483>)

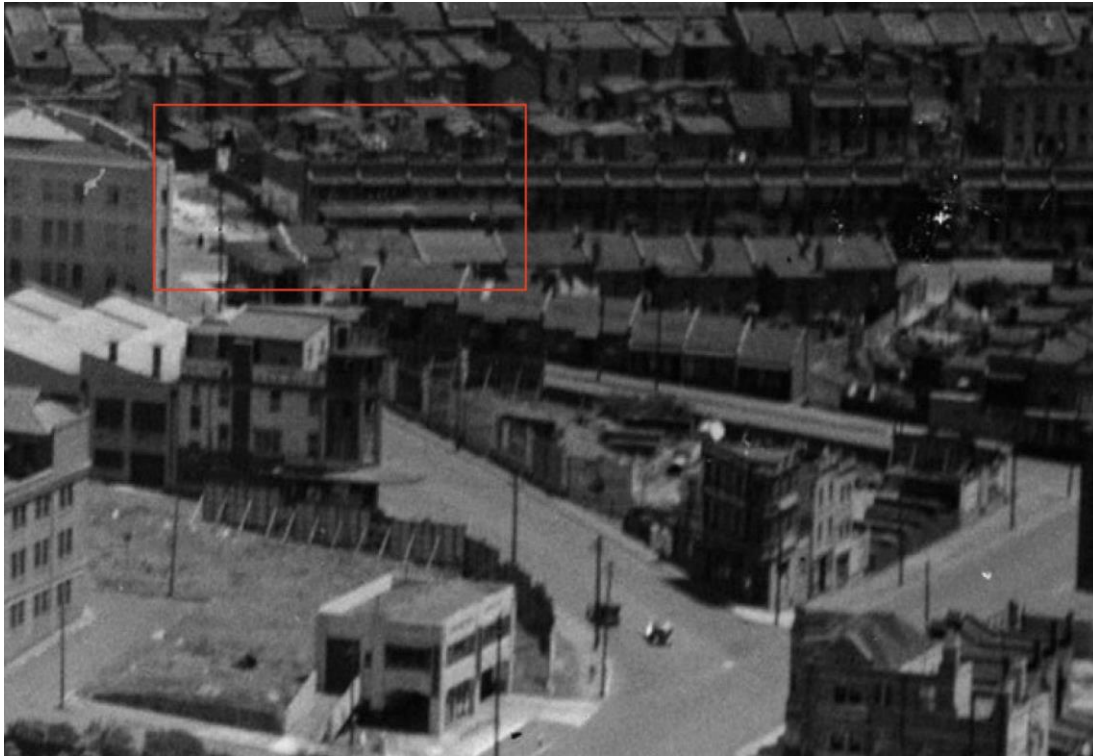
Figure 26: 1932 – Aerial view by Milton Kent, showing the vacant site and adjoining terraces as outlined (Source: SLNSW, Milton Kent aerial views of Sydney, 1932, FL8812119, <https://archival.sl.nsw.gov.au/Details/archive/110367483>)

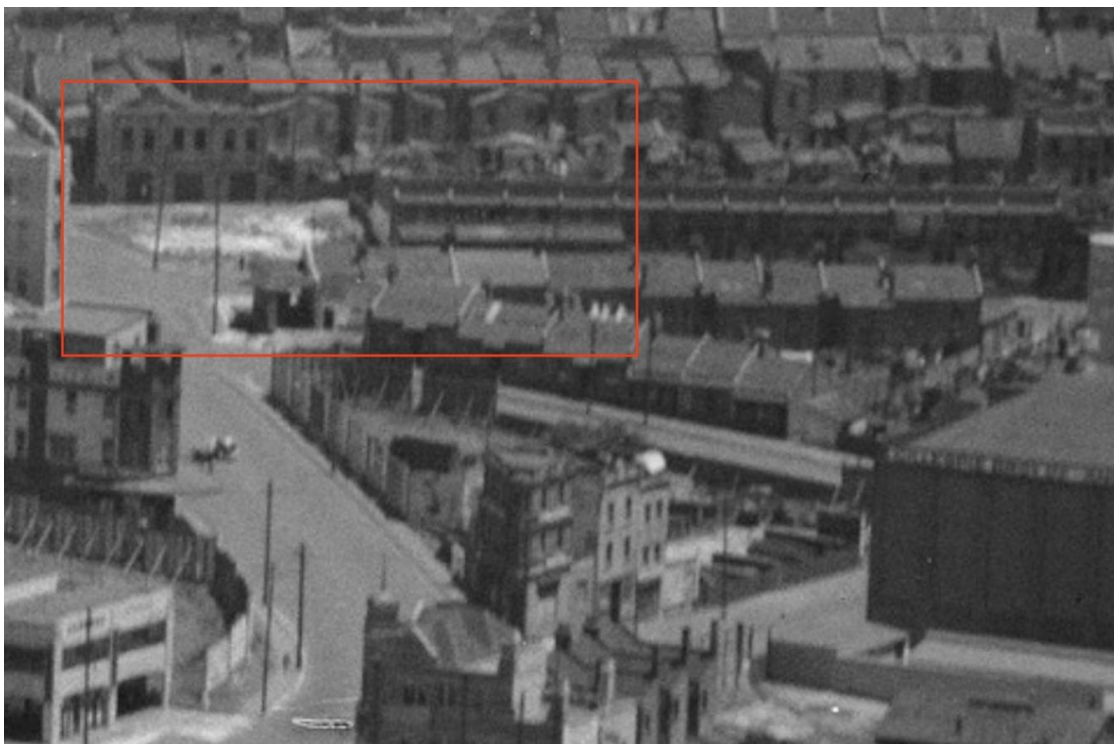
Figure 27: 1932 – Aerial view by Milton Kent, showing the vacant site and adjoining terraces as outlined (Source: SLNSW, Milton Kent aerial views of Sydney, 1932, FL8812120, <https://archival.sl.nsw.gov.au/Details/archive/110367483>)

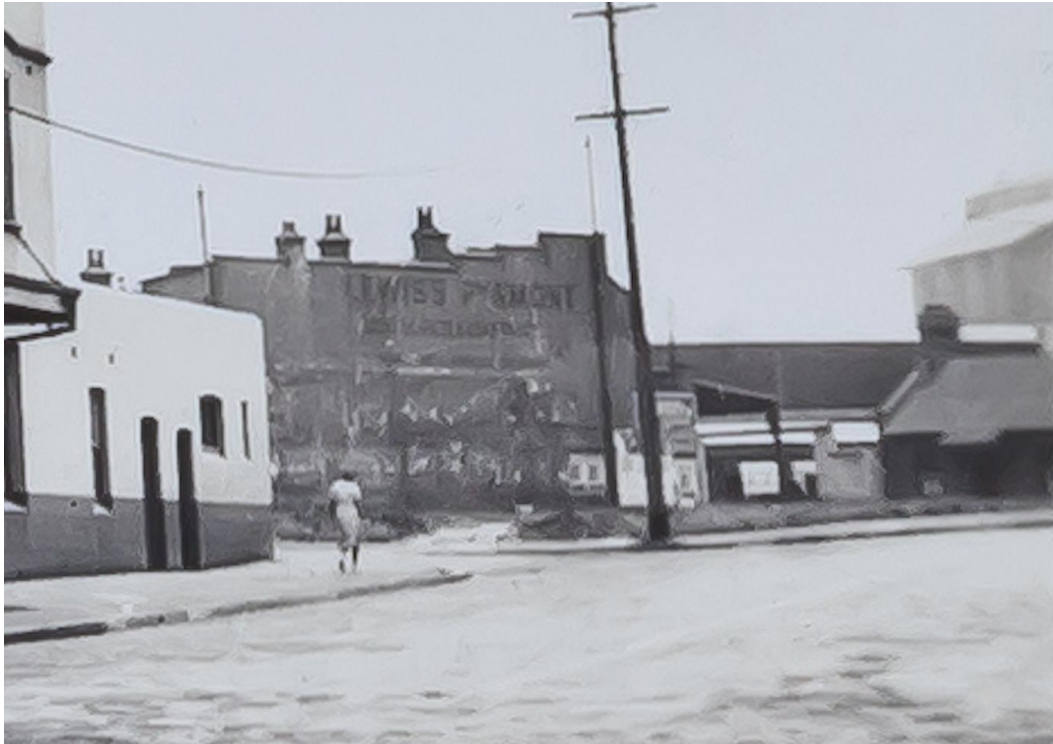
Figure 28: January 1939 – View towards the vacant site, with the Quarryman’s Hotel just visible on the left. The site appears to have been largely cleared, with a path likely cutting across (Source: Noel Butlin Archives Centre, Tooth’s Yellow Card, Quarryman’s Hotel Pyrmont, Card 2 Side 2, <https://openresearch-repository.anu.edu.au/handle/1885/104550>)

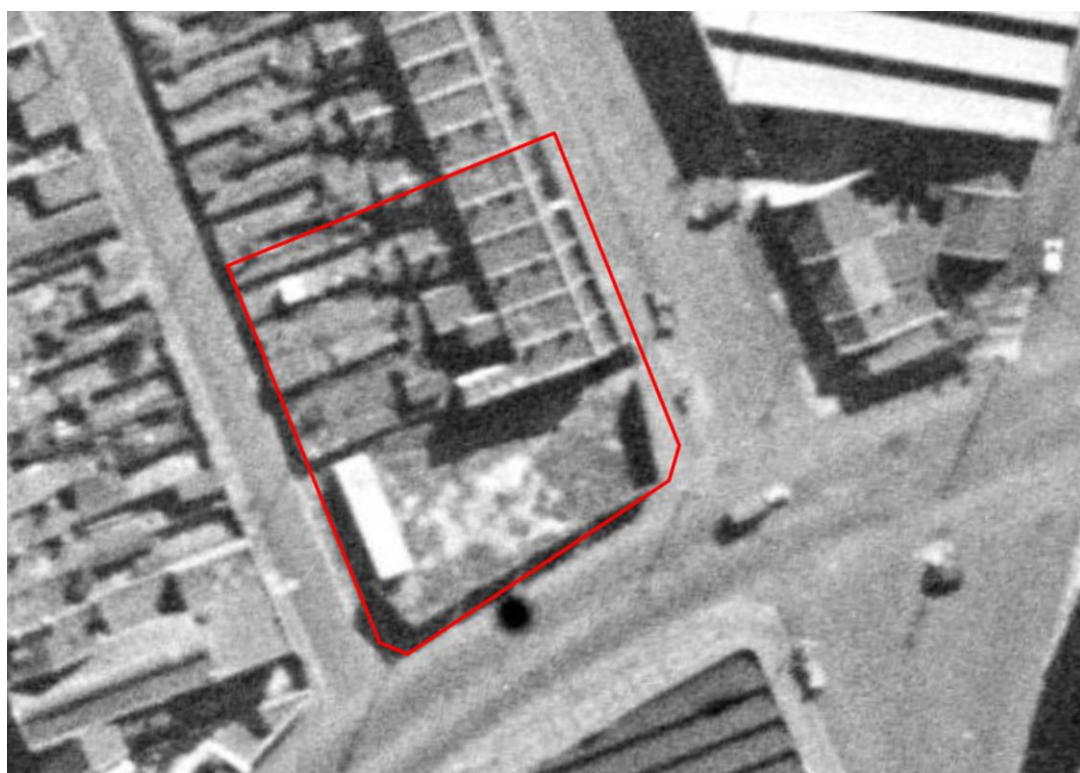
Figure 31: 1943 – Aerial photograph showing the hoarding erected in 1941, as well as a long structure along Paternoster Row, the purpose of which could not be identified (Source: NSW LRS, SIX Maps, 1943 aerial)

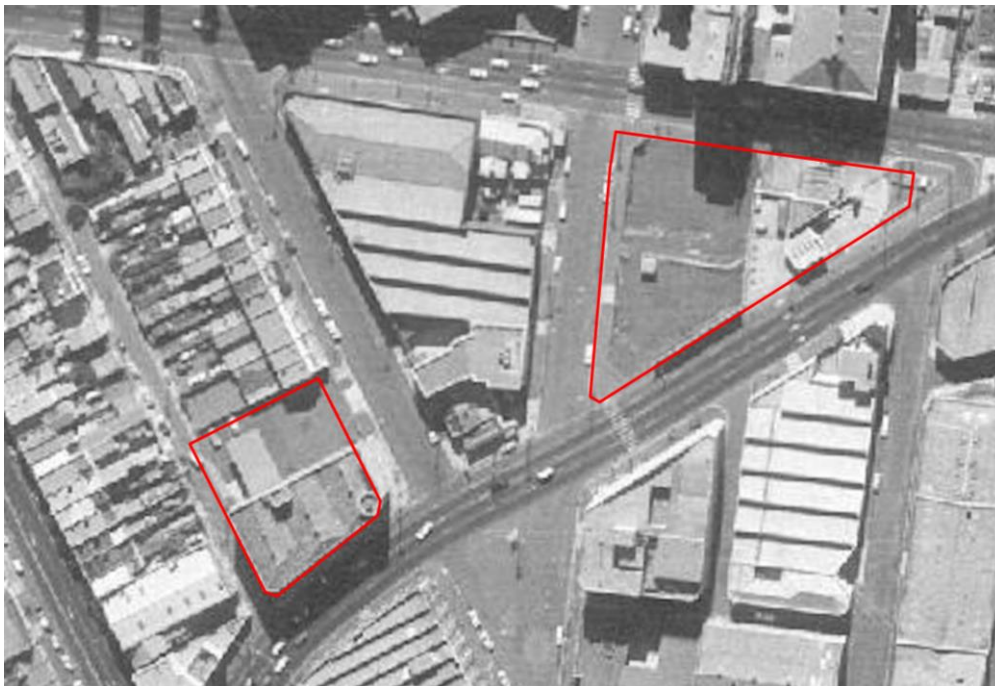
Figure 43: 15 December 1949 – Aerial photograph showing the building under construction (Source: City of Sydney Archives, A-00879983, City of Sydney Aerial Photographic Survey 1949: Image 38)

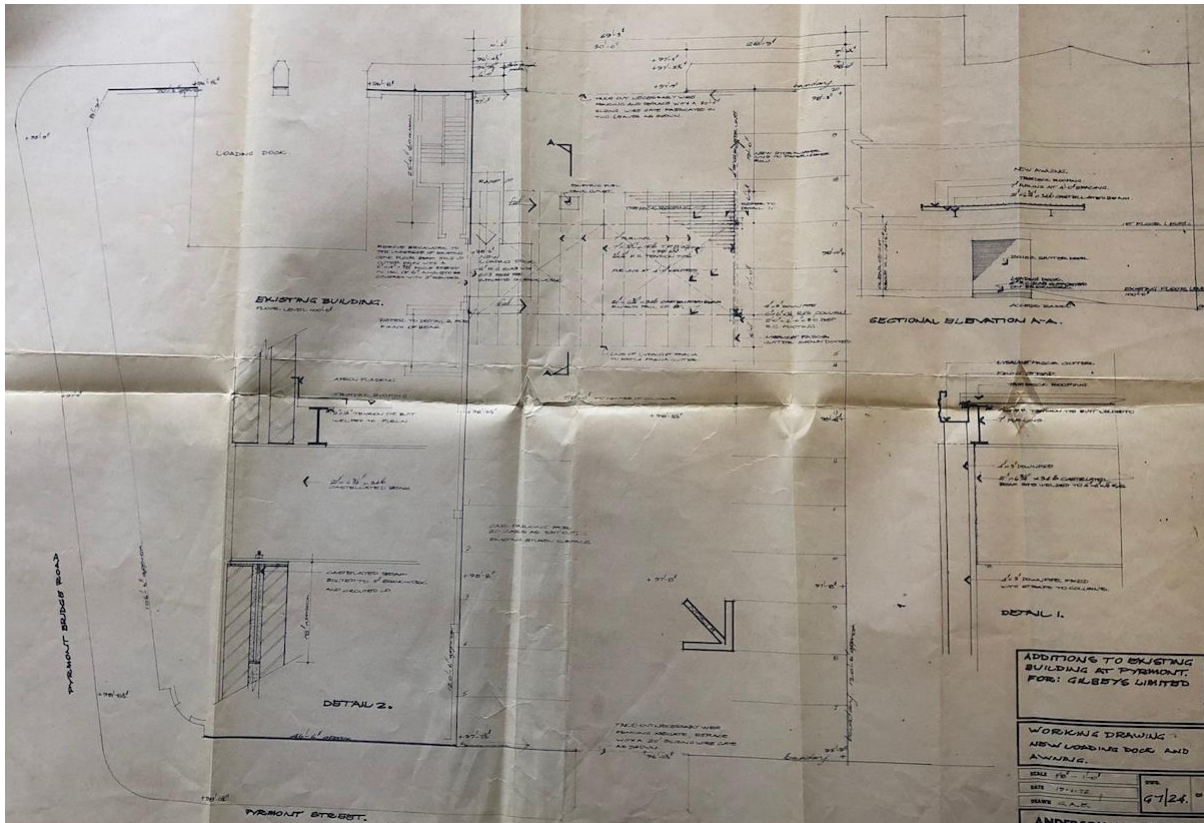
Figure 49: 1972 – Working drawing prepared by Anderson and Thomas, architects, dated 19 January 1972, as part of DA 465/71 (Source: City of Sydney Archives, DA 465/71, ‘129-135 Pyrmont Street, Pyrmont – Gilbeys Australia P/L – Use premises for parking and off-street loading’)

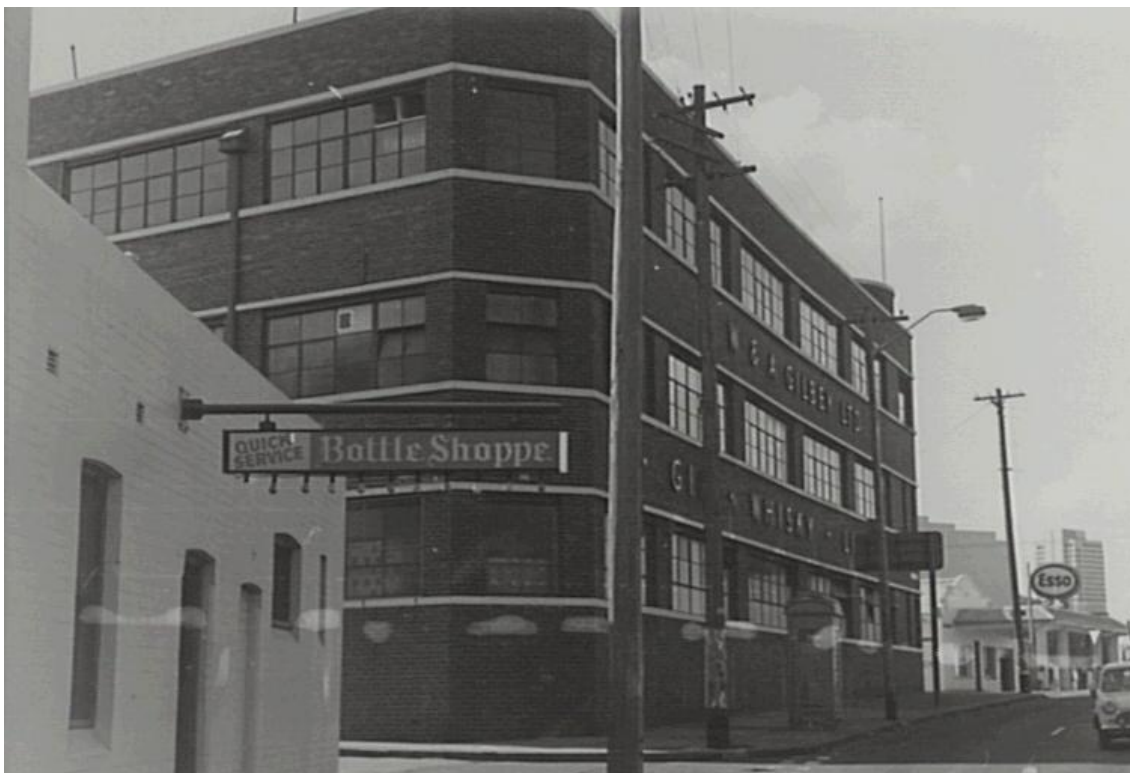
Figure 52: 6 August 1979 – The Pyrmont Bridge Road elevation of W. & A. Gilbey Ltd's factory and store (Source: City of Sydney Archives, W&A Gilbey Ltd, Bridge Road Pyrmont, 1979 (06/08/1979), [A-00007942]. <https://archives.cityofsydney.nsw.gov.au/nodes/view/568587>)

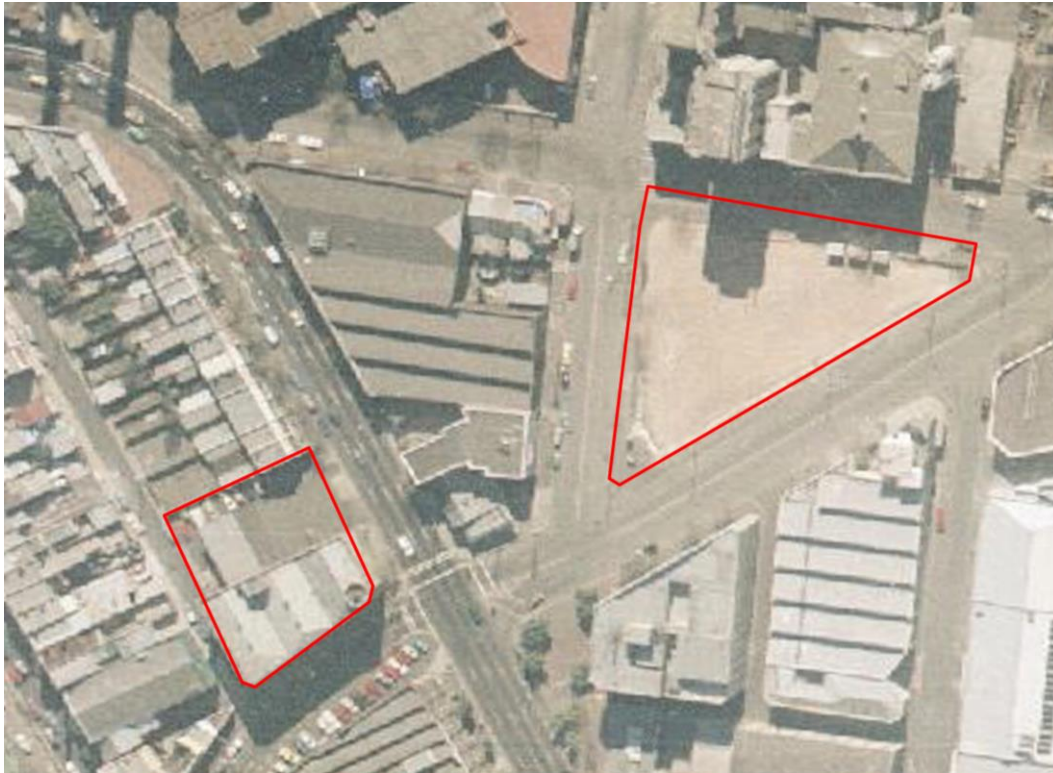
Figure 53: 1986 – Aerial photograph showing the site at 26-32 Pyrmont Bridge Road largely unchanged (Source: NSW Spatial Services, aerial photograph, 3 August 1986, 3528-22-061)

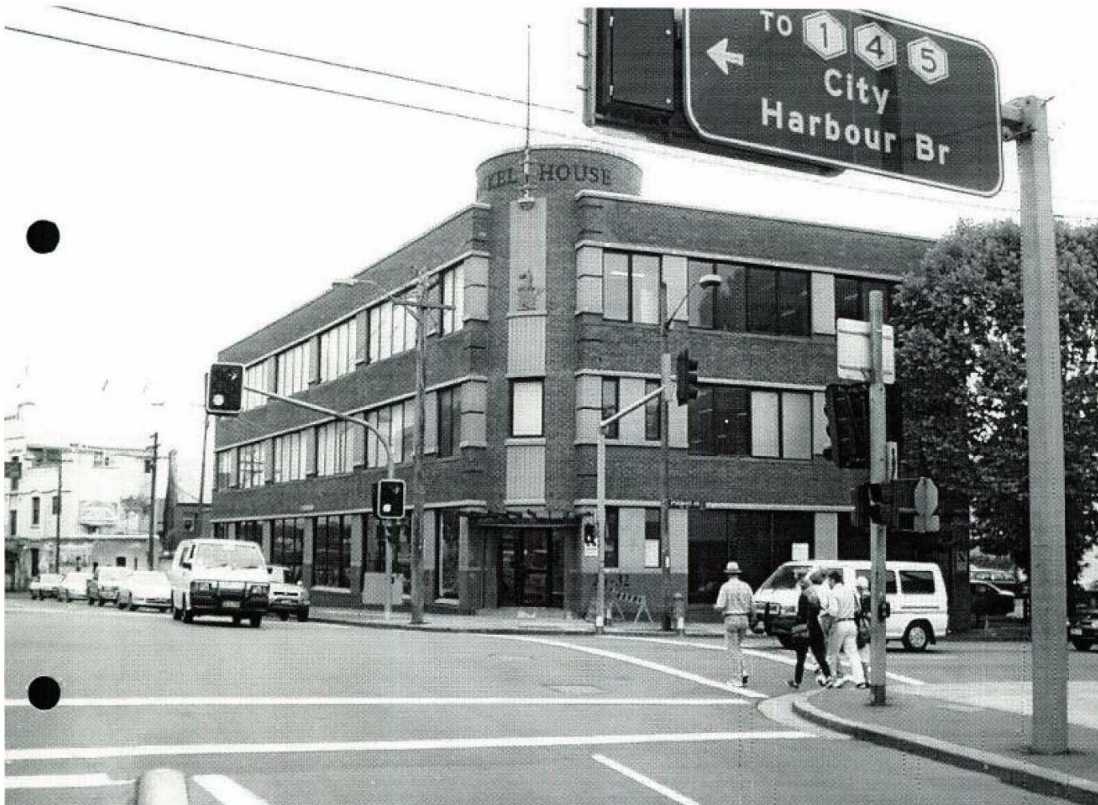
Figure 55: 1999 – ‘Frankel House’ as seen from Pyrmont Bridge Road, looking northwest. (Source: City of Sydney Archives, D1999/00812, ‘Development Applications/26-32/Pyrmont Bridge Road/Pyrmont/Alterations & Additions to Existing Building – Bulawayo Holdings Pty Ltd – 14 10 99 - \$5000000’)

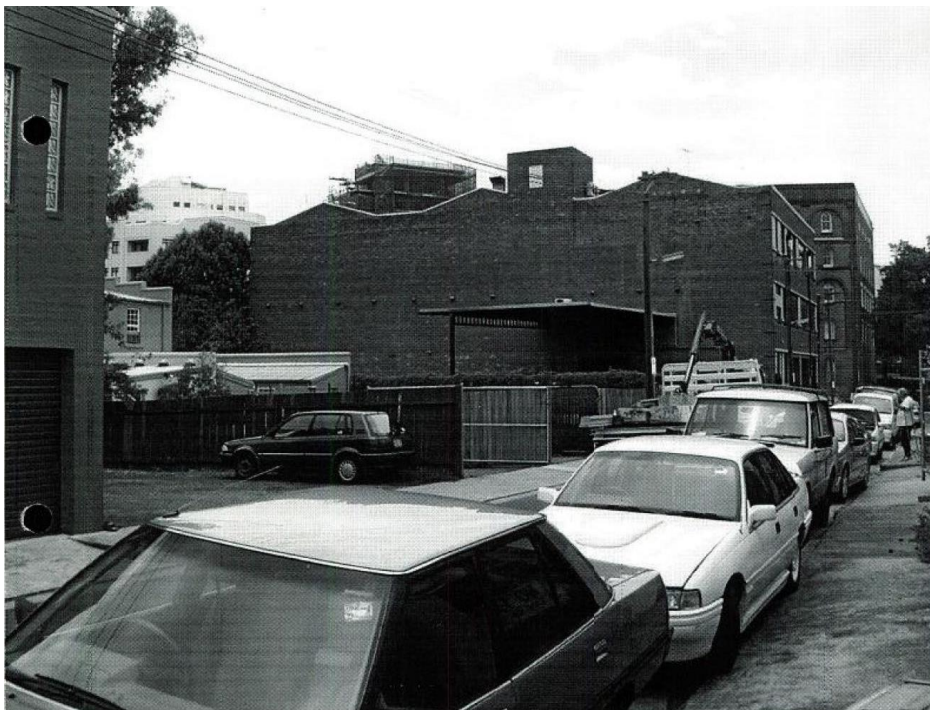
Figure 56: 1999 – Looking southeast from Paternoster Row towards the north elevation of the former Gilbey's Building, with the awning over the loading dock visible at centre. (Source: City of Sydney Archives, D1999/00812, ‘Development Applications/26-32/Pyrmont Bridge

Road/Pyrmont/Alterations & Additions to Existing Building – Bulawayo Holdings Pty Ltd – 14
10 99 - \$5000000')

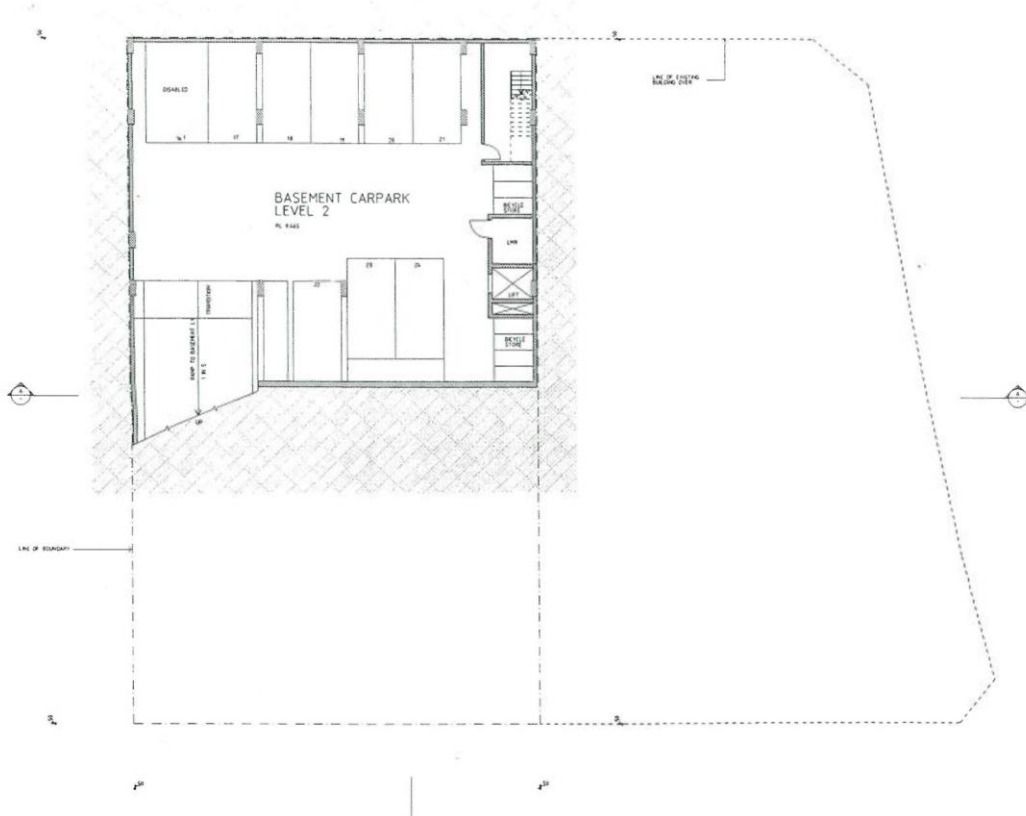
Figure 59: 1999 – Basement Level 2 plan, prepared by Allen Jack + Cottier, architects, dated 8 December 1999 (Source: City of Sydney Archives, D1999/00812, 'Development Applications/26-32/Pyrmont Bridge Road/Pyrmont/Alterations & Additions to Existing Building – Bulawayo Holdings Pty Ltd – 14 10 99 - \$5000000')

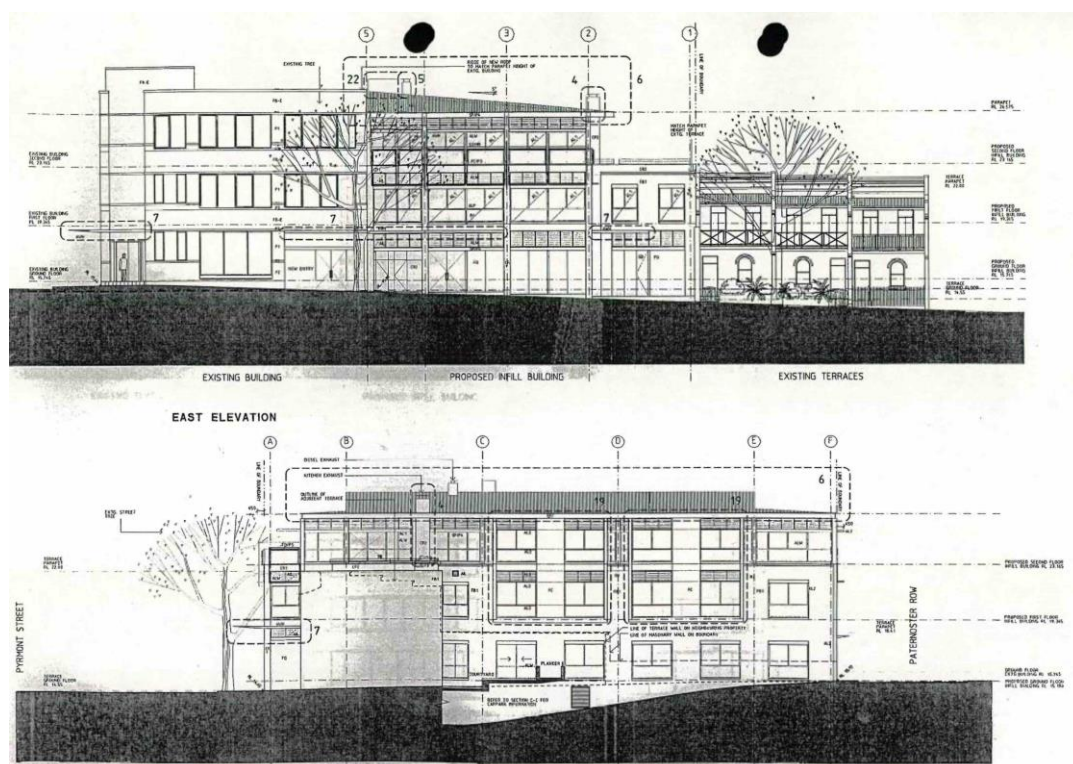
Figure 63: 2000 – East and north elevations, prepared by Allen Jack + Cottier, architects, as part of the Section 96 application, dated 7 April 2000 (Source: City of Sydney Archives, D1999/00812, ‘Development Applications/26-32/Pyrmont Bridge Road/Pyrmont/Alterations & Additions to Existing Building – Bulawayo Holdings Pty Ltd – 14 10 99 - \$5000000’)

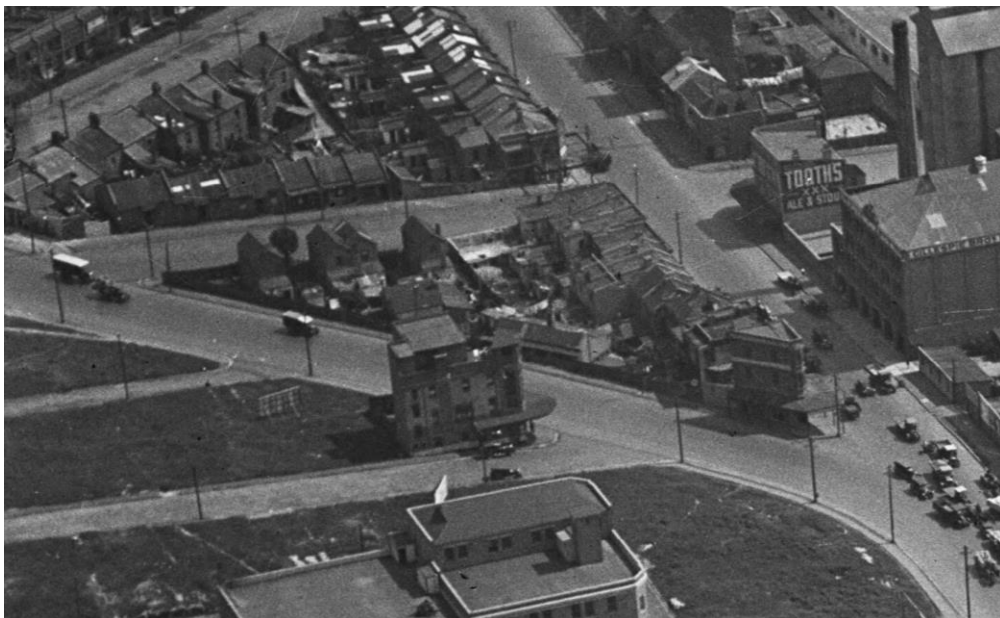
Figure 67: 1930 – Detail from aerial view showing the Eastern Construction Site fully developed, including the 1896 building on the corner of Union Street and Pymont Bridge Road, at lower right. The timber buildings to the rear of the shops at the corner of Union and Edward Streets have been demolished and the original hall replaced by residential terraces. Note the gabled buildings on Edward Street, and the single storey semi-detached cottages on Pymont Bridge Road, which are about to be demolished (Source: Fairfax Corporation. (1930). Aerial view of Darling Harbour showing Pymont Bridge closing following passage of a ship, Sydney, ca. 1930s. <http://nla.gov.au/nla.obj-163204711>)

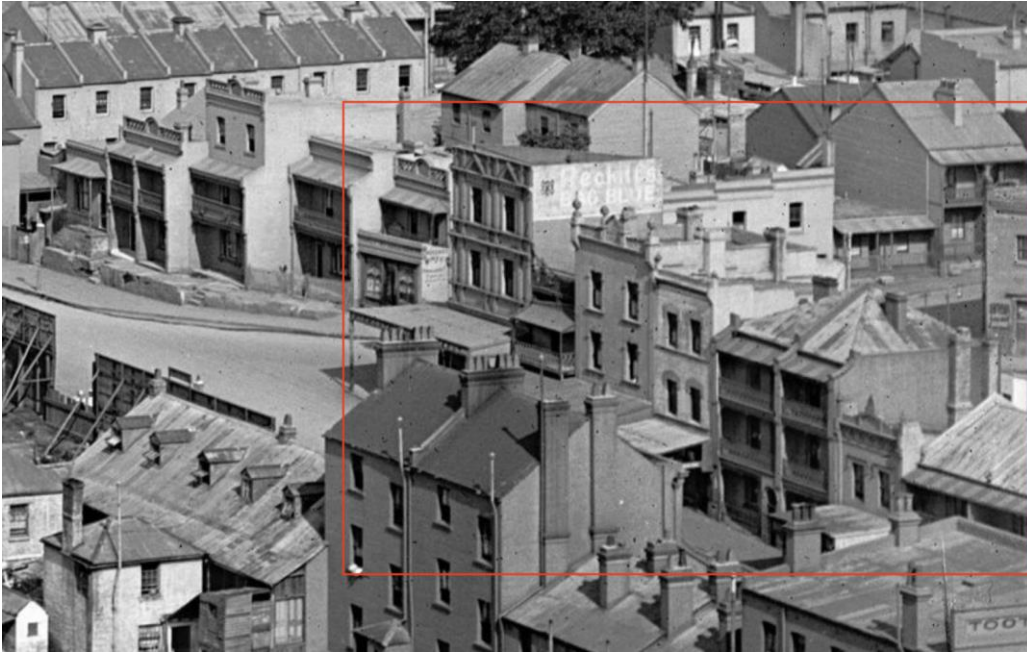
Figure 72: Late 1890s to 1900s – The buildings at 51 to 69 Union Street as outlined in red, with the decorative parapet of the double storey shop at 55 Union Street visible at lower right. Photography by Charles H. Kerry (Source: Powerhouse Collection, Sydney from Pyrmont, 85/1284-1778. <https://collection.maas.museum/object/28399>)

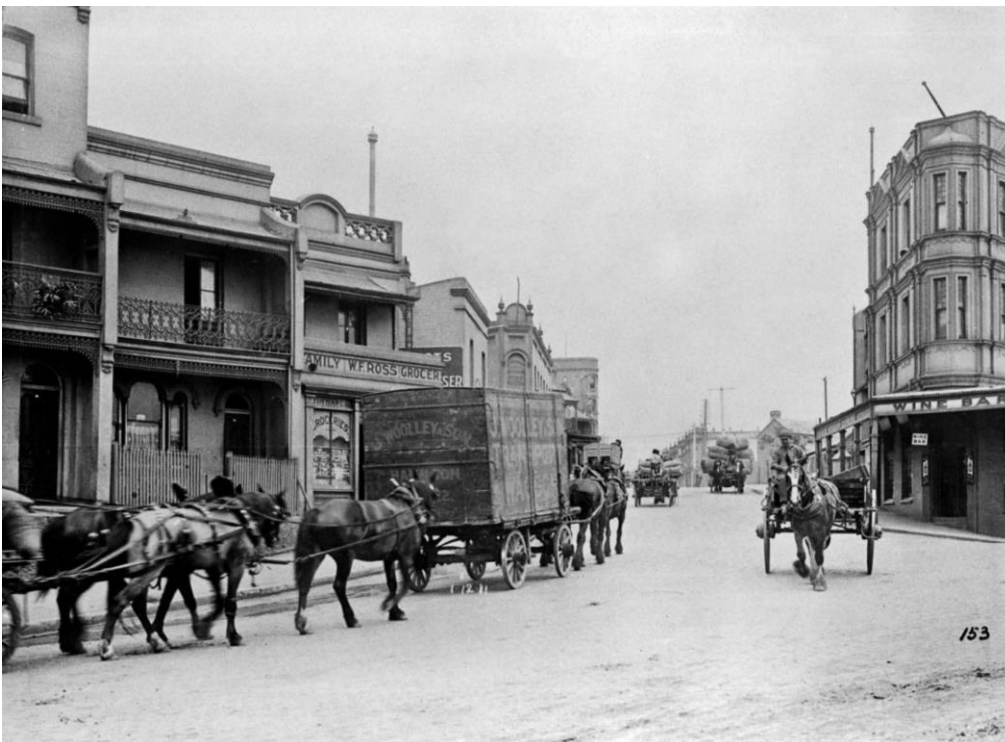
Figure 73: 1 December 1911 – Corner of Union Street and Pyrmont Bridge Road, with the Wine Bar at 69 Union Street on the right and small cottages to the rear (Source: City of Sydney Archives, Pyrmont (01/12/1911), [A-00038966]. <https://archives.cityofsydney.nsw.gov.au/nodes/view/676948>)

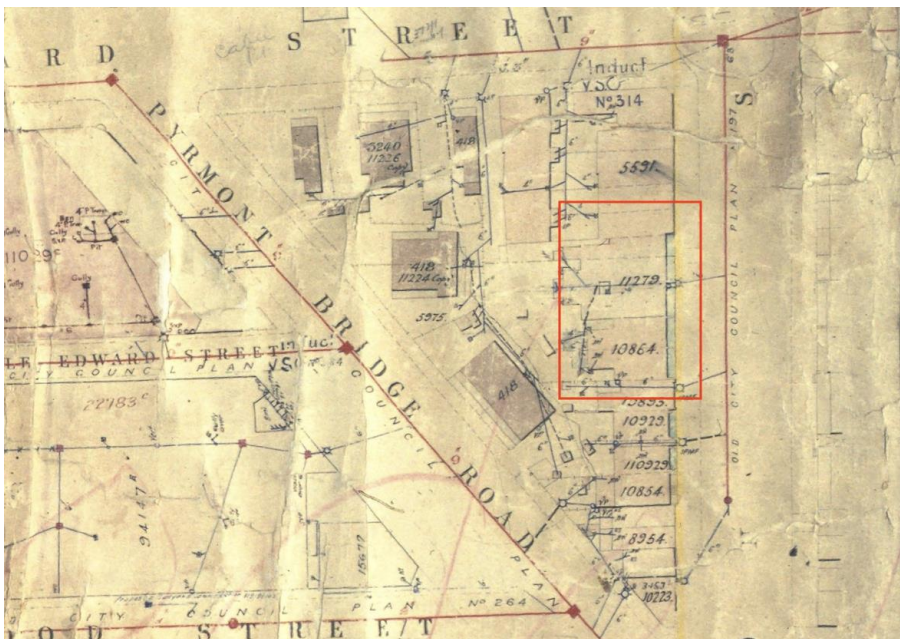
Figure 74: Detail from Blackwattle Sheet, prepared by the Board of Water Supply and Sewerage, 1908 (with later updates), showing that the hall has been demolished and replaced with double storey terraces (now five in total, area outlined). The blacksmith’s shop to the rear of 37-45 Union Street was still standing by then. (Source: Sydney Water Archives, BLKWTL 3716)
