Sydney Metro West – Pyrmont Station Construction Sites

Archaeological Research Design and
Excavation Methodology

Report to Sydney Metro

April 2022

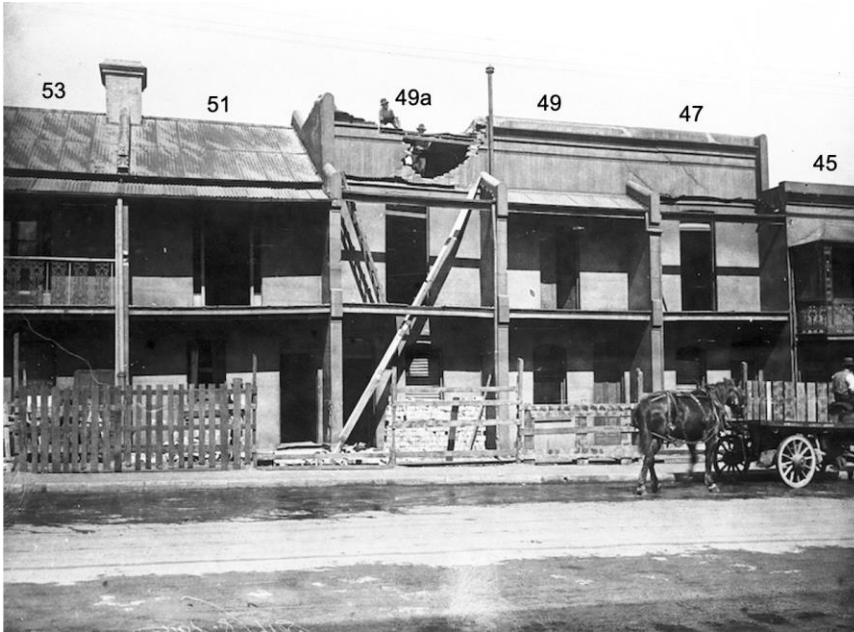
Figure 75: 8 September 1916 – Photograph of dwellings at 47-59 Union Street, Pyrmont, with workers working on the parapet. From Demolition Books. In c1905, these terraces replaced the former hall which was once located at 49/49a Union Street, before being gutted by fire in 1903. It is unclear what works were carried out to the terraces at that time, as double storey houses continued to be located at the site until the early 1930s (Source: City of Sydney Archives, Dwellings, Union St (47-59), Pyrmont, 8 September 1916 (08/09/1916), [A-00036813]. <https://archives.cityofsydney.nsw.gov.au/nodes/view/663180>)

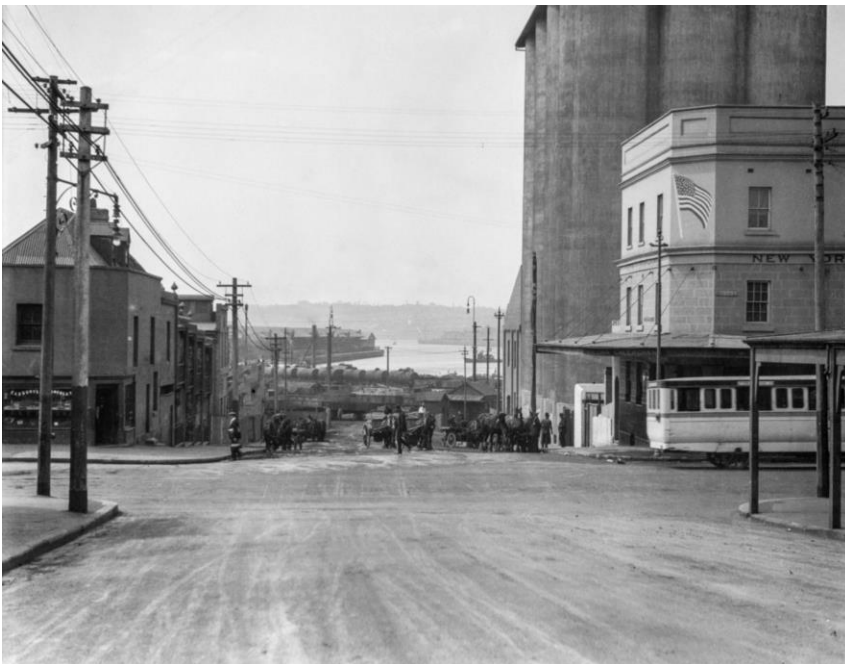
Figure 76: c1920s – Looking south from Edward Street, across Union Street, with the verandah structure of the corner building at 37 Union Street just visible on the right. Said to date from 1931, however, the verandah structure was already gone by 1929, see Figure 81 (Source: City of Sydney Archives, Edward Street, Pyrmont (01/01/1931 - 31/12/1931), [A-00011914]. <https://archives.cityofsydney.nsw.gov.au/nodes/view/572559>)

much later as a tobacconist.¹⁵⁷ It appears to have originally had a supported verandah structure running around the corner of the building (Figure 76).

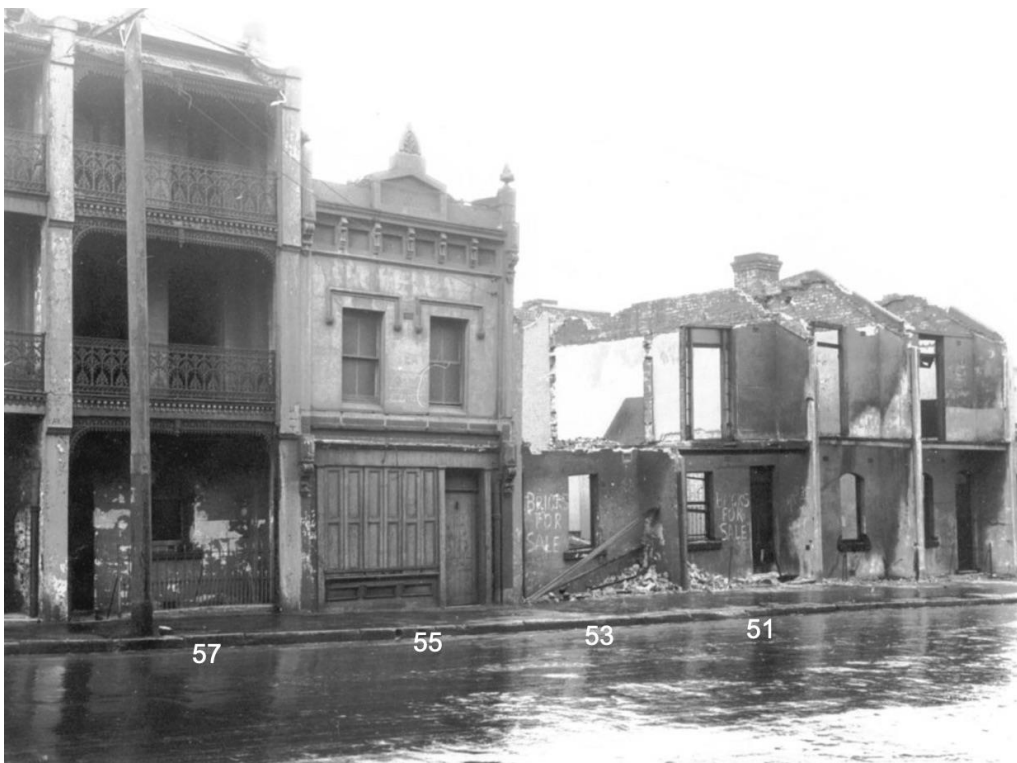
Figure 83: 20 October 1930 – Houses being demolished at Union Street, near corner of Edward Street. The shop on the left was located at 55 Union Street, however, the numbering of houses to the west (on right) was not always consistent (Source: City of Sydney Archives, Houses being demolished (20/10/1930), [A-00037644]. <https://archives.cityofsydney.nsw.gov.au/nodes/view/664011>)

While the 1907 *Assessment Books* wrongly noted all buildings as double storey structures, even though the buildings at 57 to 69 Union Street contained three, the entry shows that the site of the former hall now formed part of a row of five double storey terraced houses. This corresponds with the plan in Figure 74 and the photographs in Figure 75, Figure 77-Figure 78, and Figure 83. Various photographs showing the buildings during the 1910s and 1920s are also included below.

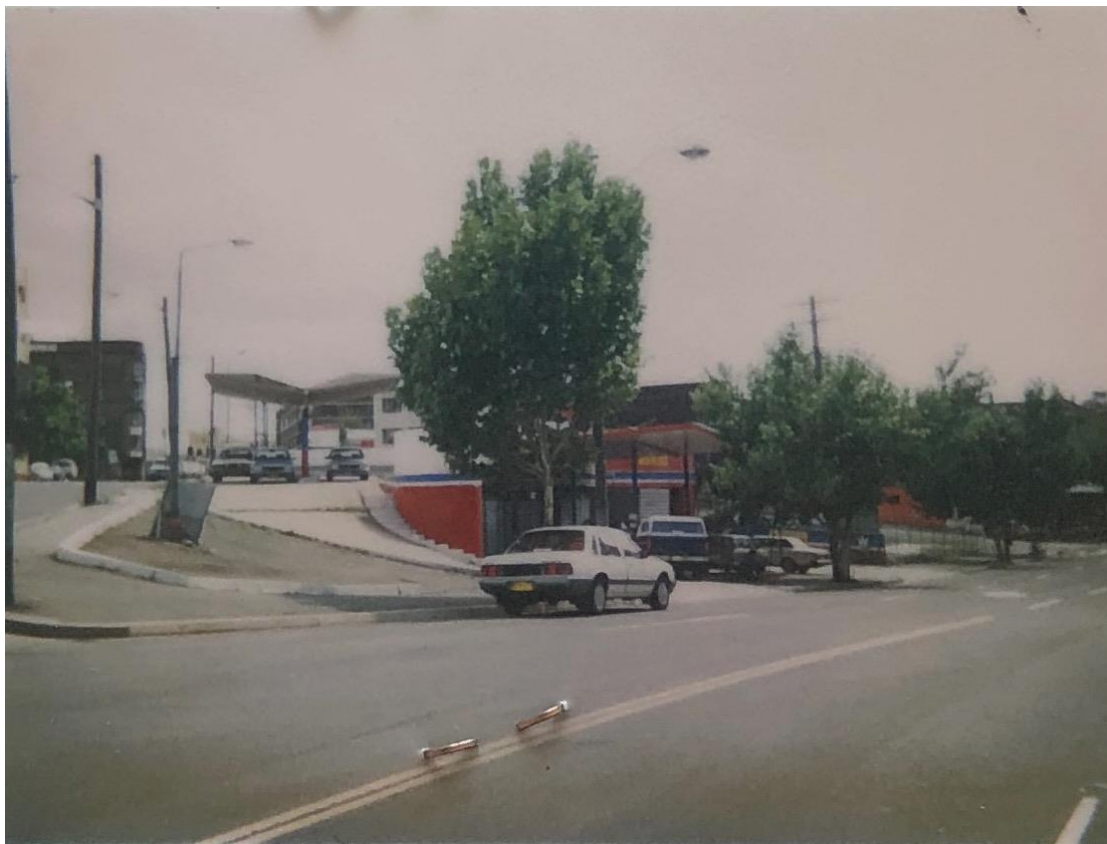
Figure 107: c1985-86 – Photograph showing the Service Station at centre prior to demolition, with a portion of the fence surrounding the parking station on the right, facing Union Street. (Source: City of Sydney Archives, BA 86/1056, '37 - 61 63 - 65 67 & 69 Union St Pyrmont - Construct New Office Warehouse Building \$1800000 22 05 86 Cedra Construction Pty Ltd (22/05/1986 - 14/02/1992).')

This was followed by a building application (BA 86/1056) approved on 11 July 1986.²⁵³ The redevelopment of the site, for Copeland Mercantile Ventures Pty Ltd, involved demolition of all existing structures at the site, including the existing service station. Prior to demolition a photograph was taken of the petrol station, which is included in Figure 107. The ground floor plan and elevations for the redevelopment, designed by Butler & Sky Pty, architects, and approved on 10 April 1987, are included in Figure 108 and Figure 109. The relevant BA file does not contain any site plan showing the location of buildings prior to redevelopment.

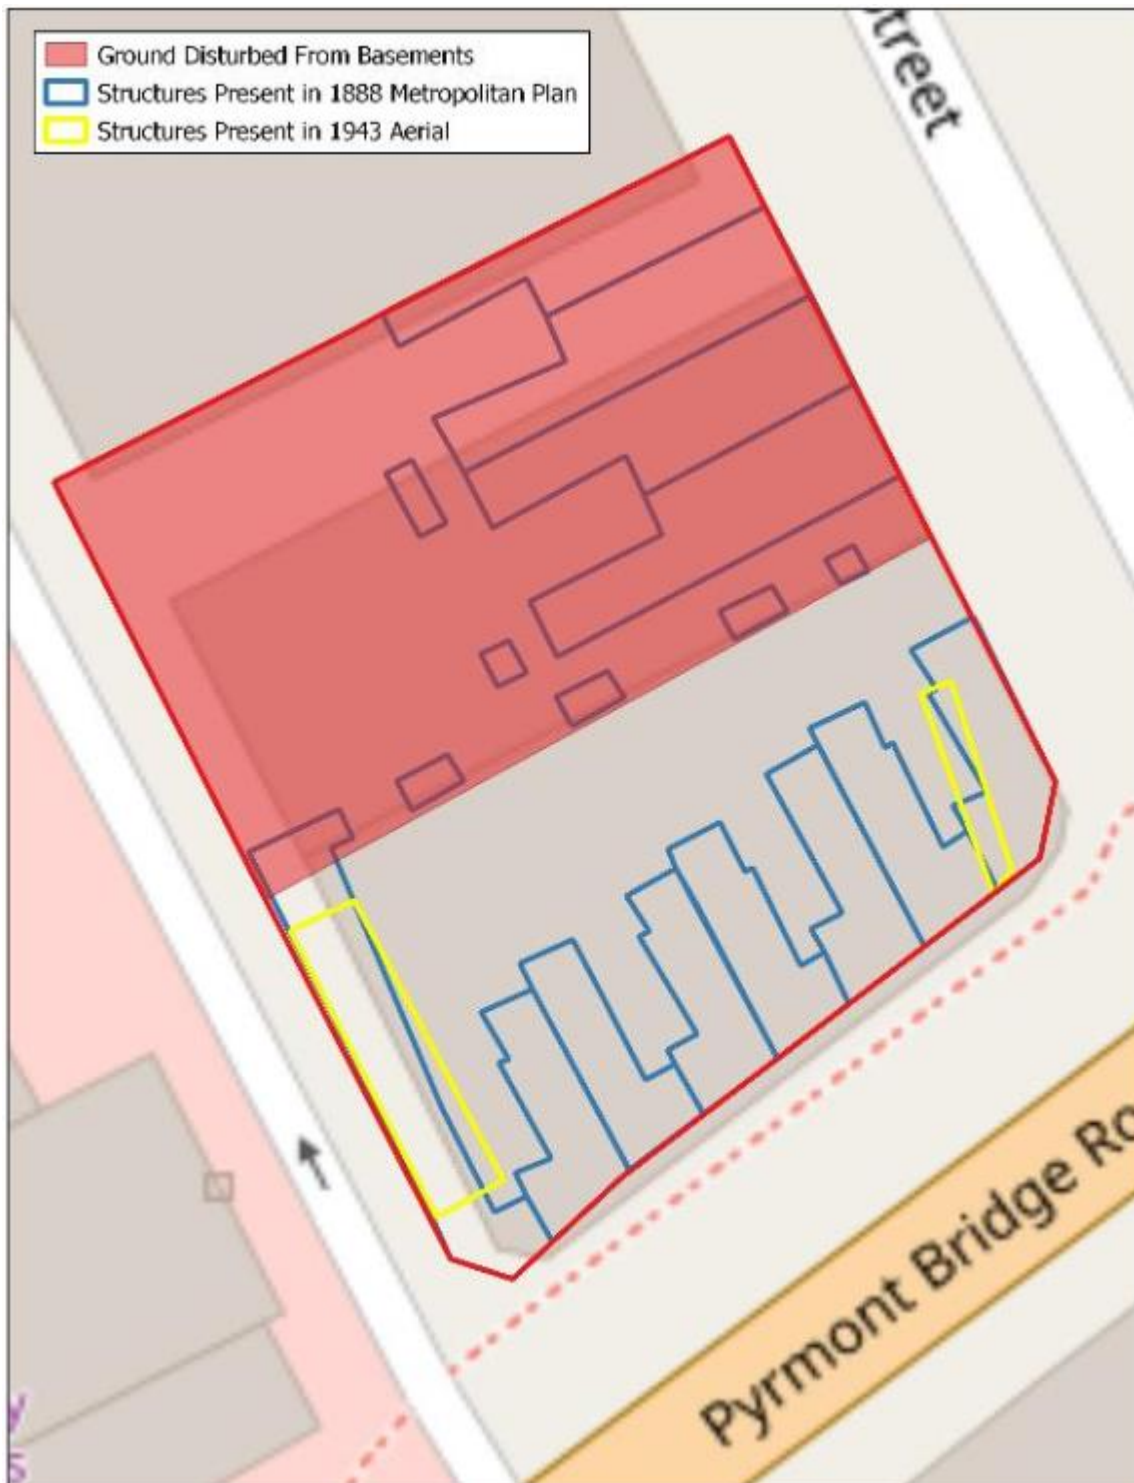
Figure 112: Overlay of potential archaeological remains within Pyrmont Station western construction site.

Phase	Site use	Predicted archaeological remains	Potential
		<p>terraces were the living and working spaces of a variety of retail trades, including bakers, grocers, drapers, newsagencies, and restaurants. Archaeological remains related to these premises would only be situated within the southern portion of the site due to basement excavation present in the north. The location of the former terrace houses with respect to the construction site and known basement excavation is provided in Figure 112.</p> <p>The area of archaeological potential within the construction site is associated with the central and rear portions of the terrace buildings, which would include rear kitchens. Privies were located within the rear yards however these are situated within the area of later basement excavation.</p> <p>Archaeological resources relating to development within these subdivisions include:</p> <ul style="list-style-type: none"> • Building foundations—sandstone or brick—associated with documented and undocumented structures; • Demolition fills, postholes and rubbish deposits; • Undocumented features including basements, drains, cesspits, utilities, cisterns and wells • Yard and workshop surfaces • Evidence of gardens and yard layouts. <p>The study area has generally low potential to contain artefact-bearing occupation/underfloor deposits.</p>

Phase 3 (1914-1947)	Resumed for road widening, potential storage area for building material or soil, residential housing and commercial properties	<p>During this phase the northern portion of the construction site still housed terraces used in both a residential and commercial capacity. However, the ground disturbance caused by the construction of the basement carpark will have undoubtedly destroyed the archaeological remains associated with this section. It is possible that some of the same potential artefacts predicted for Phase 2 may have been discarded in the southern portion of the site, or been redeposited by subsequent construction works.</p> <p>The southern portion of the site' was used for storing building materials at this time. There will likely be minimal archaeological remains associated with this use. Any such remains will likely be limited to building materials, rubbish deposits, and introduced soil deposits. Historical evidence indicates that structures related to the storage yard were likely impermanent sheds, possibly of timber construction. This would suggest that remnants of such structures will be limited to postholes, remnants of the structures' construction materials, and possibly items that were being stored within.</p>	Low

Phase 4 (1947-present)	Gilbey's Distillery and connected carpark, 'Frankel House' and connected basement carpark	<p>The current building was constructed at the beginning of this phase. Although the building was constructed on pile footings, it is likely that excavation work has resulted in considerable truncation of the western construction site in areas containing the concrete foundations for this building. Remains associated with the former use of the building as a distillery may be present in the sub-floor cavity of the building from chance discard, including glass bottles / bottle fragments, metal equipment and rubbish deposits.</p>	Moderate

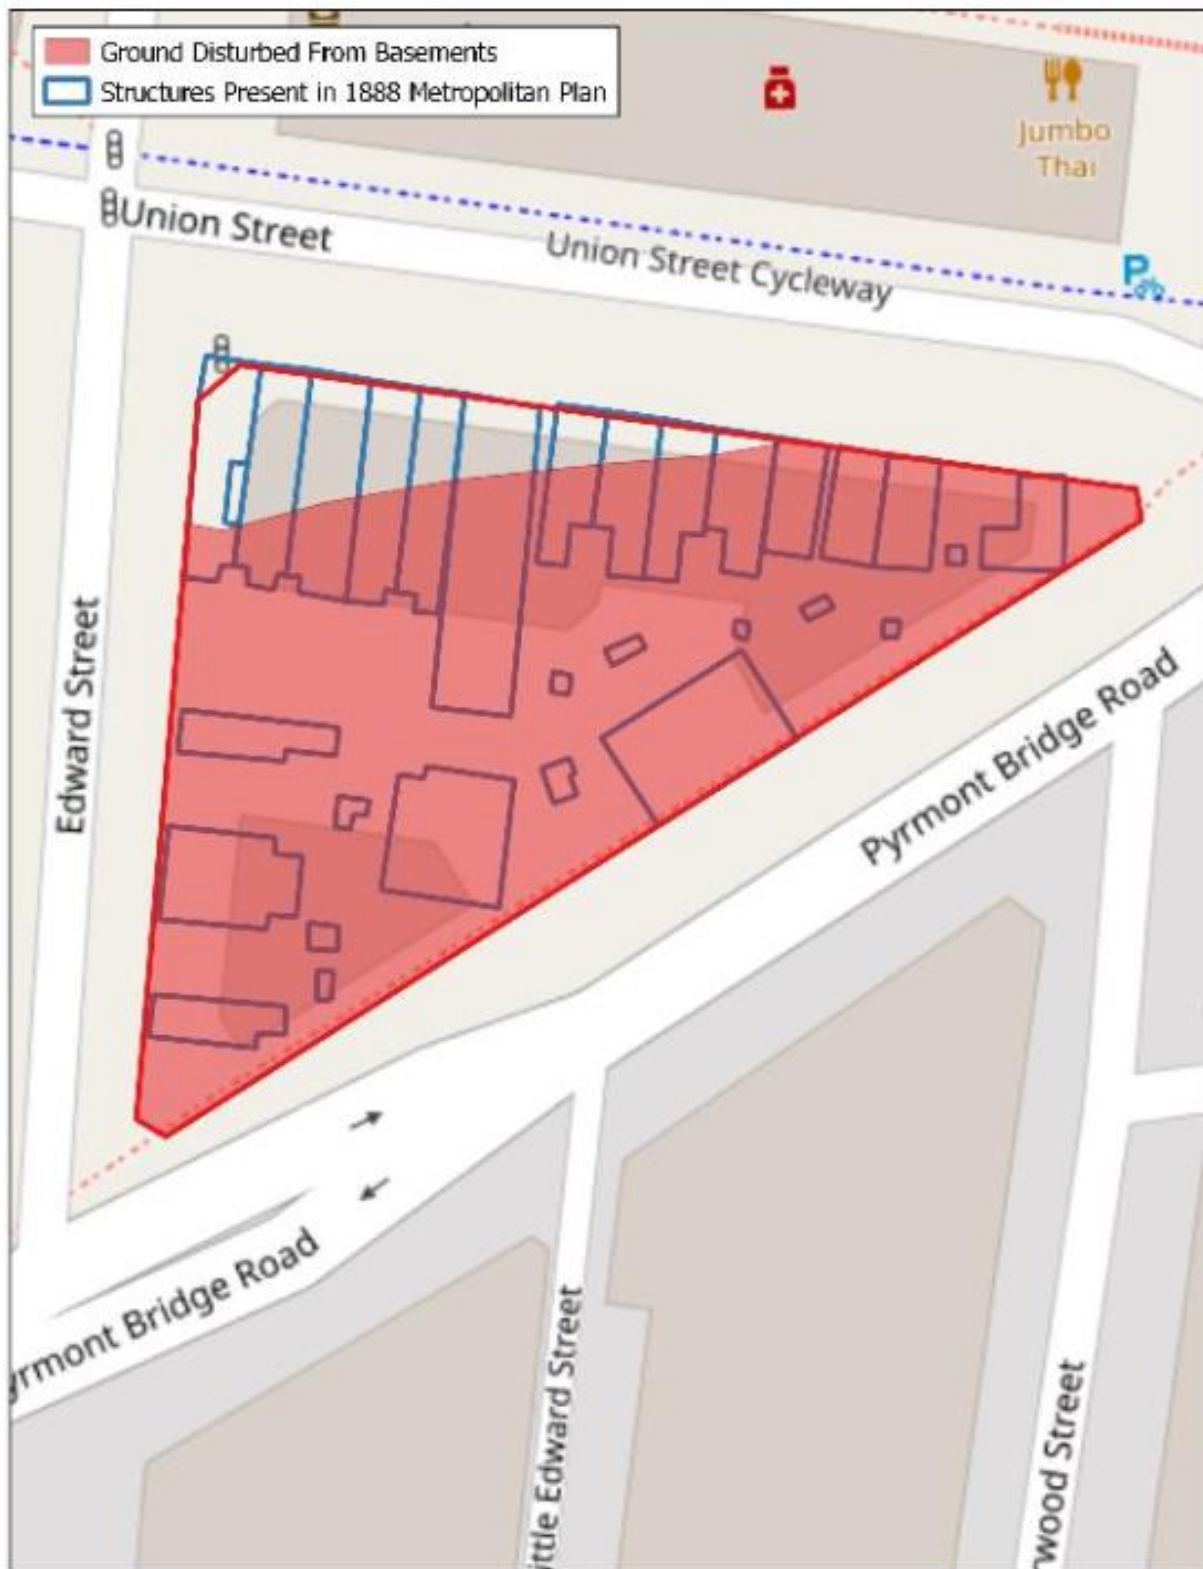
Figure 113: Overlay of potential archaeological remains within the Pyrmont Station eastern construction site.

Phase	Site use	Predicted archaeological remains	Potential
Phase 1 (1788-1878)	Part of the Ultimo Estate, potentially used for livestock grazing	Land clearing is presumed to have occurred during this time, but no known construction occurred within this Pyrmont Station western construction site during this time. Land utilised for informal grazing or farming may have left ephemeral archaeological remains such as animal bones (cattle or sheep), tree boles, fencing post holes or field drains. However, with the later development of the site and with significant basements in the northern portion of the site, these remains are not anticipated to be present.	Nil
Phase 2 (1883-1930)	Residential housing, commercial properties, 'Elder's Hall'	<p>Terrace housing used for commercial and residential tenants were constructed in 1878. These terraces were the living and working spaces of a variety of retail trades, including butchers, grocers, hairdressers, and general stores, as well as "Elder's Hall" a local community centre at the time. Archaeological remains related to these premises would only be situated within the northern portion of the site due to basement excavation present in the south. The location of the former terrace houses with respect to the construction site and known basement excavation is provided in Figure 113.</p> <p>The area of archaeological potential within the construction site is associated with the front rooms of these former terraces and only for a small section of the original Union Street row of buildings. Privies and kitchens are likely not preserved due to their presence in the rear of the properties which have been removed from excavation for basement parking.</p> <p>Archaeological resources relating to development within these subdivisions include:</p> <ul style="list-style-type: none"> • Building foundations—sandstone or brick—associated with documented and undocumented structures; • Demolition fills, postholes and rubbish deposits; • Undocumented features including basements, drains, cesspits, utilities, cisterns and wells • Yard and workshop surfaces • Evidence of gardens and yard layouts. <p>The study area has generally low potential to contain artefact-bearing occupation/underfloor deposits.</p>	Moderate for truncated remains

Phase	Site use	Predicted archaeological remains	Potential
Phase 3 (1930-1986)	Timber and building materials storage yard, and associated sheds and offices, fuel service station, car park	<p>This phase saw the western portion of the construction site used for lumber storage which would preclude the likely accumulation of significant archaeological remains. Chance archaeological remains from this phase could include timber and brick footings for walls or fences, as well as isolated rubbish deposits, however later disturbance to construct office buildings in the 1980s involved ground excavation would have likely removed all of these relatively ephemeral remains.</p> <p>The fuel service station was constructed in the eastern corner of the construction site in the 1960s. Later excavation for the construction of the 1980s office building has likely removed all remnants of this structure with the possible exception of any residual deep fuel storage tanks.</p>	<p>Nil for storage yard</p> <p>Low for deep deposits (fuel tanks) only</p>

Phase 4 (1986-present)	Commercial properties	Subsurface archaeological remains are not anticipated to be present from the construction of the 1980s office building on the site	Nil for subsurface remains

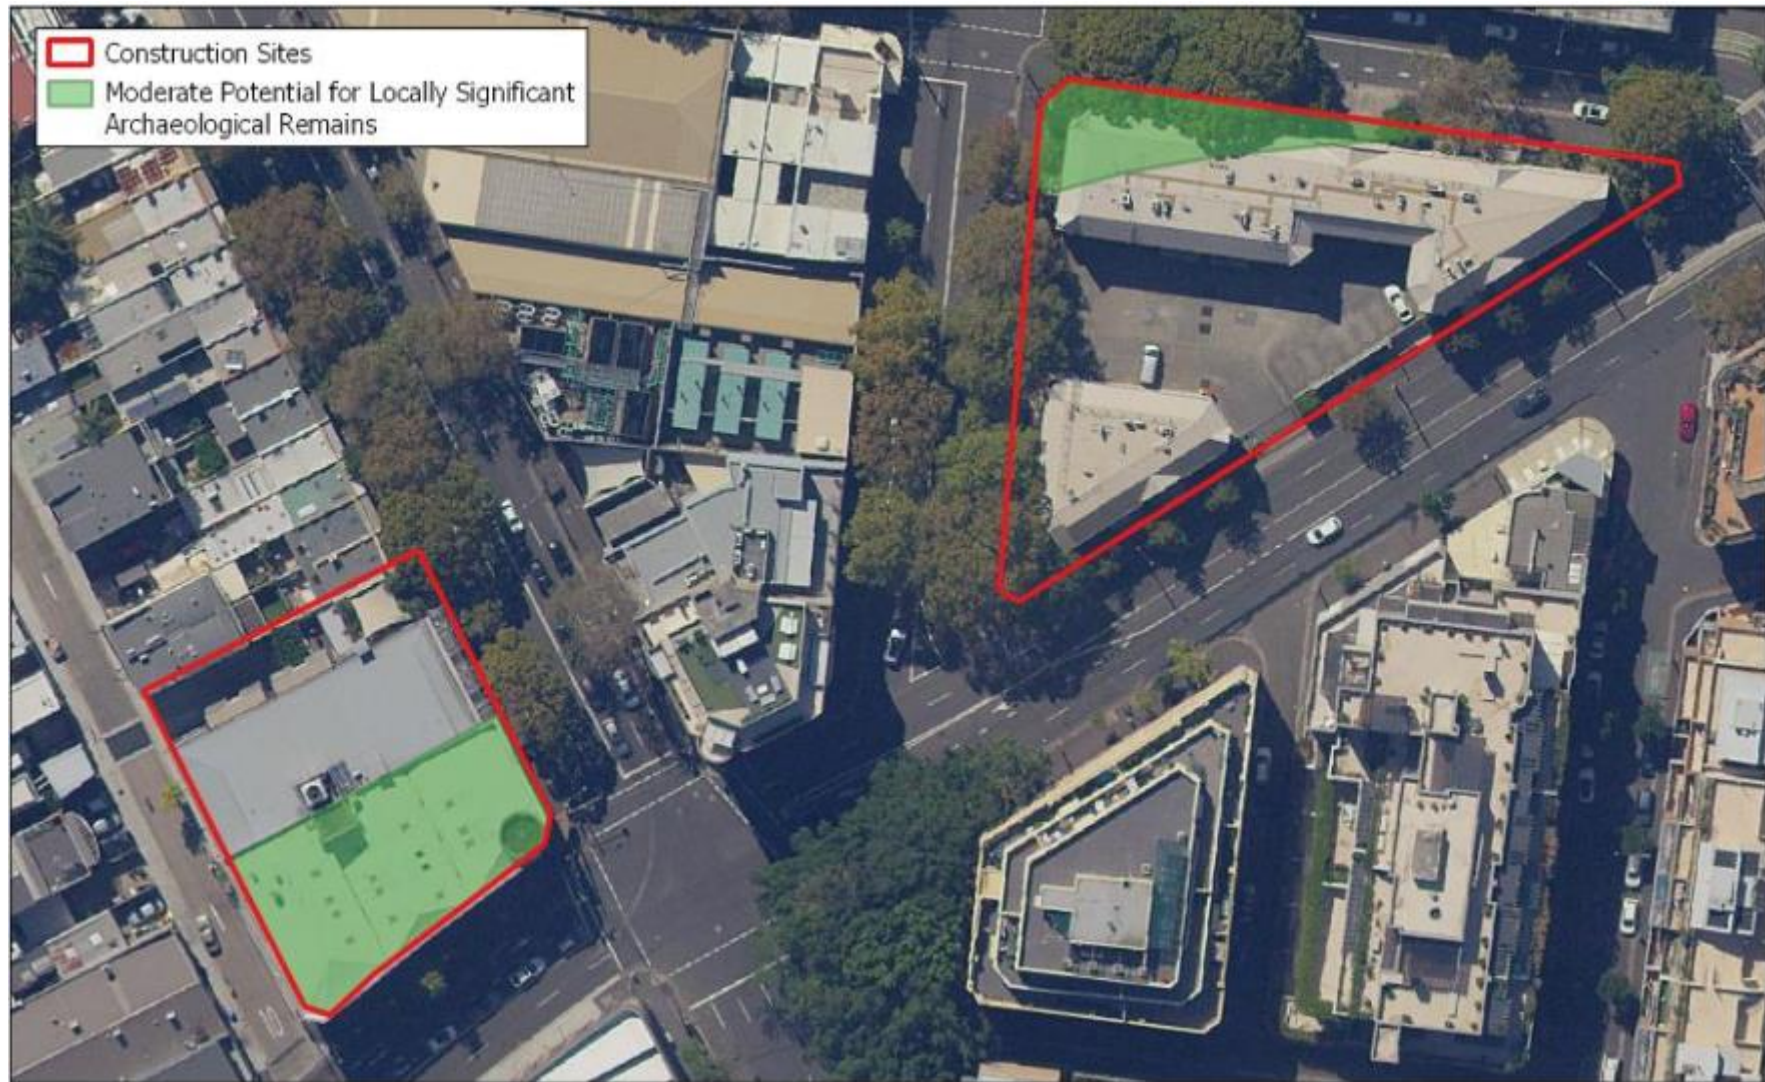
Figure 114: Significant non-Aboriginal archaeological resources at the Pyrmont Station construction sites.

- Heritage induction (completed prior to demolition; see Section 5.2)
- Unexpected Finds Procedure during demolition of extant structures and excavation within areas previously impacted by basements as illustrated on Figure 114 (see Section 5.5)
- Eastern construction site - Monitoring and salvage (if required) of excavation work within the area of moderate archaeological potential (see Figure 115)
- Western construction site - Testing and salvage (if required) of areas proposed for excavation within the area of moderate archaeological potential (see Figure 115).

A summary of predicted significant archaeological remains located within the Pyrmont Station construction sites is provided in Table 20 and the anticipated location of these remains is shown in Figure 114.

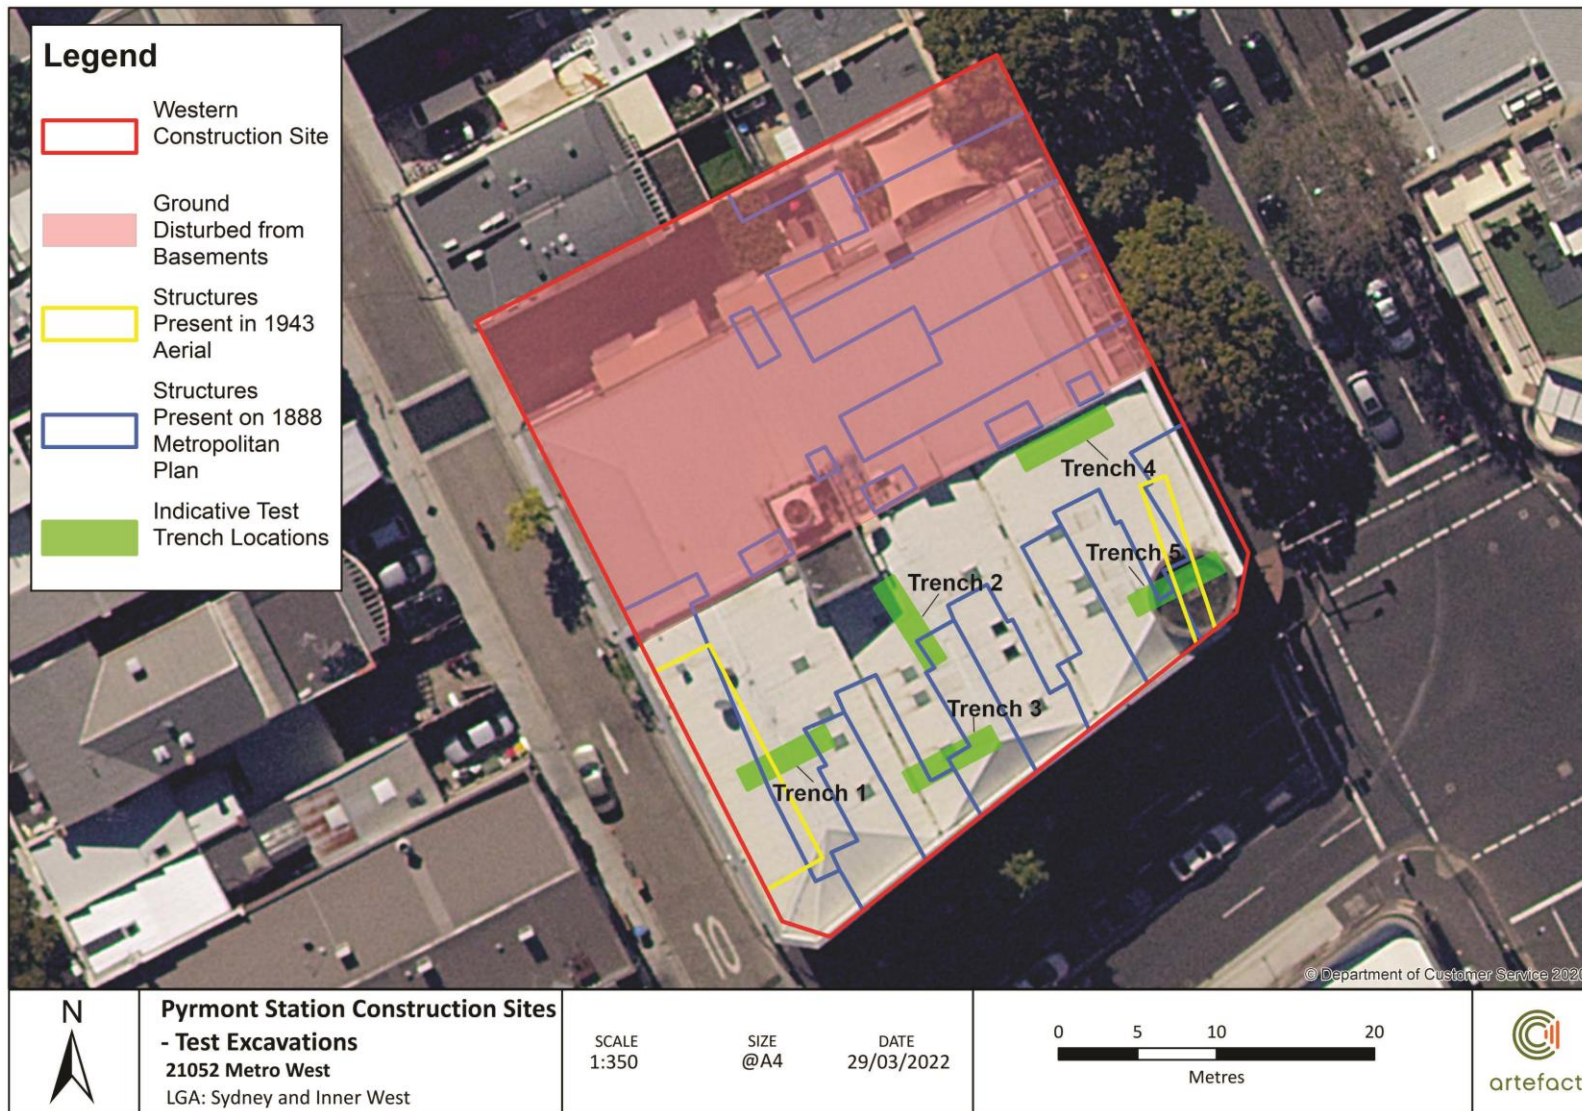
Figure 116: Proposed test trench locations – Western construction site

The test excavation program would include the excavation of five (5) test trenches within the area of moderate potential (see Figure 116). The test excavation program would target locations deemed to have a higher likelihood of containing deeper subsurface structures and intact artefact-bearing deposits, such as yards, outbuildings and structural footings based on historic mapping and research. The primary aim of the testing is to verify the extent of any previous impacts and identify whether significant archaeological deposits, structures or features survive within the site.

The 5 test trenches, measuring 1.5 metres by 6 metres, be excavated in the locations illustrated on Figure 116 and described below. The length of test trenches was selected to span the distance, wherever possible, between potential structural remains associated with neighbouring properties, therefore increasing the likelihood of encountering archaeological remains within any given trench and achieving a useful sample of the overall site.
