**Project Name:** W2B Biodiversity – Threatened Fish Monitoring

Woolgoolga to Ballina Pacific  
Highway Upgrade  
Threatened Fish Monitoring Program Annual  
Report 2018

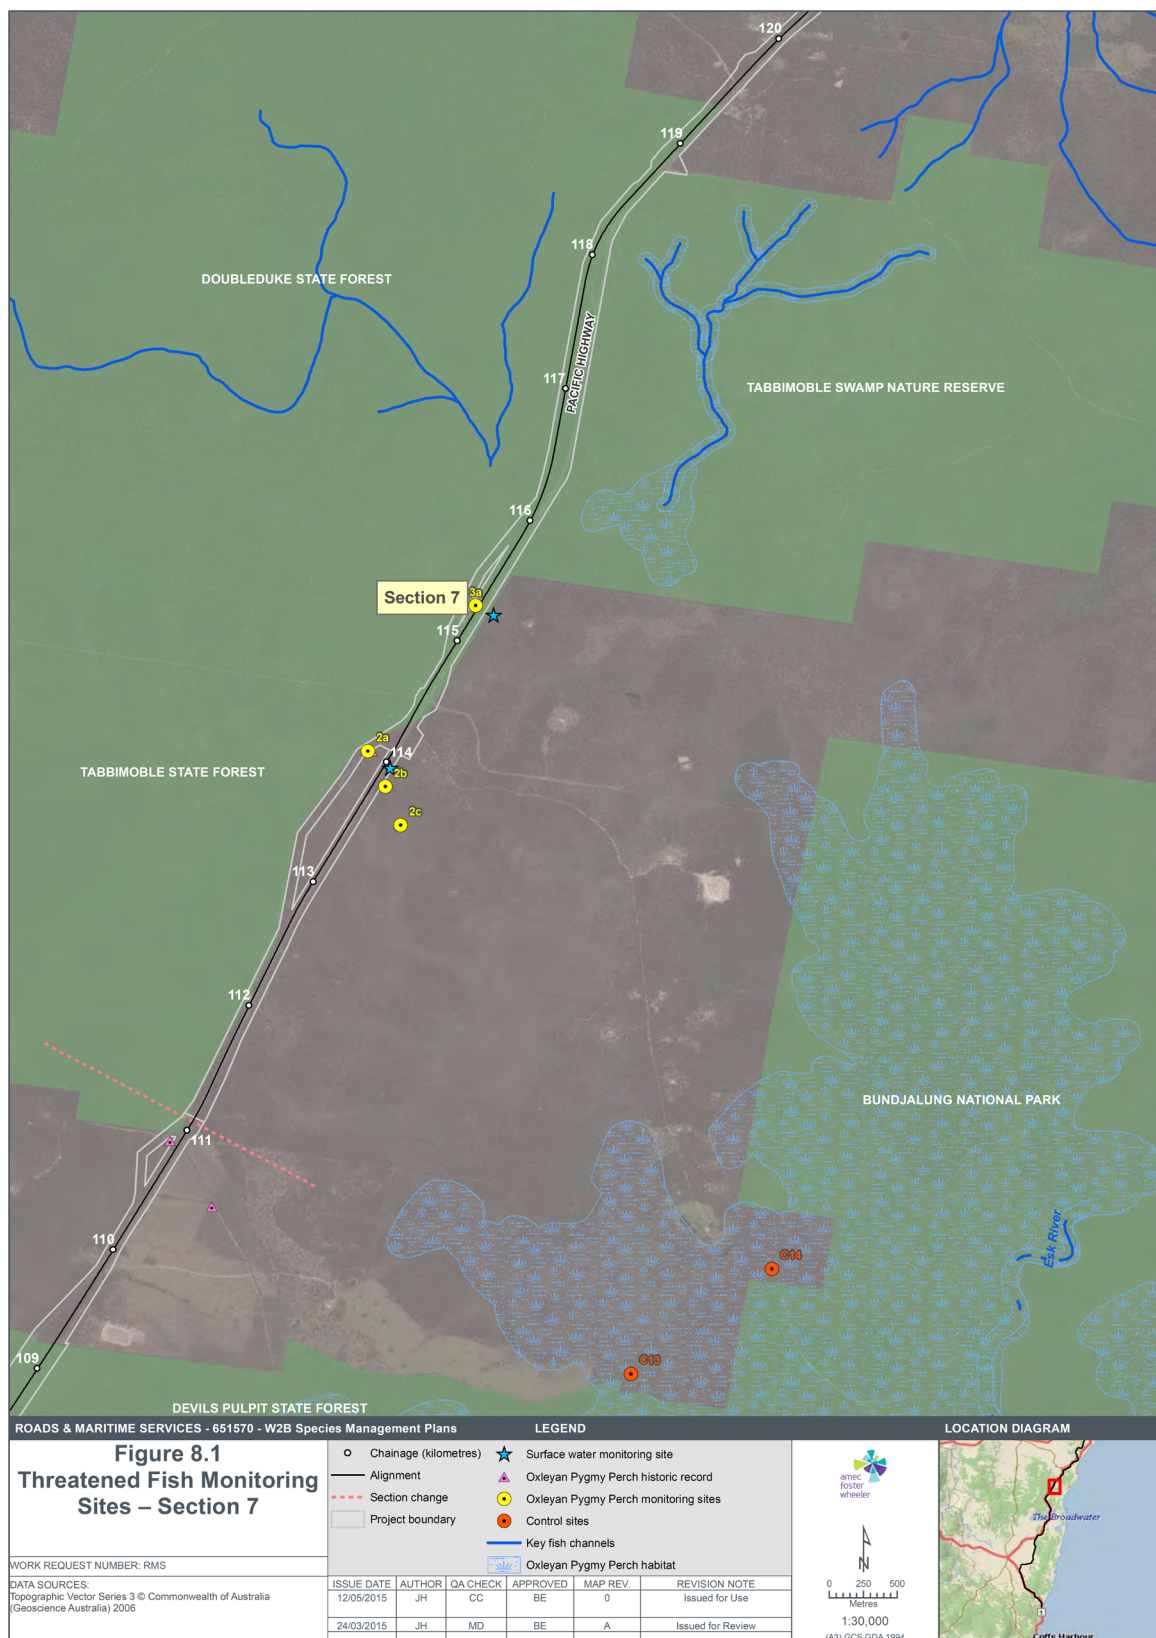
Illustration 2.1 Map of Section 7 sampling sites taken from the TFMP (RMS 2015)

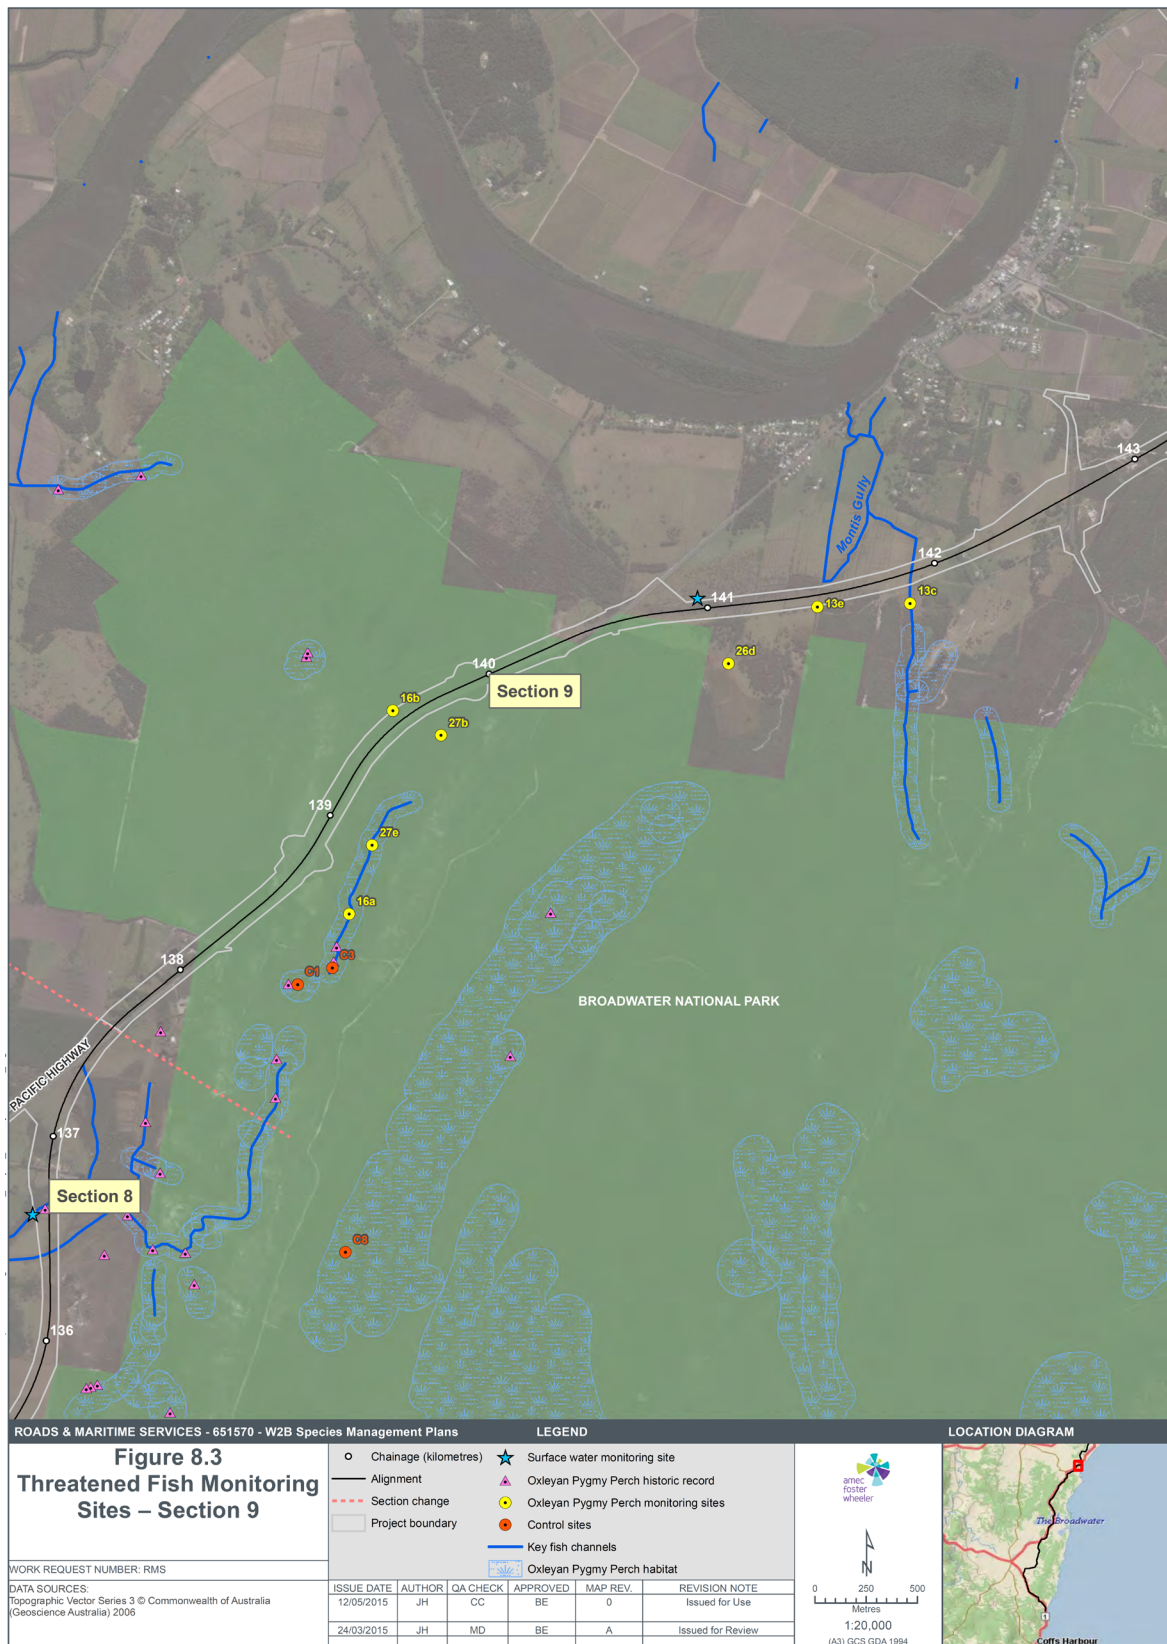
Illustration 2.3 Map of Section 9 sampling sites taken from the TFMP (RMS 2015)

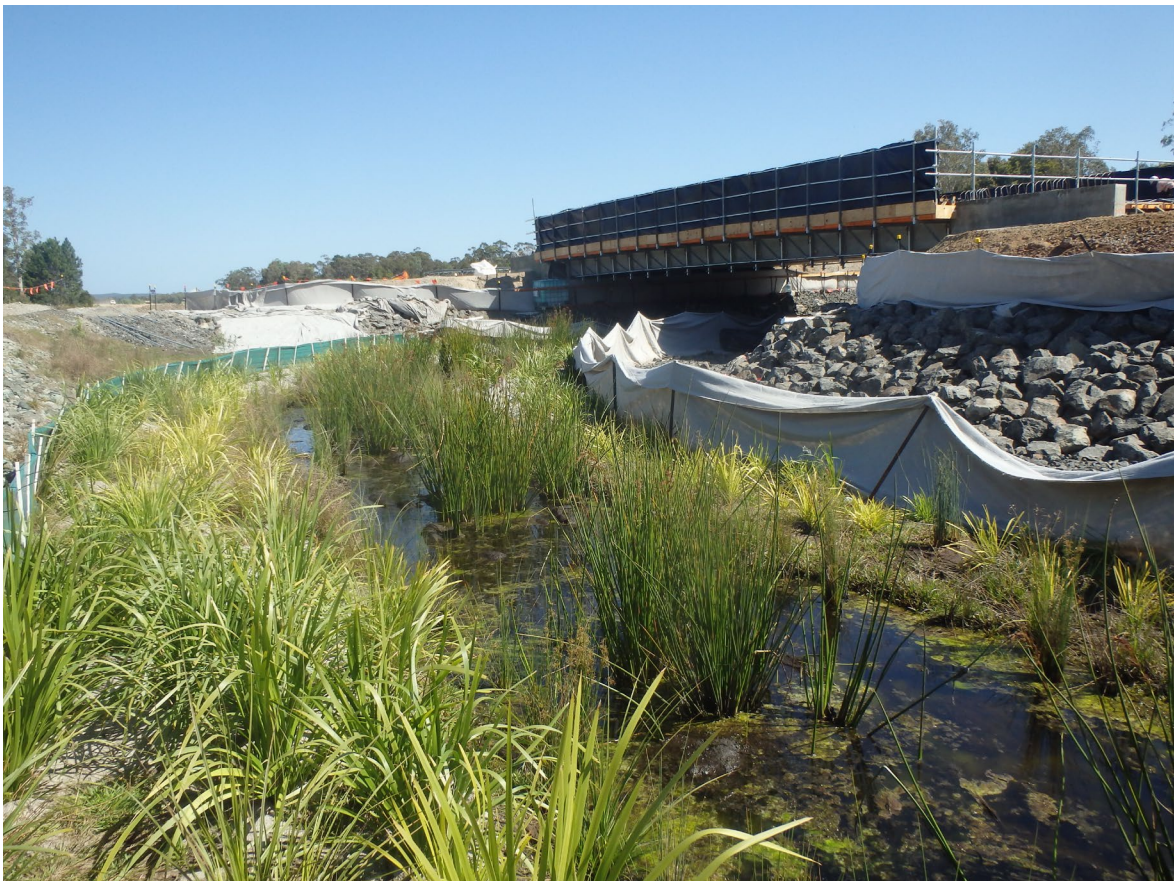
**Plate 4.1** Threatened fish management measures and stream rehabilitation at site 12a, where OPP were captured during the May 2018 survey.
