# Woolgoolga to Ballina Pacific Highway Upgrade

## Threatened Fish Monitoring Program Annual Report 2019

Construction Phase Report

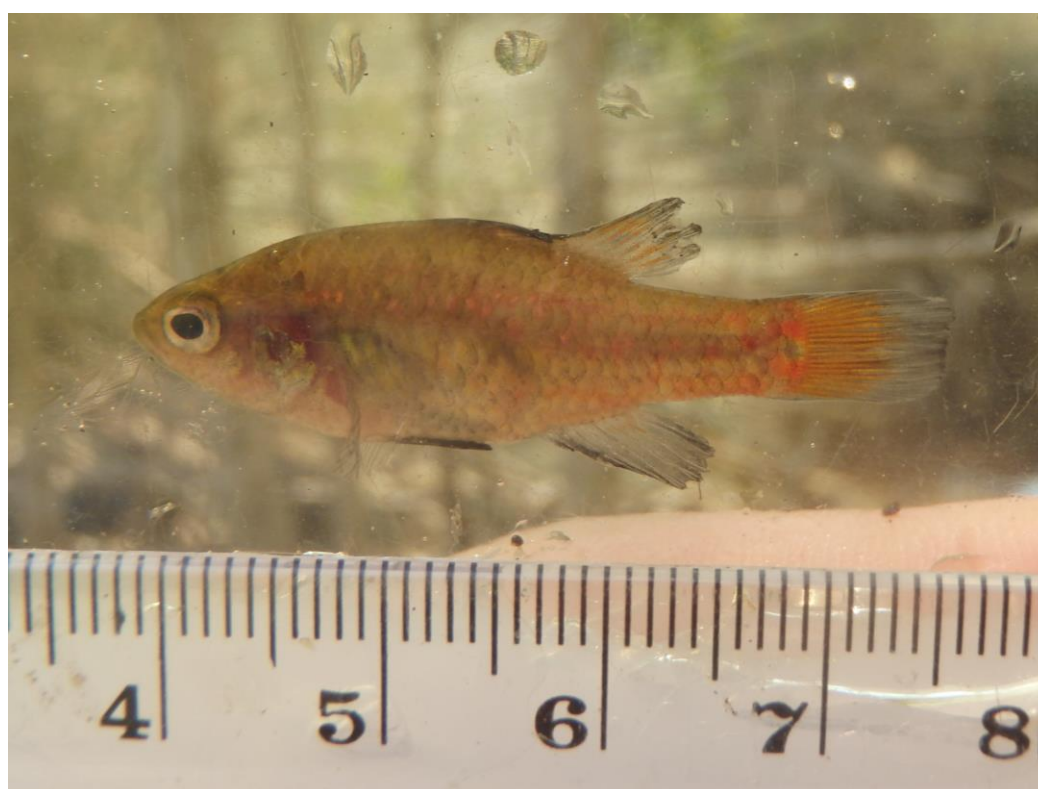
**Plate 1.1** OPP captured at site 27e during the September 2019 survey.

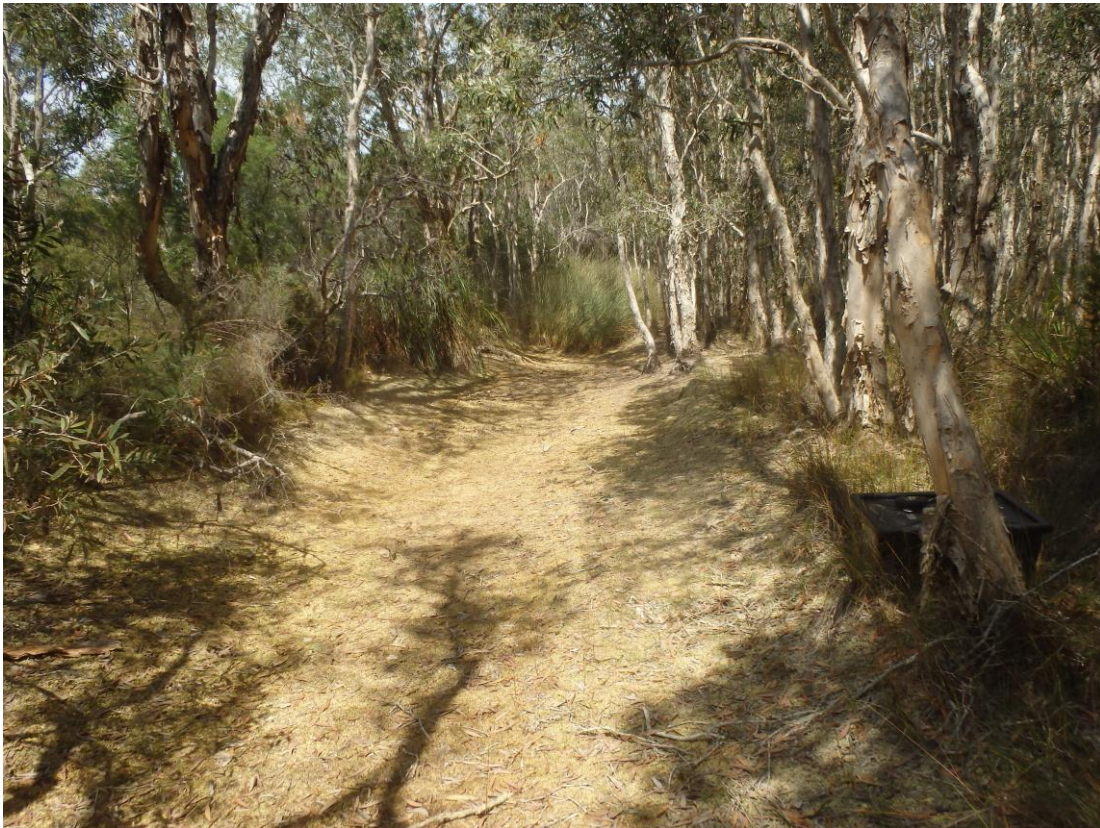
**Plate 4.2** Site 16a was dry at the time of the September 2019 survey.
