CHAFFEY DAM AUGMENTATION AND SAFETY UPGRADE

## Aboriginal Cultural Heritage Assessment

Document 301015-02980-REP-0005

October 2012

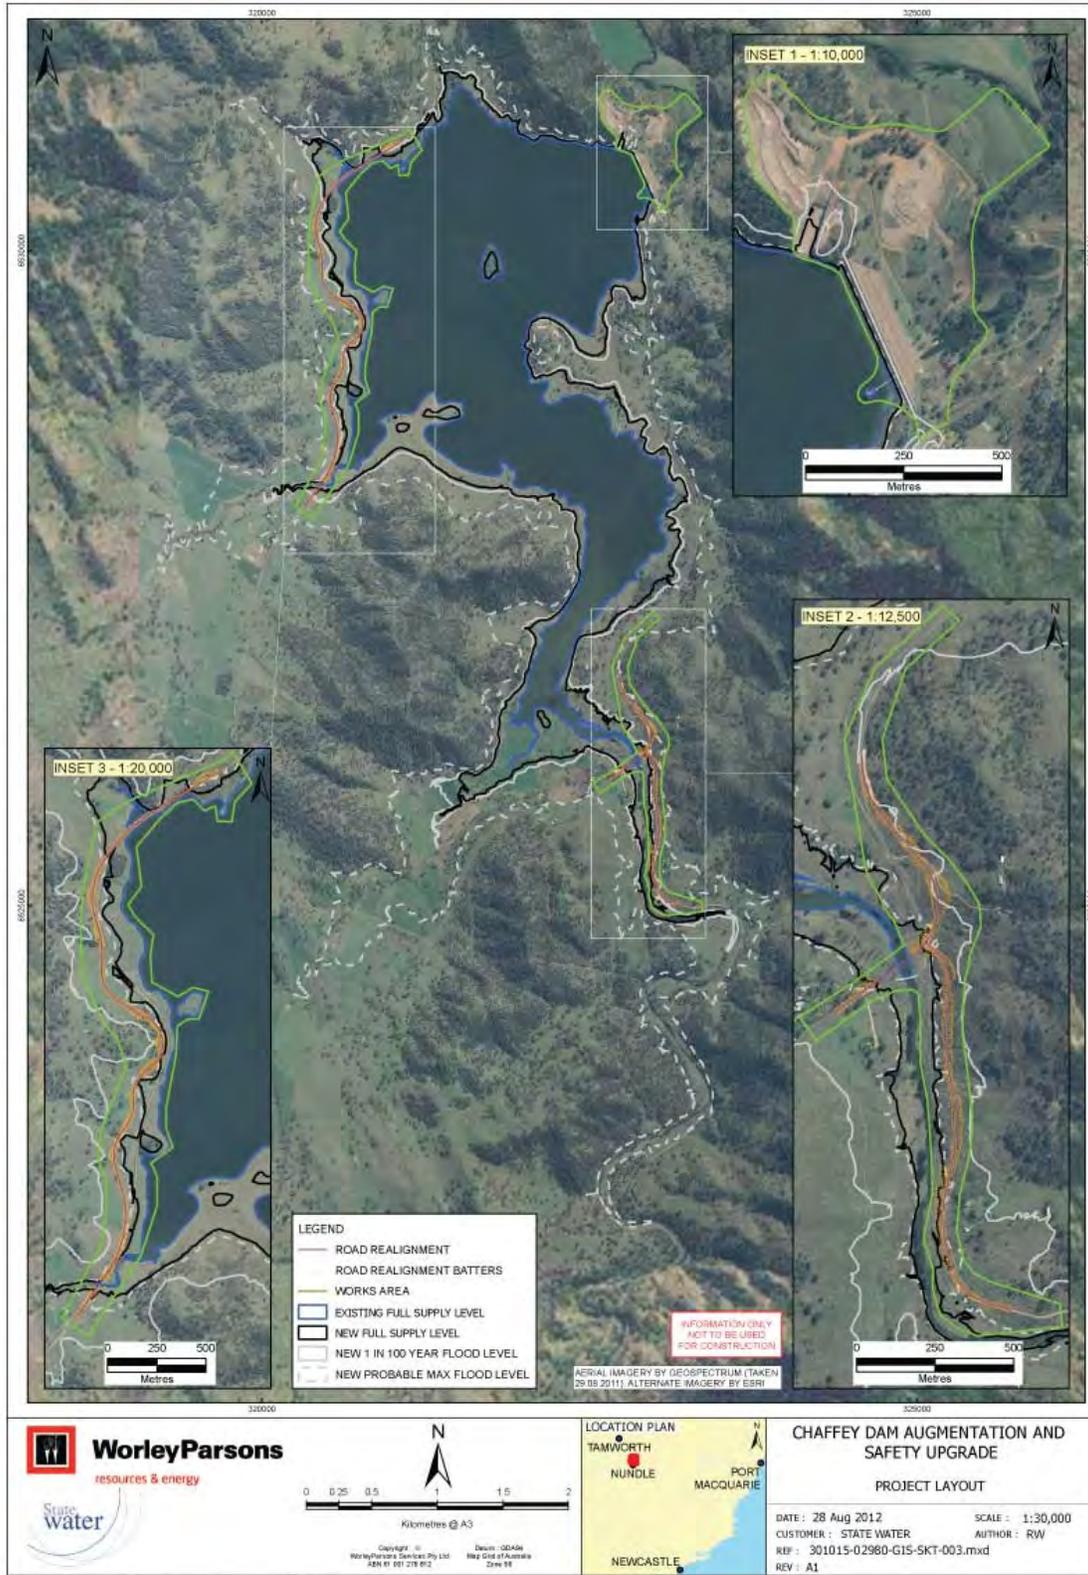
**Figure 1.1** Chaffey Dam project layout with new full supply level (black line), road realignments (orange line) and works areas (green line) (Supplied by WorleyParsons)

- Construction works at the dam wall to raise the height by 8.4 m;
- Raising of the Morning Glory Spillway by 6.5 m;
- Modification of the existing auxiliary spillway;
- Realignment of the intersection of Tamworth-Nundle Road and River Road;
- Realignment of sections of Tamworth-Nundle Road and River Road;
- Replacement of the Bowling Alley Point Bridge;
- Realignment of Western Foreshore Road from Hyde's Creek to Silver Gully;
- Modification to Hyde's Creek Bridge; and
- Modification to the existing culvert crossing at Silver Gully.

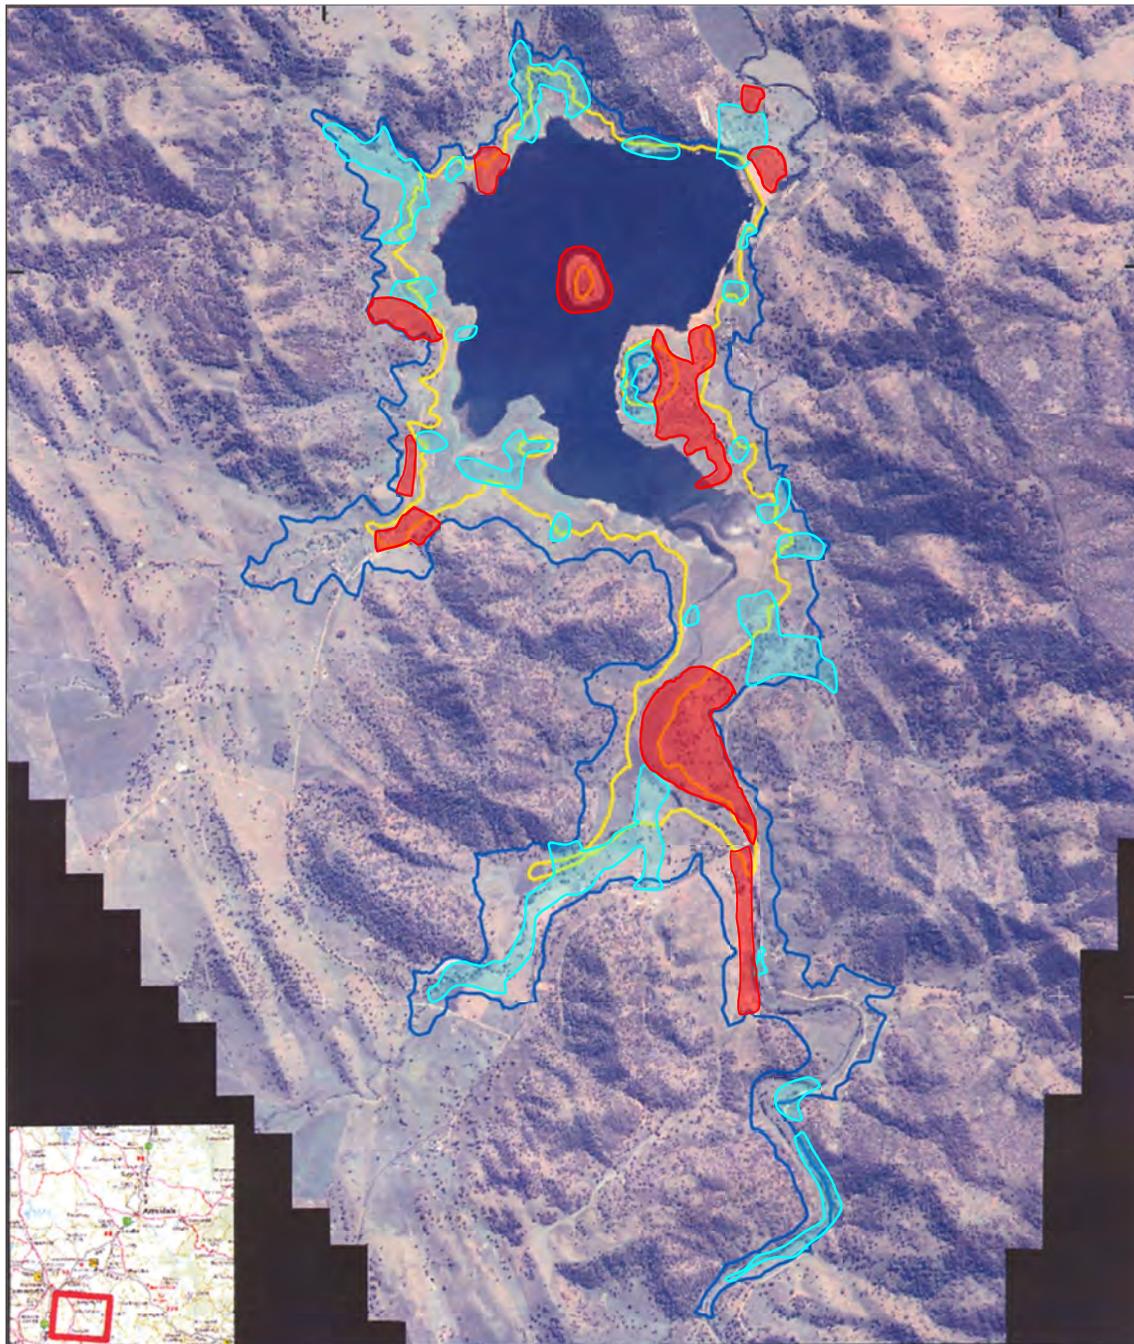
**Figure 2.1** Areas surveyed during 1990 (blue) and during 2008 (red) overlaying the proposed full supply level (yellow) (NOHC 2008: 45)

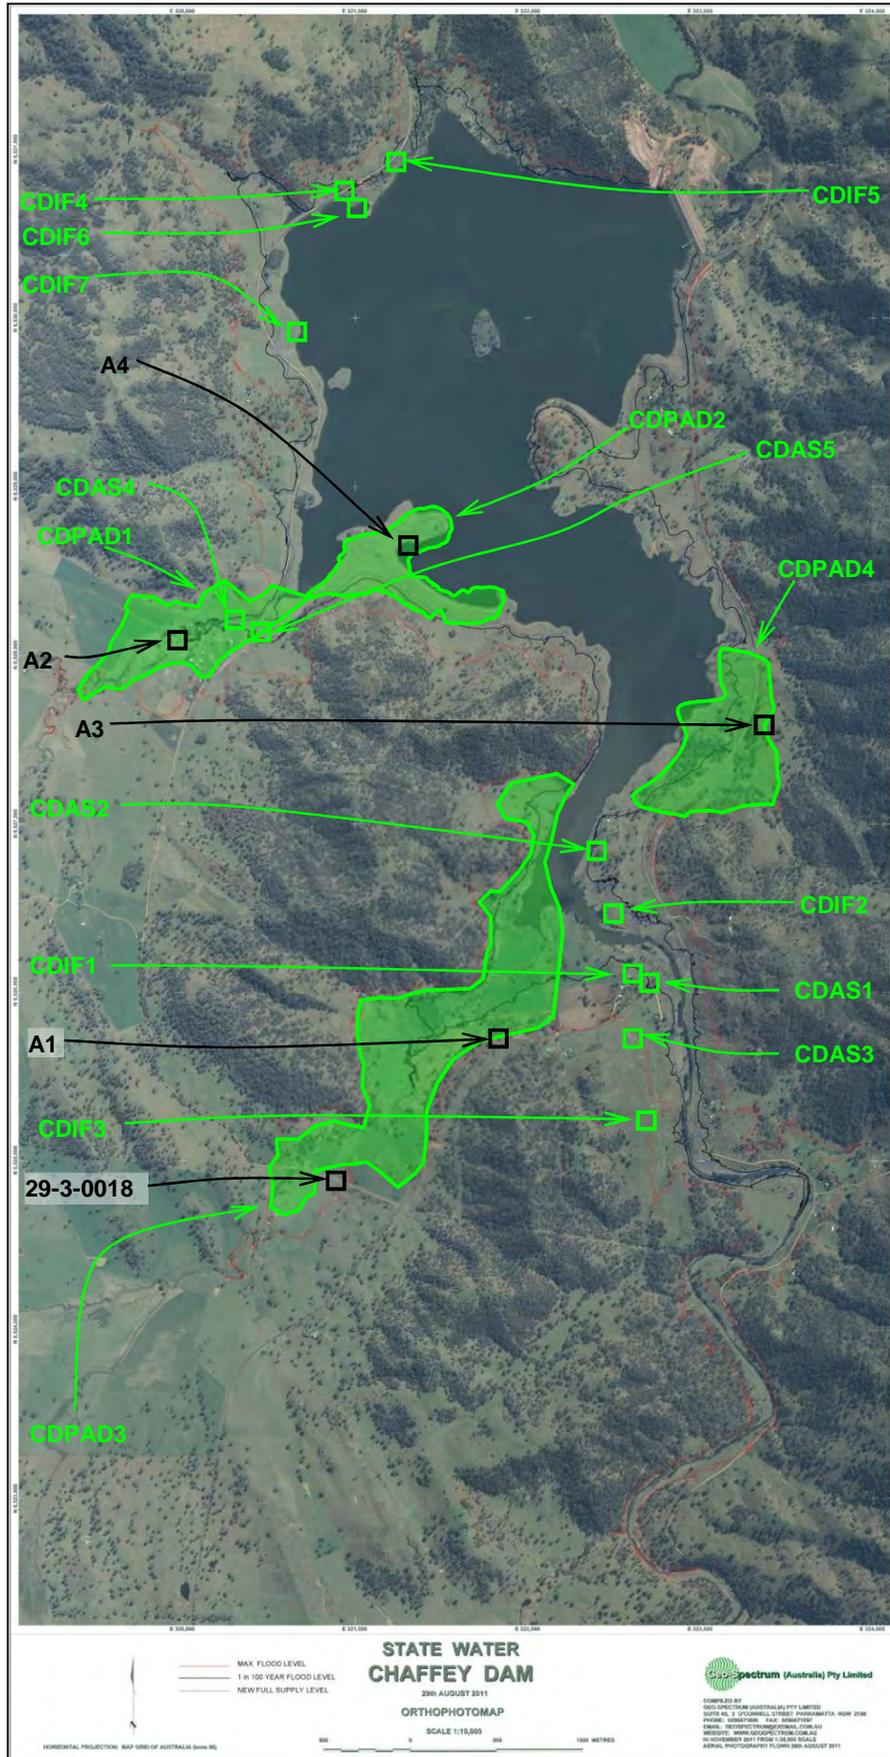
**Figure 5.1** Location of previously recorded Aboriginal heritage sites within the Chaffey Dam study area including sites recorded in the 2008 study (green) and all other sites (black)

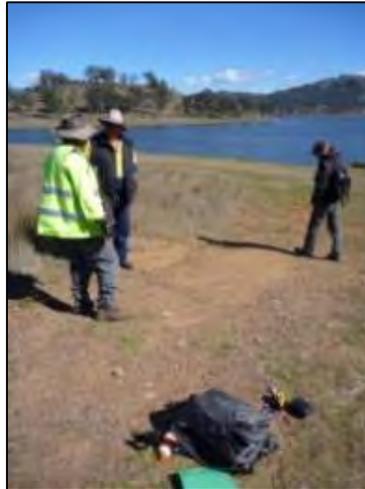
**Figure 6.1** Surface exposure and artefact location at CDIF8, looking southwest

Existing disturbance to the site includes the establishment and maintenance of a gravelled vehicle track, and small areas of sheet erosion adjacent to this. Other impacts to the site include vegetation clearance and use for pastoral/grazing purposes. The exposure incidence across the site was approximately 60%, and visibility within these exposures was approximately 30%.

The artefact is located on the verge of an established vehicle track on the eastern foreshore of Chaffey Dam, approximately 30 m within the proposed augmented full supply level. The site has low potential for subsurface Aboriginal artefacts.

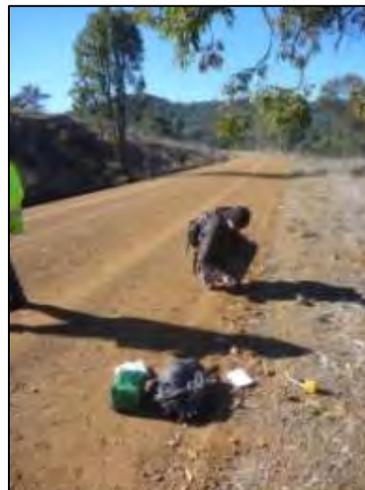
**Figure 6.2** Surface exposure and artefact location at CDIF9, looking northeast

Existing disturbance to the site includes the construction of the Western Foreshore Road, and the inundation of the Chaffey Dam. Other impacts to the site include vegetation clearance and use for pastoral/grazing purposes. The exposure incidence across the site was approximately 40%, and visibility within these exposures was approximately 40%.

The artefact is located outside of the proposed augmented full supply level, but within the works area for the Western Foreshore road realignment. The site has low potential for subsurface Aboriginal artefacts.

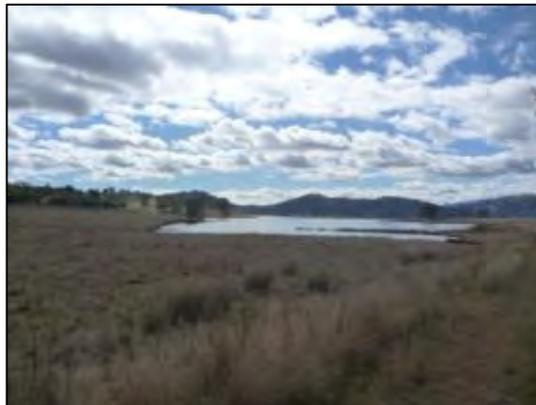
CDIF11 is located on a low gradient knoll, to the north of Hyde's Creek and adjacent to the Western Foreshore Road (Figure 6.3).

Existing disturbance to the site includes sheet erosion, denuded ground, vegetation clearance and use for pastoral/grazing purposes. The exposure incidence across the site was approximately 30%, and visibility within these exposures was approximately 40%.

The artefact is located within the proposed augmented full supply level and within the proposed works area for the Western Foreshore Road. The site has moderate to low potential for subsurface artefacts.

**Figure 6.3** Location of CDIF11, looking northeast

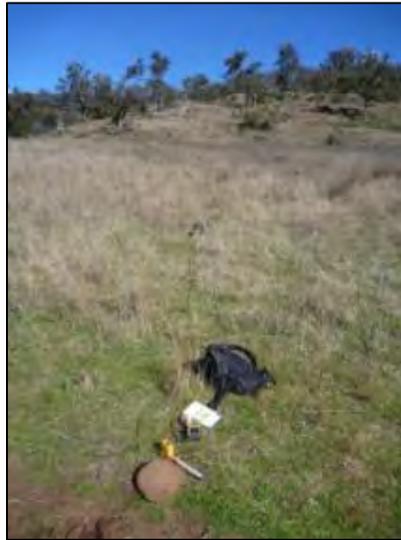
CDIF12 is located on basal flats adjacent to the current Chaffey Dam foreshore, within a stock track (Figure 6.4).

There is moderate potential for additional artefacts to occur, particularly across the lower sections of the spur crest. The soil profile consists of a sandy loam topsoil of unknown depth. There is high potential for subsurface artefacts, however it is predicted that areal incidence of artefacts will be low to moderate. The potential for *in situ* material is assessed to be moderate.

The artefact is located within the proposed augmented full supply level. The area of potential archaeological deposit identified covers an area approximately 650 x 200 m northwest-southeast, with approximately 100 m of the PAD falling within the full supply level, adjacent to the Chaffey Dam foreshore.

**Figure 6.4** View of site CFIF12, facing south

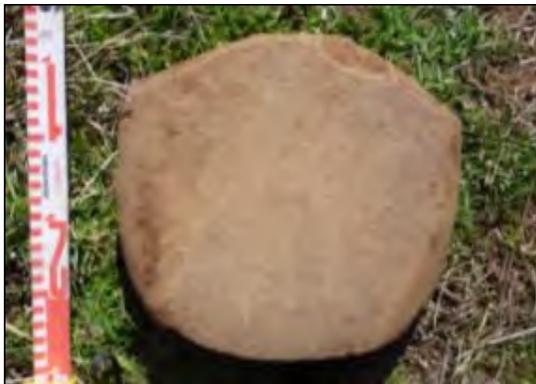
**Figure 6.5** CDIF12, concave side with evidence of grinding, rejuvenation pitting and milling around margins

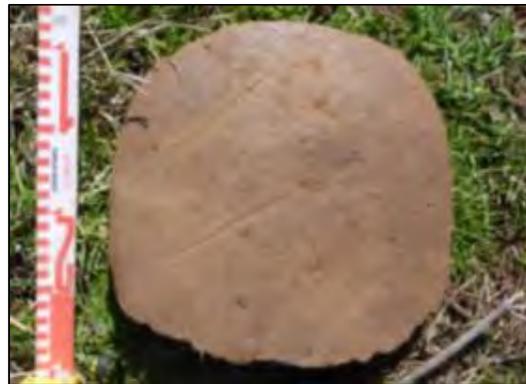
**Figure 6.6** CDIF12, convex side, with three incised lines

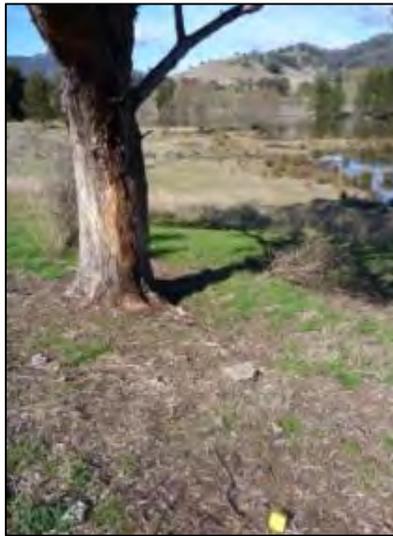
CDIF13 is located on a west facing spur crest mid slope, overlooking the Peel River (Figure 6.7).

The site comprises an isolated grey tuff flake with possible use wear, measuring 41 x 12 x 31, and associated potential archaeological deposit.

There is moderate potential for additional artefacts to occur, particularly across the lower sections of the spur crest. The soil profile consists of a sandy loam topsoil of unknown depth. There is high potential for subsurface artefacts, however it is predicted that areal incidence of artefacts will be low to moderate. The potential for *in situ* material is assessed to be low. The area of PAD covers an area approximately 800 x 145 m, and falls within previously identified CDPAD3 (NOHC 2008).

The site and associated PAD fall within the proposed augmented full supply level.

**Figure 6.7** View of CDIF13, facing southwest

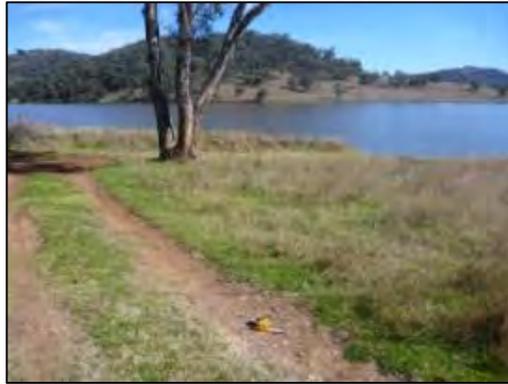
CDIF14 is located on a west facing spur crest basal slope, on Andersons Flat, south of Sheep Stallion Creek. The artefact is located within a vehicle track erosion (Figure 6.8).

This site comprises an isolated broken grey banded chalcedony flake, proximal portion with a longitudinal cone split. The artefact measures 22 x 20 x 5 mm.

Existing disturbance to the site includes establishment of a vehicle track, vegetation clearance and use for grazing/pastoral purposes. The exposure incidence across the site was approximately 60%, and visibility within these exposures was approximately 70%.

The site is within the proposed augmented full supply level.

**Figure 6.8** View of CDIF14 and exposure, facing east

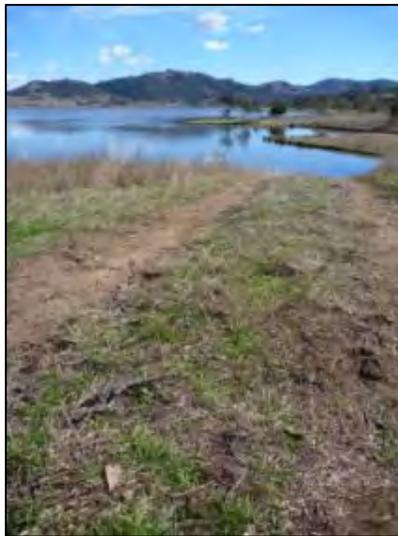
CDIF15 is located on west facing spur crest upper slopes, above the Peel River valley (Figure 6.9).

Existing disturbance to the site includes establishment of vehicle tracks, vegetation clearance and use for grazing/pastoral purposes. The exposure incidence across this site was approximately 50%, and visibility within these exposures was approximately 60%.

This site falls on the margin of the proposed augmented full supply level.

**Figure 6.9** View of CDIF15 and exposure, facing northwest

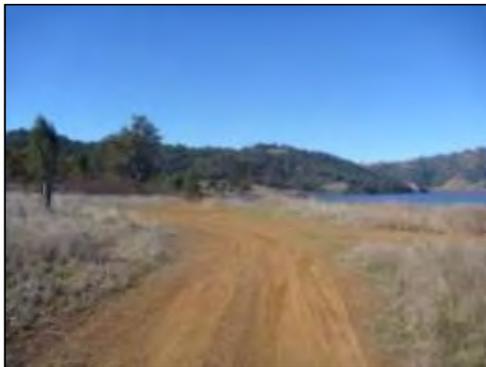
Existing disturbance to the site includes establishment of a vehicle track, some vegetation clearance, recreational use by campers, and use for stock/pastoral purposes. Exposure incidence across the site was approximately 50%, and visibility within these exposures was approximately 80%. Artefacts at this site were recorded within the established vehicle track, where visibility was greater (Figure 6.10).

There is a high potential for additional artefacts to occur. The soil profile consists of a silty sandy topsoil that appears to be at least 30 cm deep. There is moderate to high potential for subsurface artefacts, and it is predicted that areal incidence of artefacts will be moderate. The potential for *in situ* material is assessed to be moderate. The area of PAD covers an area approximately 310 x 100 m.

The artefact scatter is within the full supply level, and the associated PAD falls partially within the proposed augmented full supply level and extends an approximate 45 m to the northwest, and falls within the proposed works area for the Western Foreshore Road upgrade.

**Figure 6.10** Exposure at CDAS6, looking east

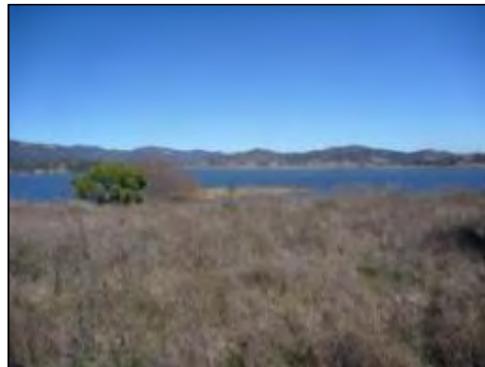
CDAS6 and the associated PAD is located on basal slopes, overlooking the original Peel River Valley to the north of Silver Gully Creek. The site is adjacent to the current Chaffey Dam foreshore, along an established vehicle track (Figure 6.10 and 6.11).

**Figure 6.11** CDAS6, looking south towards dam

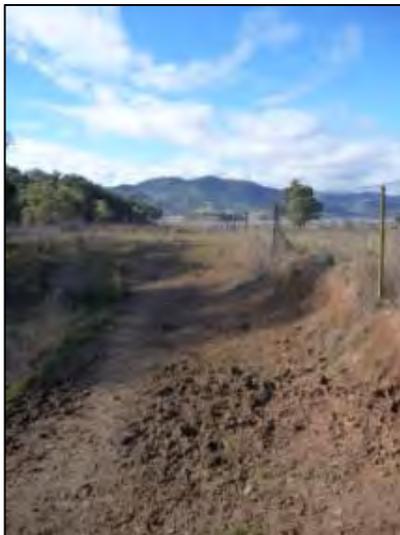
CDAS7 and the associated PAD is located on an alluvial terrace associated with Silver Gully Creek (Figure 6.12).

There is moderate to high potential for additional artefacts to occur in a subsurface context along the alluvial flats within this area. The soil profile at this site comprises a sandy loam of at least 50 cm depth in undisturbed areas. Potential for *in situ* material is considered to be low to moderate.

The area of PAD identified at this site extends for approximately 450 x 145 m, with the artefact scatter outside of the full supply level by approximately 60 m, and the area of PAD falling largely within the proposed augmented full supply level.

**Figure 6.12** View of CDAS7 with exposure, facing southeast

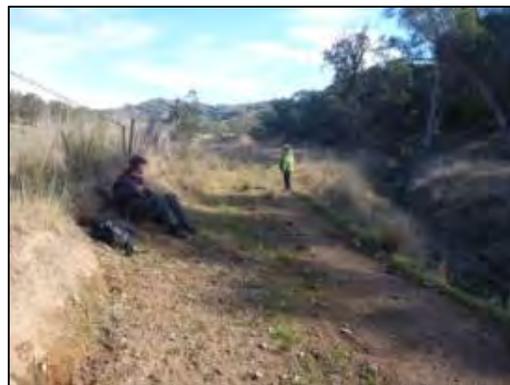
Existing disturbance to this site includes sheet and rill erosion, fence construction, vegetation clearance and use for pastoral and grazing purposes. Artefacts were identified eroding out of a bank adjacent to a paddock fenceline (Figure 6.13). The exposure incidence across this site was approximately 40%, and visibility within these exposures was approximately 50%. Outside of these exposures visibility was generally low.

**Figure 6.13** CDAS7 with eroding bank and creekbed to the right, facing northwest

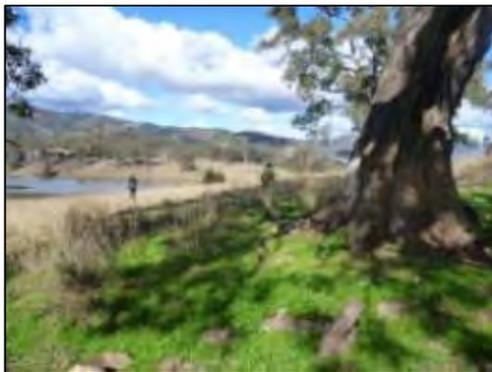
The artefact scatter comprises five stone artefacts occurring in two concentrations. The first is approximately 30 x 15 m in the east containing four artefacts, and the second is a single artefact located to the west, adjacent to a large white box eucalyptus tree (Figure 6.14). The site has an area of associated potential archaeological deposit.

There is moderate to high potential for additional artefacts to occur in a subsurface context. The soil profile at this site is a gravelly sandy loam of indeterminate depth. Potential for *in situ* material is low to moderate. The area of identified PAD is approximately 200 x 60 m.

The artefact scatter and associated PAD are largely within the proposed augmented full supply level, and extends approximately 30 m west of this.

**Figure 6.14** View of CDAS8 with dam in background, facing east

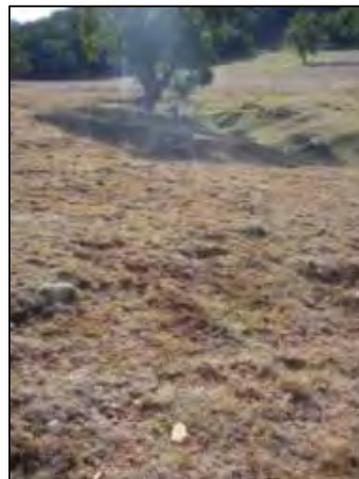
CDAS8 is located adjacent to a dry unnamed tributary of the Peel River, on a moderate gradient mid slope of a northeast facing spur crest (Figure 6.15).

**Figure 6.15** View of CDAS8 towards creek bed, looking west

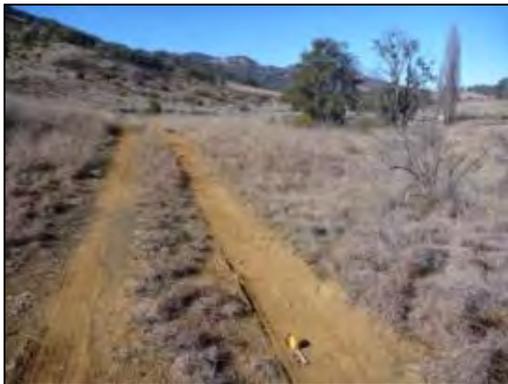
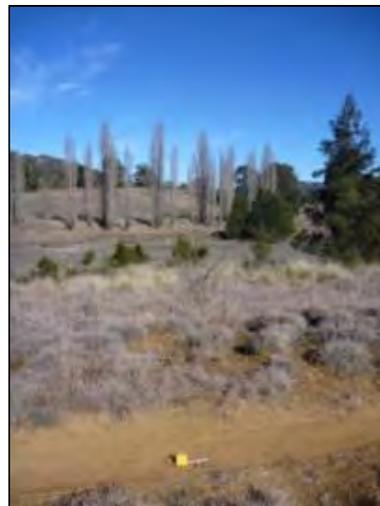
CDAS9 is located on a west facing descending spur crest midslope above the Peel River (Figures 6.16 and 6.17).

There is moderate potential for additional artefacts to occur. The soil profile consists of a sandy silt of indeterminate depth. There is high potential for subsurface artefacts, however it is predicted that areal incidence will be low to moderate. The potential for *in situ* material is assessed to be low. The area of identified PAD covers approximately 580 x 350 m.

The artefact scatter falls on the border of the full supply level, and the western 145 m portion of the PAD falls within the proposed augmented full supply level.

**Figure 6.16** View of CDAS9 including exposure, looking south

**Figure 6.17** View of CDAS9 towards Peel River, looking east

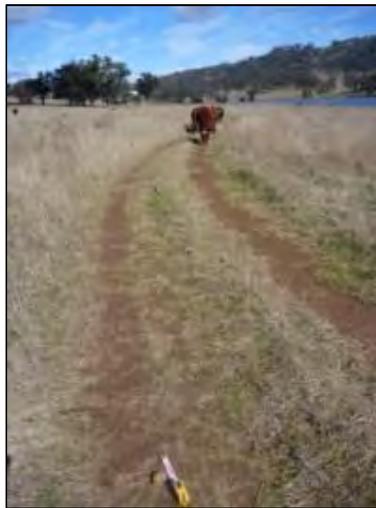
CDAS10 and associated PAD (CDPAD4) are located basal slopes associated with the Peel River valley (Figure 6.18).

There is high potential for additional artefacts to occur in a subsurface context across the basal slopes. The soil profile at this site comprises a sandy loam of indeterminate depth. Potential for *in situ* material is low to moderate.

The area of PAD identified at this site is described above (Section 5.3). The artefact scatter falls within the proposed augmented full supply level, and the area of PAD falls within and extends approximately 120 m southeast of the proposed augmented full supply level.

**Figure 6.18** View of CDAS10 and exposure, facing southwest

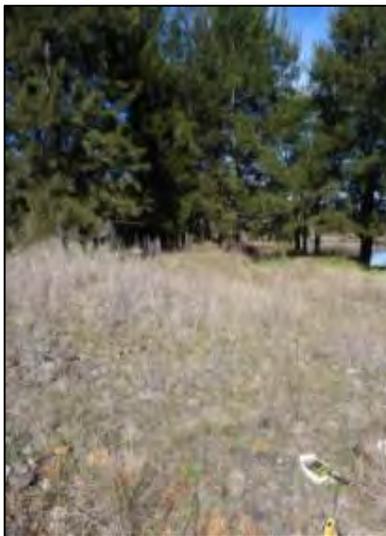
CDAS12 is located on alluvial flats adjacent to the Peel River (Figure 6.19).

The site is associated with a portion of formerly identified CDPAD3, which has been further refined to cover an area approximately 420 x 250 m, falling between two tributaries of the Peel River. There is high potential for additional artefact to occur. There is moderate potential for subsurface artefacts, however it is predicted that areal incidence of artefacts will be low, and the potential for *in situ* artefacts almost zero, due to the disturbed nature of this area.

The artefact scatter is located on the edge of the proposed augmented full supply level, and the area of PAD falls largely outside of the full supply level.

**Figure 6.19** View of CDAS19 towards Peel River, facing west

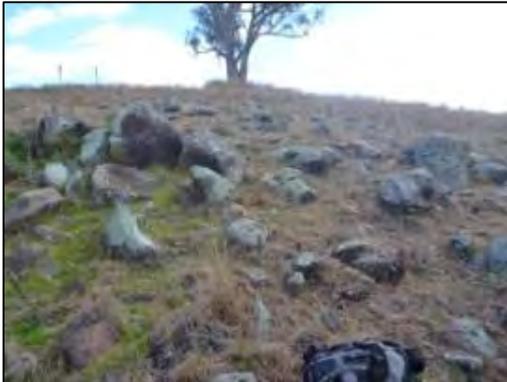
CDQ1 is located on the mid slope of a small knoll, situated between Hyde's Creek and the Peel River (Figure 6.20).

The site comprises a small outcropping of a basaltic volcanic rock, with a number of negative scars (Figure 6.21) on the *in situ* boulders and large detachment flakes discarded at the site.

The site falls on the boundary of the proposed augmented full supply level.

**Figure 6.20** View of CDQ1 rocky outcrop, looking west

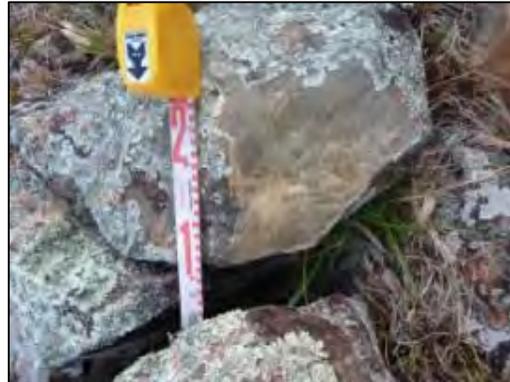
**Figure 6.21** Example of negative scar on boulders at CDQ1

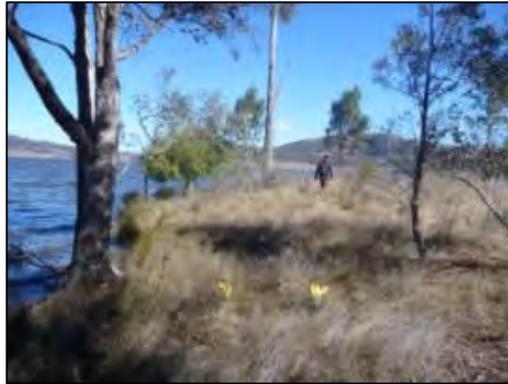
CDPAD5 is located on a descending spur crest of Goat Hill onto the Peel River valley, bordered by drainage lines (Figure 6.22). Soil deposits in this location appear to be at least 40 cm deep. The PAD is approximately 50 x 40 m in area.

This location is predicted to have moderate potential for subsurface artefacts, and the potential for *in situ* material is predicted to be moderate.

The PAD falls within and extends approximately 15 m northeast of the proposed augmented full supply level.

**Figure 6.22** View of CDPAD5, looking west

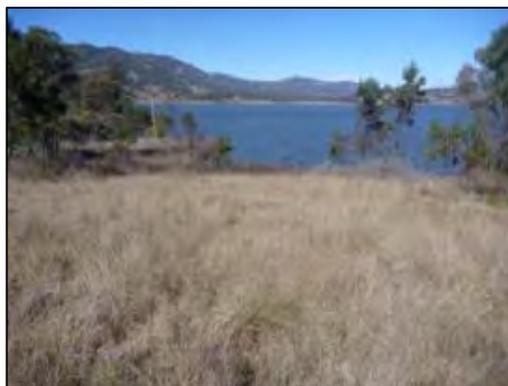
CDPAD6 is located on the toe slope of a spur crest of Goat Hill with a southern aspect, onto the Peel River valley, and bordered by drainage lines (Figure 6.23). Soil deposits in this location appear to be at least 50 cm deep. The PAD is approximately 85 x 65 m in area.

This location is predicted to have moderate to high potential for subsurface artefacts, and the potential for *in situ* material is predicted to be moderate.

The PAD falls within the proposed augmented full supply level.

**Figure 6.23** View of CDPAD6, looking south

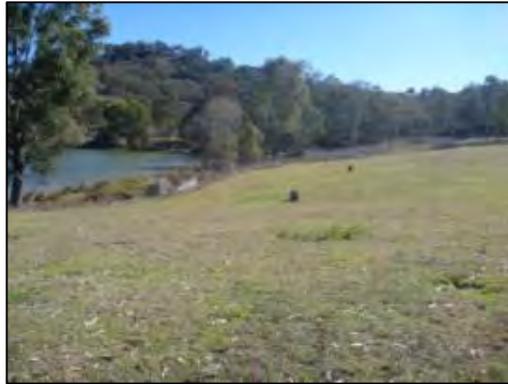
CDPAD7 is located on a descending undulating spur crest of Goat Hill, and corresponds to the lower gradient portion of the spur associated with a number of drainage lines (Figure 6.24). The soil in this location is of indeterminate depth. The PAD is approximately 150 x 85 m.

Primary forms of existing disturbance at this site are associated with vegetation clearance and use for recreational purposes, as it is adjacent to the fishing club camp grounds. Visibility at this PAD is generally low, averaging less than 5%.

The PAD falls within the proposed augmented full supply level.

**Figure 6.24** View of CDPAD7, facing west

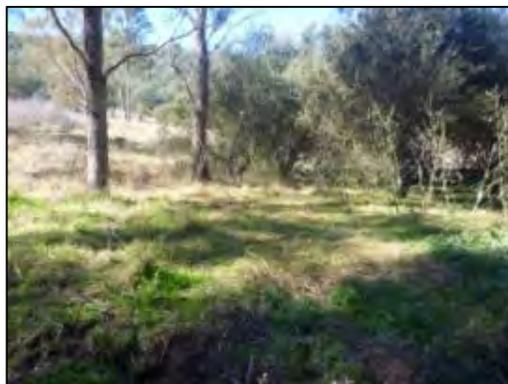
CDPAD8 is located on alluvial terraces associated with the confluence of a number of drainage lines (Figure 6.25). Soil deposits in this location appear at least 60 cm deep, but could extend below this. The PAD is approximately 150 x 100 m.

Primary forms of existing disturbance at this site are associated with vegetation clearance, use for recreational purposes including the construction of a camping ground and picnic facilities, and the establishment of the Dulegal Arboretum. Visibility at this PAD is generally low, averaging less than 15%.

The PAD falls within the proposed augmented full supply level.

**Figure 6.25** View of CDPAD8, looking east

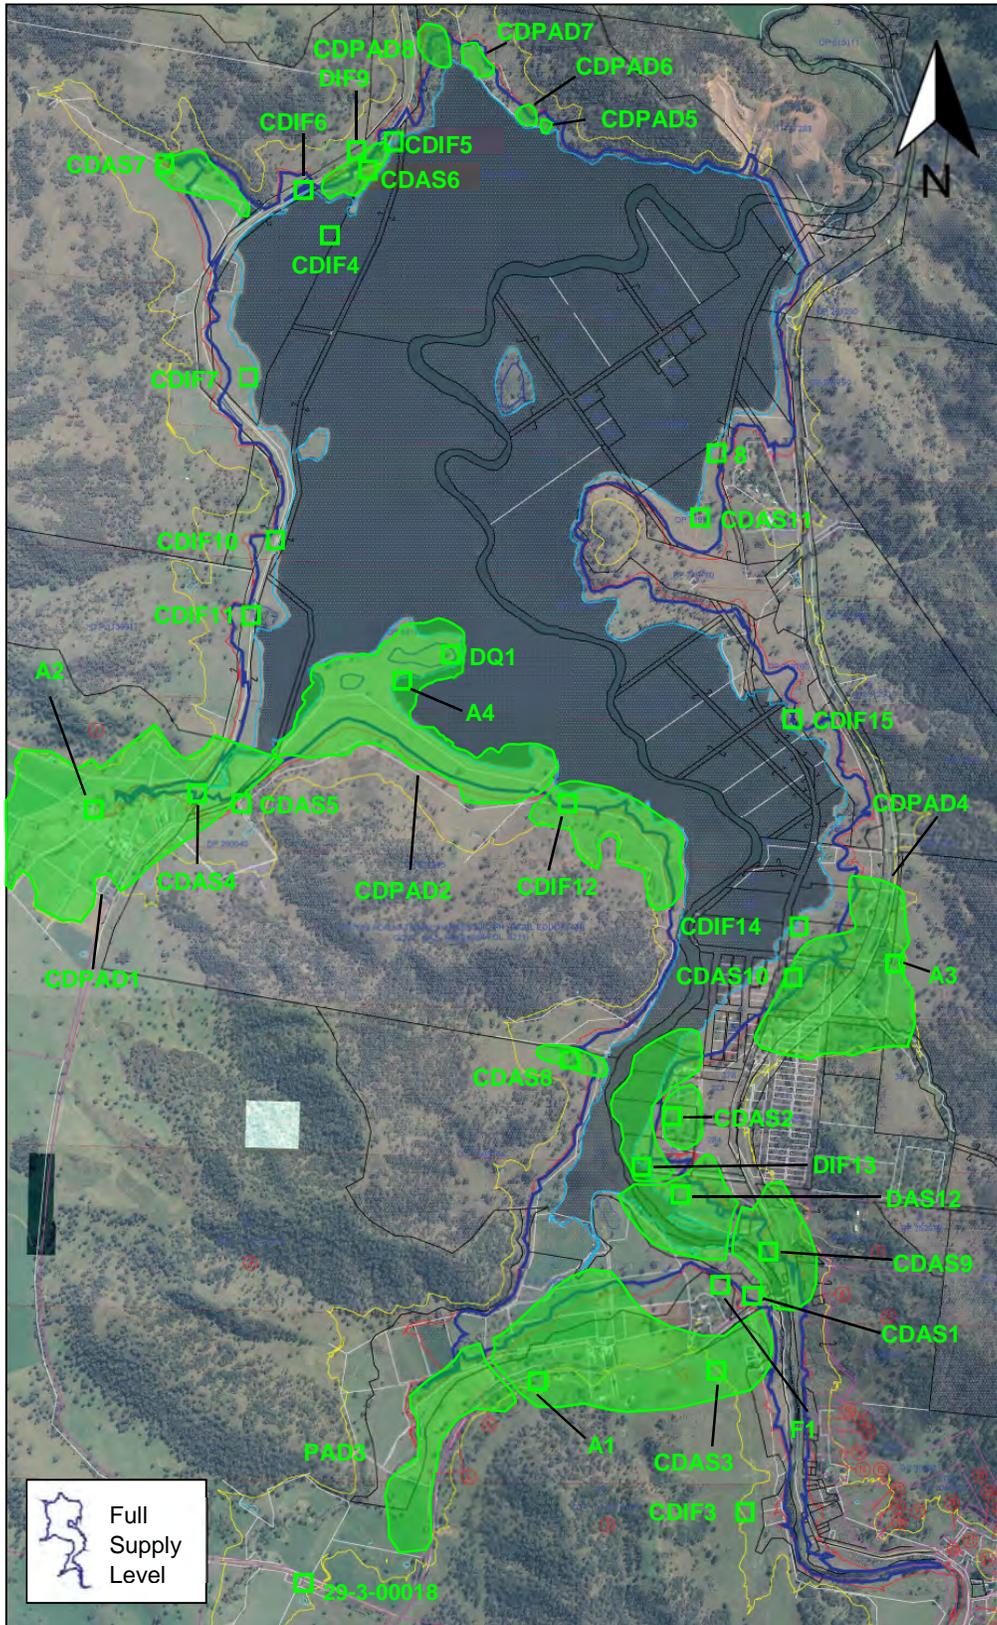
**Figure 6.26** Site and PAD locations (green)  
(Base image provided by State Water)

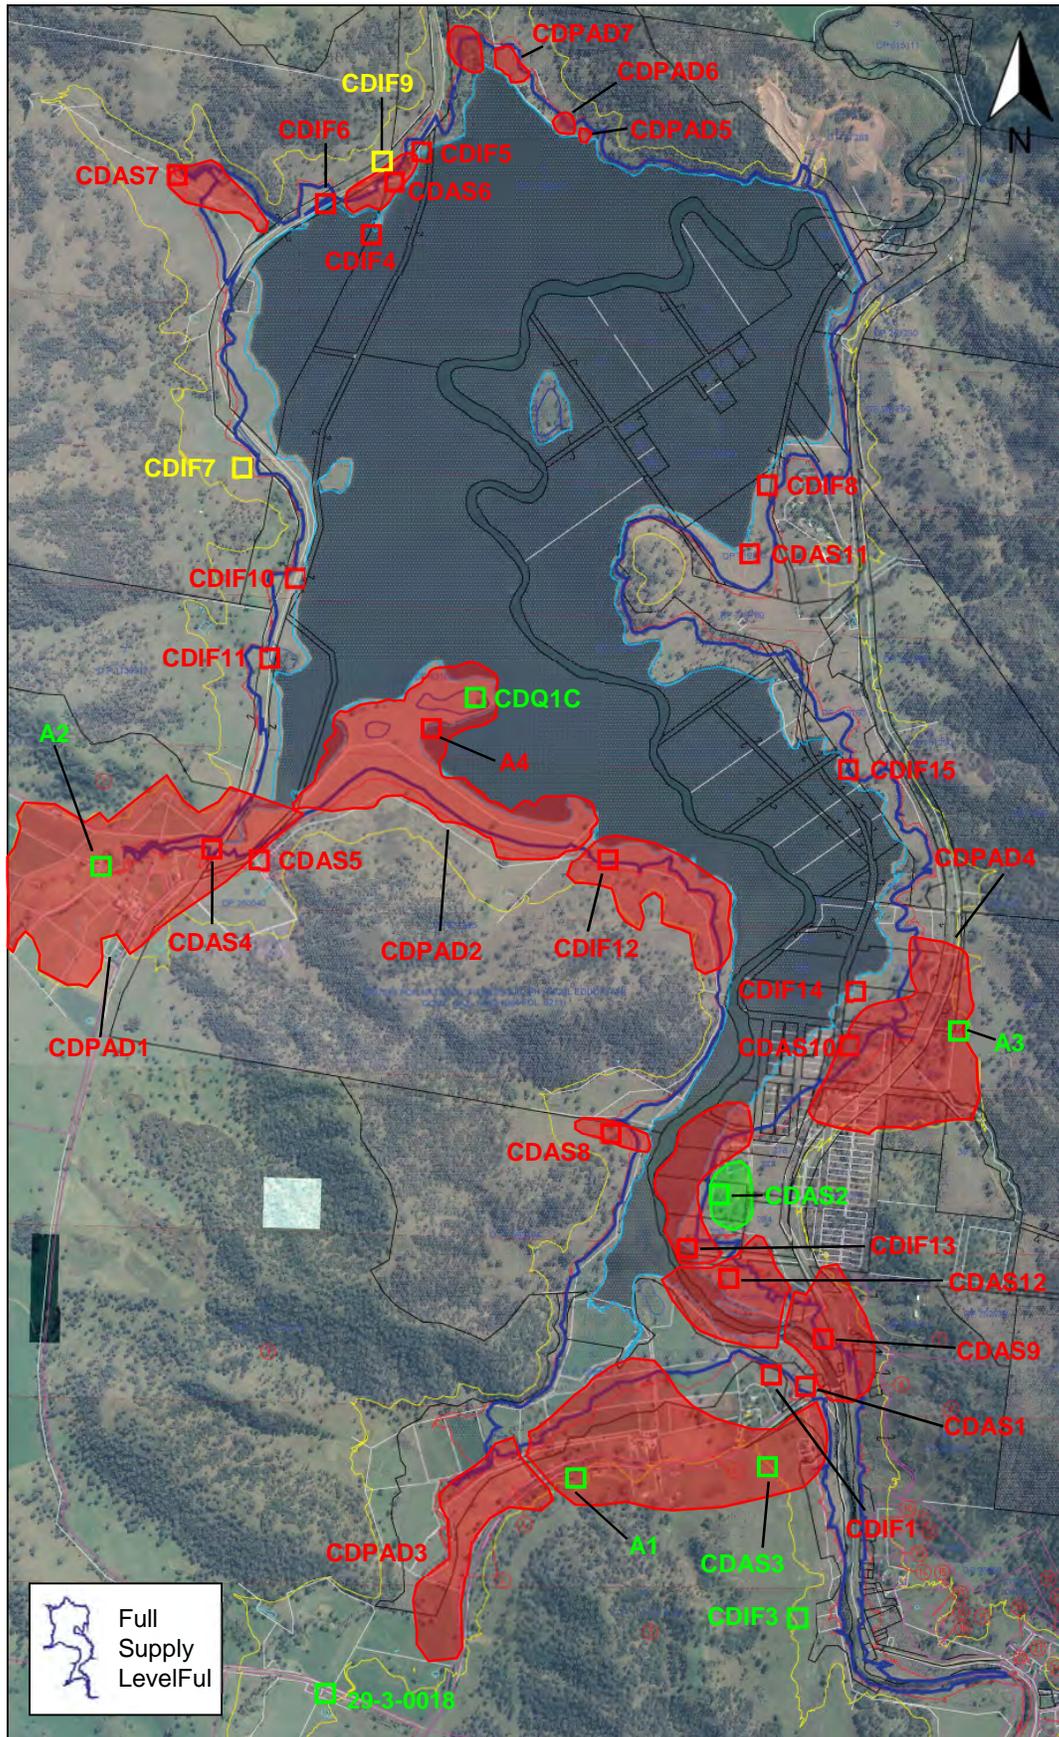
**Figure 9.1** Potential impacts at sites: impacted sites (red), sites to be fenced during road upgrades (yellow), sites that will not be impacted (green) (Provided by State Water)

CDPAD1	Inundation	directly impacted	potential destruction of part of site
CDPAD2	Inundation	directly impacted	potential destruction of part of site
CDPAD3	Inundation	directly impacted	potential destruction of part of site
CDPAD4	Inundation	directly impacted	potential destruction of part of site
CDPAD5	Inundation	directly impacted	potential destruction of part of site
CDPAD6	Inundation	directly impacted	potential destruction of part of site
CDPAD7	Inundation	directly impacted	potential destruction of part of site
CDPAD8	Inundation	directly impacted	potential destruction of part of site
