5.0 Aboriginal Heritage Field Survey Results

5.1 Physical Description of the Construction Sites

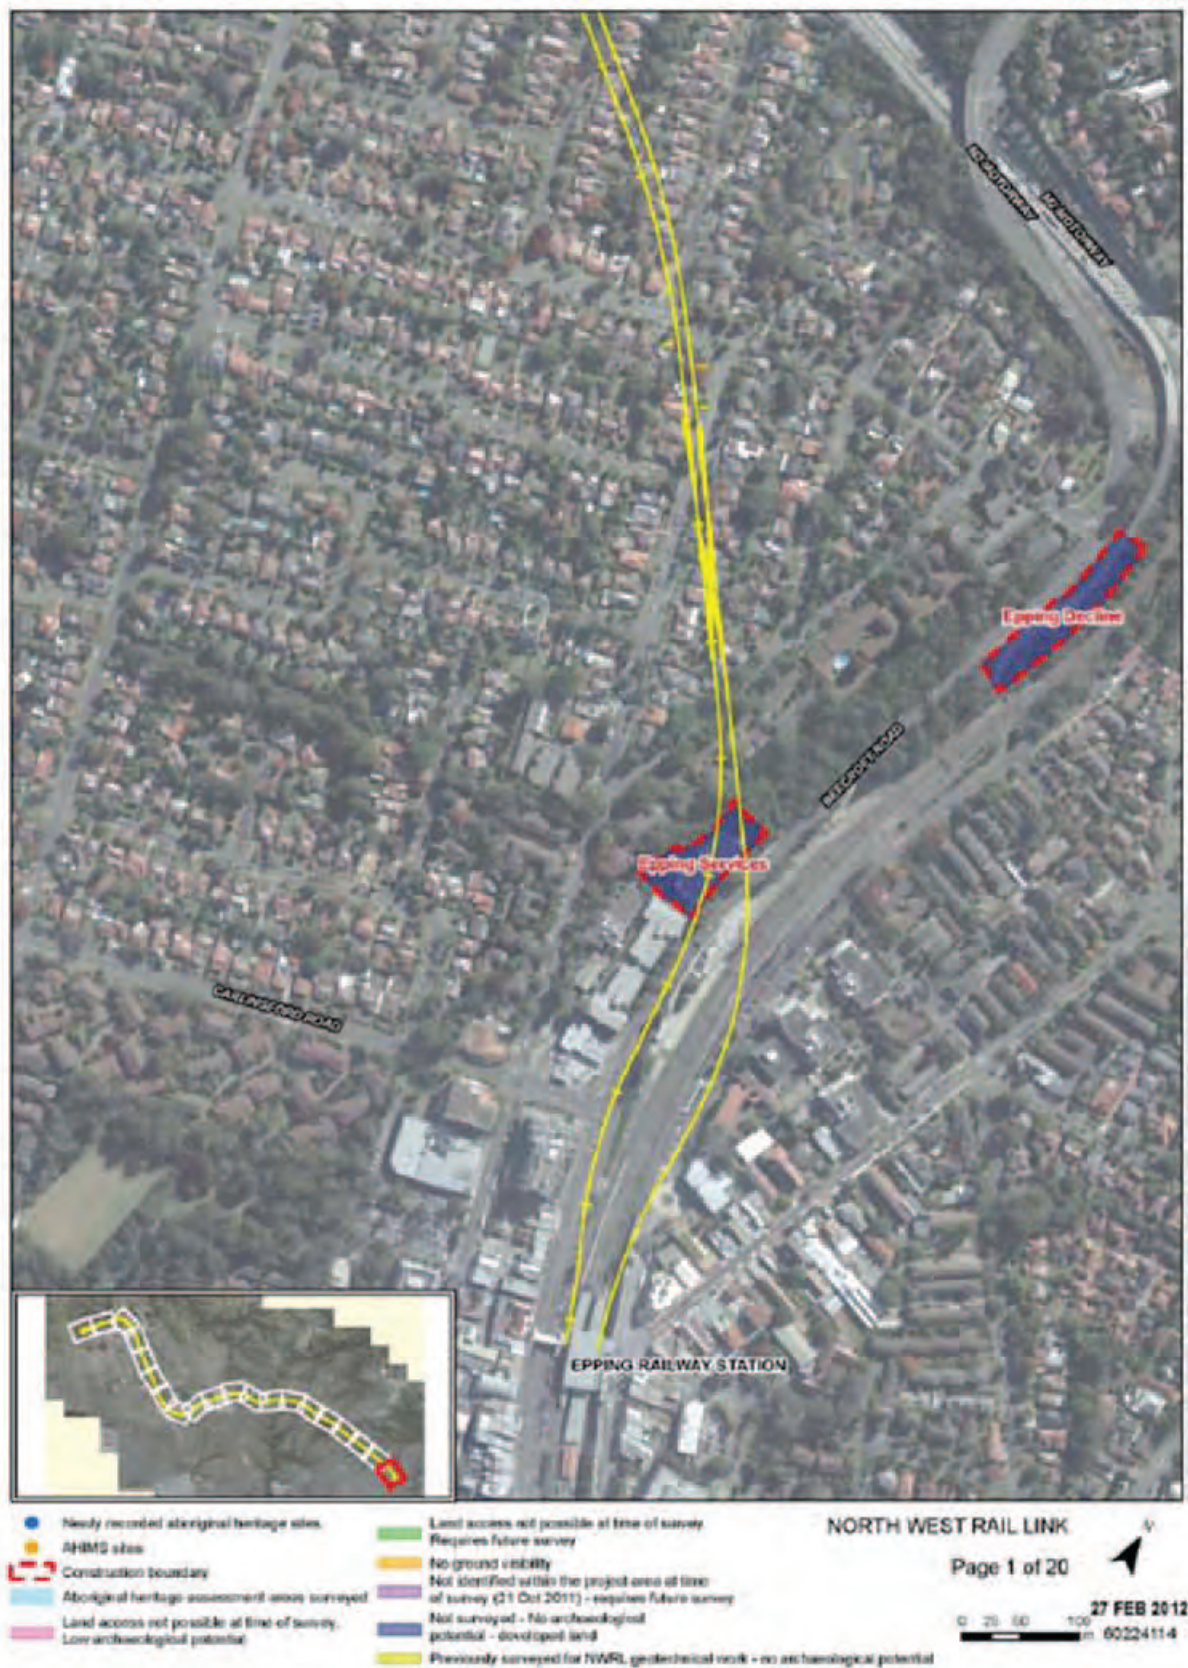
Figure 4.1 North West Rail Link construction boundaries and access areas, Epping. (Source: AECOM)

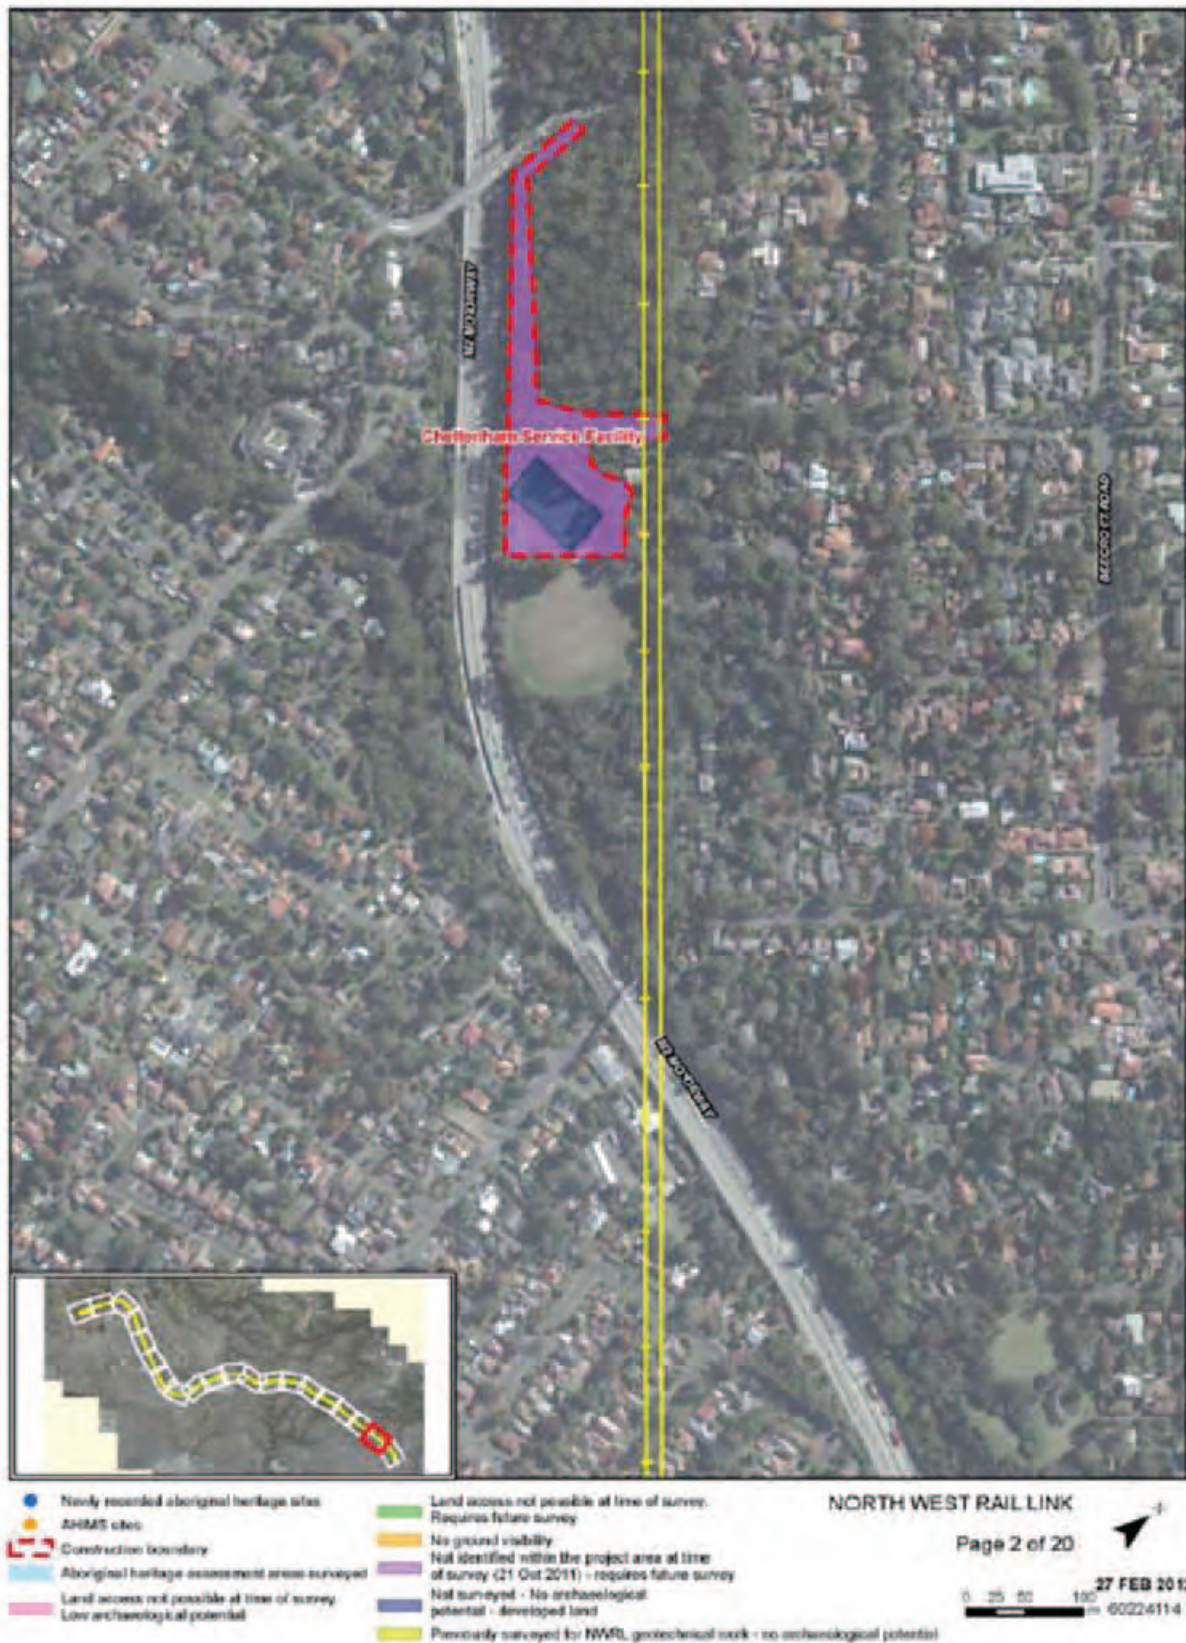
Figure 4.2 North West Rail Link alignment and Cheltenham Service Facility. (Source: AECOM)

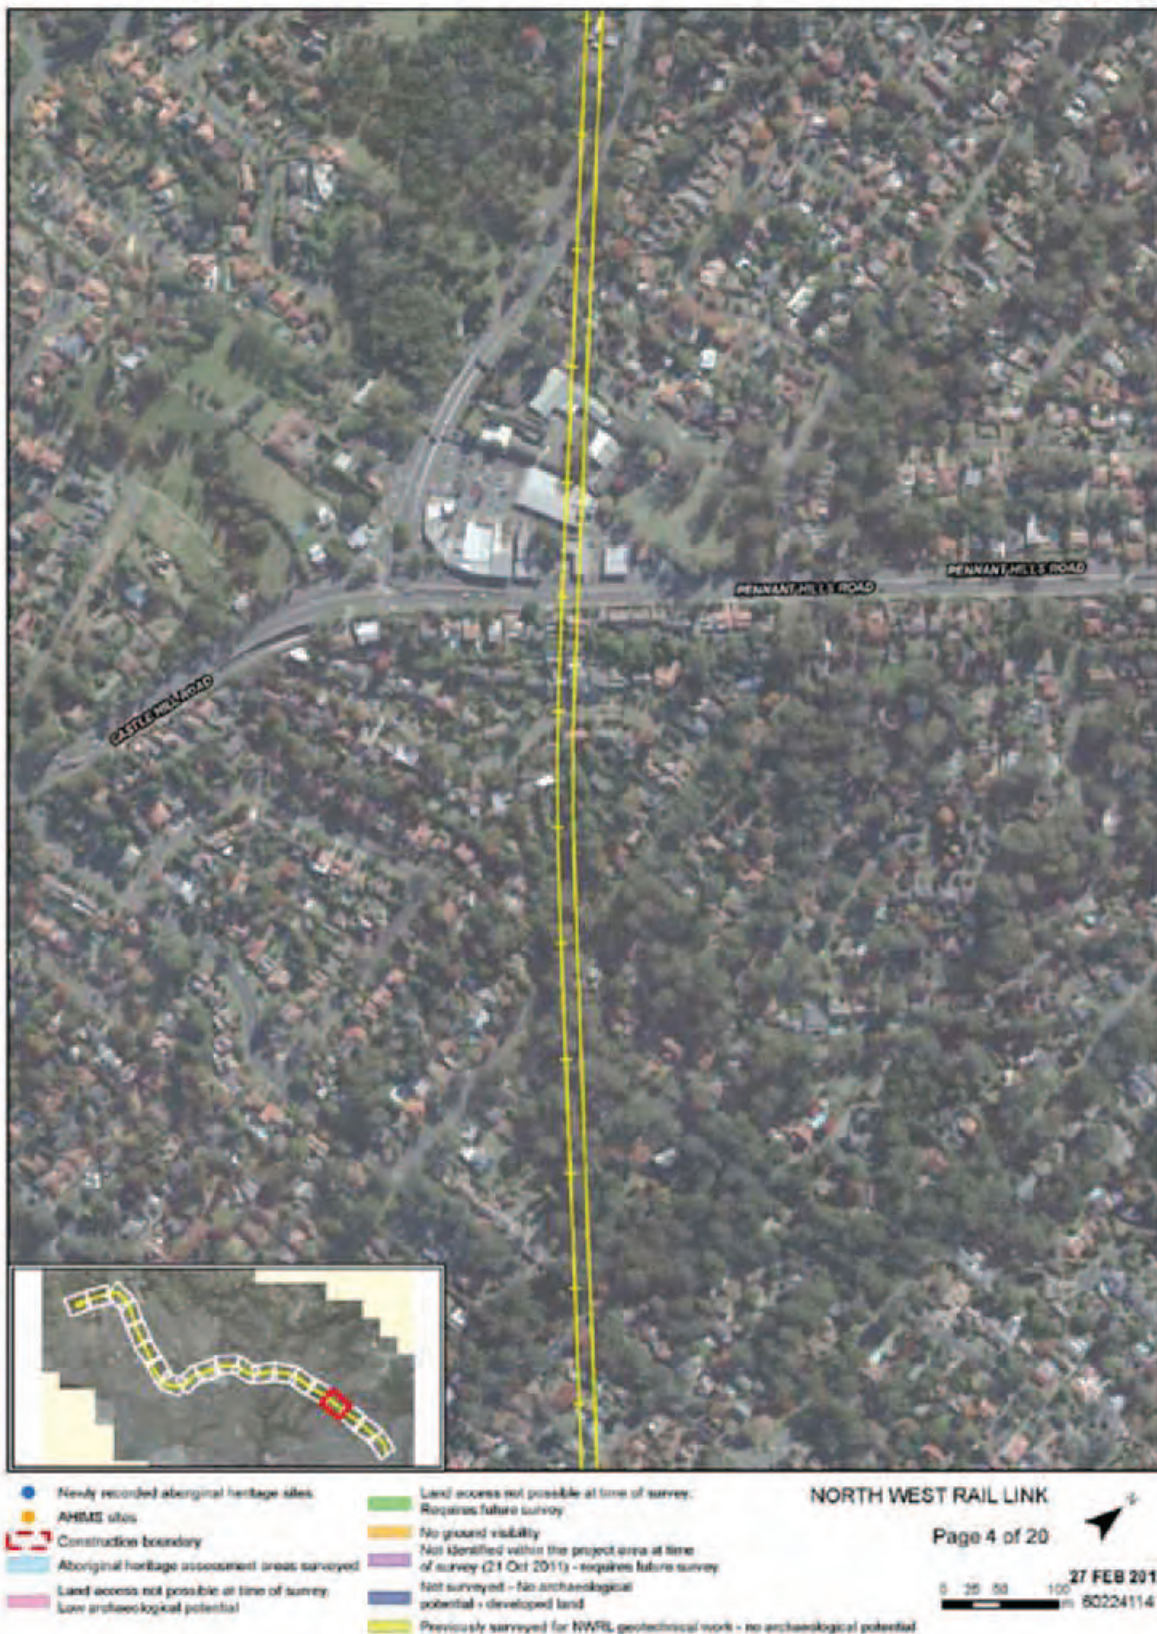
Figure 4.4 North West Rail Link construction boundaries and access areas. (Source: AECOM)

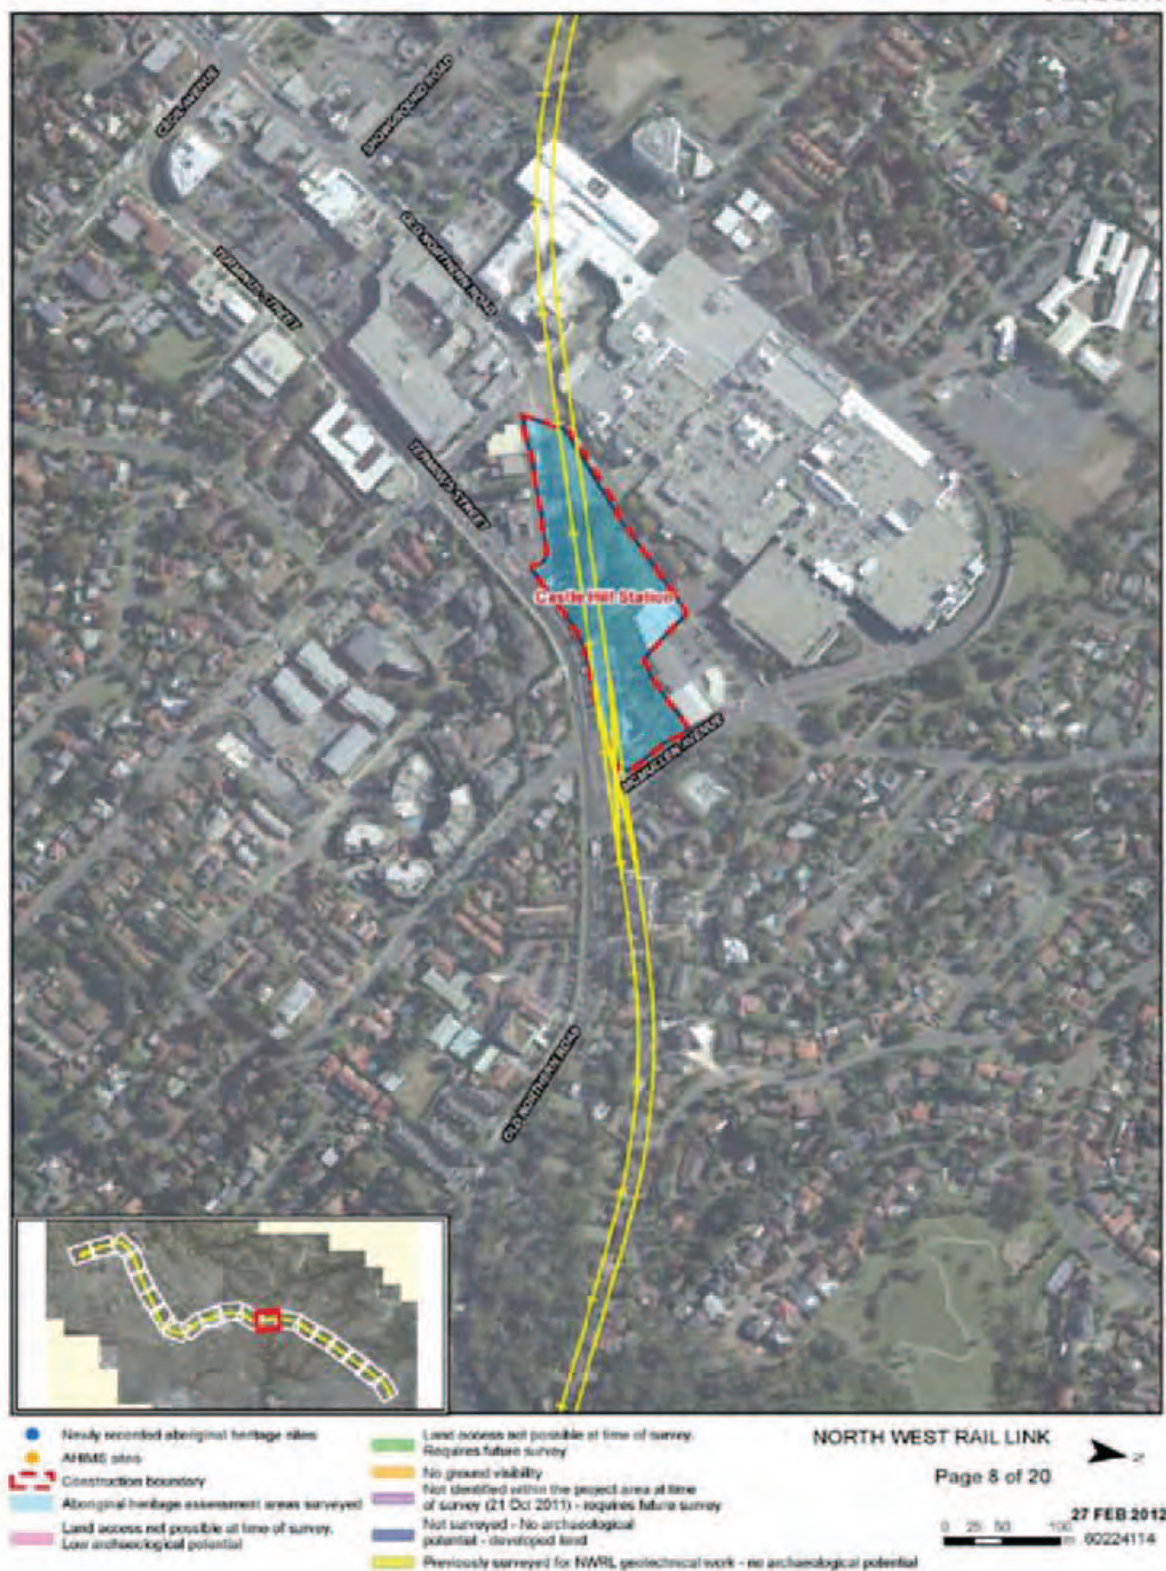
Figure 4.8 North West Rail Link alignment, Castle Hill Station Construction Boundary and Aboriginal heritage surveyed area. (Source: AECOM)

The majority of Construction Site 13 (Old Windsor Road to White Hart Drive) was surveyed where access was available (Figure 4.8 shows the locations surveyed). There was no ground surface visibility within any of the areas surveyed.

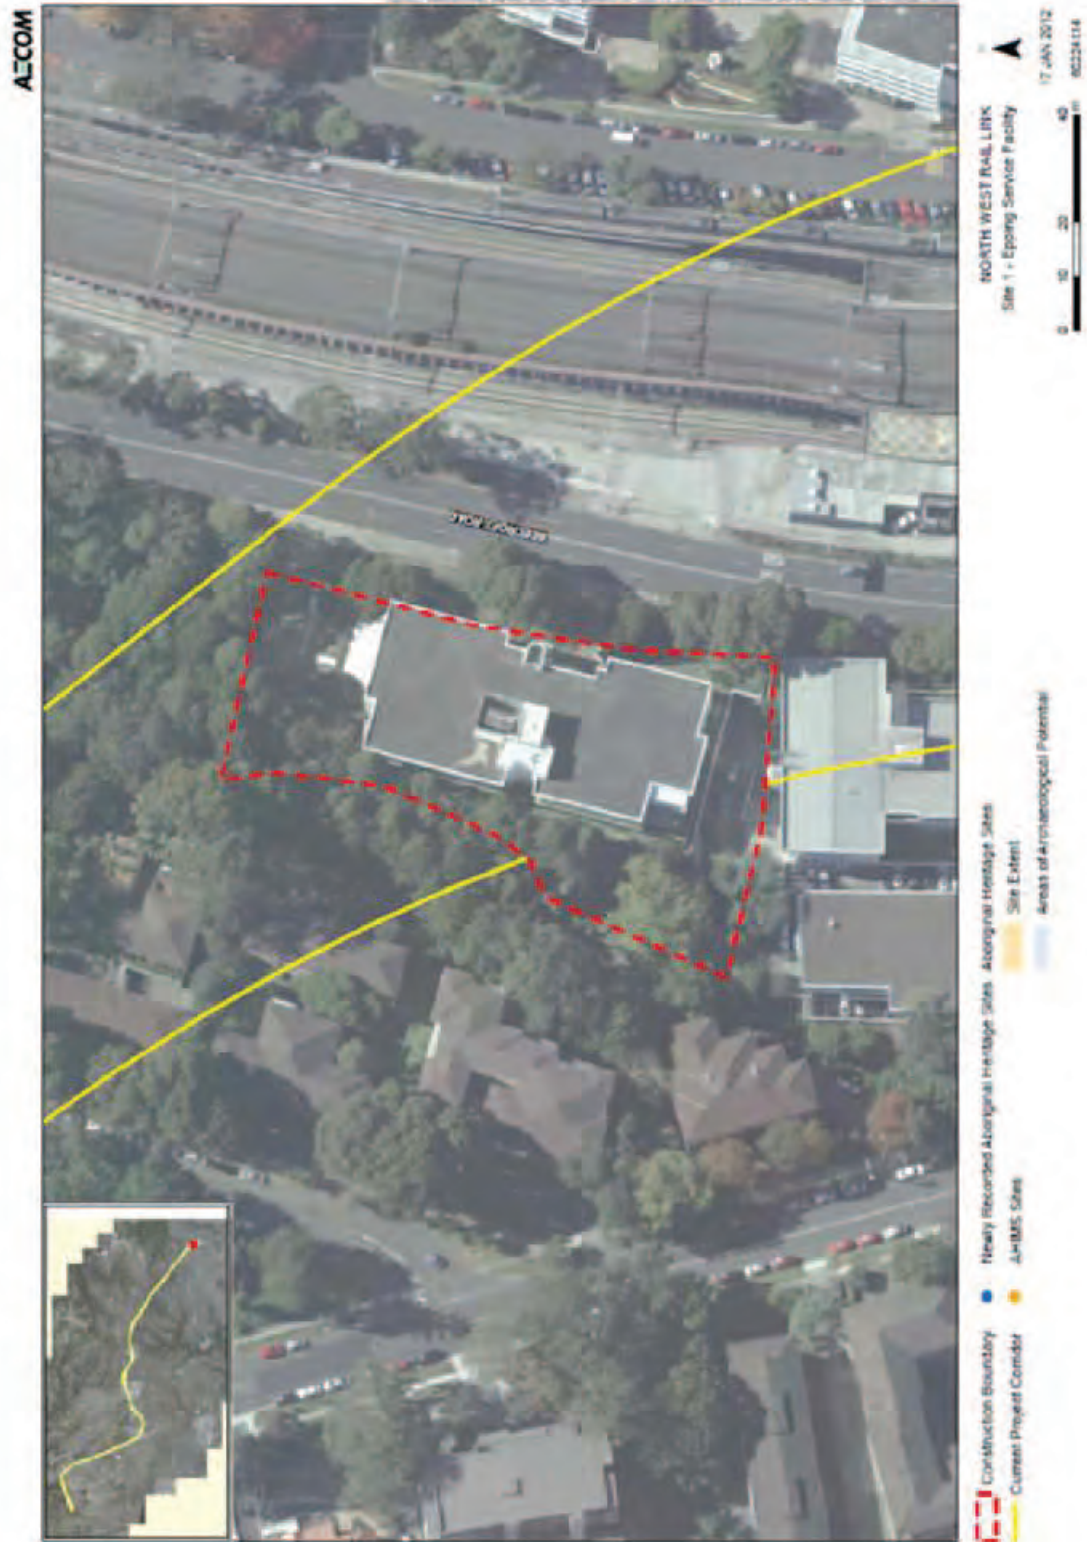
Figure 5.1 North West Rail Link Construction Site 1—Epping Service Facility, showing impact zone (construction boundary).

Construction Sites 1 and 2 (Decline and Epping services facility) may be described as disturbed with a high level of ground surface impact arising from the processes of residential development and transport infrastructure. There is no potential for Aboriginal heritage in the NWRL impact zones at Epping due to the already developed nature of the area (Figures 5.1 and 5.2).

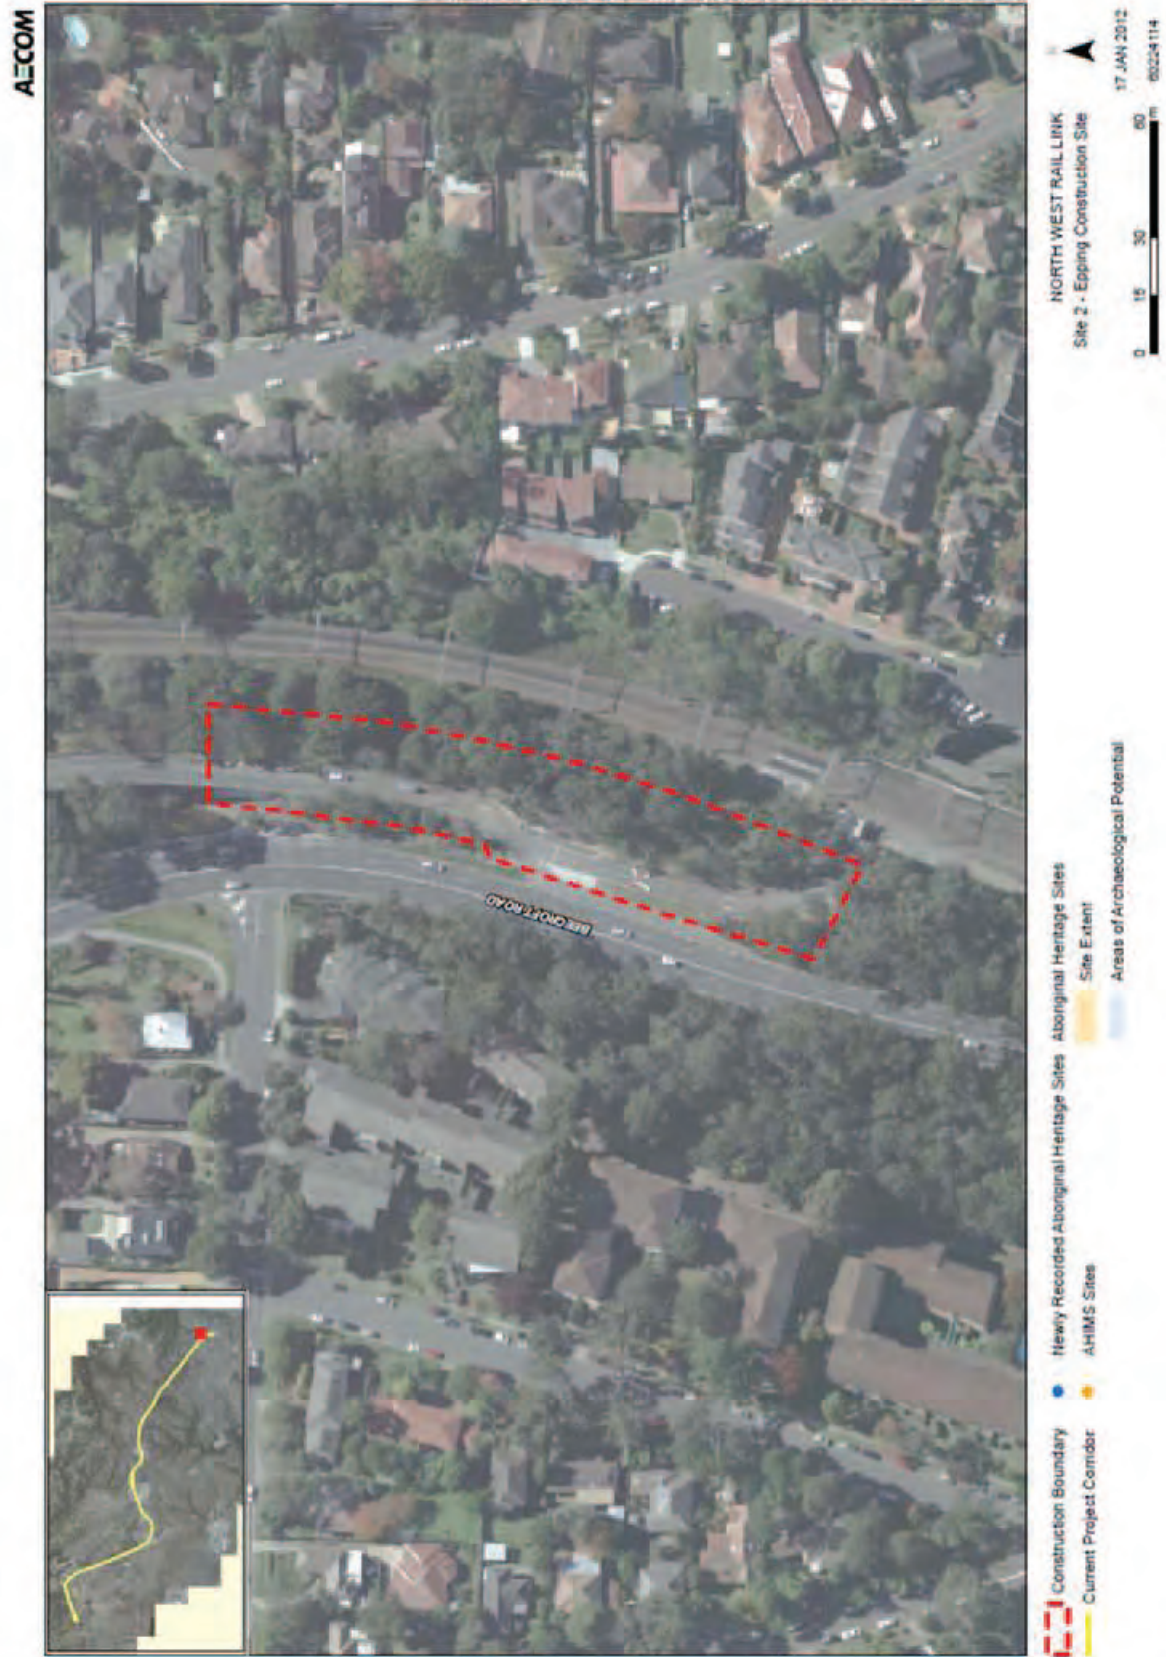
Figure 5.2 North West Rail Link Construction Site 2—Epping, showing impact zone.

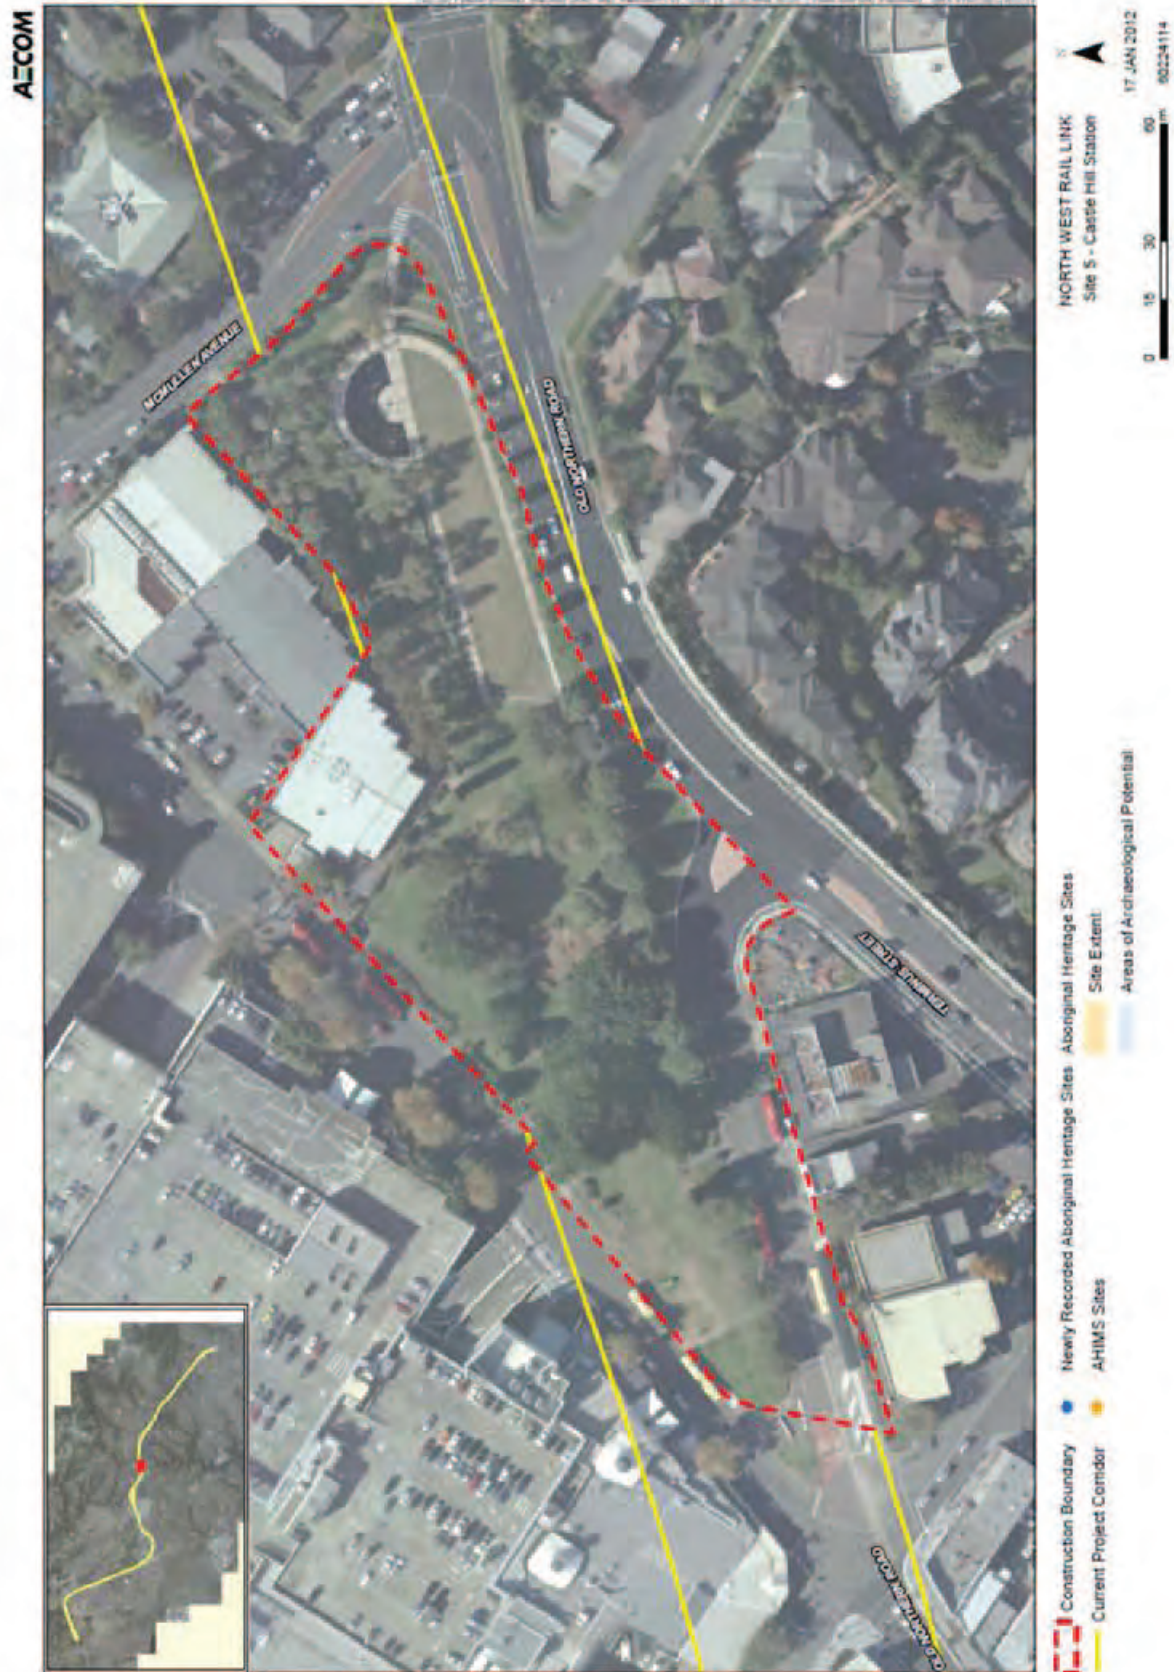
Figure 5.5 North West Rail Link Construction Site 5—Castle Hill Station, showing impact zone.

Construction Site 5 (Castle Hill Station) is to be located within the Arthur Whitting Reserve, between Old Northern Road and Old Castle Hill Road. Survey found that this land has been highly disturbed by landscaping, including gardens, lawns and exotic trees. The construction of the adjacent roads and bulk excavation around the buildings at the eastern end of the park have also caused significant disturbance. Ground surface visibility was approximately 20% with a number of small soil exposures near trees and pedestrian traffic routes. No Aboriginal objects and/or sites were observed within this construction site. There is a very low potential for intact Aboriginal sites to be present at this construction site (Figure 5.5).

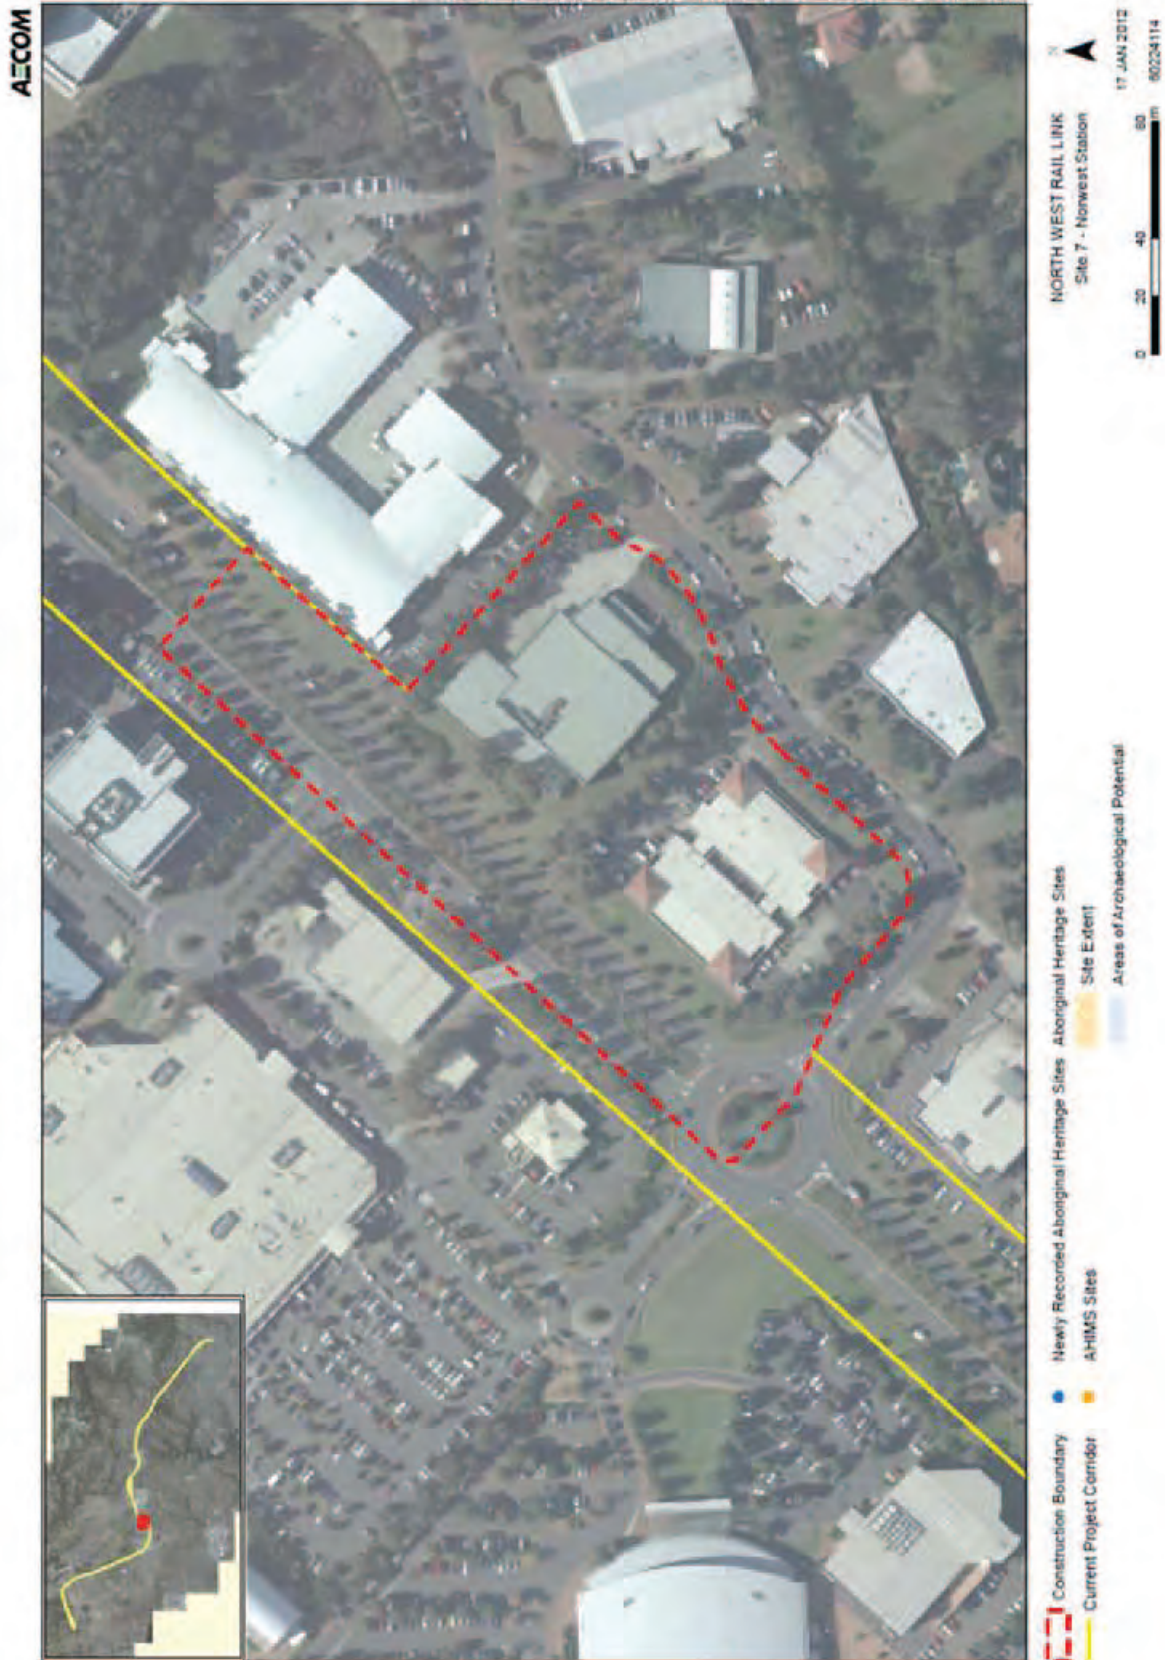
Figure 5.7 North West Rail Link Construction Site 7—Norwest Station showing impact zone.

Construction Site 7 (the Norwest Station) had approximately 30% ground surface visibility due to grass cover, existing buildings and roads (no ground exposures were present).

The area was found to be highly disturbed by modern buildings, cut and imported fills, roads and landscaping. This construction site was assessed to have very low to no potential for intact Aboriginal sites (Figure 5.7).

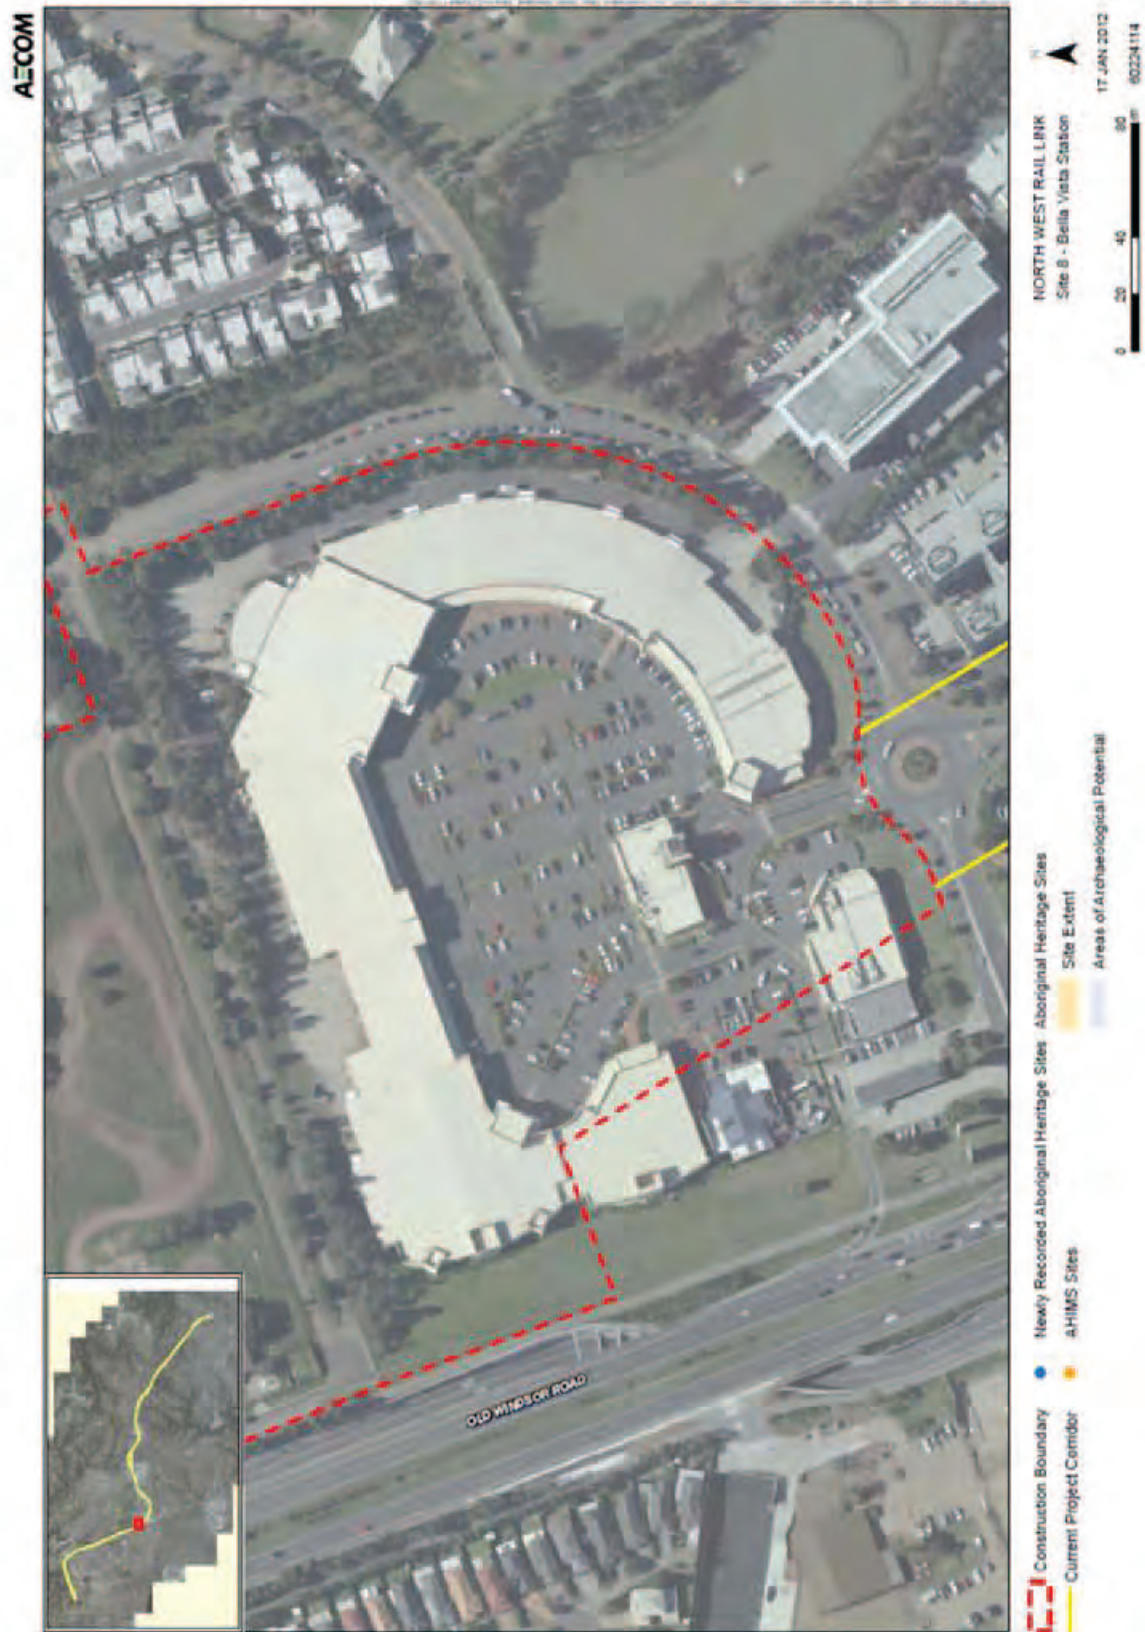
Figure 5.8 North West Rail Link Construction Site 8—Bella Vista Station showing impact zone.

Construction Site 8 (Bella Vista Station) is proposed to be contained within the land of the Homemaker Collection Shopping Centre on the corner of Old Windsor Road and Celebration Drive. Survey in this area recorded 10% ground surface visibility with exposures along the northern end of Celebration Drive.

This construction site has already been highly impacted by development. The course of the creek bank along the northern end of Celebration Drive has been modified. As such this construction site has very low to no potential for Aboriginal heritage sites (Figure 5.8).
