Technical working paper:  
Biodiversity

# NorthConnex

## Technical working paper: Biodiversity

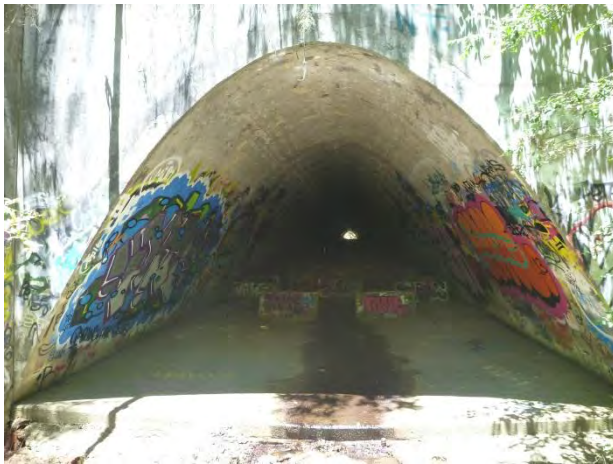
**Culvert Photo 1: Culvert 1 east of M1 Pacific Motorway**

Culvert / Building	Dimensions length, width, height (metres)	Habitat for microbats?	Habitat features	Microbats present
3	35 x 2 x 2.5 (3 openings of the dimensions above)	Potentially	<ul style="list-style-type: none"> <li>This culvert ran under the Hills M2 Motorway near West Pennant Hills.</li> <li>The culvert was surrounded by fringing vegetation.</li> <li>Water was present.</li> <li>Height and length of the culvert suitable for habitat.</li> </ul>	Unknown – culvert could not be inspected
4 & 5	35 x 7 x 4	Yes	<ul style="list-style-type: none"> <li>This culvert ran under the Hills M2 Motorway near West Pennant Hills.</li> <li>The culvert was surrounded by fringing vegetation.</li> <li>Water was present but not flowing.</li> <li>Cracks were suitable for microbats.</li> </ul>	None seen
6	35 x 1.5 x 1.5 (2 openings of the above dimensions)	Yes	<ul style="list-style-type: none"> <li>This culvert ran under the Hills M2 Motorway near North Rocks.</li> <li>The culvert was surrounded by fringing vegetation.</li> <li>Water was present but not flowing.</li> <li>Cracks were suitable for microbats.</li> </ul>	None seen

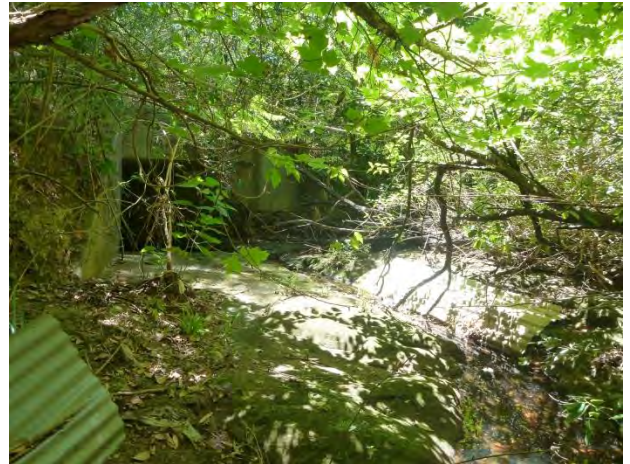
**Culvert Photo 2: Culvert 2 under Junction Road**

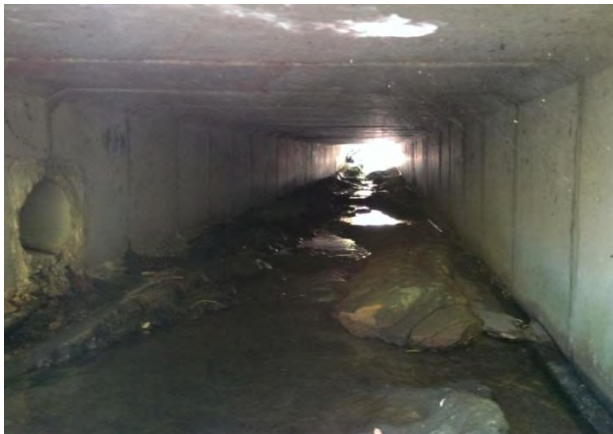
**Culvert Photo 3: Culvert 2**

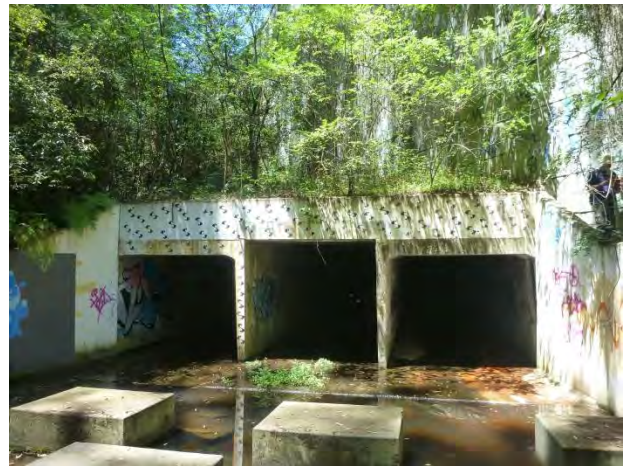
**Culvert Photo 4: Culvert 3 north of Hills M2 Motorway**

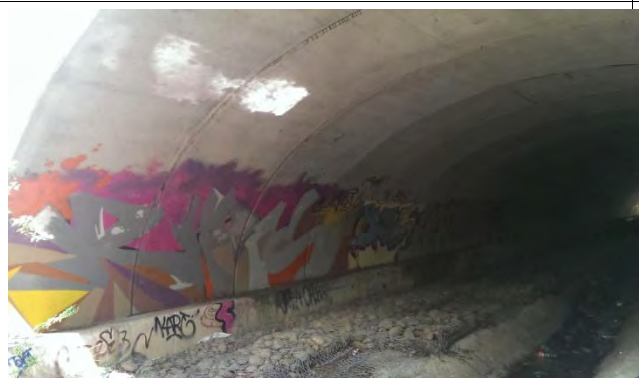
**Culvert Photo 5: Culvert 4 northern side, the southern side is mapped as culvert 5**

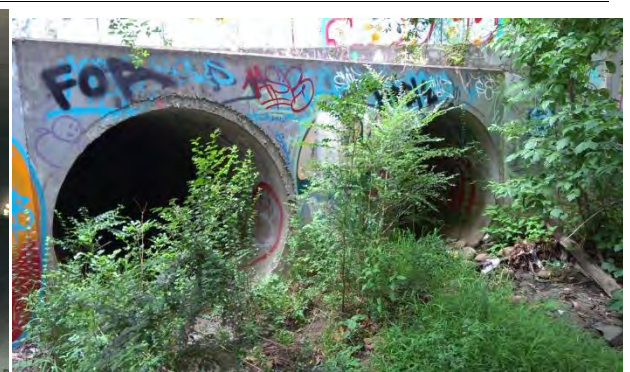
**Culvert Photo 6: Culvert 6 at the northern side of the Hills M2 Motorway**
