## **Appendix E    Archaeological Assessment**

**Re: Due Diligence Advice for Aboriginal archaeological heritage for the Horsley Park Meter Station upgrade – FINAL**

**Our Ref: Matter # 18669**

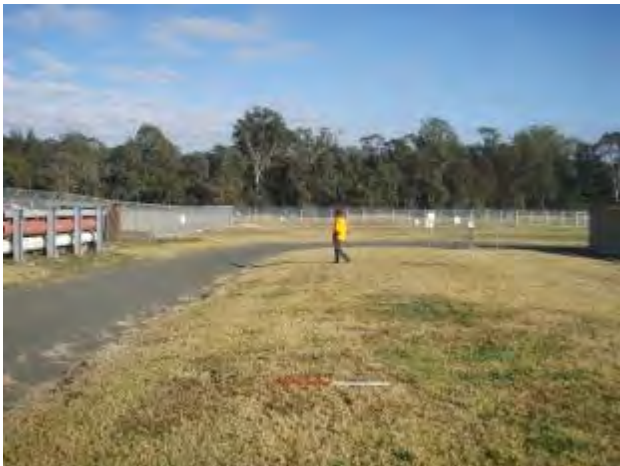
The accessible sections of the Project Area were surveyed. Ground surface visibility was generally very low due to dense grass cover and the presence of paved surfaces, buildings and meter station infrastructure (Plate 1 and Plate 2). Odd exposures were evident around the bases of trees and along fencelines, and these were all inspected.

**Plate 1: Dense grass cover through the Project Area, restricting ground surface visibility. View to west.**

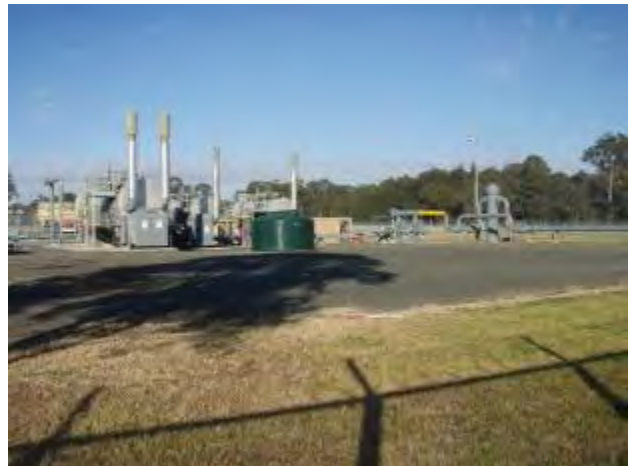
**Plate 2: Paved surfaces, buildings and infrastructure within the Project Area. View to SW.**

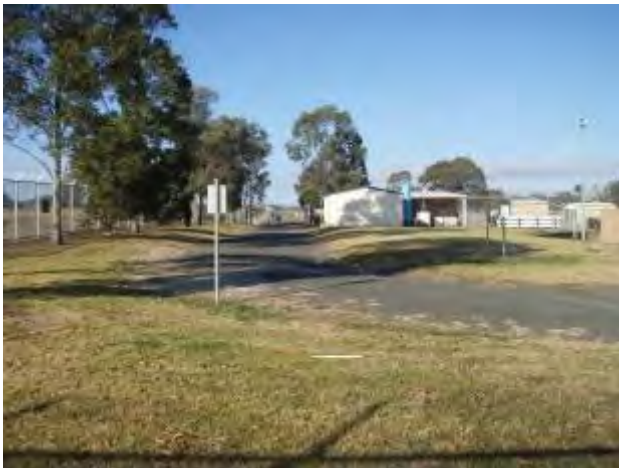
The entire Project Area has been highly disturbed through the installation of the existing gas meter station and associated infrastructure, including buildings; paved roads and surfaces; fences; and underground pipelines and cables (Plate 3 and Plate 4). It is evident that extensive excavation and earth movement has taken place across the whole area, with the main facility located on a levelled artificial terrace (Plate 5 and Plate 6). The original vegetation has been completely cleared from within the Project Area.

**Plate 3: Buildings and paved roads within the Project Area. View to south.**

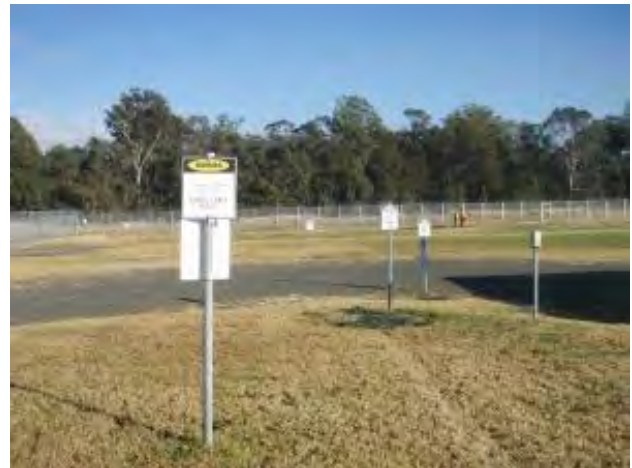
**Plate 4: Underground cables and pipelines within the Project Area. View to west.**

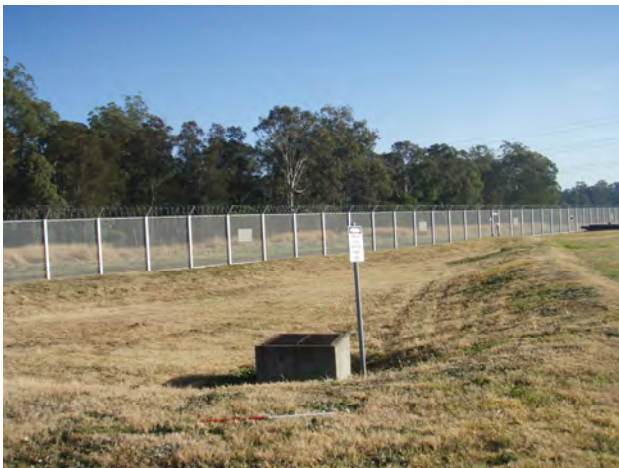
**Plate 5: Previous excavation and earth movement within the Project Area (south-west corner). View to NW.**

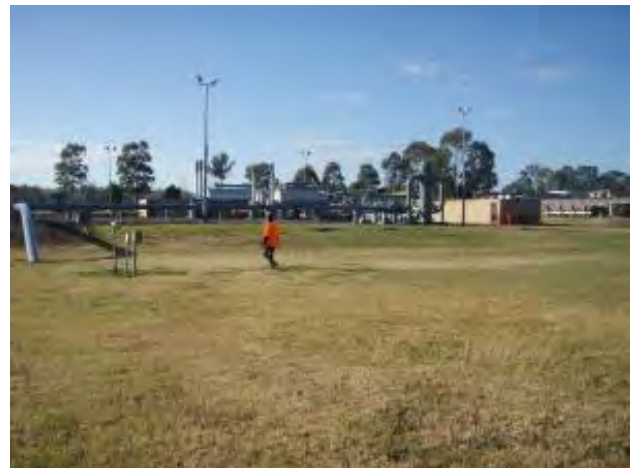
**Plate 6: Main facility within the Project Area located on a levelled artificial terrace. View to SE.**

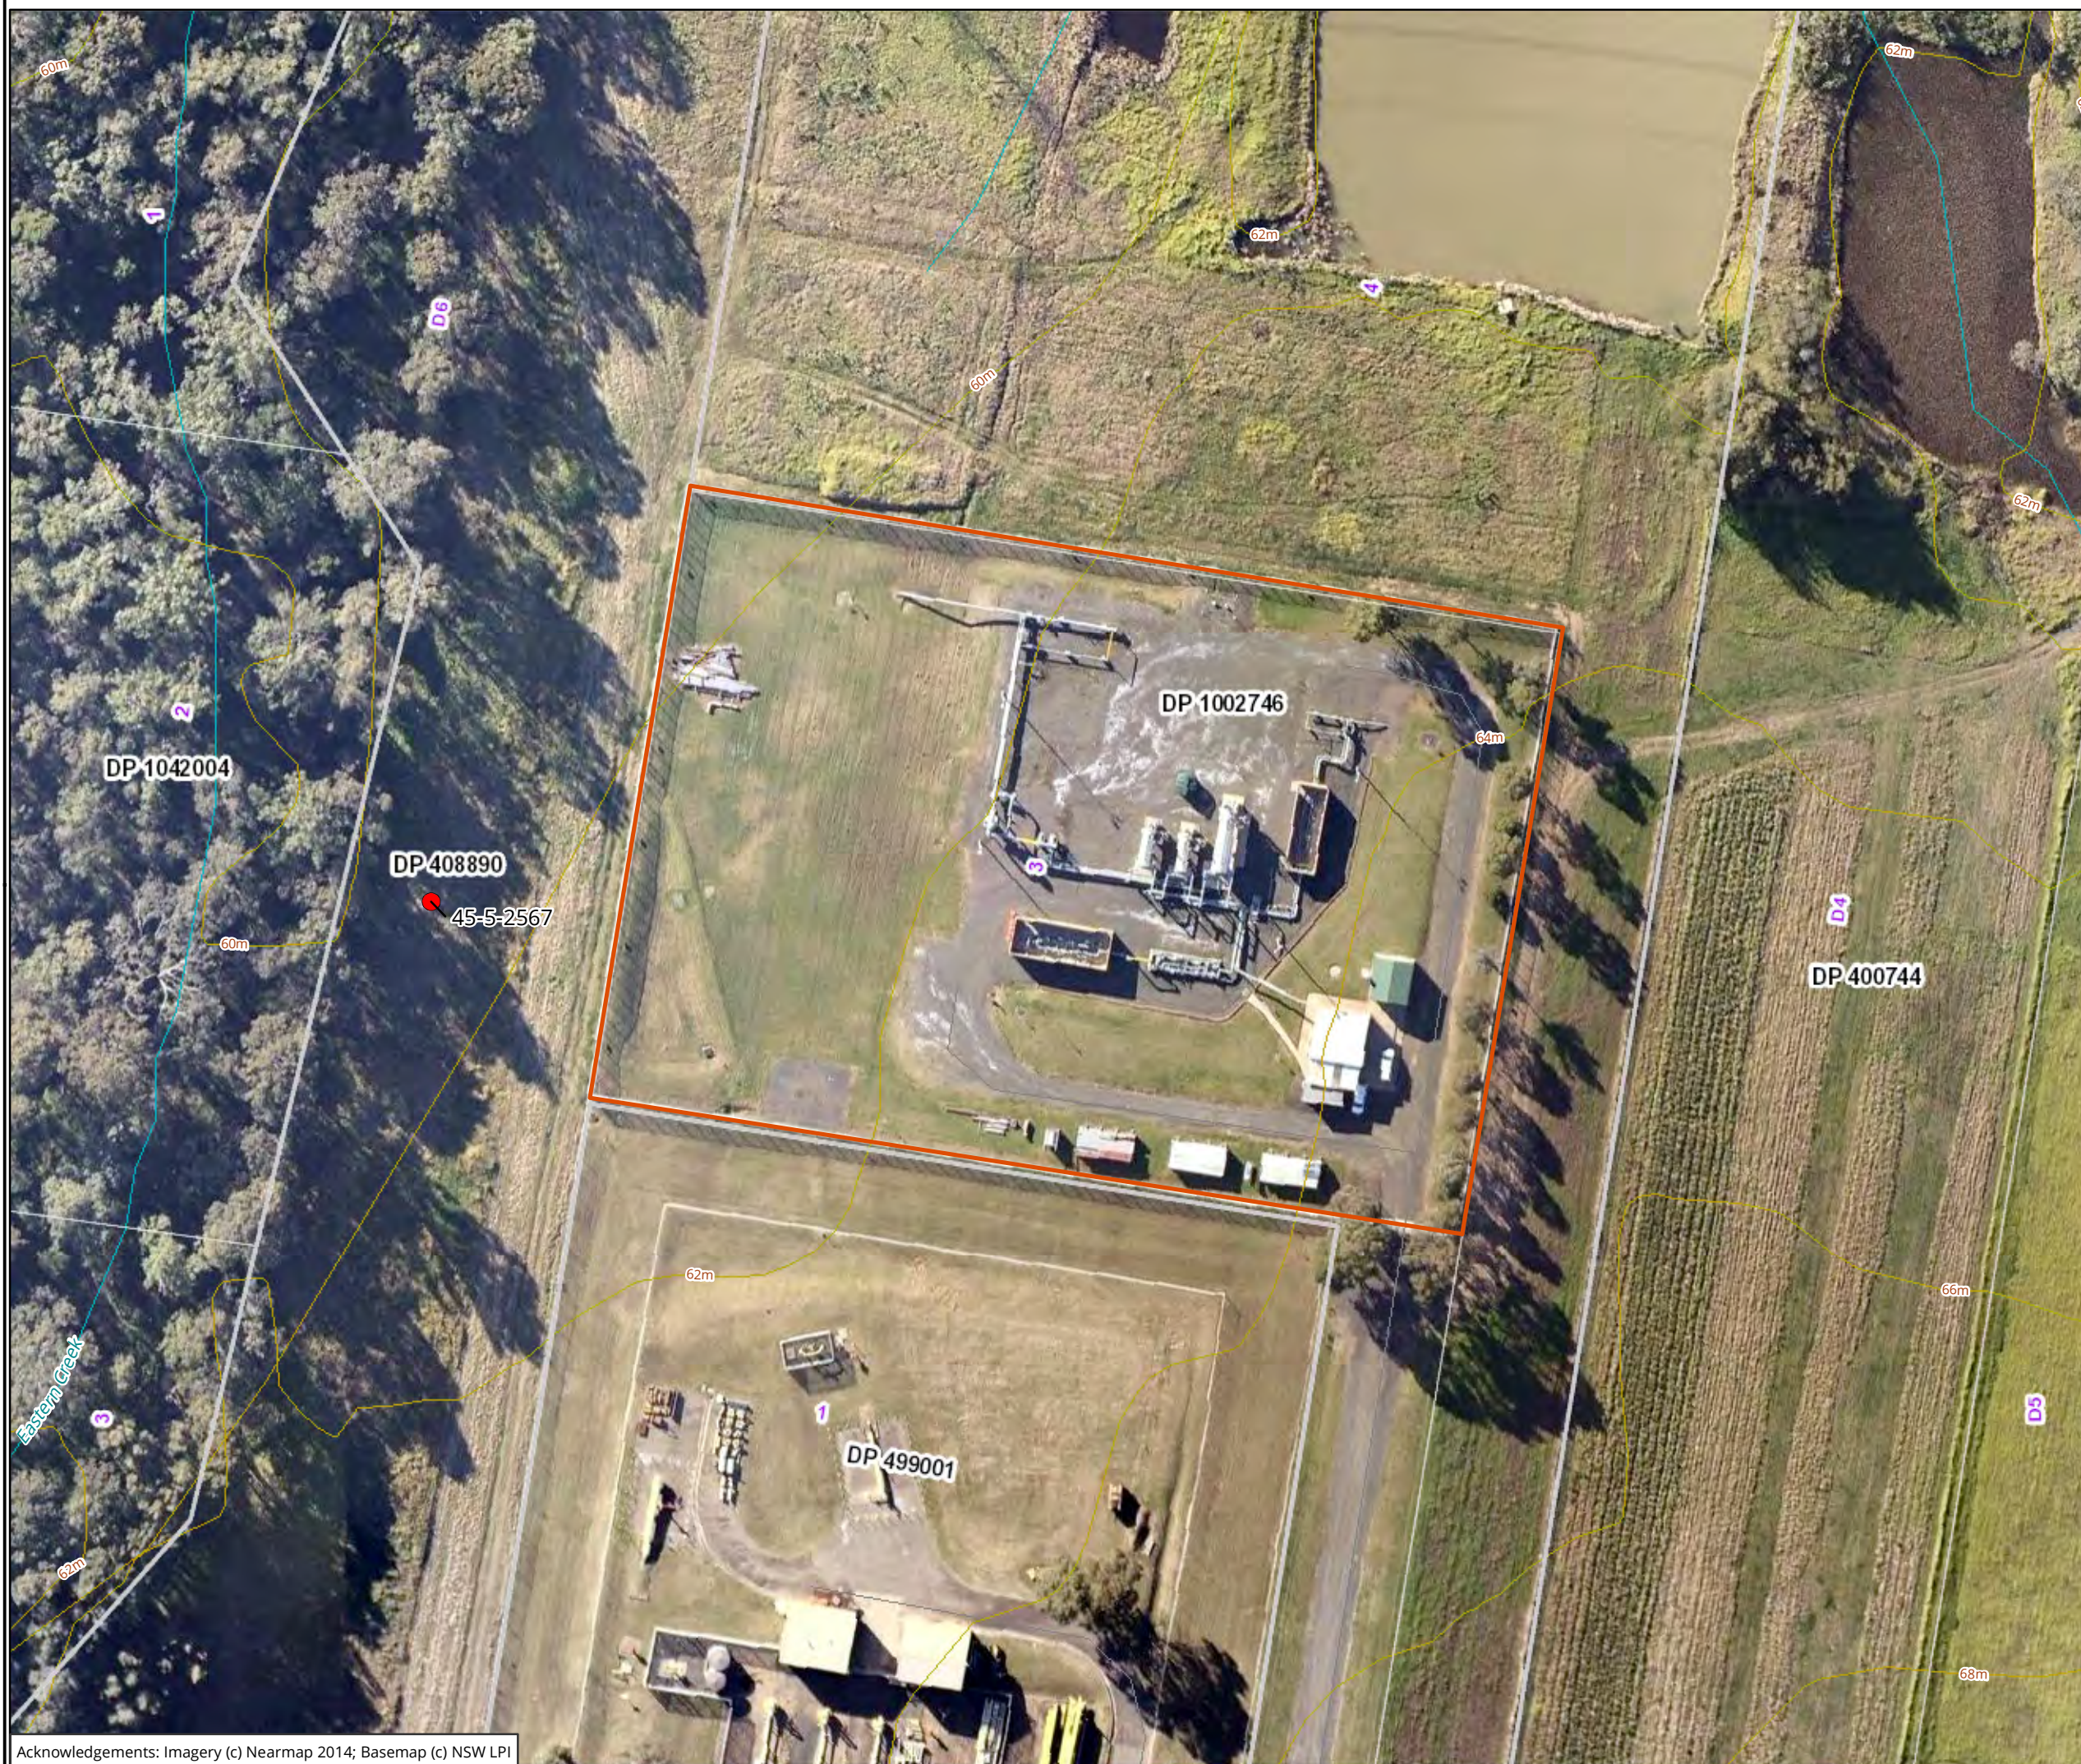
Figure 2: Project Area Detail

Site 45-5-2567 is an artefact scatter that is located 20-30 metres to the west of the western boundary of the Project Area (Figure 2). The site was recorded in 1999 during a survey of the proposed Eastern Gas Pipeline Route. As recorded on the site card, the site comprised two silcrete artefacts (one flake and one core) located on a vehicle track in a heavily disturbed market garden area. It was determined to be unlikely that other archaeological material was present due to the high level of disturbance. It is noted on the site card that Consent to Destroy with salvage was applied for; however, the site is currently recorded on the AHIMS
