**PROPOSED BARANGAROO FERRY HUB**

**ENVIRONMENTAL IMPACT STATEMENT**

**- AQUATIC ECOLOGY ASSESSMENT**

**Marine Pollution Research Pty Ltd**  
**November 2014**

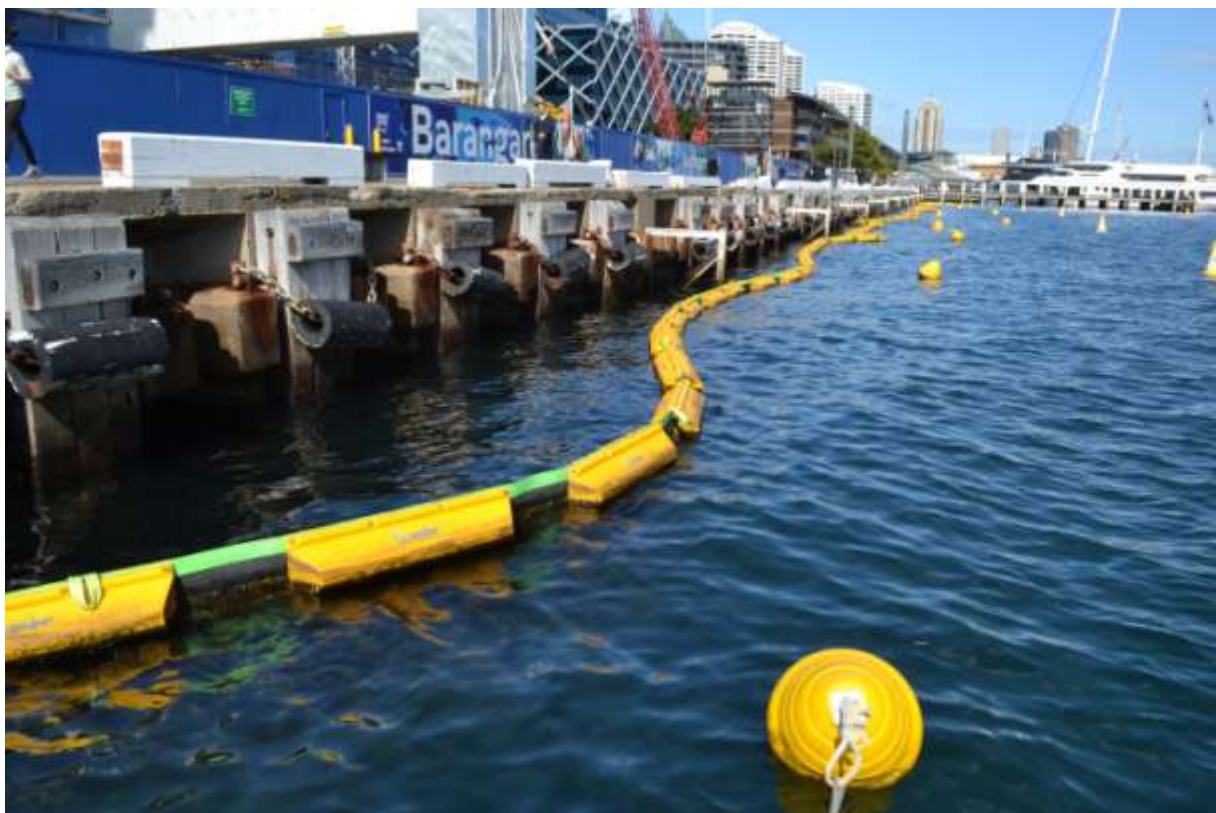
Figure 7 Foreshore at Barangaroo showing concrete caissons with wooden barge boards and chain plus rubber fenders. The metal frames seen in the distance hold the silt curtain off the wharf front. The silt curtain extends to about the 6 metre depth.

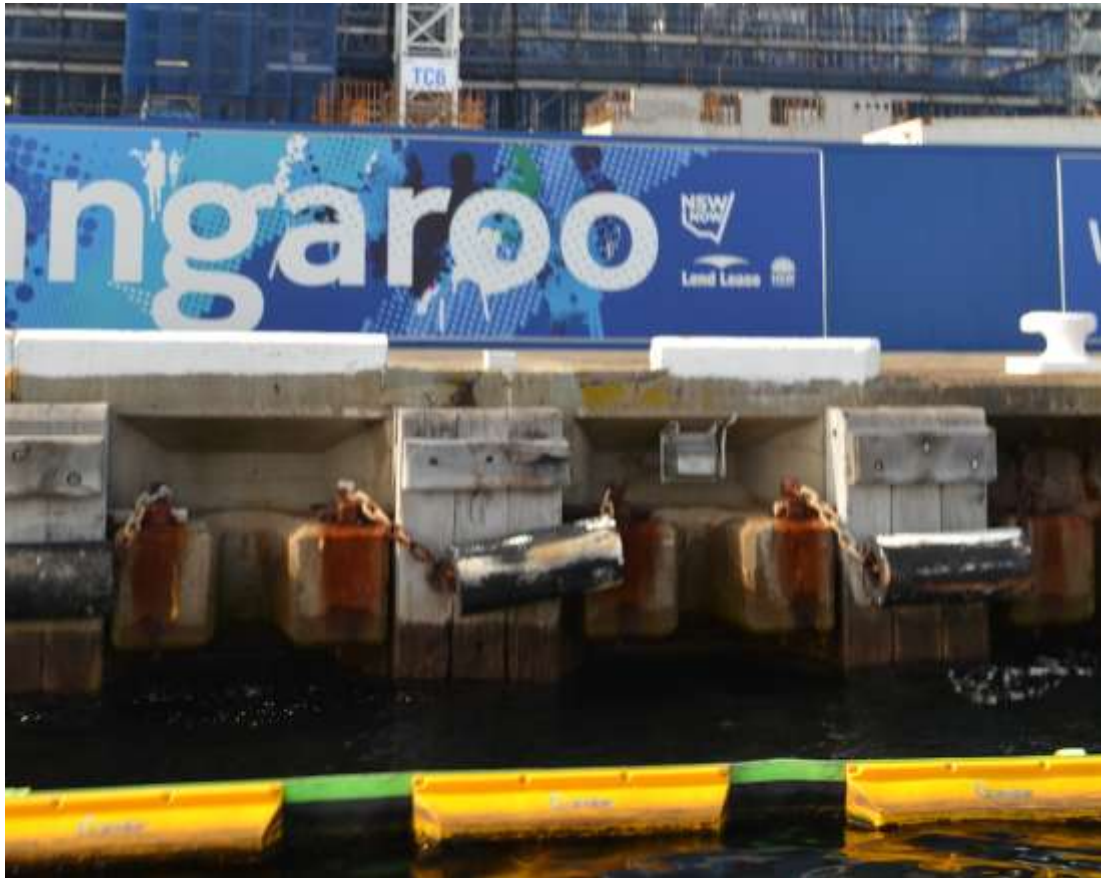
Figure 8 Close up of caissons showing unit details.

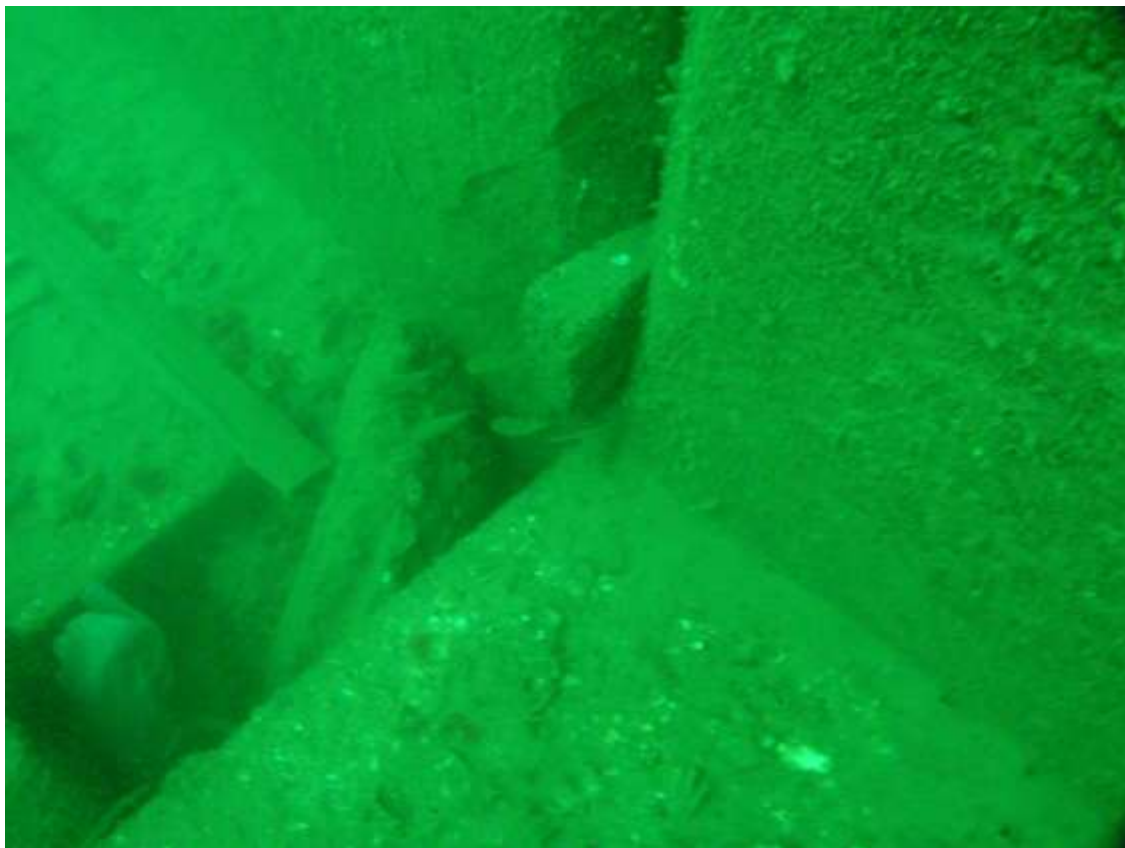
Figure 9 Each caisson has a broad concrete base and there are gaps of about 5 centimetres wide between each caisson unit with rubber gaskets between the units. The exposed portions of these gaps provide shelter habitat for fish, in this case cardinal fish.

- Small reef fish observed during the survey included cardinal fish and eastern hula fish, always clustered around the crevices between caisson units (refer to Figure 9). Pygmy leatherjackets were observed in the kelp stands and fan bellied leatherjackets were observed feeding along the vertical walls. Predatory fish observed on the caisson walls included luderick and bream.

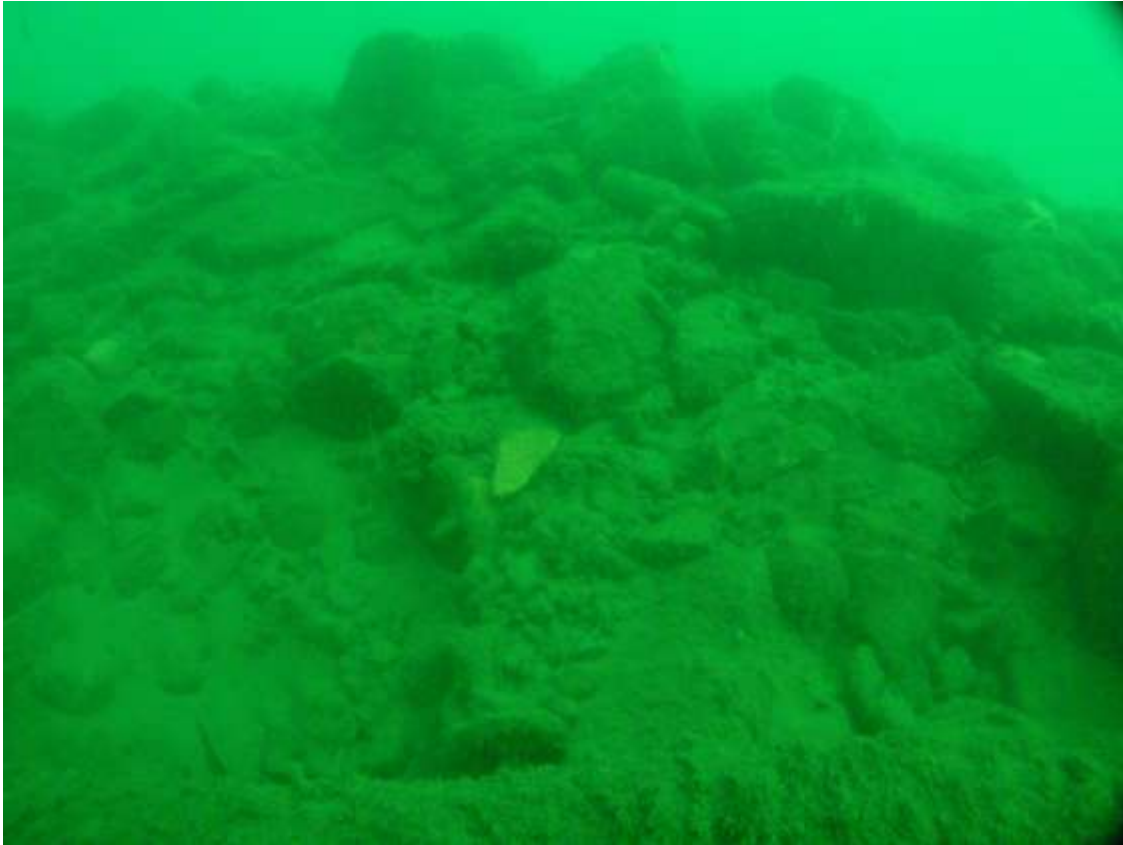
Figure 10 There is a variable width band of rock rubble from the caisson base that extends offshore some 5 metres and up to about 15 metres.

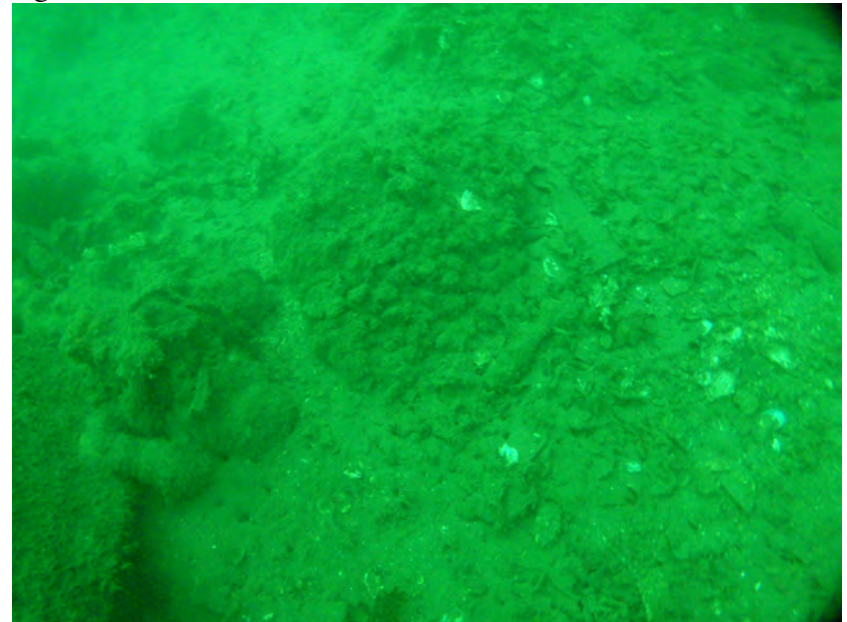
Figure 24 Smothered shell bed.

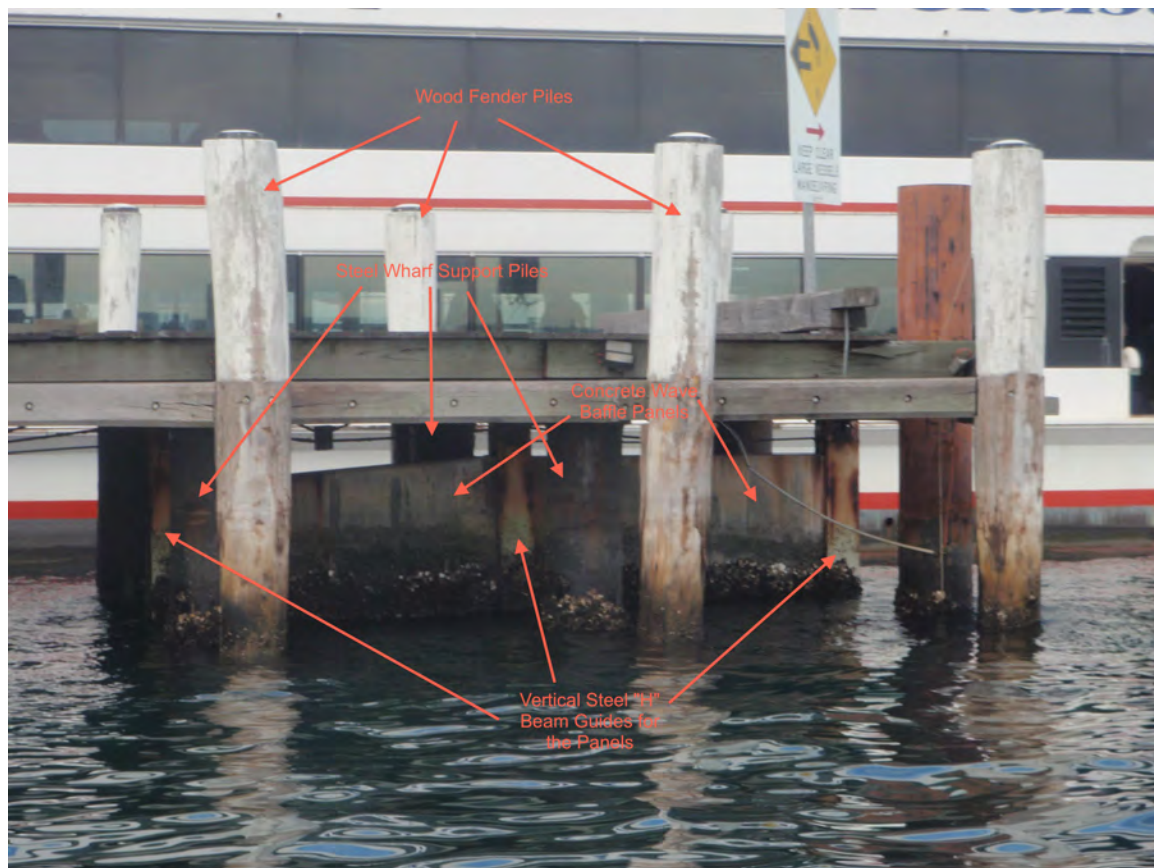
Figure 3 Outer section of Wharf 10 Jetty showing two suspended wave baffles

The concrete wave baffles shown in Figure 3 are supported off the seabed by steel rods under the wharf decking, but for most of the other baffles the steel rods have given way and the concrete baffles have settled onto the seabed, held in place vertically by the “H” beam piles. Figure 4 shows another section of the wharf with a partially supported wave baffle panel and a number of support rods hanging from the wharf deck underside.

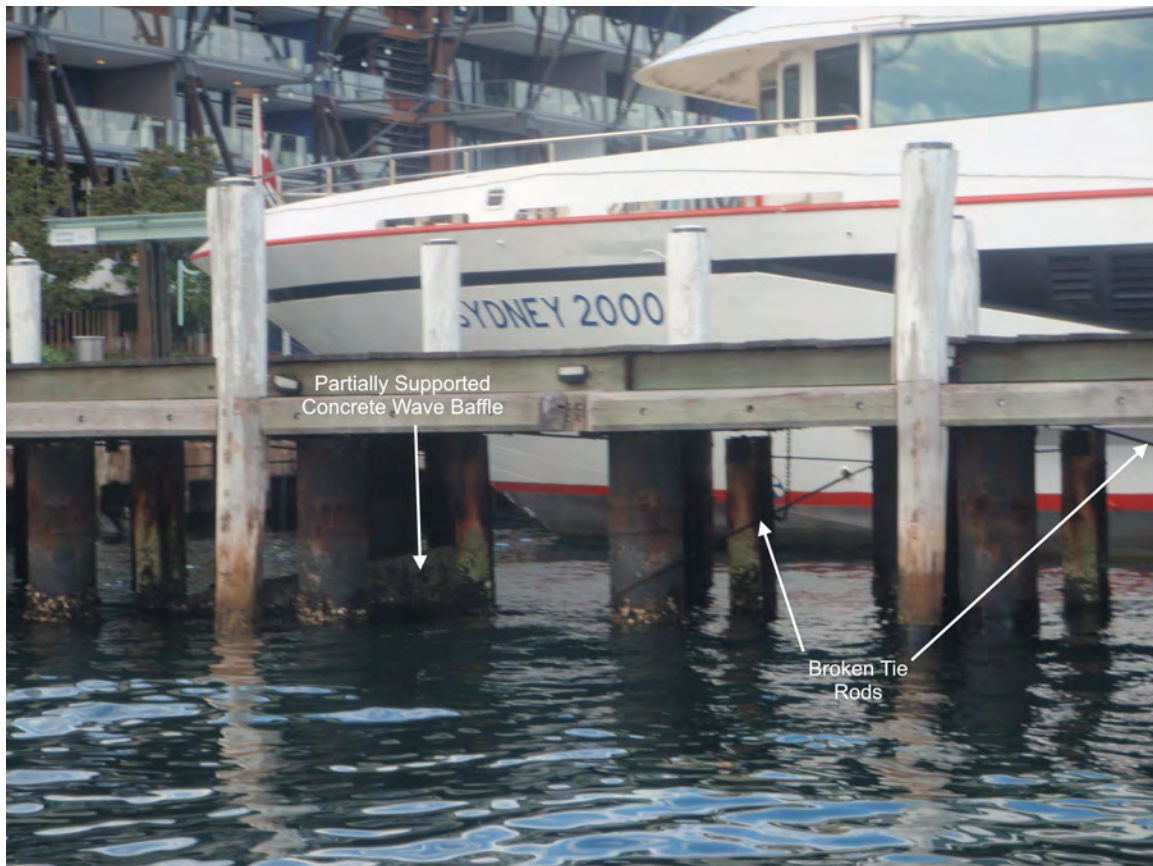
Figure 4 Middle Section of Wharf 10 Jetty showing a partially supported concrete wave baffle and a number of broken tie rods.

Only three of the wave baffles are still suspended in the water column with the remainder on the bottom. The wave baffles on the bottom are smothered in silt and support little if any attached biota. The suspended wave baffles and the H beams support an assemblage of encrusting biota that is similar to that found on adjacent piles and would be found on all the remaining King Street wharves and on the Barangaroo seawall.

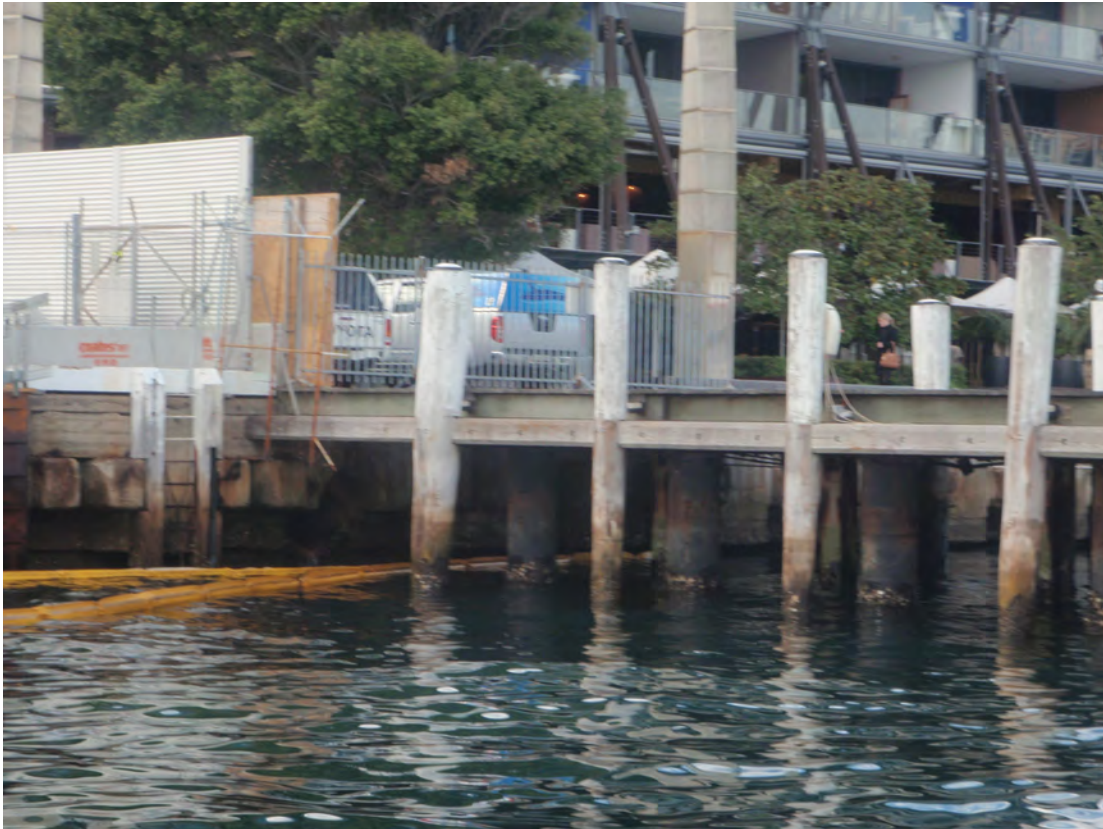
King Street Wharf Jetty 10 is built out from a reclamation that is held in place by a sandstone rock and concrete retaining wall (Figure 5) and the soft sediment seabed beyond the retaining wall is more or less level, having been dredged in the past. Dredged depths are around 10.2 to 10.3m below chart datum (Indian Spring Low Water ISLW).

Figure 5 View of sandstone and concrete retaining wall at the shore-end of Wharf 10 Jetty. The floating boom and construction fencing to the left side of the wharf are part of the Barangaroo construction works, and there is a stormwater outfall to the left of the jetty.

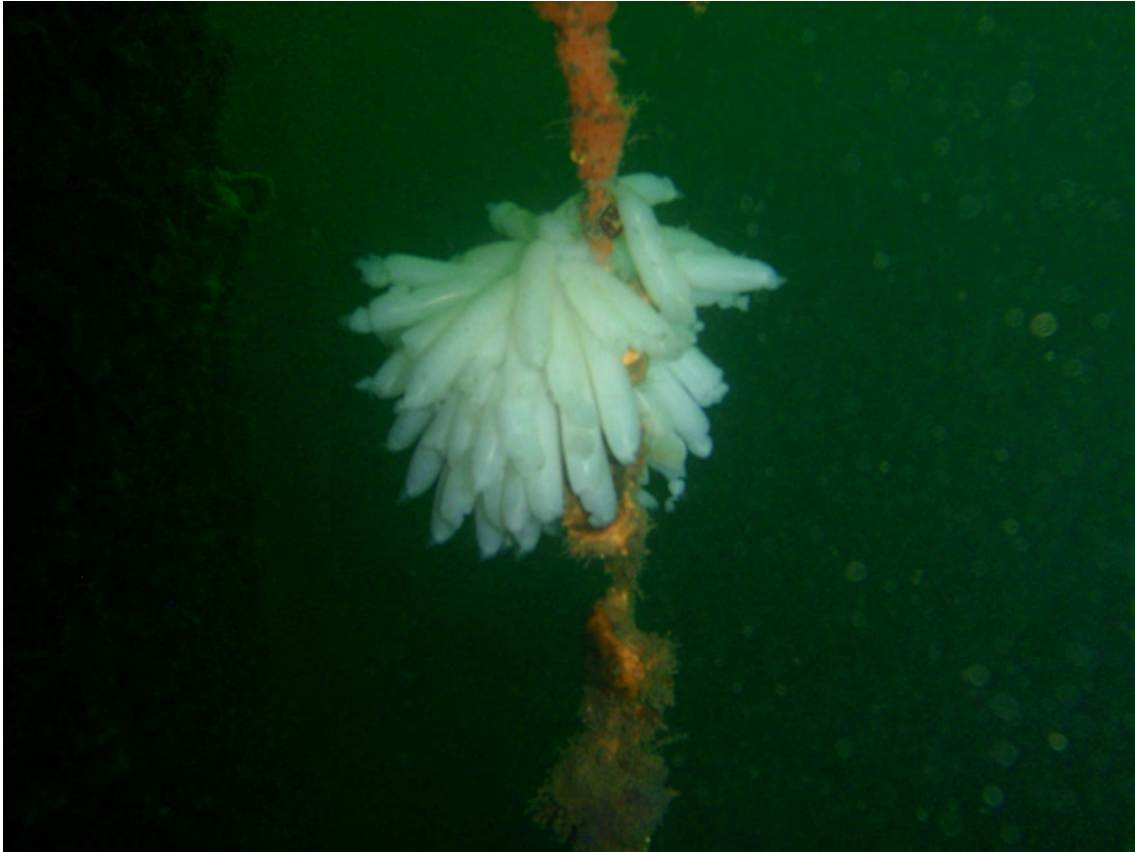
Figure 15 A broken tie rod suspended below the water surface supporting an encrusting orange sponge, a colony of *Ciona sp.* ascidians and small aborescent bryozoans.
