HISTORICAL ARCHAEOLOGICAL ASSESSMENT & RESEARCH DESIGN

Sydney Metro City & Southwest Chatswood to Sydenham

Historical Archaeological Assessment
& Research Design

FINAL_14102016

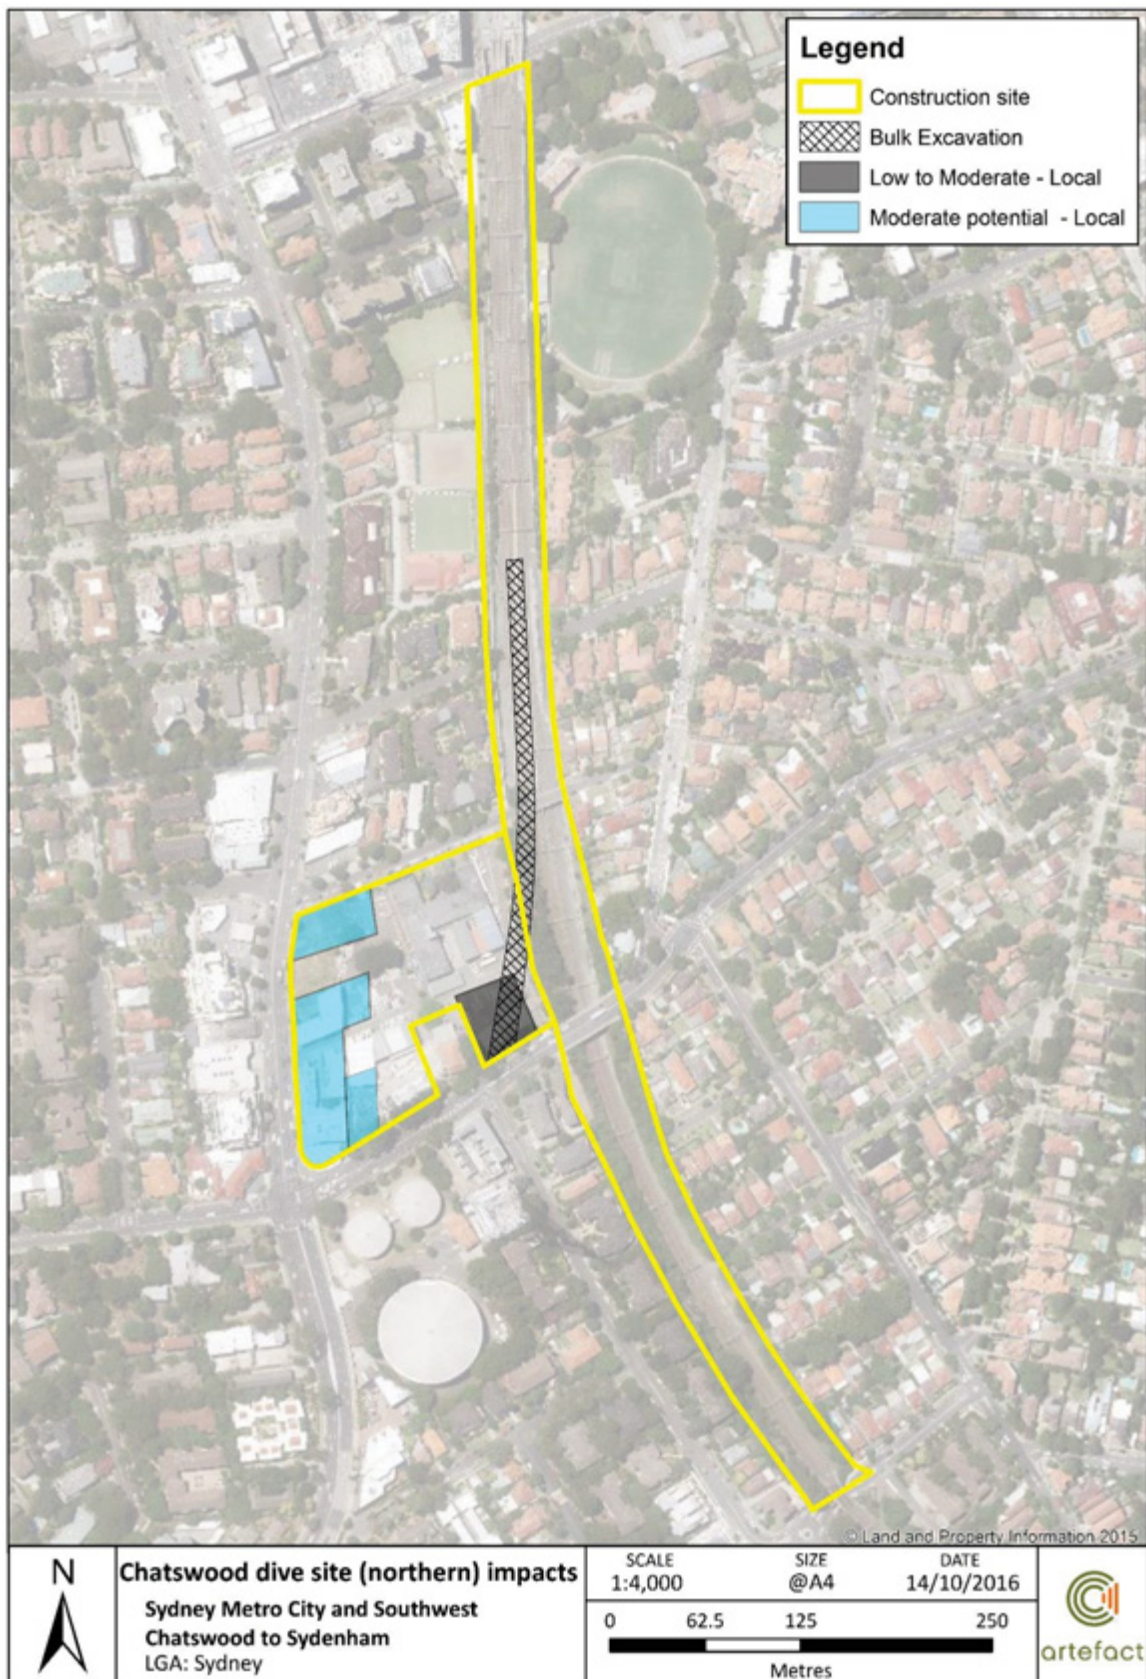
Figure 2-19: Potential archaeological impacts - Chatswood dive site

- Ground disturbance works associated with the removal of existing structures and the Nelson Street bridge
- Bulk excavation required in the construction of the dive site
- Excavation to construct the site access and egress ramp
- Localised excavation to upgrade or install in-ground services required for the establishment of the water treatment plant, site offices, staff amenities and the spoil and dive works facilities
- Foundation works for the establishment of site amenities and facilities
- Clearing and ground works would impact up to 500mm across the whole site.

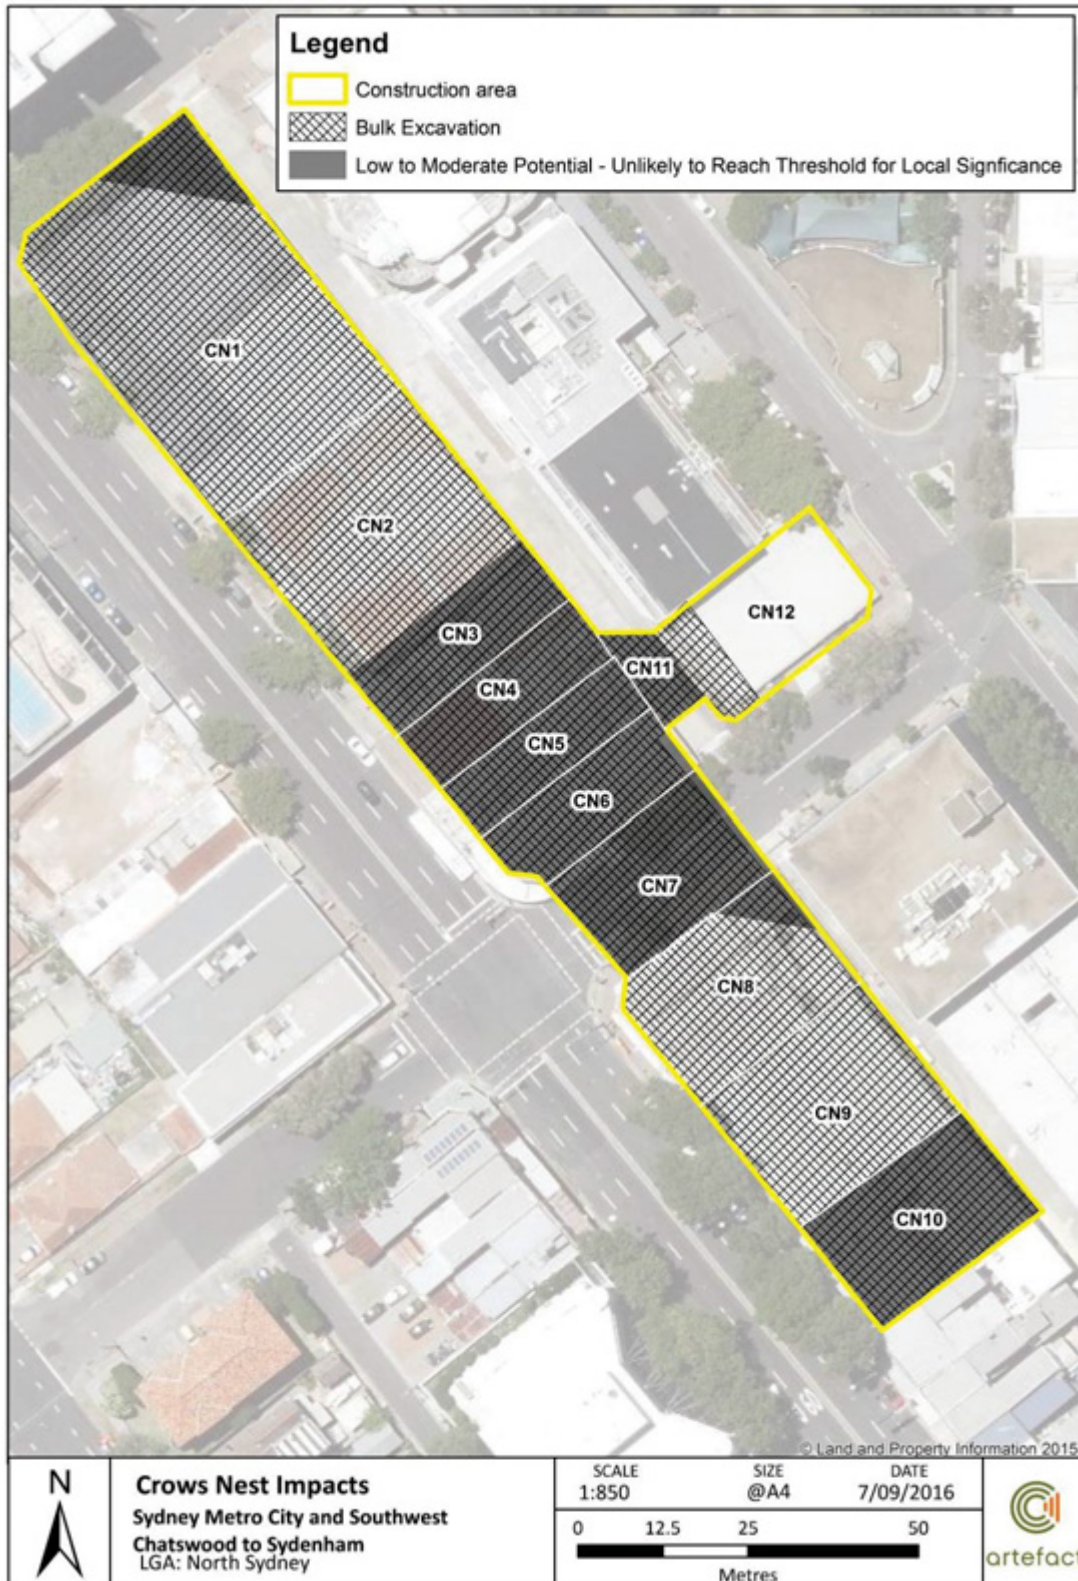
Figure 3-15: Potential archaeological impacts - Crows Nest Station site

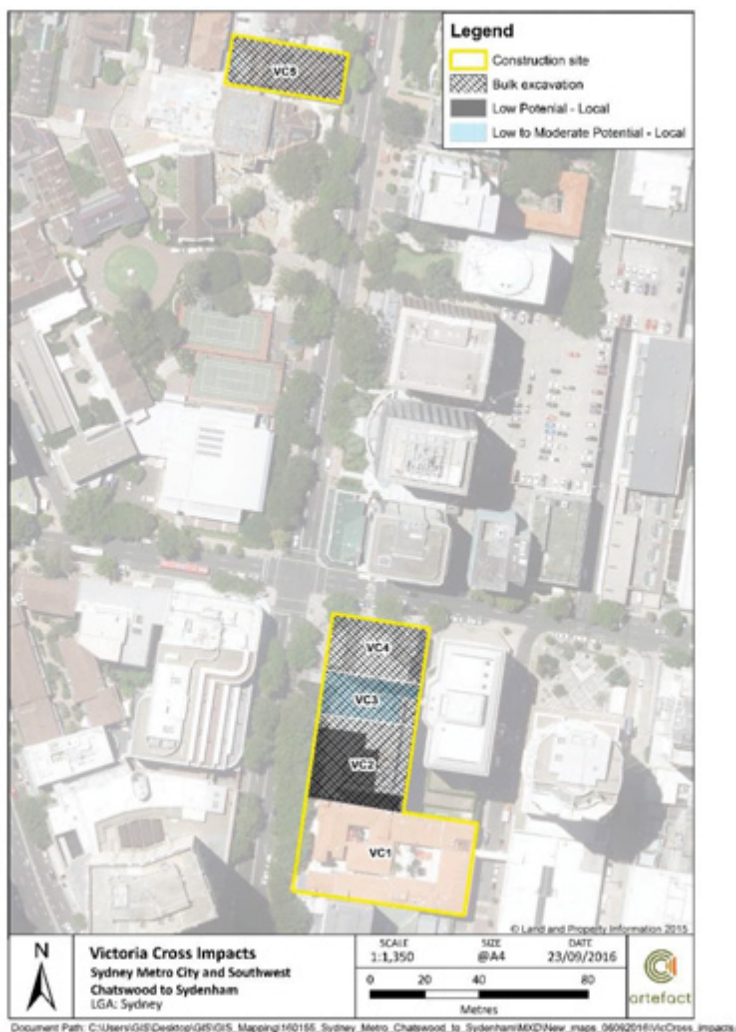
Figure 4-15: Potential archaeological impacts - Victoria Cross Station site

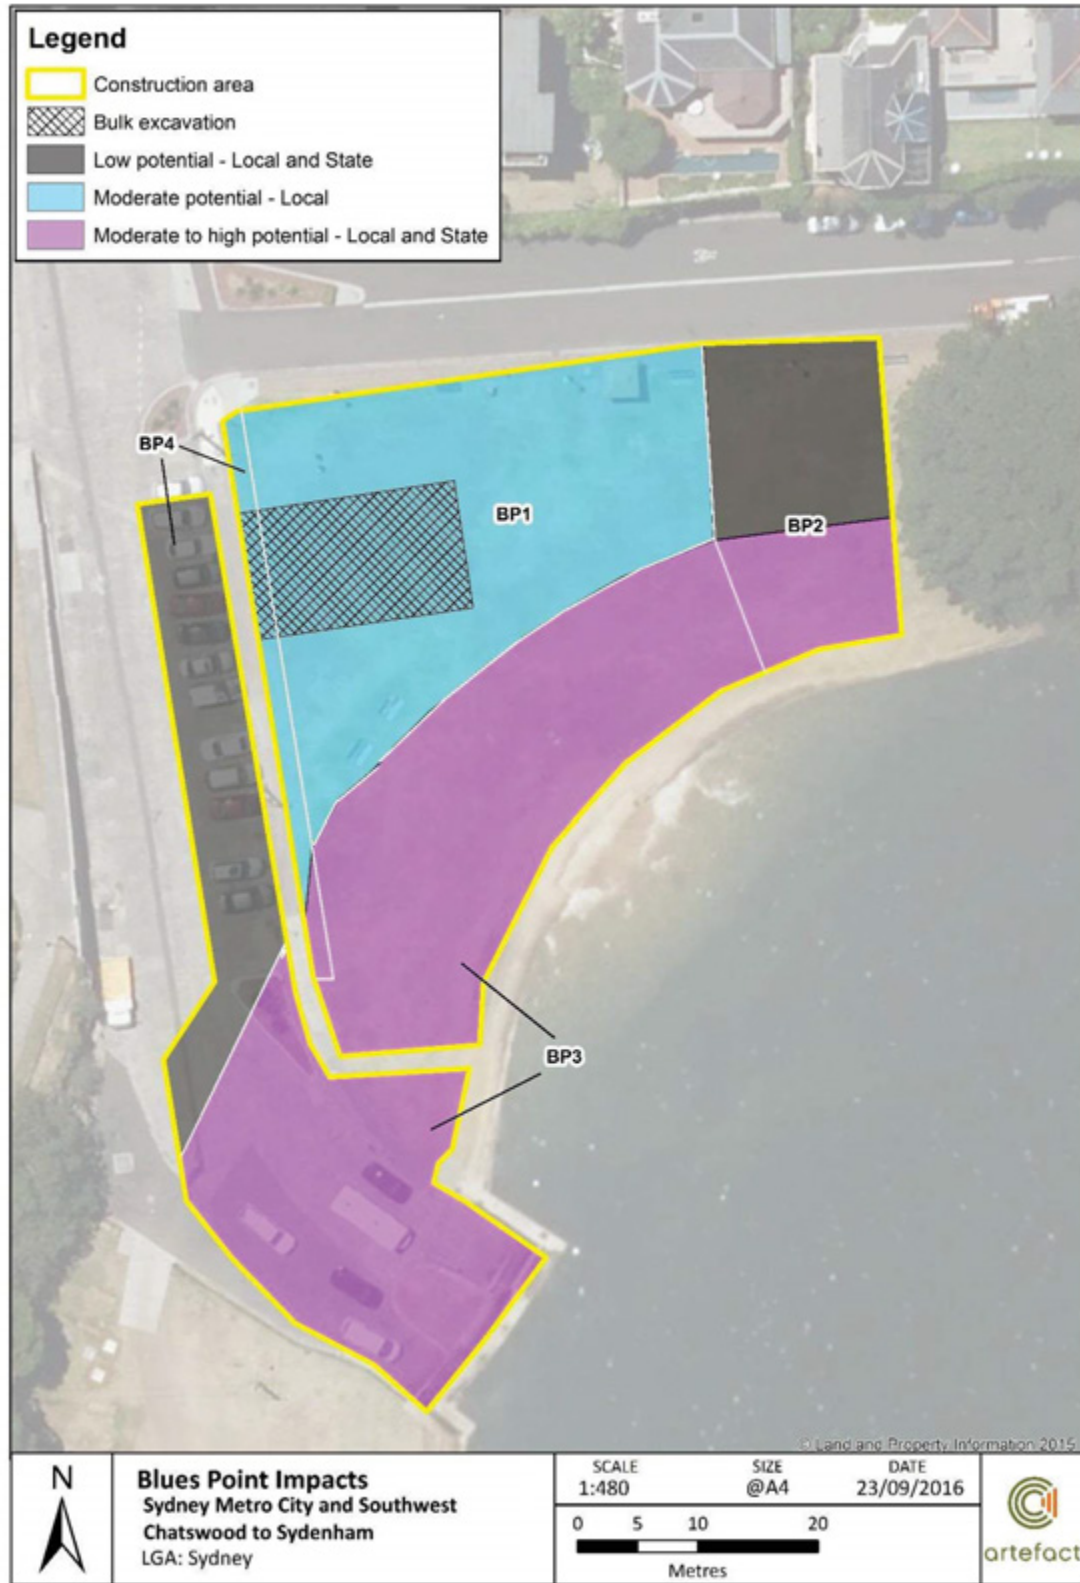
Figure 5-19 Potential archaeological impacts - Blues Point temporary site
