SYDENHAM TO BANKSTOWN

Sydney Metro City & Southwest Sydenham to Bankstown Upgrade

Historical Archaeological Assessment
& Research Design

Report to Transport for NSW

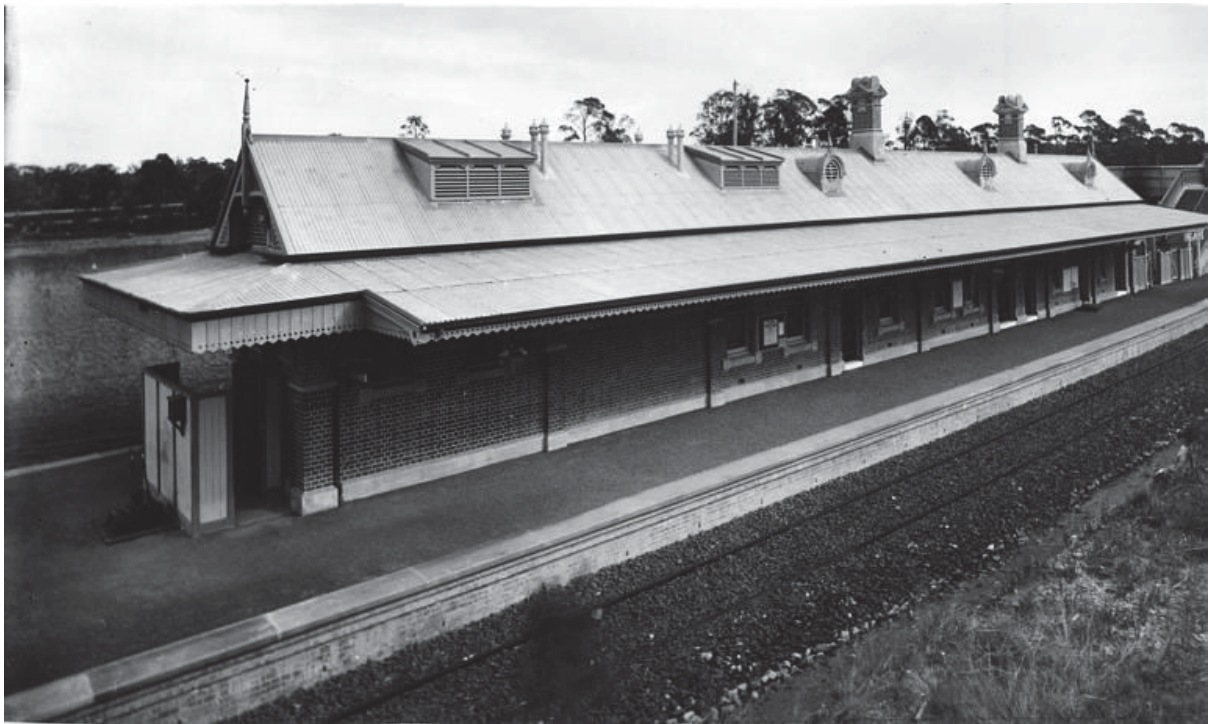
Figure 2-4 Belmore Station as constructed in 1890s. Source: OEH SHI.

The most important stations on the line from a heritage perspective, Belmore, Canterbury and Marrickville, were built with impressive near-identical brick buildings (Figure 2-4). The intermediate stations (Campsie, Dulwich Hill and Hurlstone Park) receiving more modest timber buildings, possibly due to the economic austerity required by the onset of the depression of the 1890s. These were later replaced with brick buildings. The depression also suppressed the profitability of the line and the extension to Liverpool did not proceed. However, suburban development followed in the early twentieth century, particularly during the interwar period when many War Service homes were built west of Canterbury.

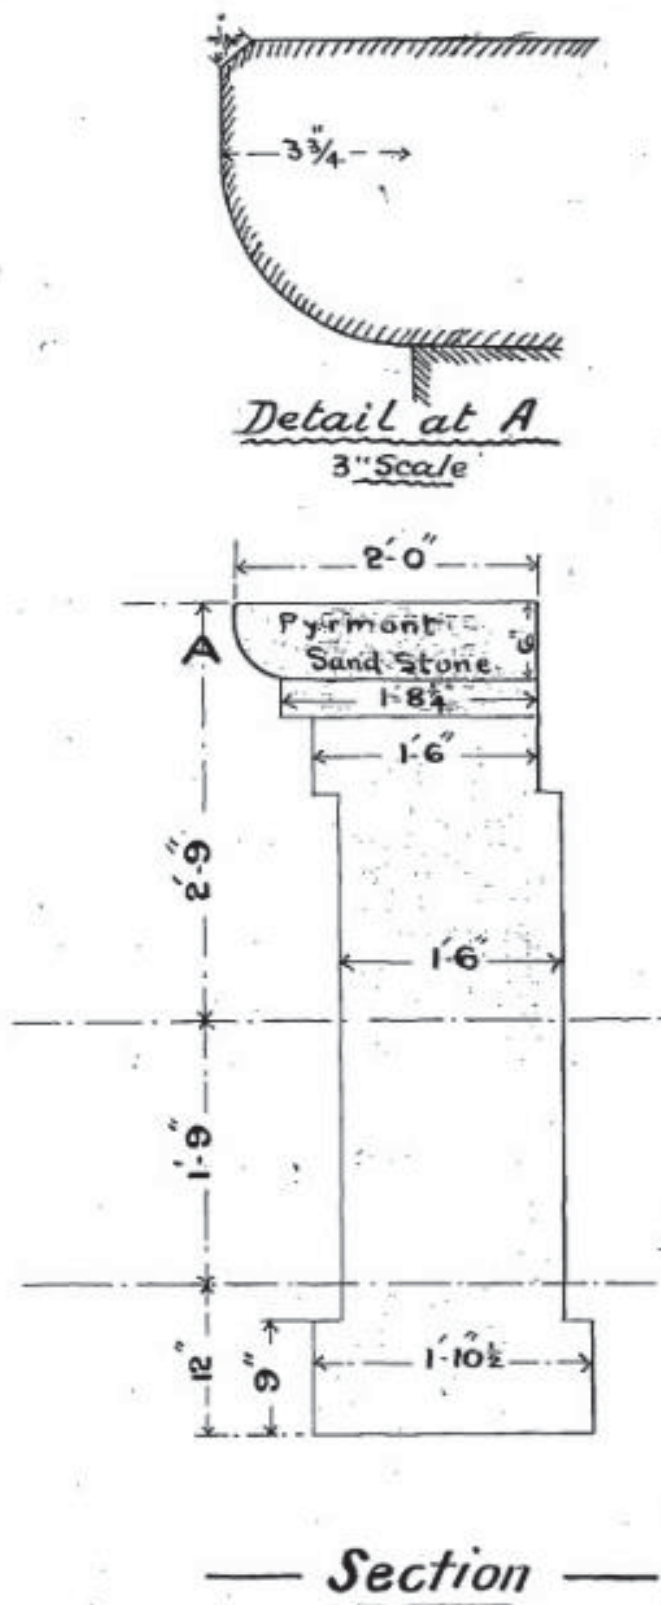
Figure 3-10: Drawing of the original stone capping for the island platform walls. Source: Sydney Trains Plan Room 0424649.

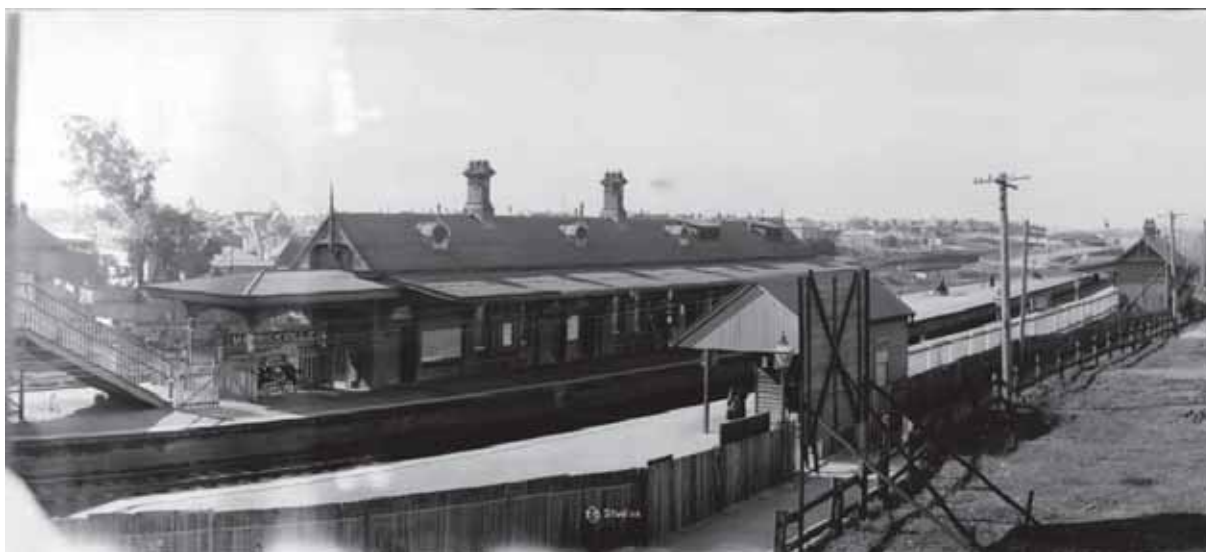
Figure 3-19: Marrickville Station in 1930s, showing original location of the booking office.
Source: Sydney Trains Plan Room.

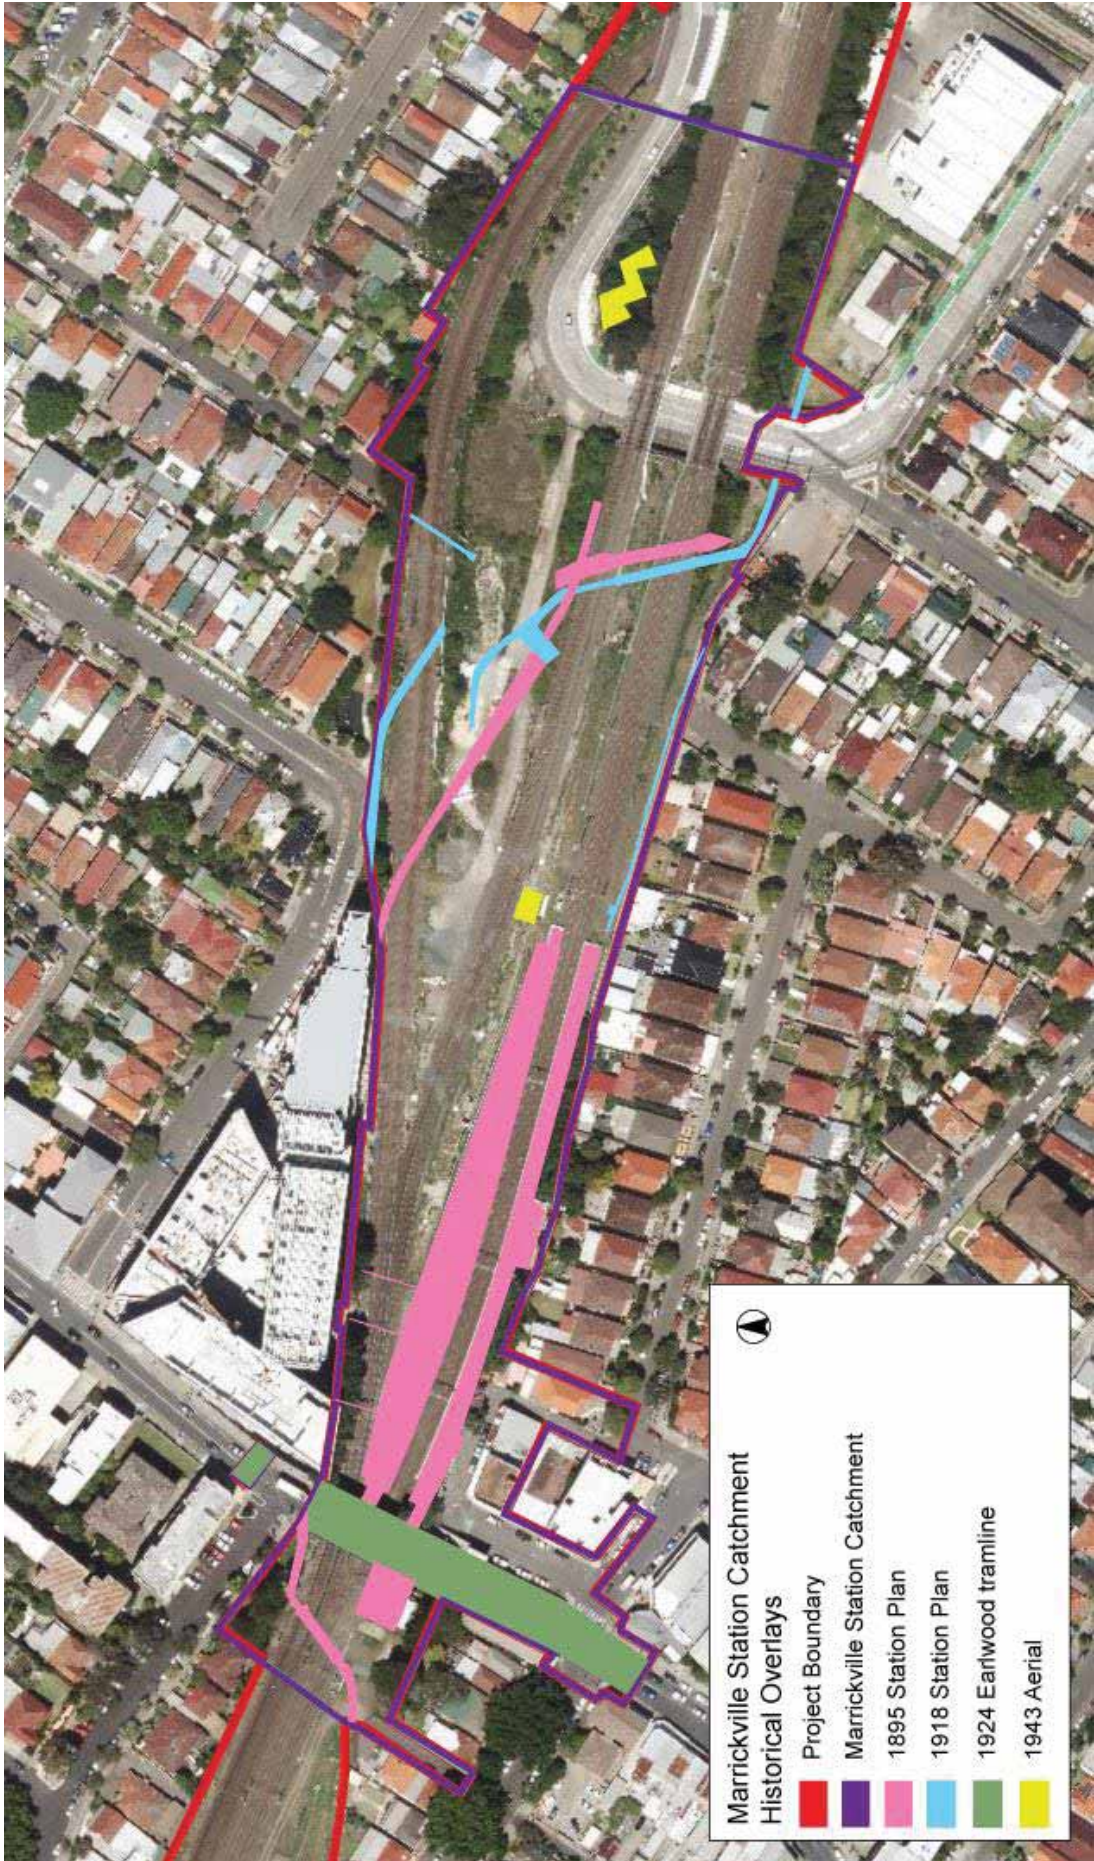
Figure 3-22: Historical overlay for Marrickville Station Catchment

The former level crossing was replaced by the current Illawarra Road overbridge in 1911. Archaeological remains of the level crossing could be present within the study area. The Earlwood Line tram line ran across the Illawarra Road overbridge in 1924, and remains of the former track could remain under the current surface of the road.

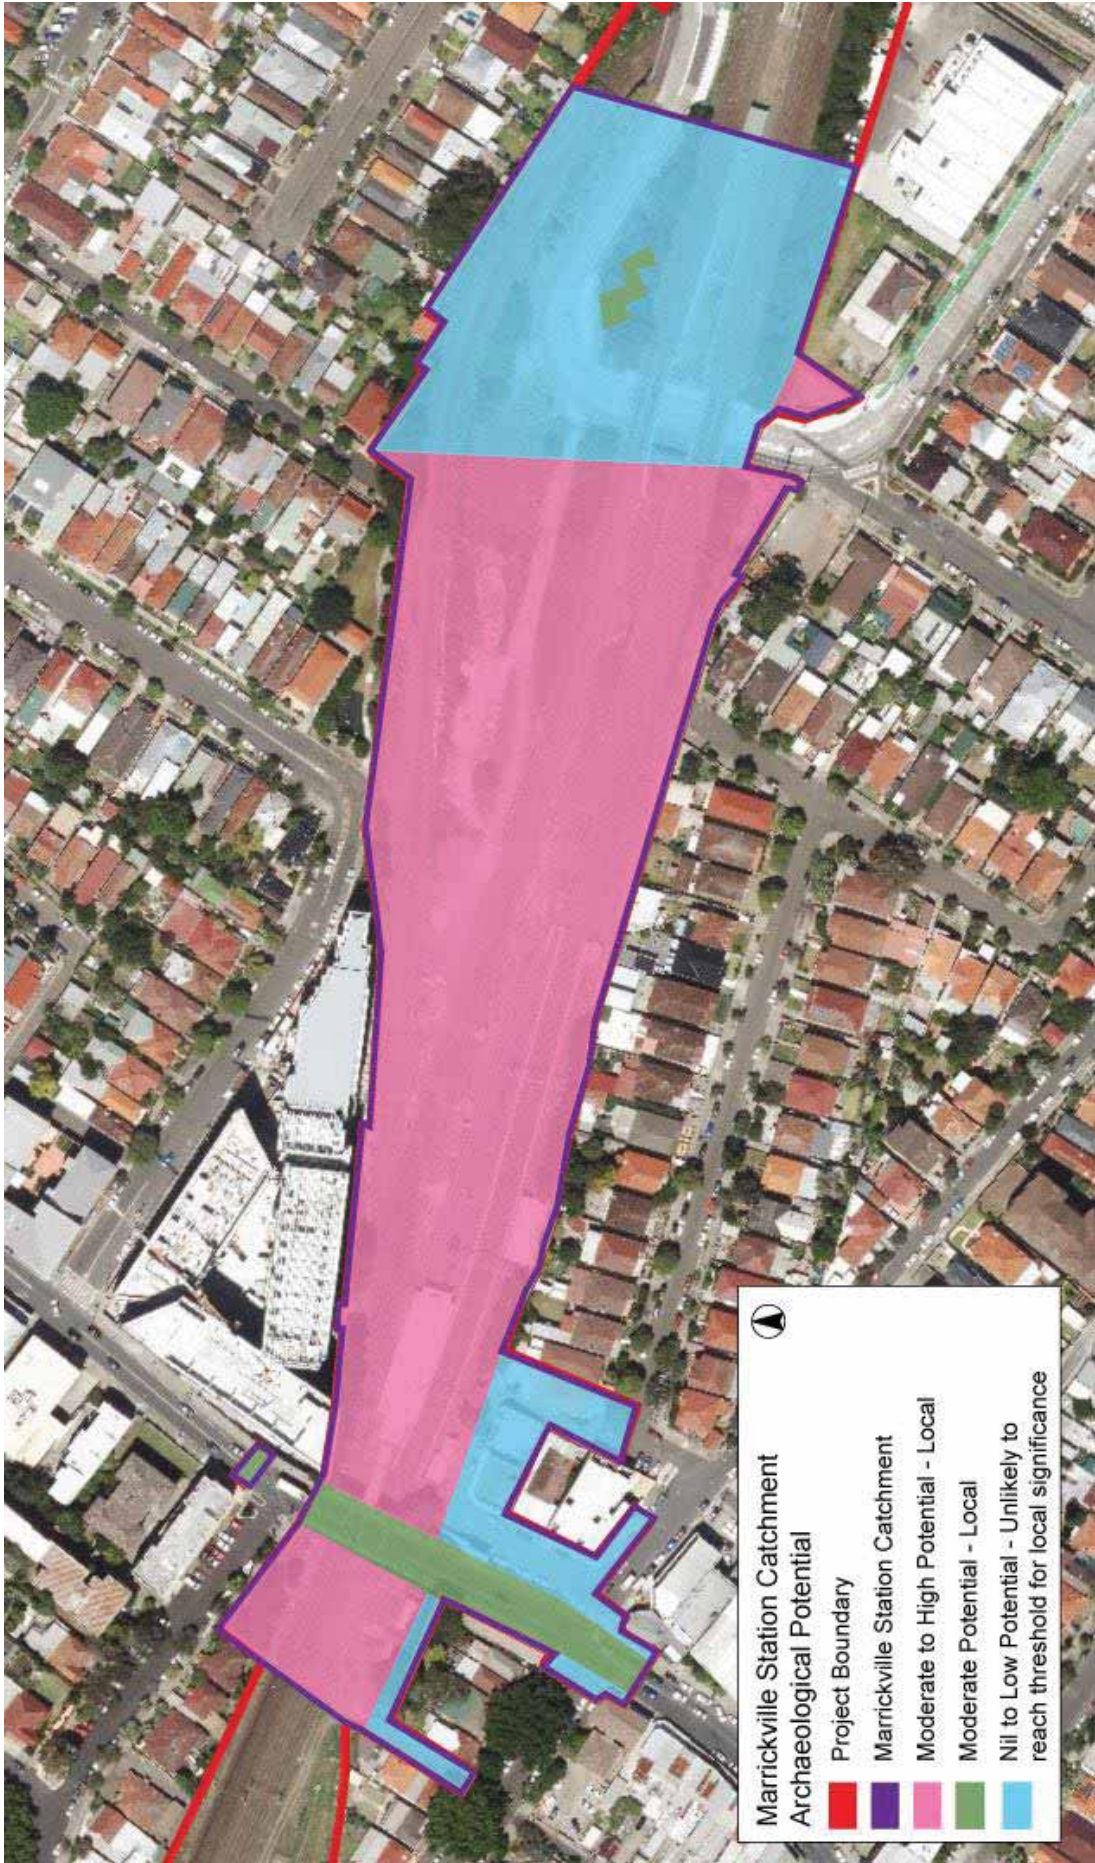
Figure 3-23: Archaeological potential for Marrickville Station Catchment

Marrickville Station Catchment has moderate to high potential for archaeological remains associated with Phase 3 that would potentially be of local significance. Construction of the station platforms, gas pipeline and CSR utility installation and trenching, the installation of drainage pipes, single grate drainage pits, gas pipelines and CSR utilities have the potential to impact on archaeological remains of this phase. The removal and replacement of the Illawarra Road overbridge has the potential to impact on archaeological remains associated with the former Illawarra Road level crossing. The construction of the noise wall along the southern boundary of the station has the potential to impact on former remains of rail infrastructure. The proposed works in the area of the WWII air raid shelter are not confirmed, although it is assumed that vegetation in the area would be removed. This would have a minor impact on potential remains of the WWII air raid shelter.

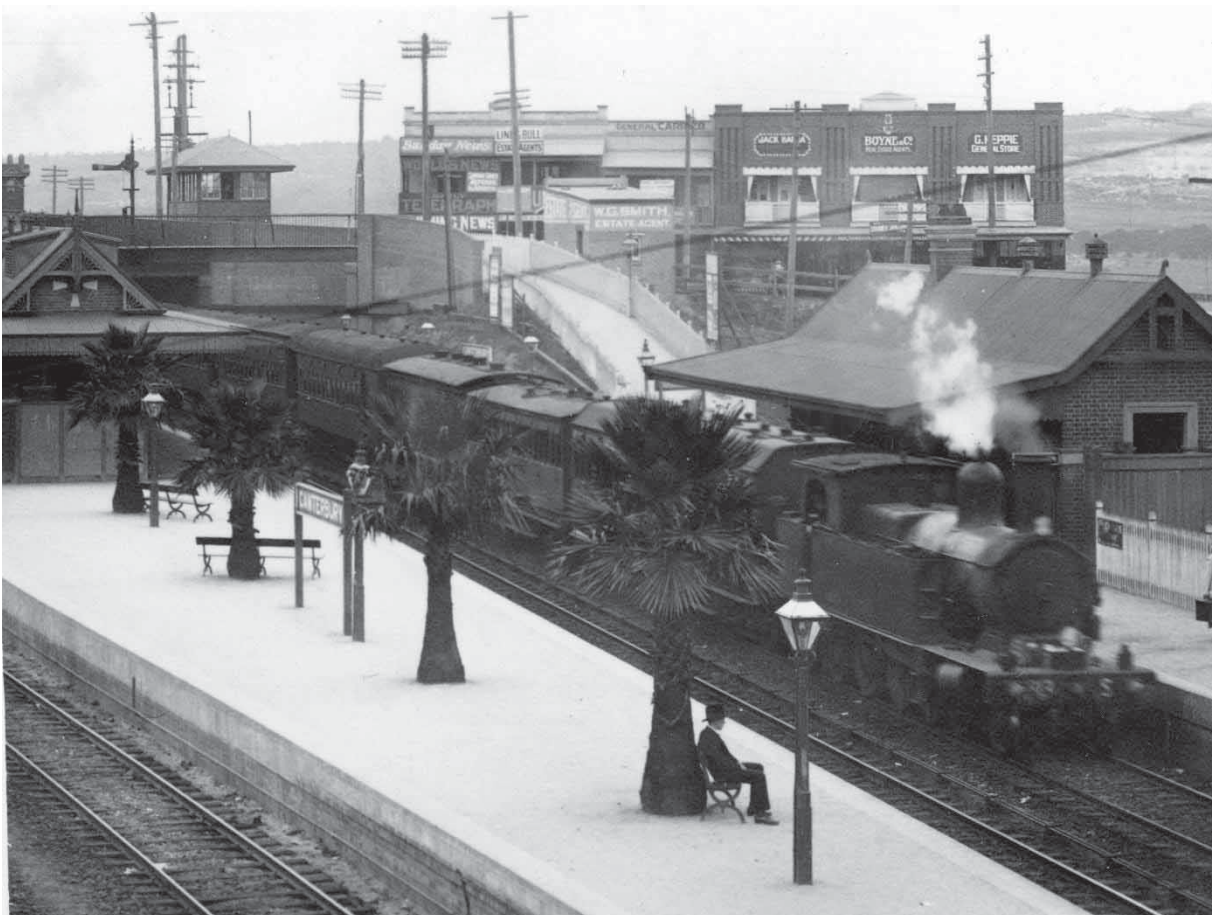
Figure 4-13: n.d. Canterbury Railway Station, showing platforms capping had been removed possibly with the realignment in 1927. Source: ARHS: 023606.

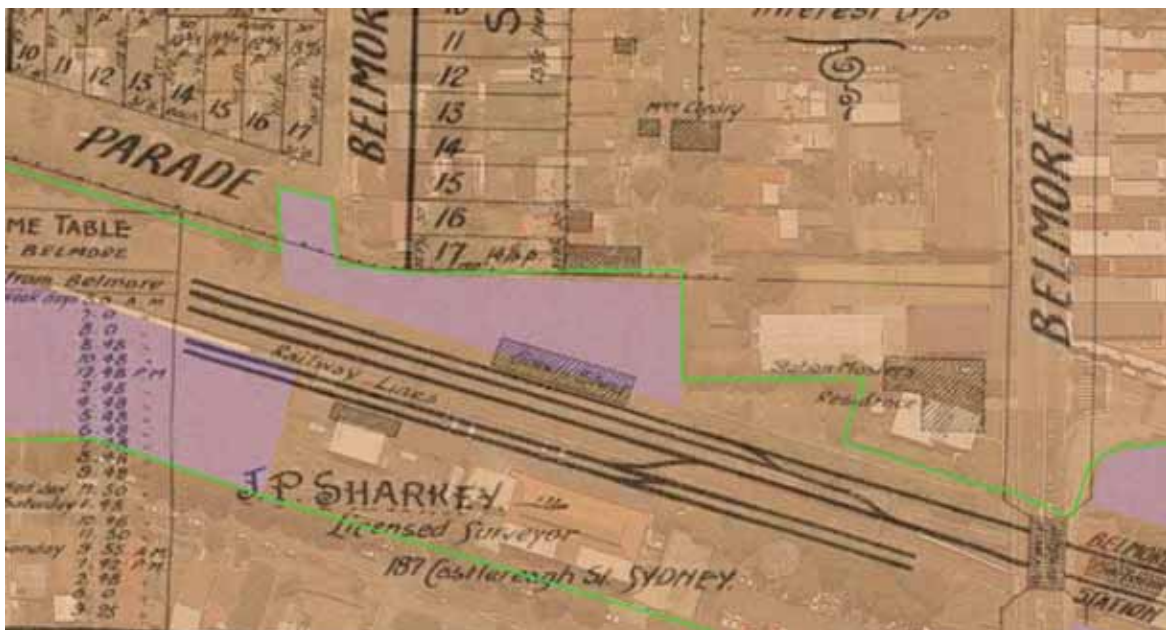
Figure 5-8: 1895 plan of the Terminus Estate subdivision, showing location of the goods shed, sidings, platform and station master's residence at Belmore Station. Compound areas are highlighted in blue. Source: SLNSW call no. Z/SP/B12.
