SYDENHAM TO BANKSTOWN

> Technical Paper 4 - Aboriginal  
heritage assessment

# Sydney Metro City & Southwest Sydenham to Bankstown Upgrade

Aboriginal Heritage Impact  
Assessment

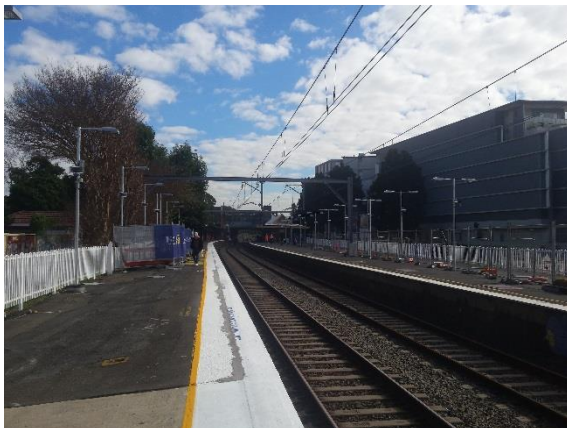
**Plate 2: Marrickville Station survey unit view east**

There was very little surface visibility outside the rail corridor due to sealed roads, pathways, structures and grass (Plate 2). Surface visibility improved within the rail corridor, however it was still fairly limited due to rail station infrastructure and ballast. Areas of improved ground surface visibility were observed within the rail corridor to the east of Marrickville Station. Exposures were noted within an area where erosion had occurred (Plate 3).

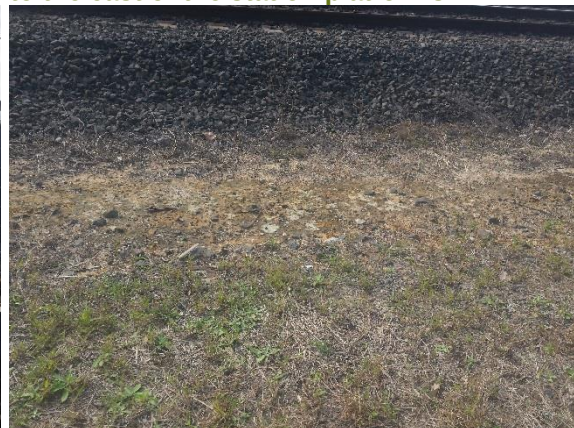
**Plate 3: Marrickville Station survey unit-small area of erosion observed within the rail corridor to the east of the station platforms**

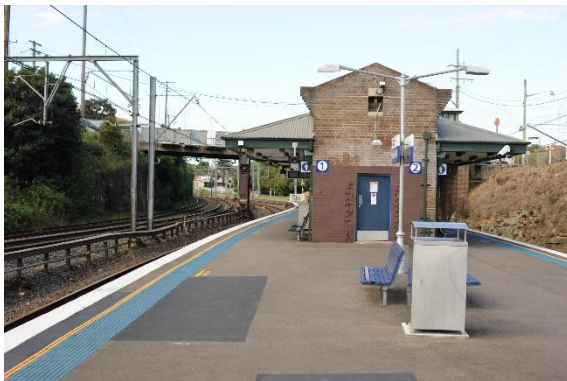
**Plate 4: View west along platform, rail corridor is located within a cut below Wardell Road**

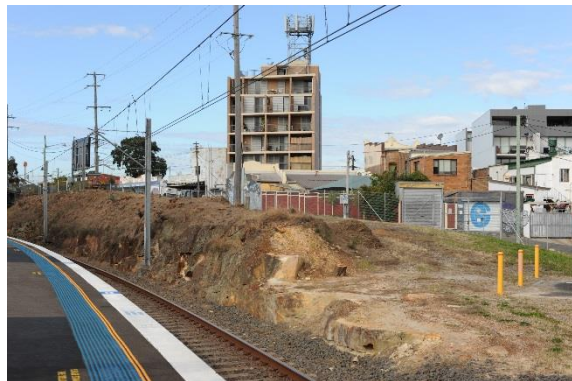
**Plate 5: Underlying Hawkesbury sandstone is visible from station concourse**

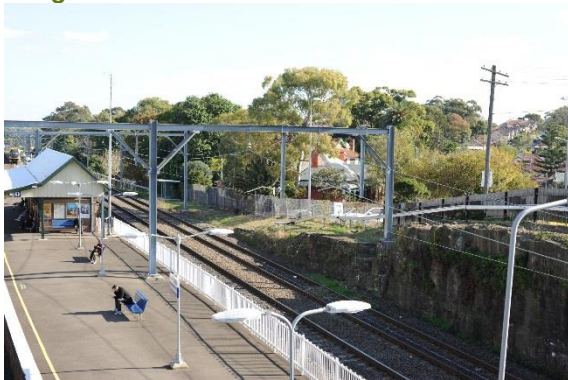
**Plate 6: View west from the upper concourse area. The original crest and slope landform can be seen on the right hand side of the image**

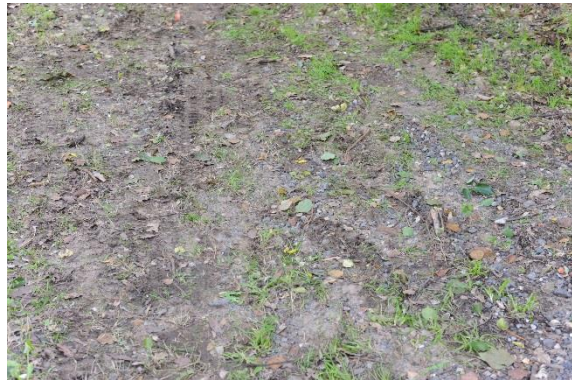
**Plate 7: Exposures down track of Hurlstone Park within the rail corridor. Introduced fill was evident within exposures**

Visibility was generally limited throughout the survey unit. Outside of the rail corridor visibility was impeded by sealed roads, pathways, carparks and structures. Inside the rail corridor visibility was impeded by structures, sealed surfaces, rail ballast and vegetation. Some exposures did occur within areas of erosion within the corridor, where introduced fill was observed and no Aboriginal objects were identified.

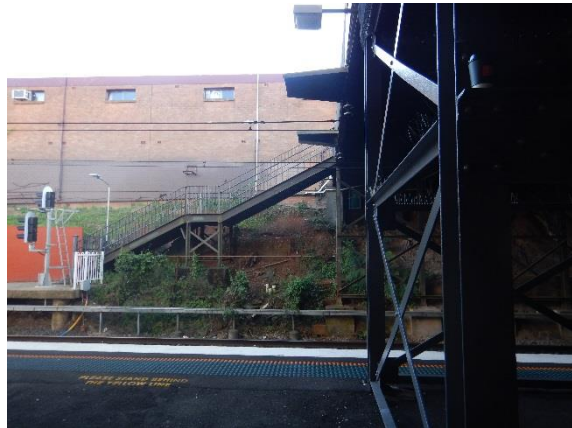
**Plate 11: Campsie Station is located within a cut below street level**

Visibility was low throughout the survey unit due to the built up nature of the area. Visibility was impeded by sealed surfaces, structures and vegetation. Some surface visibility within the rail corridor was observed across the proposed compound area (Plate 10). Introduced gravels were evident across the ground surface. No Aboriginal objects were identified. As with the majority of stations in the study area, the Campsie Station is located within a cut below street level (Plate 11).

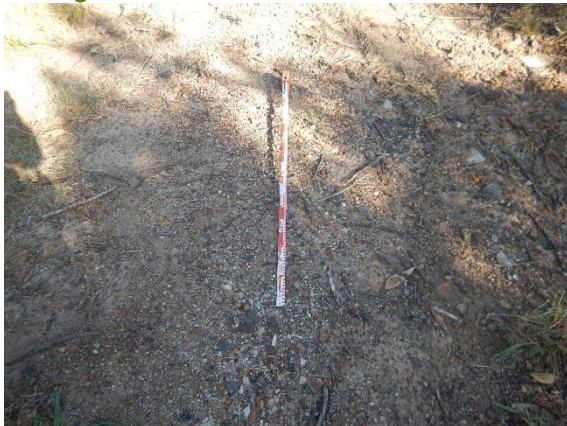
**Plate 12: Exposures were rare within the survey unit and no Aboriginal objects were identified. Introduced fill was evident throughout**

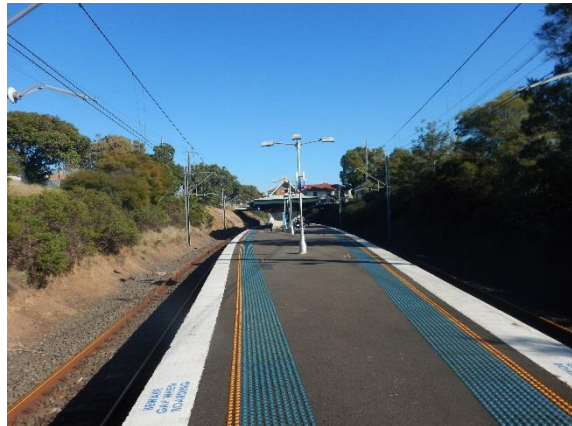
**Plate 13: Belmore station view west along platforms 1 and 2. This photo shows the cutting and Burwood Avenue overbridge in the distance**

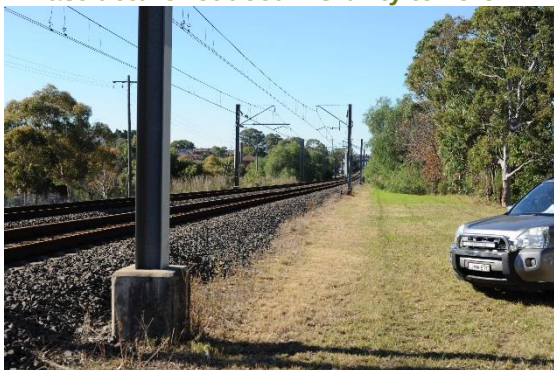
**Plate 18: View east along proposed construction compound adjacent to Wiley Park. Dense vegetation and rail infrastructure reduced visibility to zero**

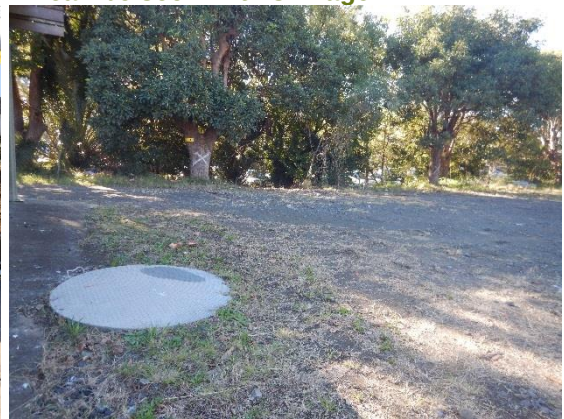
**Plate 20: View across portion of proposed construction compound (north of Punchbowl Station). A drain and introduced fill can be seen in this image**

The station platforms and rail are located within a shallow cut below street level (Plate 19). The construction compound to the north of Punchbowl Station was found to have been heavily disturbed. Large quantities of fill were evident across the site and it appears that the area is currently used as a construction compound during rail possessions (Plate 20).

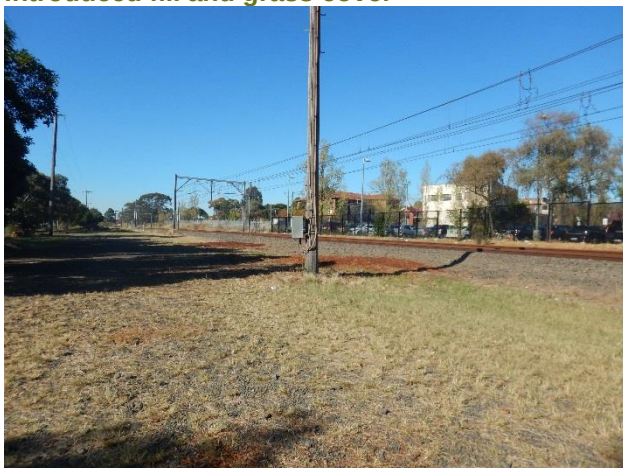
**Plate 21: View east across proposed construction compound (north of Punchbowl Station). Visibility is low across area due to introduced fill and grass cover**

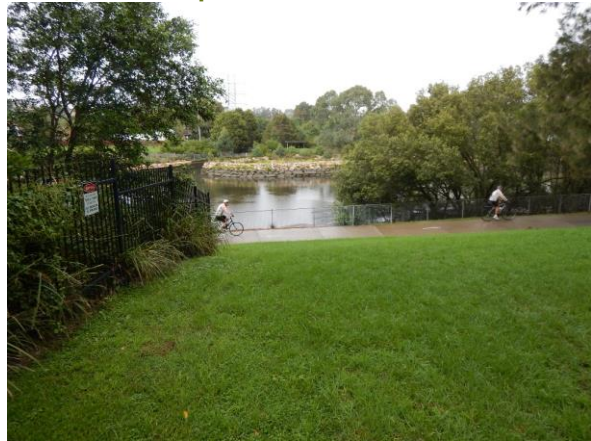
**Plate 29: View of artificial ground and the concrete abutment at foreshore of the Cooks River, south aspect**

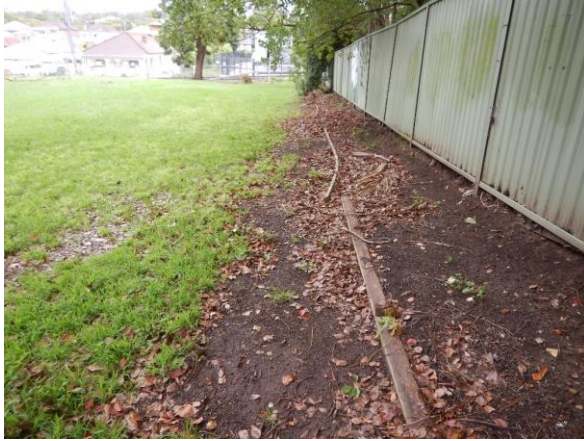
**Plate 30: Introduced topsoil at northern edge of survey unit, west aspect**

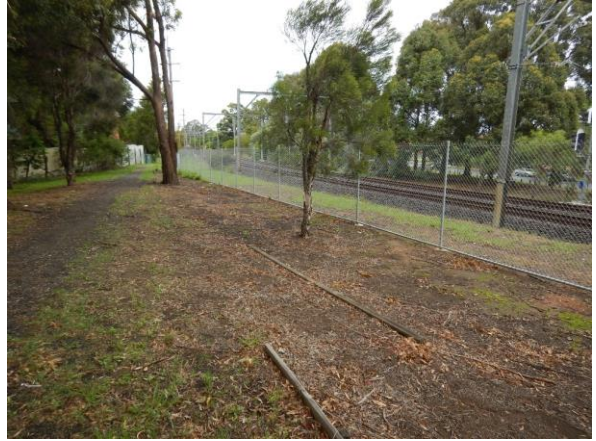
**Plate 31: View of introduced soil and exposed underlying clay, south aspect**

The ground in this section of survey unit has been heavily eroded and redressed with imported soils. Clay exposures reveal the original shallow depth of the original topsoil in the area. As such, the original topsoil has been almost entirely removed from the study area.
